# Joint Services Wiring Action Group

Primary Support Clamp

Deformation

Date: 01 JUL 24

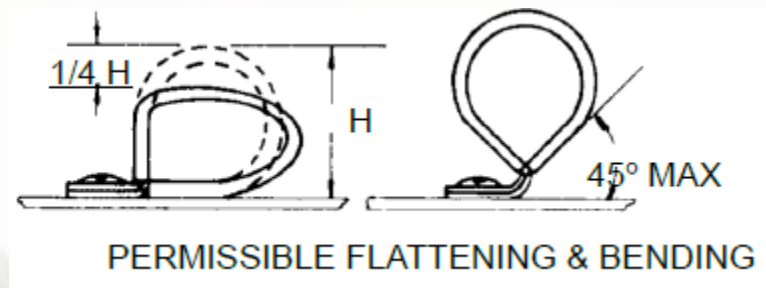
- An Aircraft manufacturers process specifications allows artisans to flatten, deform and/or bend clamps up to 45° angle.
  - Covers various aircraft in military service.
  - Round cable clamps may be flattened by a maximum of  $\frac{1}{4}$  the overall height (H) of the clamp diameter to clear structural interferences. See Figure 8.
  - Cable clamps may be flattened to a maximum of  $\frac{1}{4}$  H to clear structural interferences.
  - Cable clamps may be bent to a maximum of 45 degrees to clear structural interferences.
  - Deformation of clamps after installation is normal and is not cause for rejection, provided:
    - (1) Approximately 50 percent of the ends of the cushion are in contact; or
    - (2) The cushion ribs are intermeshed to provide a barrier; and
    - (3) The wire(s) in the installed condition do not contact the metal band.

Based on NAVAIR vibration testing in 2013 and the clamp manufacturers response to bending/ flattening, it is recommended that a caution statement prohibiting the bending/ flattening of clamps be added to the NAVAIR 01-1A-505-1 / TO 1-1A-14 / TM 1-1500-323-24-1

Bending / flattening of clamps are prohibited as it may lead to premature failure.
