# C5 Horizontal Stabilizer EWIS Analysis, AWT Testing, and Physical Audit

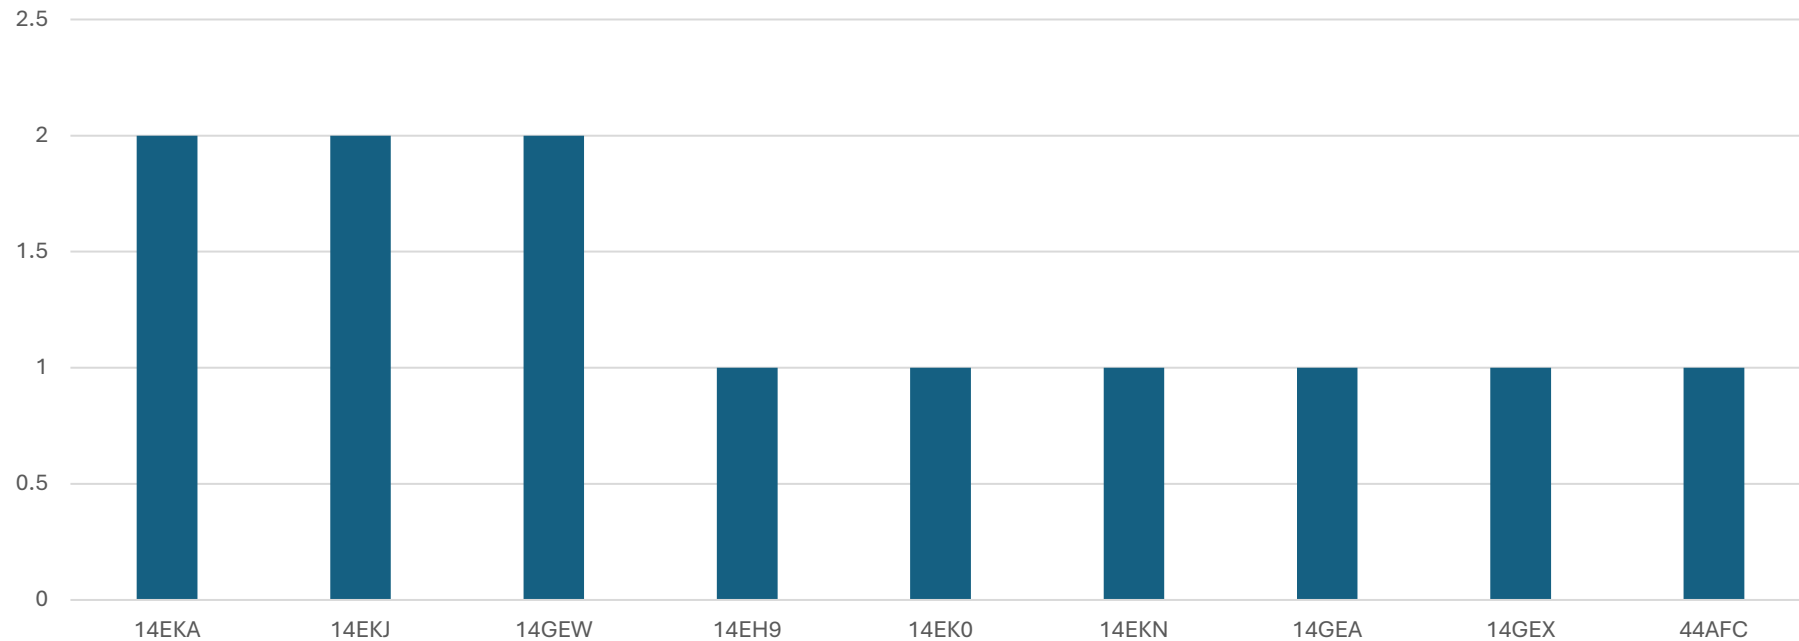
C5 Pitch Axis and HS CNDs by TO 00-20-02  
2017-2025

- Gathered using TO 00-20-2 guidance for CND's:
- Action Taken H
- How Mal Codes: 672, 799, 812, 948
- Total Man Hours: 72.8

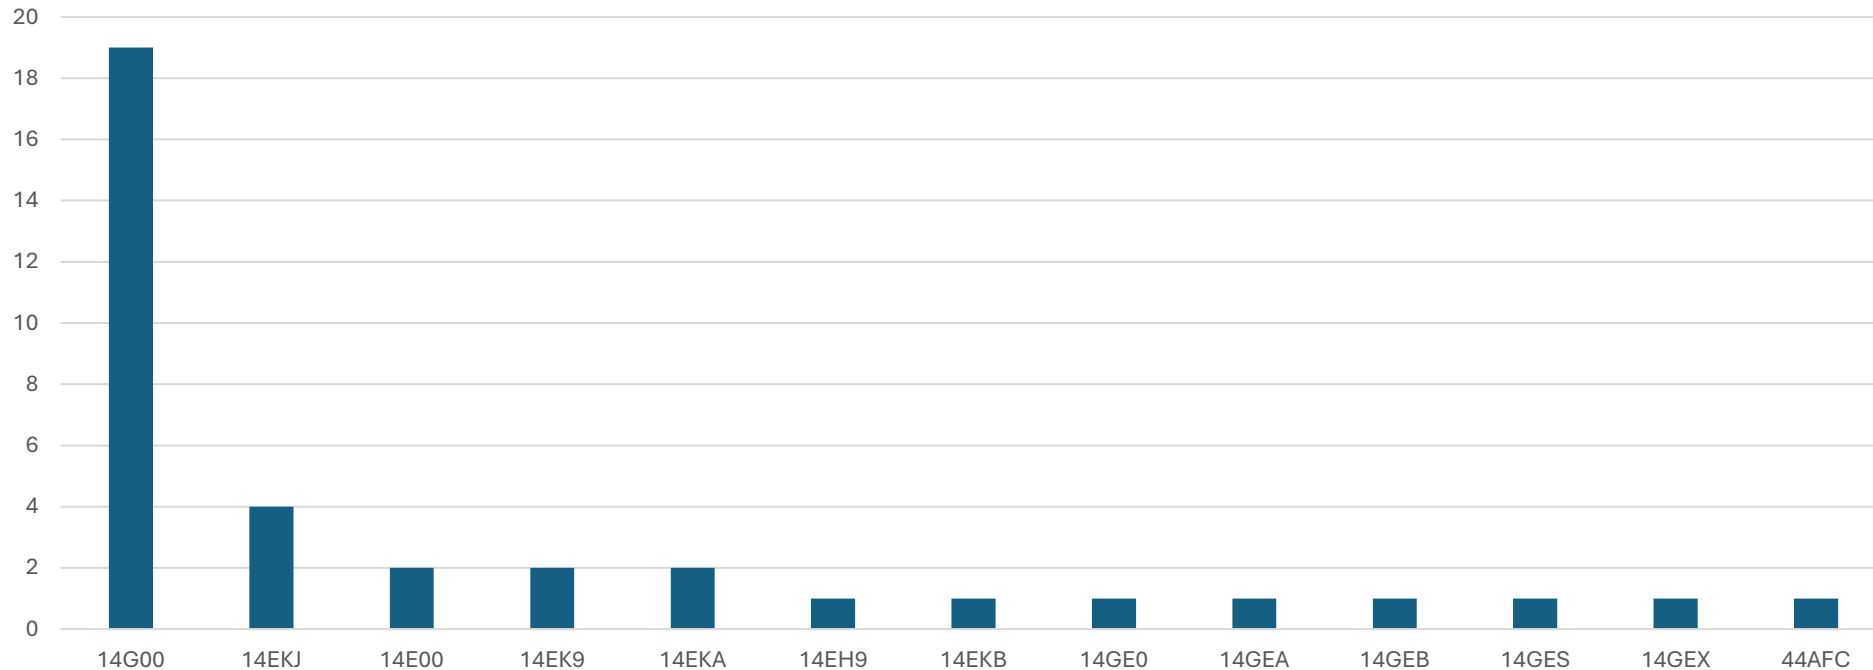
C5 Pitch Axis and Pitch Trim CND Search  
2017-2025

- Searching Corrective Actions for “CND uncovers additional write-ups
- Most of these write-ups are excluded by To 00-20-2, recorded under Action Taken X
- Total Maintenance Man Hours: 303
