# C5 Stability Augmentation Subsystem Reliability Analysis, AWTs Testing, and Physical Audit

Joseph Ronca  
SR Database Engineer | WSIRD Team Lead  
Kihomac INC  
[Joseph.ronca.ctr@us.af.mil](mailto:Joseph.ronca.ctr@us.af.mil)  
[Joseph.ronca@kihomac.com](mailto:Joseph.ronca@kihomac.com)

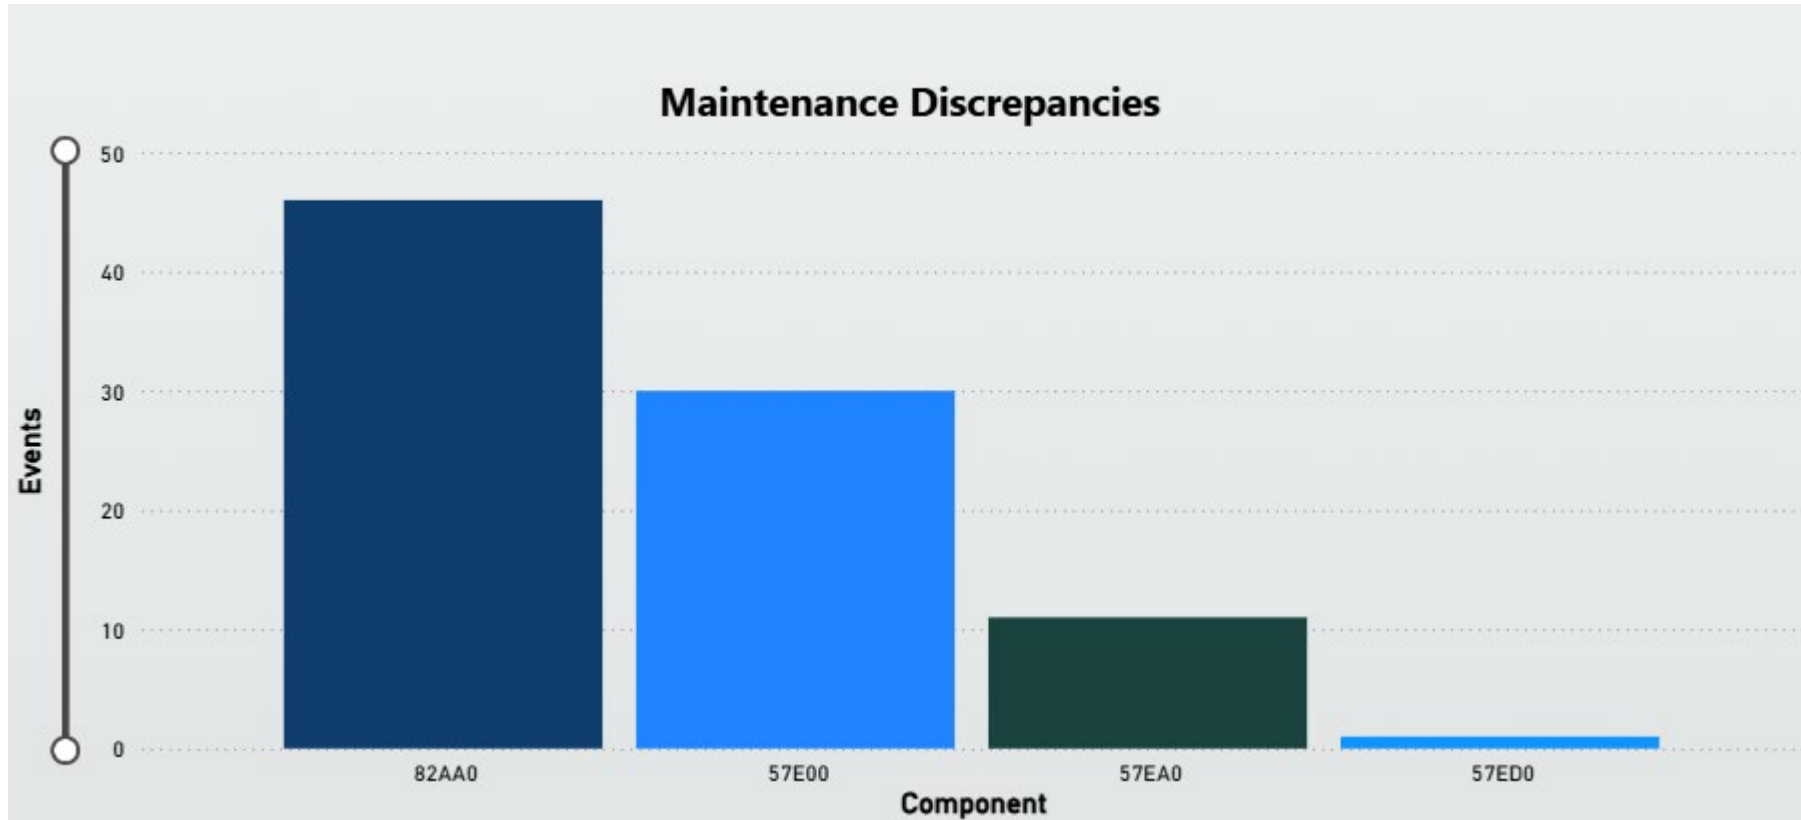
# TO Defined Cannot Duplicate Events

276 Maintenance Man Hours (MMH) and 458 NMC Hours aligned to CND events across fleet

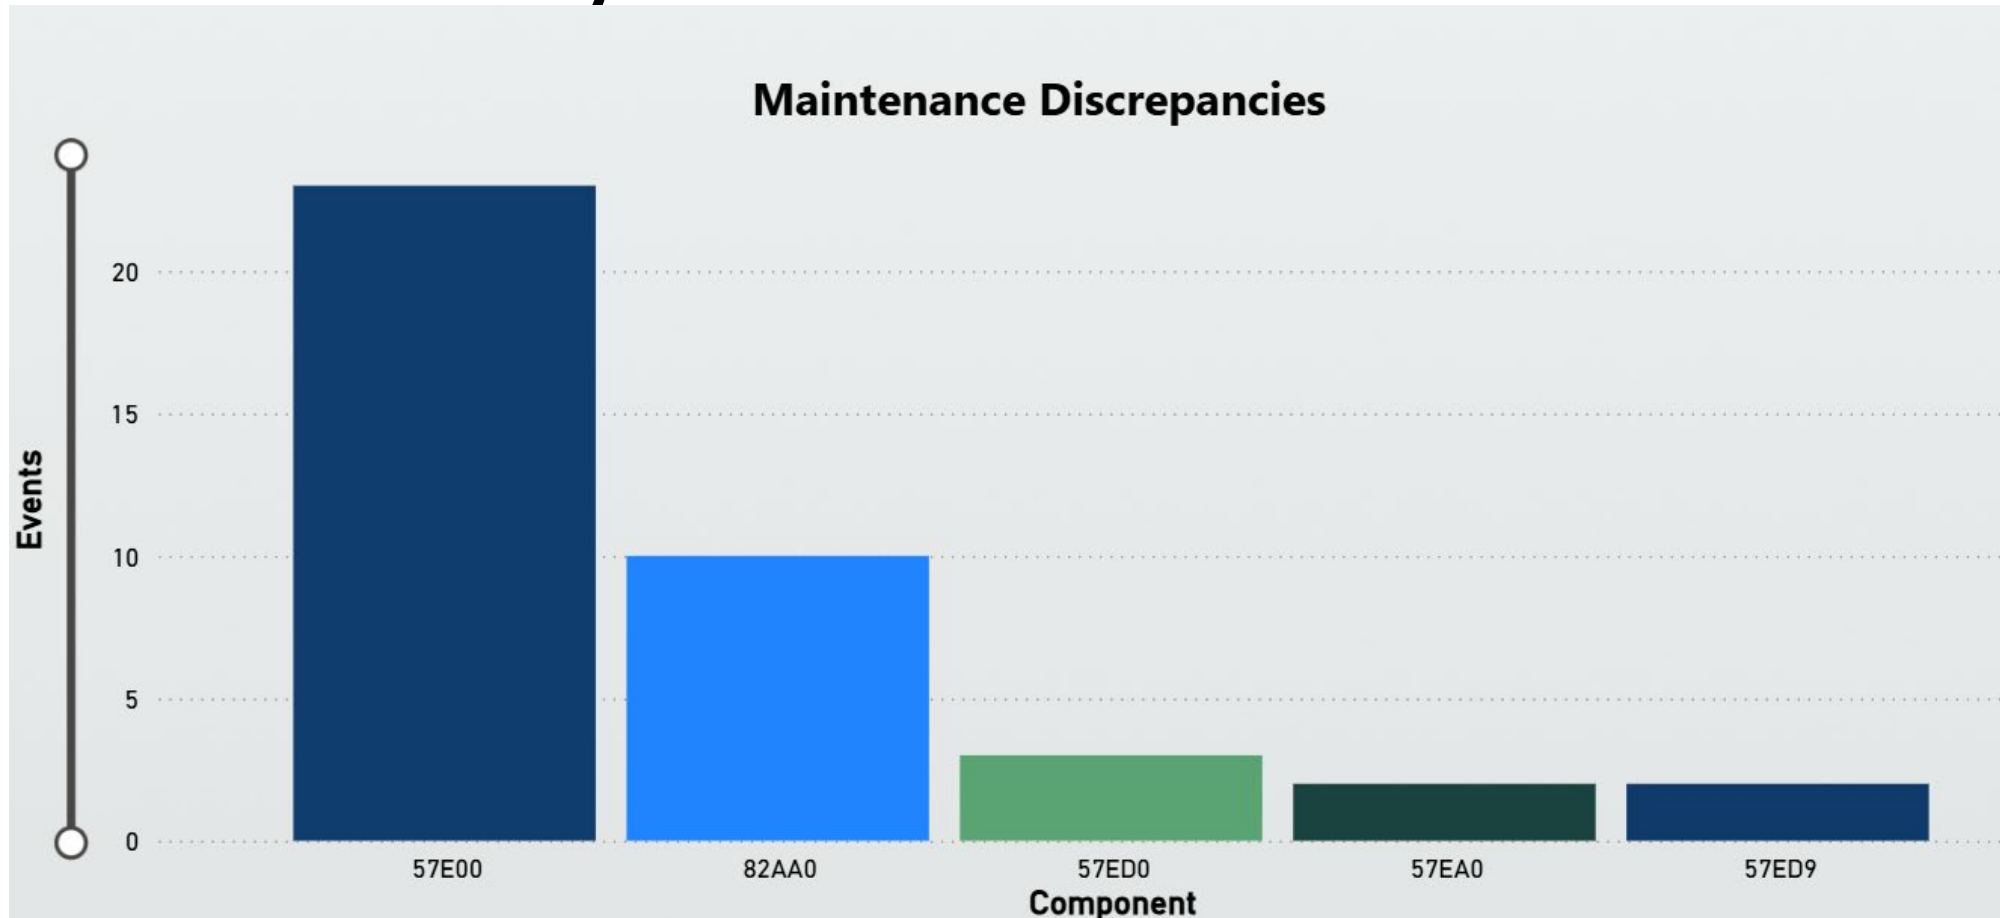
# Cannot Duplicate Events by Corrective Action Analysis

40 additional write ups under Action Taken J & X include “CND” in Corrective Action or Discrepancy  
These write ups account for 229 MMH’s and 48 NMC Hours

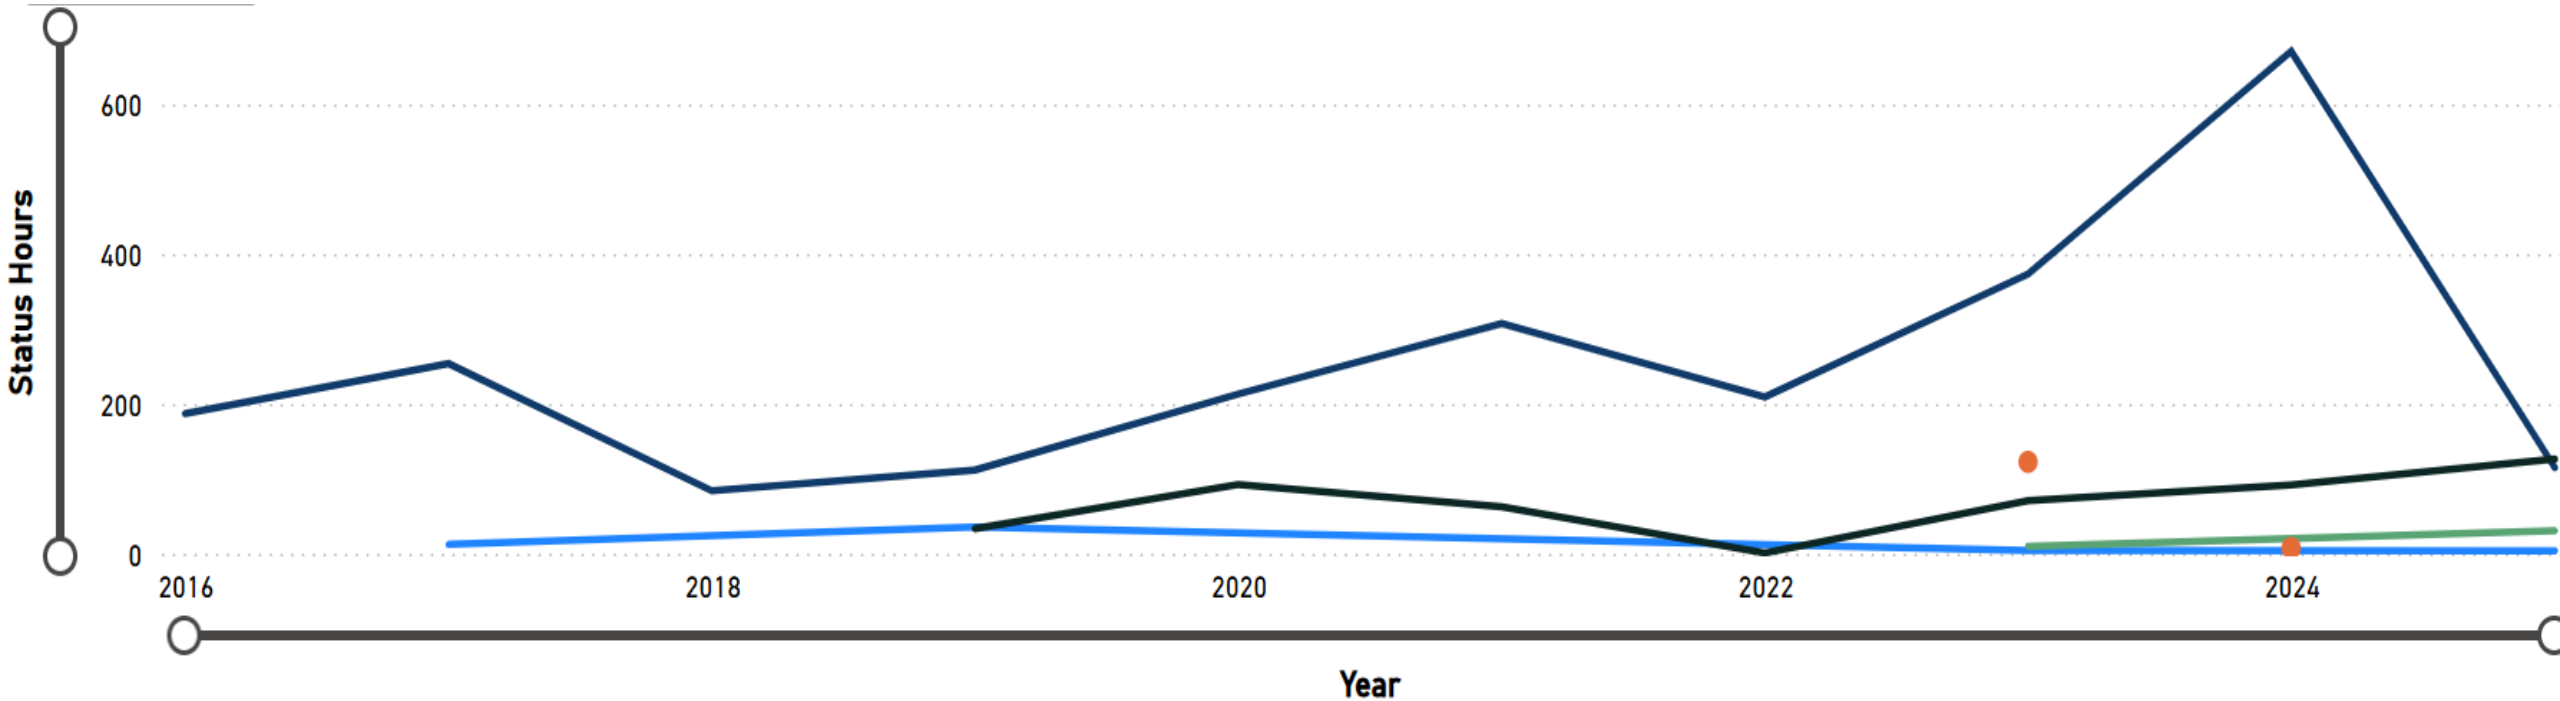
# NMC Trend 82AA0

Unscheduled, Non-mission Capable Maintenance hours trended up from 2016 – 2024

2,535 NMCMU Hours, \$23,420,129 in NMC “Cost”

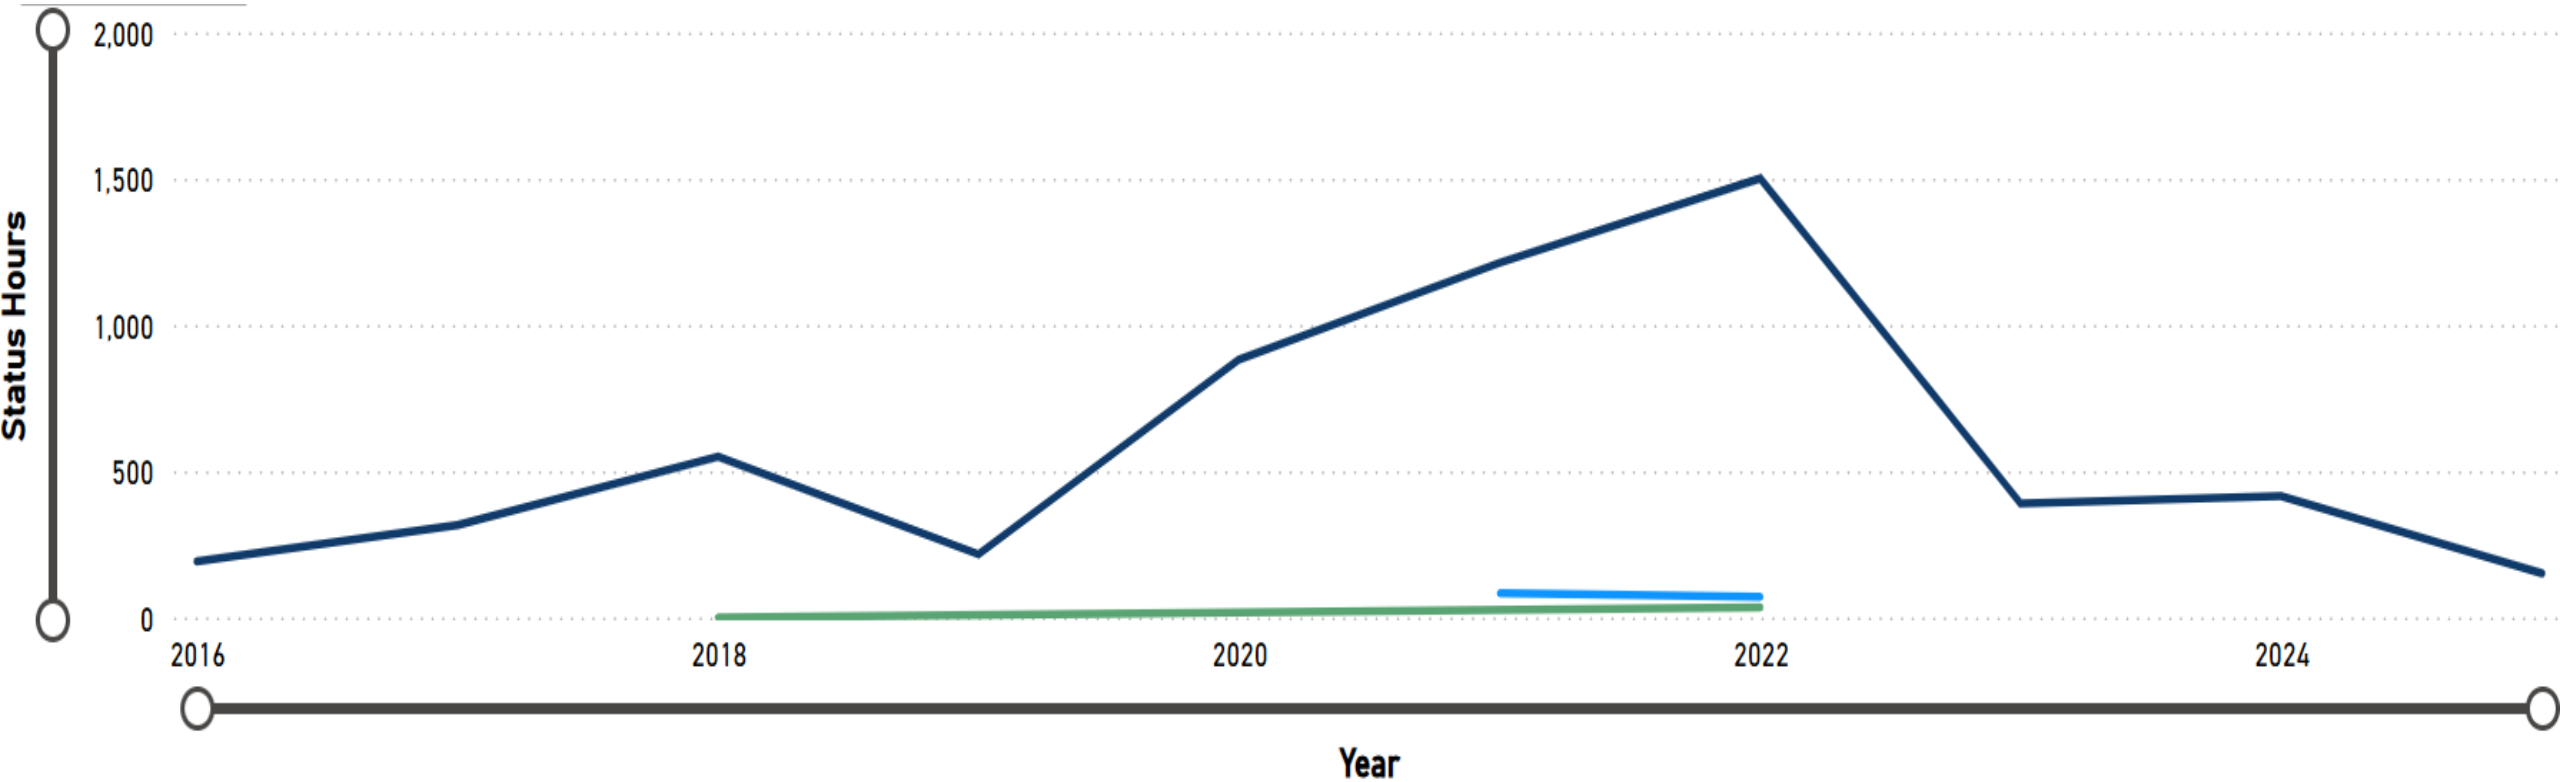
# NMC Trend

Unscheduled, Non-mission Capable Maintenance hours trended up from 2016 – 2022

5,981 NMCMU Hours, \$55,275,446 in NMC “Cost”
