RE: Northern Avenue Bridge Superstructure Removal Project
City of Boston, Suffolk County
Submittal of Project Notification Form

Project Notification Form

Northern Avenue Bridge Superstructure Removal Project

Northern Avenue Bridge
Over
Fort Point Channel

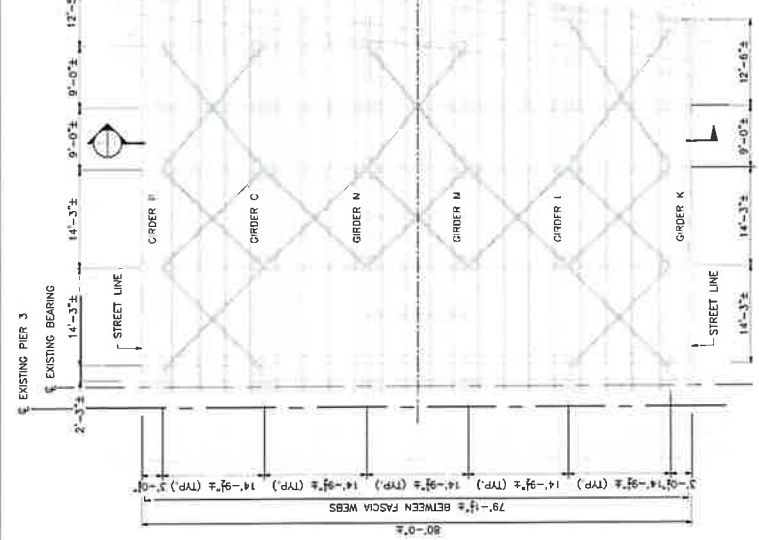
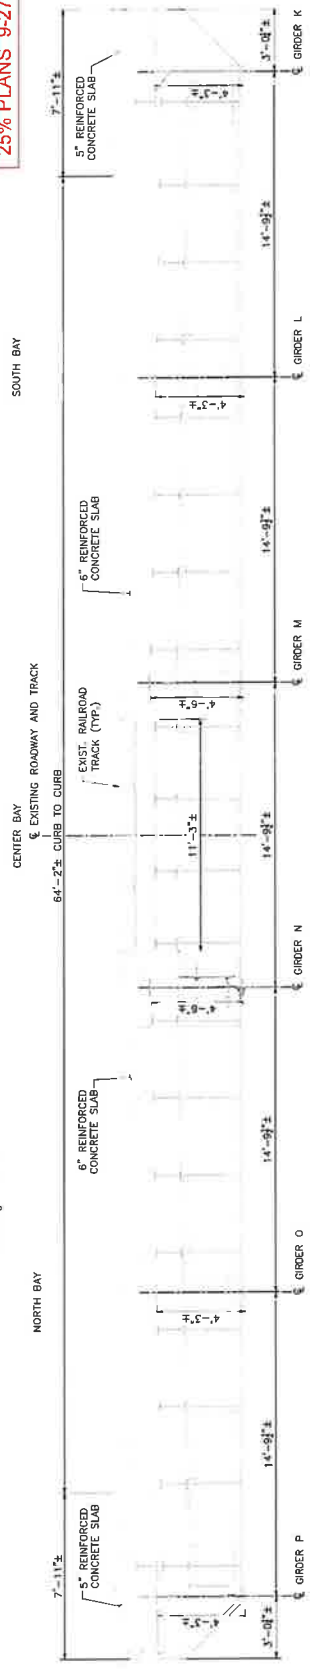
EXISTING FRAMING PLAN - EXISTING SPAN 3
SCALE: 1/8" = 1'-0"

4. THE EXISTING STRUCTURAL ELEMENTS ARE IN ADVANCED STAGES OF DETRIORATION. LOCAL FAILURES ARE POSSIBLE. NUMEROUS STRINGERS AT PIER 3 HAVE HAD TIMBER BLOCKING INSTALLED DUE TO SEVERE DETRIORATION OF THE EXISTING STRUCTURAL ELEMENTS. THE CONTRACTOR IS SOLELY RESPONSIBLE FOR ENSURING THE SAFETY AND STABILITY OF THE EXISTING ELEMENTS DURING AND THROUGH ALL THE STAGES OF REMOVAL AND DISPOSAL.

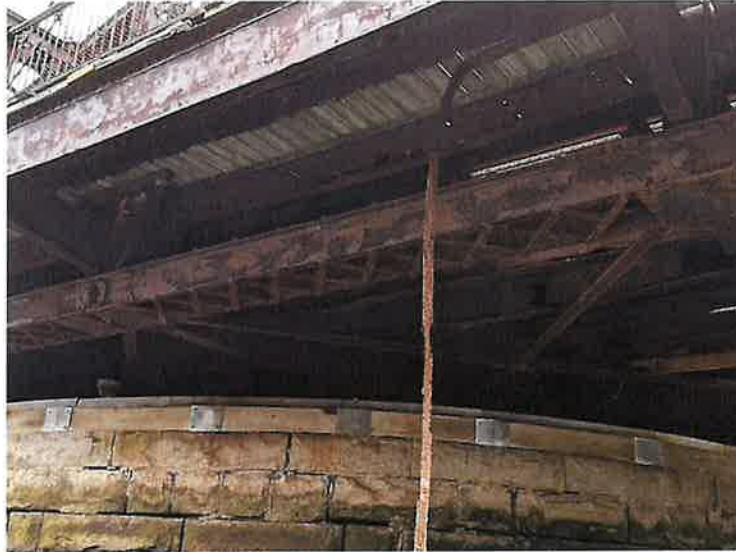
Photo 19: Swing Span, North Sidewalk Bay, East of Floorbeam FB14, Stringer 2 (Looking True Northeast)

The sidewalk cantilever brackets have small rust holes to the webs, areas of full loss of the flanges, and severely deteriorated top flange tie plates. The sidewalk stringers have areas of moderate to severe loss including detached webs from the top flanges and rust holes up to full height. Along the north sidewalk of the swing span, there is a sidewalk stringer with a detached bottom flange hanging from the superstructure (**refer to Photo 19**).

Isolated stringers have detached webs and bottom flanges in the swing span.

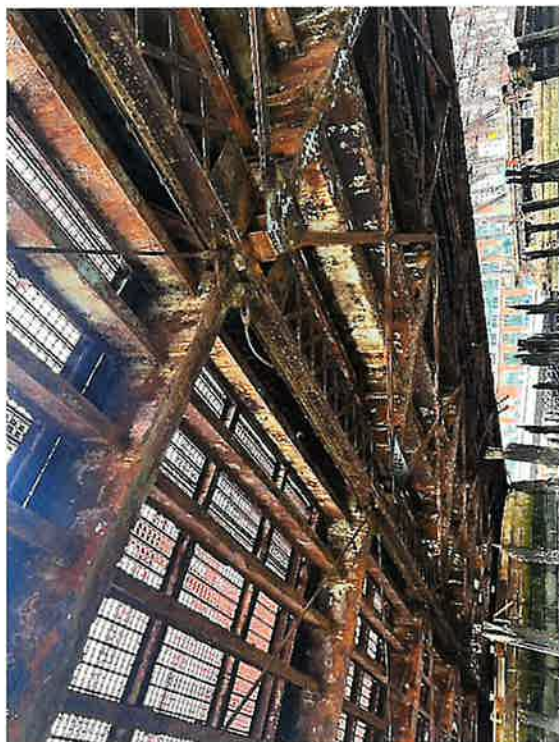
Center Trusses at L18L19 & L20L21 (2022)

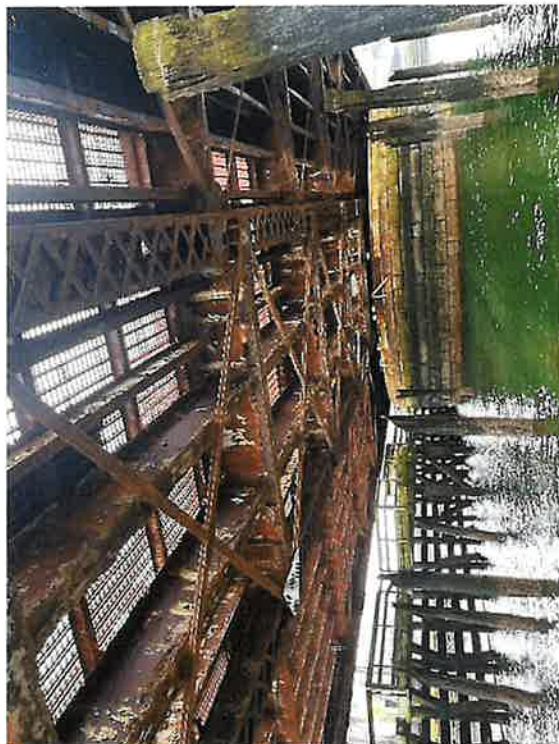
Center Trusses at L18L19 & L20L21 (2024)

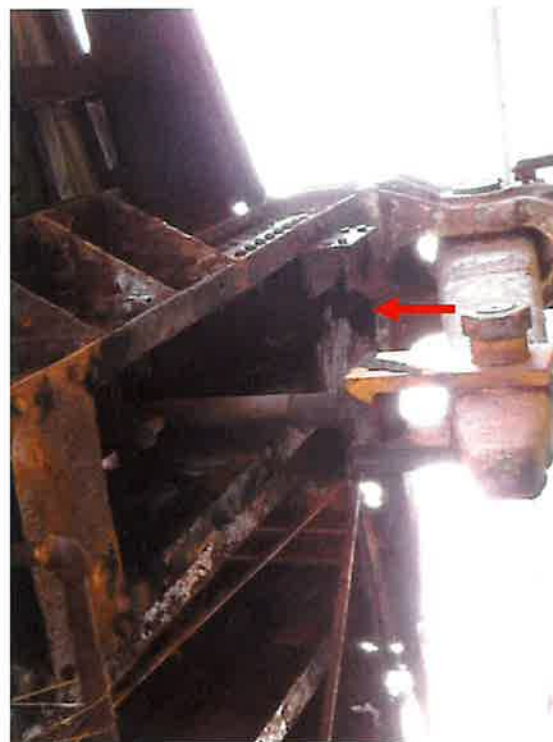
North Truss at L9L10 at L9 (2017)

North Truss at L9L10 at L9 (2024)
*Advanced deterioration of existing rust hole since the 2017 inspection.

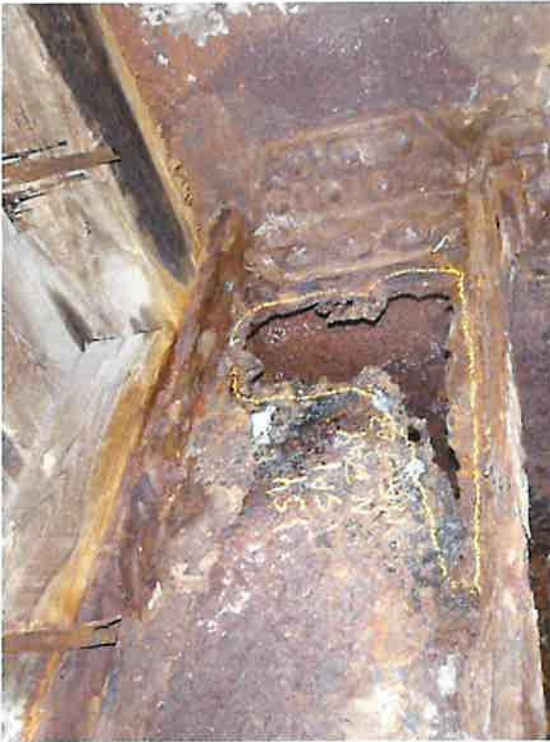
North Bay, Btw FB2 & FB3 – Stringer S4 (2017)

North Bay, Btw FB2 & FB3 – Stringer S4 (2024)
*Progressive deterioration of existing rust hole since the 2017 inspection.

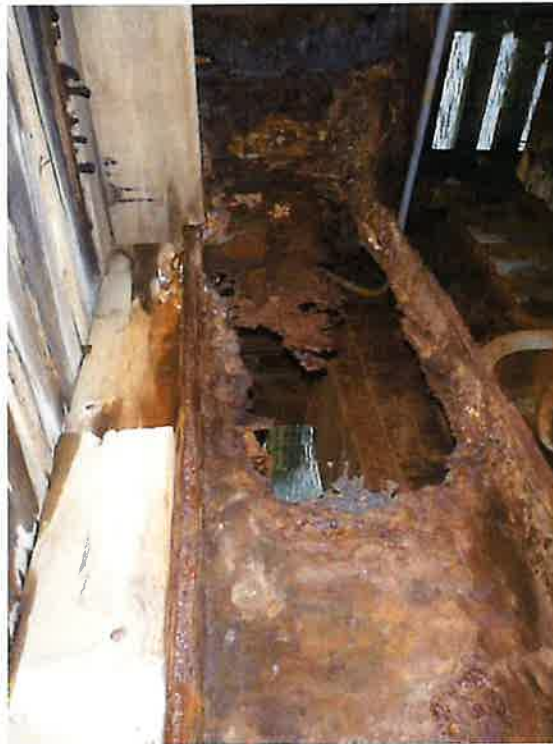
South Bay, Btw FB23 & FB24 – Stringer S1 (2017)

South Bay, Btw FB23 & FB24 – Stringer S1 (2024)
*Advanced deterioration of existing rust hole since the 2017 inspection.

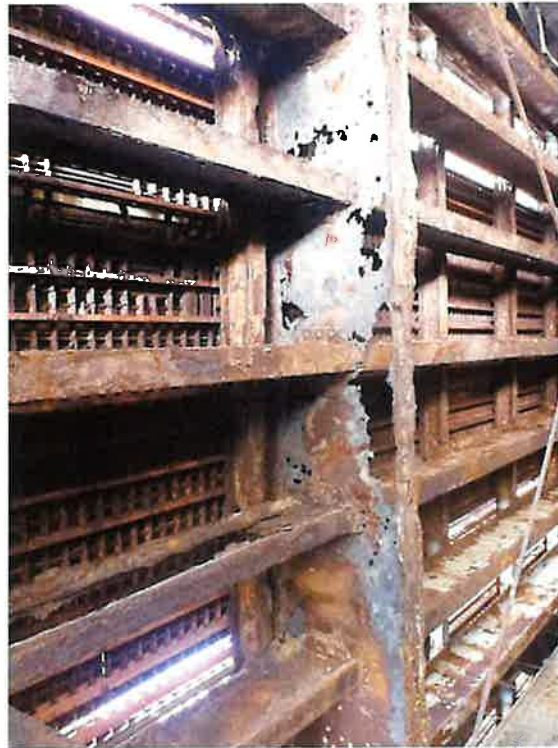
Swing Span, North Bay - Floorbeam FB10 (2017)

Swing Span, North Bay - Floorbeam FB10 (2024)
*Advanced deterioration of existing rust hole since the 2017 inspection.

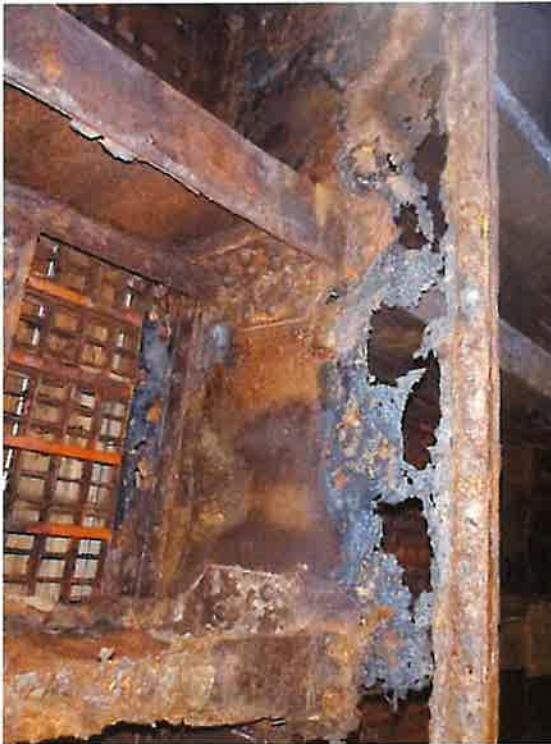
Swing Span , North Bay - Floorbeam FB17 (2017)

Swing Span , North Bay - Floorbeam FB17 (2024)
*Advanced deterioration of existing rust hole since the 2017 inspection.

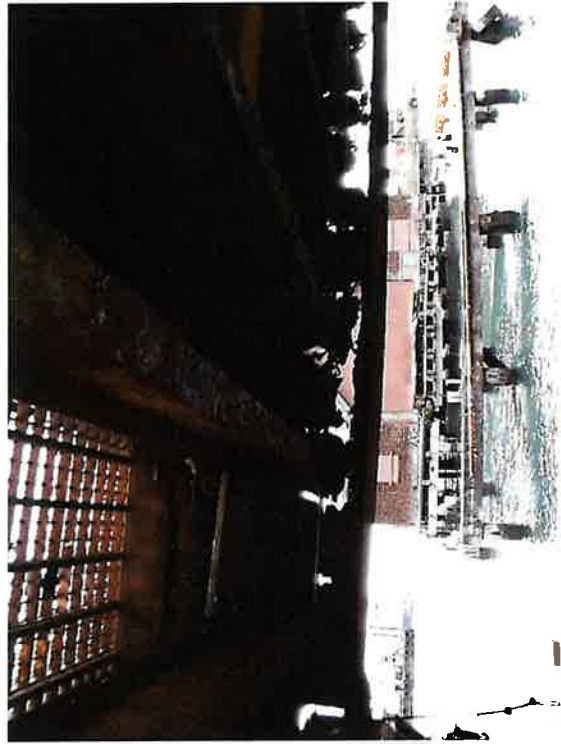
Swing Span, North Bay - Floorbeam FB22 (2017)

Swing Span, North Bay - Floorbeam FB22 (2024)
*Advanced deterioration of existing rust hole since the 2017 inspection.
