Inspection Report

Property Address:
9205 Sand Dune Cove
Parrish FL 34219

KMI Home Inspections, Inc.

Date: 12/4/2024	Time:	Report ID:
Property: 9205 Sand Dune Cove Parrish FL 34219	Customer: Chrissy Brahler	Real Estate Professional:

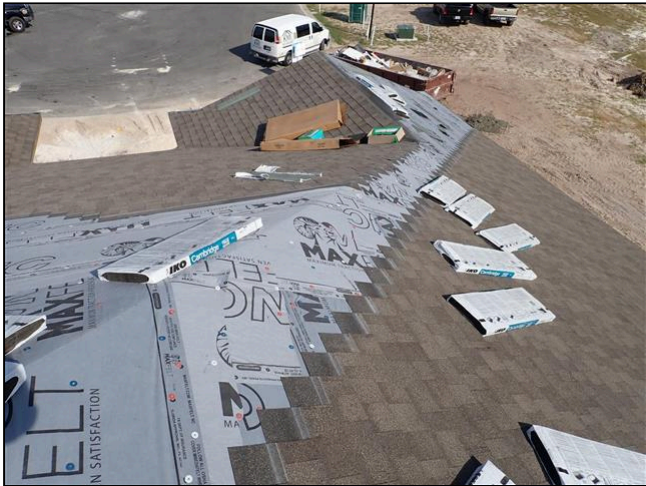
1.0 Item 1(Picture)

1.0 Roof installation is not complete. UPDATED 12-17-24: Roof covering complete.

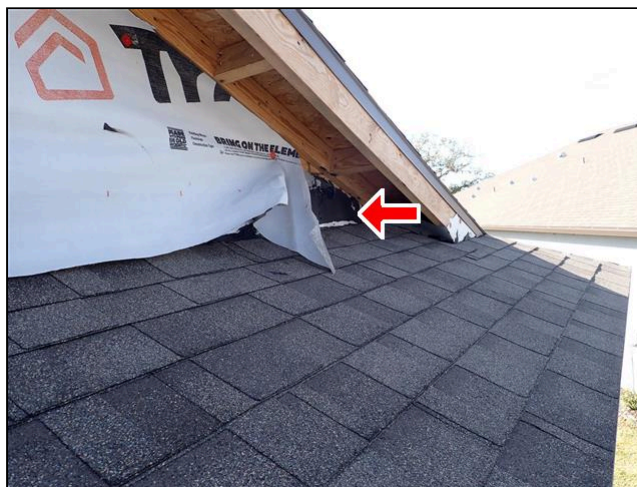
1.1 Item 1(Picture)

1.1 Flashing at the front gable is present (for your information)

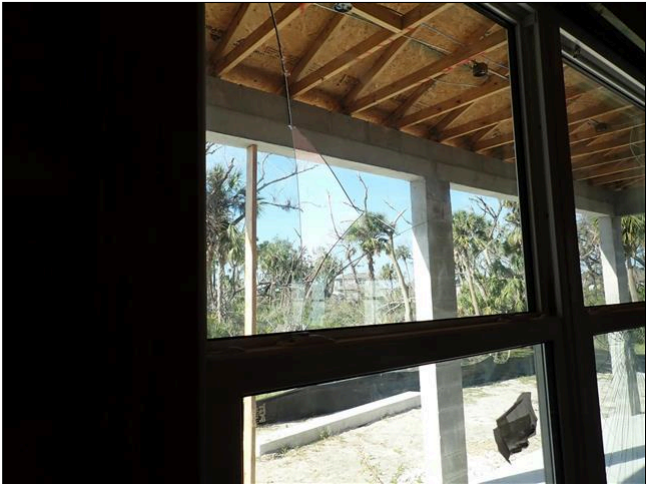
4.6 Item 2(Picture)

4.6 Three windows are broken at the rear of the home and the right side of the home. Recommend replace as needed.

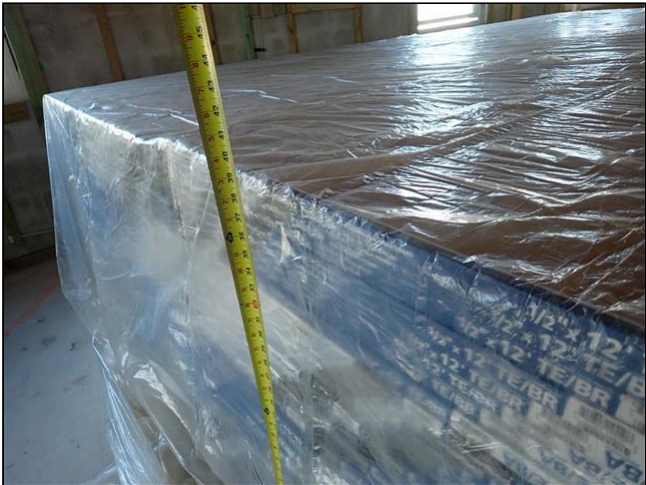
5.3 Item 2(Picture)

5.3 Excessively tall drywall stacks may put undue stress on the floor and floor system components. Recommend distributing the weight accordingly.

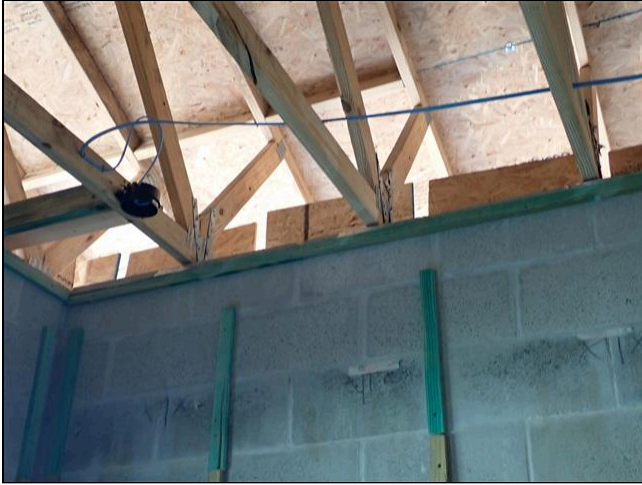
5.5 Item 25(Picture)

5.5 (2) Sand debris present on top of the interior wall framing suggest that a soda blast treatment may have occurred at the home. Recommend complete removal of all associated debris. UPDATED 12-17-24: Soda blast remnants still present.

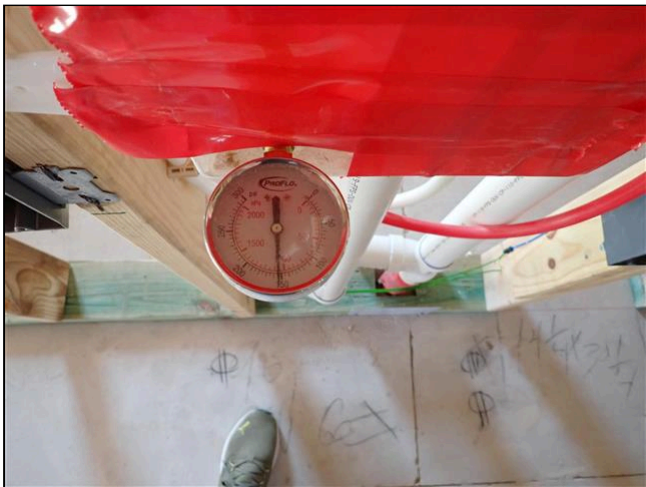
6.1 Item 1(Picture)

6.1 Water lines under pressure test.

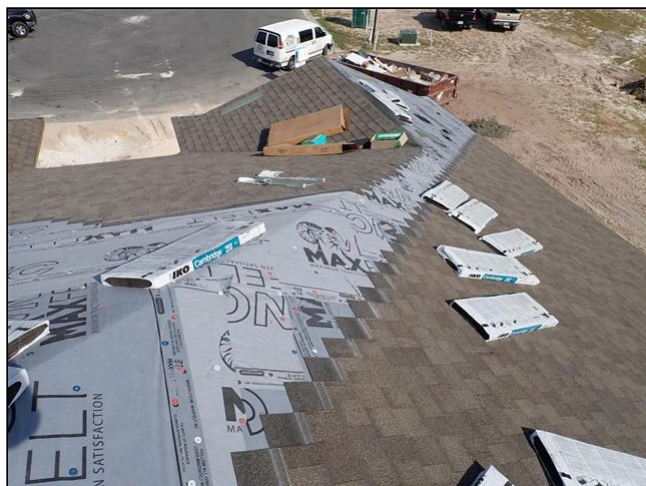
1.0 Item 1(Picture)

Roof installation is not complete. UPDATED 12-17-24: Roof covering complete.

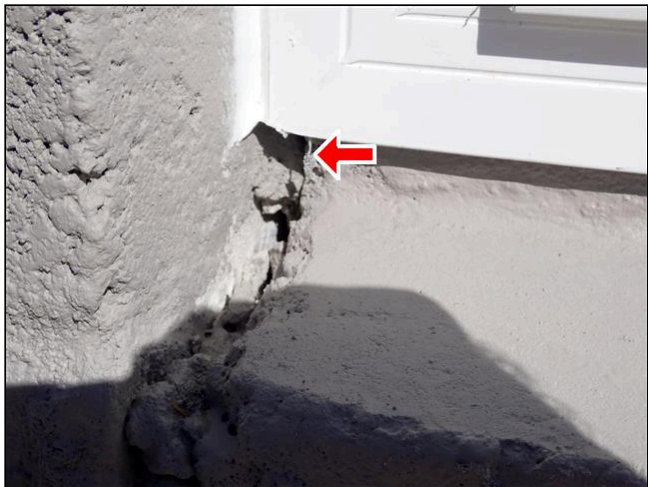
2.2 Item 5(Picture)

Caulking at exterior windows is missing at several locations at the lower corners around the perimeter of the home. Recommend installing caulk per manufacturers installation instructions. UPDATED 12-17-24: Stucco coating filling the gaps.

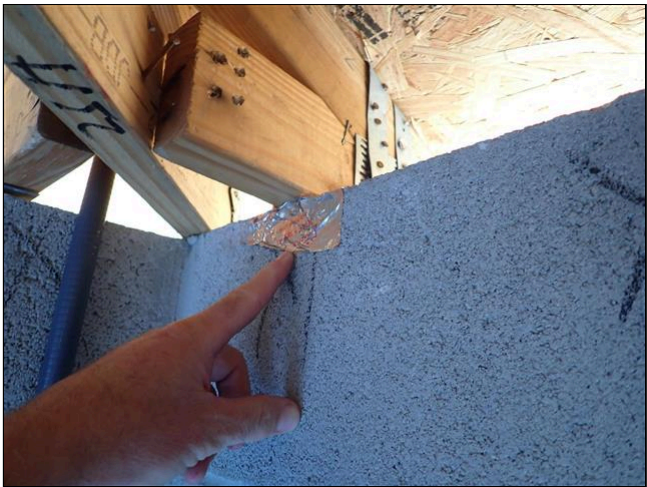
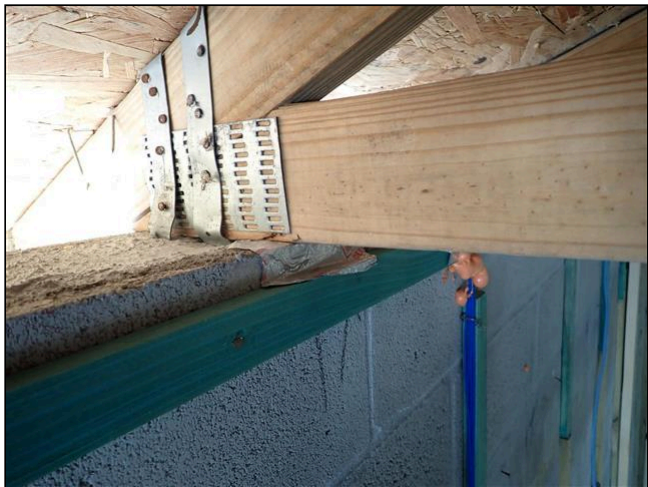
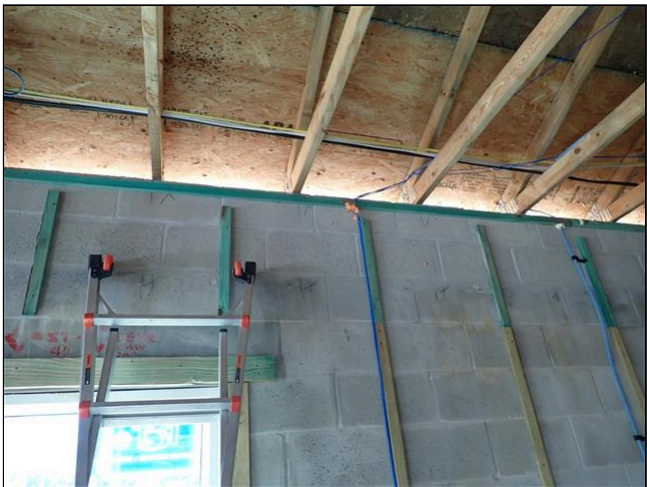
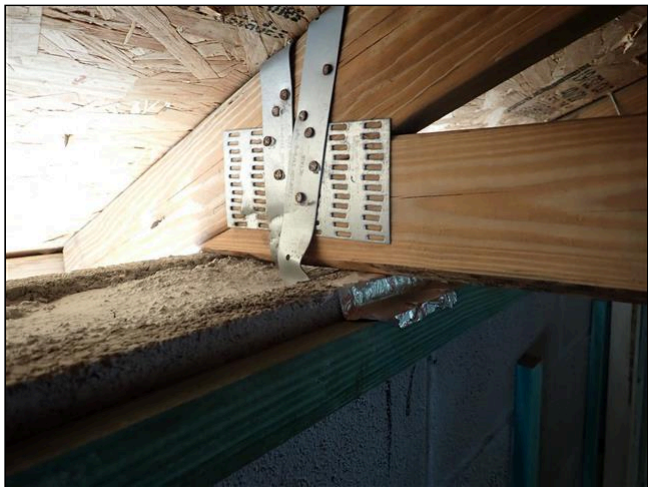
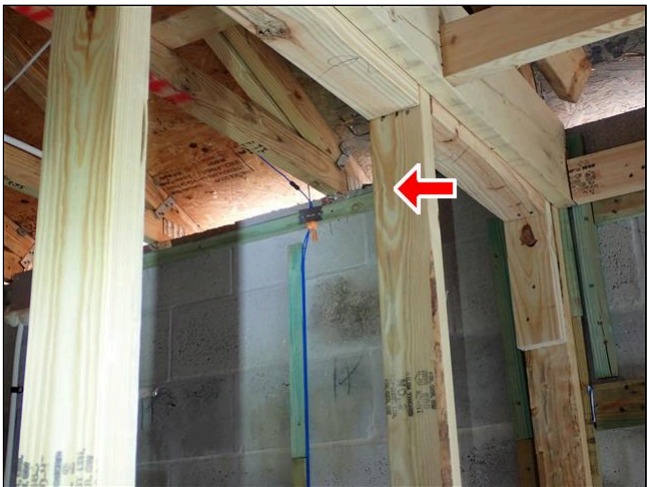
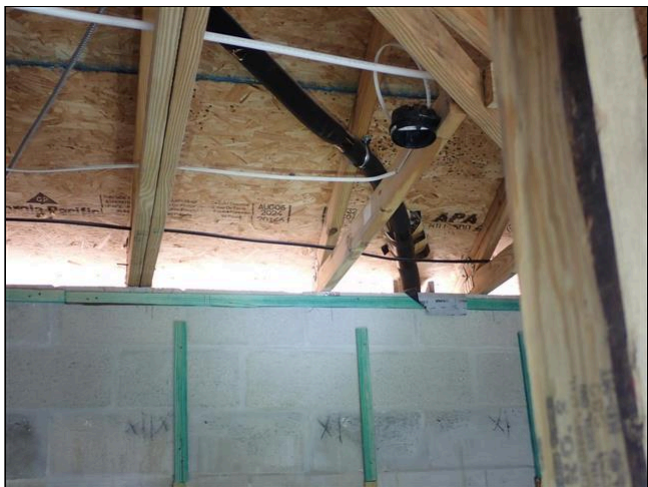
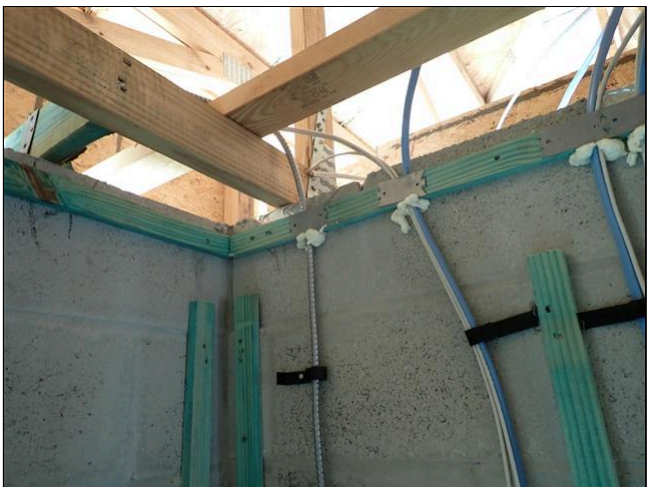
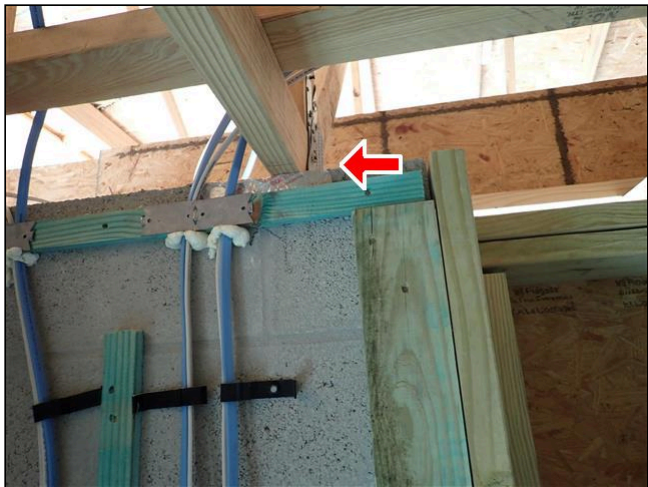
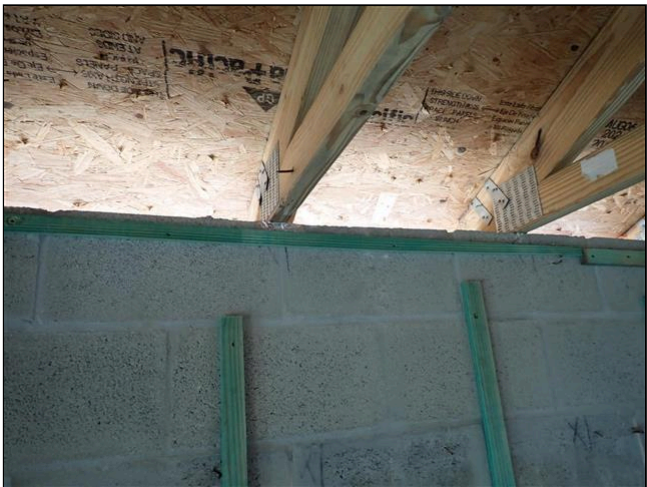
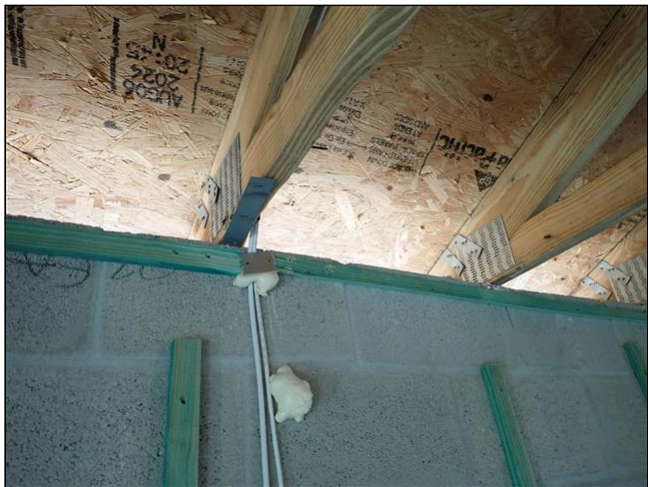
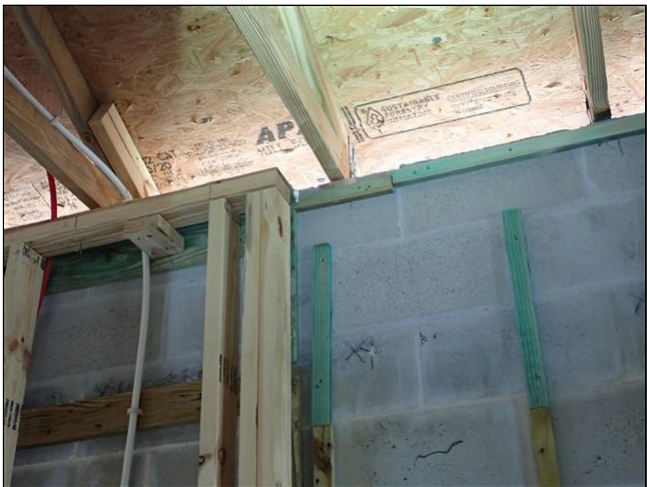
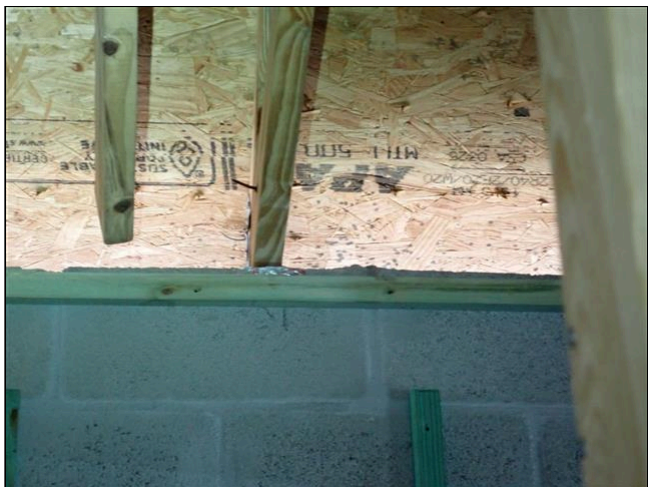
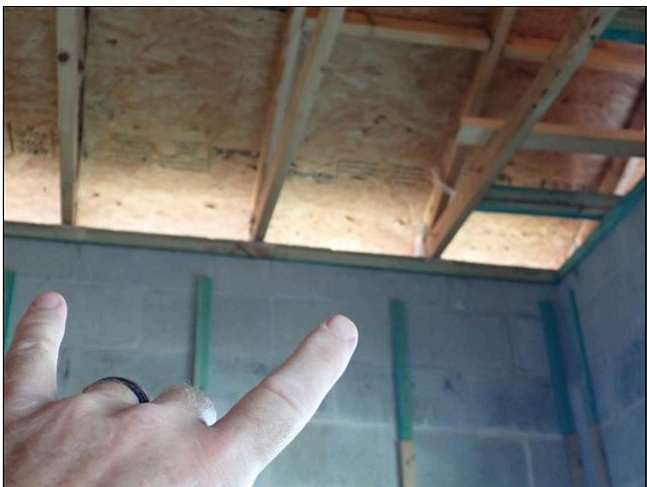
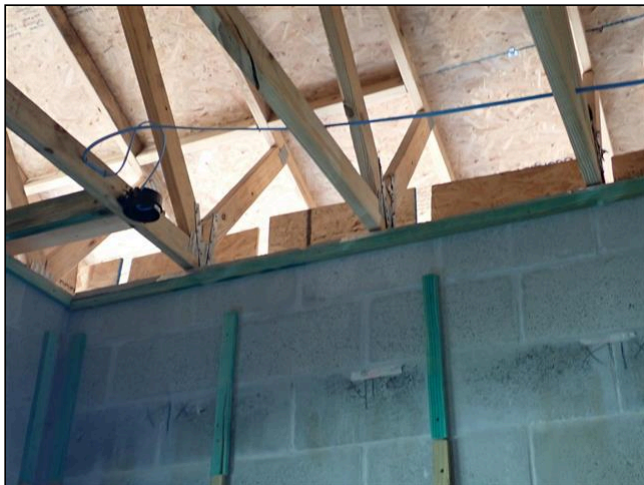
(1) Multiple trusses have missing bearing plates or are sitting on top of the truss straps around the perimeter of the home. Truss bearing plates act as a moisture barrier between the truss and the block. Trusses that sit on top of the truss straps are not effective. Recommend correct as needed. UPDATED 12-17-24: Garage Trusses visually confirmed that truss plates are present.

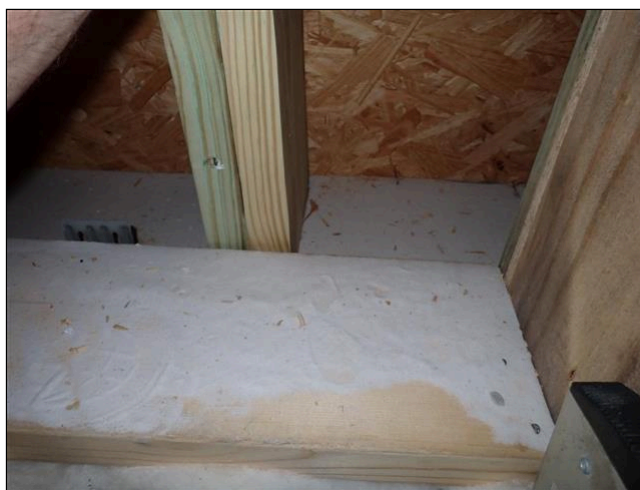
5.5 Item 27(Picture)

(2) Sand debris present on top of the interior wall framing suggest that a soda blast treatment may have occurred at the home. Recommend complete removal of all associated debris. UPDATED 12-17-24: Soda blast remnants still present.

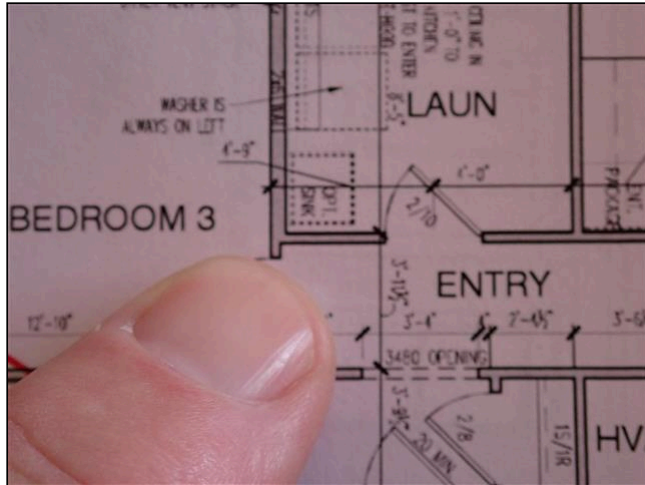
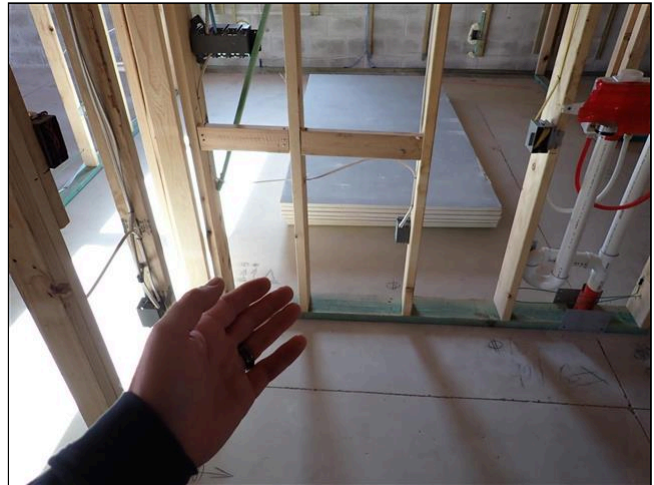
Optional laundry tub is currently not plumbed. Owner to verify if this option was selected.

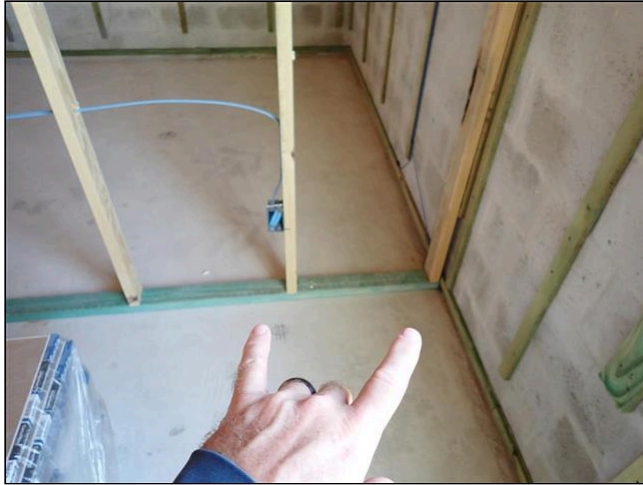
7.3 Item 3(Picture)

(2) Location of the outlet on the left wall of the master bedroom does not match the drawings. Owner to determine if current location is acceptable.

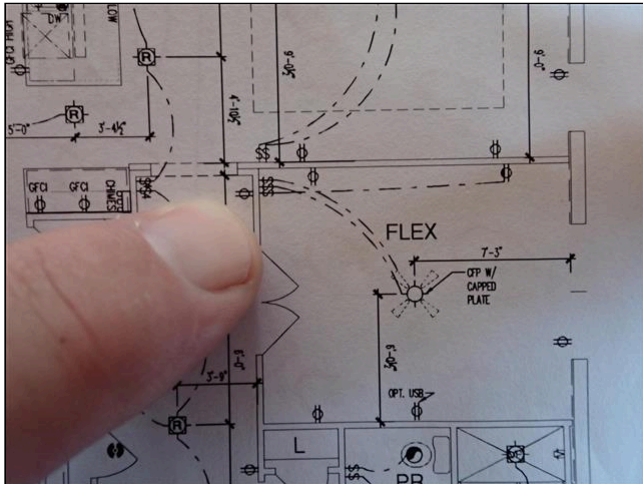
7.3 Item 5(Picture)

(3) Location of the switches at the flex room does not match the drawings. Owner to determine if current location is acceptable.

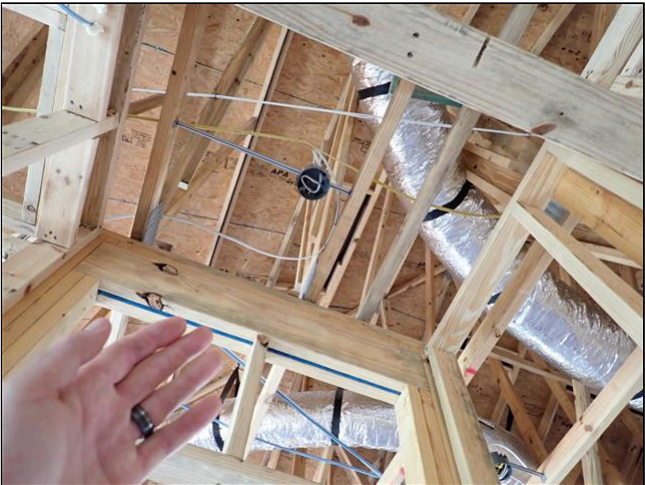
8.3 Item 2(Picture)

Return air duct is not present per the drawings outside of the master bedroom entry. Recommend correct as needed.

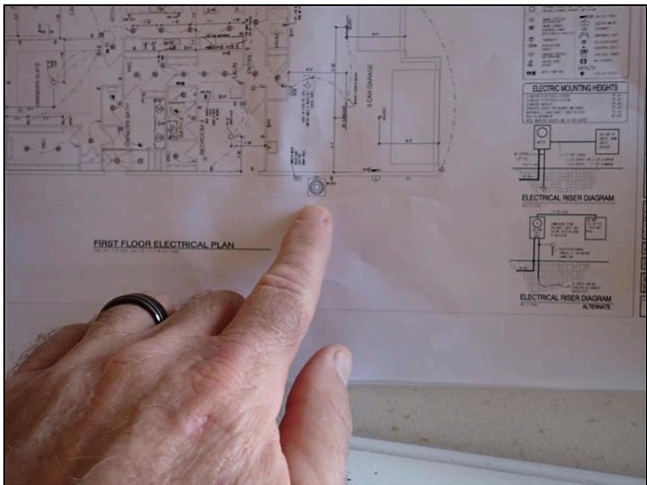
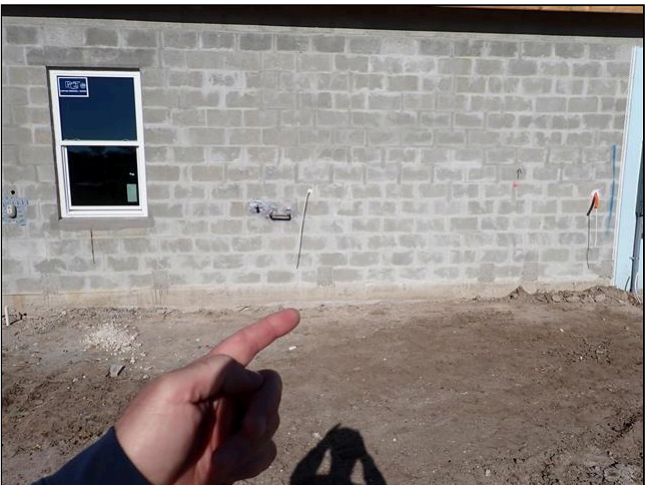
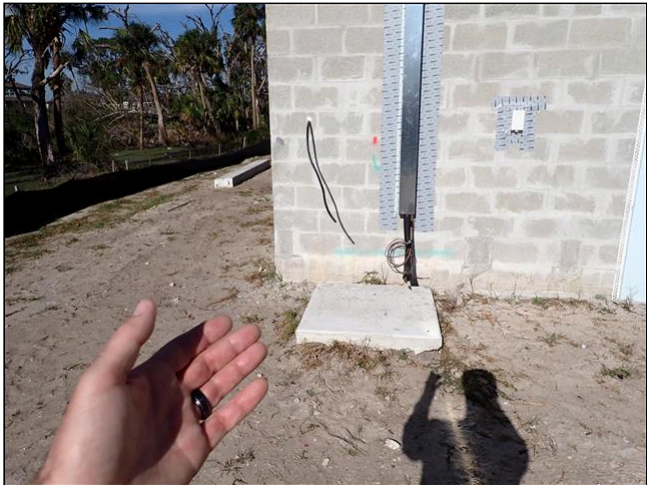
Condenser pad and related components are located at the left rear corner of the home. This is a discrepancy from the drawings that indicate the condenser should be located at the left side of the home closer to the front. Owner to determine if this location is acceptable.
