## **Inspection Report**

**KMI Home Inspections, Inc.**

**Kapp A. McMullin, HI11423  
5932 Wildwood Ave.  
Sarasota, Florida 34231  
941-350-2927**

<b>Date:</b> 11/26/2021	<b>Time:</b>	<b>Report ID:</b>
<b>Property:</b>	<b>Customer:</b>	<b>Real Estate Professional:</b>

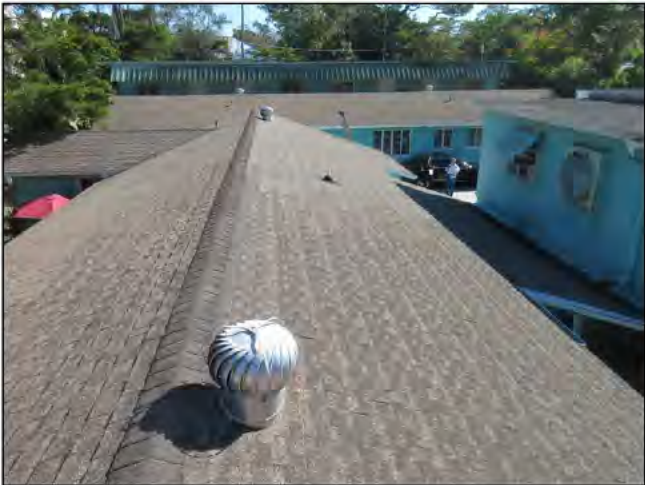
1.0 Item 2(Picture)

1.0 1732/1736- Roof covering has significant granular loss and has exceeded its useful life expectancy. Membrane roof covering above the garage unit and 8 Plex shows several areas that pond water. Tree limbs are in contact with the garage roof and the 8 Plex roof and should be trimmed. Recommend further review from a licensed roofing contractor and repair as needed.

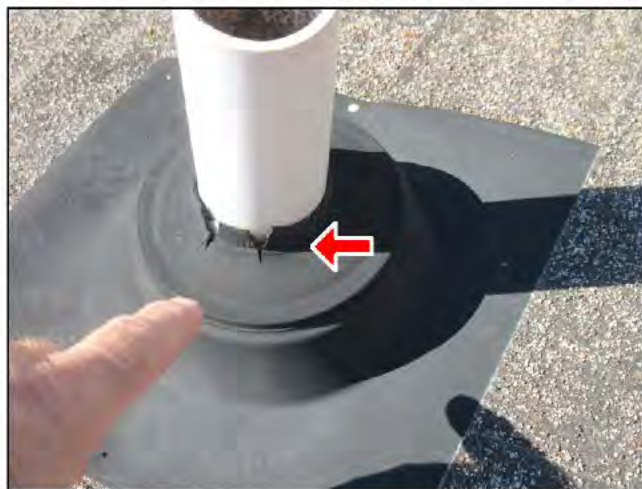
1.1 Item 2(Picture)

**1.1 1732/1736-** Several flashing boots are damaged or installed improperly. Repairs are needed. Bitumen flashing above the 8 Plex has pulled loose near the plumbing vent pipe. Recommend a licensed roofing contractor repair as needed.

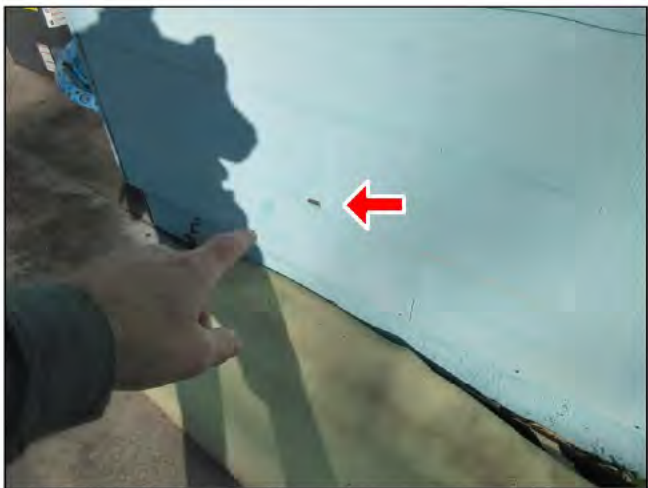
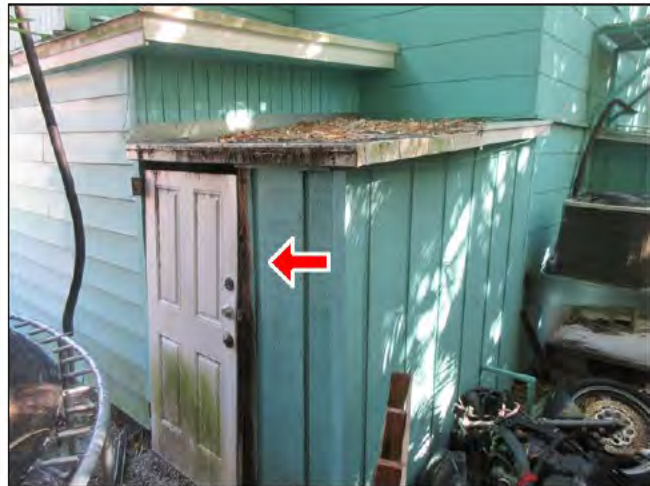
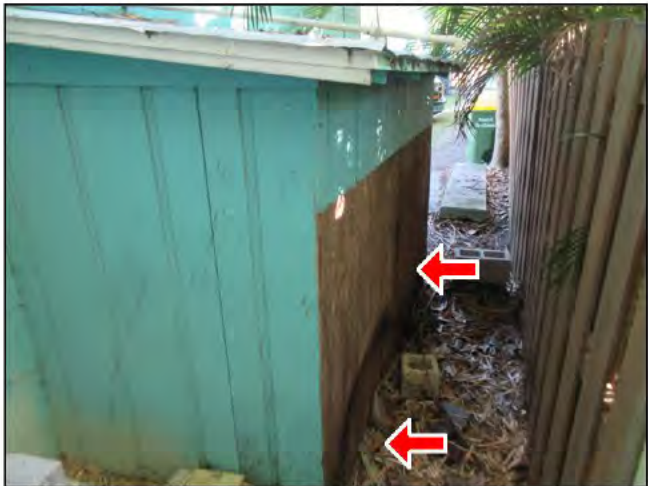
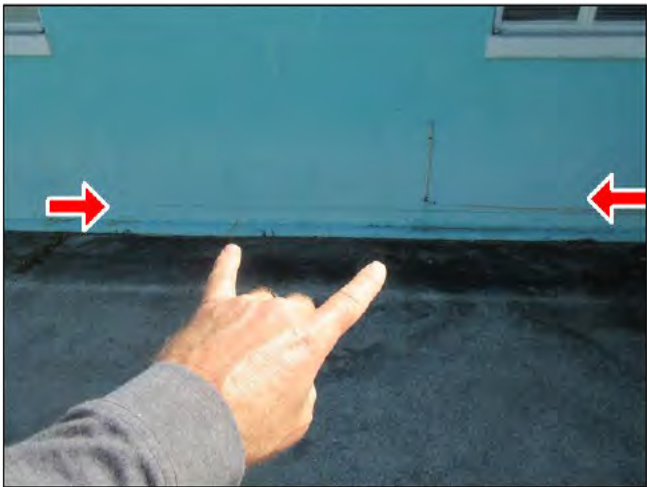
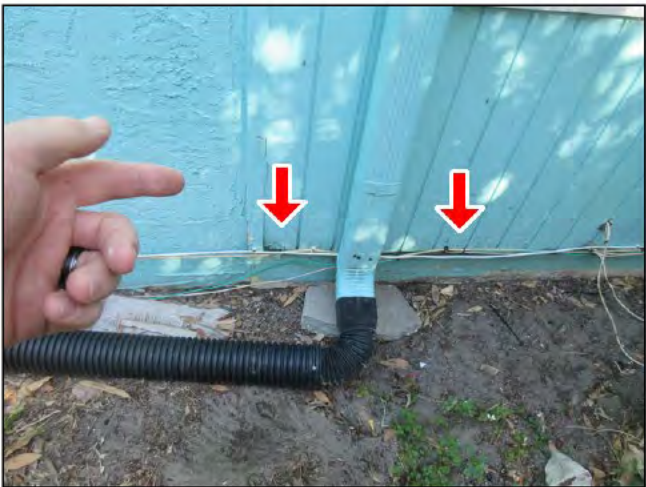
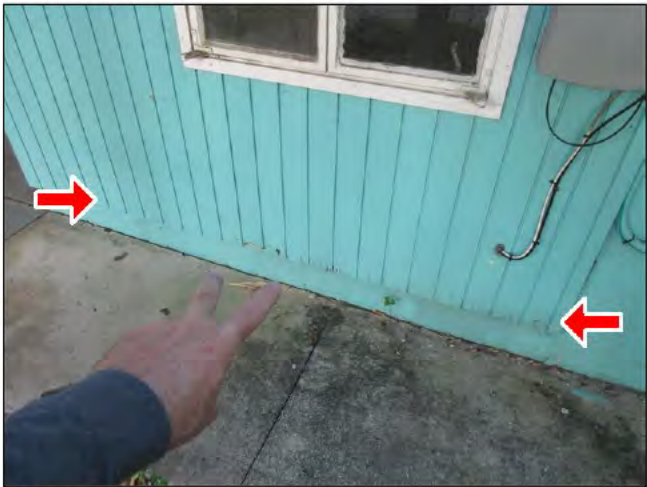
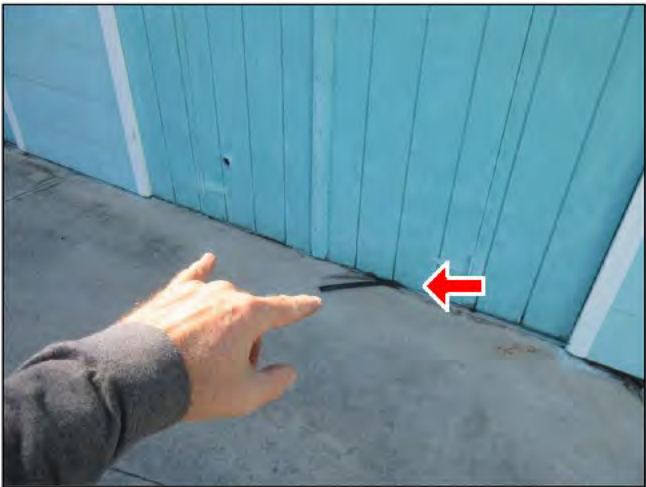
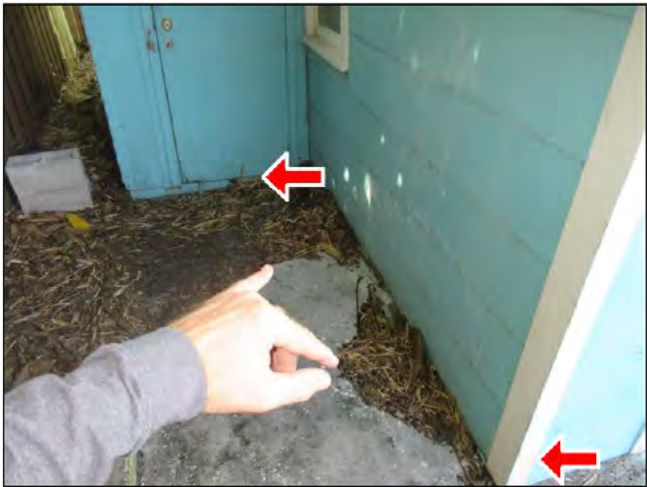
2.0 1732- Multiple slate tiles are damaged or cracked on the perimeter of the unit. Garage- Rear and side sheds are deteriorated at the door frame and/or siding and need repairs. 8 Plex- Masonry coating on the rear of the lower units has several hairline settlement cracks. Displacement was not observed (for your information). 8 Plex- Wood siding at the lower level is partially deteriorated in several areas. Recommend repair as needed.

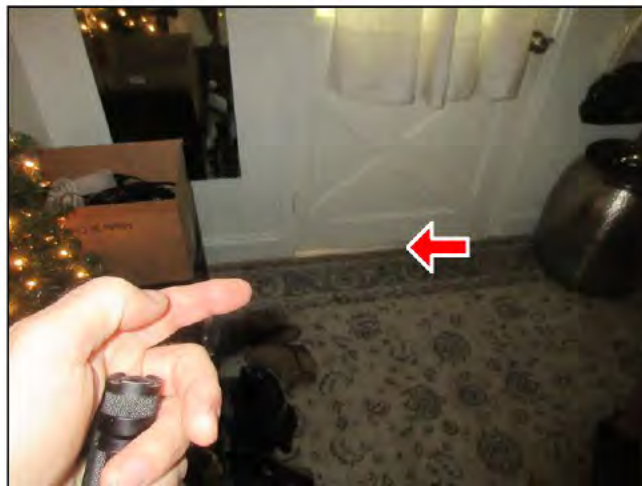
2.1 Item 2(Picture)

**2.1** 1732- Front and rear entry doors are missing weather stripping. 1736- Front and rear entry doors are missing weather stripping.

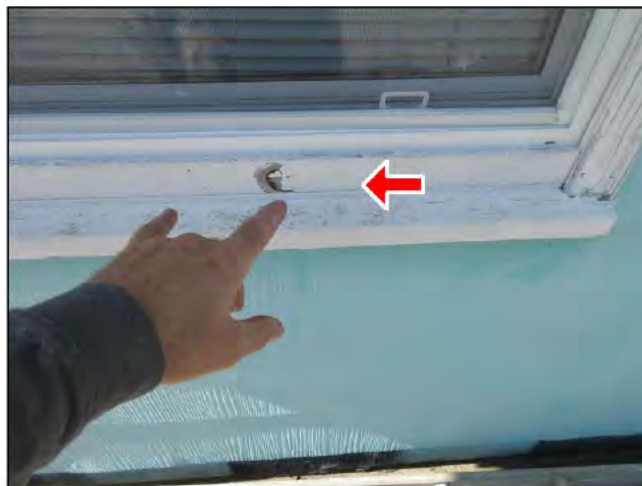
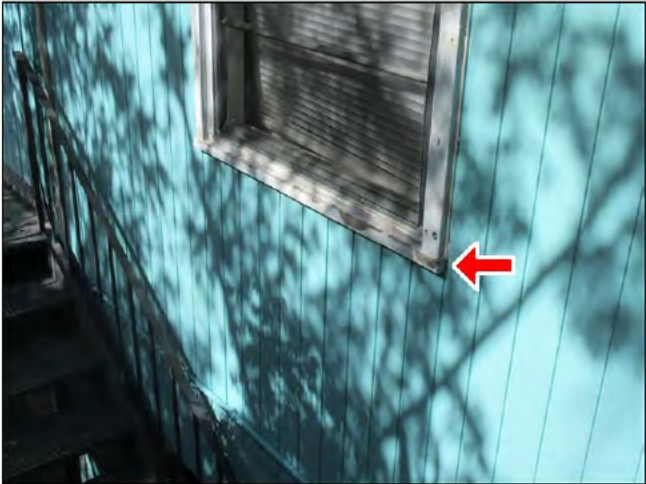
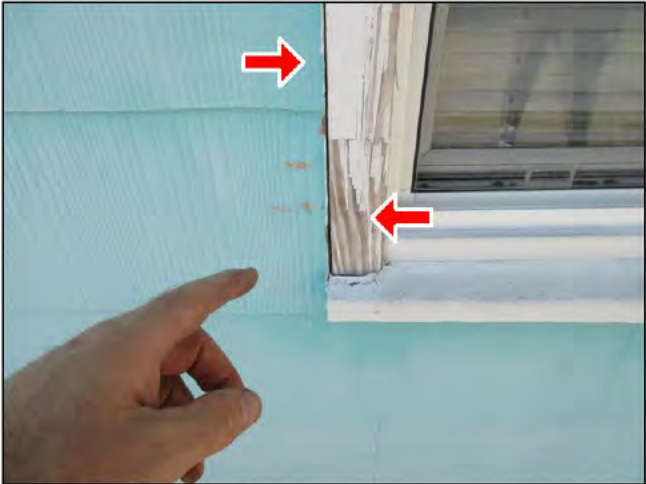
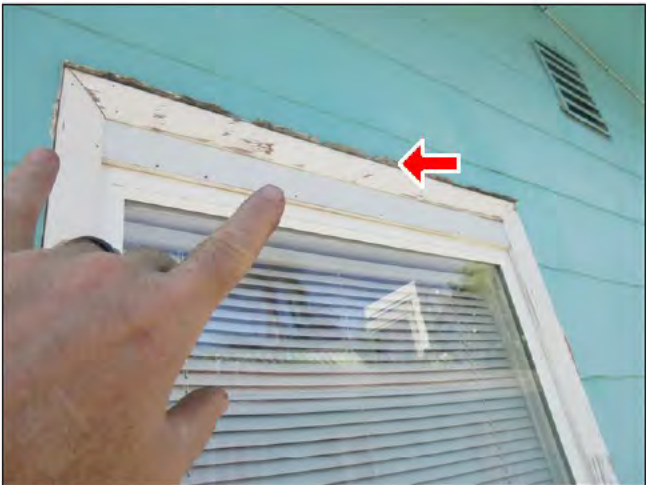
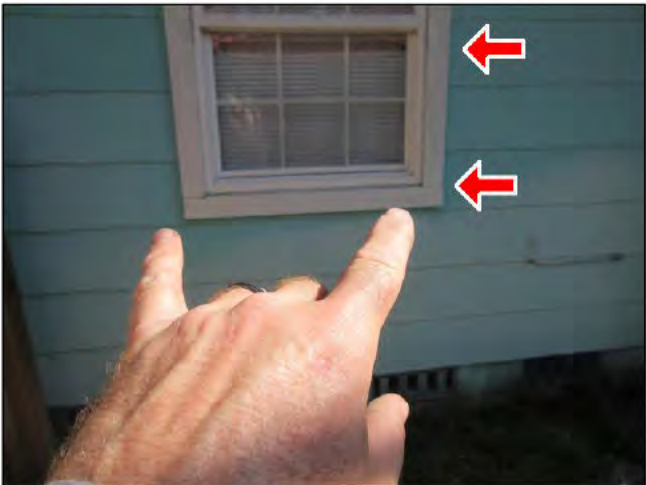
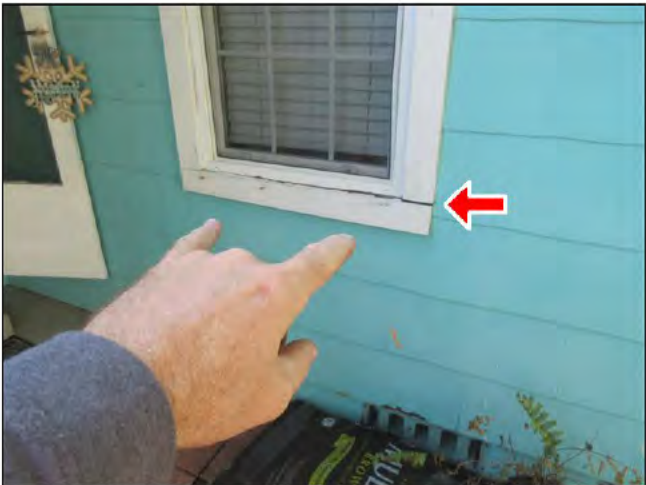
**2.2** Multiple window frames or trim around the units are peeling paint. Recommend seal, prep and paint as needed.

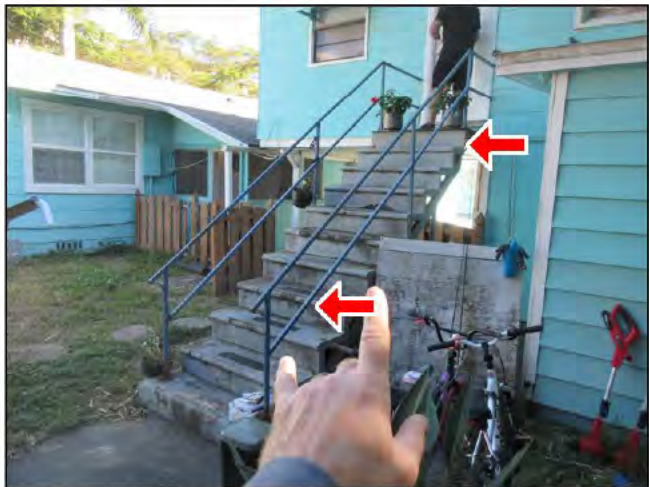
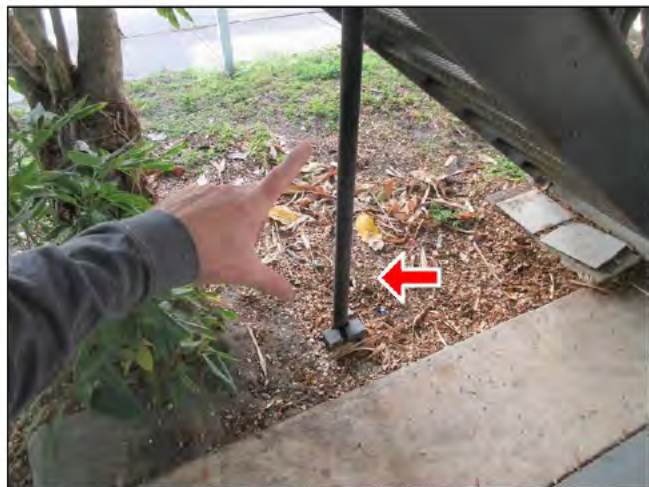
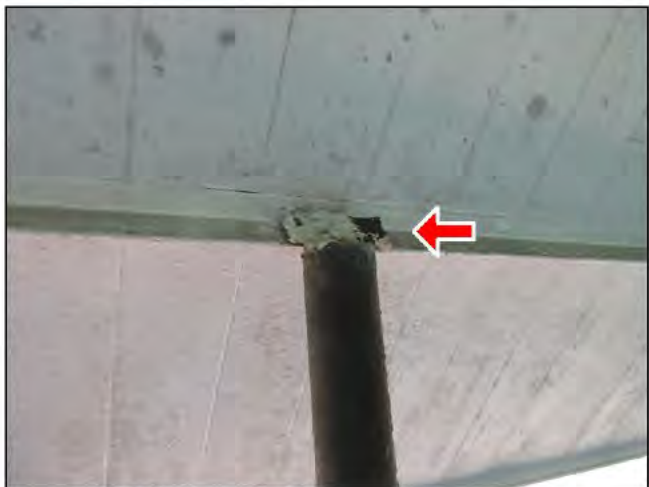
2.3 Garage- There is a platform at the rear side wall of the upper garage apartment near one of the windows. The purpose of this platform is unknown. Pickets on the handrail leading to the upper garage apartment are spaced too far apart for safety. Recommend 4" max spacing for safety. Support post below the right side stairs (facing front) of the 8 Plex is loose and needs securing. At least one support post for the metal awning on the back side of the 8 Plex is loose and needs securing at the top.

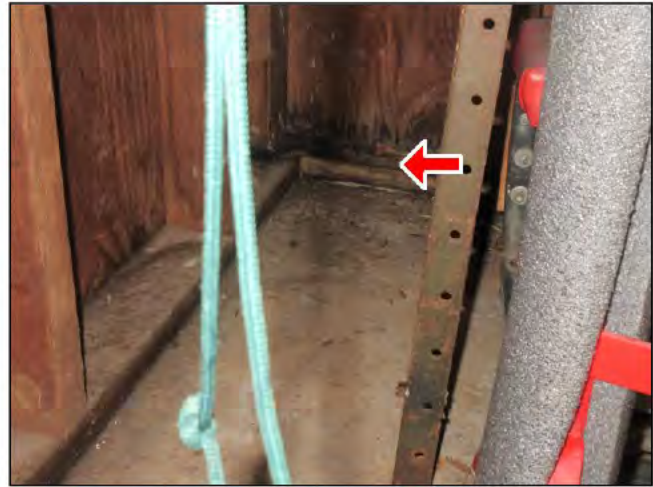
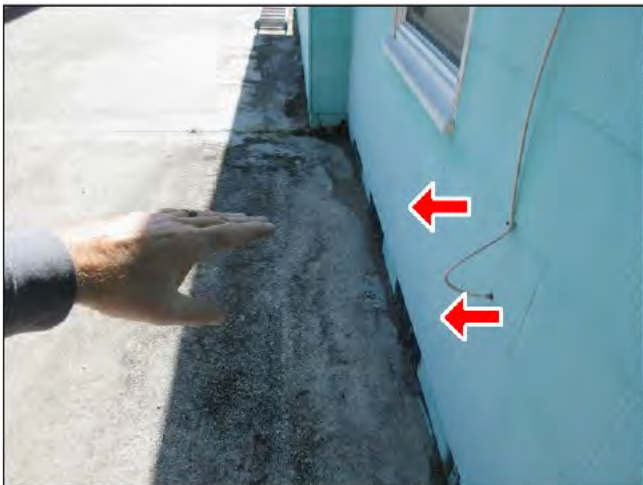
**2.4** Water stains are present on some of the lower components of the garage walls. Drainage may need to be corrected in these areas. Recommend monitoring during a heavy rain and correcting as needed. Concrete slopes towards the foundation vents on the left side of the Duplex. Water may enter the crawlspace during periods of heavy rain. Recommend monitoring and correcting as needed.

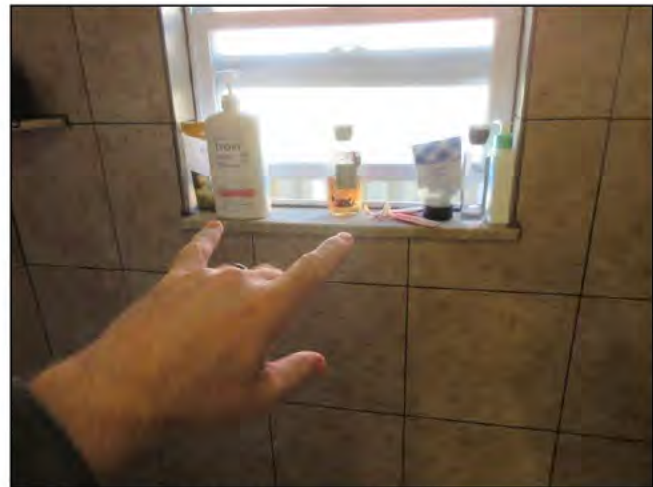
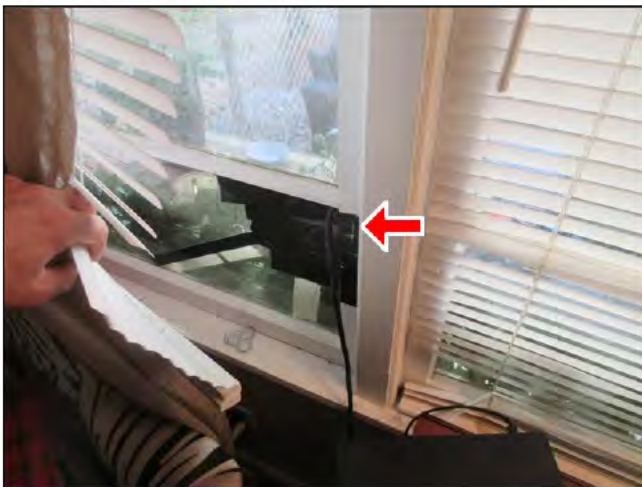
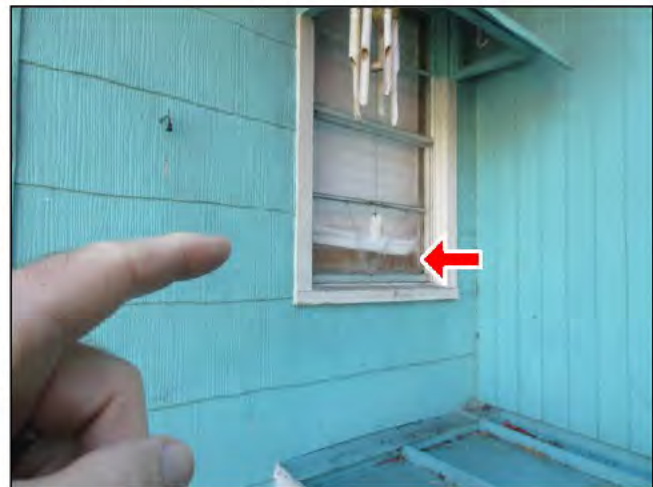
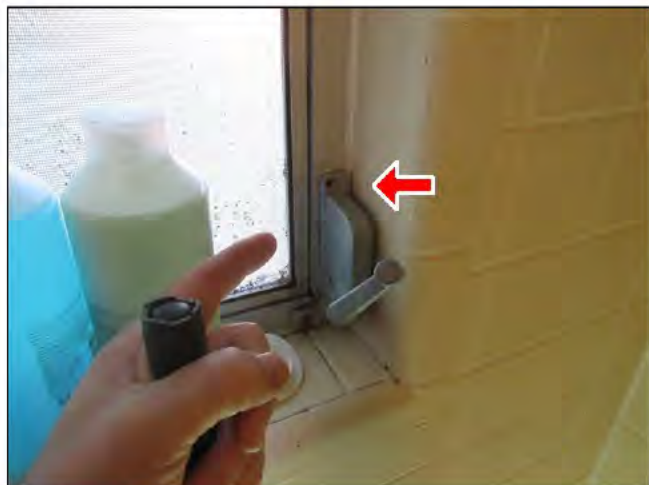
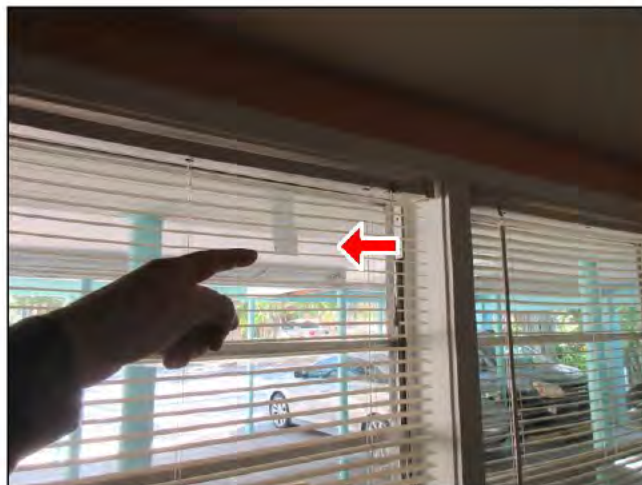
**4.6** 1732- Several windows difficult to operate or missing screens throughout the unit. 1736- One window at the front of the home is damaged at the glass pane. Garage- One window at the side of the home is damaged at the glass pane. Shower window crank unit is missing a screw and needs repair to operate properly. 8 Plex- Multiple windows are missing screens or are difficult to operate.

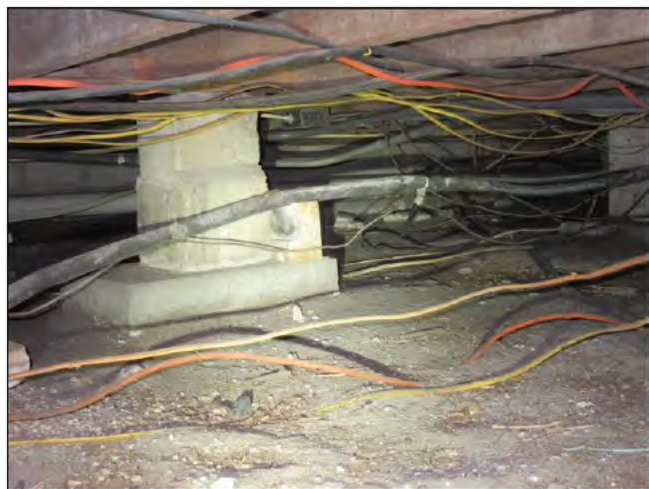
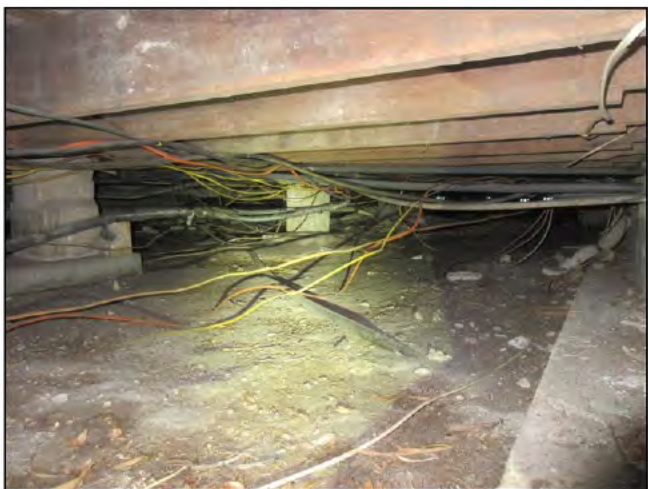
5.0 1732/1736- Crawl space photos included.

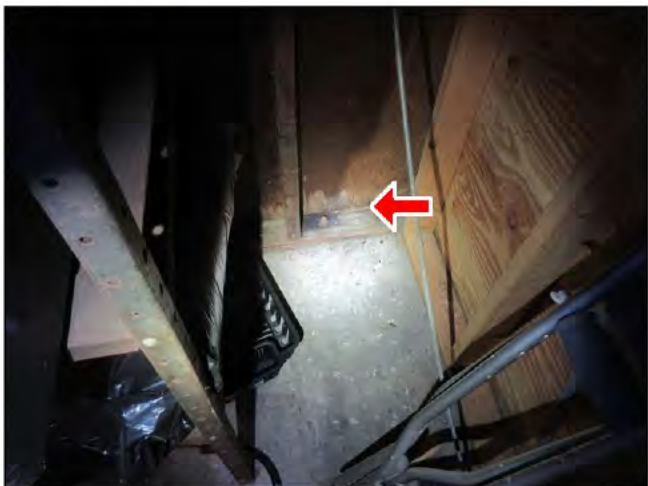
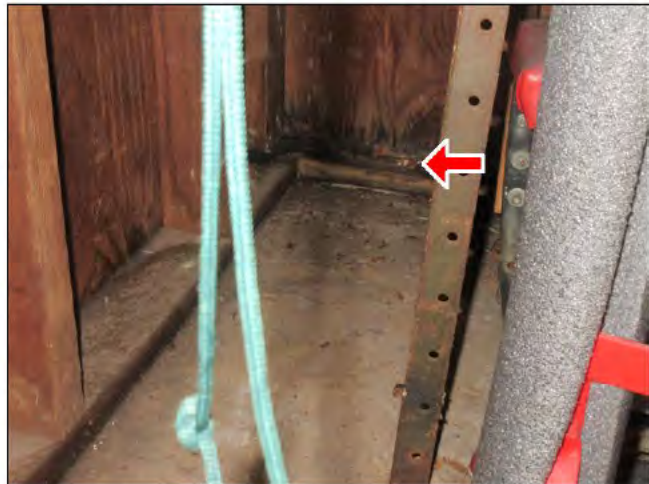
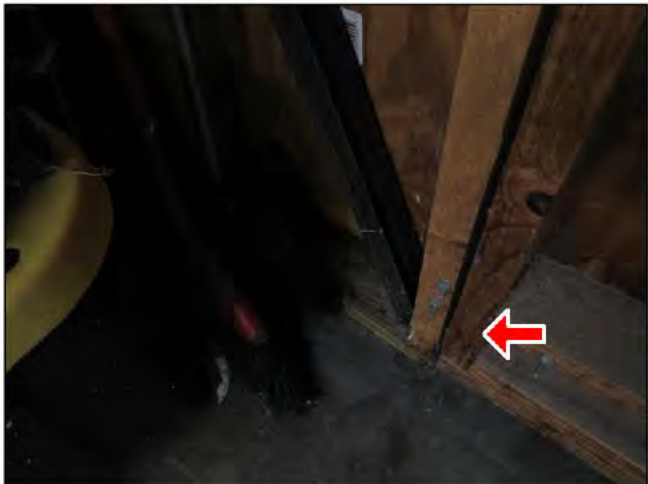
5.1 Garage- Several studs and bottom plates at the rear and side walls of the garage are deteriorated and need repairs. Water stains are present at several locations.

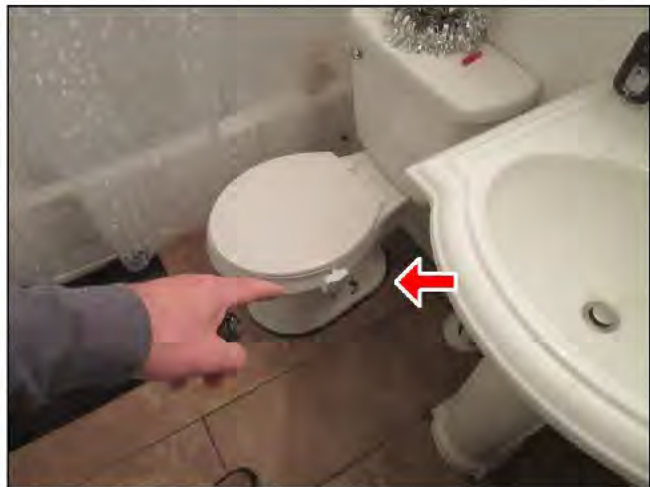
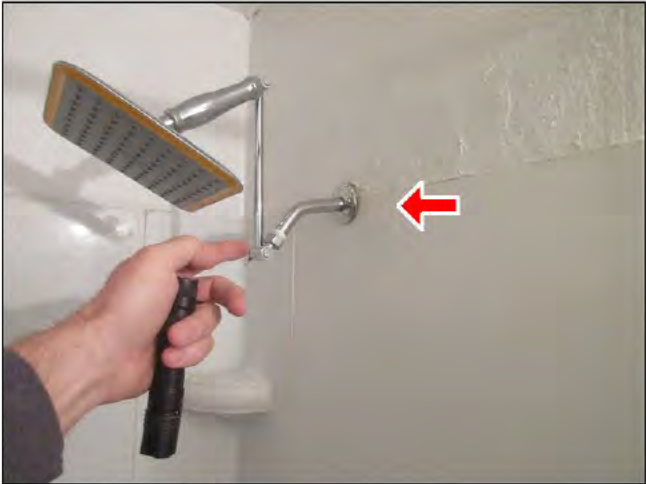
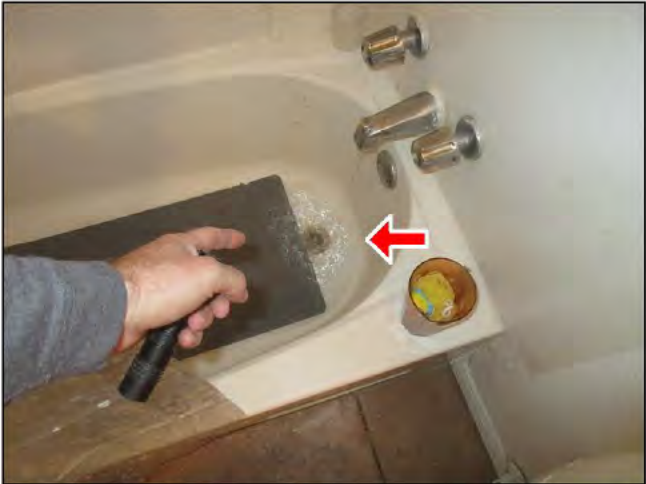
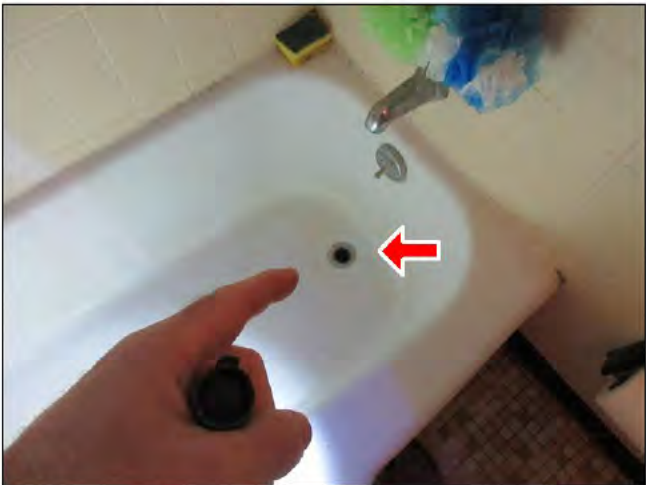
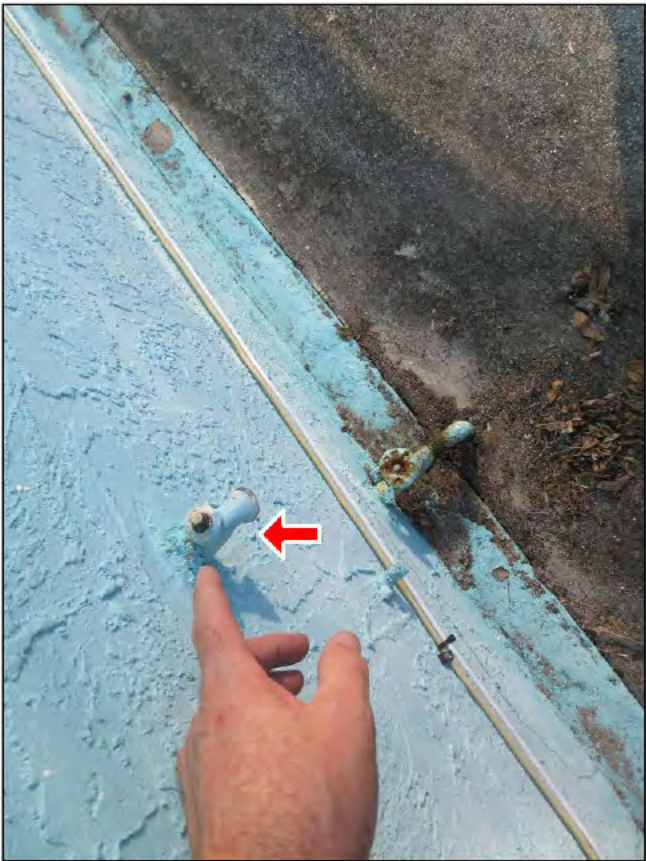
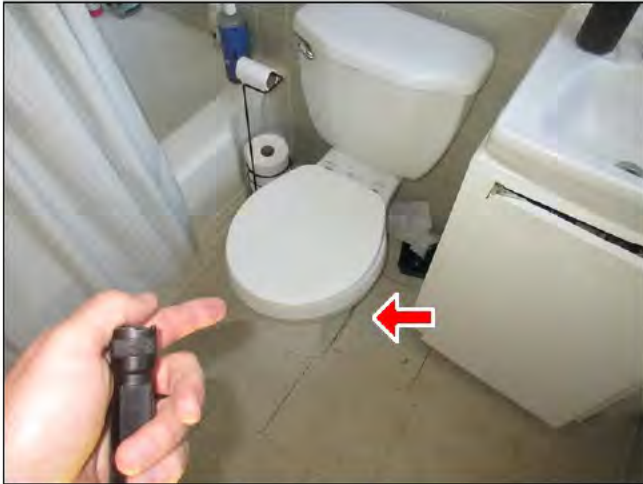
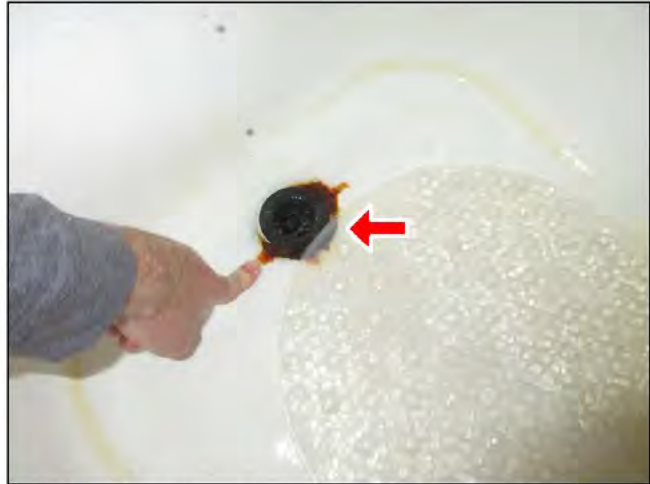
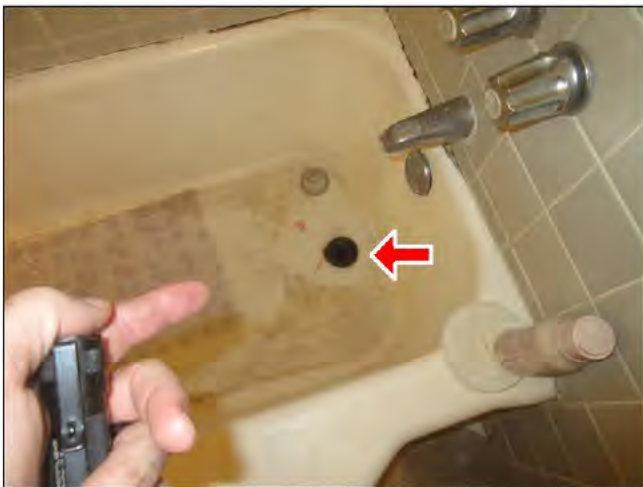
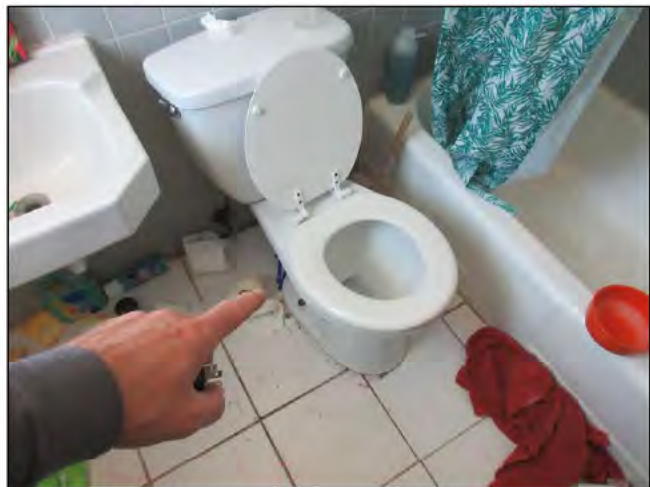
**6.1** 1732- Sink faucet is dripping at the guest bathroom. 1736- Toilet is loose at the floor at the hall bath. Repairs may include replacing the wax ring. We were unable to view this area from below to determine the condition of the flooring component below. Shower head is loose and needs securing. Tub drain is slow to drain. Garage- Tub drain is missing the stopper. 8 Plex- Hose bib knob at the rear of the building is damaged and needs replacing. Unit 3- Toilet is loose at the floor at the hall bath. Unit 3- Tub drain area is corroded and tub is missing the stop valve. Unit 2- Tub drain is slow to drain. Unit 8- Toilet is loose at the floor at the hall bath. Unit 7- Bathroom sink has several hairline cracks present.

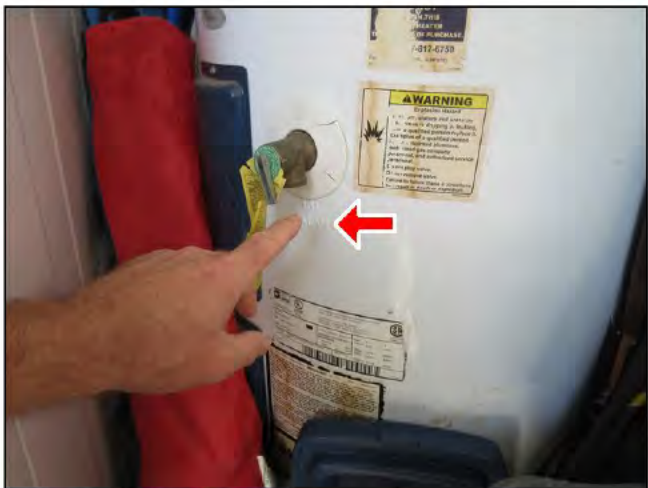
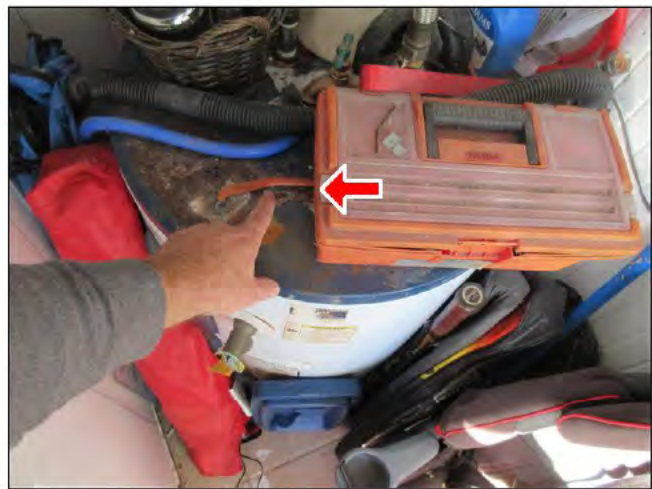
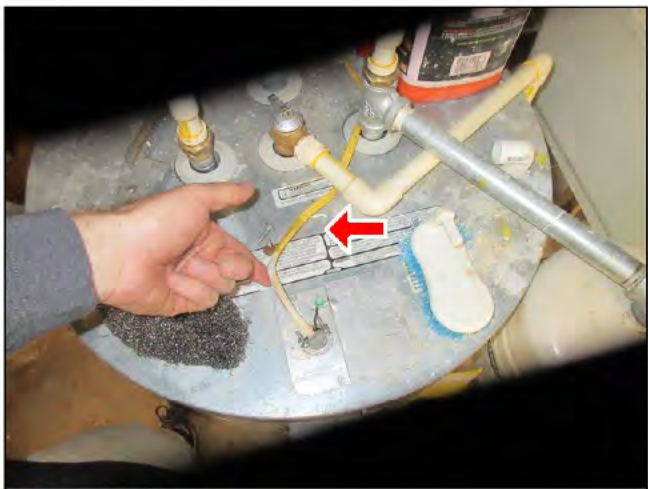
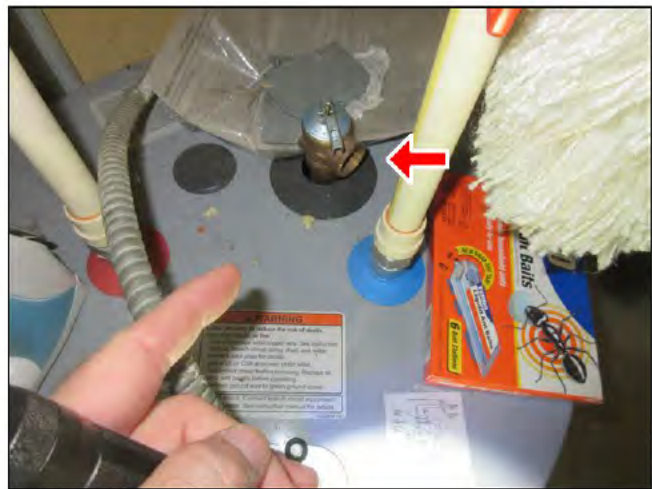
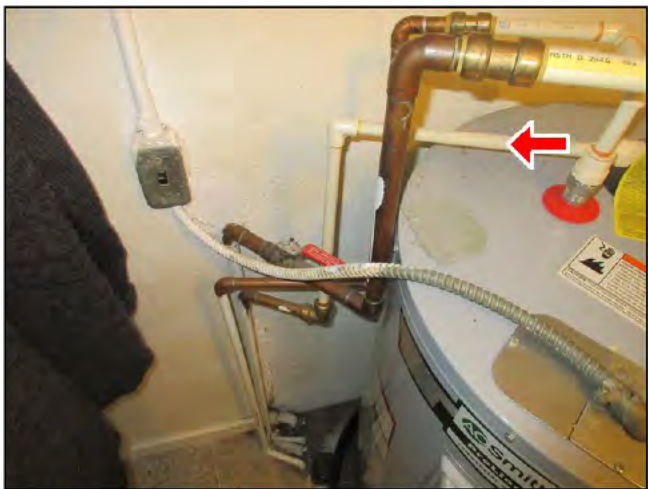
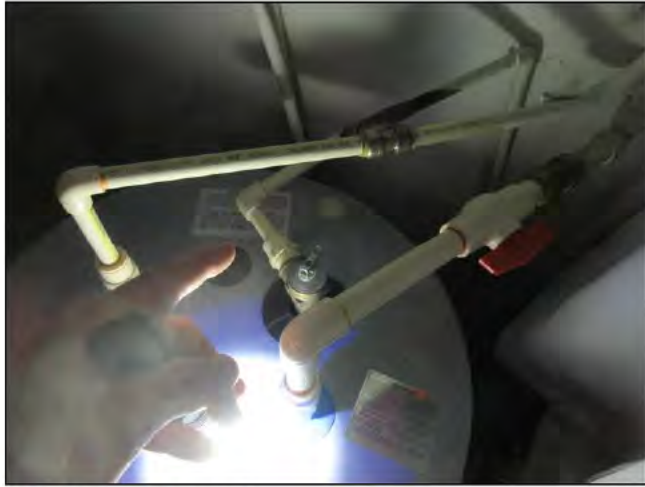
**6.2** 1732- Water Heater is missing a T & P Relief valve pipe. 1736- Water Heater is missing a T & P Relief valve pipe and has exposed romex wiring that should be encased. Garage- Water Heater has exposed romex wiring that should be encased. Unit 4- Water Heater is missing a T & P Relief valve pipe. Unit 3- Water Heater has an inappropriately sized T & P Relief valve pipe. T & P Pipes should be 3/4" diameter and not reduced to 1/2". Unit 2- Water Heater has an inappropriately sized T & P Relief

valve pipe. T & P Pipes should be 3/4" diameter and not reduced to 1/2". Unit 7- Water Heater is missing a T & P Relief valve pipe.

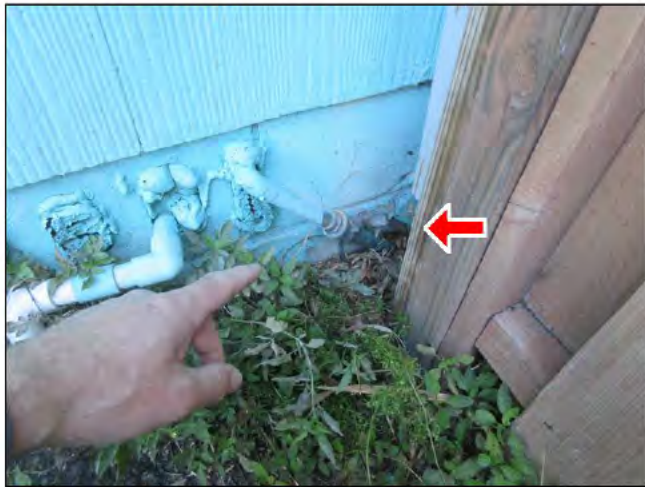
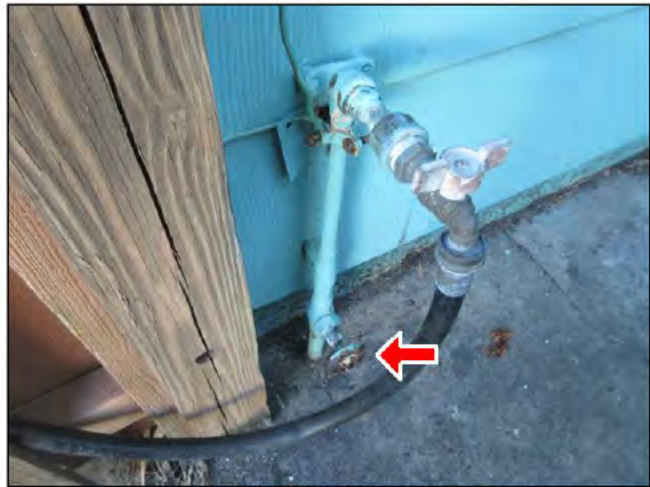
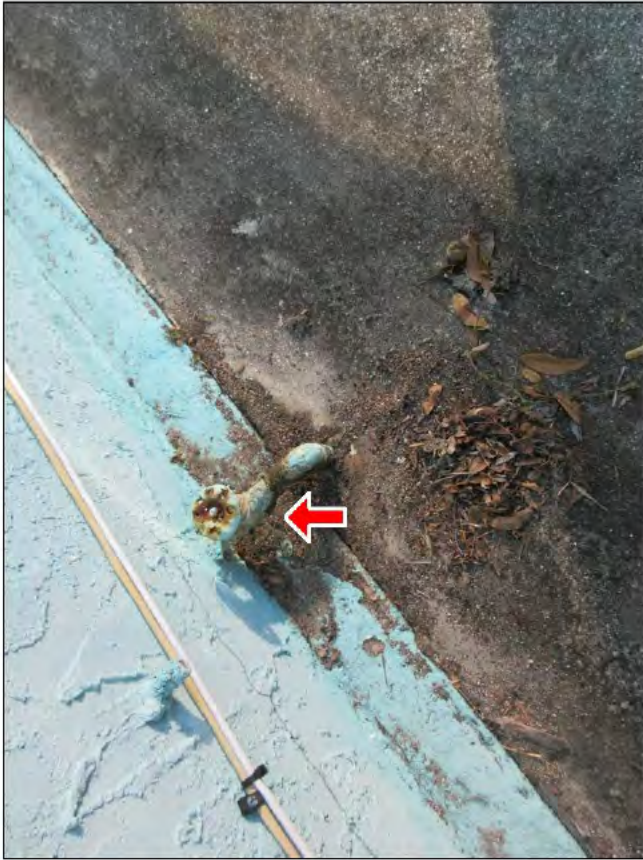
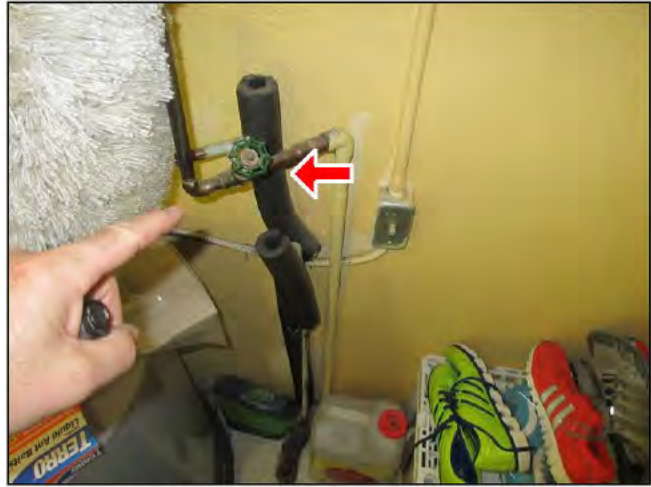
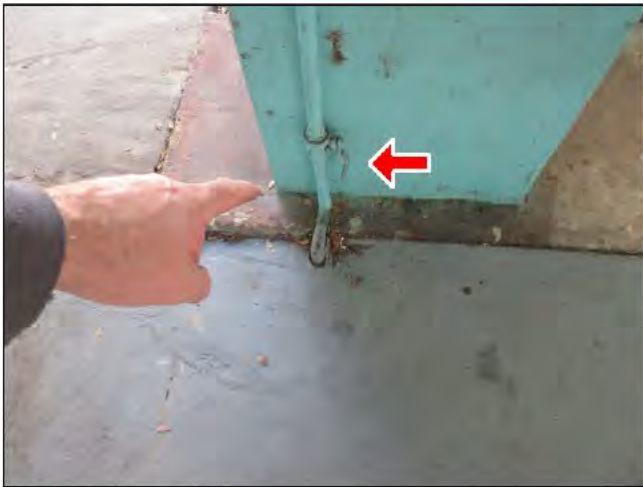
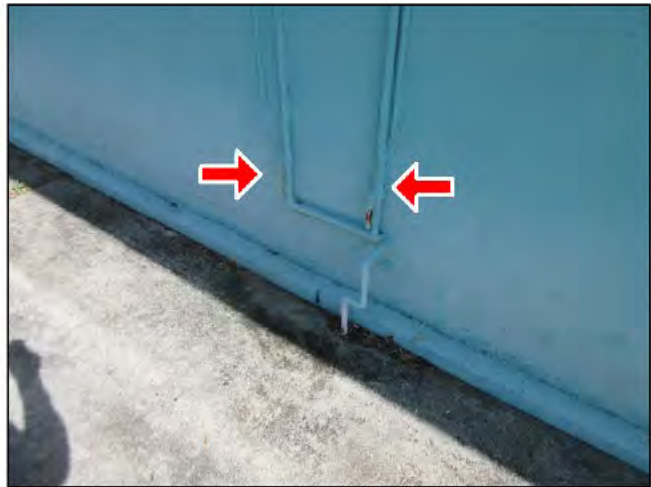
**6.3 1732/1736-** Main water shut-off (see photo). Garage- Main water shut-off (see photo). 8 Plex- Several water shut-off valves were observed at the front and rear of the 8 Plex (see photo's). We were unable to determine which valve was for which specific unit during this inspection. Unit 4- Shut-off valve was present behind the water heater.

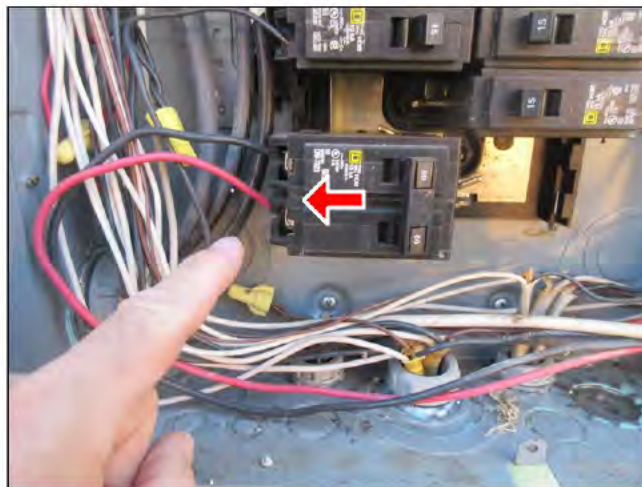
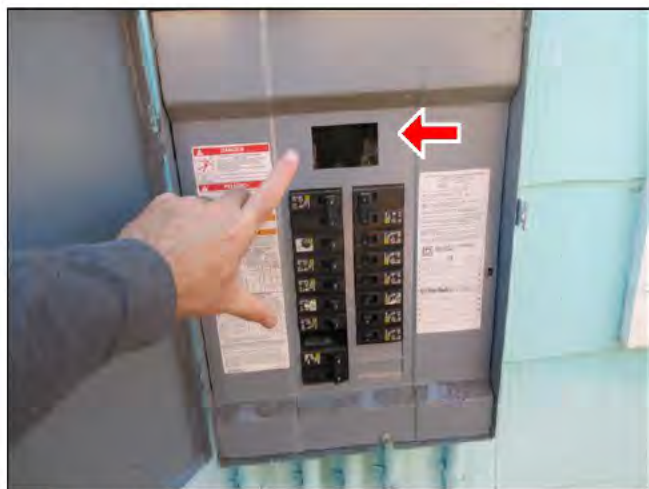
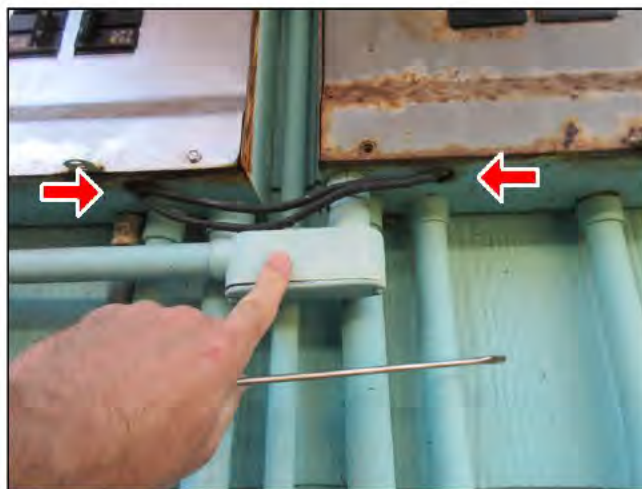
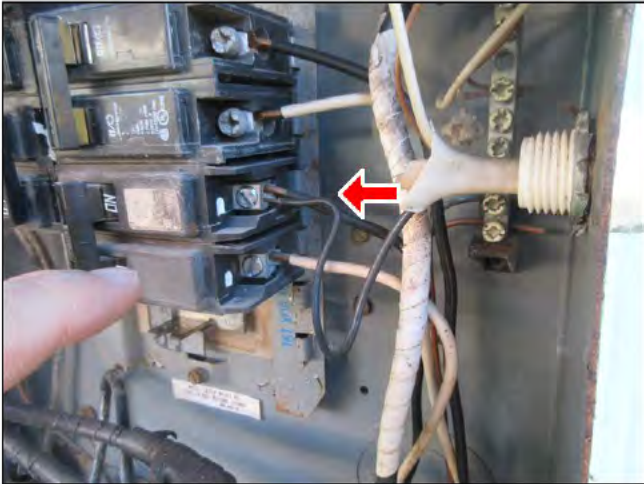
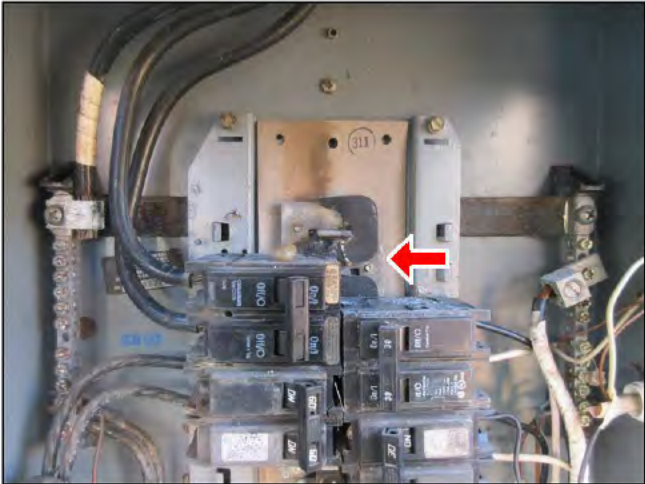
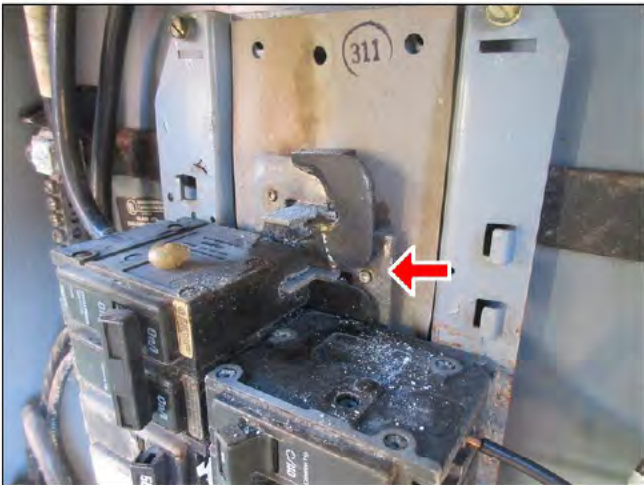
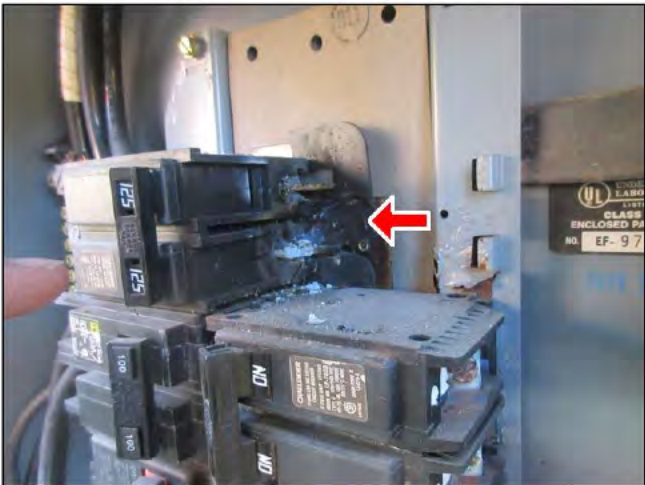
**7.1** 1732- Double tap present in the Federal Pacific sub-panel in the kitchen. Multiple issues are present at the Challenger meterbase panels at the right side of the home including: missing romex connectors, exposed wires, double wiring at circuits, burned or damaged breakers. Repairs are needed

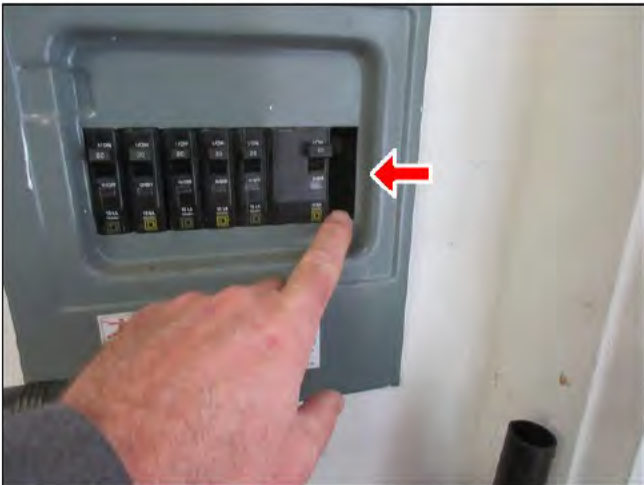
7.1 Item 9(Picture)

and safety hazards are present within these panels. Many insurance companies have issues with Federal Pacific and Challenger electrical panels. We recommend you check with your insurance company regarding these panels. 1736- Square D distribution panel in the kitchen is missing a knock out cover. Garage- Main panel has missing romex connectors, improper panel cover screws and mixed ground and neutral wires that should be terminated on separate grounding and neutral bars. Panel cover has water stains on the front from a leaking valve above. Unit 3- Double taps are present in the sub-panel in the kitchen. Unit 7- Square D distribution panel in the kitchen is missing a knock out cover. Recommend further evaluation from a licensed electrical contractor and repair as needed.

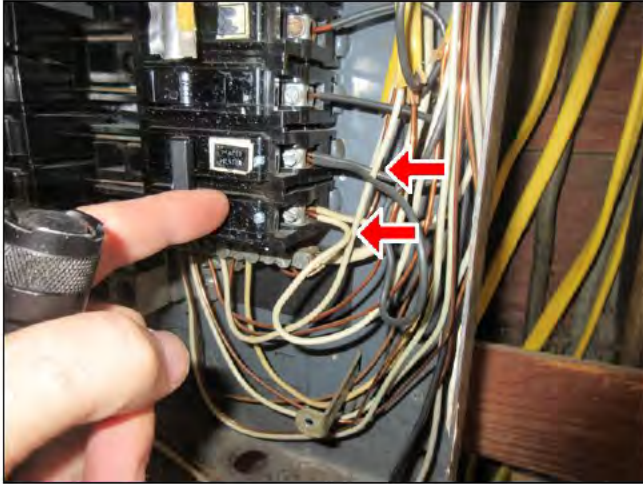
7.2 Item 1(Picture)

**7.2** Garage- Several breakers have double wiring and/or over fused breakers. Recommend further evaluation from a licensed electrical contractor and repair as needed.

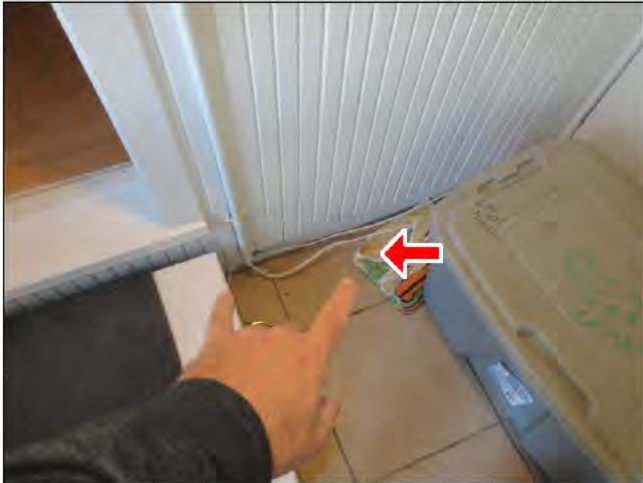
7.3 Item 1(Picture)

**7.3** 1732- Exposed romex wiring running along the floor near the rear entry door should be secured and encased in conduit. Several open slices are present in the water heater area. 1736- Three prong outlet at the rear of the home at the left side of the rear entry door is either not working properly or is ungrounded. Ceiling fan in the living room is missing a blade. Improperly wired attic light is present in the attic above the pull down stairs. Garage- Open splice observed above the electrical distribution panel. Rear storage area has an improperly wired and installed overhead light. Unit 8- At least one three prong outlet is wired incorrectly at the living room (hot/neutral reversed). Unit 5- At least one three prong outlet is wired incorrectly at the dining room (open ground). Recommend further evaluation from a licensed electrical contractor and repair as needed.

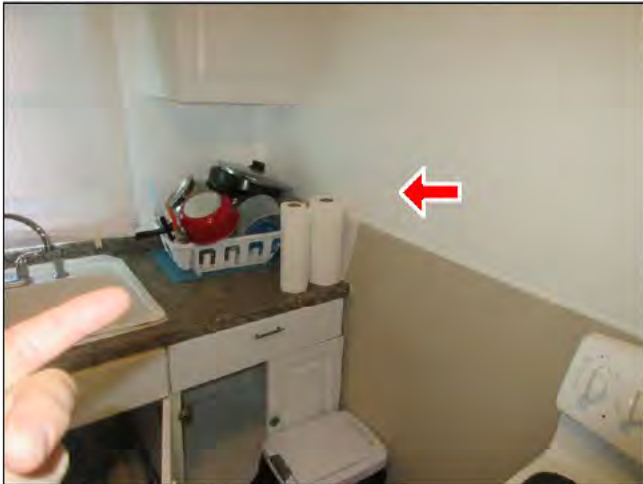
7.5 Item 1(Picture)

**7.5** Few GFCI receptacles were present at the units. Recommend safety upgrade to GFCI receptacles at the exterior of units, garage, bathrooms, kitchens and any receptacle within 6' of a water source.

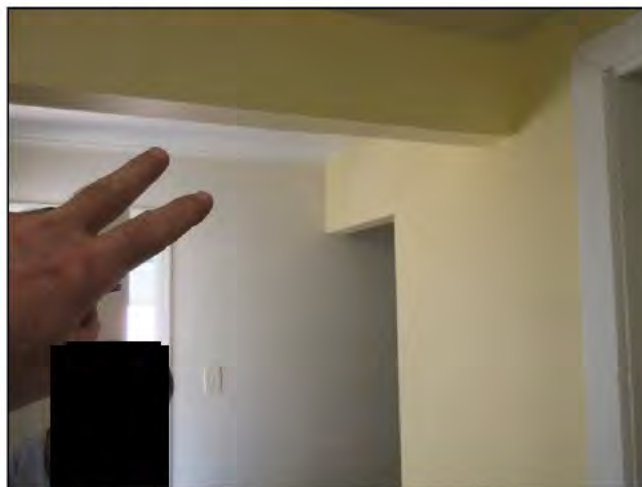
7.8 Item 2(Picture)

**7.8 Multiple Smoke detectors missing or not working throughout the units. Recommend safety upgrade to include smoke detectors in each room of every unit.**
