## **Inspection Report**

**KMI Home Inspections, Inc.**

**Kapp A. McMullin, HI11423  
5932 Wildwood Ave.  
Sarasota, Florida 34231  
941-350-2927**

<b>Date:</b> 11/26/2021	<b>Time:</b>	<b>Report ID:</b>
<b>Property:</b>	<b>Customer:</b>	<b>Real Estate Professional:</b>

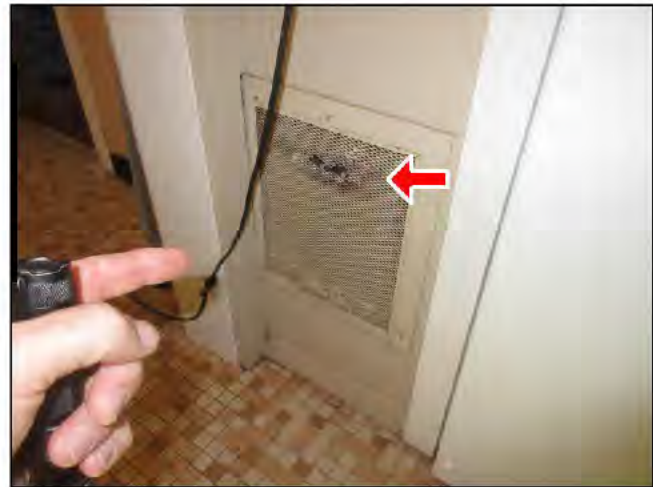
8.0 Item 2(Picture)

**8.0** 1732- The air handler closet is blocked with a large entertainment center. We were unable to observe this area. Garage- Wall mounted heater in the guest bath has a damaged or melted cover. This is considered unsafe and should be repaired or removed. 8 Plex- Older Wall Mounted Heating Elements were not inspected.

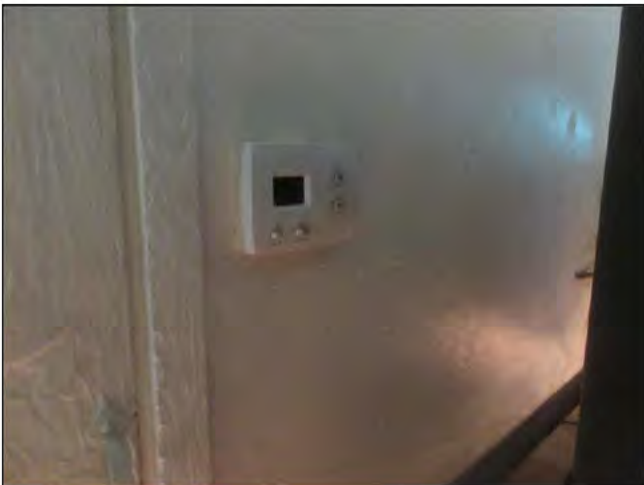
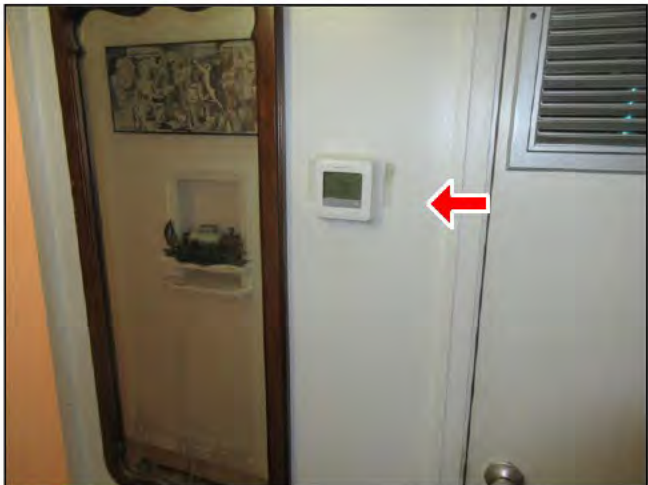
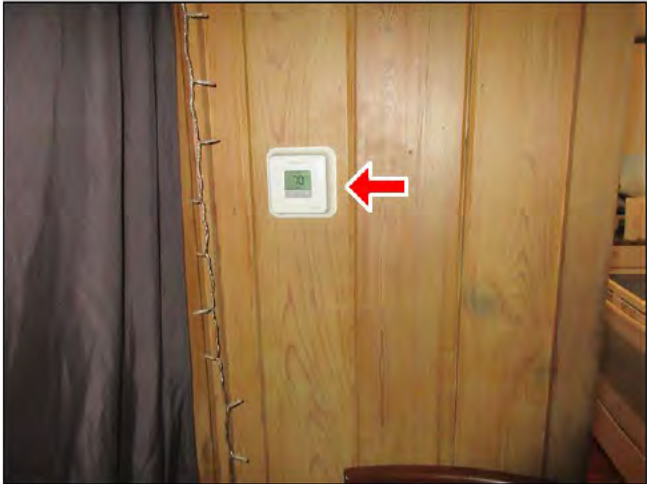
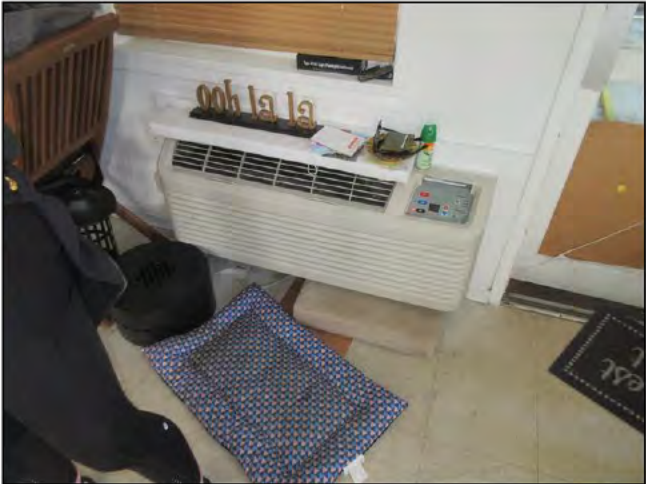
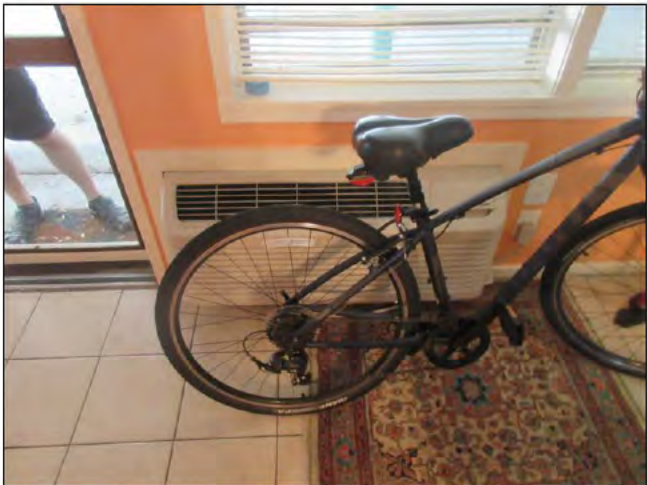
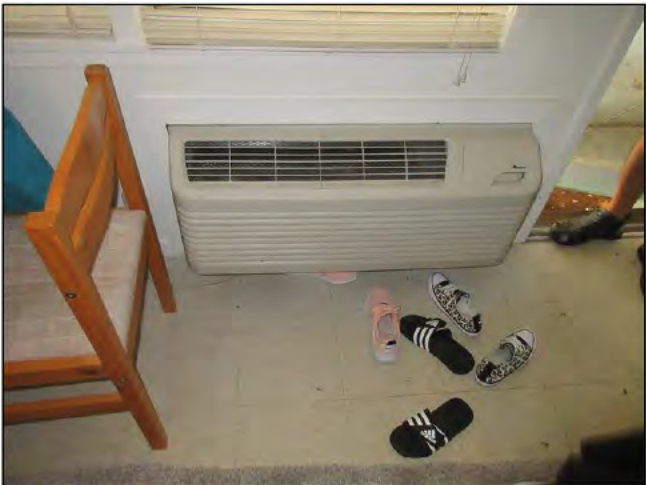
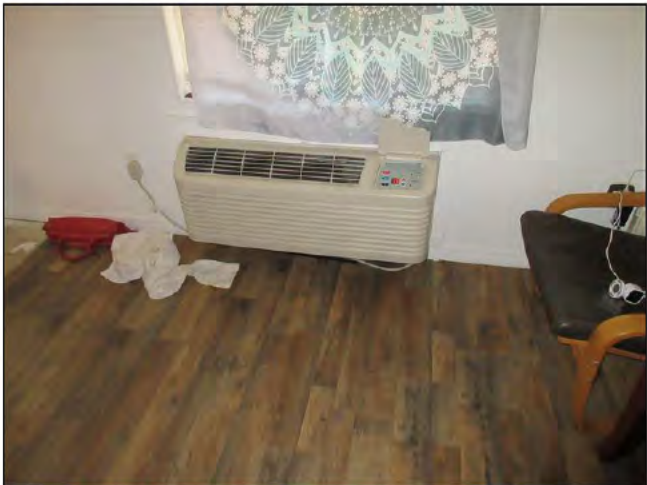
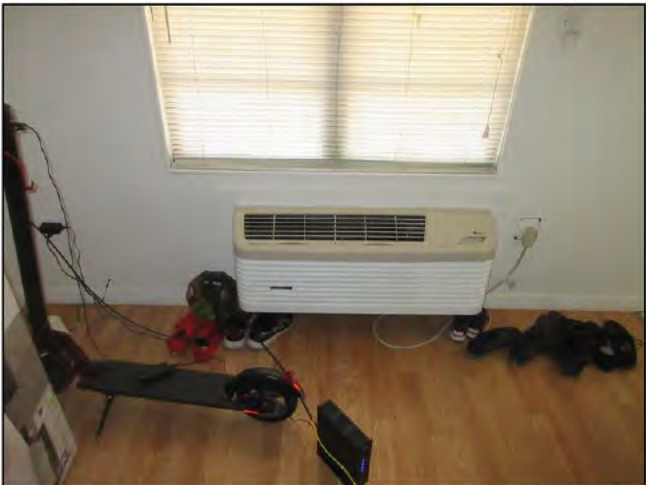
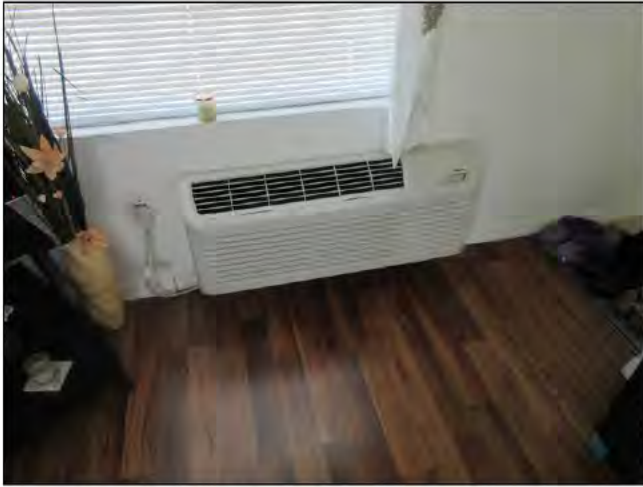
**8.1** 1732- The thermostat is located in the living room. 1736- The thermostat is located in the living room. Garage- The thermostat is located in the living room. 8 Plex- Thermostats located on the wall units.

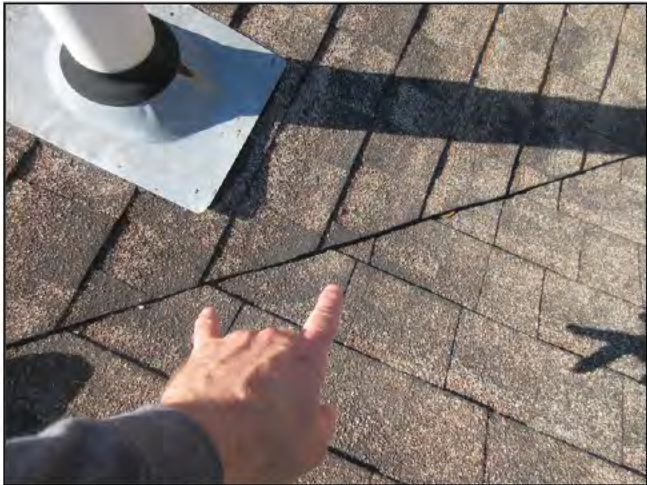
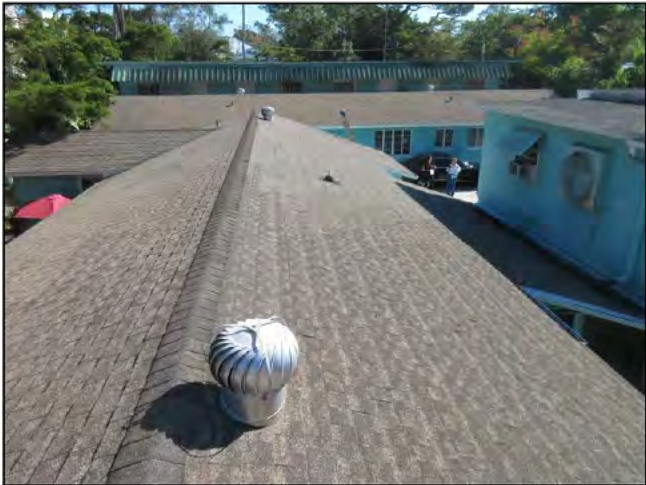
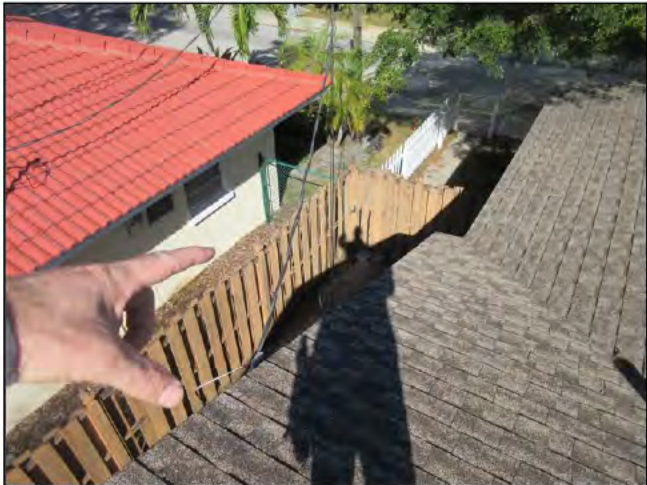
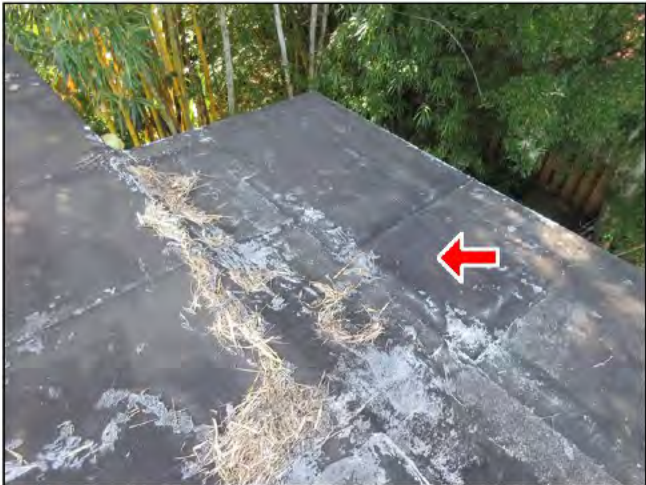
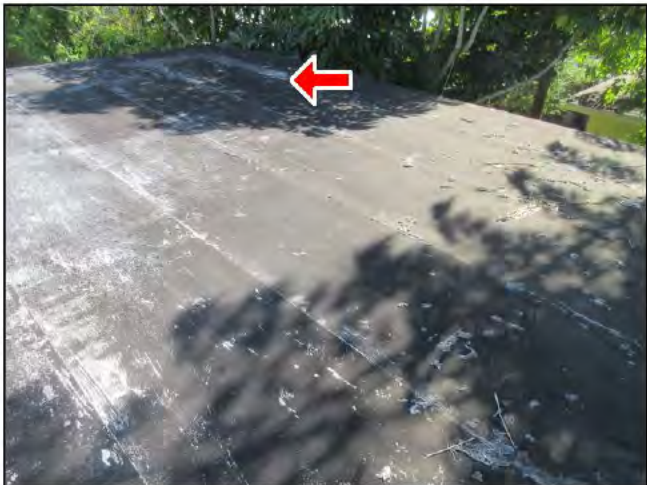
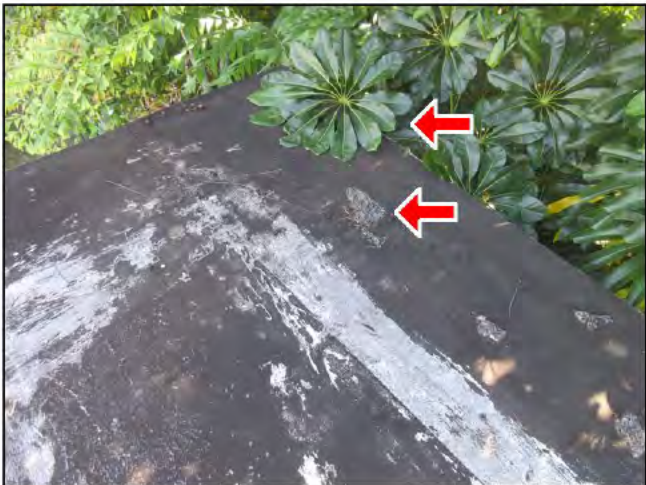
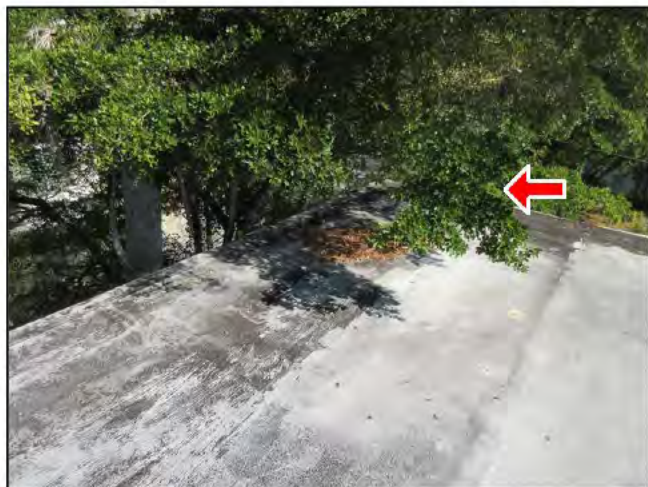
1732/1736- Roof covering has significant granular loss and has exceeded its useful life expectancy. Membrane roof covering above the garage unit and 8 Plex shows several areas that pond water. Tree limbs are in contact with the garage roof and the 8 Plex roof and should be trimmed. Recommend further review from a licensed roofing contractor and repair as needed.

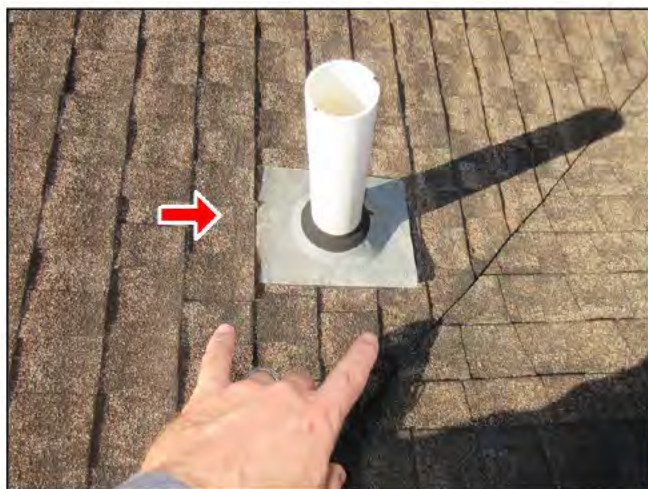
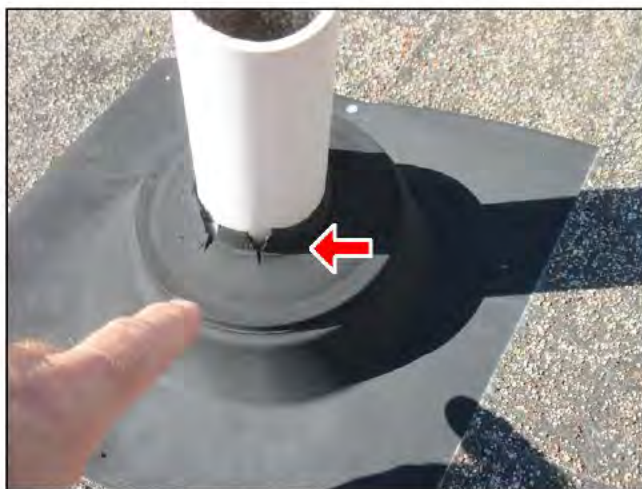
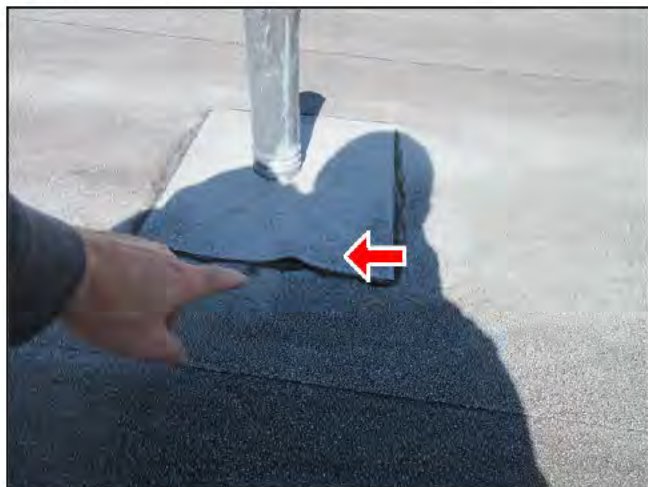
1732/1736- Several flashing boots are damaged or installed improperly. Repairs are needed. Bitumen flashing above the 8 Plex has pulled loose near the plumbing vent pipe. Recommend a licensed roofing contractor repair as needed.

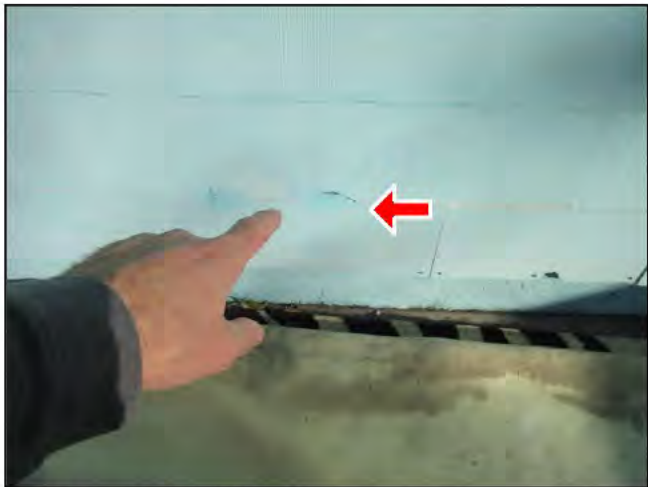
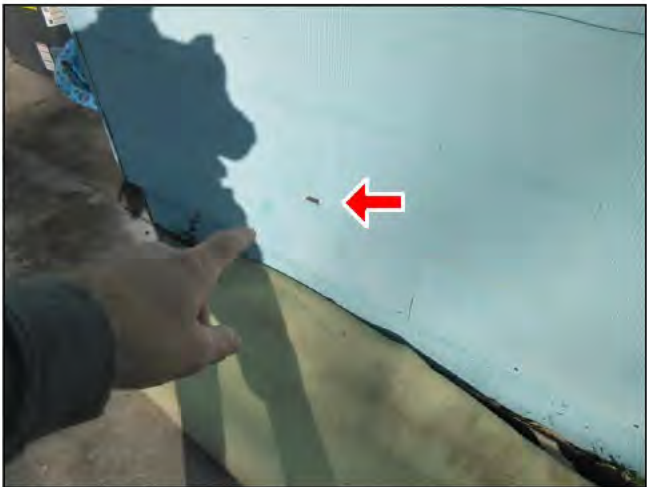
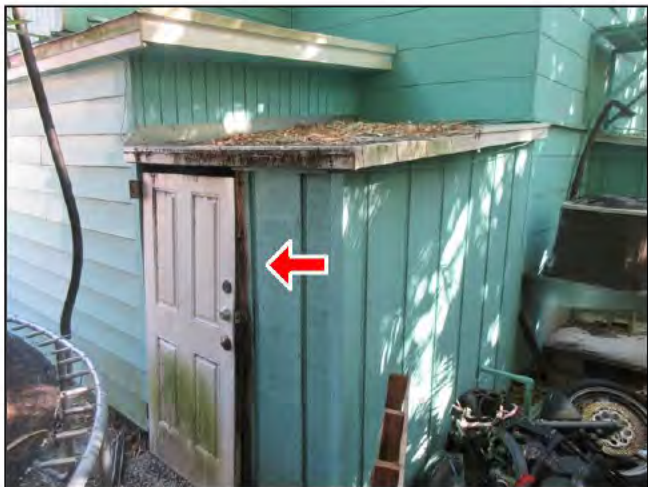
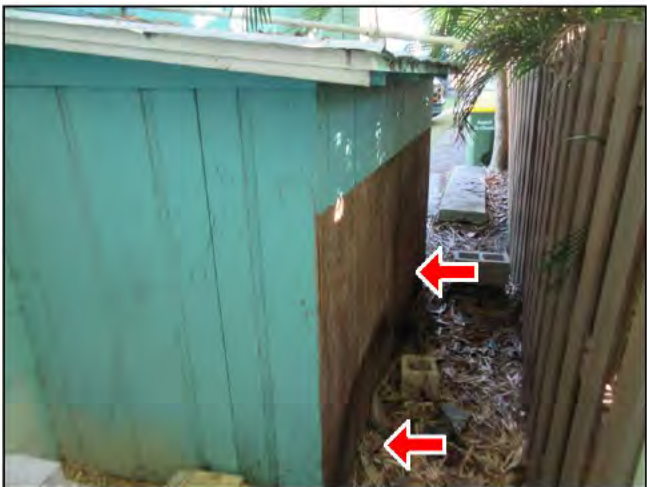
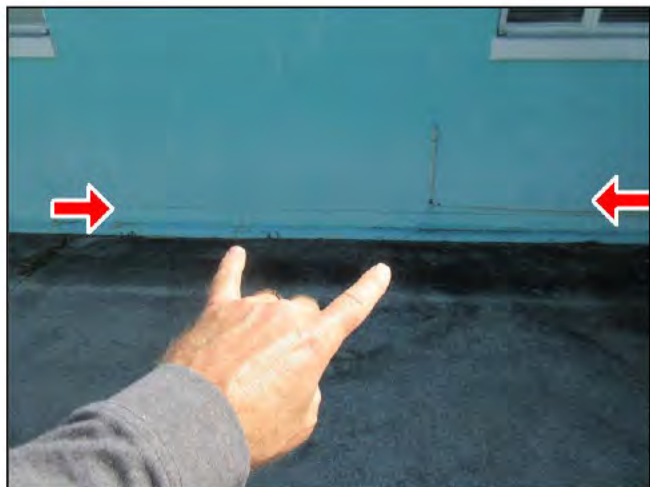
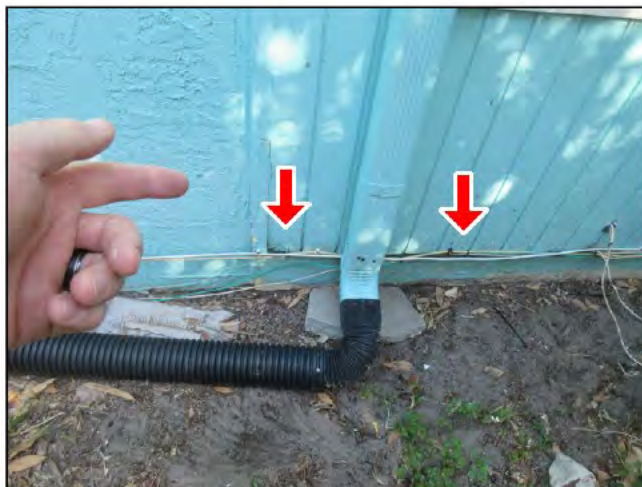
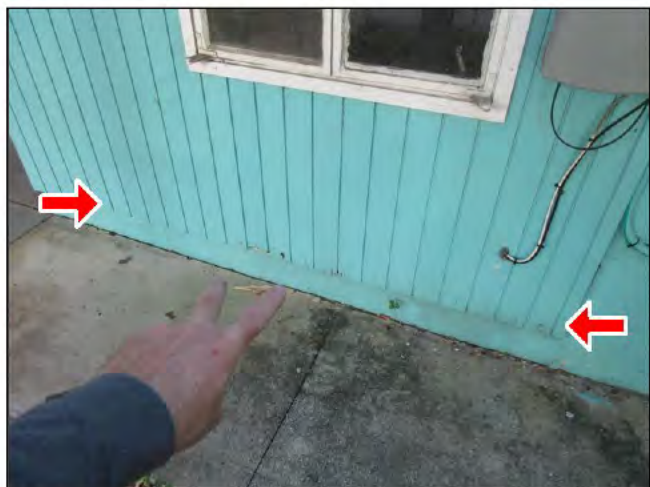
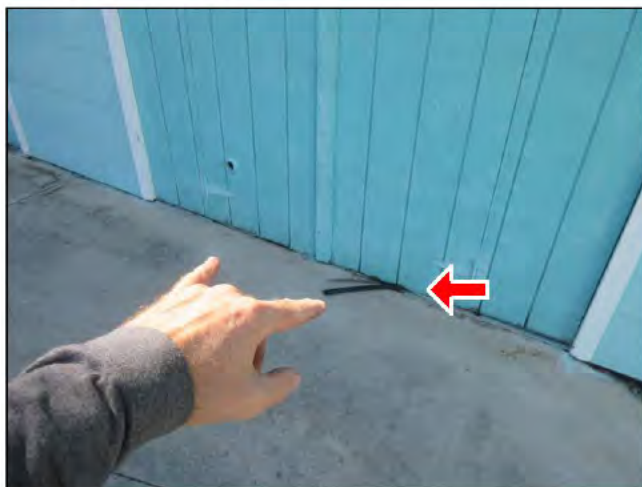
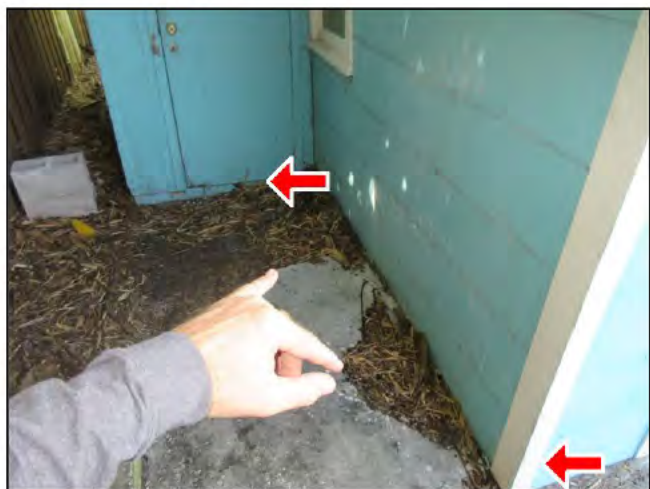
1732- Multiple slate tiles are damaged or cracked on the perimeter of the unit. Garage- Rear and side sheds are deteriorated at the door frame and/or siding and need repairs. 8 Plex- Masonry coating on the rear of the lower units has several hairline settlement cracks. Displacement was not observed (for your information). 8 Plex- Wood siding at the lower level is partially deteriorated in several areas. Recommend repair as needed.

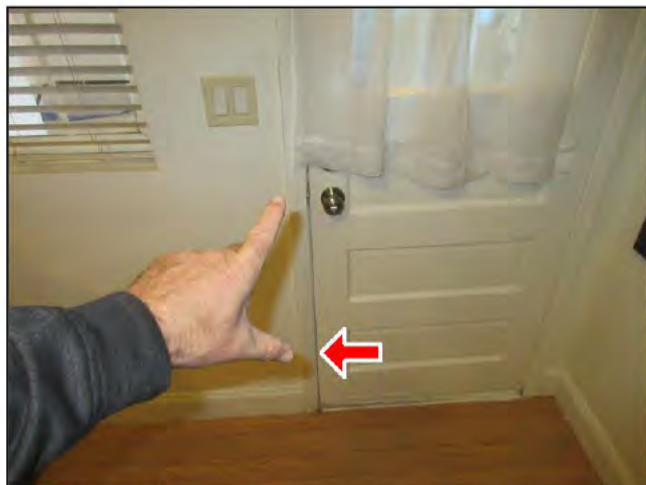
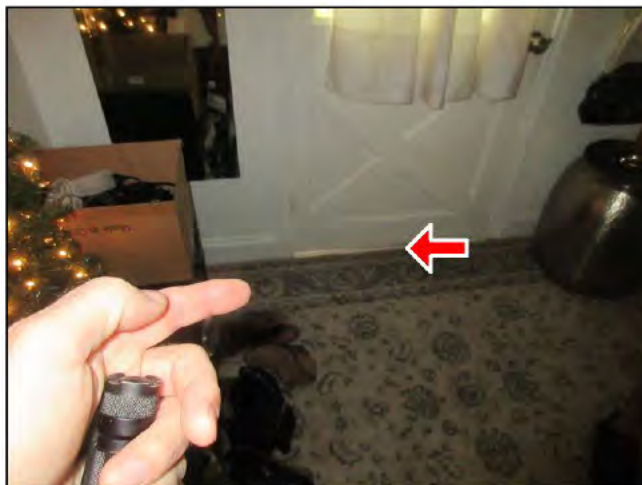
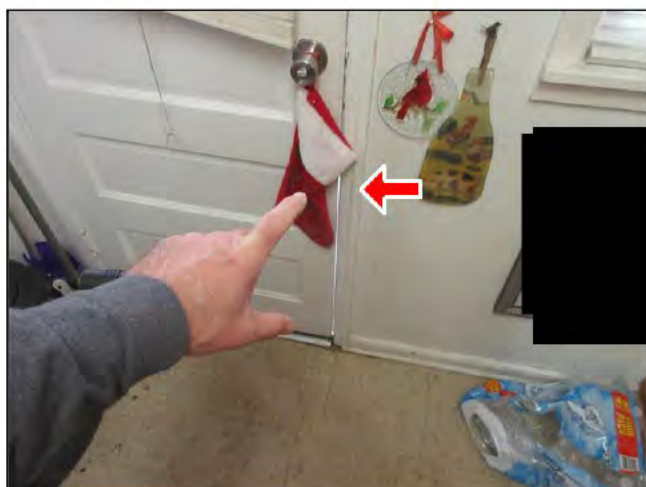
1732- Front and rear entry doors are missing weather stripping. 1736- Front and rear entry doors are missing weather stripping.

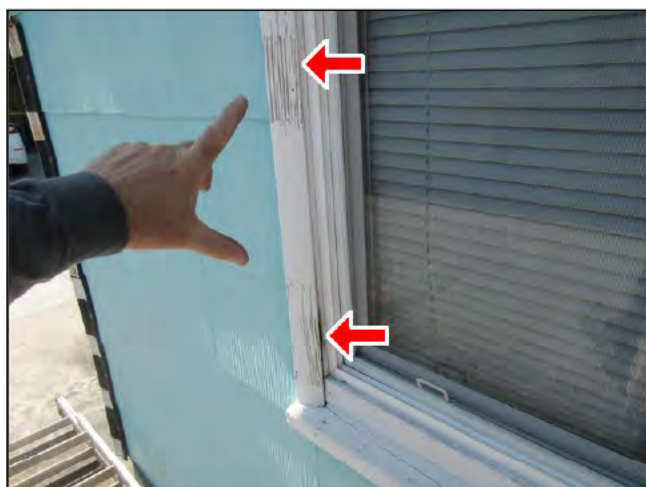
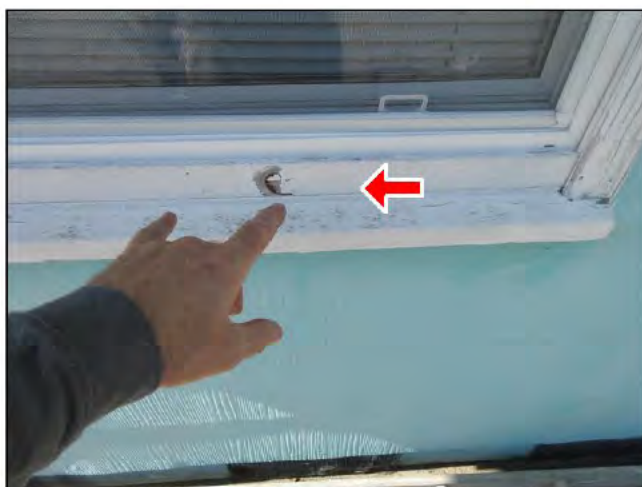
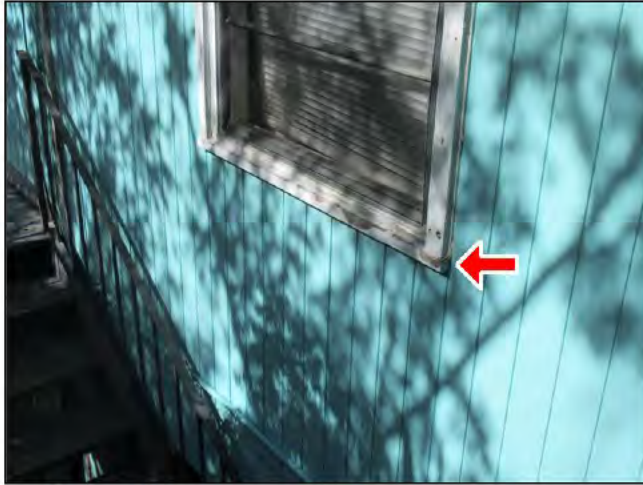
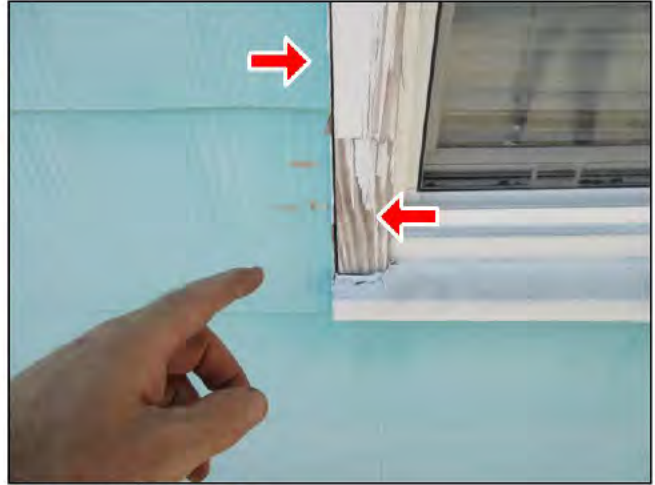
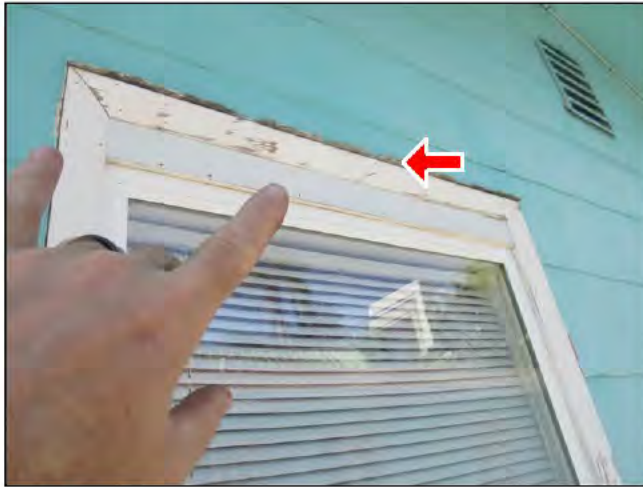
Multiple window frames or trim around the units are peeling paint. Recommend seal, prep and paint as needed.

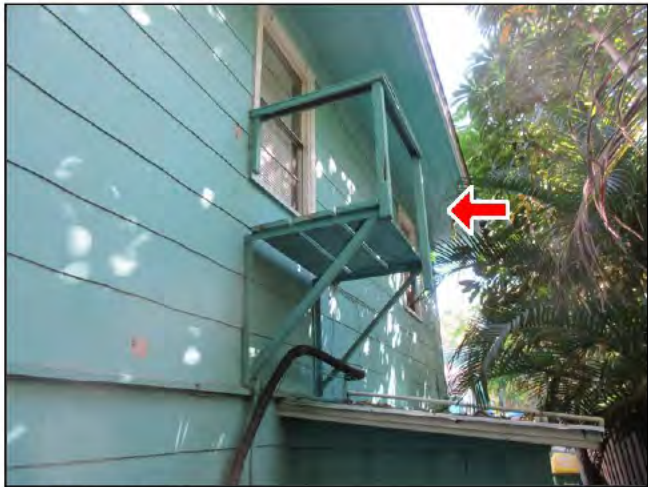
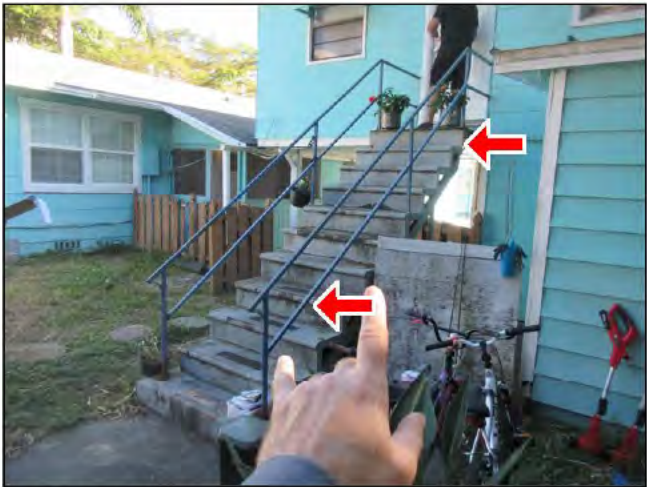
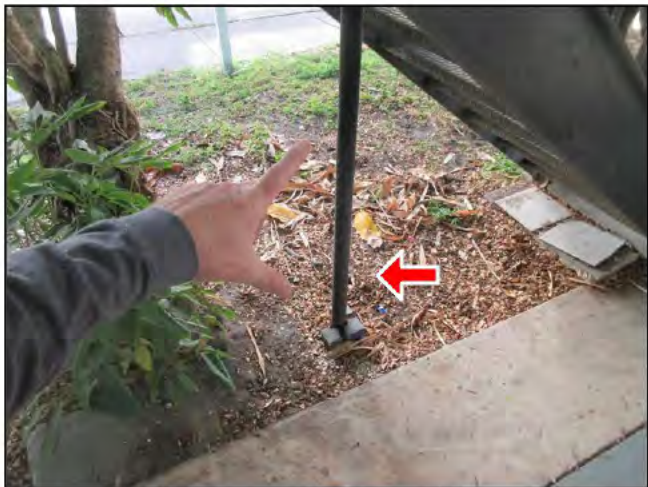
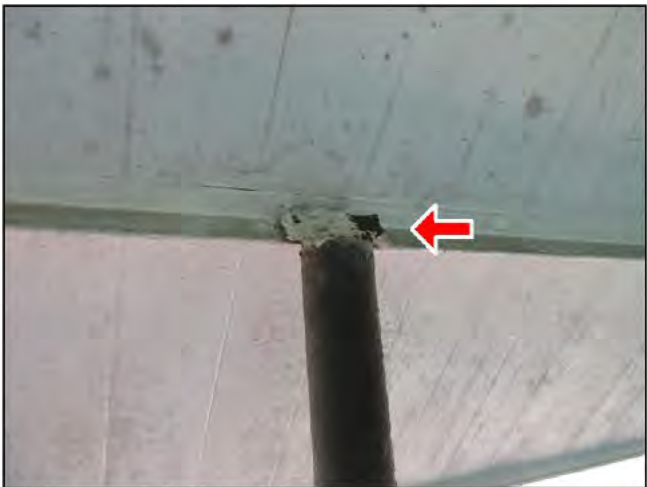
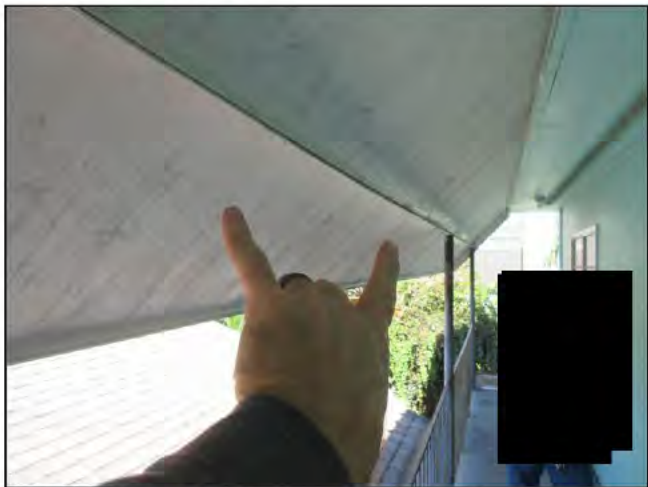
Garage- There is a platform at the rear side wall of the upper garage apartment near one of the windows. The purpose of this platform is unknown. Pickets on the handrail leading to the upper garage apartment are spaced too far apart for safety. Recommend 4" max spacing for safety. Support post below the right side stairs (facing front) of the 8 Plex is loose and needs securing. At least one support post for the metal awning on the back side of the 8 Plex is loose and needs securing at the

top.

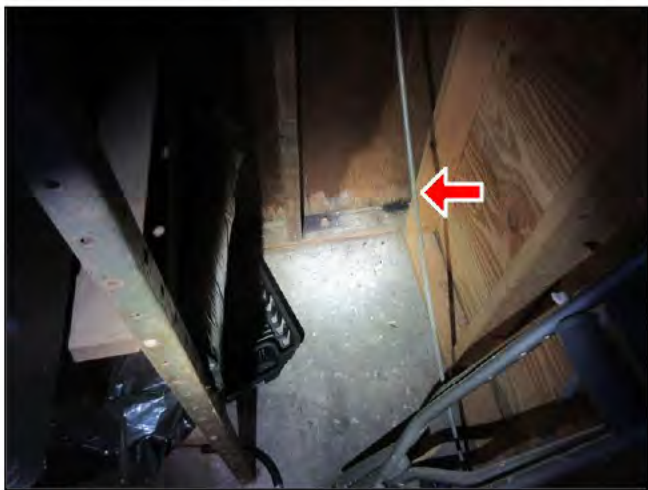
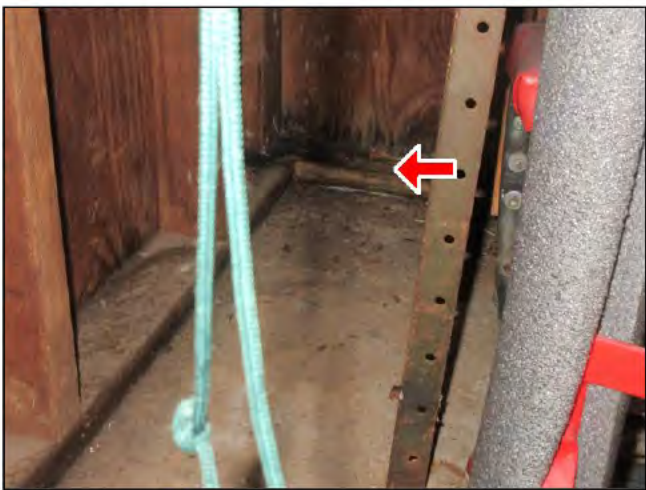
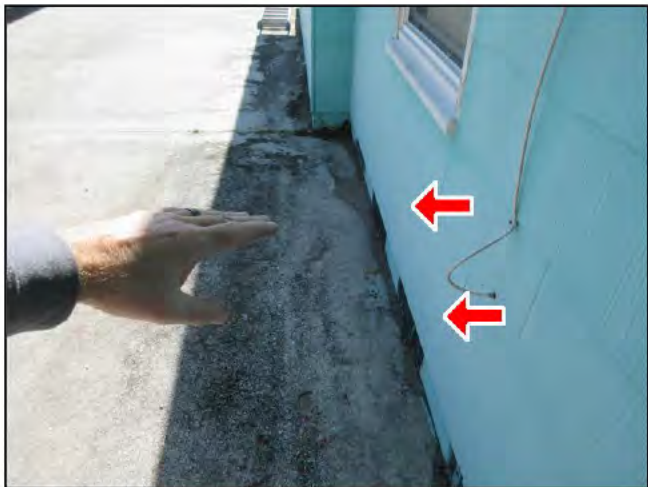
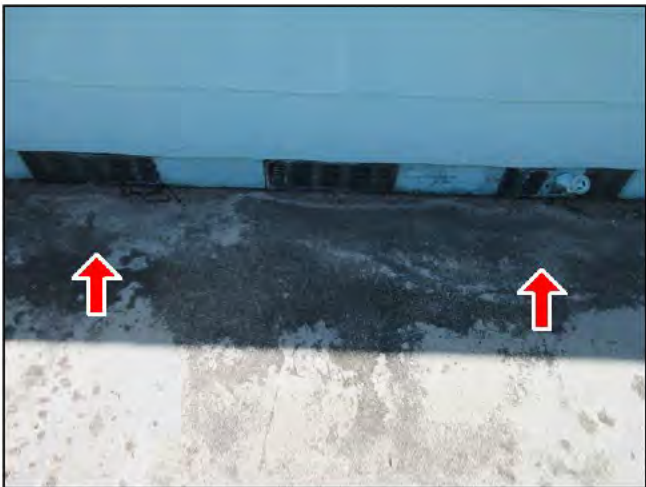
Water stains are present on some of the lower components of the garage walls. Drainage may need to be corrected in these areas. Recommend monitoring during a heavy rain and correcting as needed. Concrete slopes towards the foundation vents on the left side of the Duplex. Water may enter the

crawlspace during periods of heavy rain. Recommend monitoring and correcting as needed.

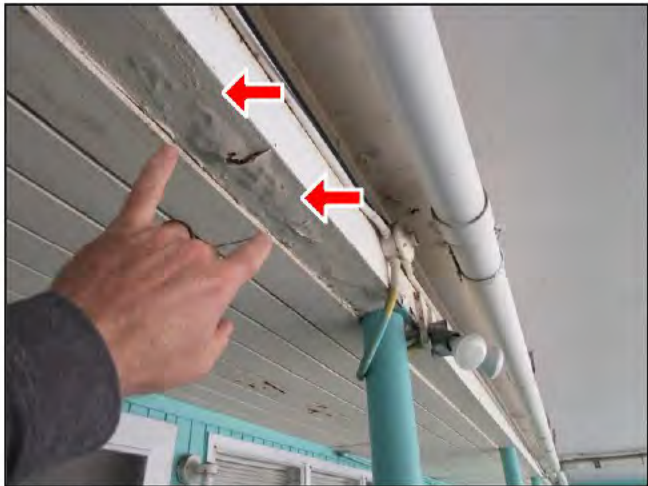
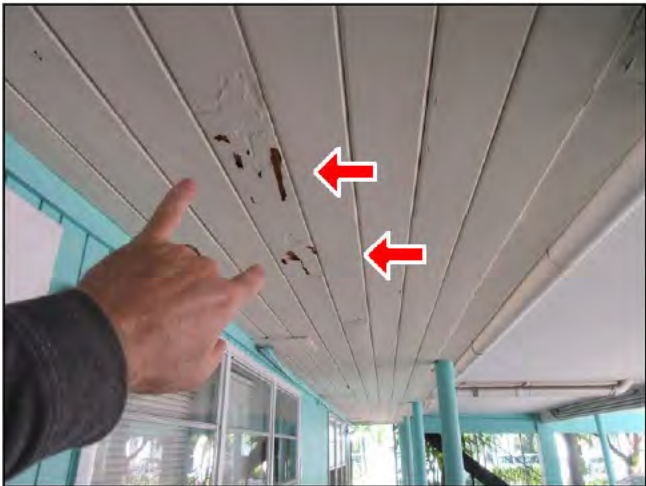
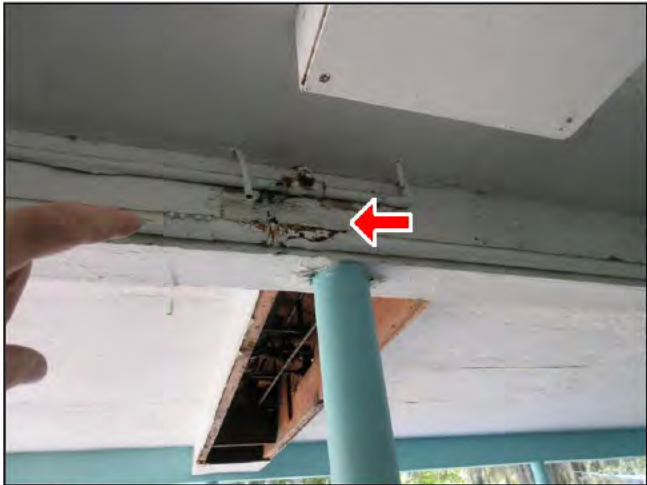
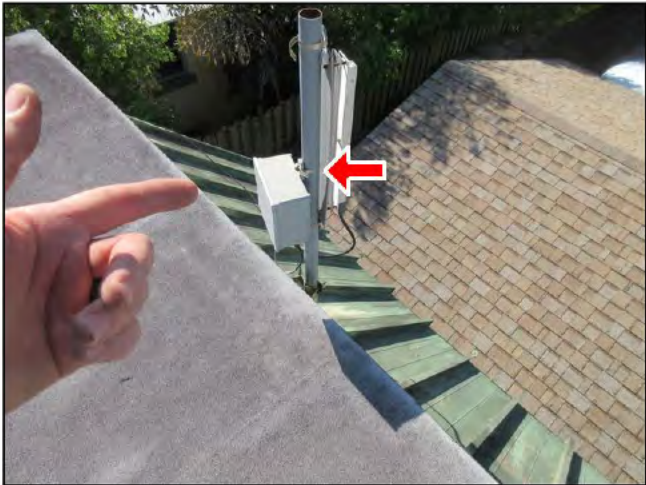
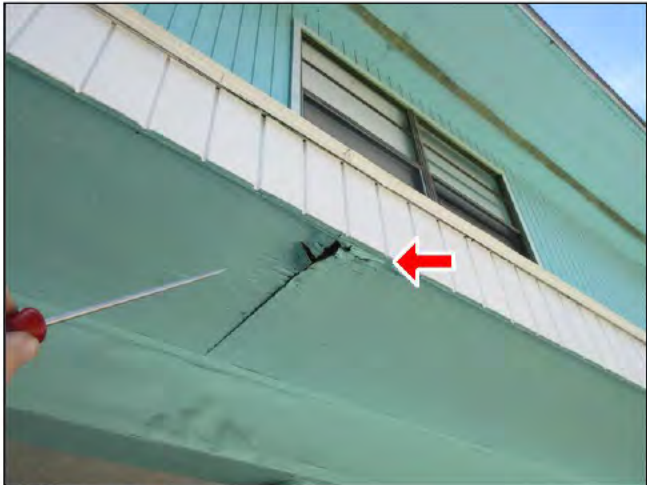
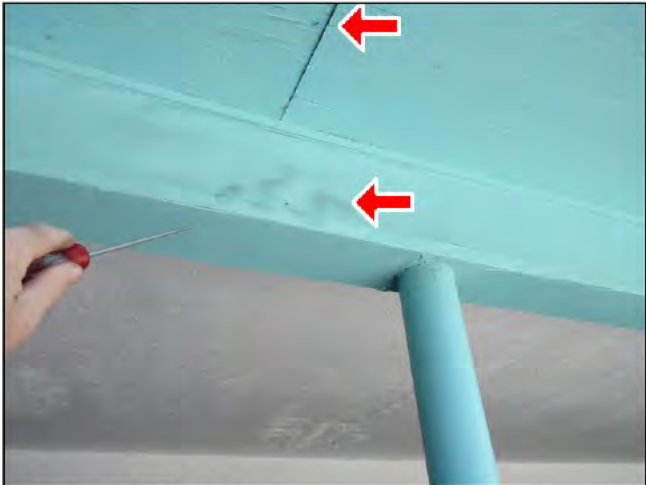
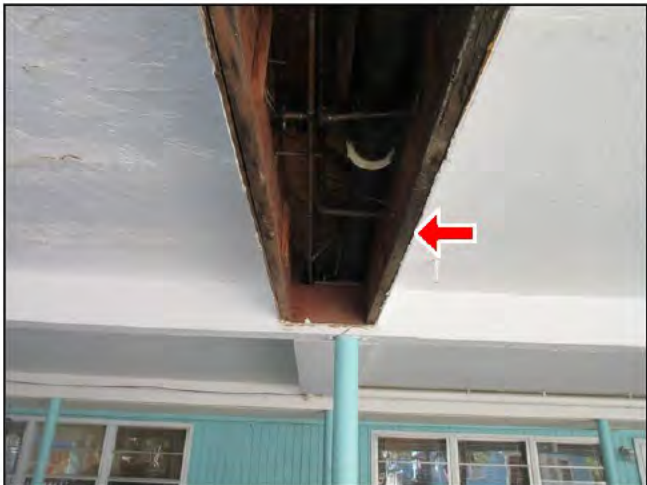
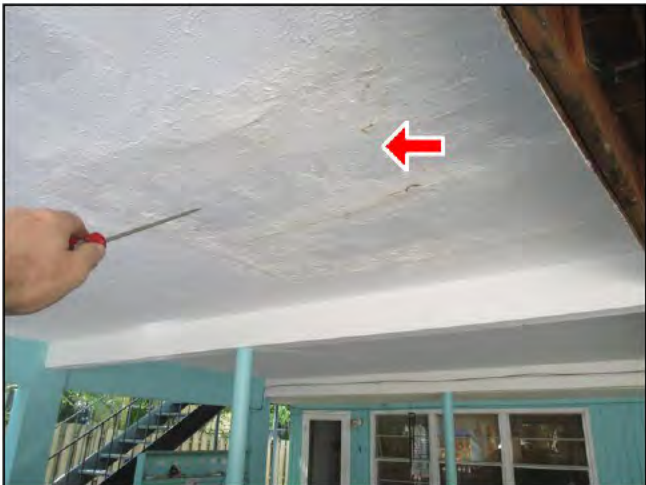
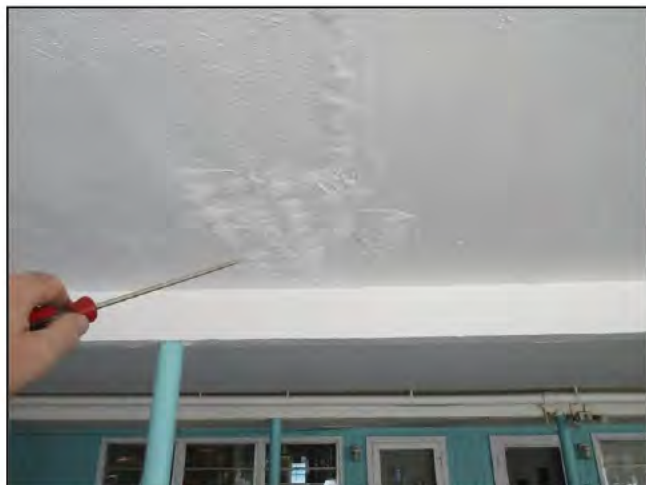
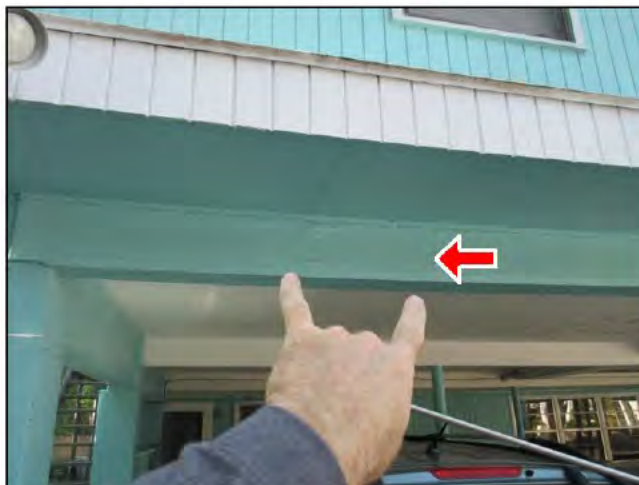
8 Plex- Ceiling and beams above the carport of the 8 Plex is damaged/deteriorated or missing or peeling paint at several areas. Repairs are needed. Former antenna mast is loose and needs securing or removal above the 8-Plex.

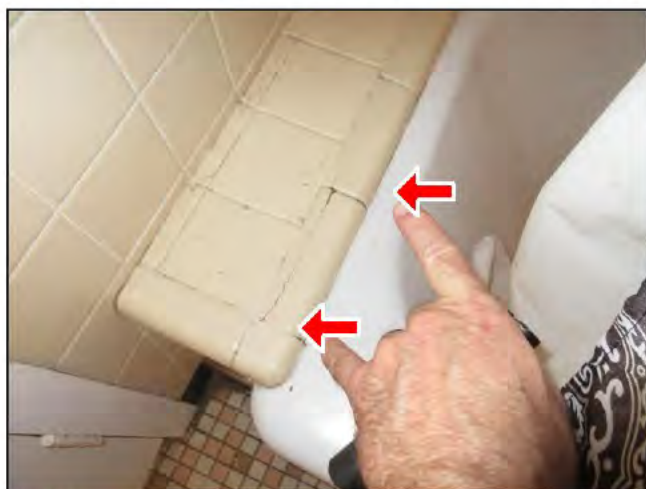
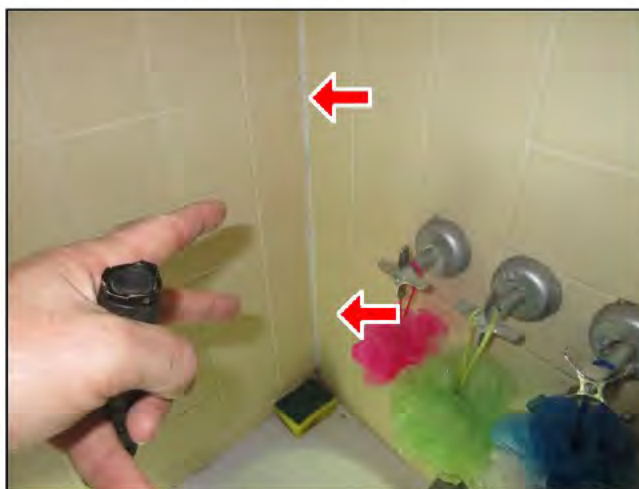
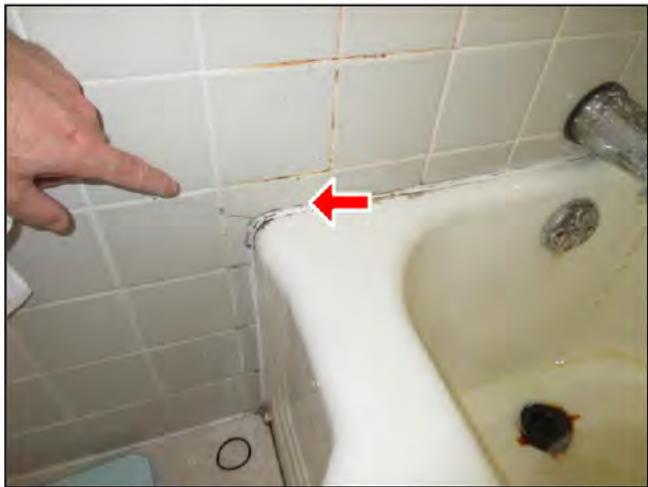
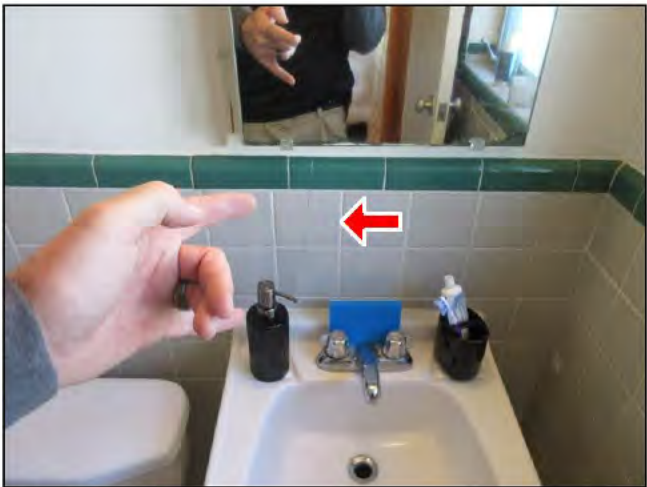
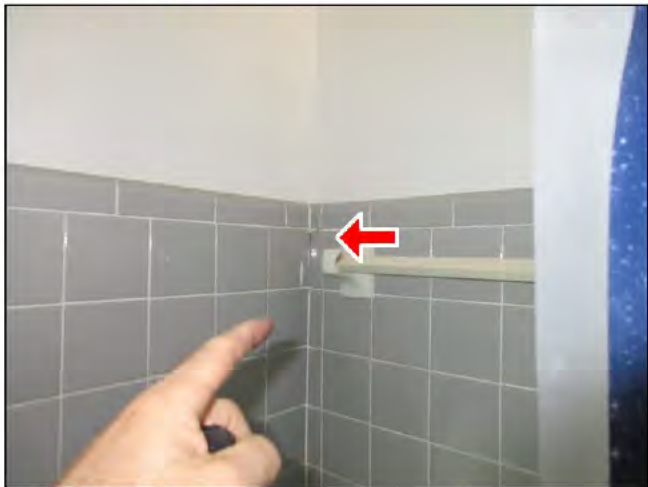
Garage- Several tiles are loose or cracked at the shower surround. Repairs are needed. Unit 3- Several tiles are loose or cracked at the tile shower and wall surround. Repairs are needed. Unit 7- Several tiles are loose or cracked at the tile shower and wall surround. Repairs are needed.

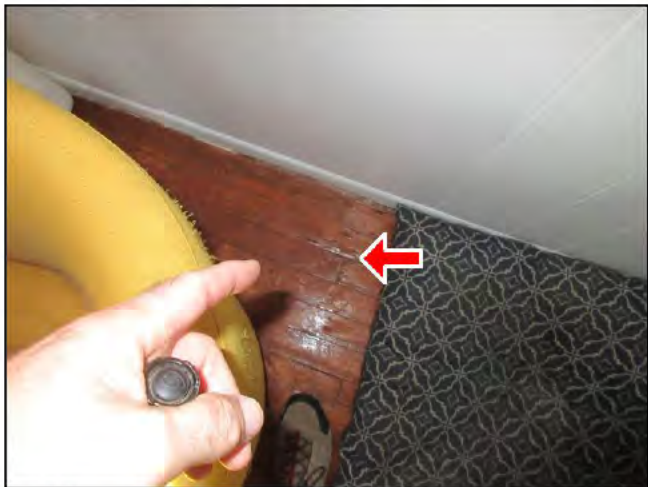
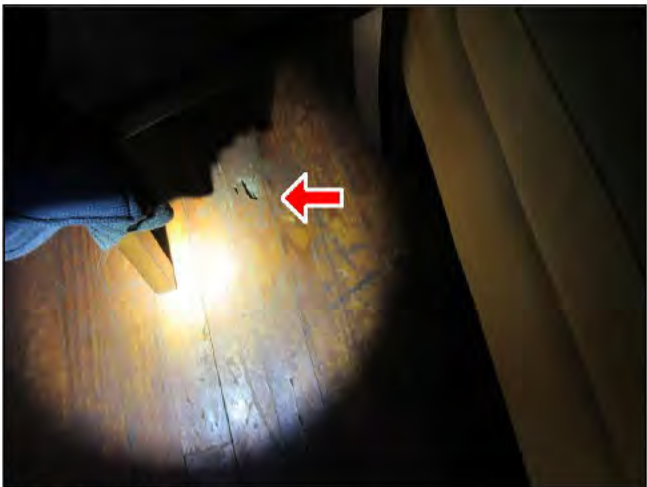
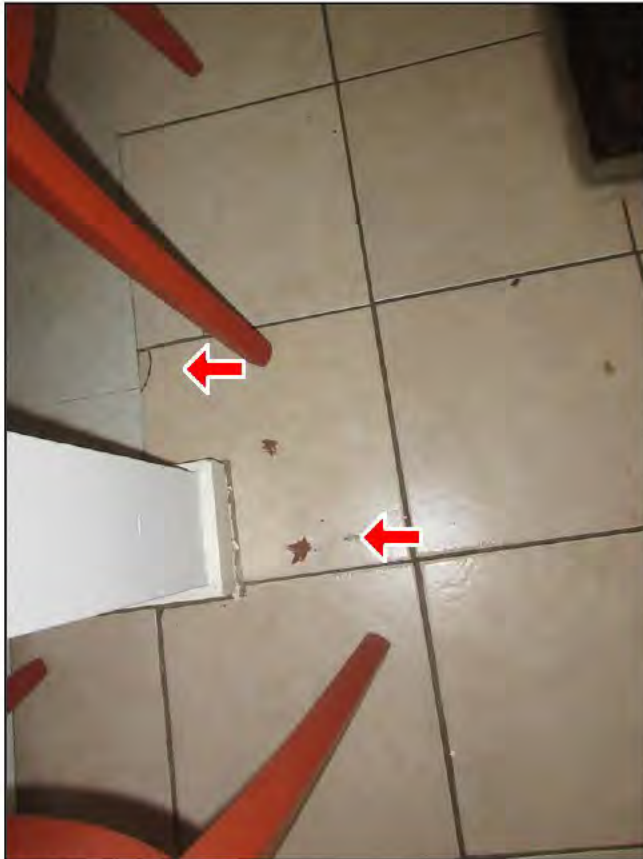
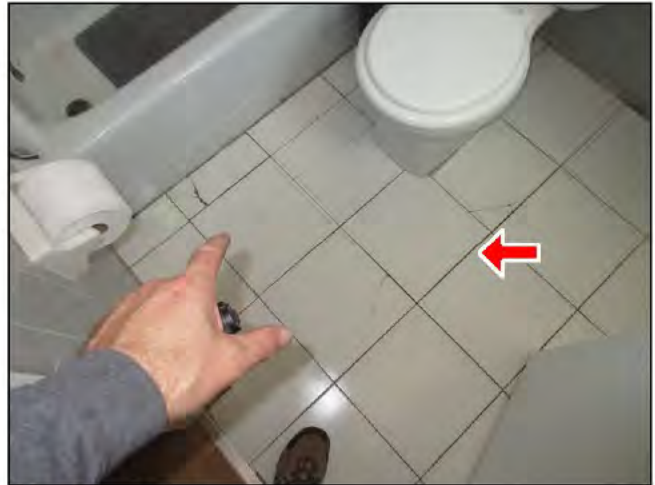
Garage- Wood floor at the living room is damaged at several locations. Unit 3- Several damaged or chipped floor tiles are present in the kitchen/living room. Unit - Several damaged or chipped floor tiles are present in the bathroom. Recommend repair as needed.

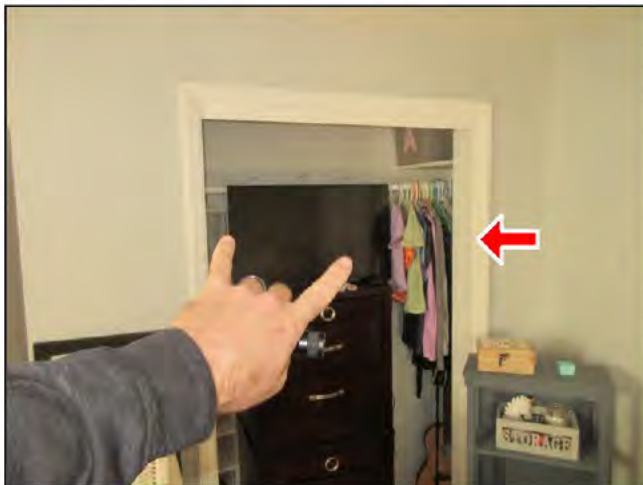
4.5 Item 1(Picture)

1732- Closet door is missing at the front guest bedroom.
