## **Inspection Report**

**KMI Home Inspections, Inc.**

**Kapp A. McMullin, HI11423  
5932 Wildwood Ave.  
Sarasota, Florida 34231  
941-350-2927**

<b>Date:</b> 11/26/2021	<b>Time:</b>	<b>Report ID:</b>
<b>Property:</b>	<b>Customer:</b>	<b>Real Estate Professional:</b>

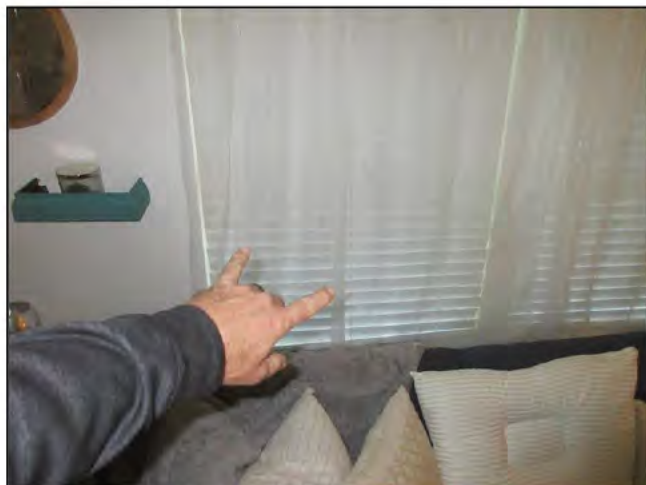
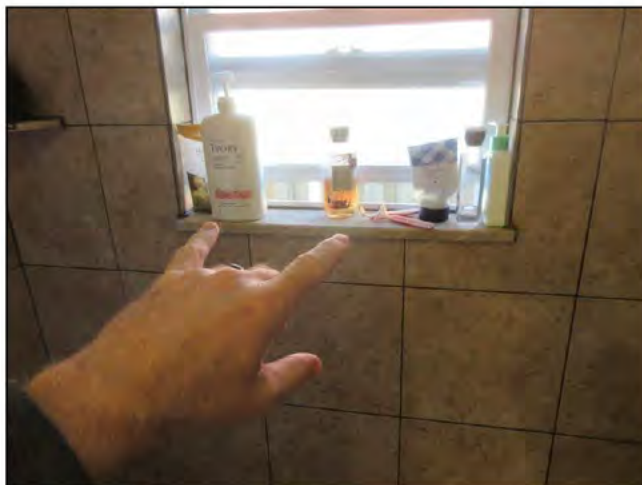
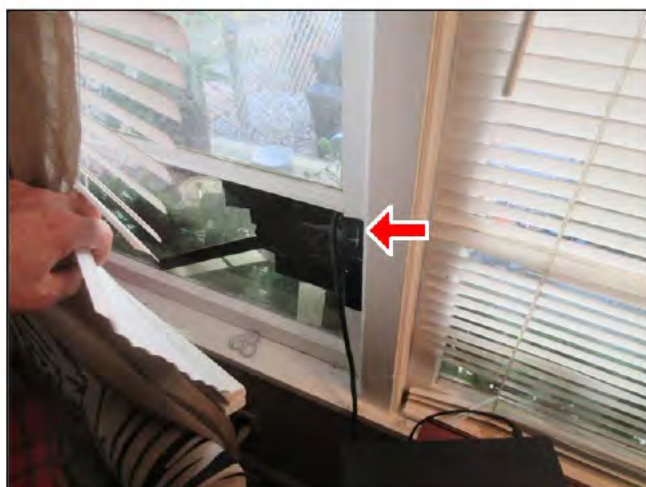
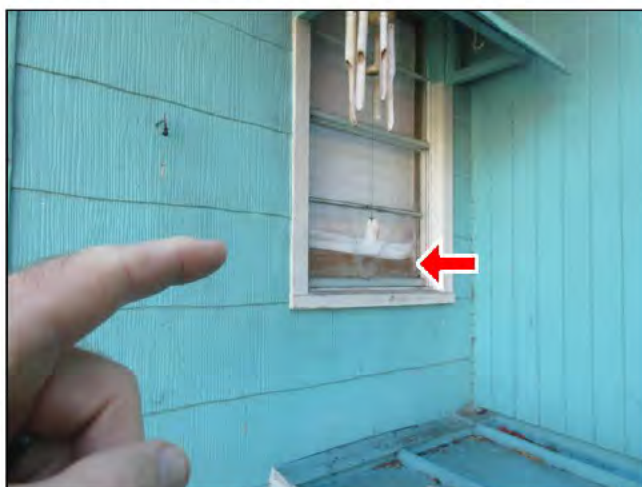
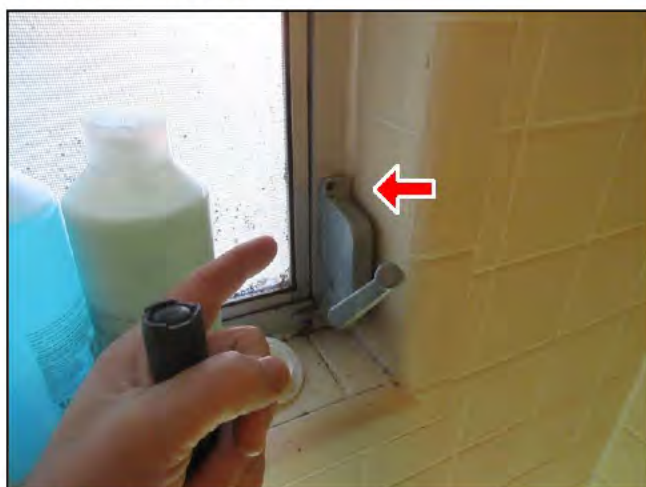
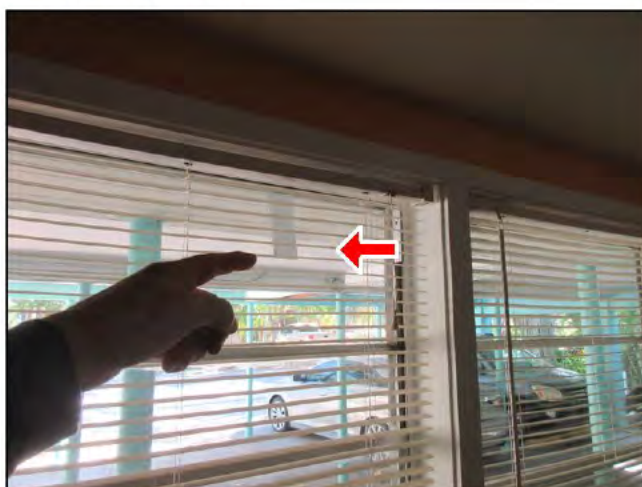
1732- Several windows difficult to operate or missing screens throughout the unit. 1736- One window at the front of the home is damaged at the glass pane. Garage- One window at the side of the home is damaged at the glass pane. Shower window crank unit is missing a screw and needs repair to operate properly. 8 Plex- Multiple windows are missing screens or are difficult to operate.

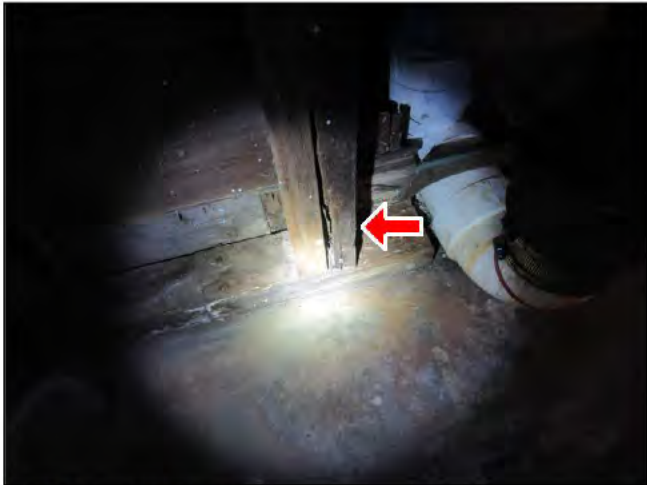
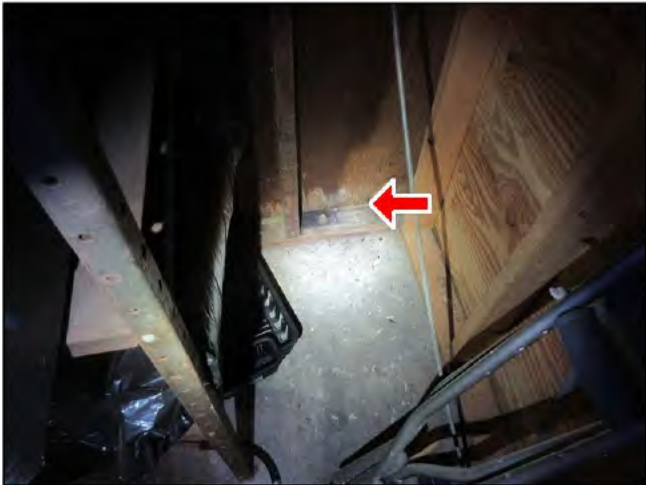
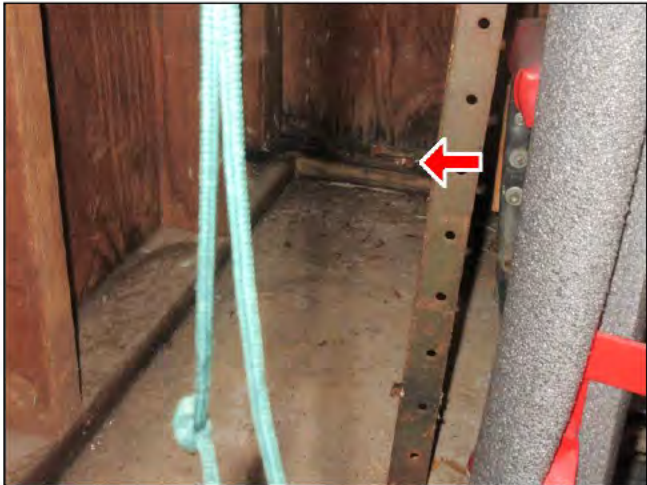
Garage- Several studs and bottom plates at the rear and side walls of the garage are deteriorated and need repairs. Water stains are present at several locations.

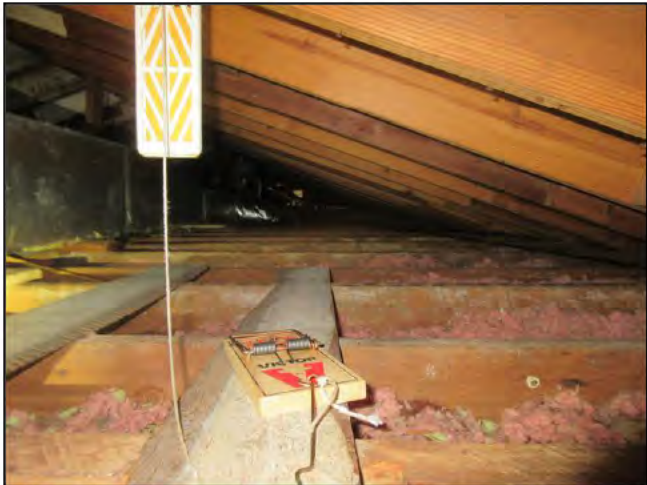
5.5 Item 1(Picture)

1732/1736- Firewall separation between the units is not present in the attic (for your information). Recommend install as needed. All Remaining Units- attic access was not present or accessible to view roof structure and components.

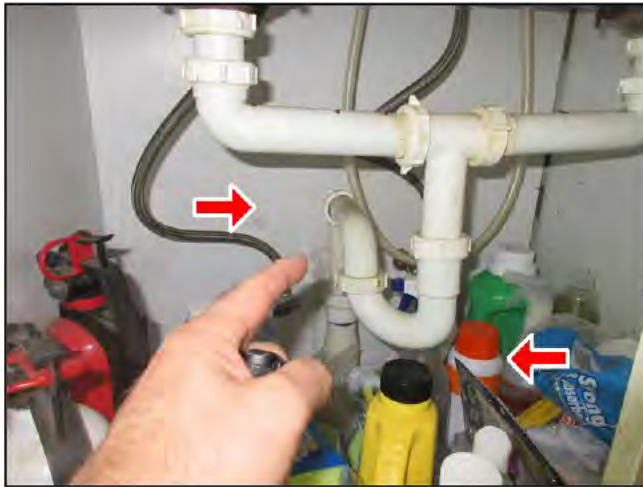
6.0 Item 1(Picture)

Garage- Plumbing waste line below the kitchen sink has an s-trap that should be converted to a p-trap.

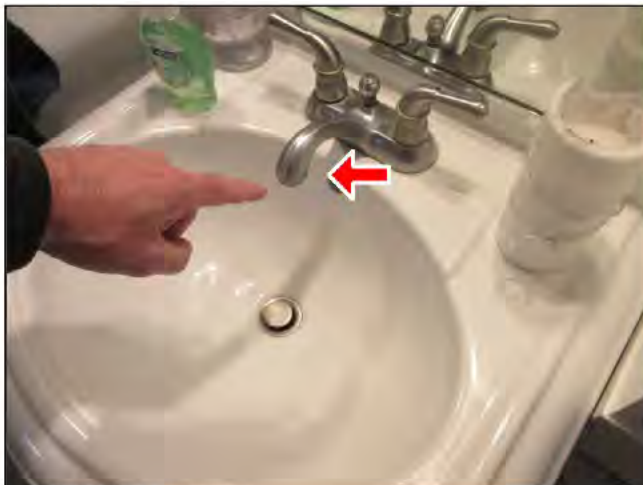
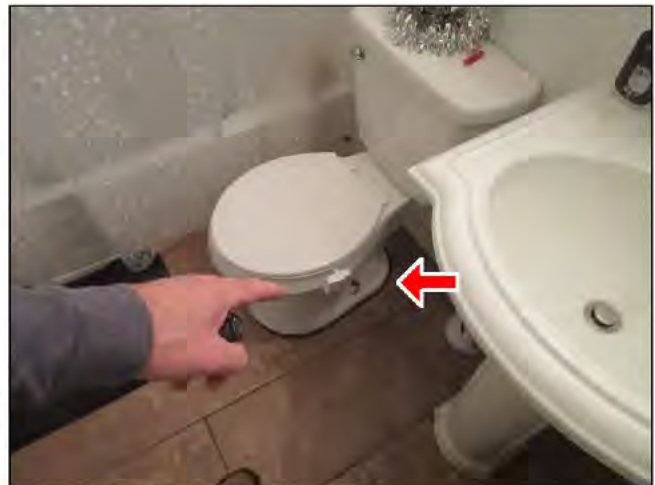
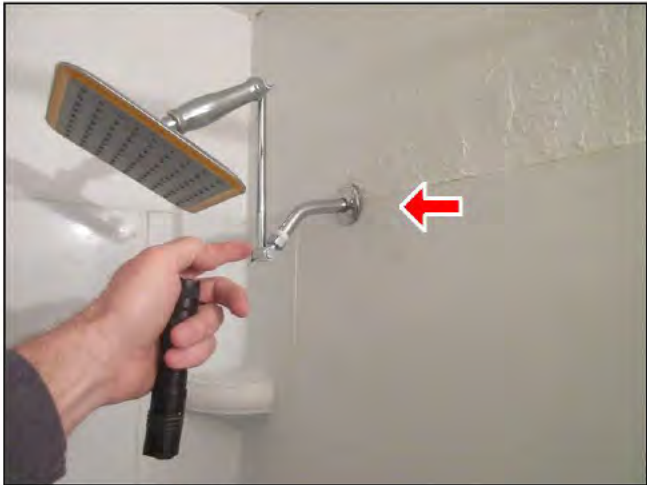
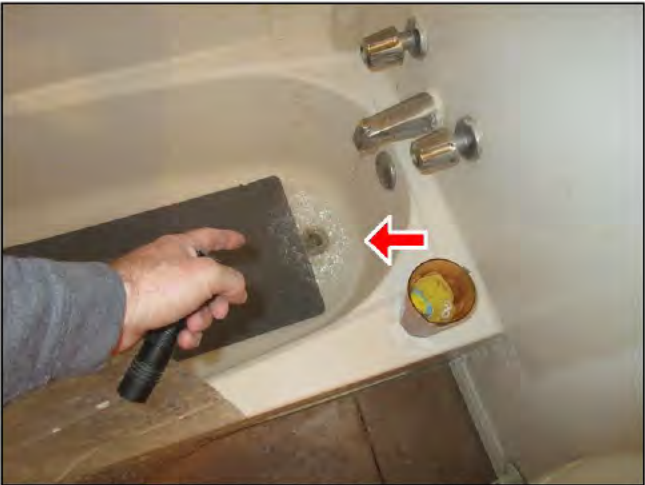
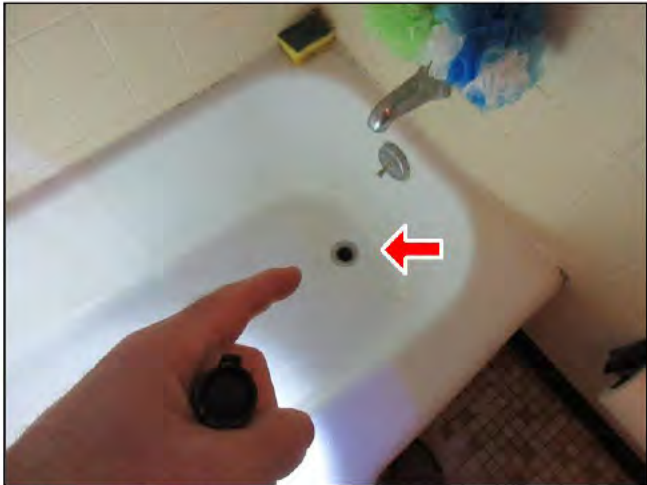
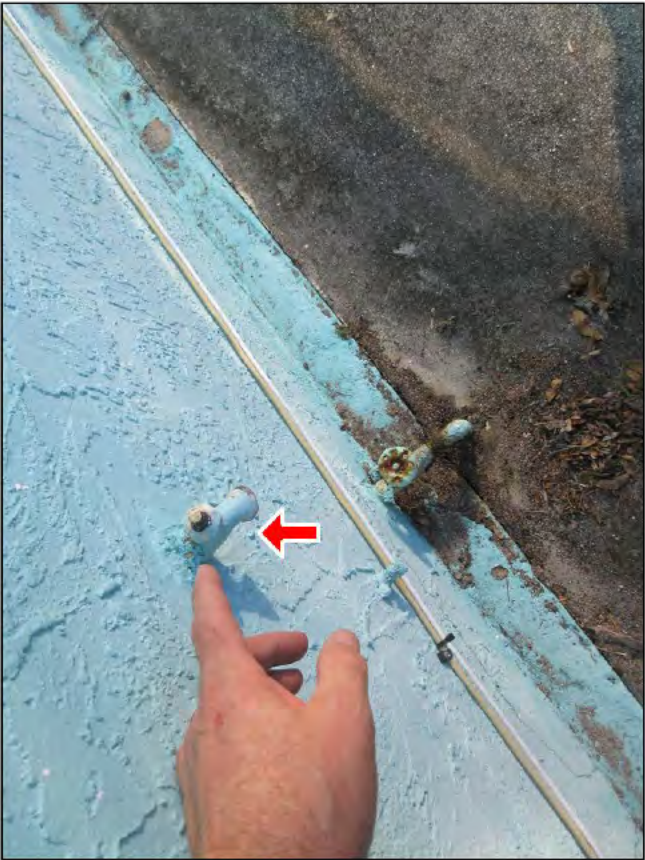
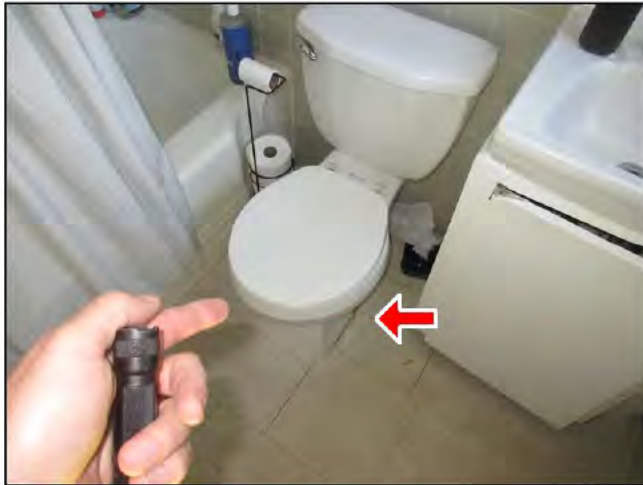
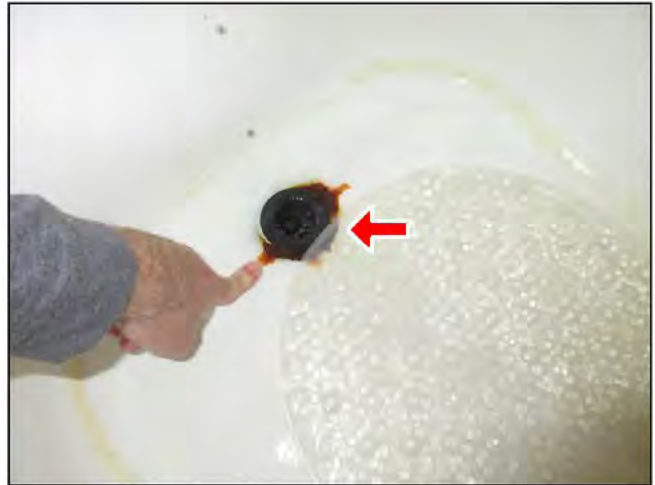
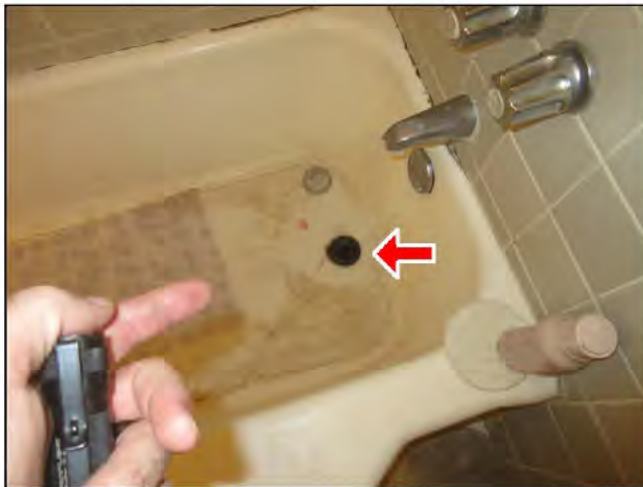
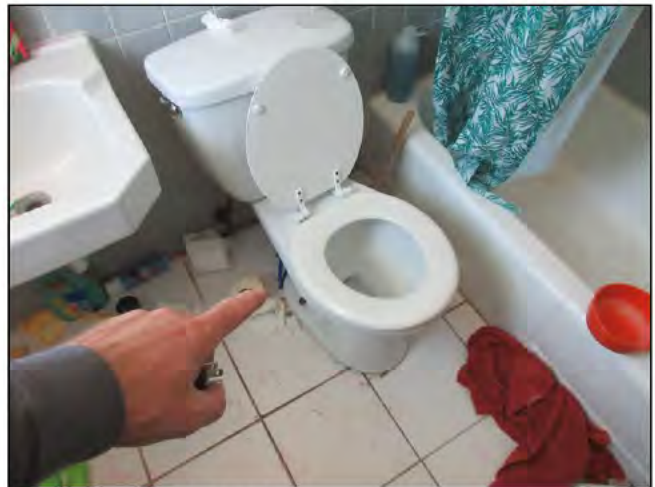
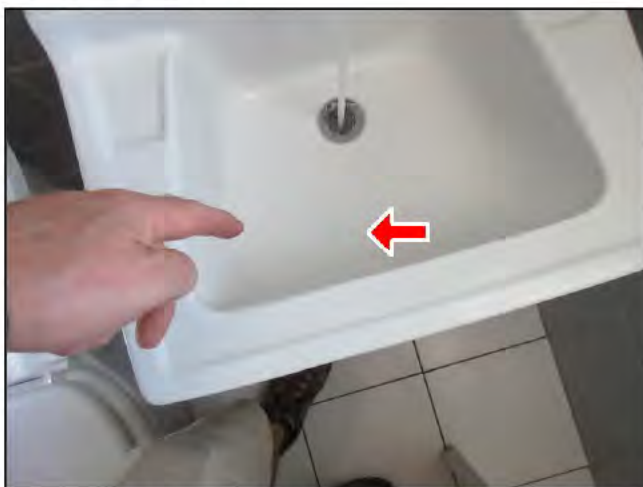
1732- Sink faucet is dripping at the guest bathroom. 1736- Toilet is loose at the floor at the hall bath. Repairs may include replacing the wax ring. We were unable to view this area from below to determine the condition of the flooring component below. Shower head is loose and needs securing. Tub drain is slow to drain. Garage- Tub drain is missing the stopper. 8 Plex- Hose bib knob at the rear of the building is damaged and needs replacing. Unit 3- Toilet is loose at the floor at the hall bath. Unit 3- Tub drain area is corroded and tub is missing the stop valve. Unit 2- Tub drain is slow to drain. Unit 8- Toilet is loose at the floor at the hall bath. Unit 7- Bathroom sink has several hairline cracks present.

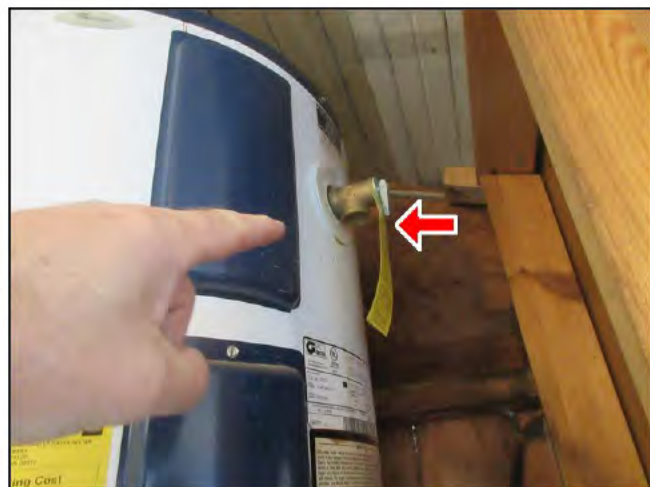
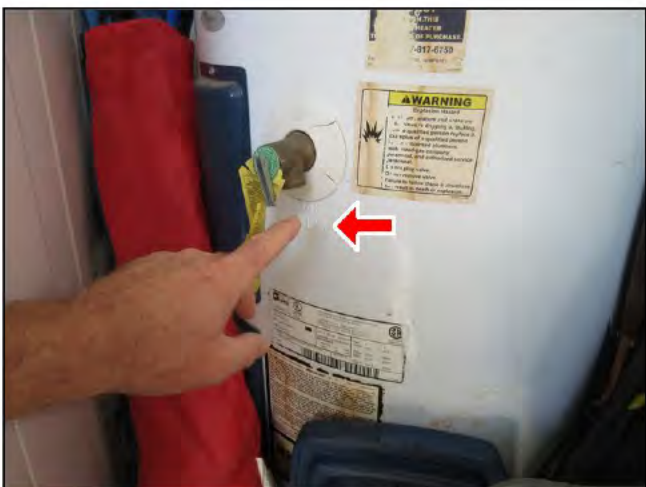
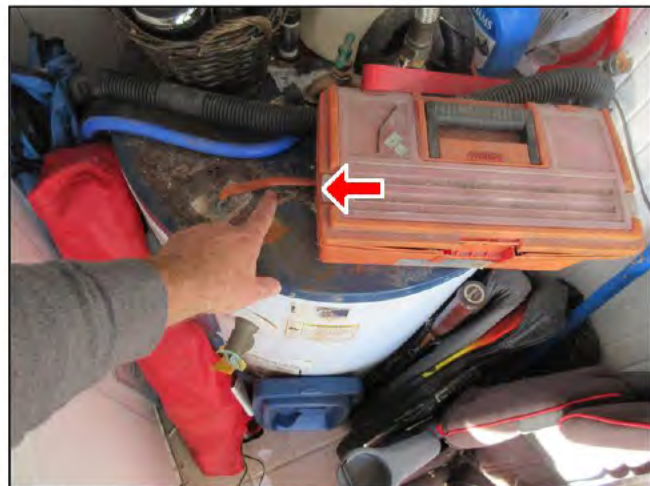
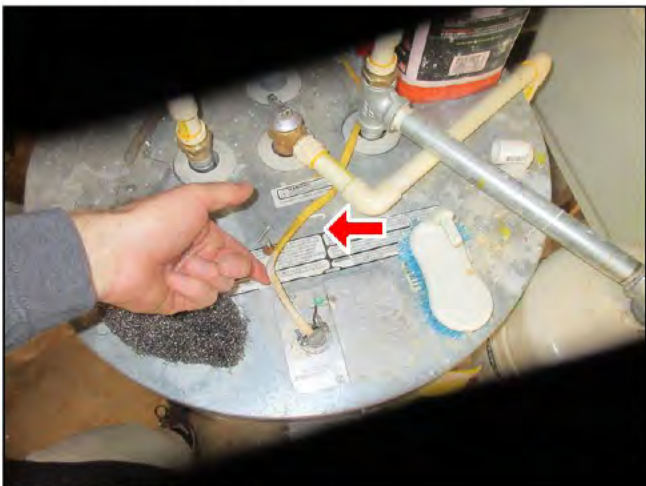
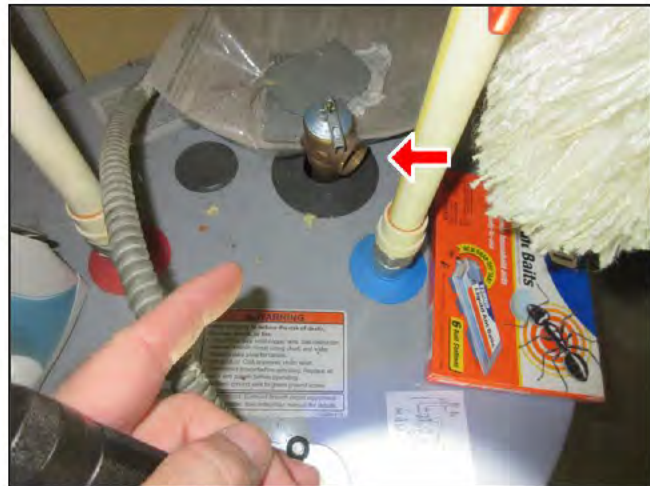
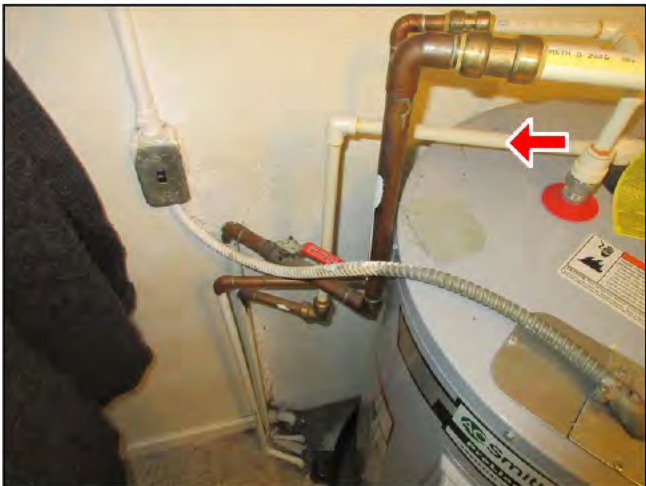
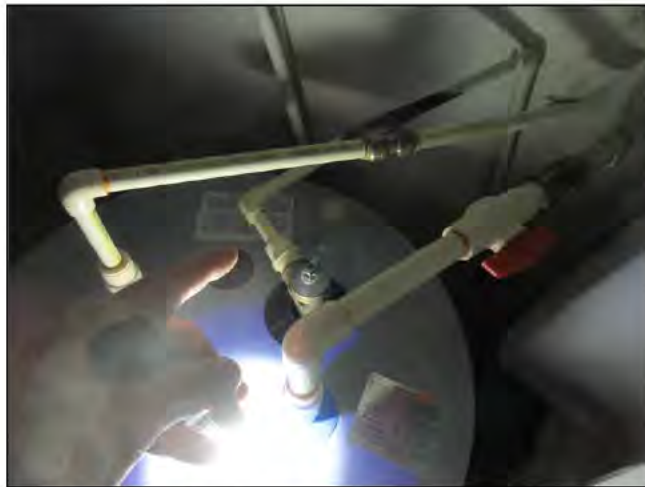
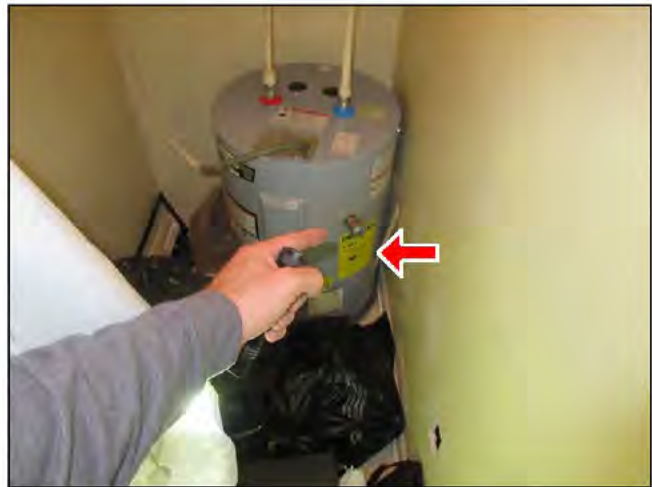
1732- Water Heater is missing a T & P Relief valve pipe. 1736- Water Heater is missing a T & P Relief valve pipe and has exposed romex wiring that should be encased. Garage- Water Heater has exposed romex wiring that should be encased. Unit 4- Water Heater is missing a T & P Relief valve pipe. Unit 3- Water Heater has an inappropriately sized T & P Relief valve pipe. T & P Pipes should be 3/4" diameter and not reduced to 1/2". Unit 2- Water Heater has an inappropriately sized T & P Relief valve pipe. T &

P Pipes should be 3/4" diameter and not reduced to 1/2". Unit 7- Water Heater is missing a T & P Relief valve pipe.

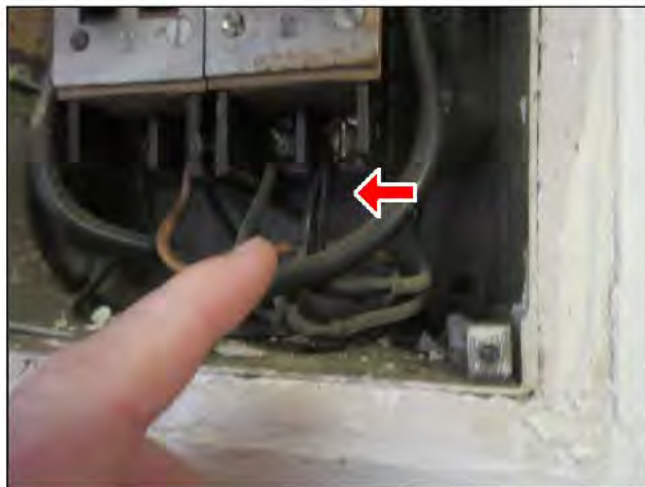
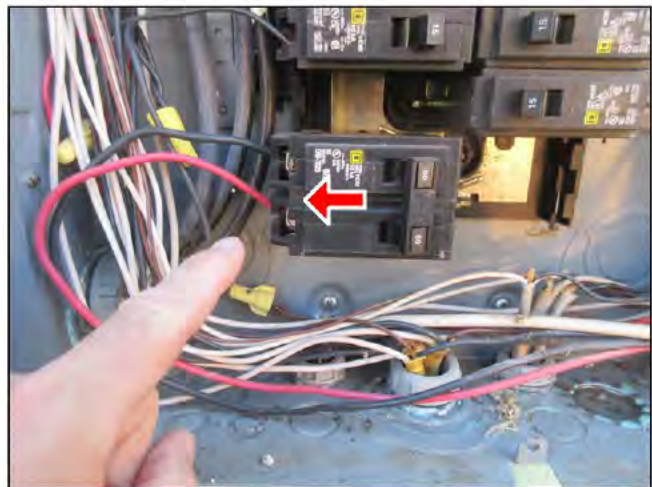
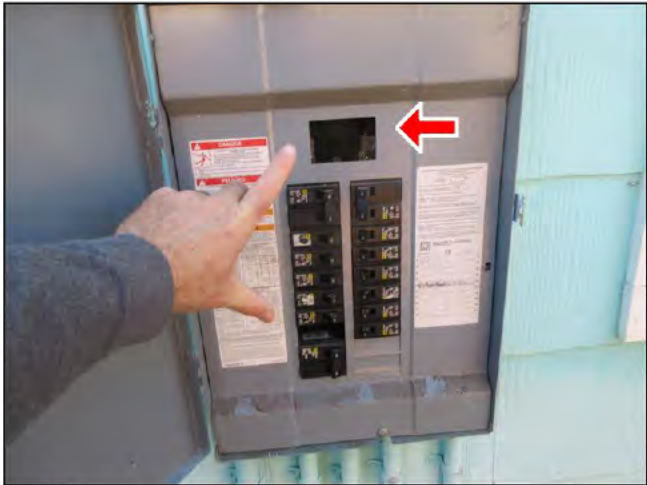
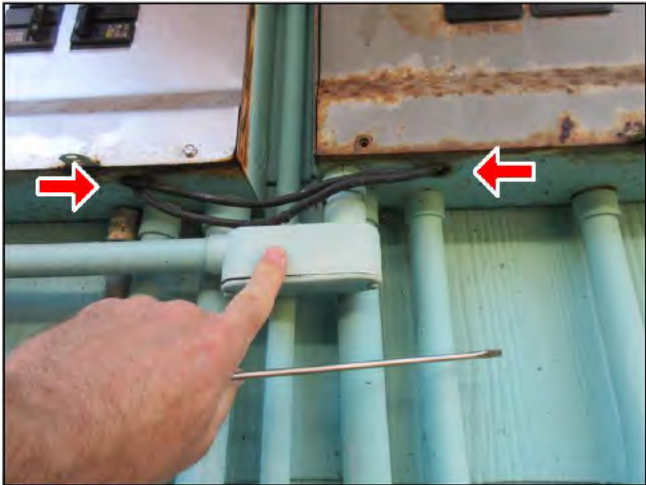
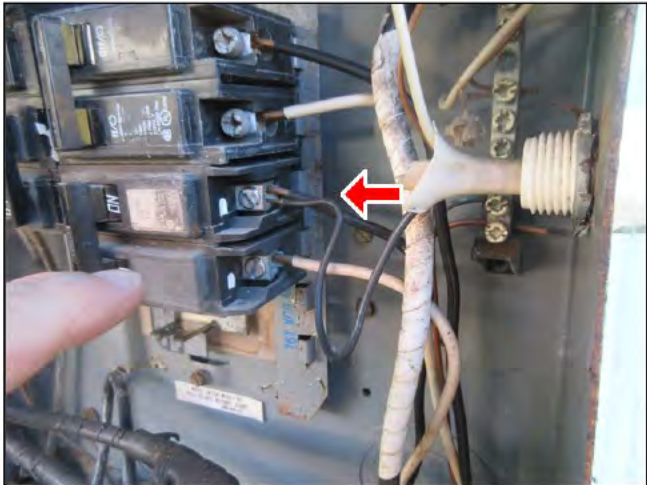
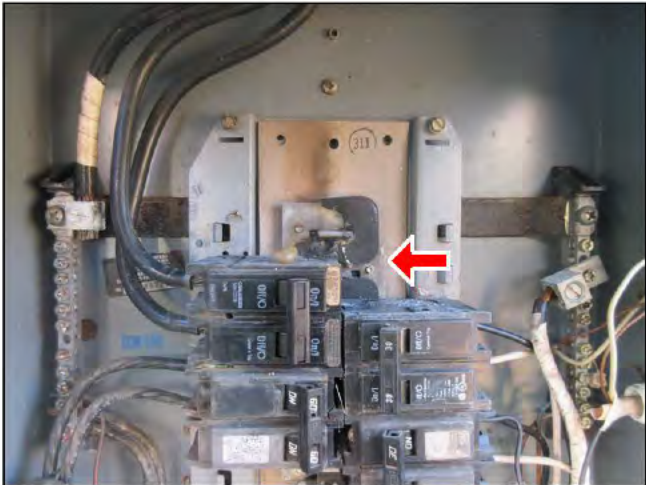
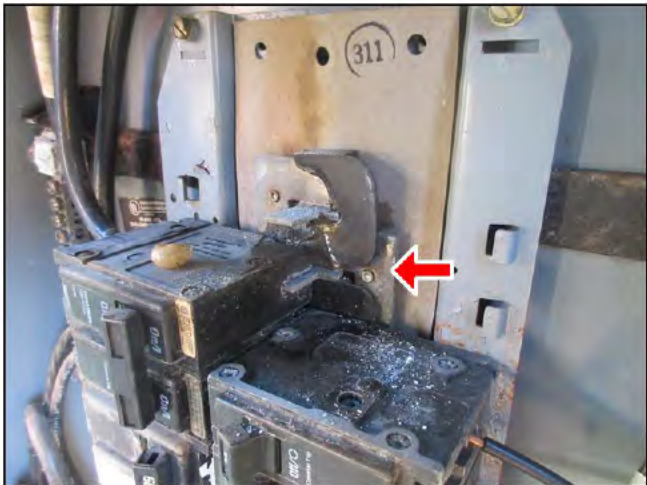
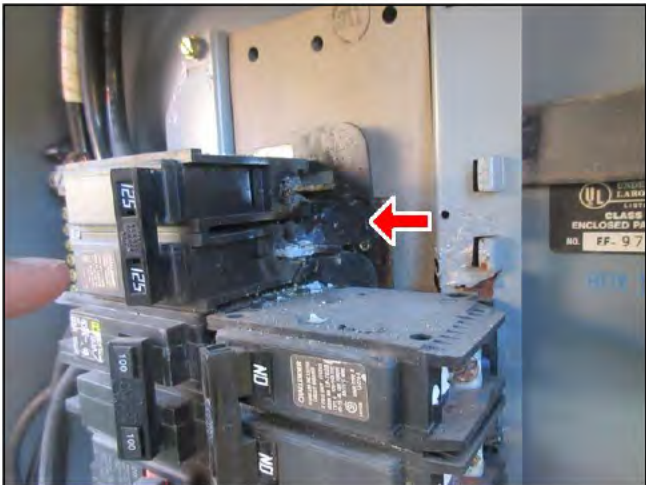
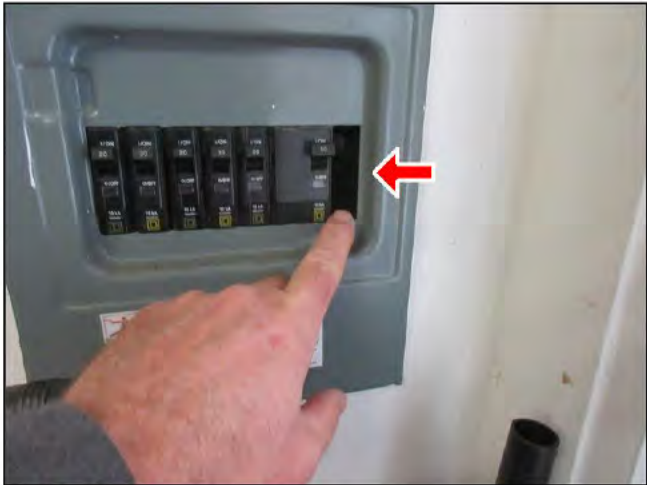
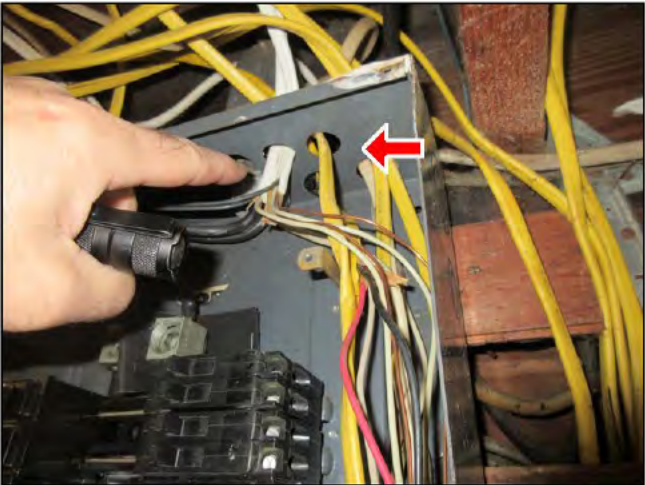
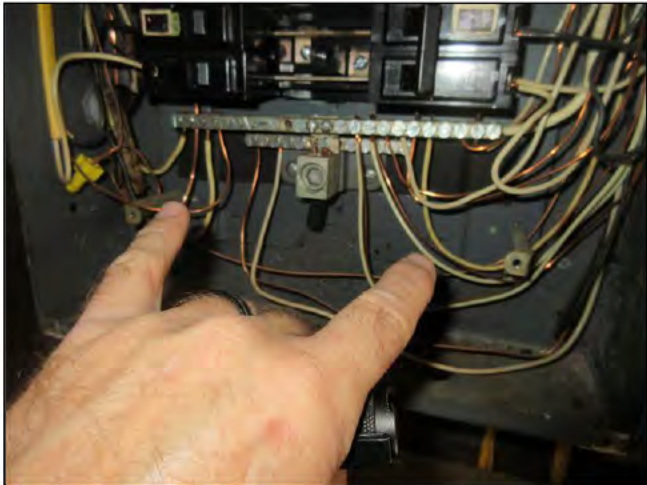
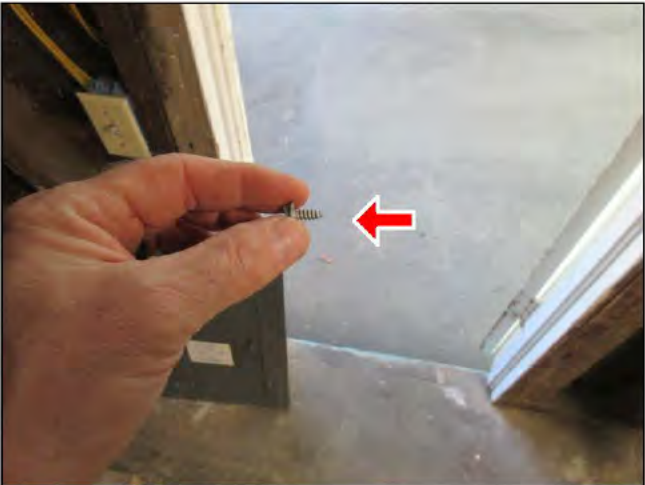
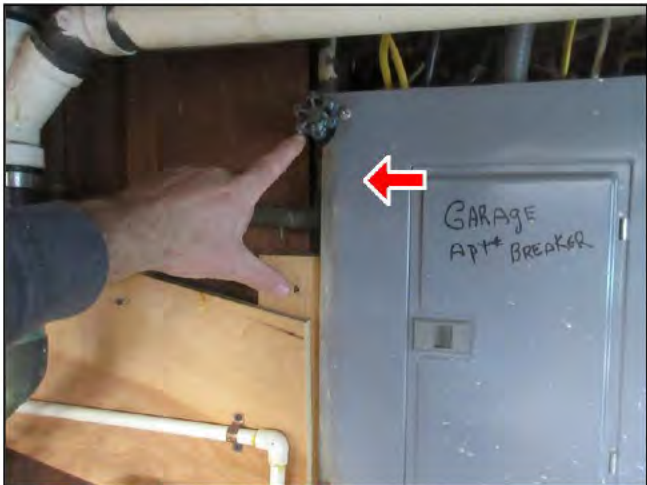
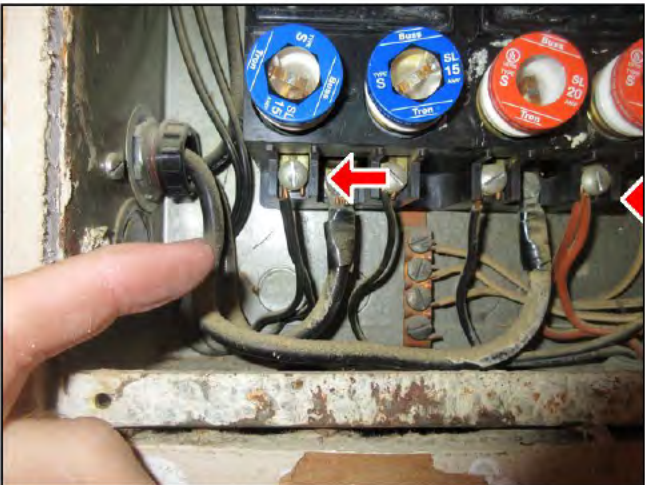
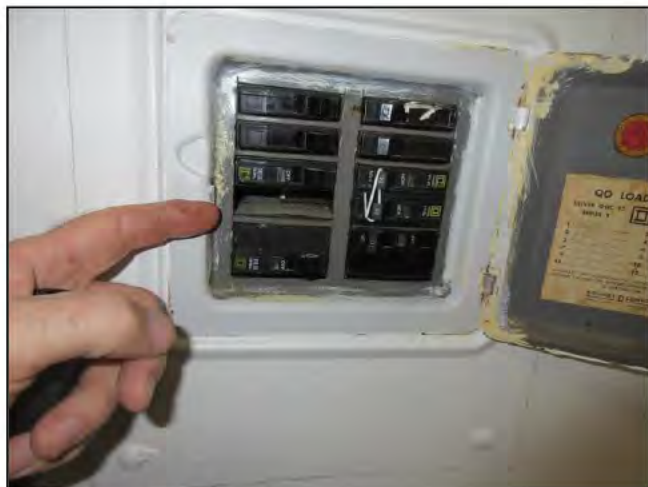
1732- Double tap present in the Federal Pacific sub-panel in the kitchen. Multiple issues are present at the Challenger meterbase panels at the right side of the home including: missing romex connectors, exposed wires, double wiring at circuits, burned or damaged breakers. Repairs are needed and safety hazards are present within these panels. Many insurance companies have issues with Federal Pacific and Challenger electrical panels. We recommend you check with your insurance company regarding these panels. 1736- Square D distribution panel in the kitchen is missing a knock out cover. Garage- Main panel has missing romex connectors, improper panel cover screws and mixed ground and neutral wires that should be terminated on separate grounding and neutral bars. Panel cover has water stains on the front from a leaking valve above. Unit 3- Double taps are present in the sub-panel in the kitchen. Unit 7- Square D distribution panel in the kitchen is missing a knock out cover. Recommend further evaluation from a licensed electrical contractor and repair as needed.

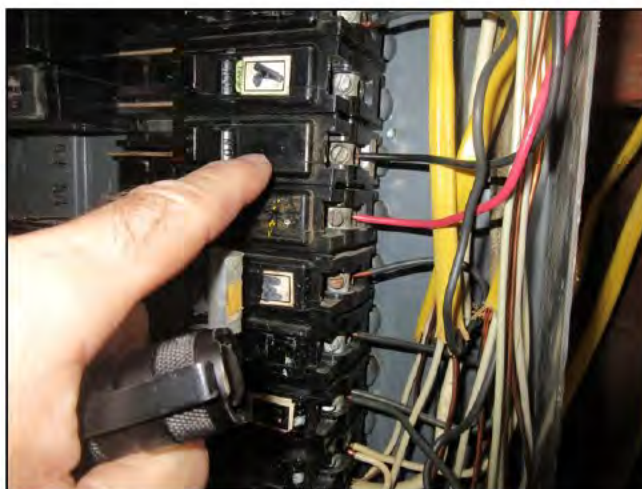
7.2 Item 2(Picture)

Garage- Several breakers have double wiring and/or over fused breakers. Recommend further evaluation from a licensed electrical contractor and repair as needed.

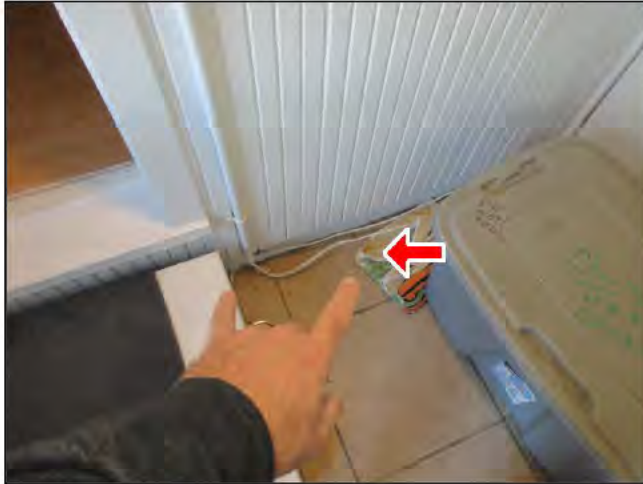
7.3 Item 1(Picture)

1732- Exposed romex wiring running along the floor near the rear entry door should be secured and encased in conduit. Several open slices are present in the water heater area. 1736- Three prong outlet at the rear of the home at the left side of the rear entry door is either not working properly or is ungrounded. Ceiling fan in the living room is missing a blade. Improperly wired attic light is present in the attic above the pull down stairs. Garage- Open splice observed above the electrical distribution panel. Rear storage area has an improperly wired and installed overhead light. Unit 8- At least one three prong outlet is wired incorrectly at the living room (hot/neutral reversed). Unit 5- At least one three prong outlet is wired incorrectly at the dining room (open ground). Recommend further evaluation from a licensed electrical contractor and repair as needed.

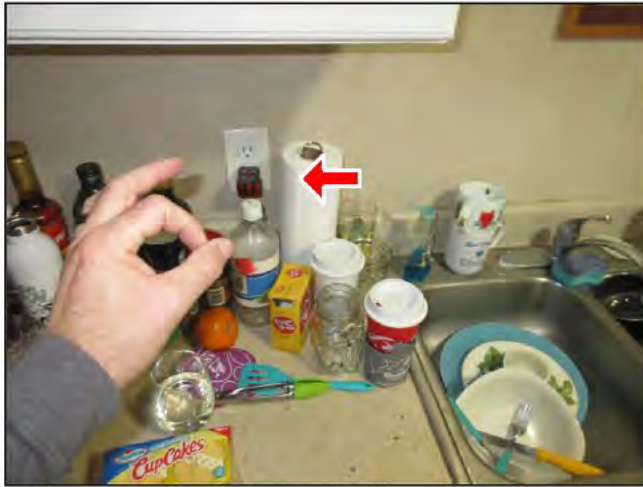
7.4 Item 1(Picture)

Unit 4- Three prong outlet near the kitchen sink did not work when tested. Unit 5- Three prong outlet near the kitchen sink is showing an open ground. Recommend further evaluation from a licensed electrical contractor and repair as needed.

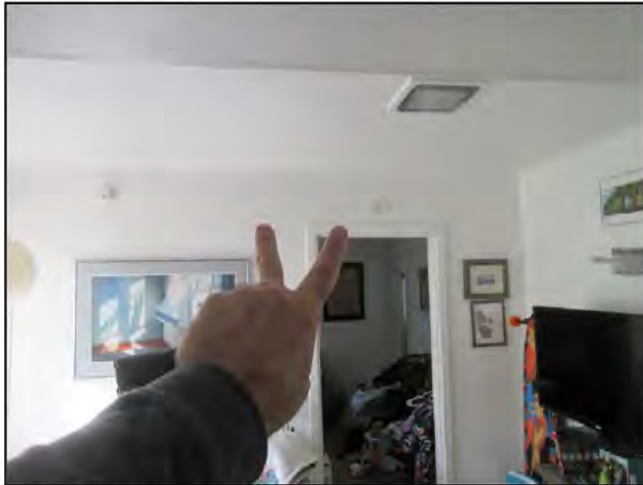
7.8 Item 1(Picture)

Multiple Smoke detectors missing or not working throughout the units. Recommend safety upgrade to include smoke detectors in each room of every unit.

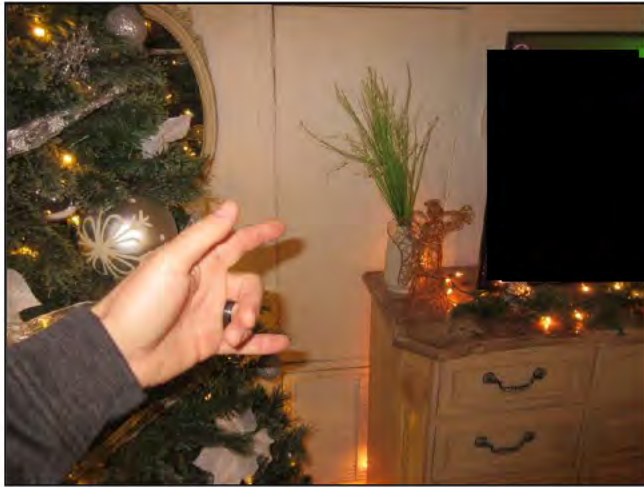
8.0 Item 1(Picture)

1732- The air handler closet is blocked with a large entertainment center. We were unable to observe this area. Garage- Wall mounted heater in the guest bath has a damaged or melted cover. This is considered unsafe and should be repaired or removed. 8 Plex- Older Wall Mounted Heating Elements were not inspected.

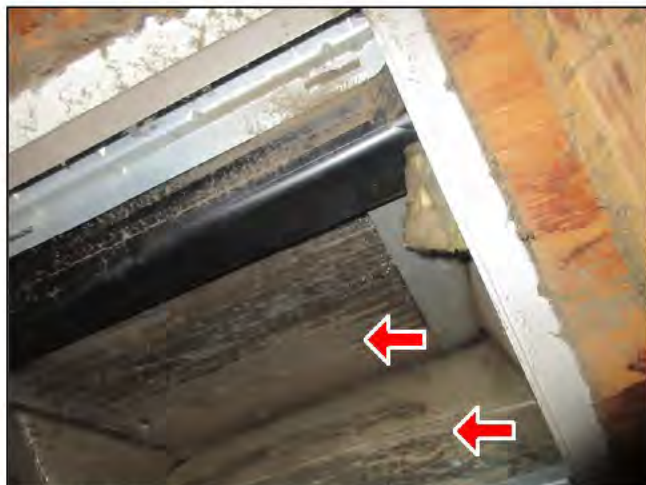
8.3 Item 1(Picture)

Garage- A-coil at the air handler is dirty and needs cleaning and servicing. Recommend service from a licensed HVAC Contractor.

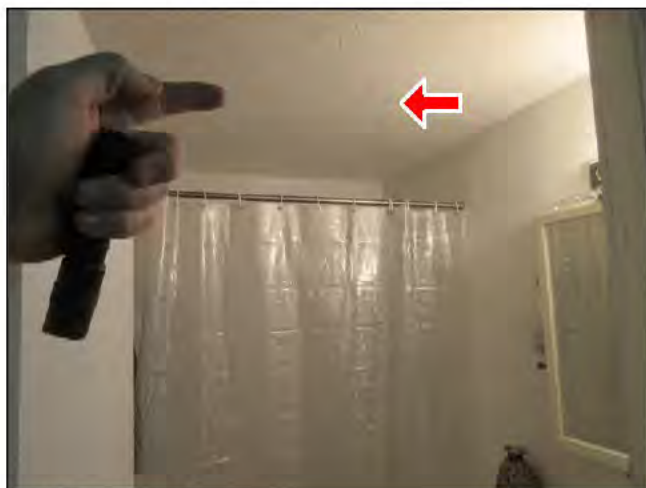
9.4 Item 1(Picture)

1736- Ventilation is not present at the hall bath. Recommend installing vent fan as needed.

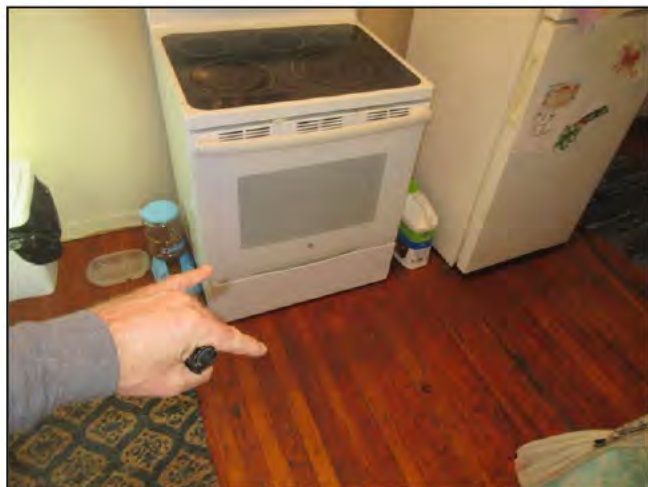
10.1 Item 1(Picture)

Garage- The anti-tip bracket is missing at the range. The anti-tip bracket prevents the range from inadvertently tipping over. Recommend install as needed.

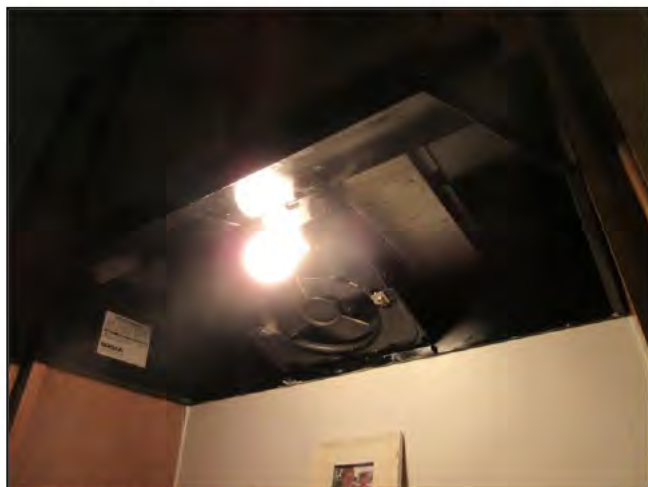
10.2 Item 1(Picture)

1732- Range hood is missing light covers and filters.
