Inspection Report

KMI Home Inspections, Inc.

Date: 8/1/2024	Time:	Report ID:
Property:	Customer:	Real Estate Professional:

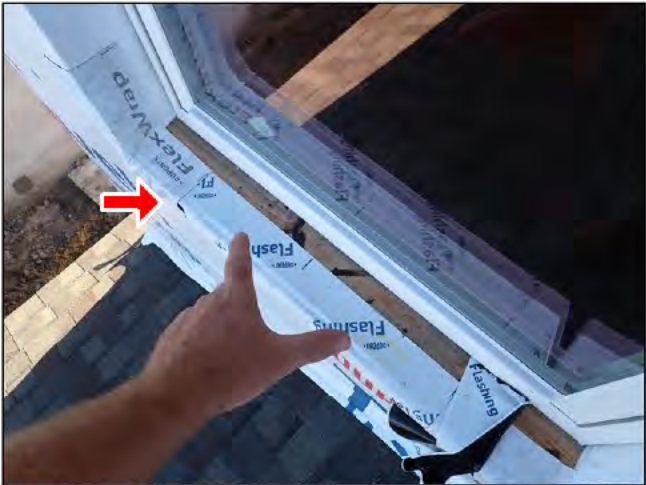
2.2 Item 2(Picture)

2.2 Upper front left corner windows do not have a complete installation. Recommend completing the installation and installing the proper flashing as needed.

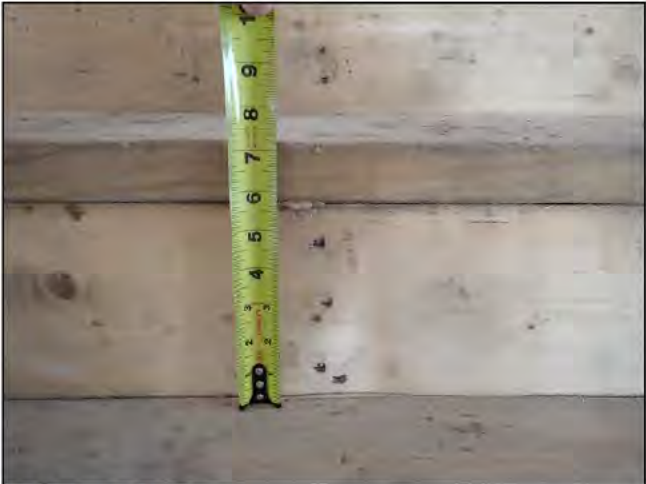
4.3 Item 2(Picture)

4.3 Several steps at the base of the stairs are not uniform in height and need correcting (2" variance). Recommend correct as needed.

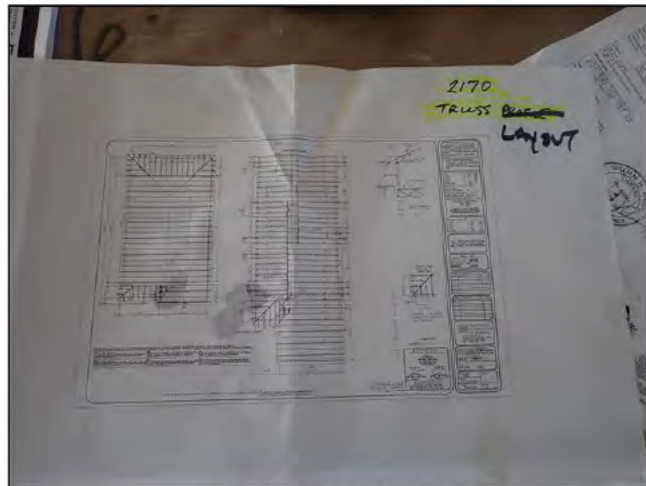
5.5 Item 11(Picture)

5.5 (3) Straps and Simpson SDWC connectors per drawings.

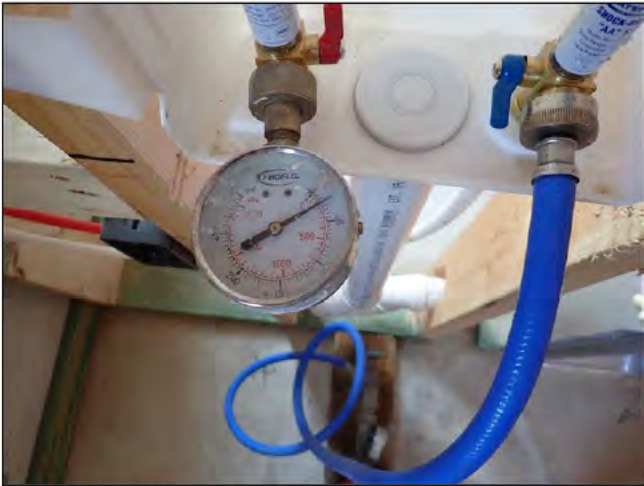
6.1 Item 1(Picture)

6.1 (1) Water supply lines under test pressure (for your information).

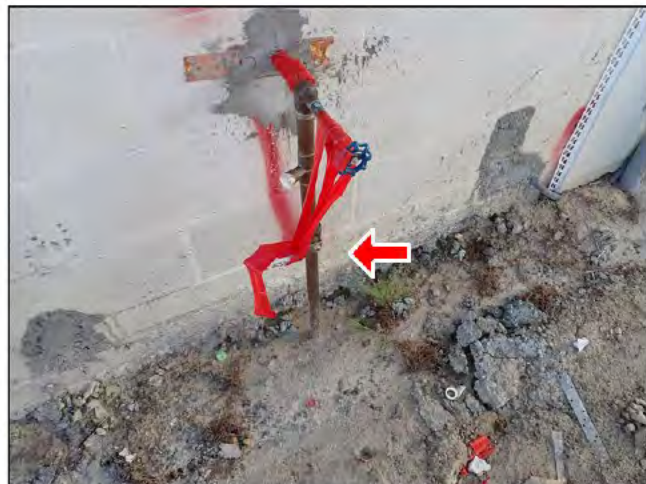
6.3 Item 1(Picture)

6.3 The main shut off is the white lever located outside on the right side of the home. This is for your information.

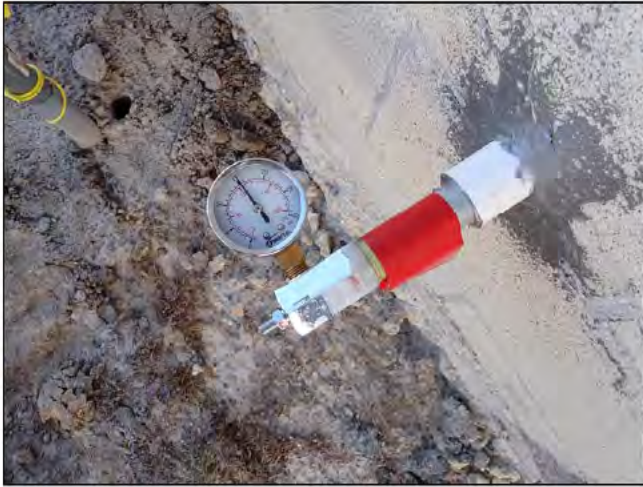
6.4 Item 1(Picture)

6.4 Gas pipe test under pressure. Bonding of the gas line present.

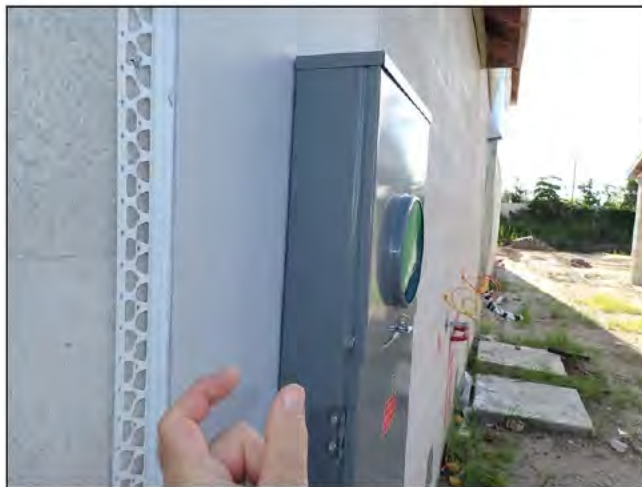
7.1 Item 1(Picture)

7.1 Exterior panel mounted correctly with rear air gap. Distribution box present in the garage however breaker installation is incomplete.

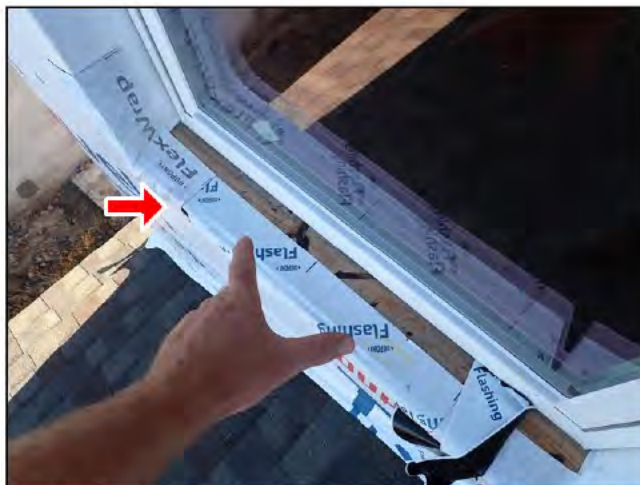
2.2 Item 2(Picture)

Upper front left corner windows do not have a complete installation. Recommend completing the installation and installing the proper flashing as needed.

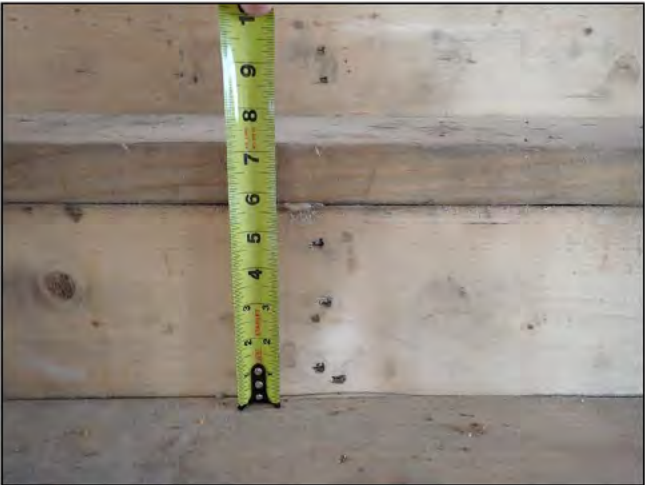
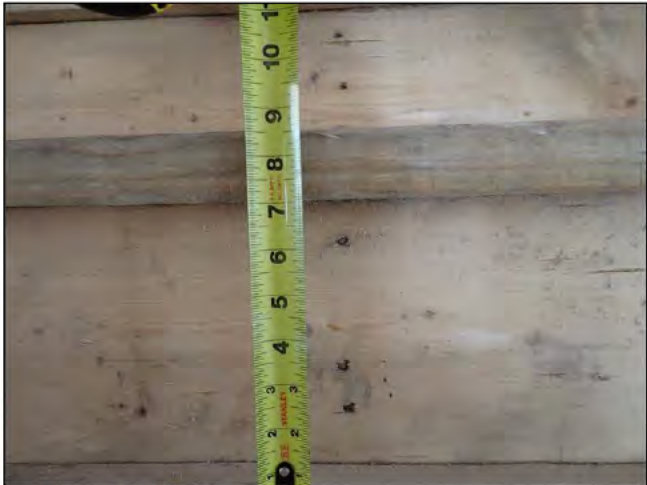
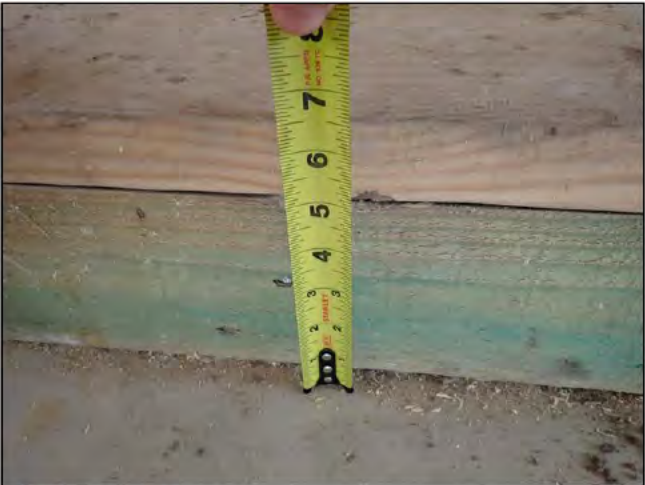
Several steps at the base of the stairs are not uniform in height and need correcting (2" variance). Recommend correct as needed.

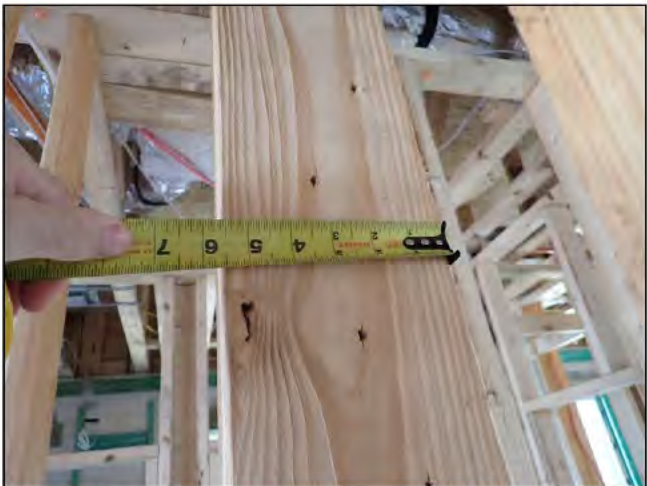
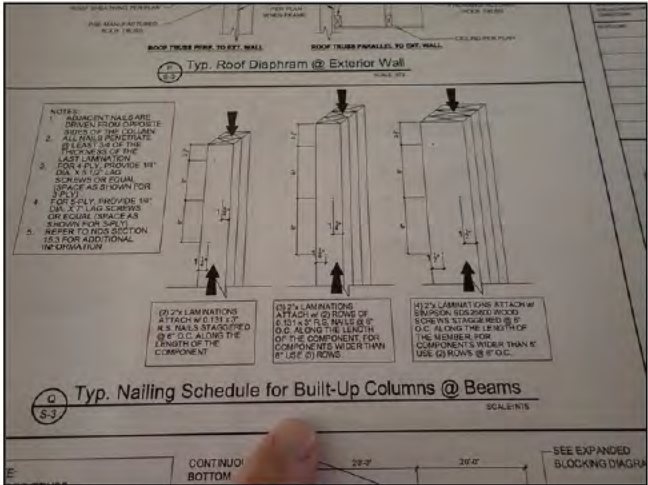
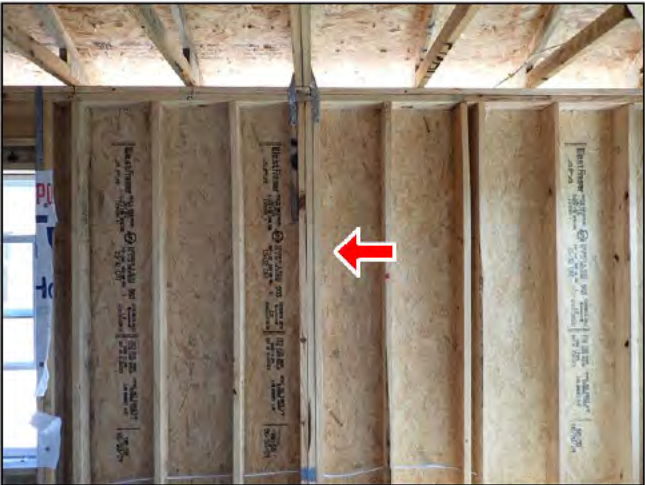
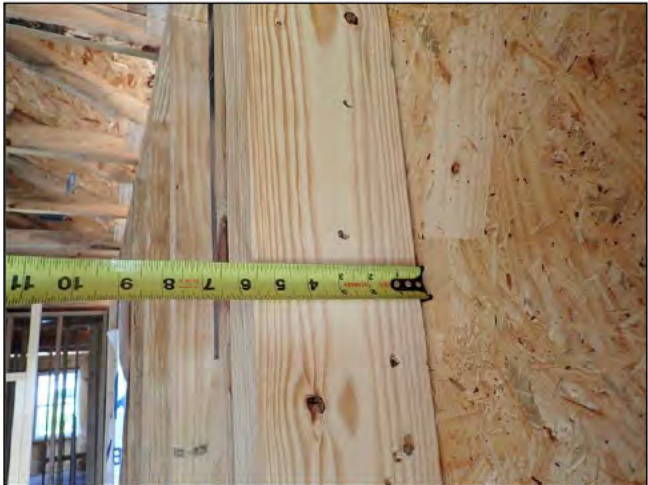
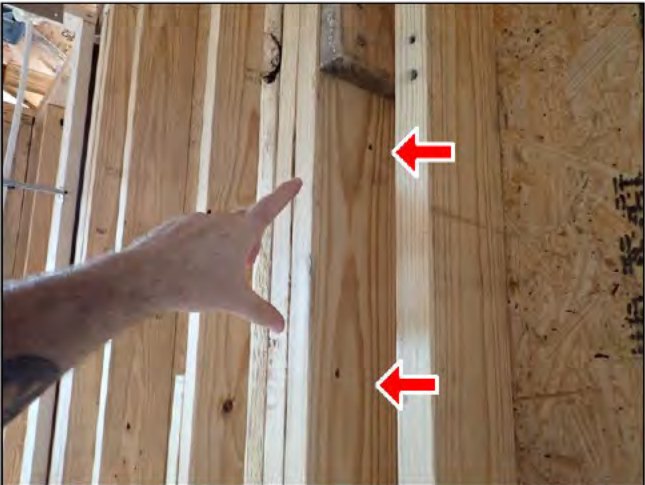
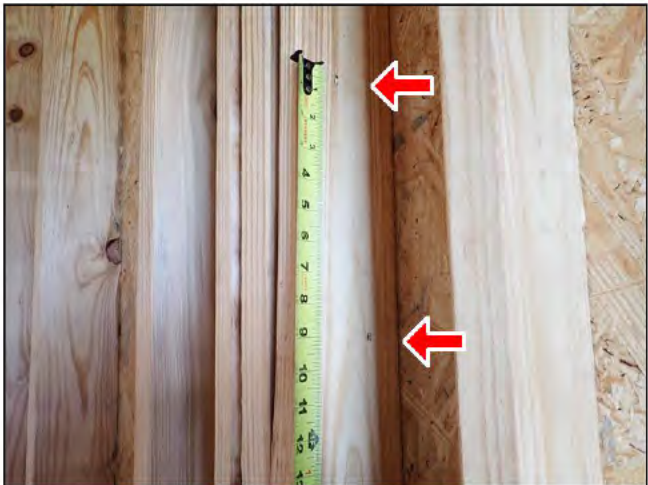
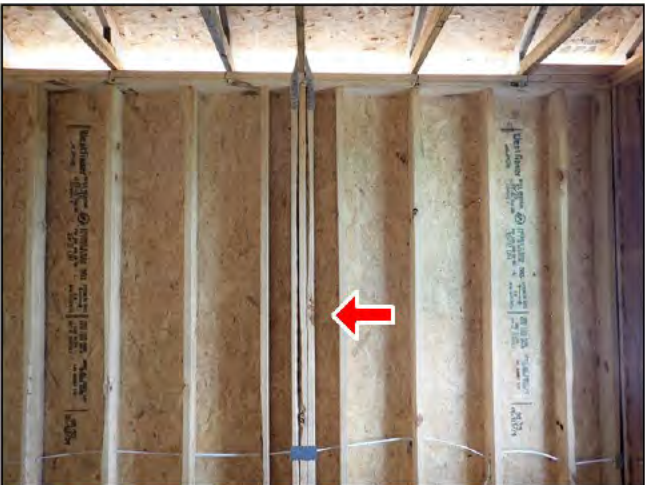
(1) Several built up columns on the lower level and upper level do not have the fasteners installed per the blue print specifications. Recommend correct as needed to comply with drawing specifications.

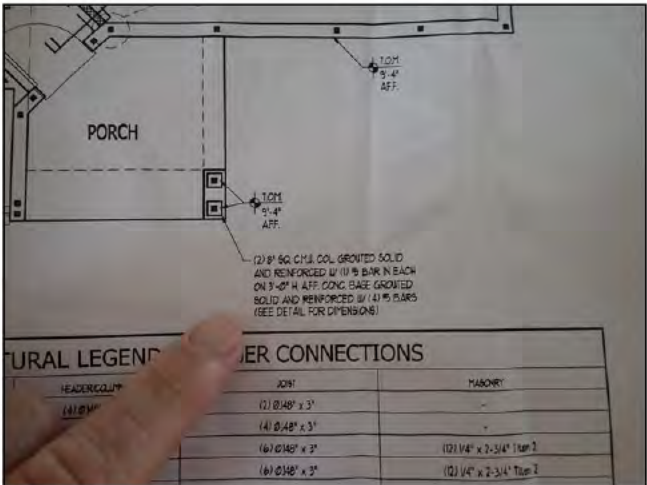
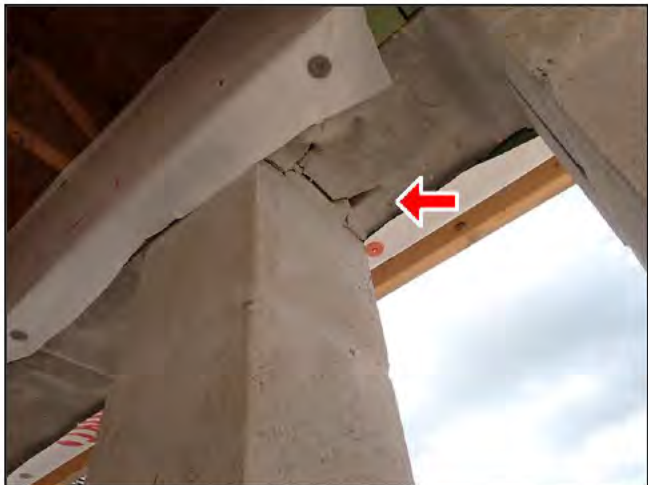
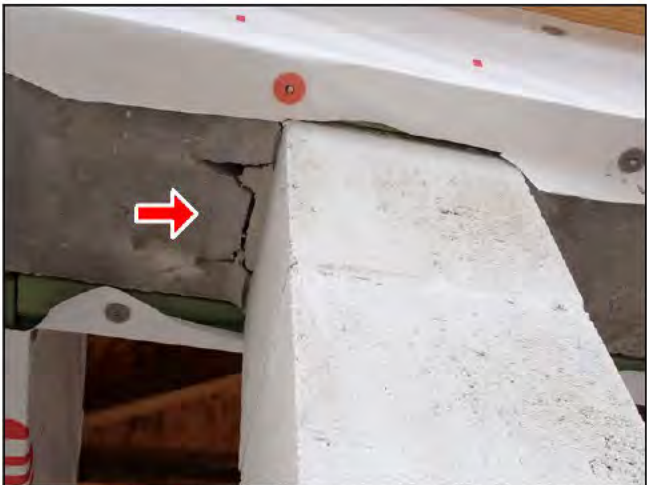
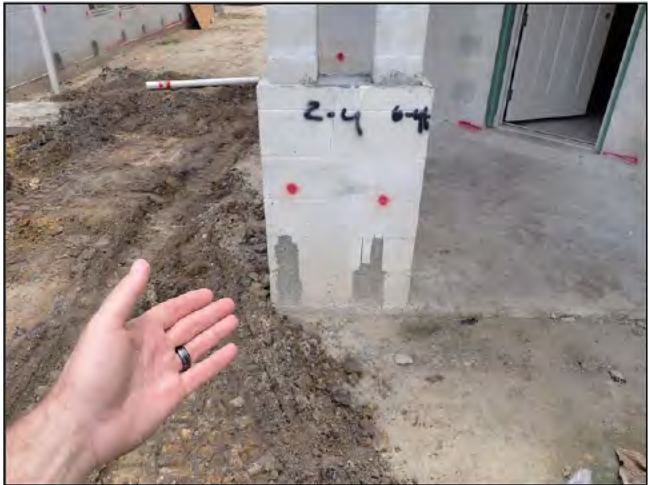
(2) We were unable to confirm the inside upper column is filled with grout per the drawing specifications. This column sounds hollow when struck unlike the outer column that sounds solid when struck. There appears to be separation or movement at the top of this column as well. Recommend confirm fill and correct movement as needed.

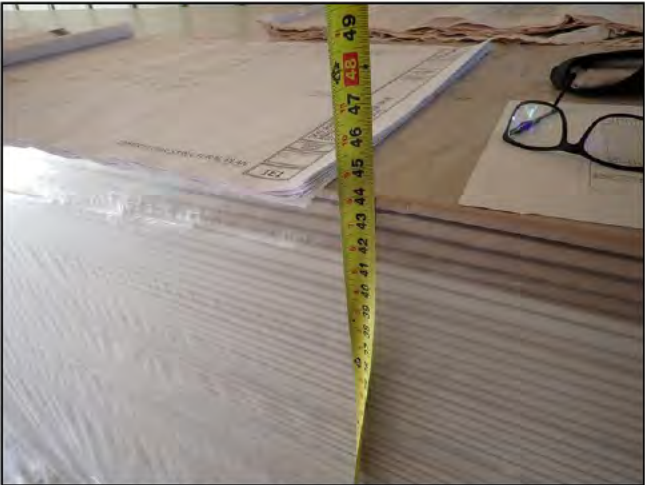
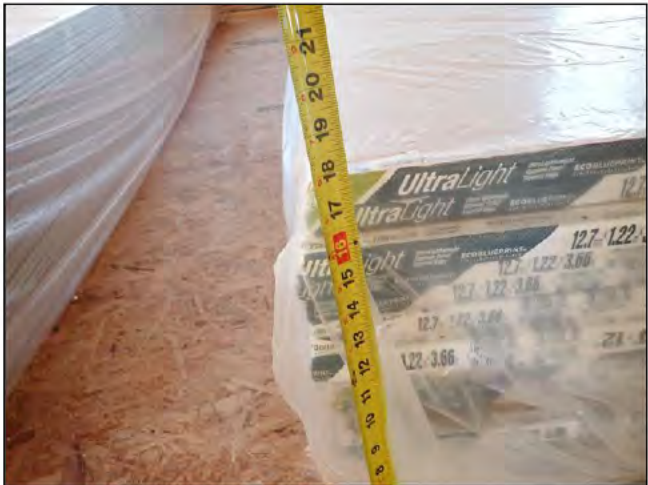
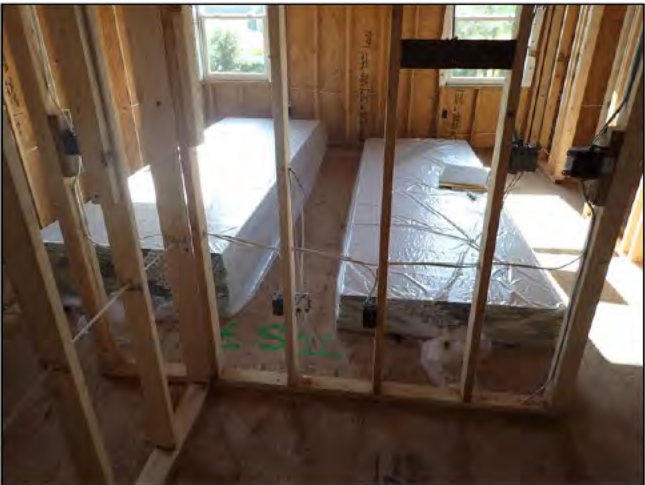
Excessively tall drywall stacks may put undue stress on the floor and floor system components. Recommend distributing the weight accordingly.

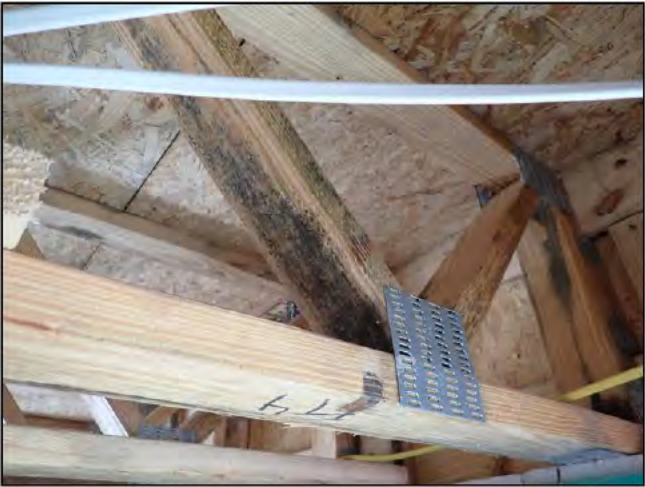
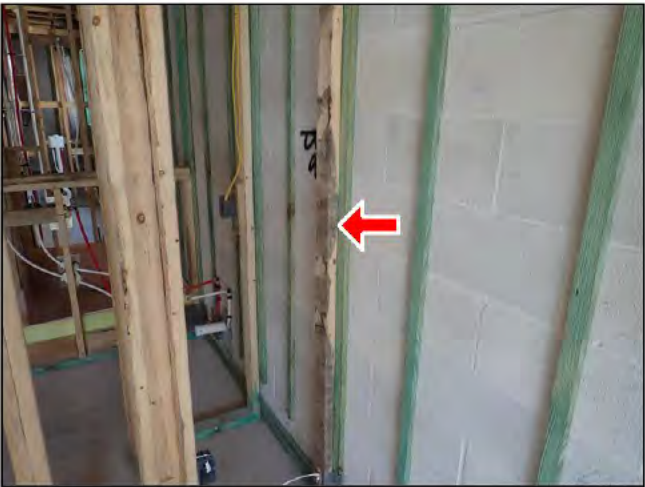
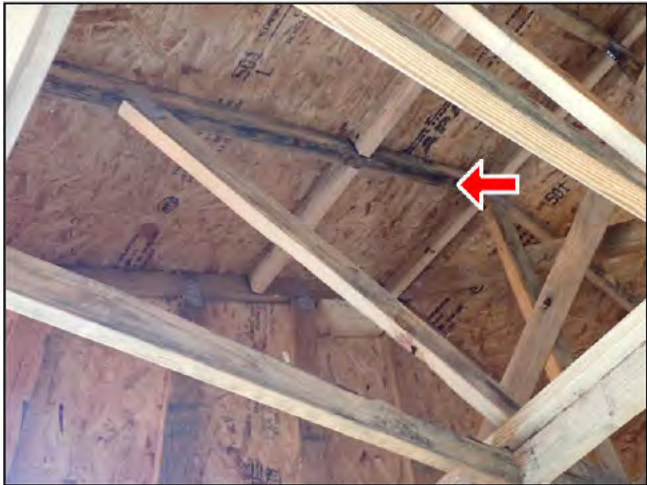
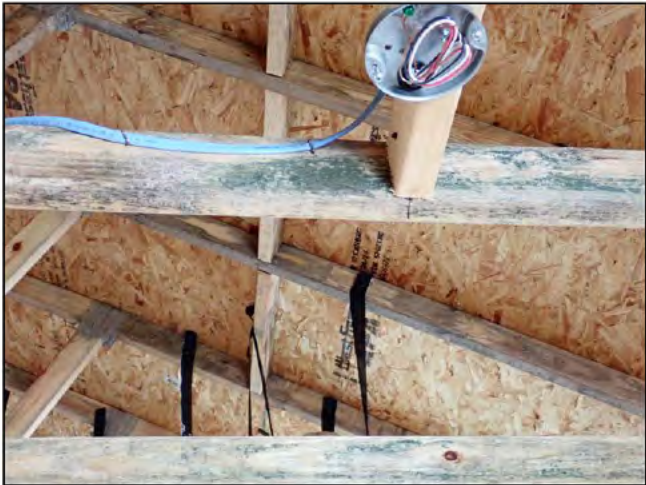
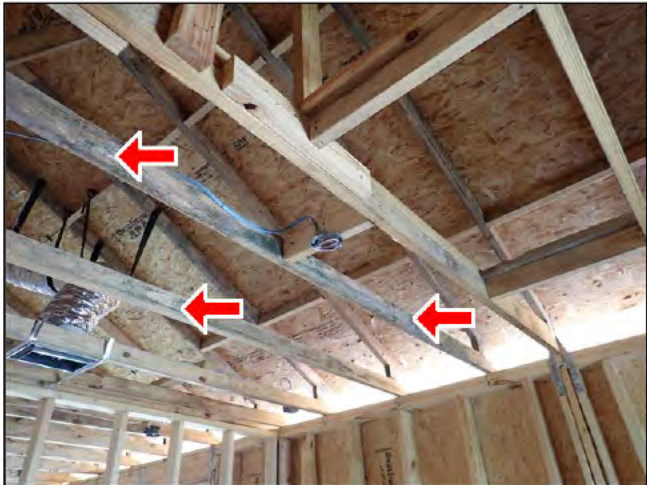
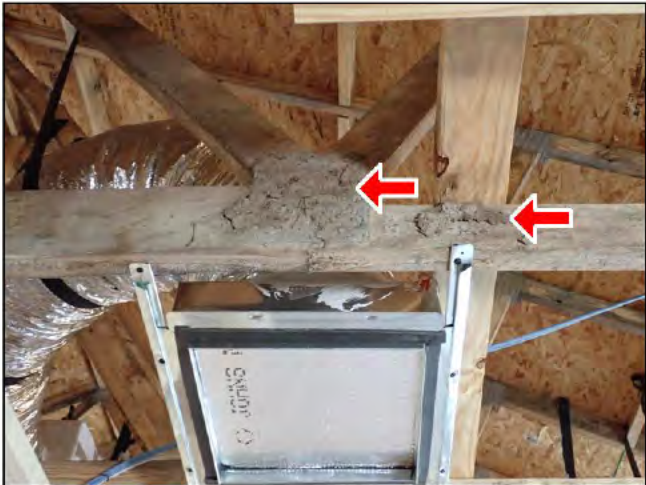
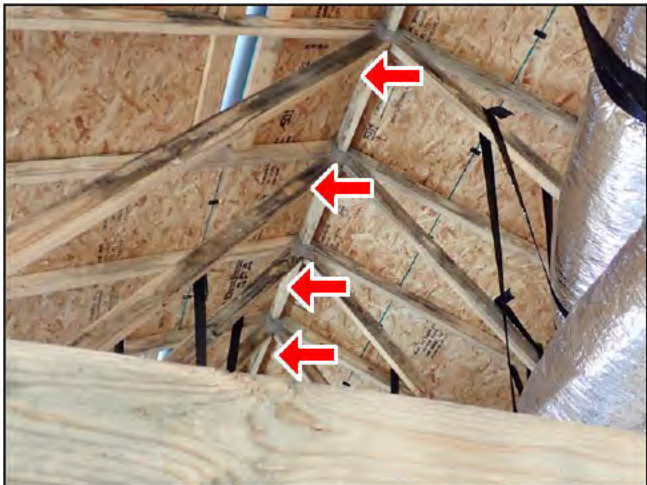
(1) Several roof framing, floor truss assemblies and studs have areas that are stained with an unknown substance. Recommend testing the substance from an environmental assessor as needed.

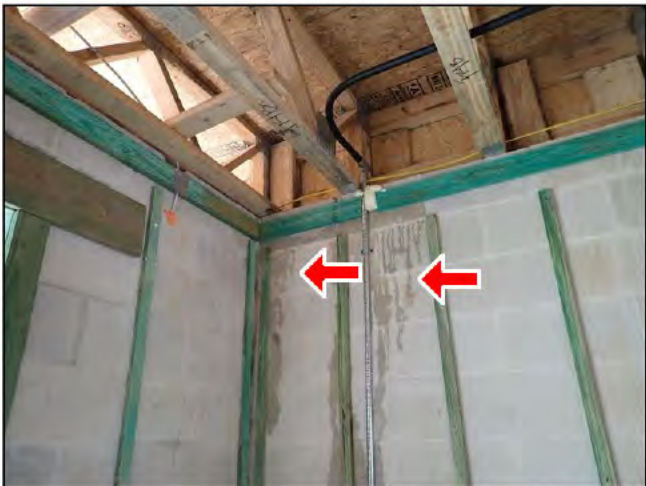
6.0 Item 2(Picture)

Shower pan is leaking at the upstairs rear bathroom. Recommend correct and re-test as needed.
