Inspection Report

Property Address:
4663 Cedron Court
Sarasota FL 34240

KMI Home Inspections, Inc.

Date: 3/11/2025	Time:	Report ID:
Property: 4663 Cedron Court Sarasota FL 34240	Customer: Marci Whitford	Real Estate Professional: Debra Forkan Coldwell Banker

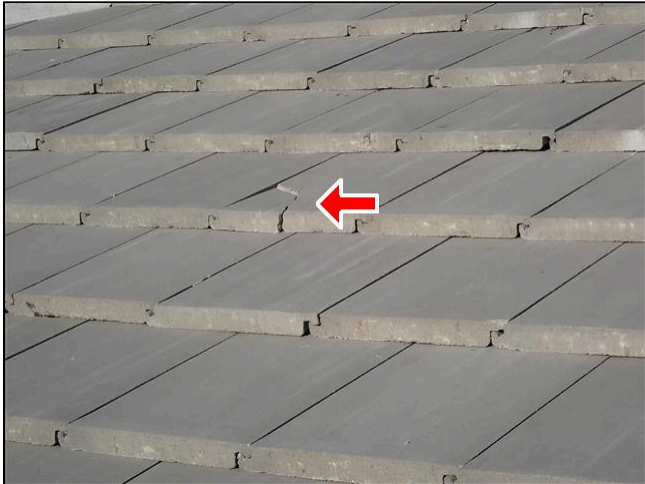
1.0 Item 3(Picture)

1.0 Several roofing tiles are cracked or chipped at various locations around the perimeter of the home. Recommend a licensed roofing contractor repair as needed.

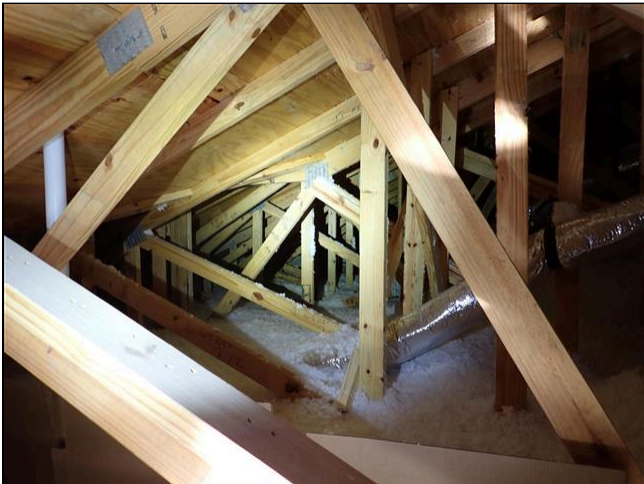
5.5 Item 1(Picture)

5.5 Attic photo's (for your information).

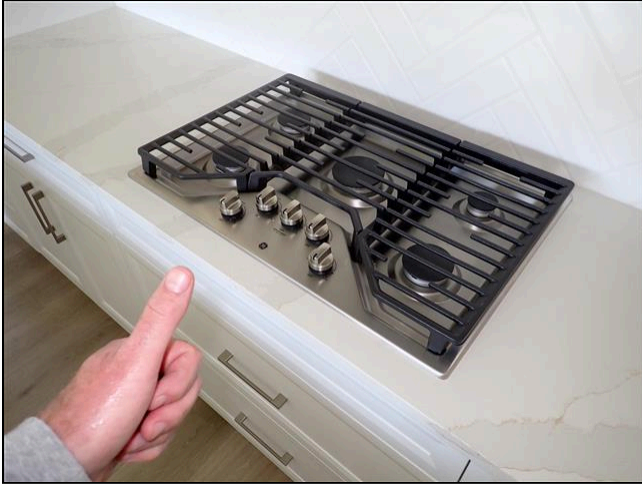
6.2 Item 5(Picture)

6.2 (2) UPDATED 3-12-25: Gas Turned On. Cooktop was operational, Water heater was operational. All plumbing fixtures were tested other than the kitchen sink (taped off).

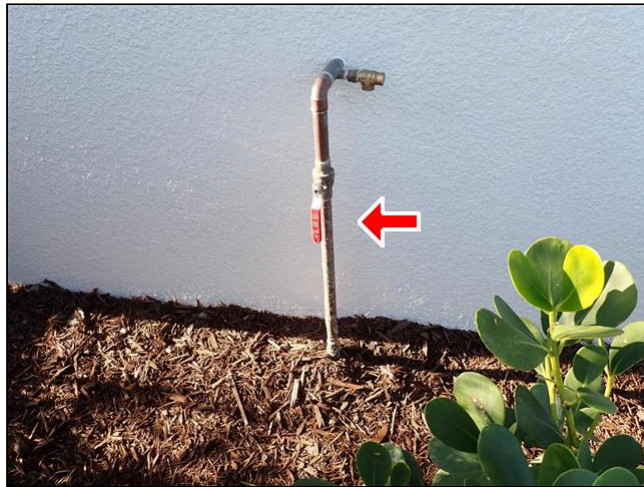
6.3 Item 1(Picture)

6.3 The main shut off is the Red Knob located outside on the right side of the home. This is for your information.

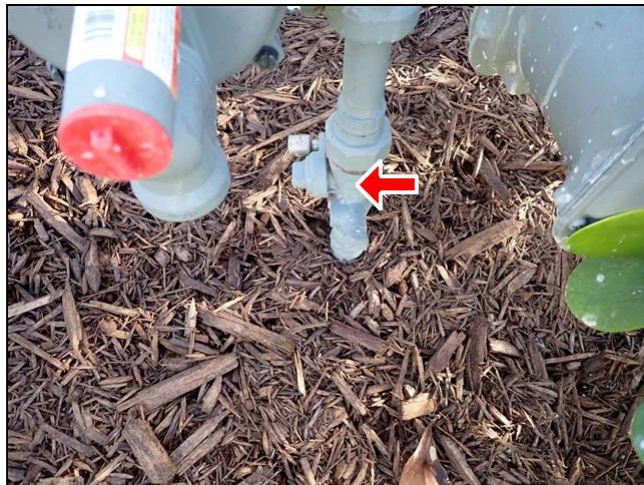
6.5 Item 1(Picture)

6.5 The main fuel shut off is at the gas meter outside on the left side of the home (for your information). The gas was off during this inspection and did not allow for the testing of any of the gas appliances.

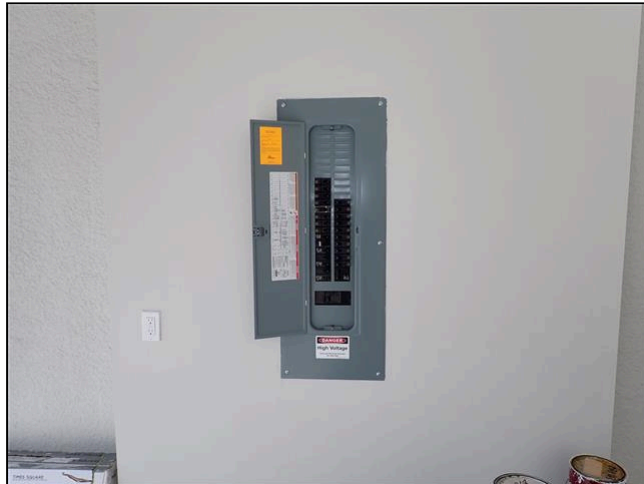
7.7 Item 1(Picture)

7.7 The main panel is located in the garage.

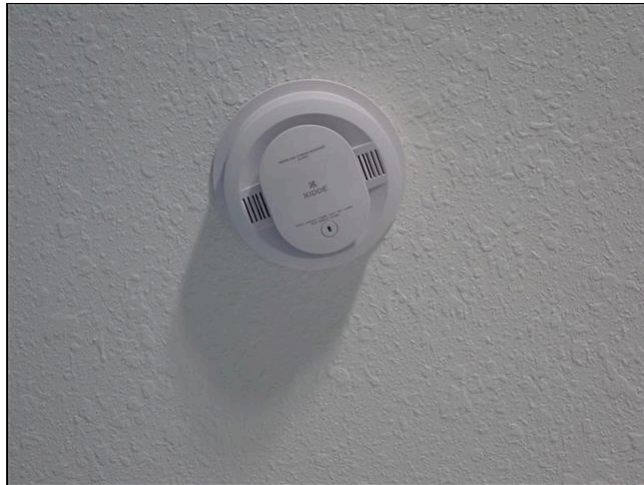
7.8 Item 1(Picture)

7.8 Smoke detectors are present and should be tested upon moving into the home.

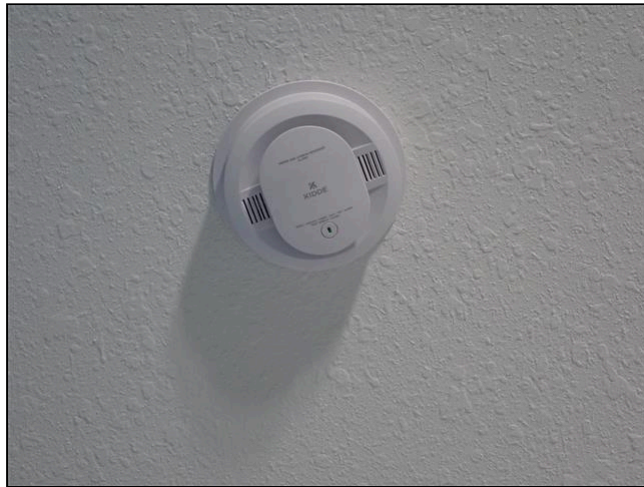
7.9 Item 1(Picture)

7.9 Carbon monoxide detector is present and should be tested upon moving into the home.

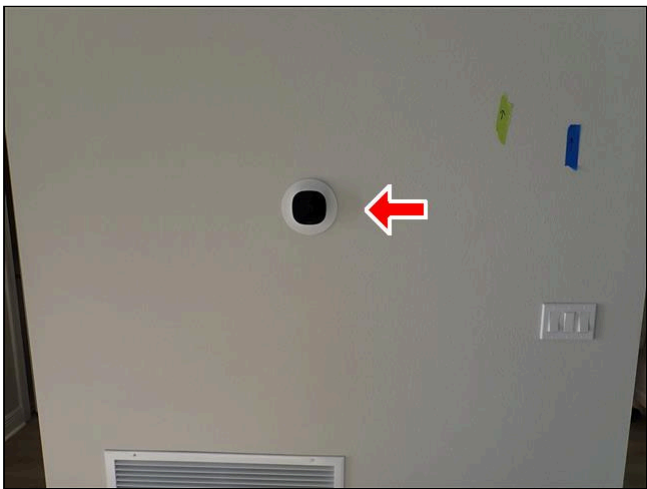
8.1 Item 1(Picture)

8.1 The thermostat is located in the hallway near the kitchen.

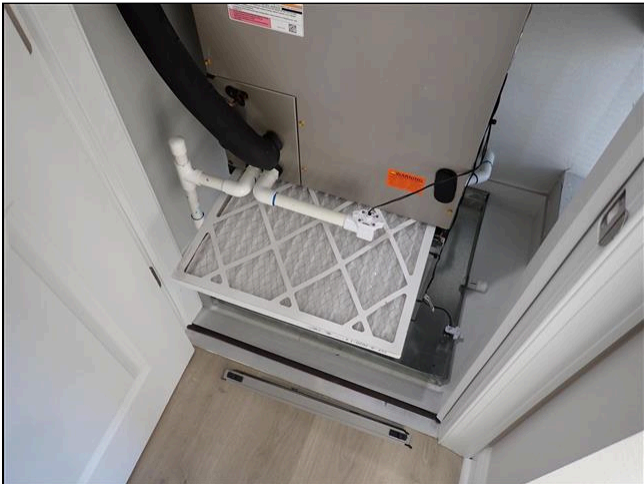
8.3 Item 1(Picture)

8.3 Filter location (see photo)

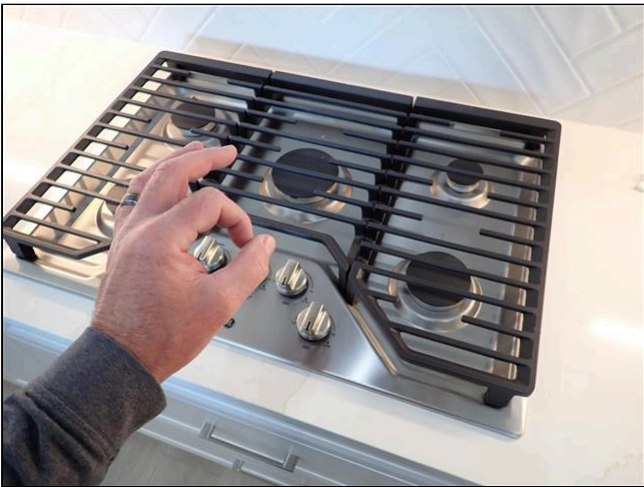
10.1 Item 1(Picture)

10.1 The cooktop was not inspected for proper operation because the gas was not on during this inspection (for your information).

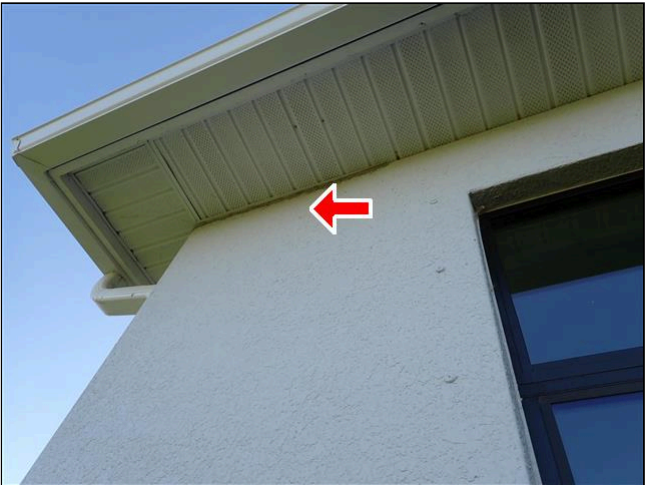
2.0 Item 2(Picture)

2.0 Paint is missing at the upper left and right rear corners of the home. Recommend prep and paint as needed.

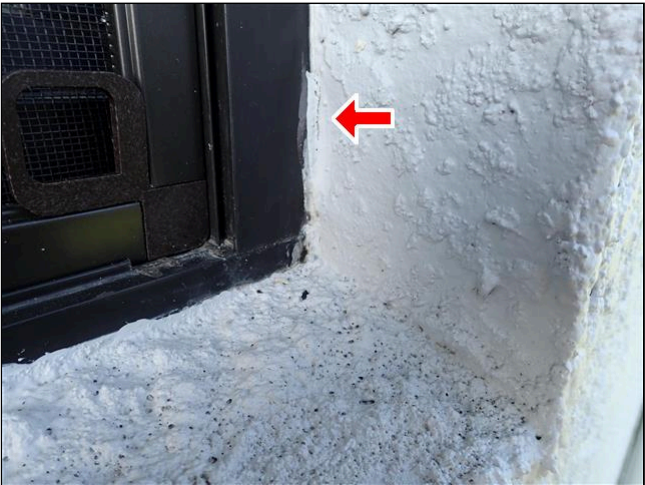
2.2 Item 4(Picture)

2.2 Several windows around the perimeter of the home have missing or checked caulk at the window frame and stucco joints. Recommend sealing as needed from a qualified contractor to prevent water intrusion at these locations.

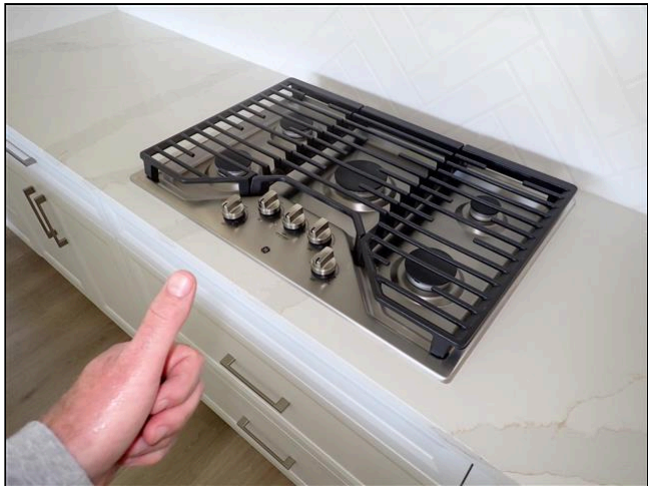
6.2 Item 5(Picture)

(2) UPDATED 3-12-25: Gas Turned On. Cooktop was operational, Water heater was operational. All plumbing fixtures were tested other than the kitchen sink (taped off).
