Date: 8/1/2024	Time:	Report ID:
Property: 9216 Tequila Sunrise Drive Sarasota FL 34241	Customer: Layne Hazlip	Real Estate Professional:

In Attendance: Inspector Only	Type of building: Single Family (2 story)	Approximate age of building: New Construction
Temperature: Over 65 (F) = 18 (C)	Weather: Cloudy	Ground/Soil surface condition: Damp
Rain in last 3 days: Yes	Radon Test: No	Water Test: No
Home Occupied: No	Recently Painted Interior: No	Recently Painted Exterior: No
Excluded Items: Pre-Drywall Inspection Only	Sewer Camera Inspection: No

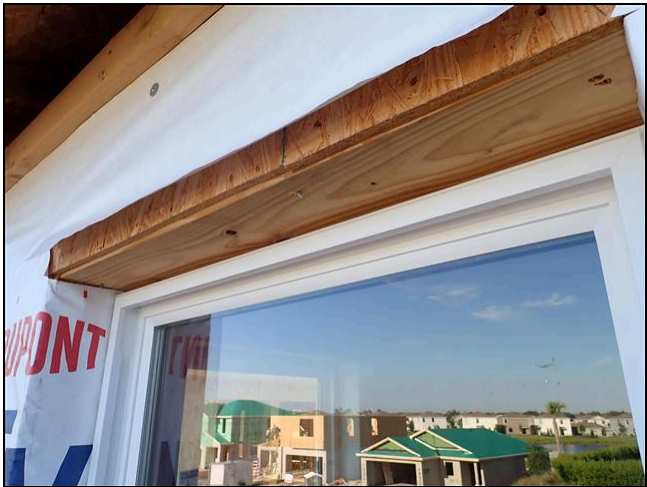
2.2 Item 3(Picture)

2.2 Upper front left corner windows do not have a complete installation. Recommend completing the installation and installing the proper flashing as needed.

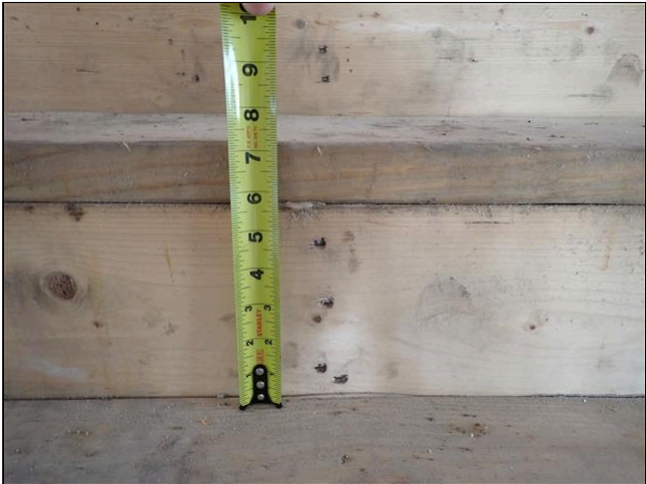
4.3 Item 2(Picture)

4.3 Several steps at the base of the stairs are not uniform in height and need correcting (2" variance). Recommend correct as needed.

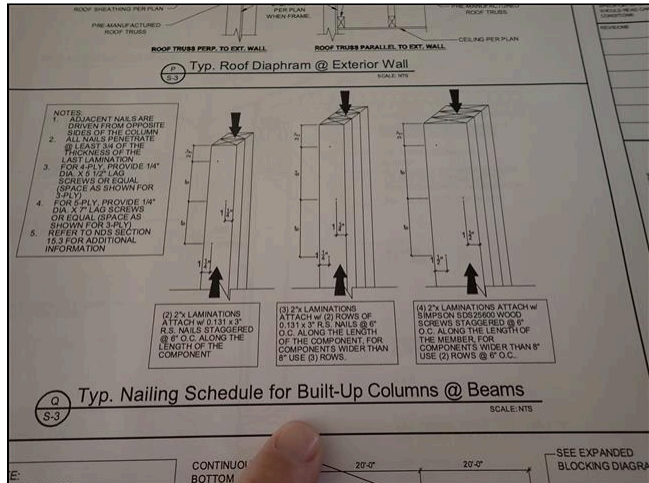
5.2 Item 3(Picture)

5.2 (1) Several built up columns on the lower level and upper level do not have the fasteners installed per the blue print specifications. Recommend correct as needed to comply with drawing specifications.

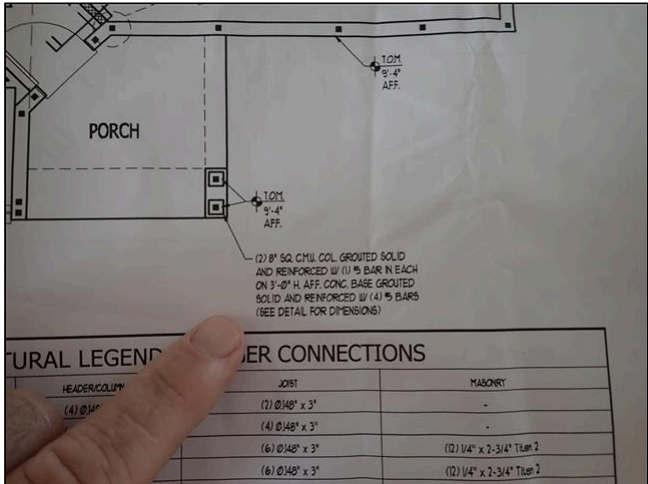
5.2 Item 11(Picture)

5.2 (2) We were unable to confirm the inside upper column is filled with grout per the drawing specifications. This column sounds hollow when struck unlike the outer column that sounds solid when struck. There appears to be separation or movement at the top of this column as well. Recommend confirm fill and correct movement as needed.

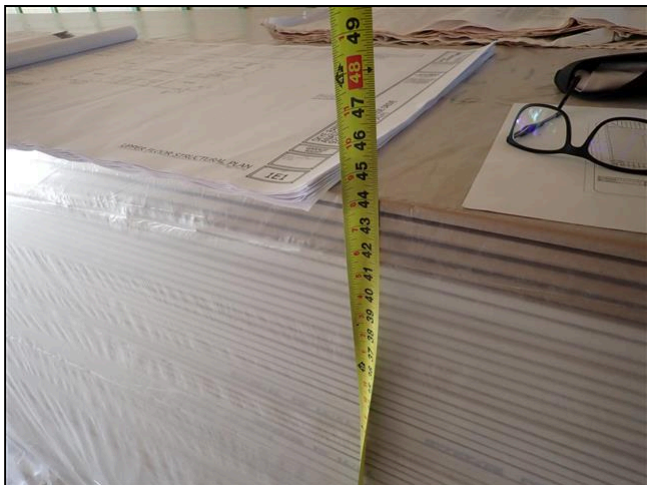
5.3 Item 2(Picture)

5.3 Excessively tall drywall stacks may put undue stress on the floor and floor system components. Recommend distributing the weight accordingly.

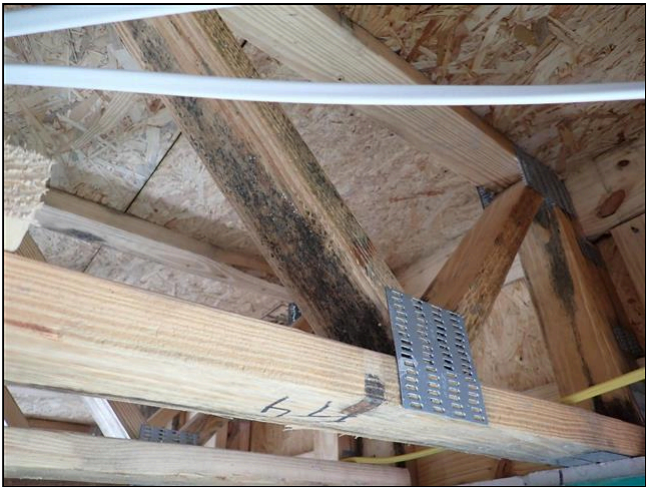
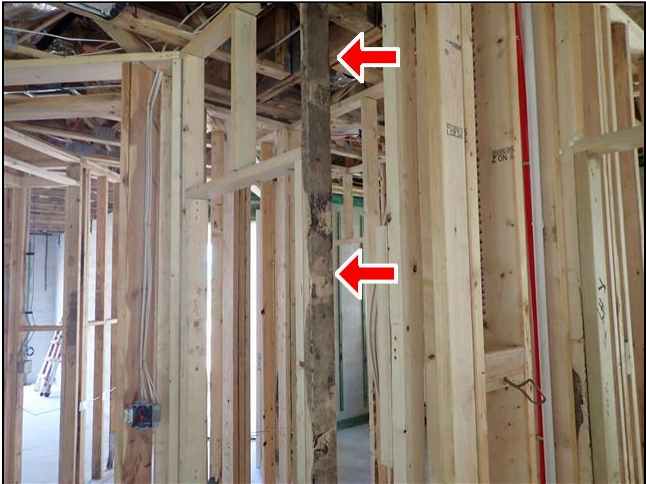
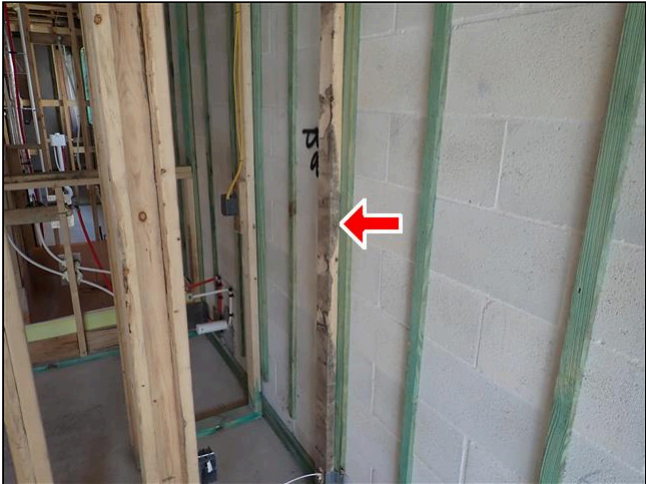
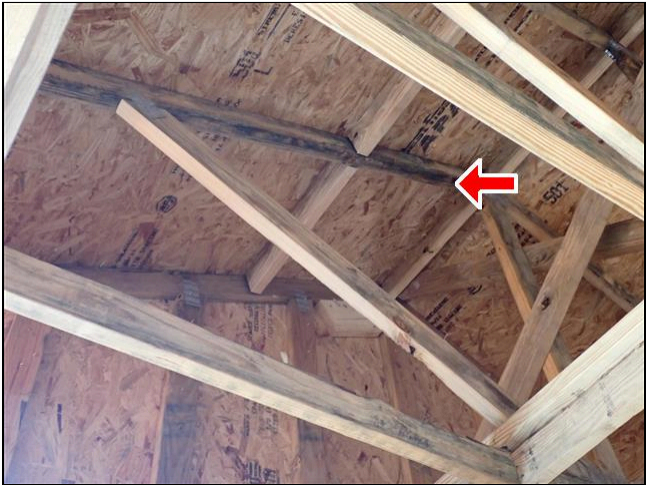
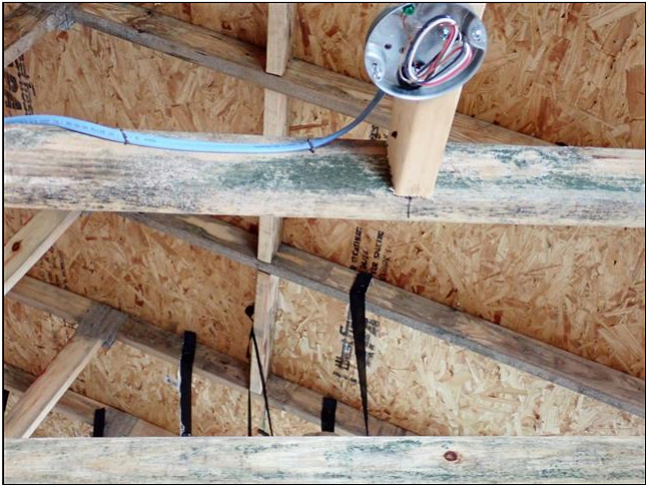
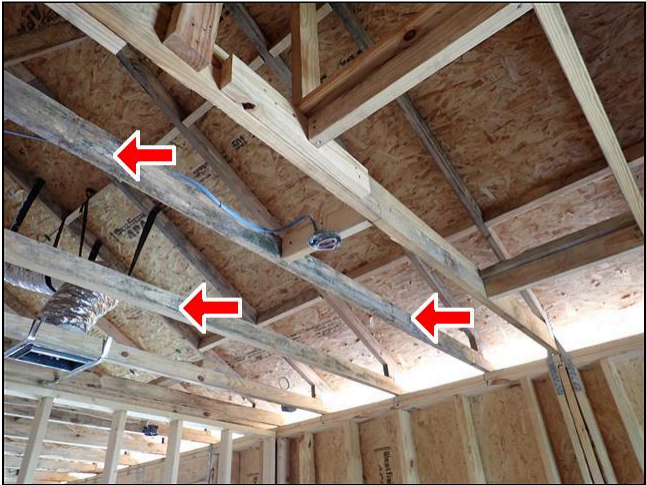
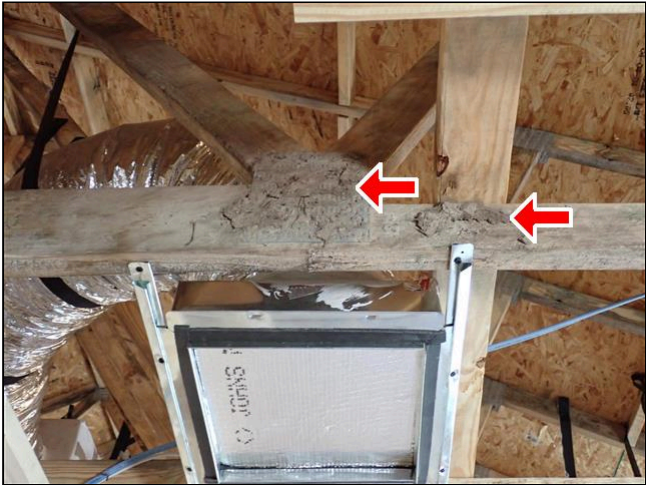
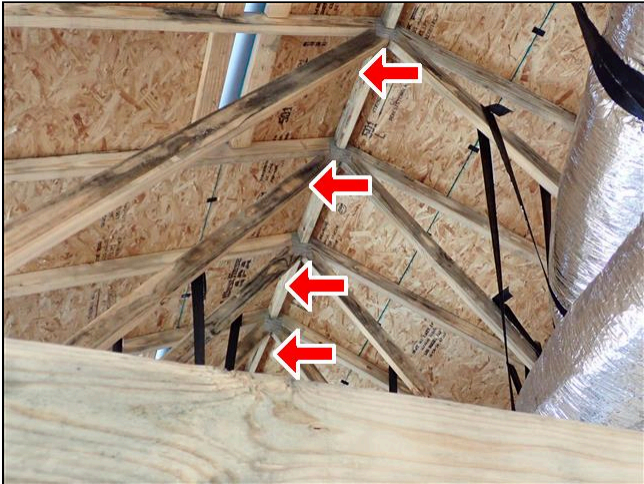
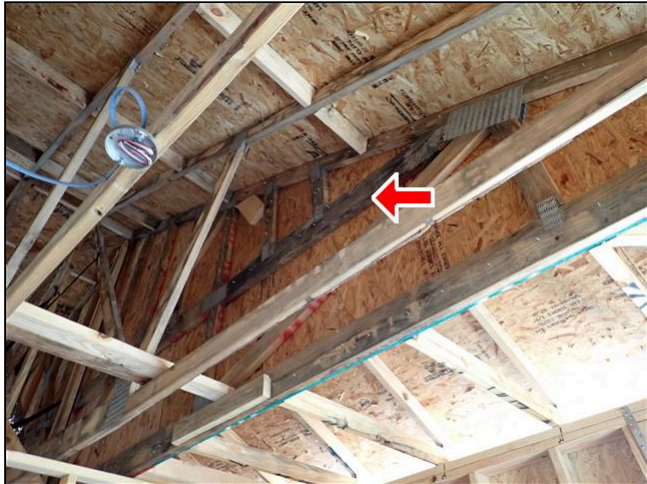
5.5 (1) Several roof framing, floor truss assemblies and studs have areas that are stained with an unknown substance. Recommend testing the substance from an environmental assessor as needed.

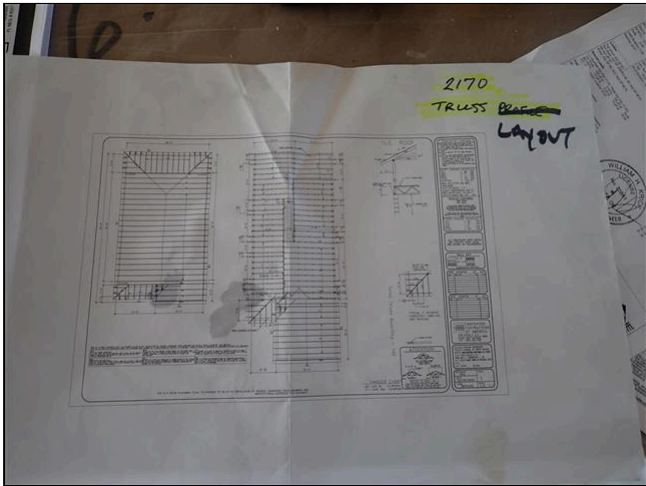
5.5 Item 11(Picture)

5.5 (2) Truss layout.

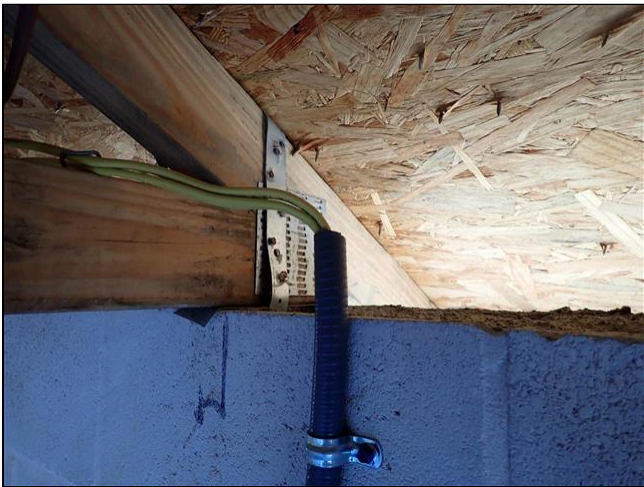
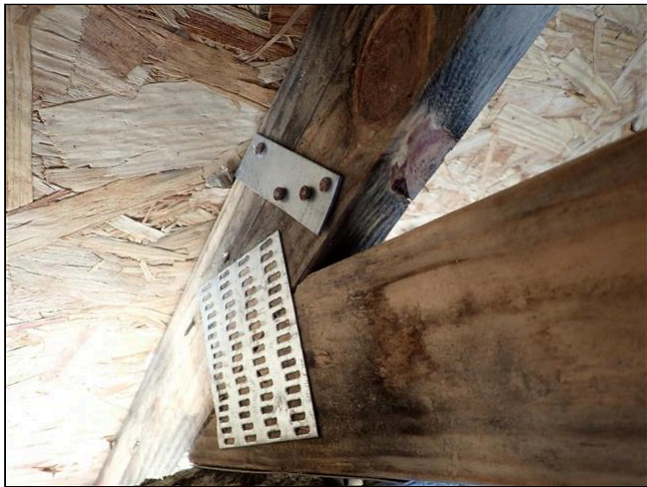
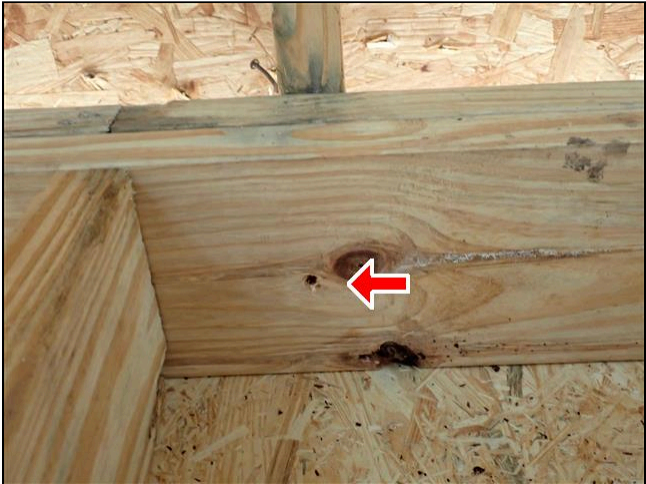
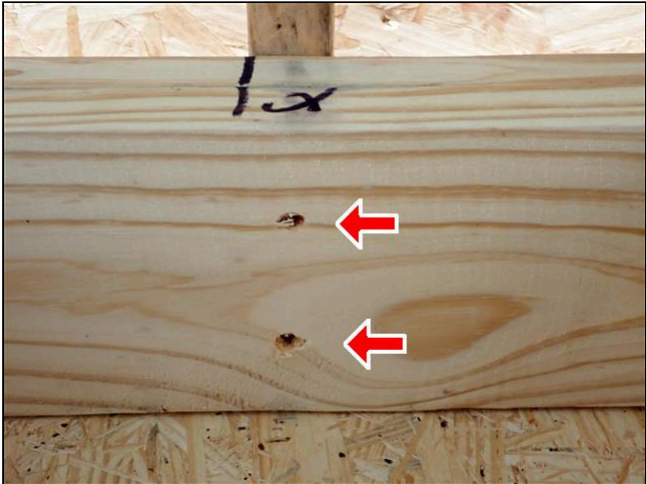
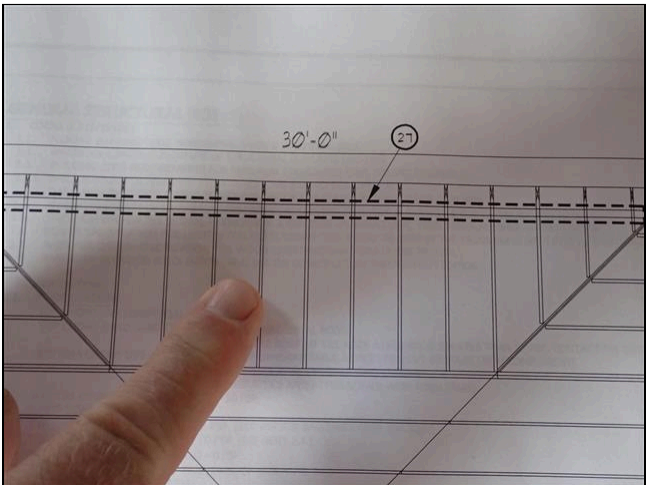
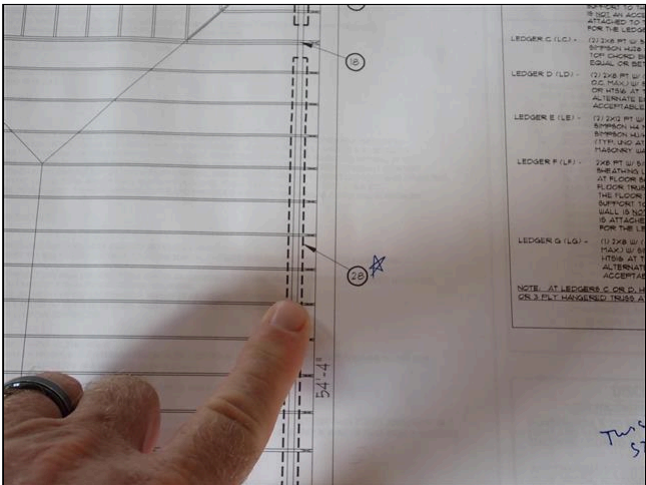
5.5 (3) Straps and Simpson SDWC connectors per drawings.

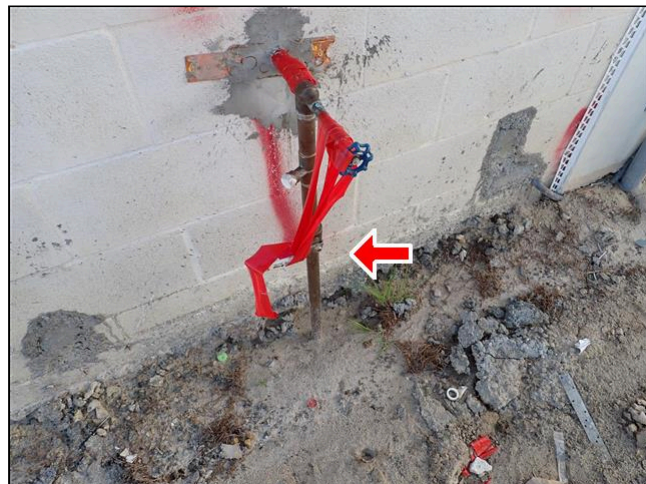
6.3 Item 1(Picture)

6.3 The main shut off is the white lever located outside on the right side of the home. This is for your information.

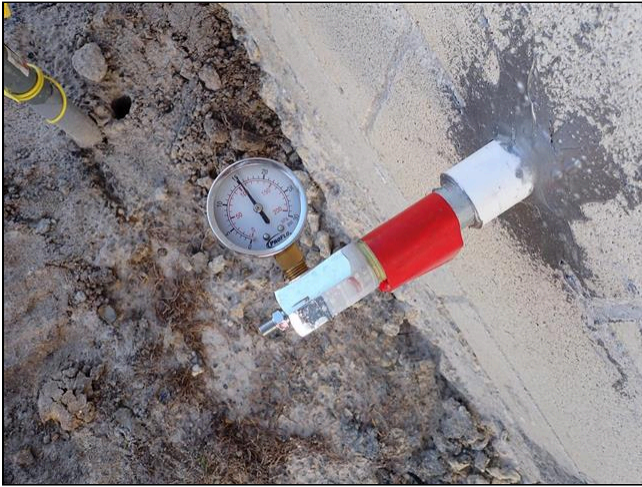
6.4 Item 1(Picture)

6.4 Gas pipe test under pressure. Bonding of the gas line present.

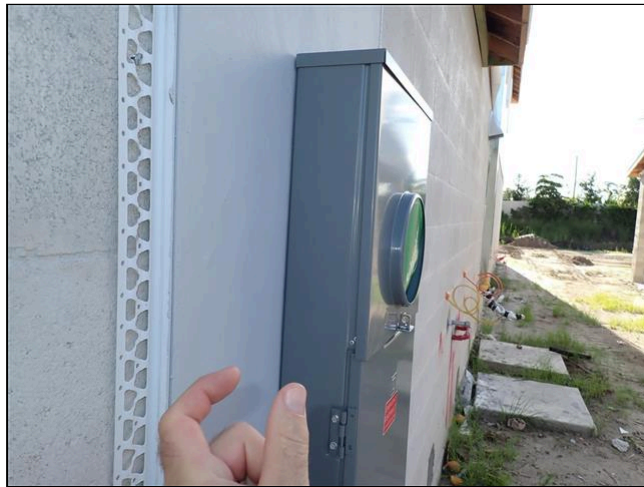
7.1 Item 1(Picture)

7.1 Exterior panel mounted correctly with rear air gap. Distribution box present in the garage however breaker installation is incomplete.

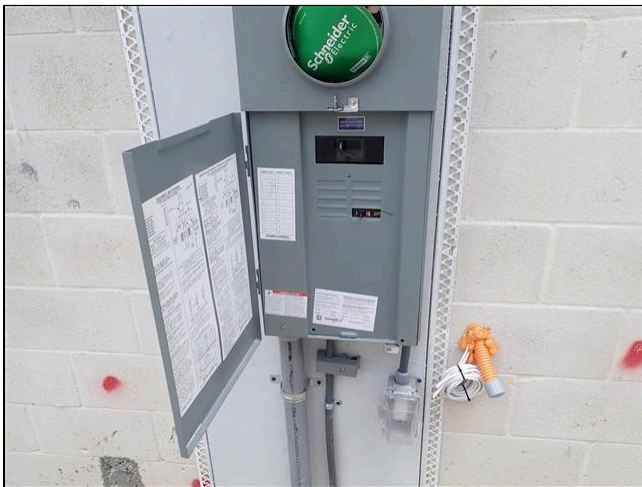
7.7 Item 1(Picture)

7.7 The main shut-off is located outside on the right side of the home near the meterbase. The main distribution panel is located in the garage (for your information).

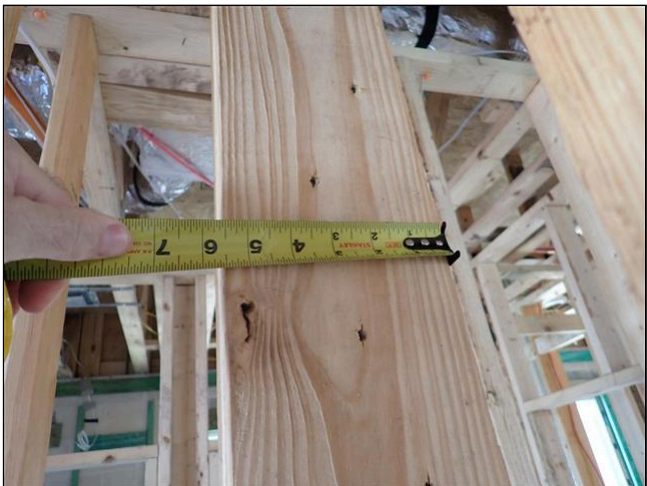
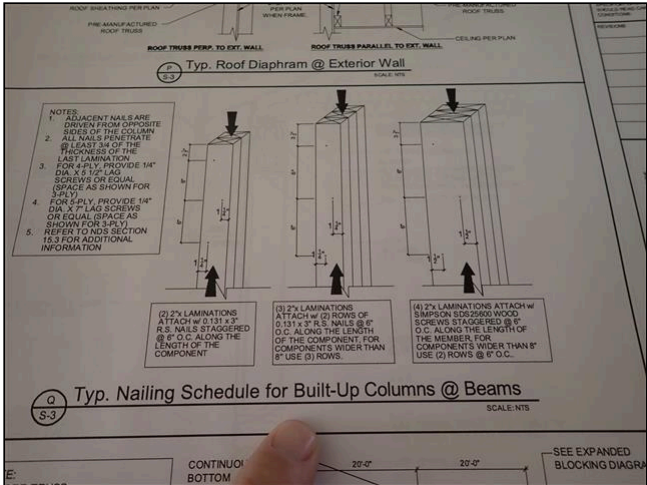
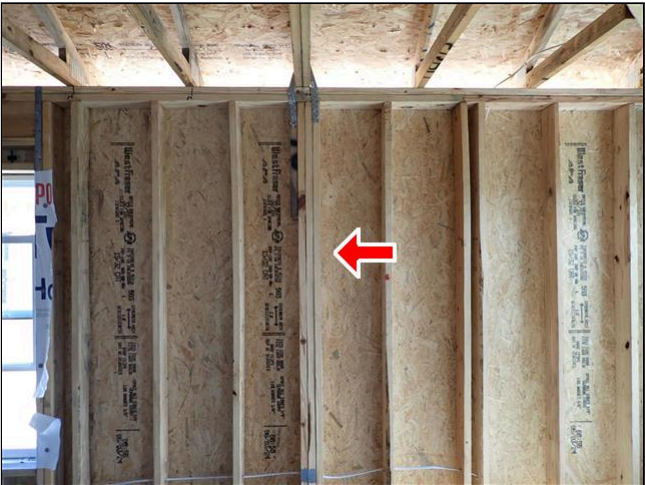
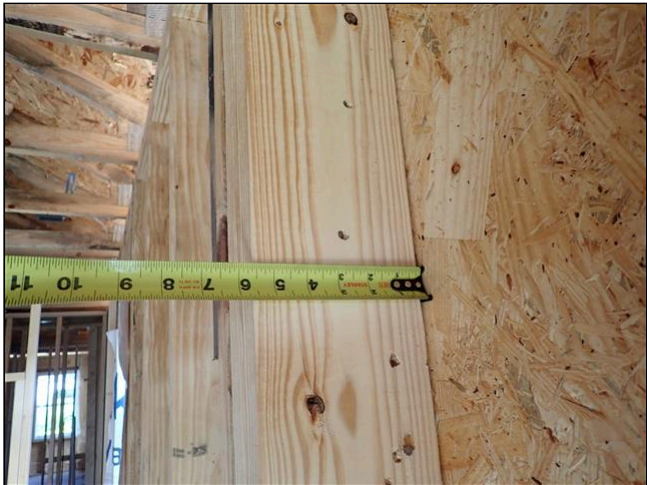
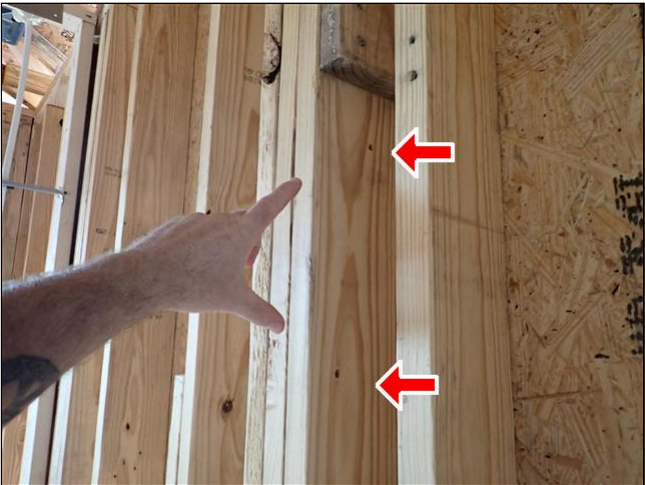
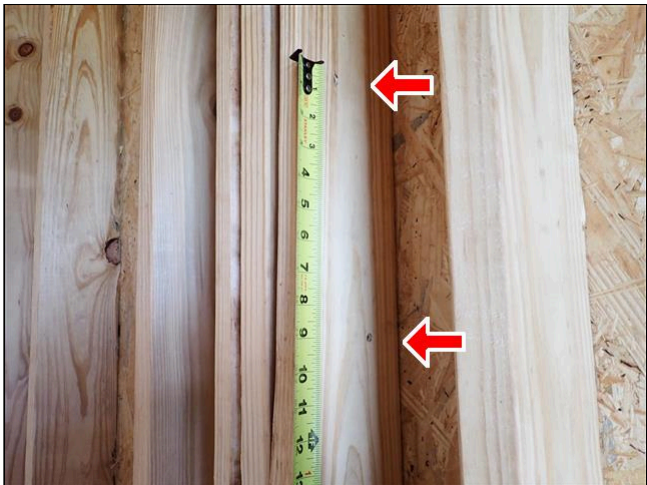
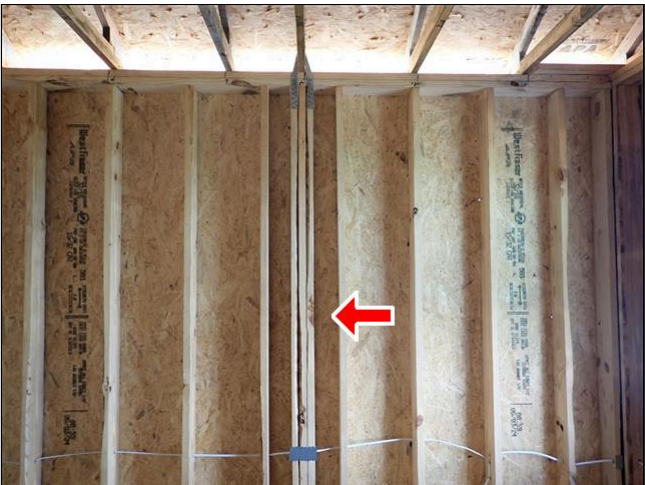
(1) Several built up columns on the lower level and upper level do not have the fasteners installed per the blue print specifications. Recommend correct as needed to comply with drawing specifications.

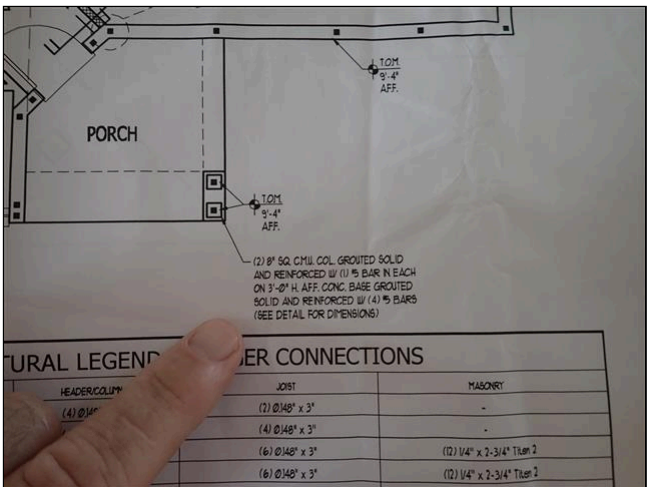
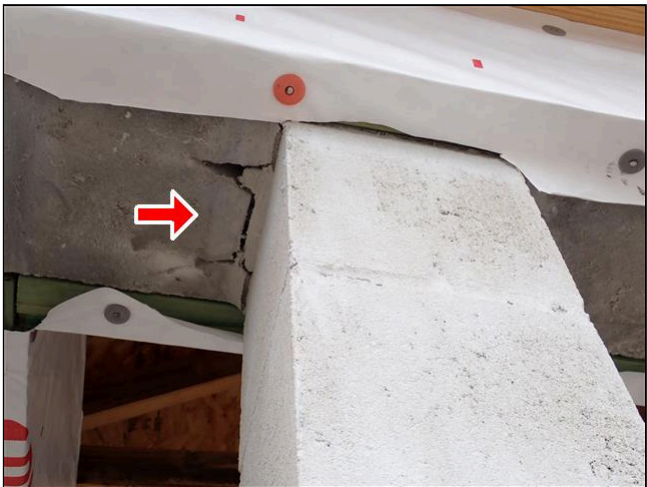
(2) We were unable to confirm the inside upper column is filled with grout per the drawing specifications. This column sounds hollow when struck unlike the outer column that sounds solid when struck. There appears to be separation or movement at the top of this column as well. Recommend confirm fill and correct movement as needed.

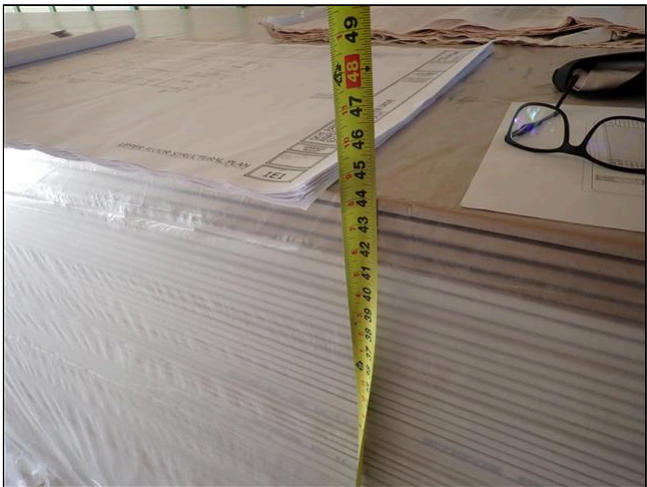
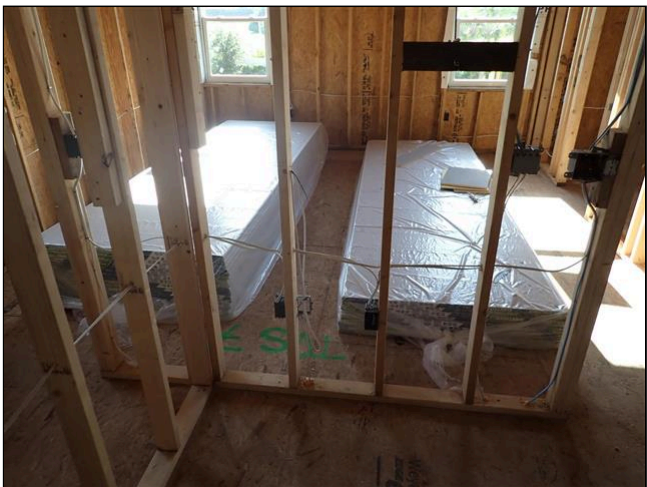
Excessively tall drywall stacks may put undue stress on the floor and floor system components. Recommend distributing the weight accordingly.

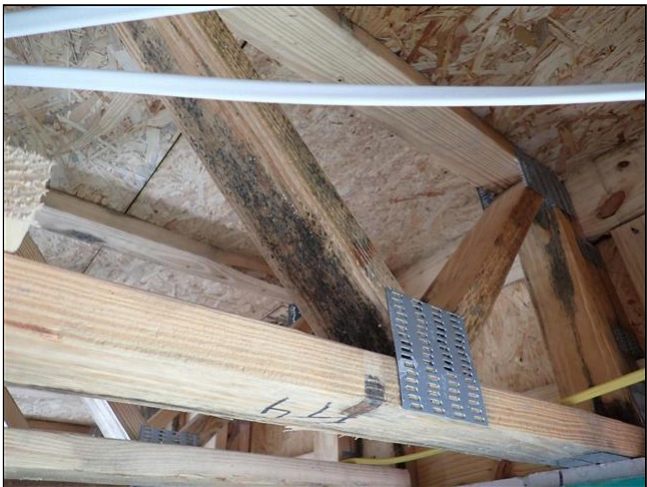
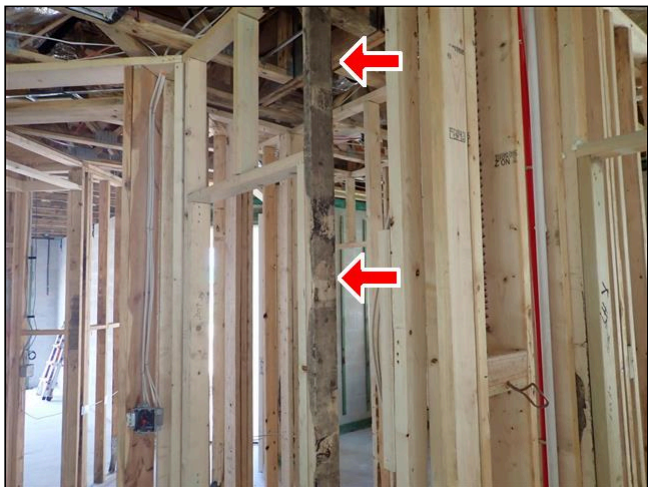
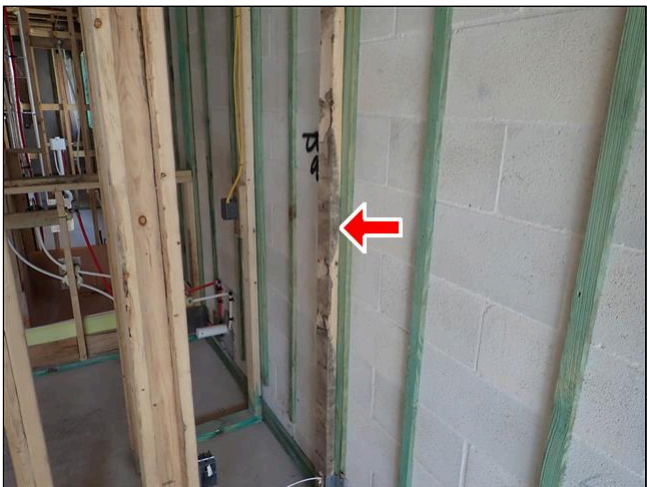
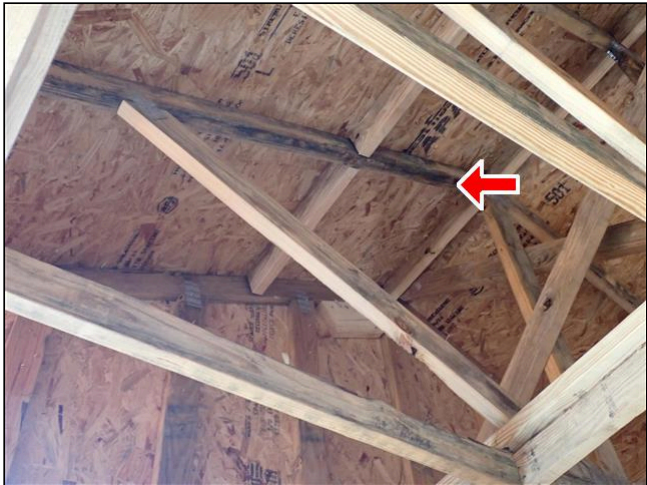
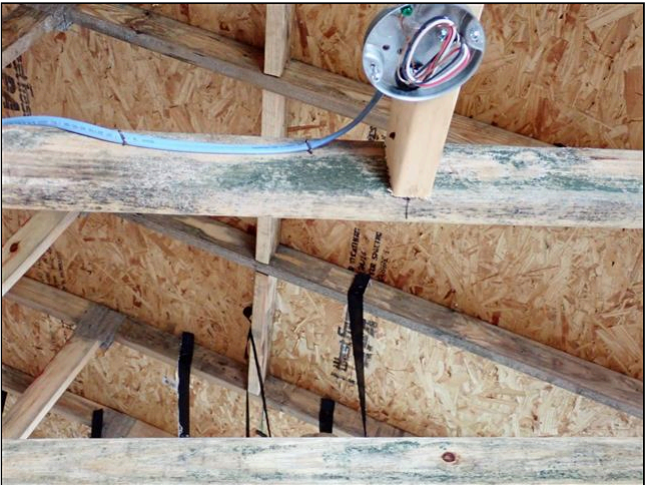
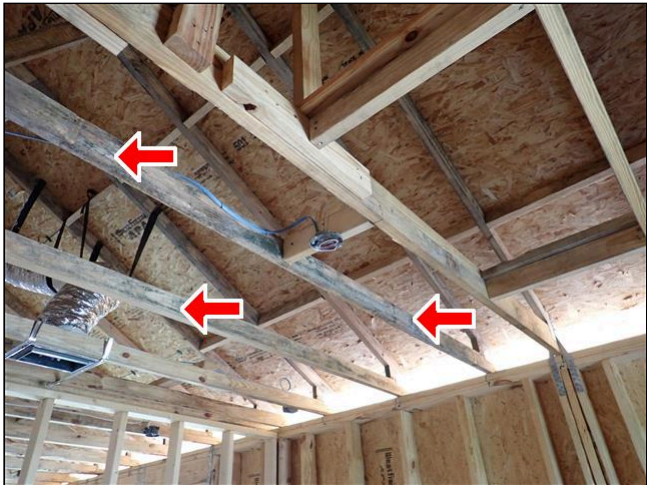
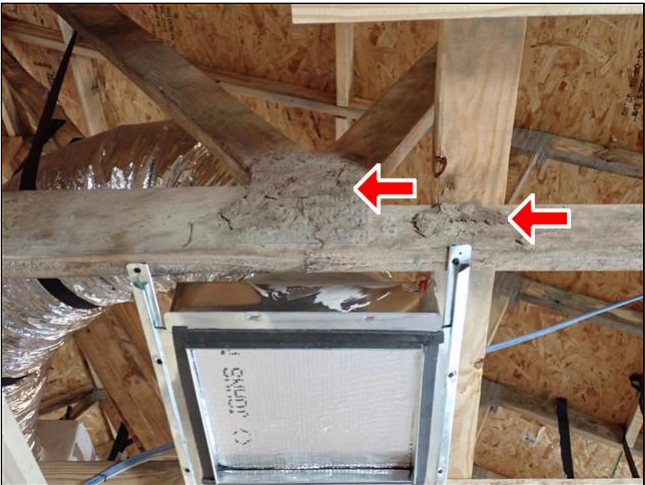
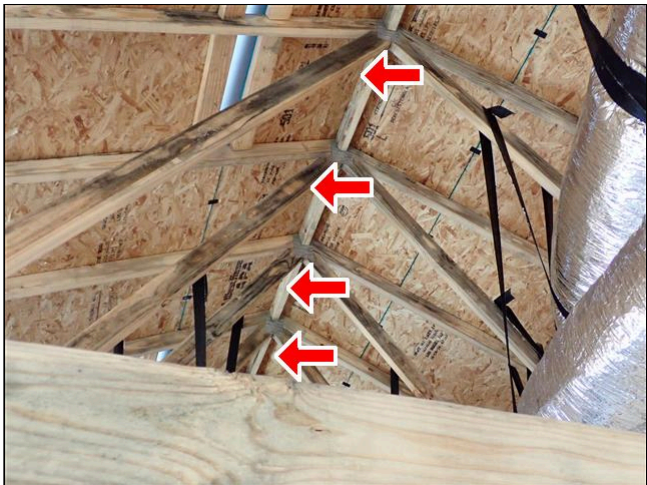
(1) Several roof framing, floor truss assemblies and studs have areas that are stained with an unknown substance. Recommend testing the substance from an environmental assessor as needed.

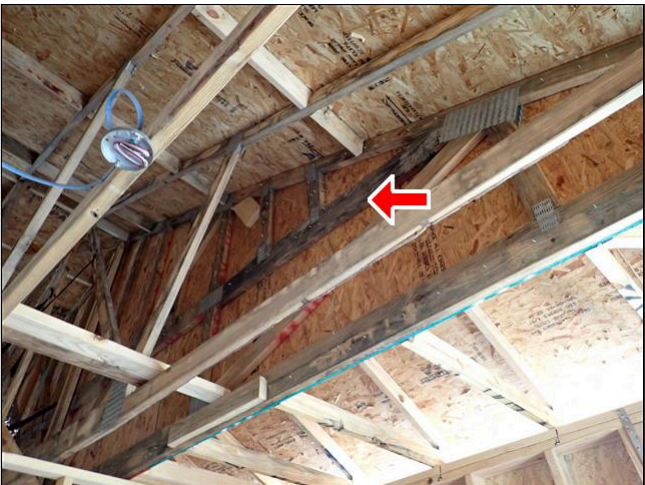
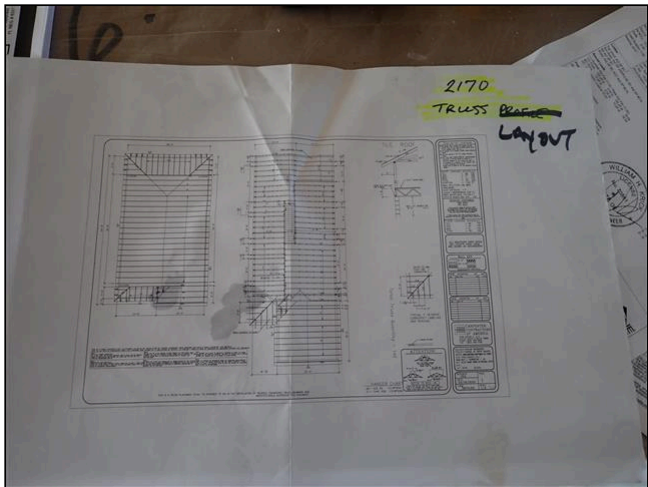
(2) Truss layout.

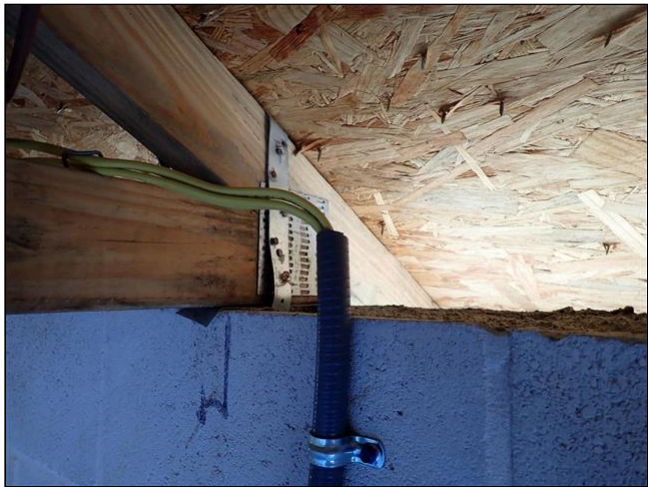
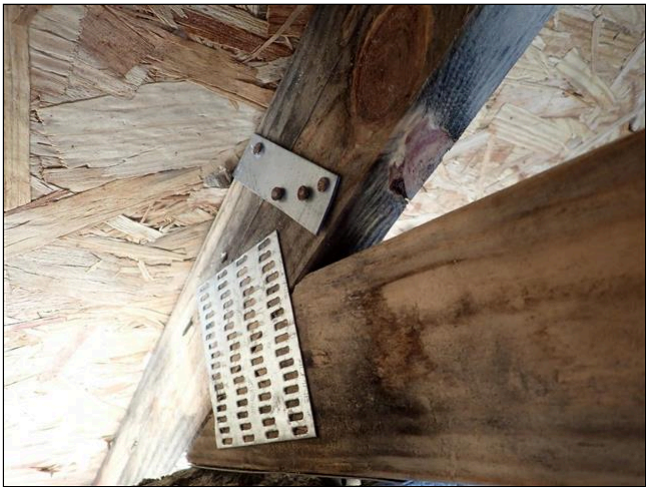
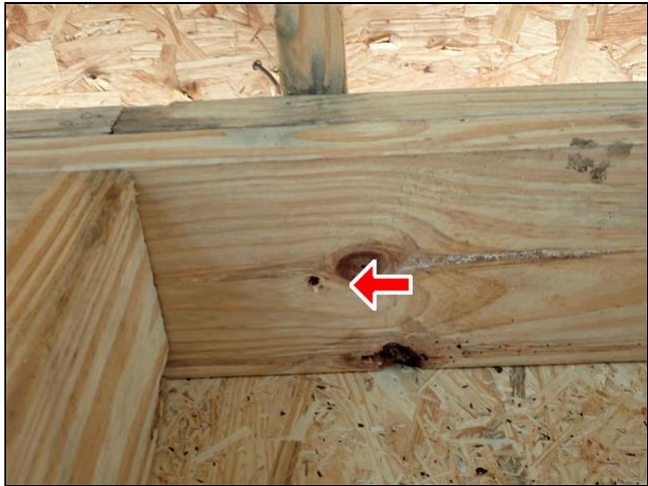
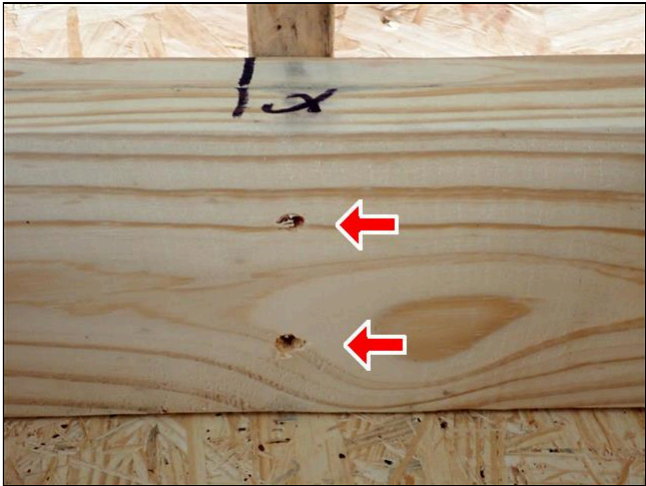
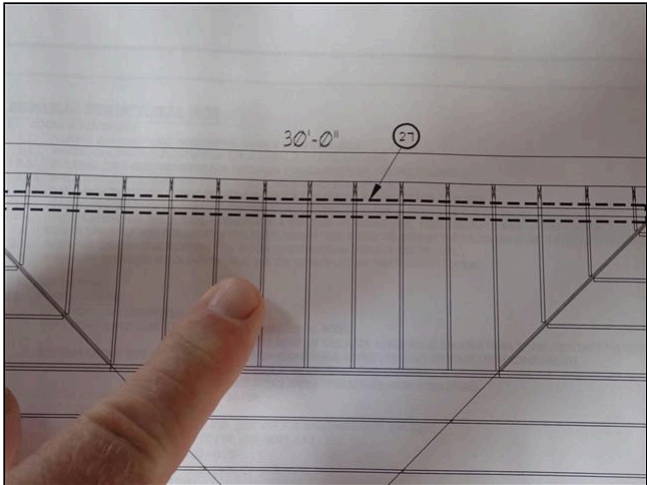
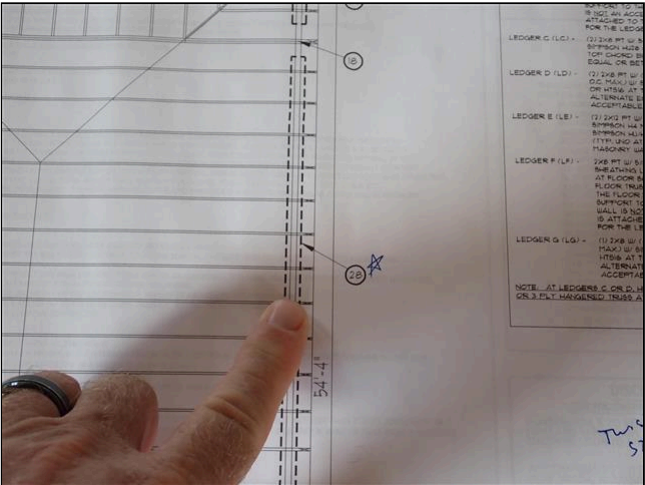
(3) Straps and Simpson SDWC connectors per drawings.

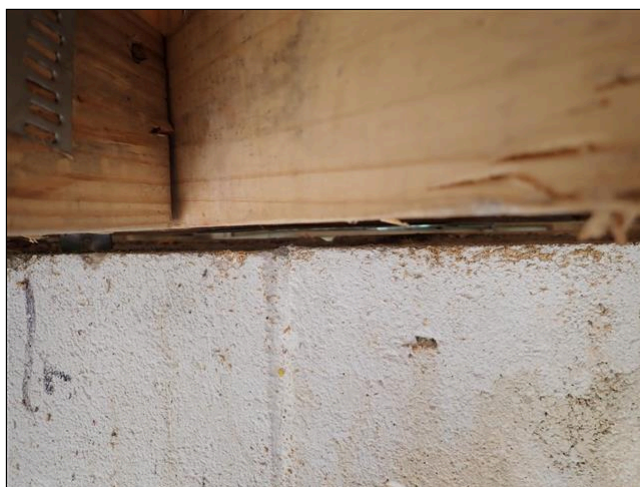
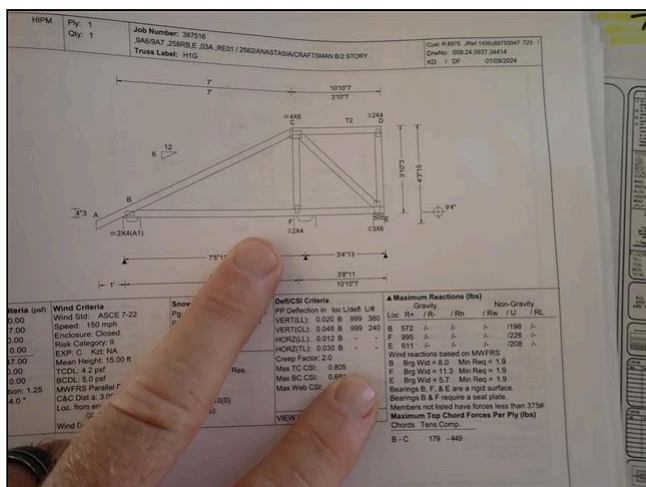
(5) Several floor trusses appear to be sitting on top of the metal straps along the right side of the home near the back patio and the kitchen area. Recommend correct strap alignment as needed.
