Inspection Report

308 Ohio Place, 1730 Morrill St, 1732/1736 Morrill St.
Sarasota Florida 34236

KMI Home Inspections, Inc.

Date: 11/26/2021	Time:	Report ID:
Property: 308 Ohio Place, 1730 Morrill St, 1732/1736 Morrill St. Sarasota Florida 34236	Customer: George Chung Cho Chung	Real Estate Professional: Kimberly Colgate Private Wealth Realty, Inc.

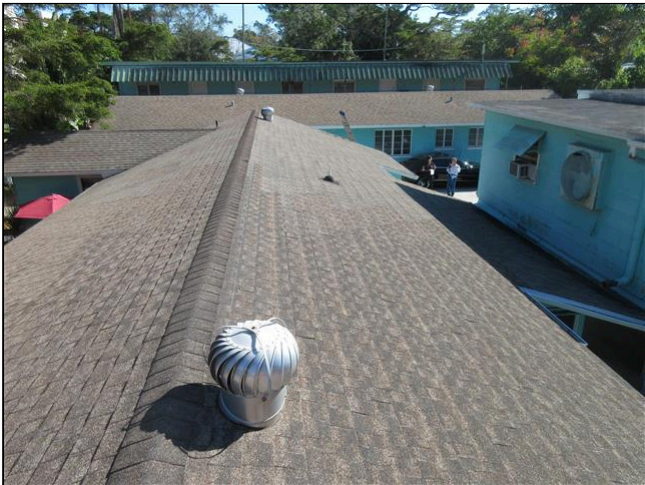
1.0 Item 2(Picture)

1.0 1732/1736- Roof covering has significant granular loss and has exceeded its useful life expectancy. Membrane roof covering above the garage unit and 8 Plex shows several areas that pond water. Tree limbs are in contact with the garage roof and the 8 Plex roof and should be trimmed. Recommend further review from a licensed roofing contractor and repair as needed.

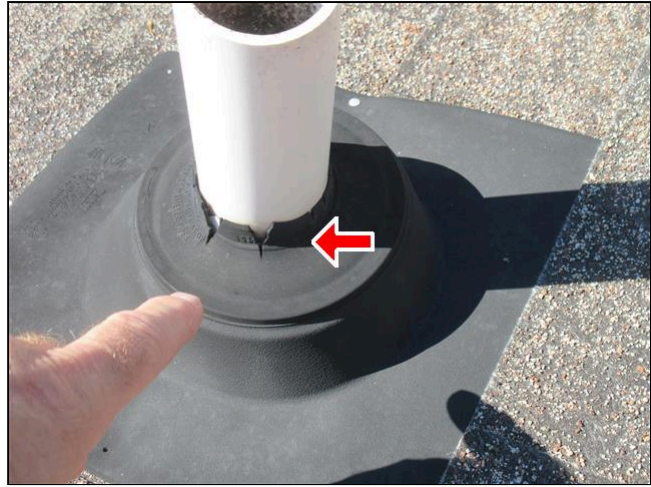
1.1 Item 2(Picture)

1.1 1732/1736- Several flashing boots are damaged or installed improperly. Repairs are needed. Bitumen flashing above the 8 Plex has pulled loose near the plumbing vent pipe. Recommend a licensed roofing contractor repair as needed.

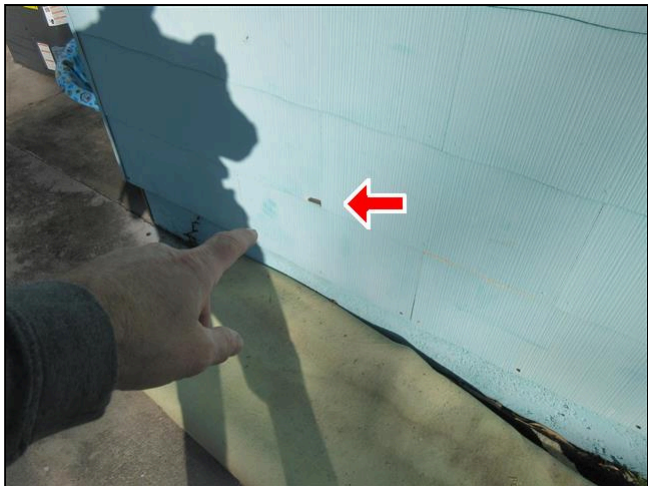
2.0 Item 2(Picture)

2.0 1732- Multiple slate tiles are damaged or cracked on the perimeter of the unit. Garage- Rear and side sheds are deteriorated at the door frame and/or siding and need repairs. 8 Plex- Masonry coating on the rear of the lower units has several hairline settlement cracks. Displacement was not observed (for your information). 8 Plex- Wood siding at the lower level is partially deteriorated in several areas. Recommend repair as needed.

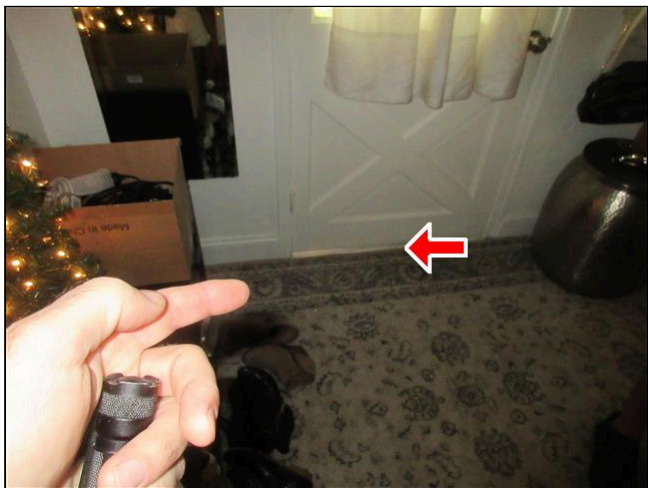
2.1 Item 2(Picture)

2.1 1732- Front and rear entry doors are missing weather stripping. 1736- Front and rear entry doors are missing weather stripping.

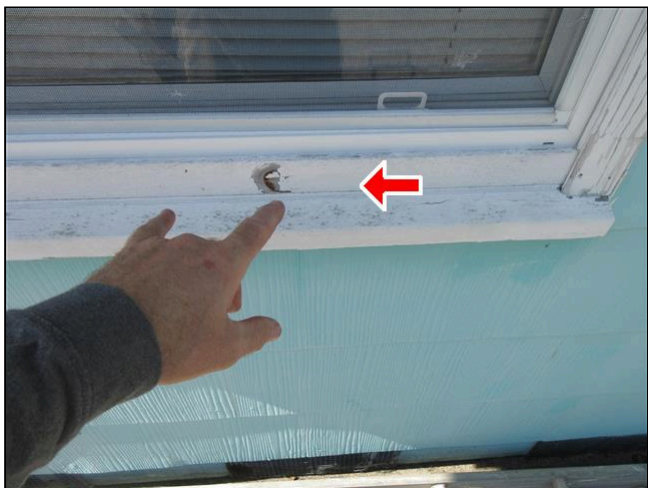
2.2 Item 2(Picture)

2.2 Multiple window frames or trim around the units are peeling paint. Recommend seal, prep and paint as needed.

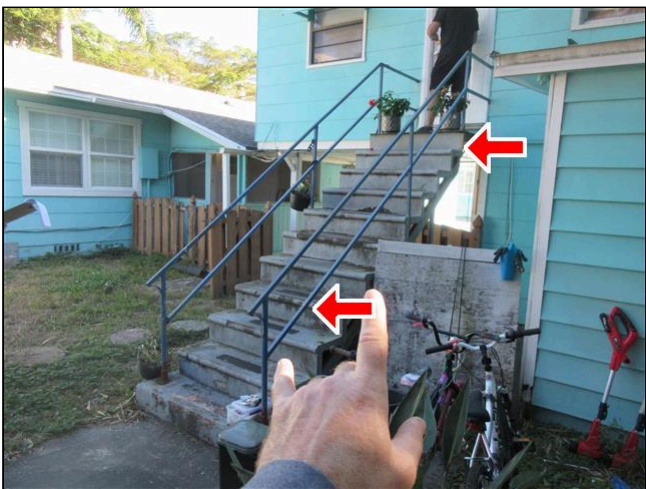
2.3 Item 2(Picture)

2.3 Garage- There is a platform at the rear side wall of the upper garage apartment near one of the windows. The purpose of this platform is unknown. Pickets on the handrail leading to the upper garage apartment are spaced too far apart for safety. Recommend 4" max spacing for safety. Support post below the right side stairs (facing front) of the 8 Plex is loose and needs securing. At least one support post for the metal awning on the back side of the 8 Plex is loose and needs securing at the top.

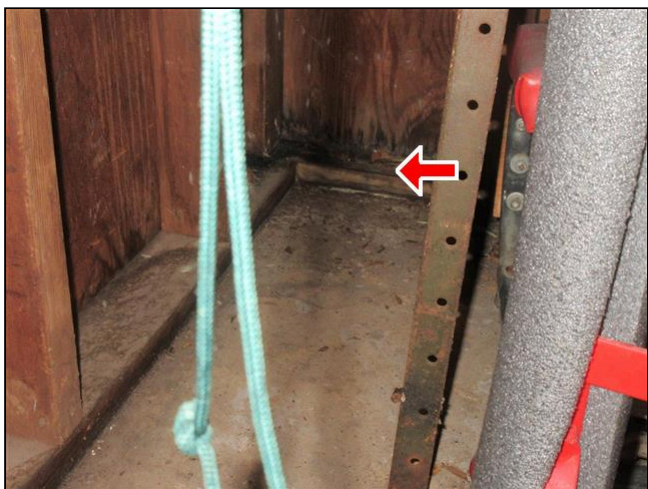
2.4 Item 2(Picture)

2.4 Water stains are present on some of the lower components of the garage walls. Drainage may need to be corrected in these areas. Recommend monitoring during a heavy rain and correcting as needed. Concrete slopes towards the foundation vents on the left side of the Duplex. Water may enter the crawlspace during periods of heavy rain. Recommend monitoring and correcting as needed.

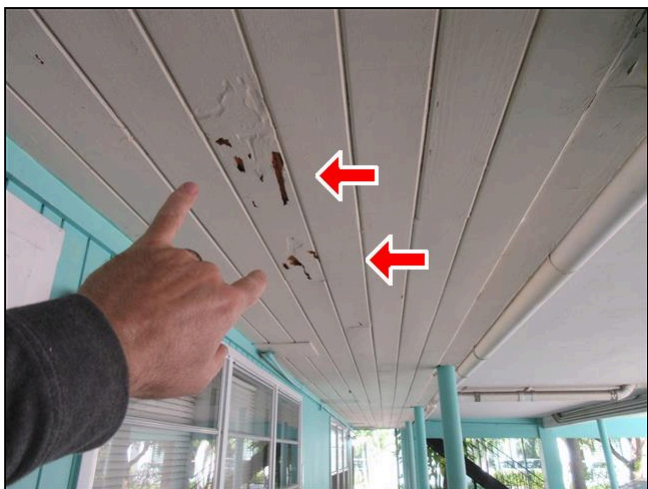
2.5 Item 2(Picture)

2.5 8 Plex- Ceiling and beams above the carport of the 8 Plex is damaged/deteriorated or missing or peeling paint at several areas. Repairs are needed. Former antenna mast is loose and needs securing or removal above the 8-Plex.

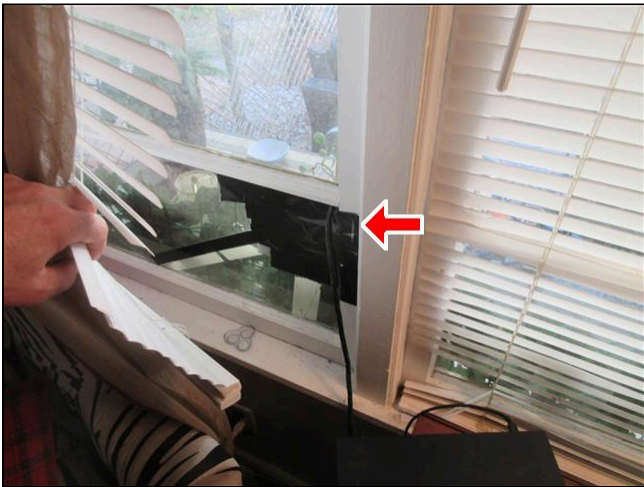
4.6 Item 3(Picture)

4.6 1732- Several windows difficult to operate or missing screens throughout the unit. 1736- One window at the front of the home is damaged at the glass pane. Garage- One window at the side of the home is damaged at the glass pane. Shower window crank unit is missing a screw and needs repair to operate properly. 8 Plex- Multiple windows are missing screens or are difficult to operate.

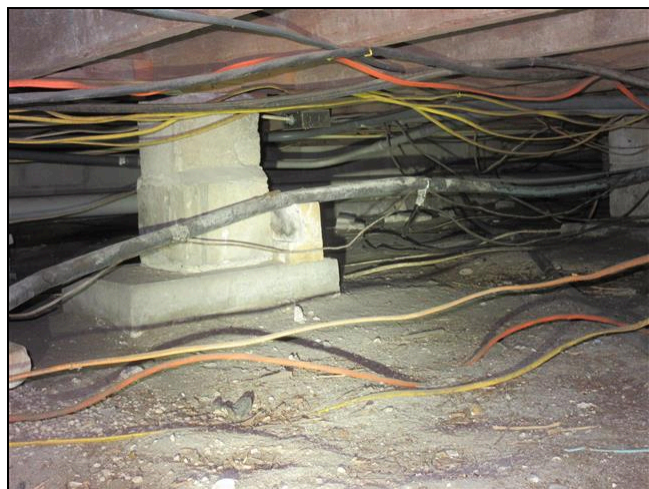
5.0 Item 1(Picture)

5.0 1732/1736- Crawl space photos included.

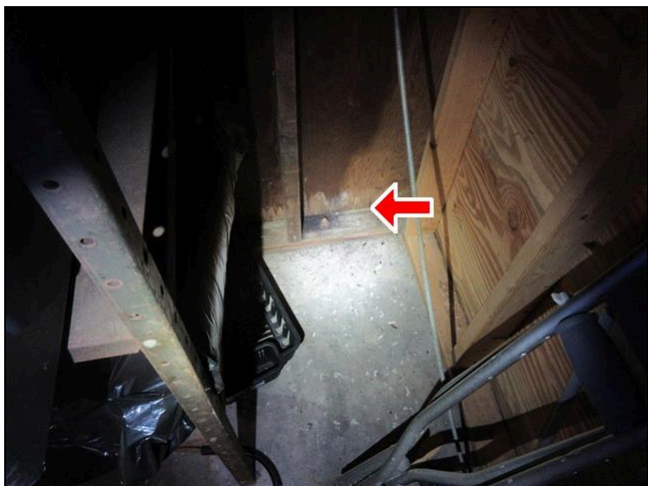
5.1 Item 2(Picture)

5.1 Garage- Several studs and bottom plates at the rear and side walls of the garage are deteriorated and need repairs. Water stains are present at several locations.

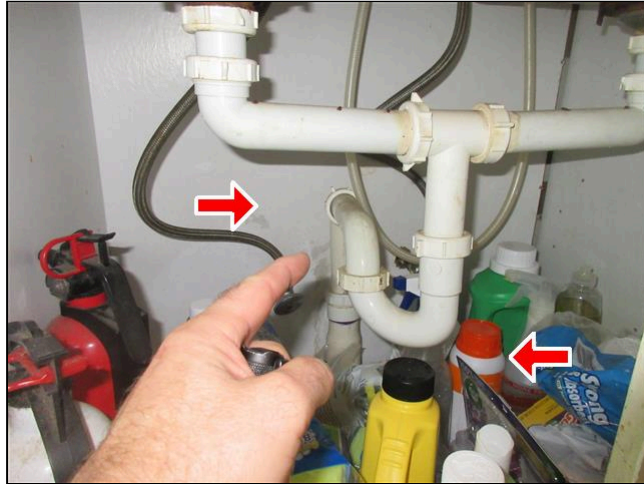
6.0 Item 1(Picture)

6.0 Garage- Plumbing waste line below the kitchen sink has an s-trap that should be converted to a p-trap.

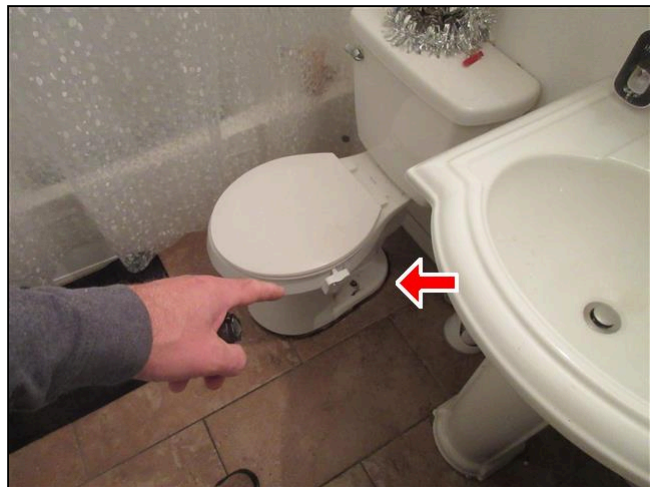
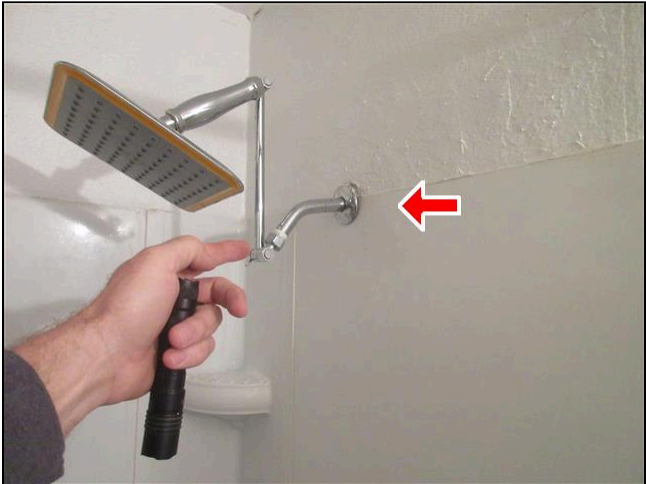
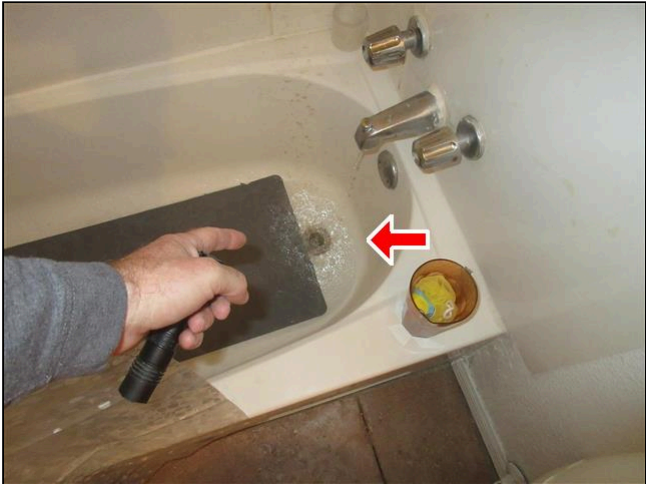
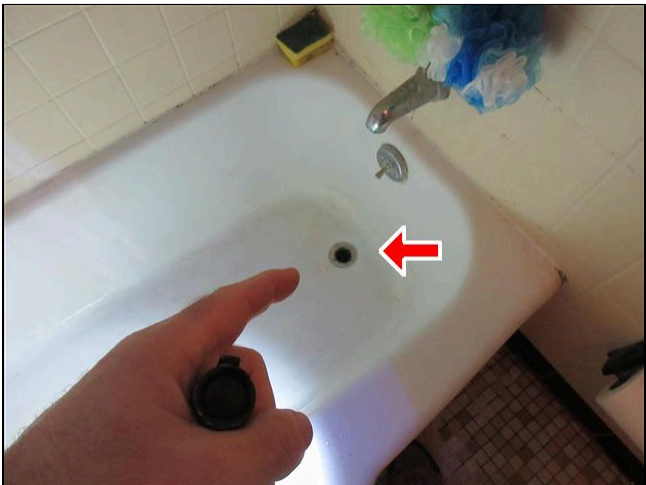
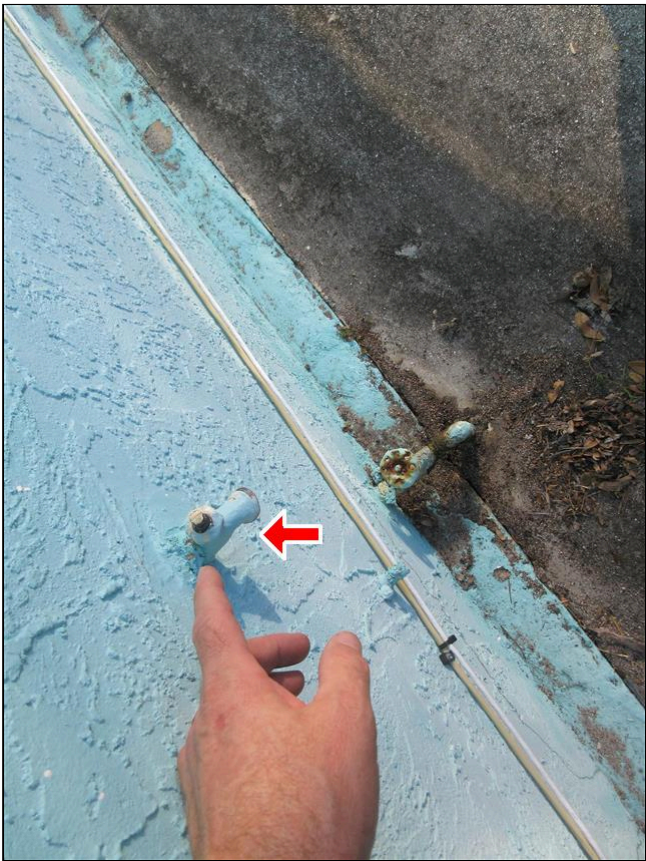
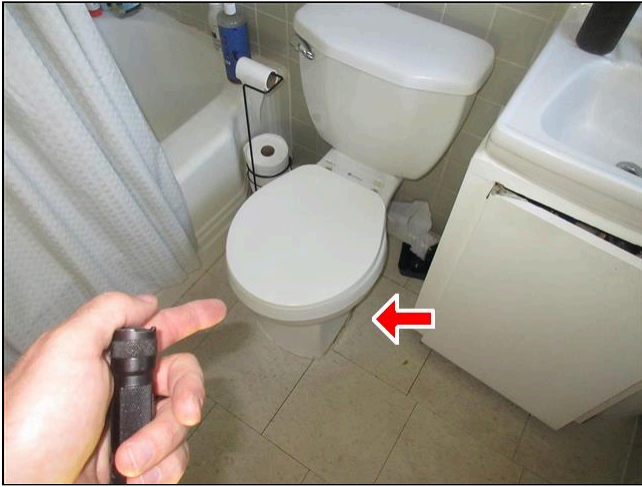
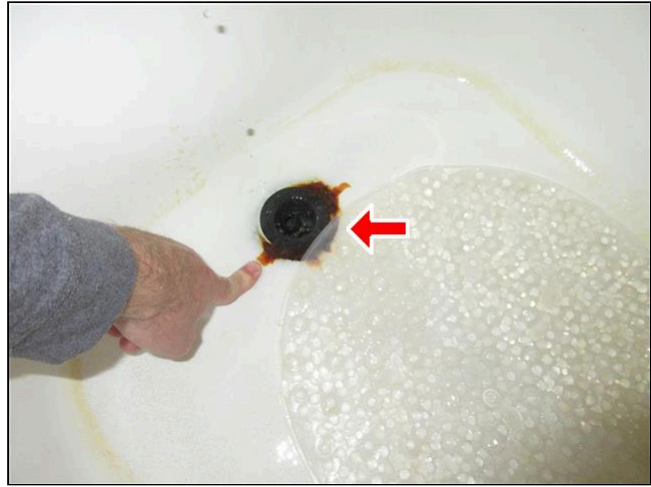
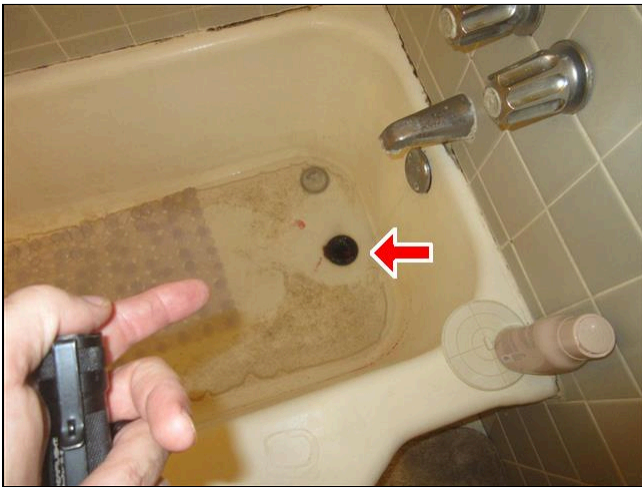
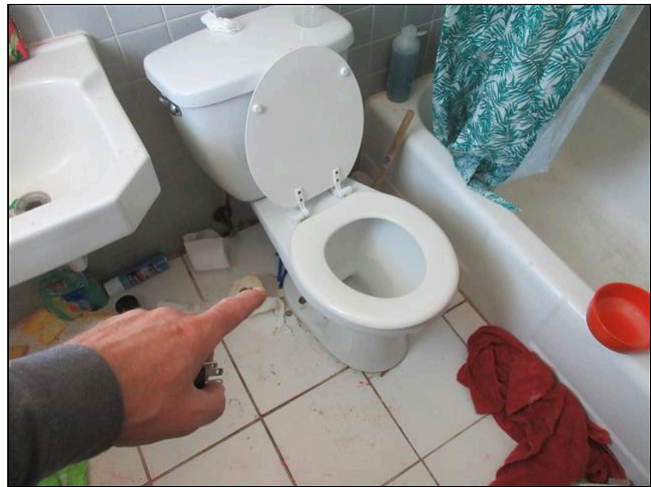
6.1 1732- Sink faucet is dripping at the guest bathroom. 1736- Toilet is loose at the floor at the hall bath. Repairs may include replacing the wax ring. We were unable to view this area from below to determine the condition of the flooring component below. Shower head is loose and needs securing. Tub drain is slow to drain. Garage- Tub drain is missing the stopper. 8 Plex- Hose bib knob at the rear of the building is damaged and needs replacing. Unit 3- Toilet is loose at the floor at the hall bath. Unit 3- Tub drain area is corroded and tub is missing the stop valve. Unit 2- Tub drain is slow to drain. Unit 8- Toilet is loose at the floor at the hall bath. Unit 7- Bathroom sink has several hairline cracks present.

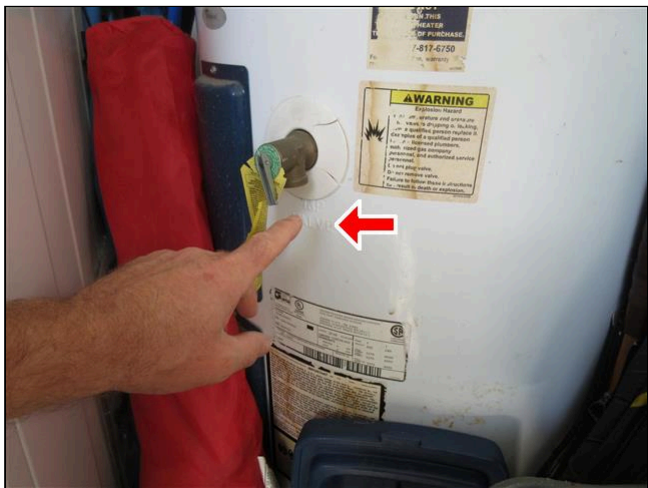
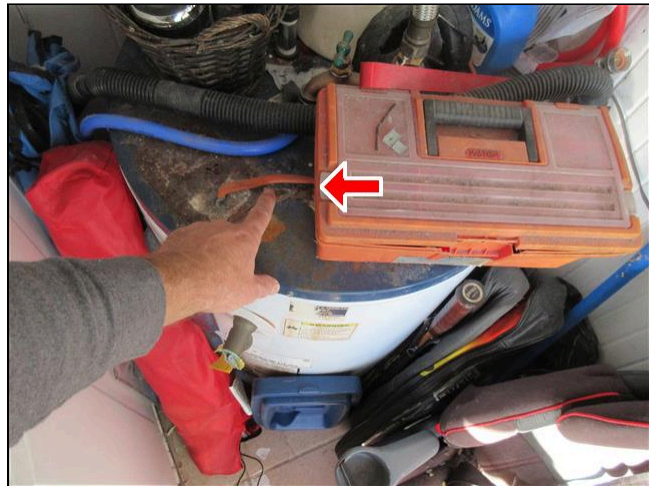
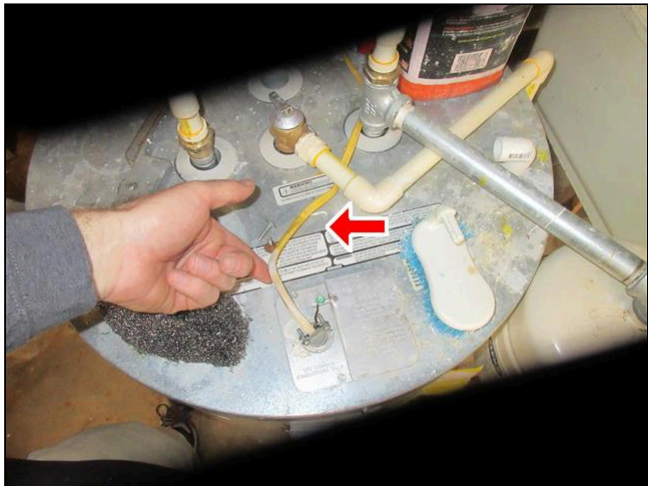
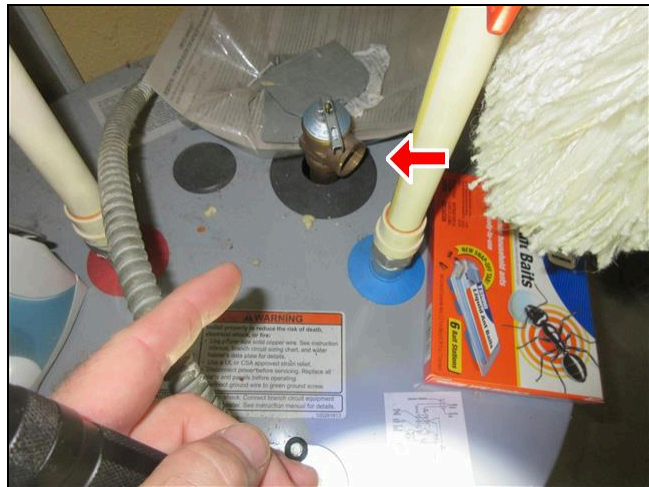
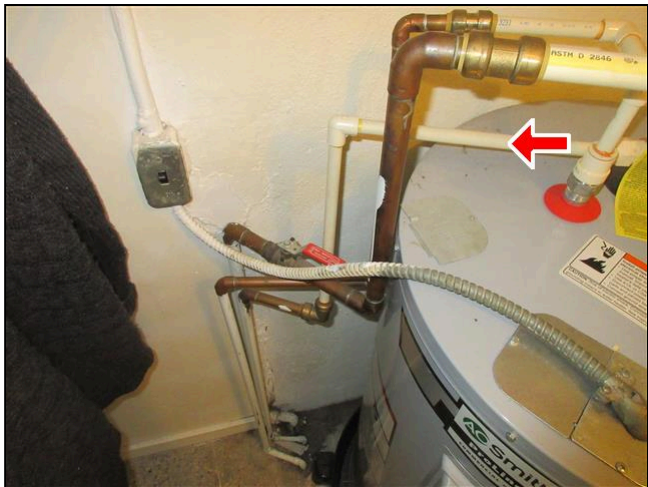
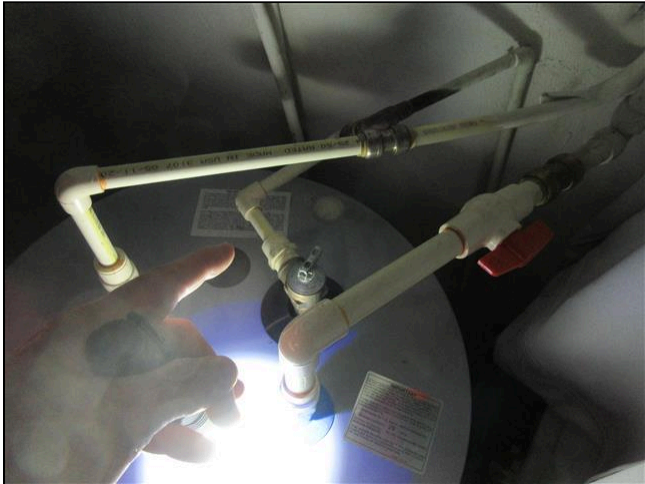
6.2 1732- Water Heater is missing a T & P Relief valve pipe. 1736- Water Heater is missing a T & P Relief valve pipe and has exposed romex wiring that should be encased. Garage- Water Heater has exposed romex wiring that should be encased. Unit 4- Water Heater is missing a T & P Relief valve pipe. Unit 3- Water Heater has an inappropriately sized T & P Relief valve pipe. T & P Pipes should be 3/4" diameter and not reduced to 1/2". Unit 2- Water Heater has an inappropriately sized T & P Relief

valve pipe. T & P Pipes should be 3/4" diameter and not reduced to 1/2". Unit 7- Water Heater is missing a T & P Relief valve pipe.

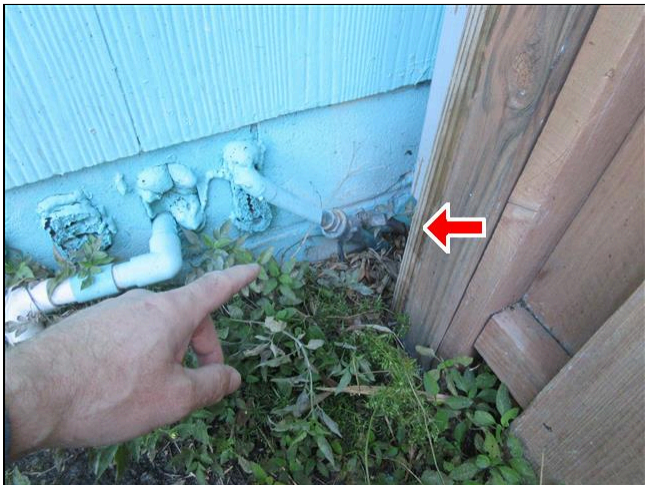
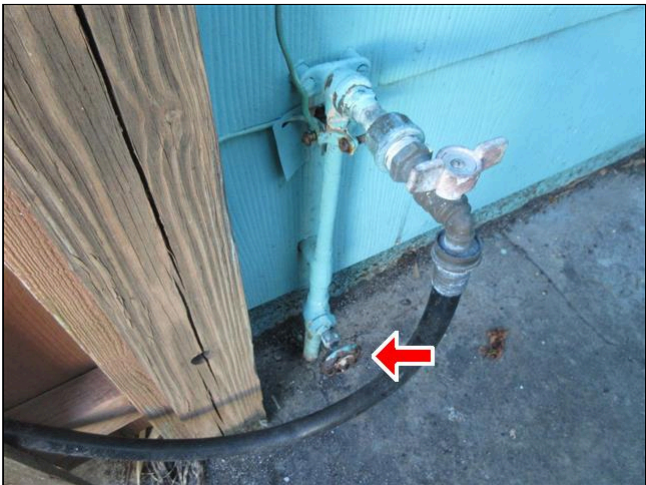
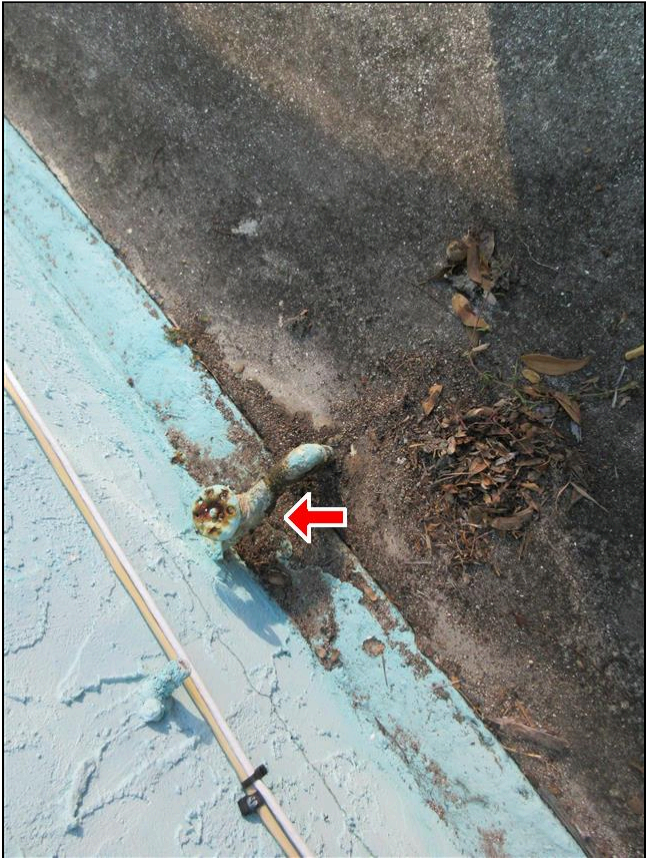
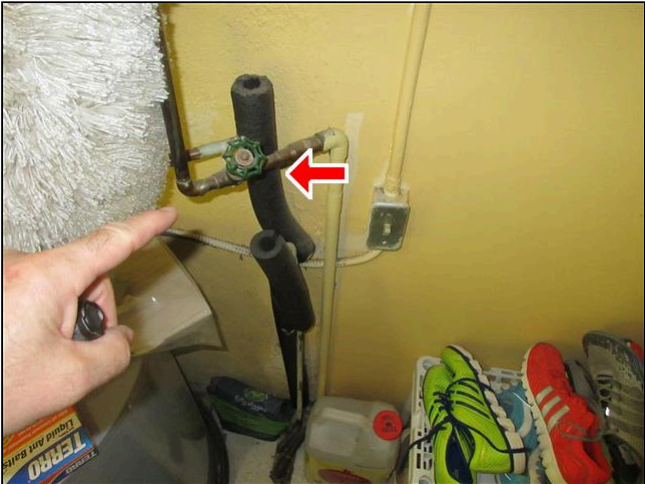
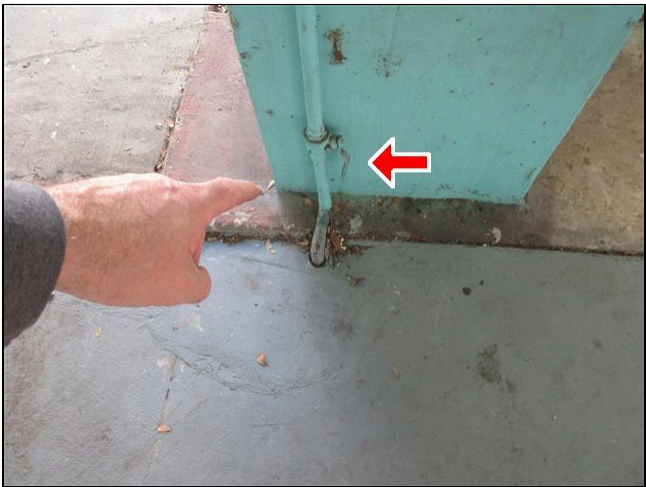
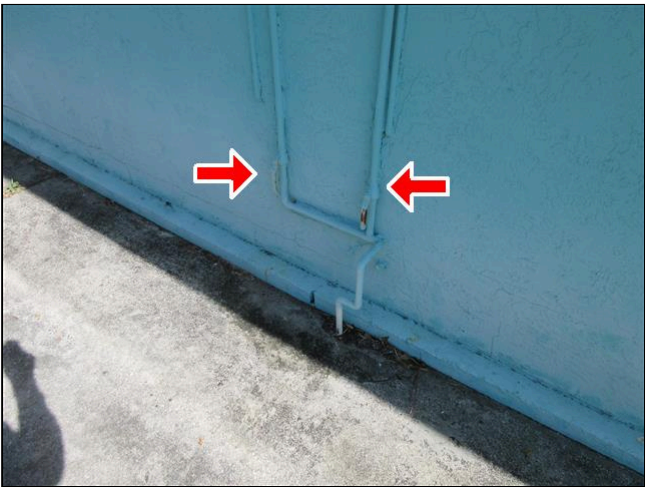
6.3 1732/1736- Main water shut-off (see photo). Garage- Main water shut-off (see photo). 8 Plex- Several water shut-off valves were observed at the front and rear of the 8 Plex (see photo's). We were unable to determine which valve was for which specific unit during this inspection. Unit 4- Shut-off valve was present behind the water heater.

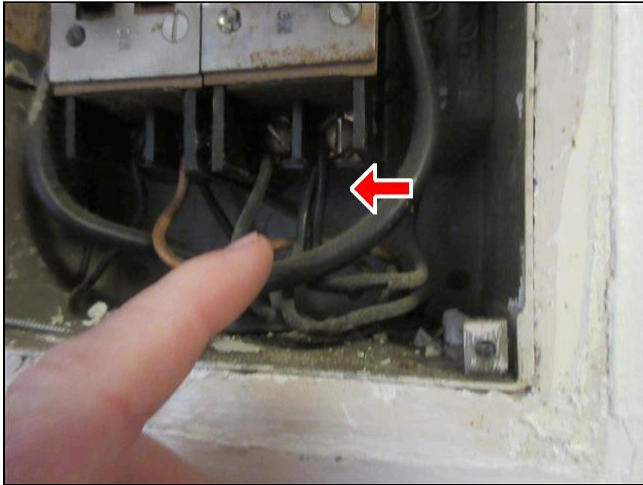
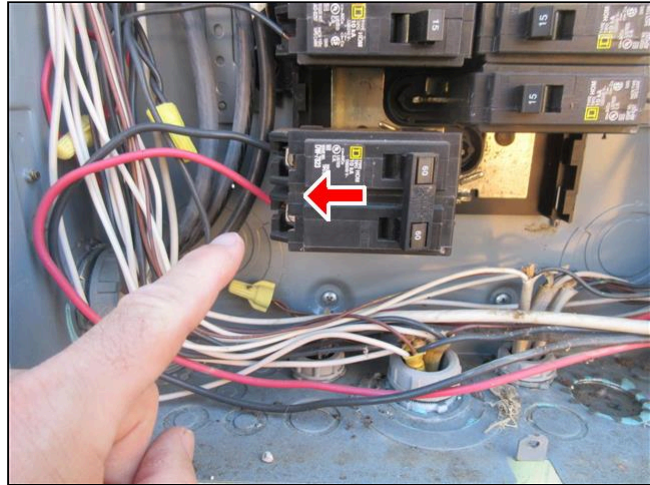
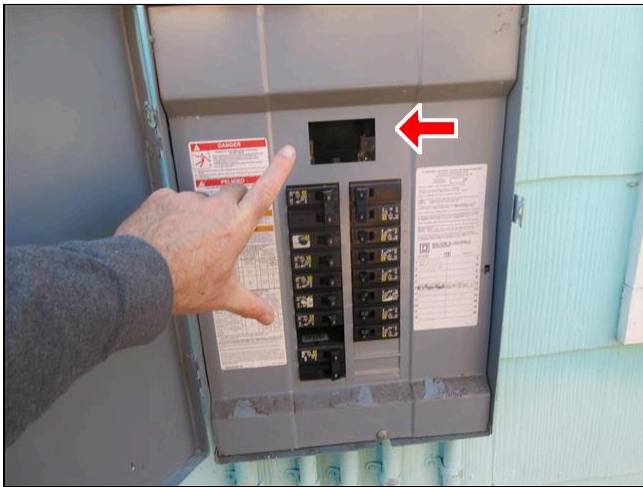
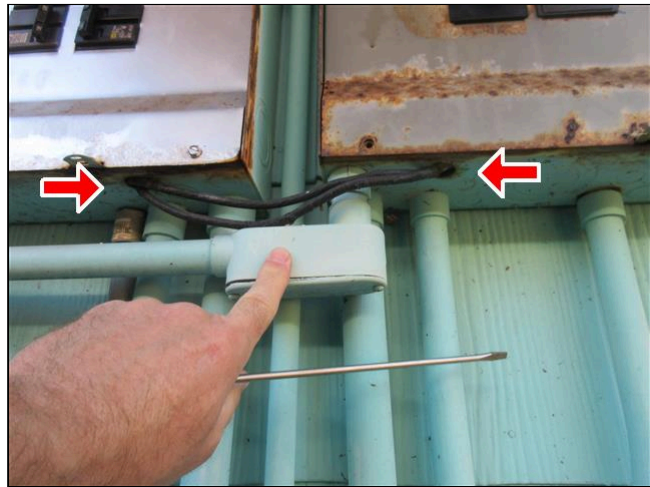
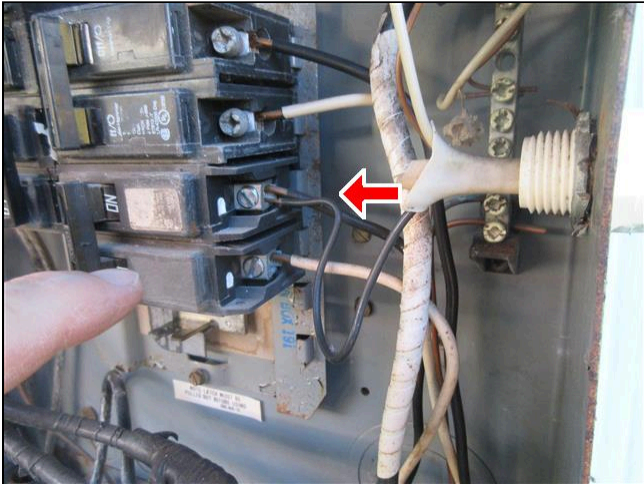
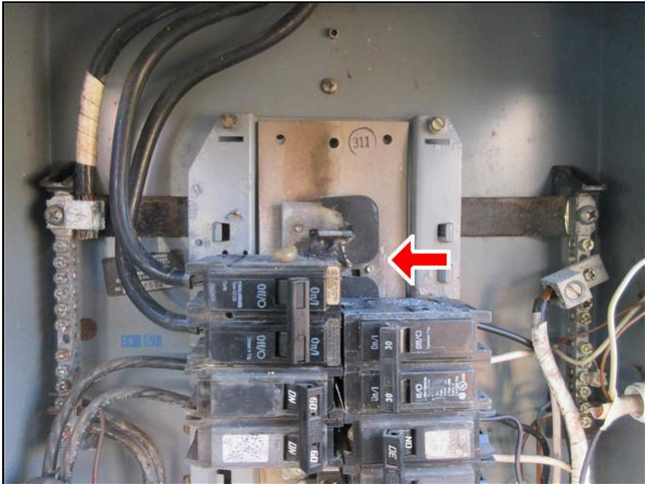
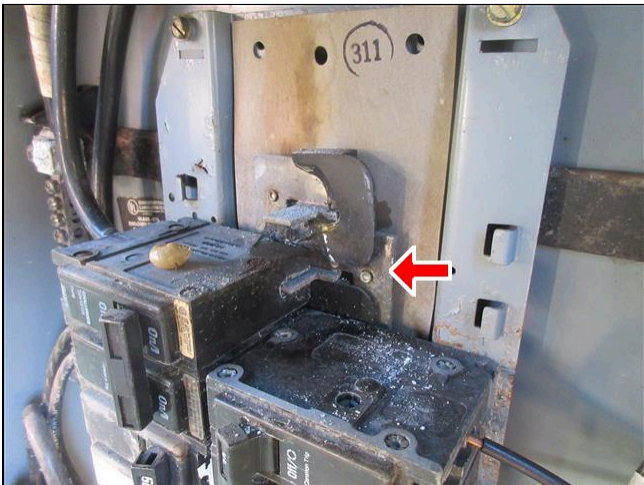
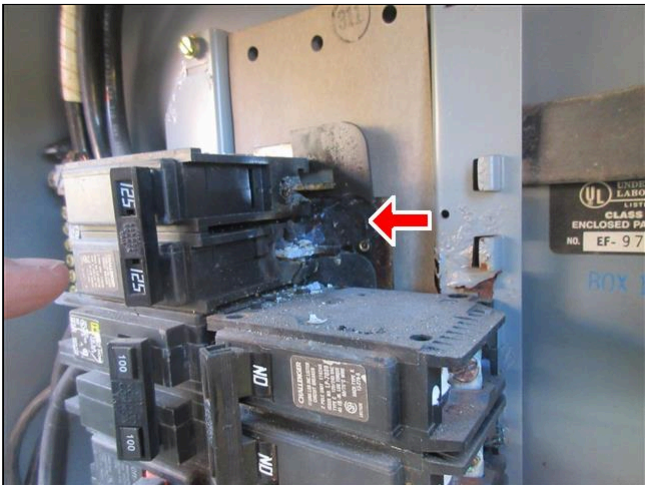
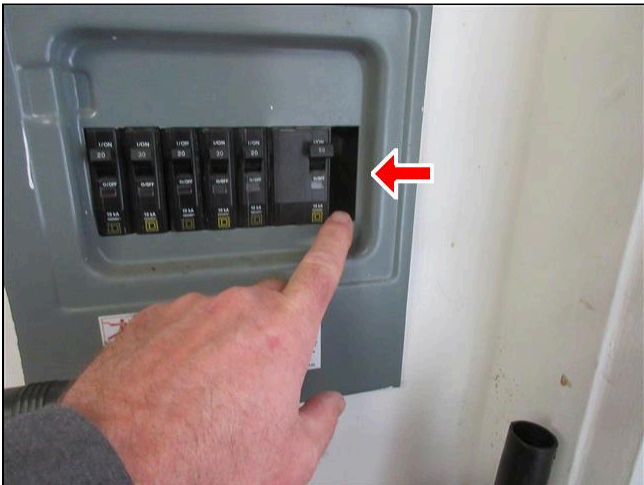
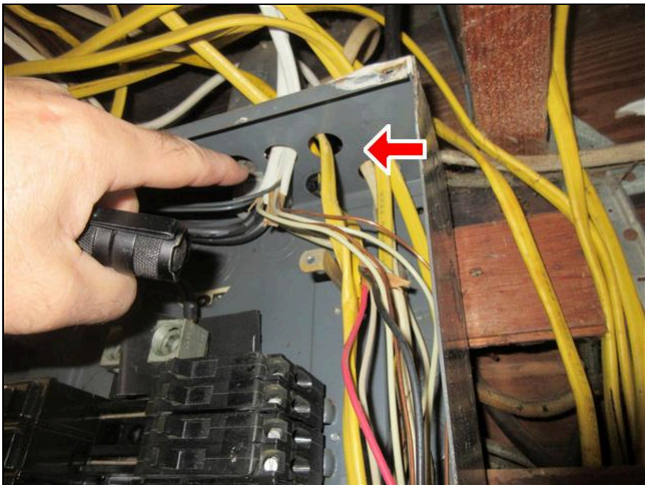
7.1 1732- Double tap present in the Federal Pacific sub-panel in the kitchen. Multiple issues are present at the Challenger meterbase panels at the right side of the home including: missing romex connectors, exposed wires, double wiring at circuits, burned or damaged breakers. Repairs are needed

and safety hazards are present within these panels. Many insurance companies have issues with Federal Pacific and Challenger electrical panels. We recommend you check with your insurance company regarding these panels. 1736- Square D distribution panel in the kitchen is missing a knock out cover. Garage- Main panel has missing romex connectors, improper panel cover screws and mixed ground and neutral wires that should be terminated on separate grounding and neutral bars. Panel cover has water stains on the front from a leaking valve above. Unit 3- Double taps are present in the sub-panel in the kitchen. Unit 7- Square D distribution panel in the kitchen is missing a knock out cover. Recommend further evaluation from a licensed electrical contractor and repair as needed.

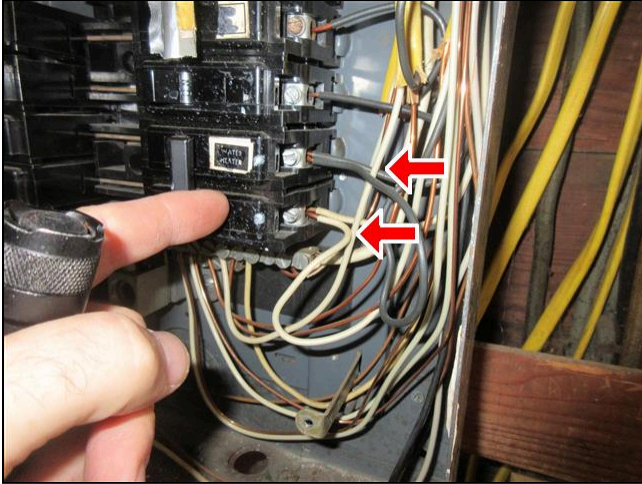
7.2 Item 1(Picture)

7.2 Garage- Several breakers have double wiring and/or over fused breakers. Recommend further evaluation from a licensed electrical contractor and repair as needed.

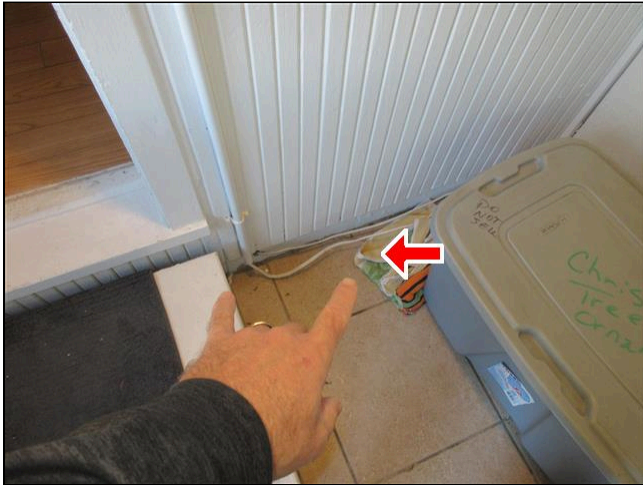
7.3 Item 1(Picture)

7.3 1732- Exposed romex wiring running along the floor near the rear entry door should be secured and encased in conduit. Several open slices are present in the water heater area. 1736- Three prong outlet at the rear of the home at the left side of the rear entry door is either not working properly or is ungrounded. Ceiling fan in the living room is missing a blade. Improperly wired attic light is present in the attic above the pull down stairs. Garage- Open splice observed above the electrical distribution panel. Rear storage area has an improperly wired and installed overhead light. Unit 8- At least one three prong outlet is wired incorrectly at the living room (hot/neutral reversed). Unit 5- At least one three prong outlet is wired incorrectly at the dining room (open ground). Recommend further evaluation from a licensed electrical contractor and repair as needed.

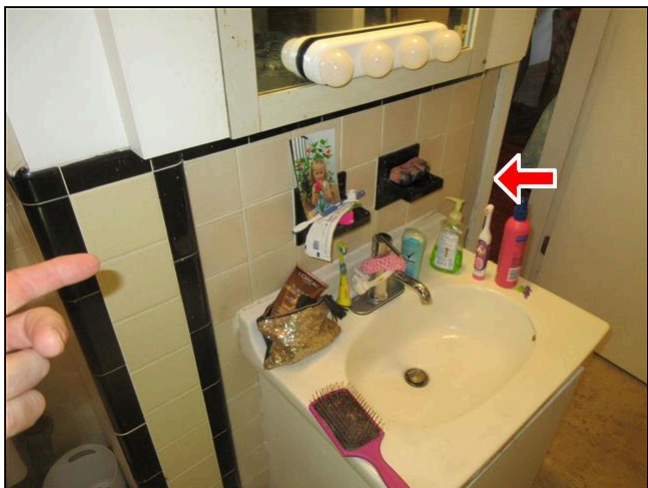
7.5 Item 2(Picture)

7.5 Few GFCI receptacles were present at the units. Recommend safety upgrade to GFCI receptacles at the exterior of units, garage, bathrooms, kitchens and any receptacle within 6' of a water source.

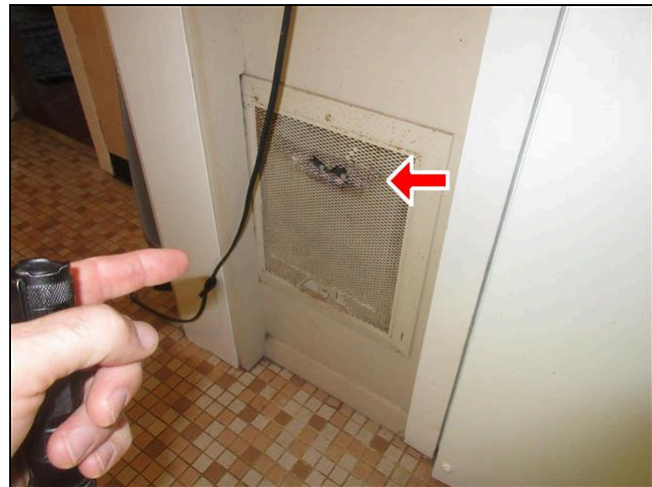
8.0 Item 2(Picture)

8.0 1732- The air handler closet is blocked with a large entertainment center. We were unable to observe this area. Garage- Wall mounted heater in the guest bath has a damaged or melted cover. This is considered unsafe and should be repaired or removed. 8 Plex- Older Wall Mounted Heating Elements were not inspected.

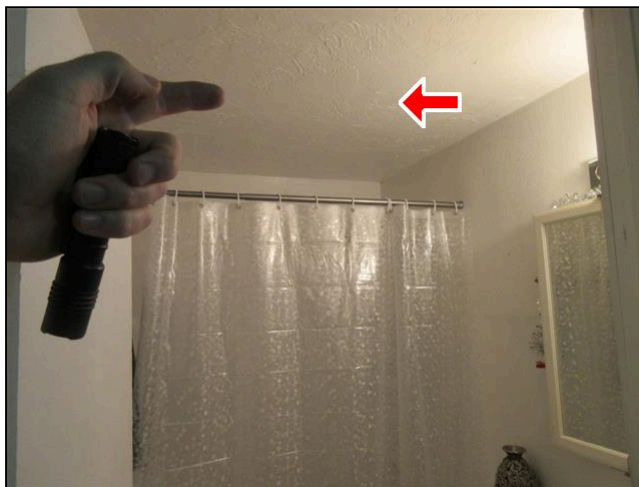
9.4 Item 1(Picture)

9.4 1736- Ventilation is not present at the hall bath. Recommend installing vent fan as needed.

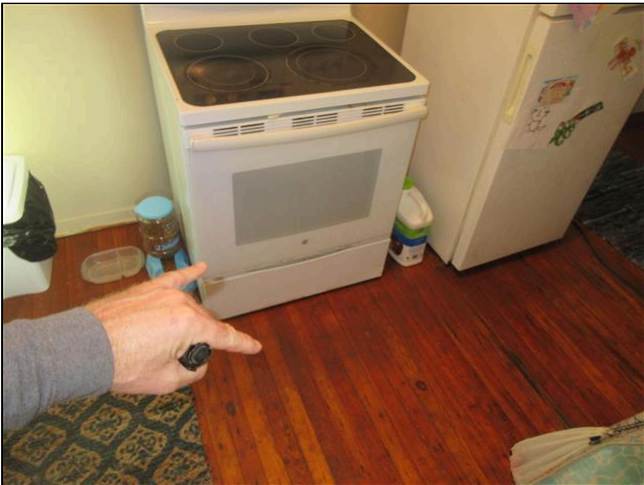
10.1 Item 1(Picture)

10.1 Garage- The anti-tip bracket is missing at the range. The anti-tip bracket prevents the range from inadvertently tipping over. Recommend install as needed.

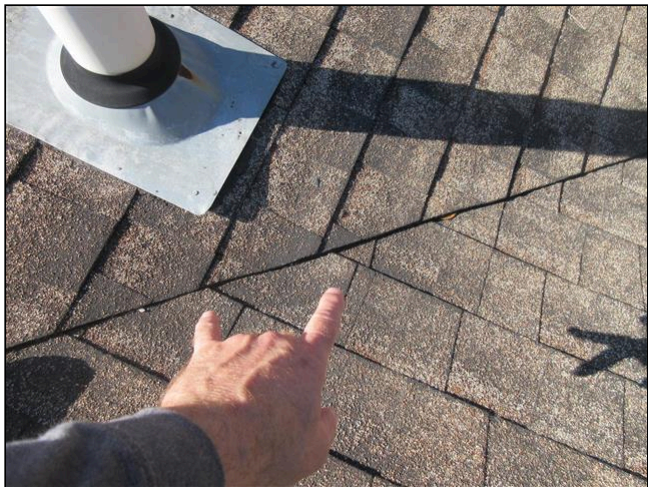
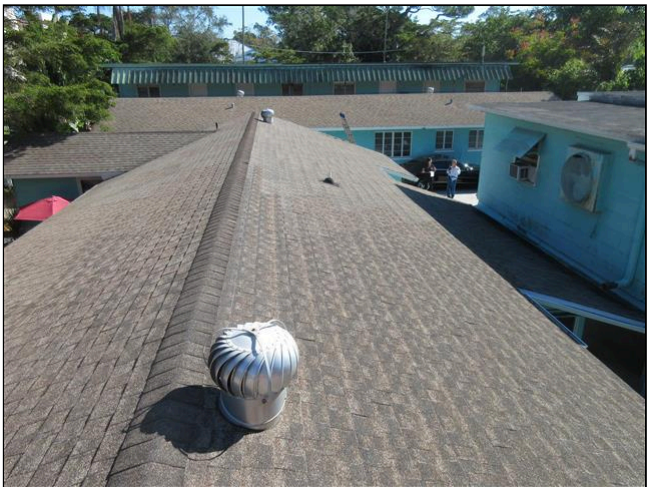
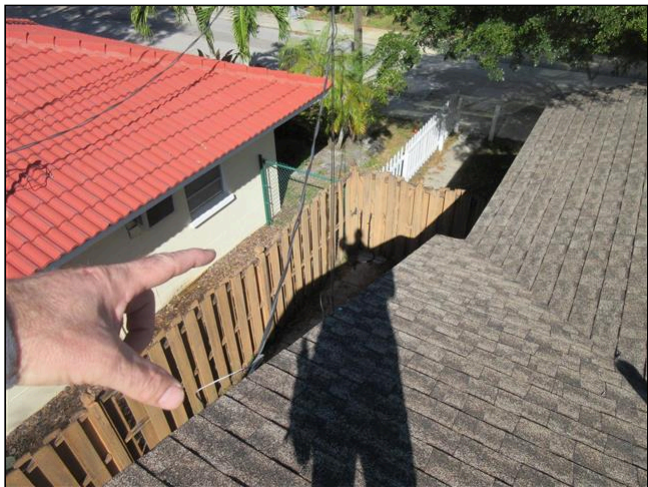
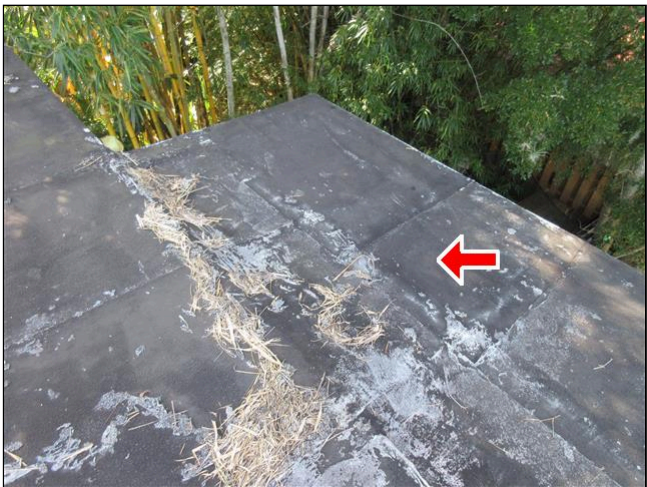
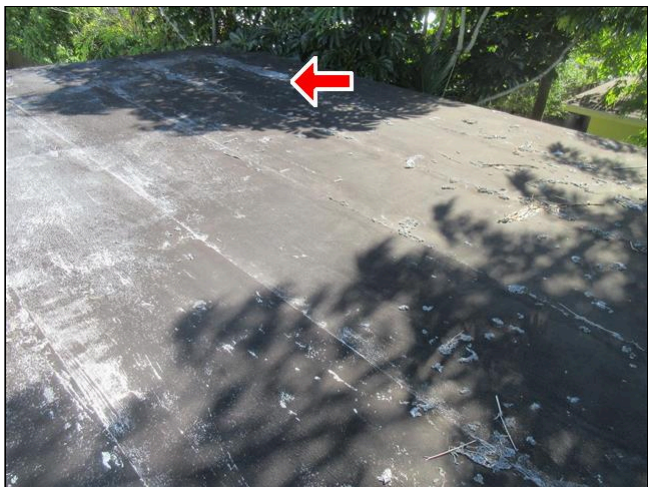
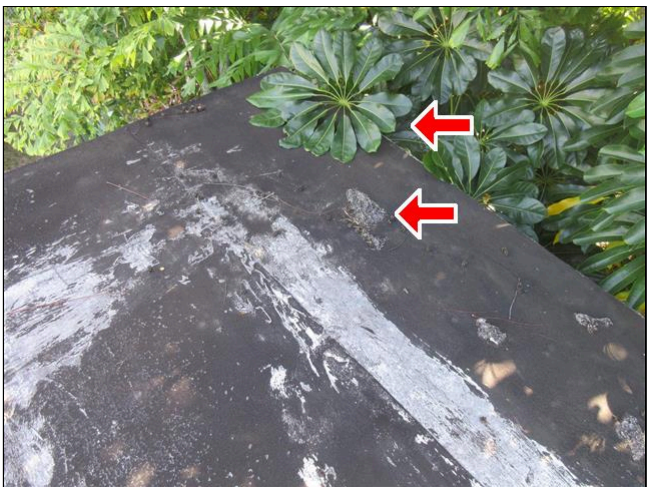
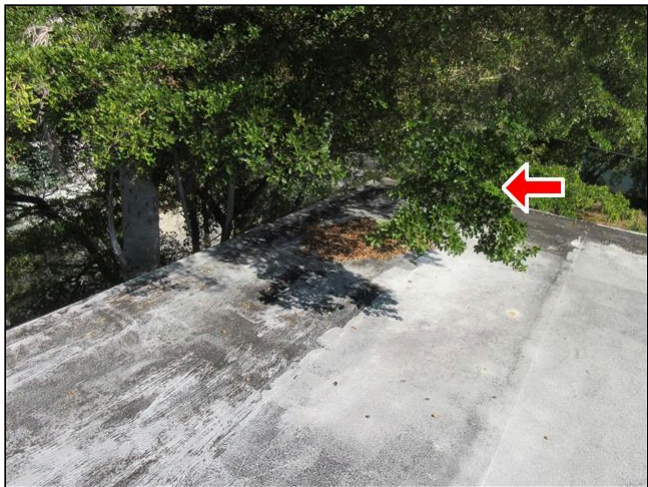
1732/1736- Roof covering has significant granular loss and has exceeded its useful life expectancy. Membrane roof covering above the garage unit and 8 Plex shows several areas that pond water. Tree limbs are in contact with the garage roof and the 8 Plex roof and should be trimmed. Recommend further review from a licensed roofing contractor and repair as needed.

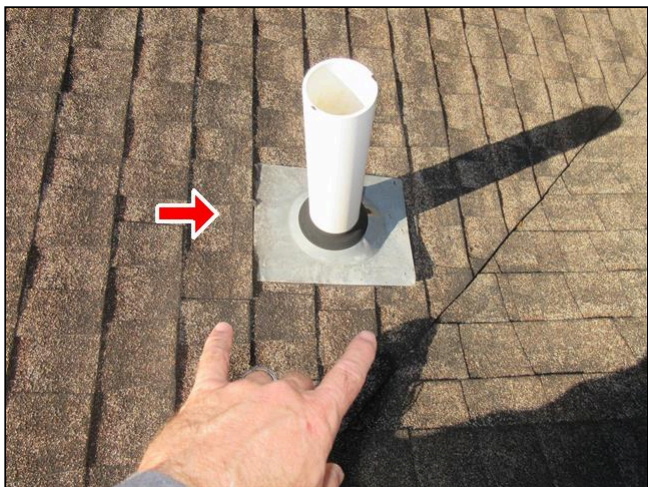
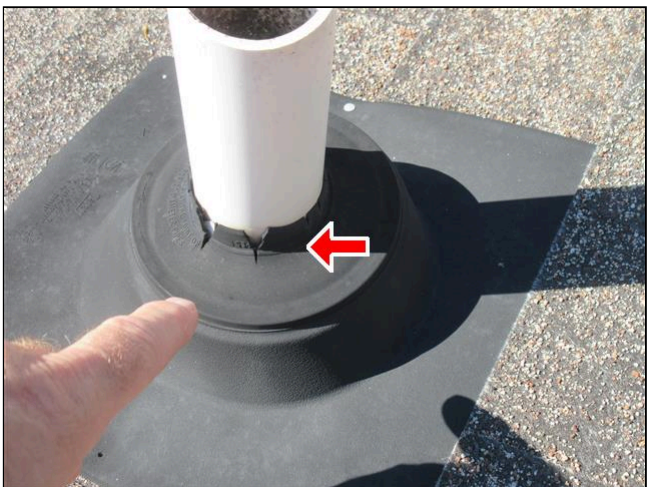
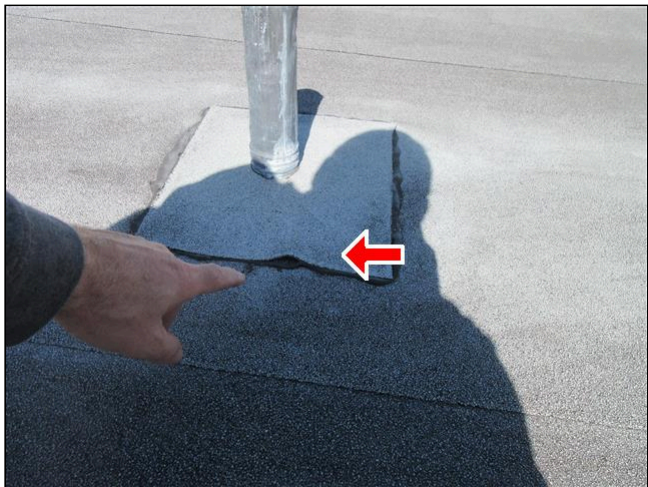
1732/1736- Several flashing boots are damaged or installed improperly. Repairs are needed. Bitumen flashing above the 8 Plex has pulled loose near the plumbing vent pipe. Recommend a licensed roofing contractor repair as needed.
