Inspection Report

308 Ohio Place, 1730 Morrill St, 1732/1736 Morrill St.
Sarasota Florida 34236

KMI Home Inspections, Inc.

Date: 11/26/2021	Time:	Report ID:
Property: 308 Ohio Place, 1730 Morrill St, 1732/1736 Morrill St. Sarasota Florida 34236	Customer: George Chung Cho Chung	Real Estate Professional: Kimberly Colgate Private Wealth Realty, Inc.

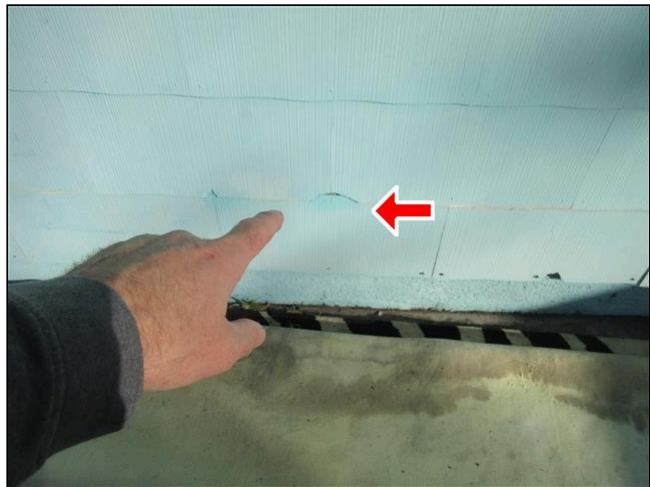
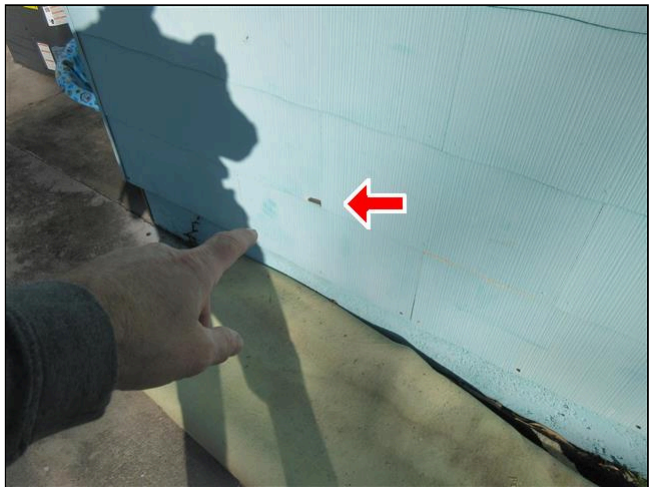
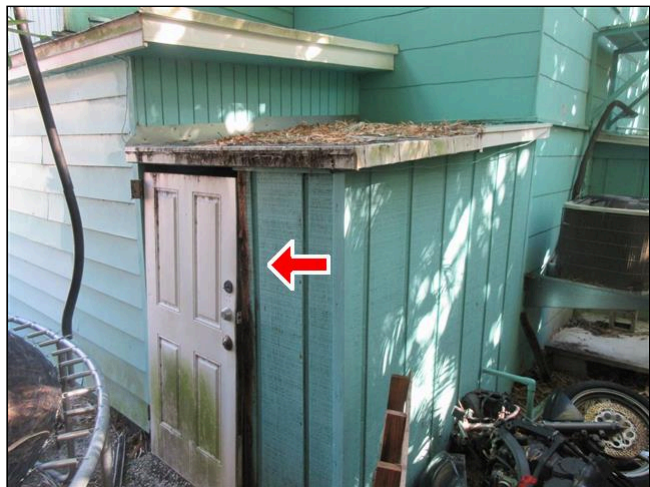
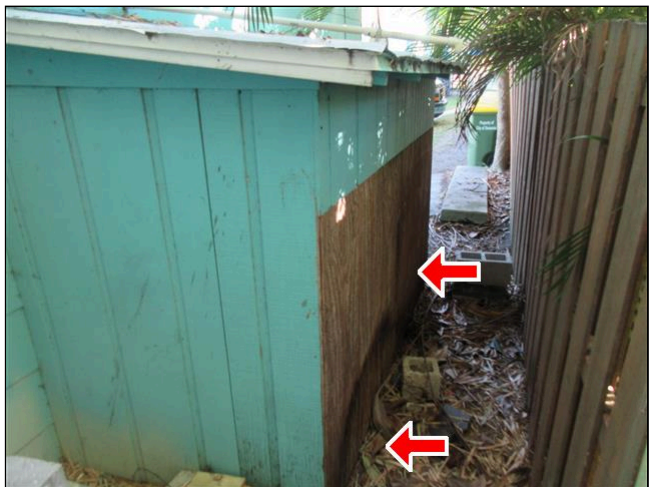
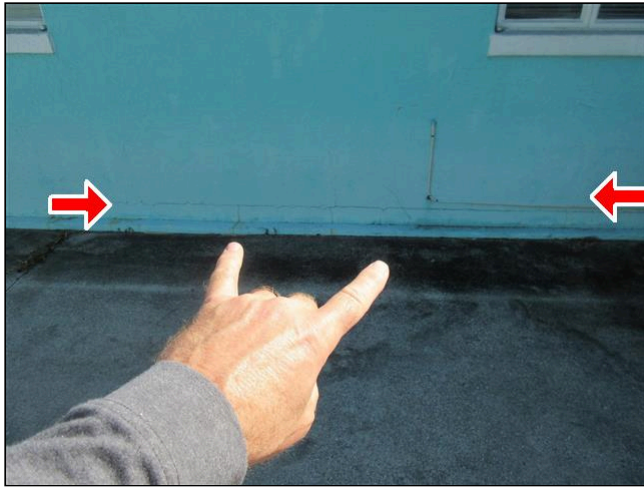
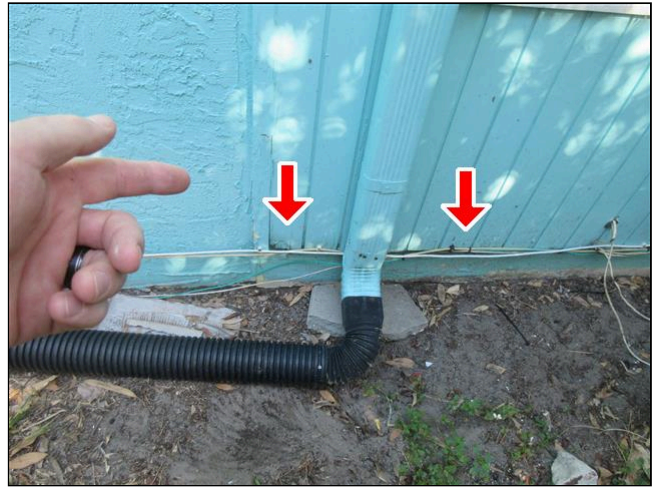
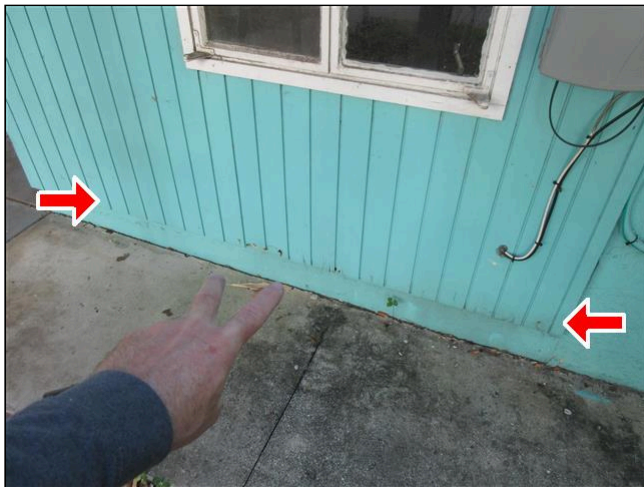
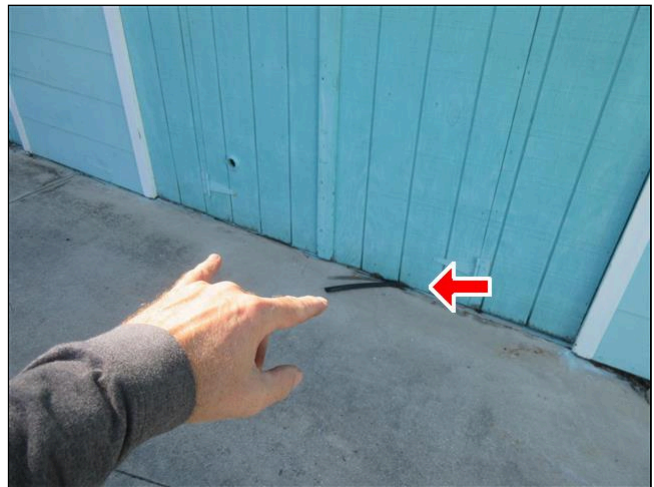
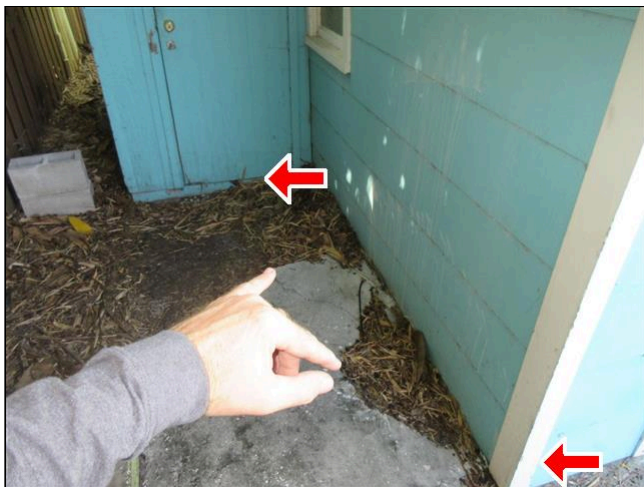
1732- Multiple slate tiles are damaged or cracked on the perimeter of the unit. Garage- Rear and side sheds are deteriorated at the door frame and/or siding and need repairs. 8 Plex- Masonry coating on the rear of the lower units has several hairline settlement cracks. Displacement was not observed (for your information). 8 Plex- Wood siding at the lower level is partially deteriorated in several areas. Recommend repair as needed.

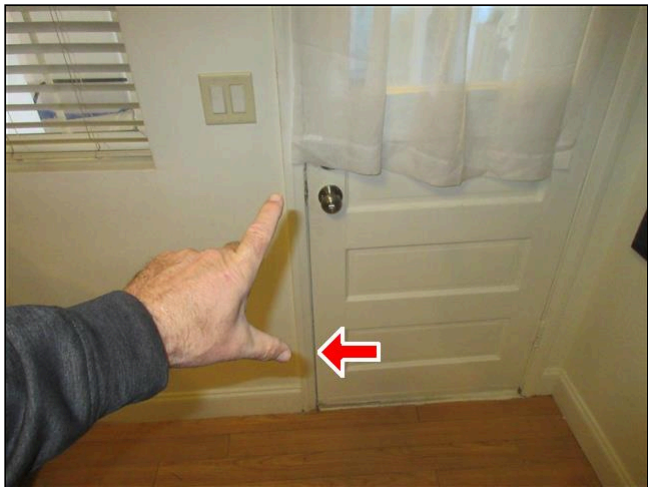
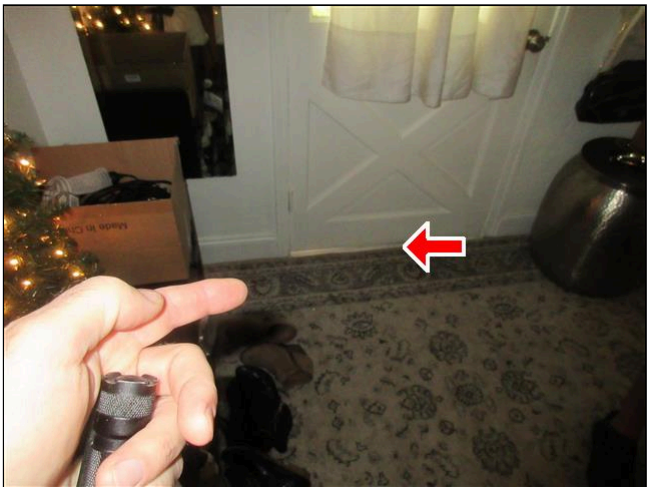
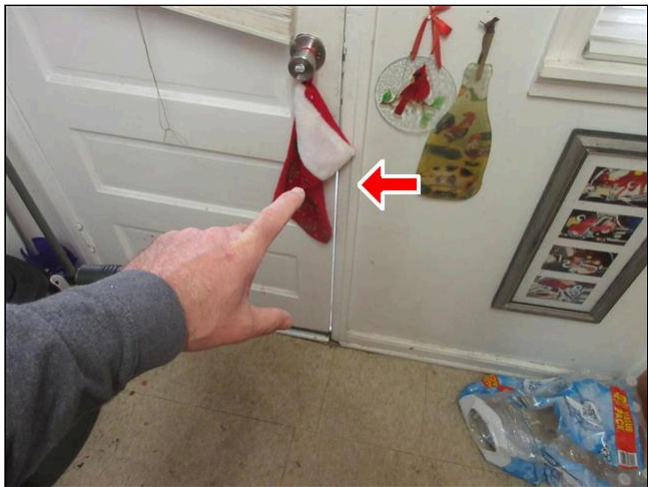
1732- Front and rear entry doors are missing weather stripping. 1736- Front and rear entry doors are missing weather stripping.

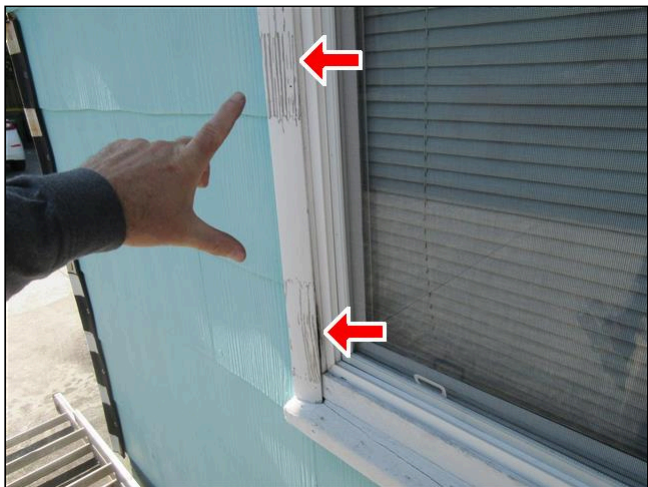
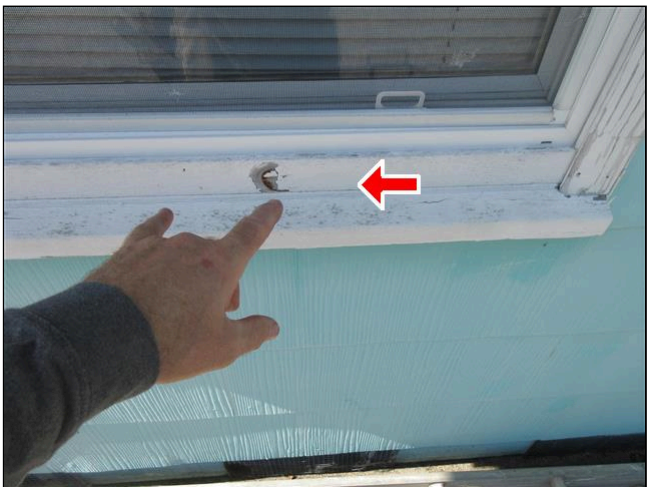
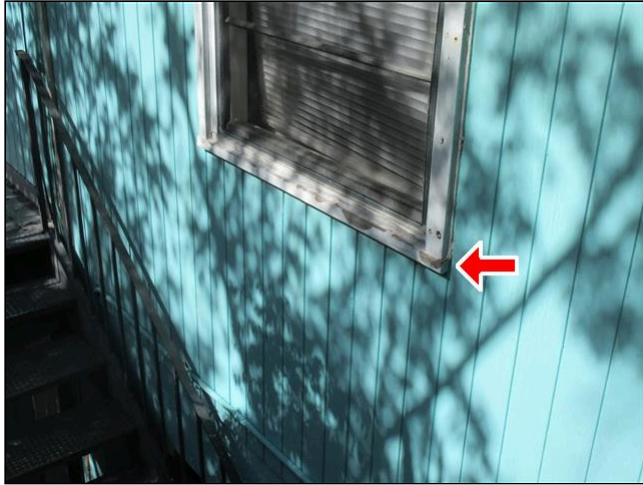
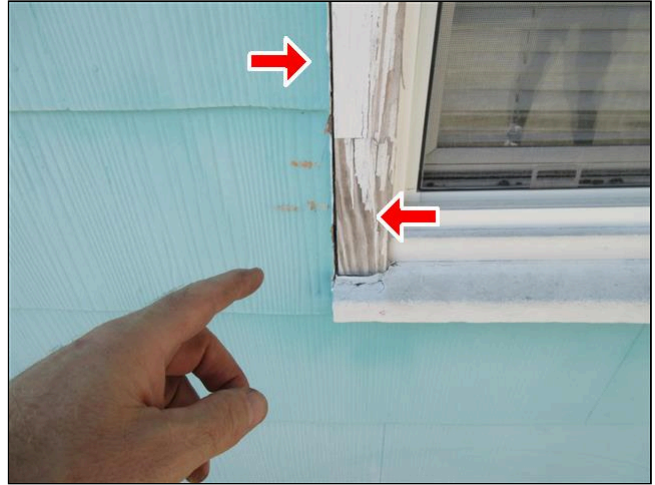
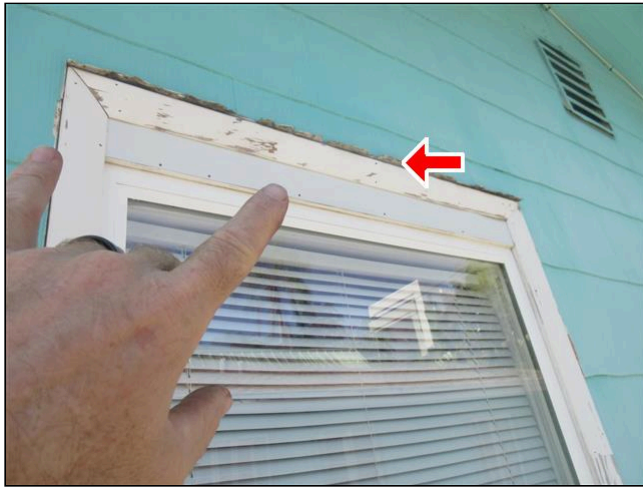
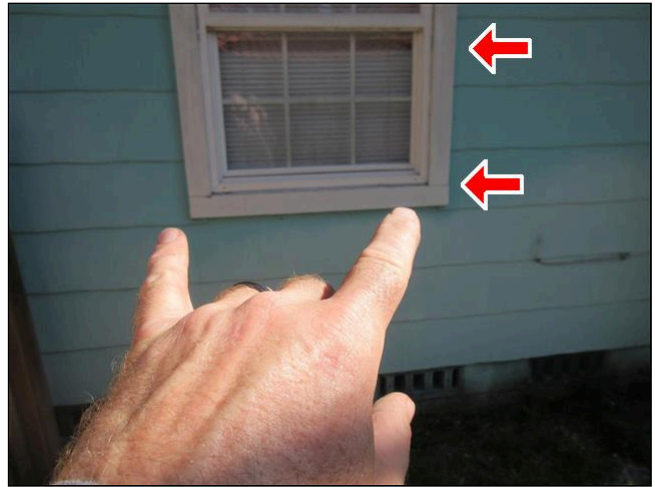
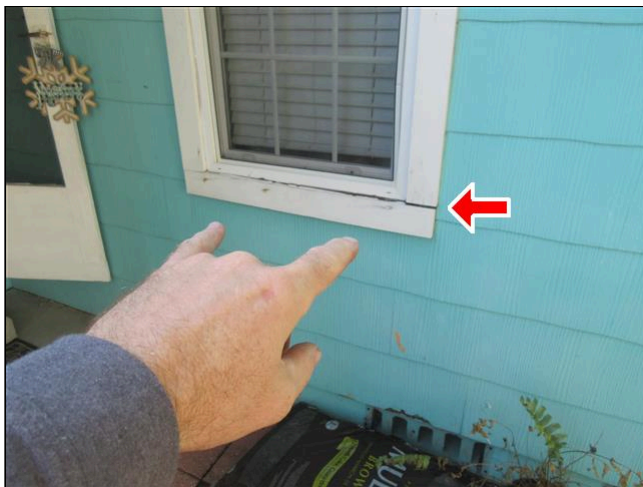
Multiple window frames or trim around the units are peeling paint. Recommend seal, prep and paint as needed.

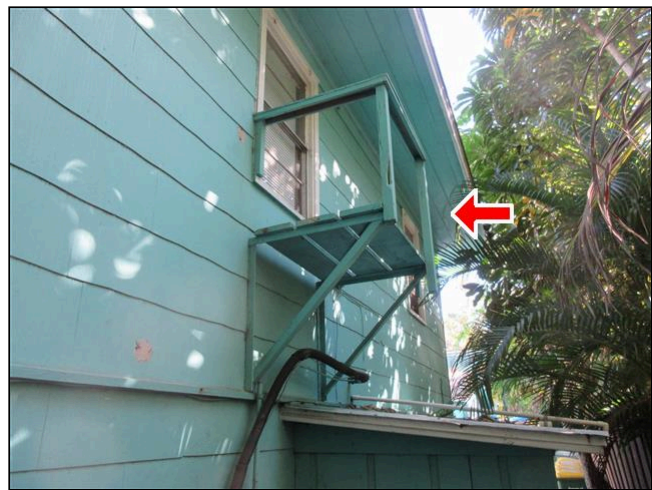
2.3 Item 1(Picture)

Garage- There is a platform at the rear side wall of the upper garage apartment near one of the windows. The purpose of this platform is unknown. Pickets on the handrail leading to the upper garage apartment are spaced too far apart for safety. Recommend 4" max spacing for safety. Support post below the right side stairs (facing front) of the 8 Plex is loose and needs securing. At least one support post for the metal awning on the back side of the 8 Plex is loose and needs securing at the

top.

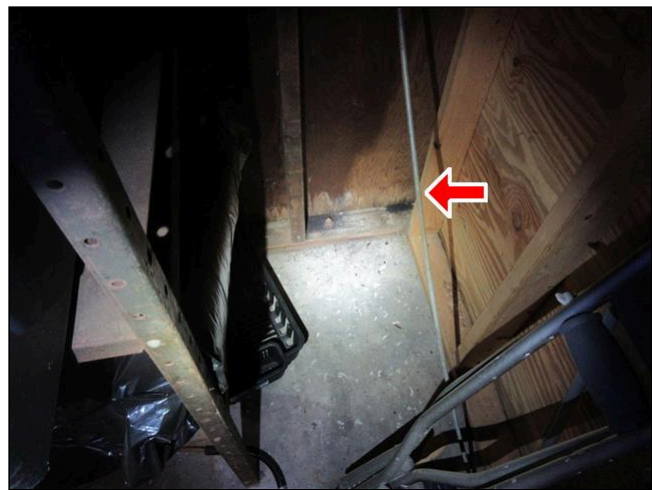
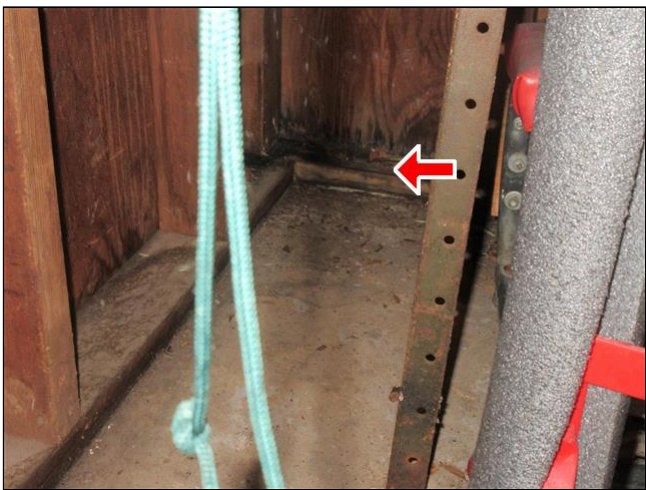
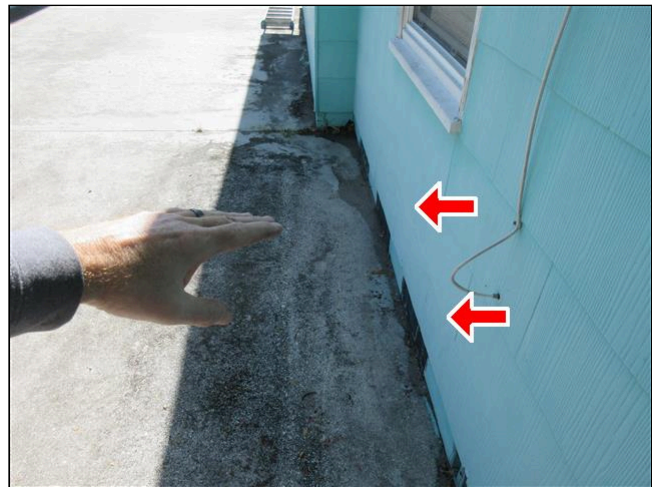
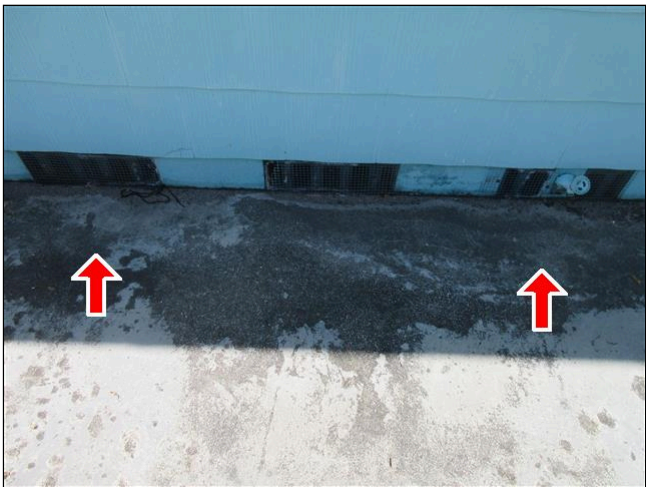
Water stains are present on some of the lower components of the garage walls. Drainage may need to be corrected in these areas. Recommend monitoring during a heavy rain and correcting as needed. Concrete slopes towards the foundation vents on the left side of the Duplex. Water may enter the

crawlspace during periods of heavy rain. Recommend monitoring and correcting as needed.

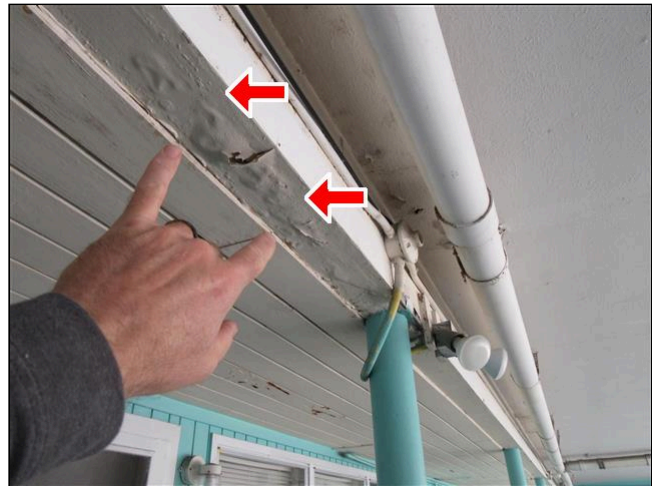
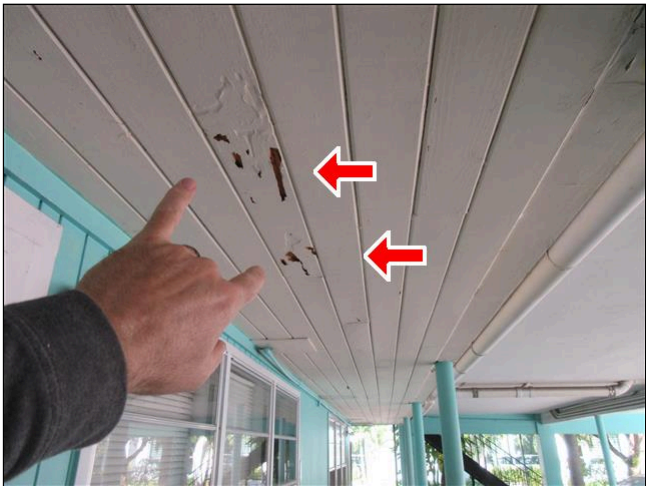
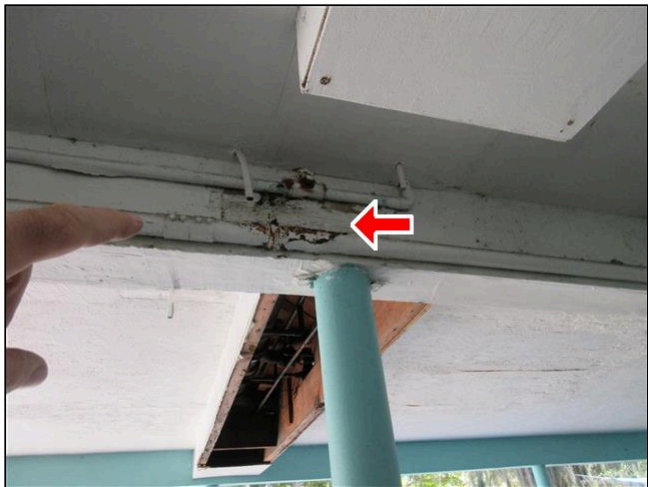
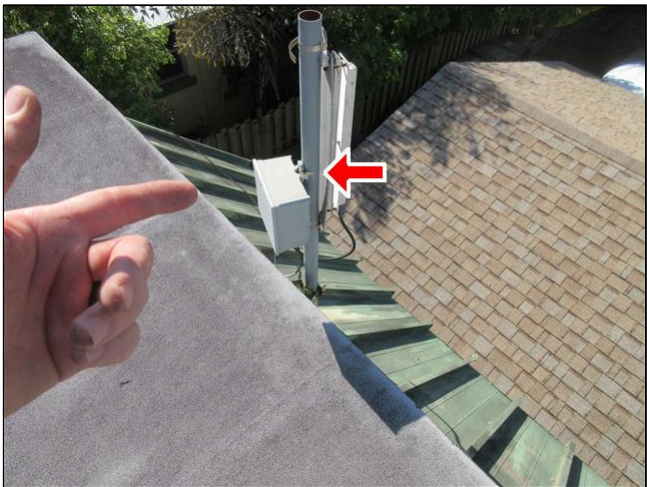
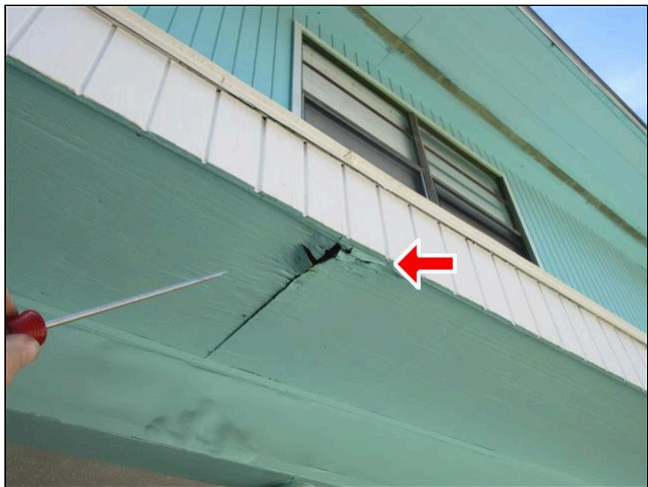
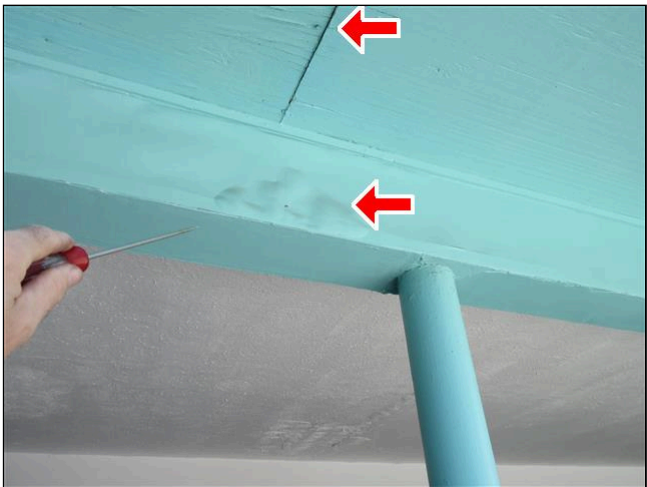
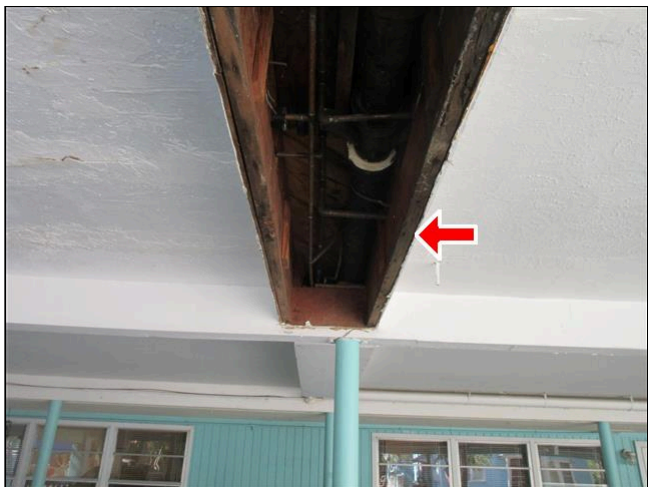
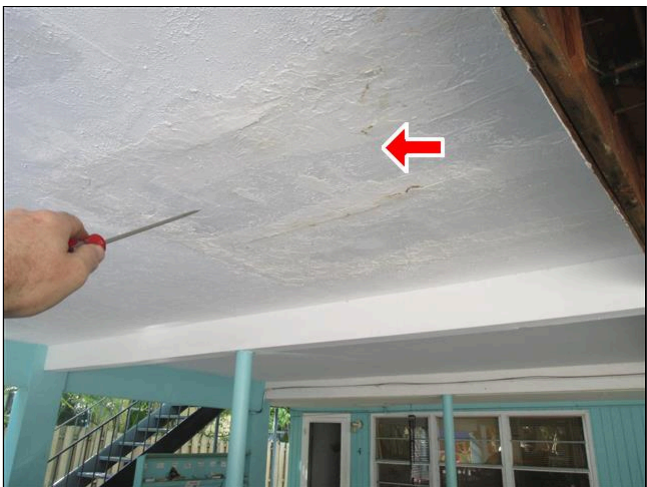
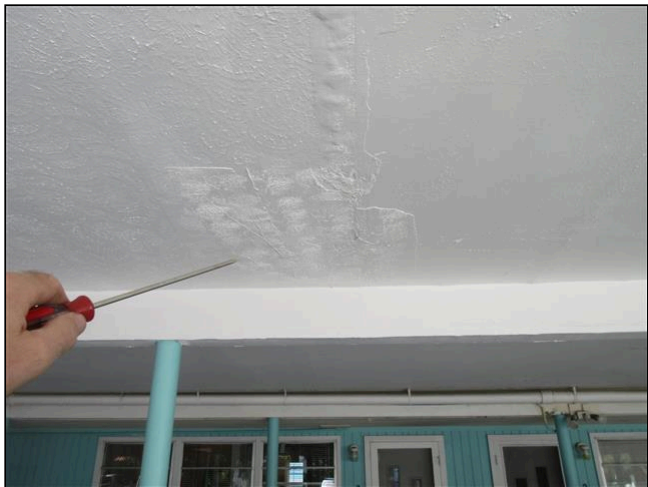
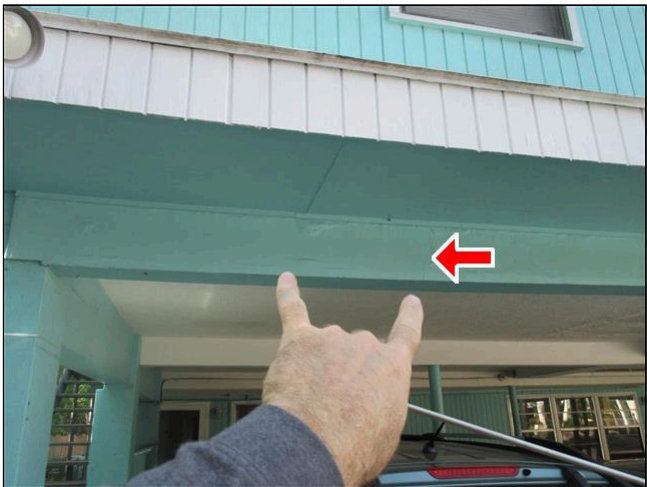
8 Plex- Ceiling and beams above the carport of the 8 Plex is damaged/deteriorated or missing or peeling paint at several areas. Repairs are needed. Former antenna mast is loose and needs securing or removal above the 8-Plex.

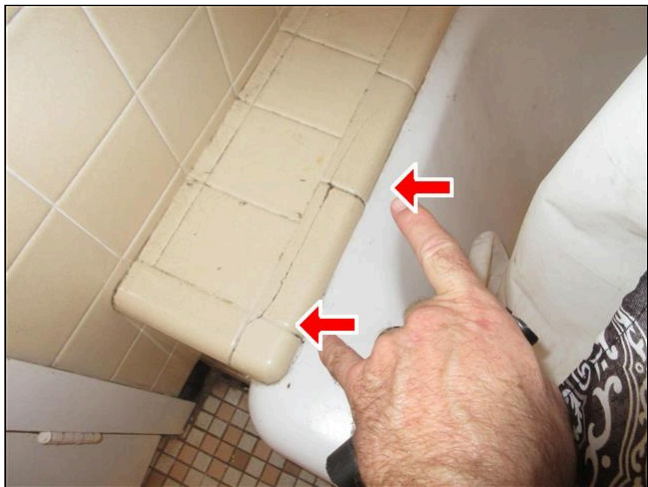
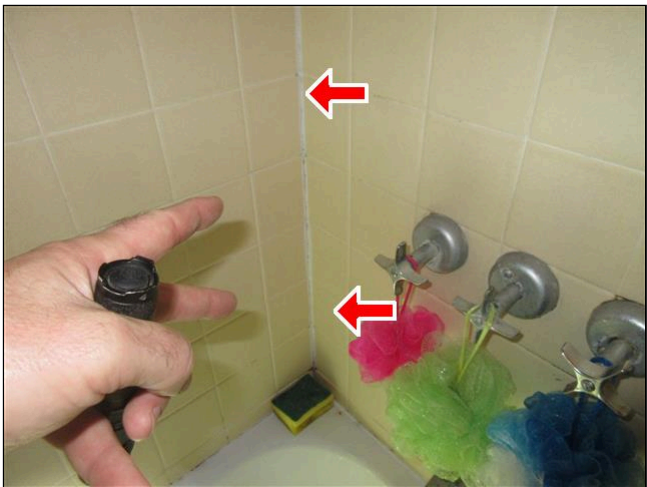
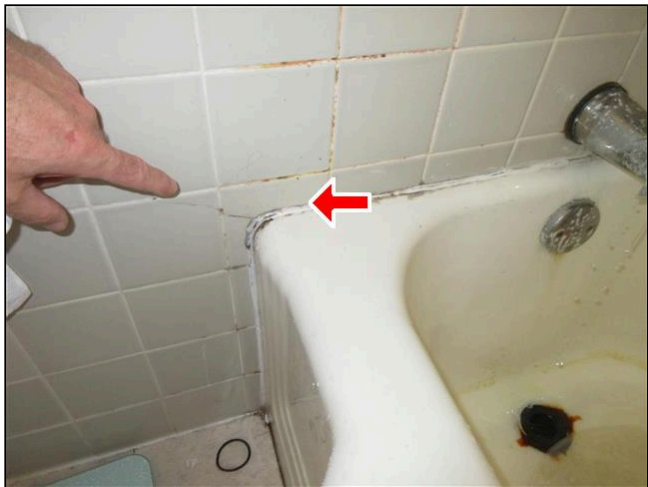
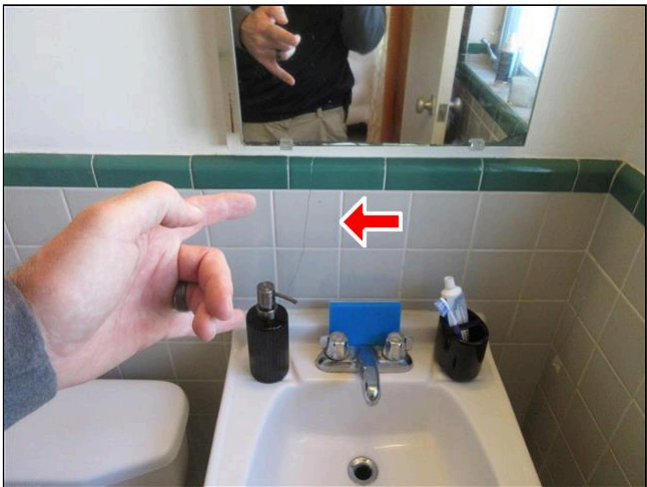
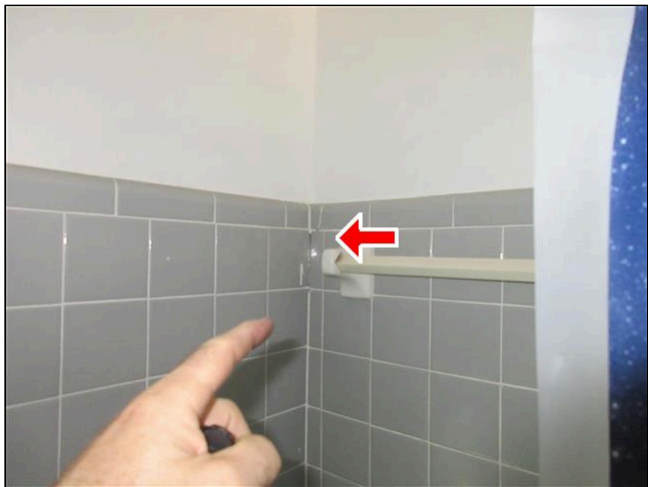
Garage- Several tiles are loose or cracked at the shower surround. Repairs are needed. Unit 3- Several tiles are loose or cracked at the tile shower and wall surround. Repairs are needed. Unit 7- Several tiles are loose or cracked at the tile shower and wall surround. Repairs are needed.

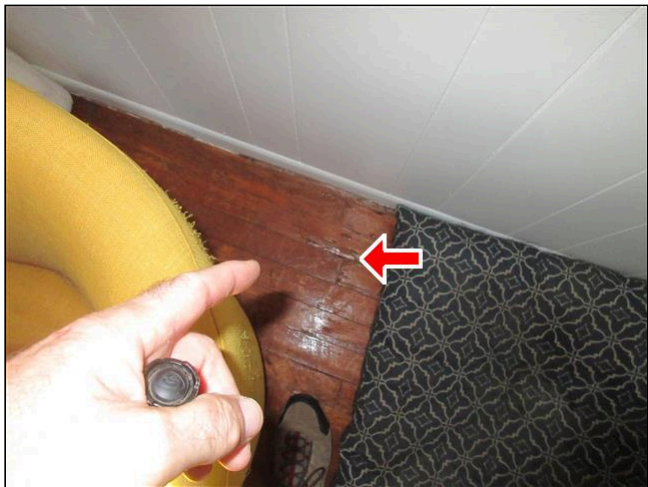
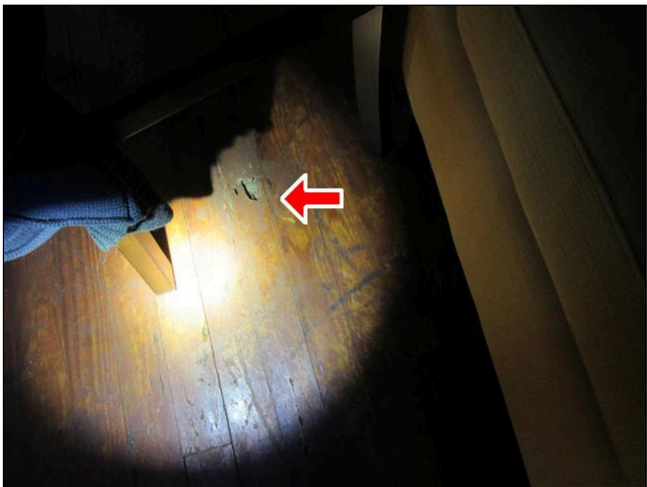
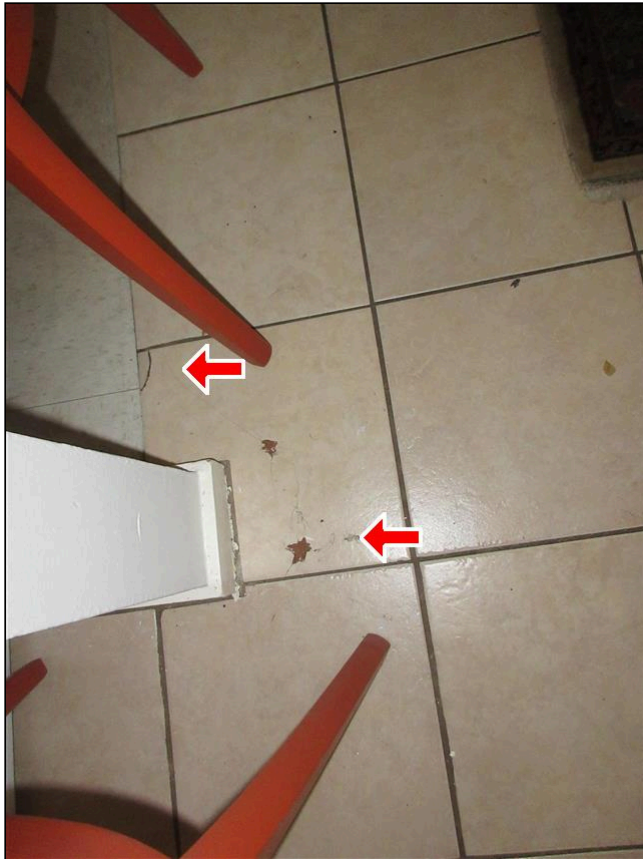
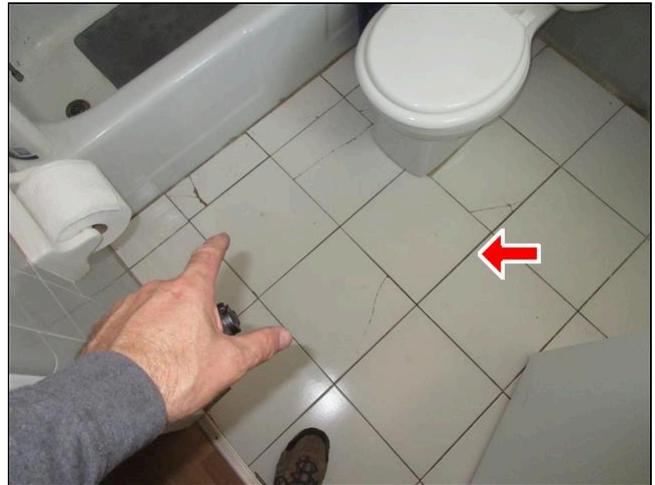
Garage- Wood floor at the living room is damaged at several locations. Unit 3- Several damaged or chipped floor tiles are present in the kitchen/living room. Unit - Several damaged or chipped floor tiles are present in the bathroom. Recommend repair as needed.

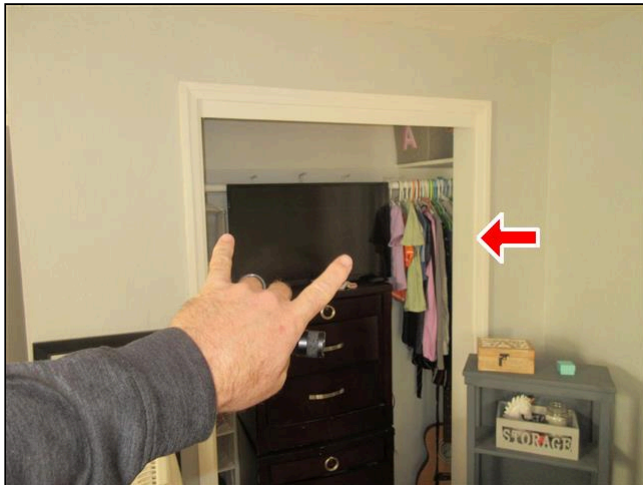
4.5 Item 1(Picture)

1732- Closet door is missing at the front guest bedroom.

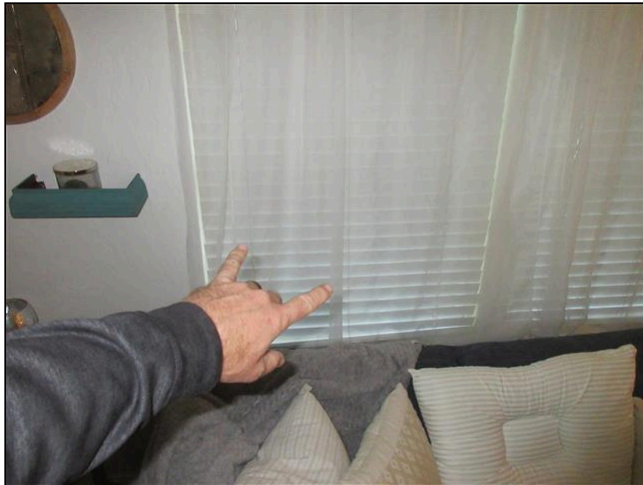
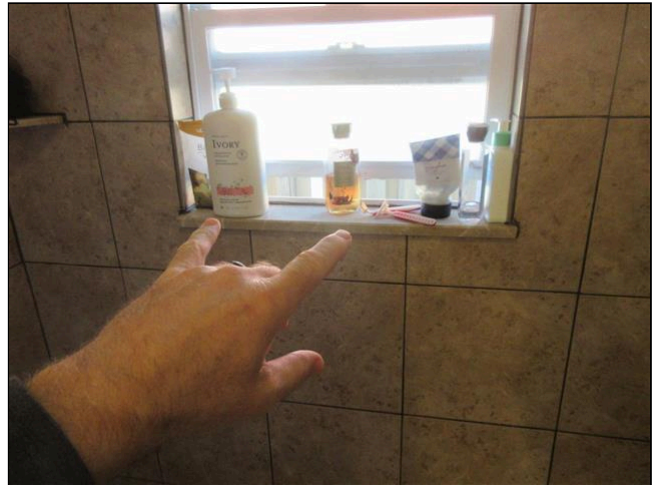
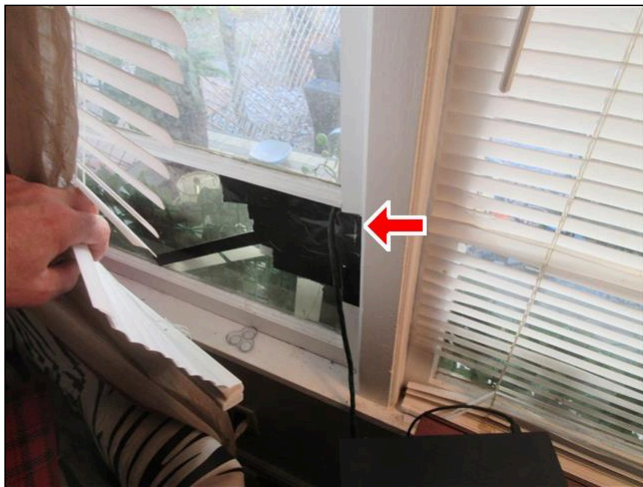
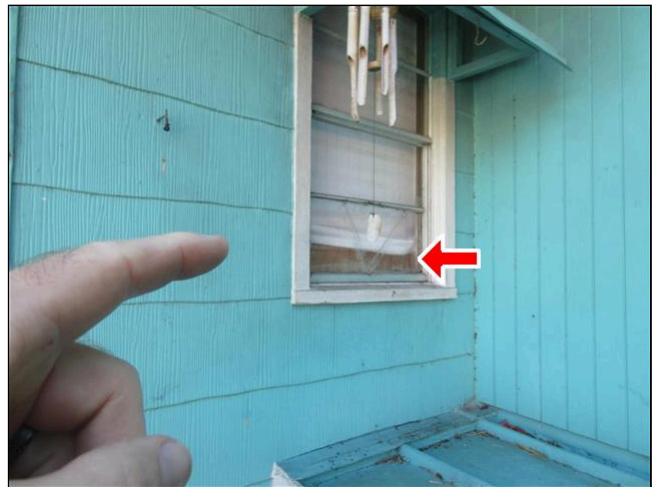
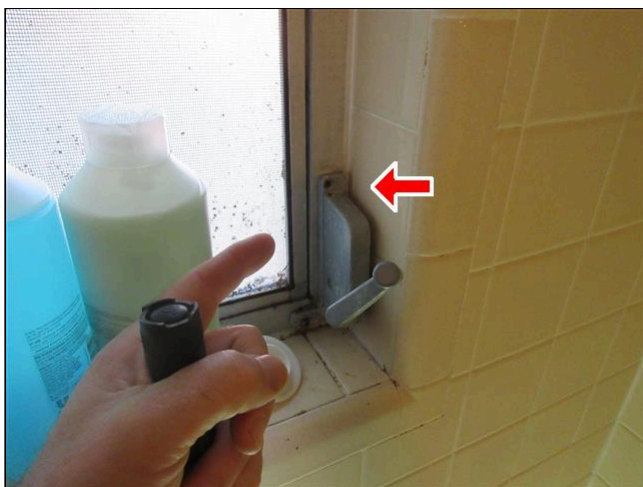
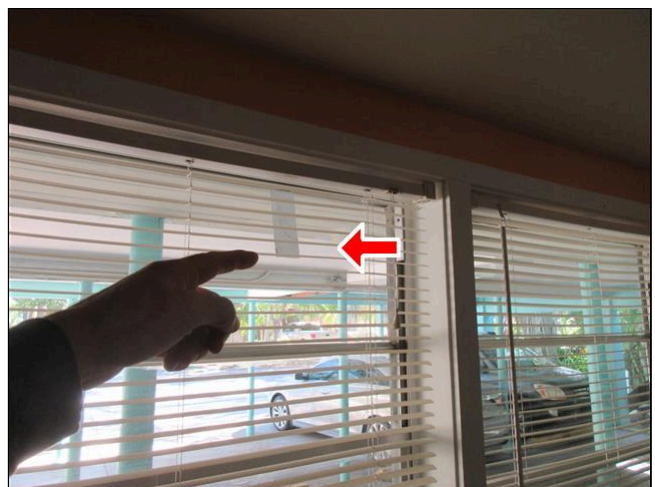
1732- Several windows difficult to operate or missing screens throughout the unit. 1736- One window at the front of the home is damaged at the glass pane. Garage- One window at the side of the home is damaged at the glass pane. Shower window crank unit is missing a screw and needs repair to operate properly. 8 Plex- Multiple windows are missing screens or are difficult to operate.

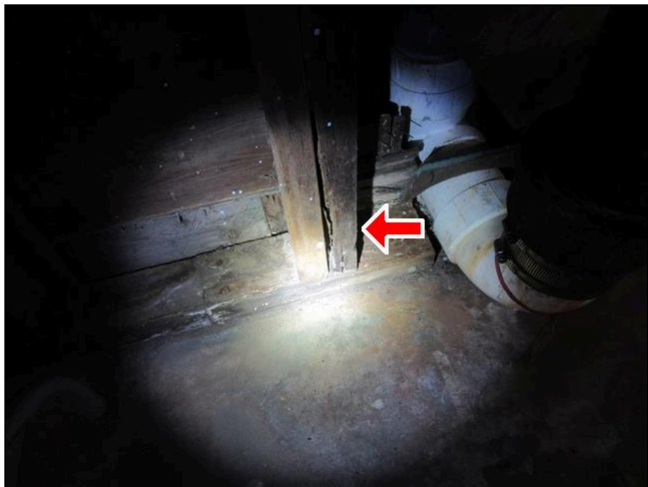
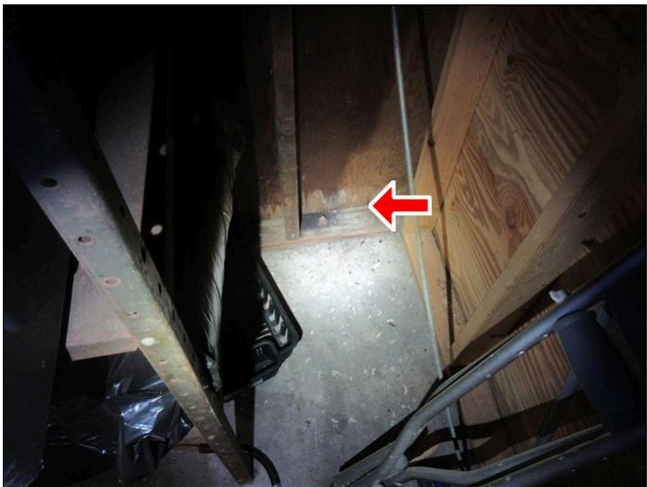
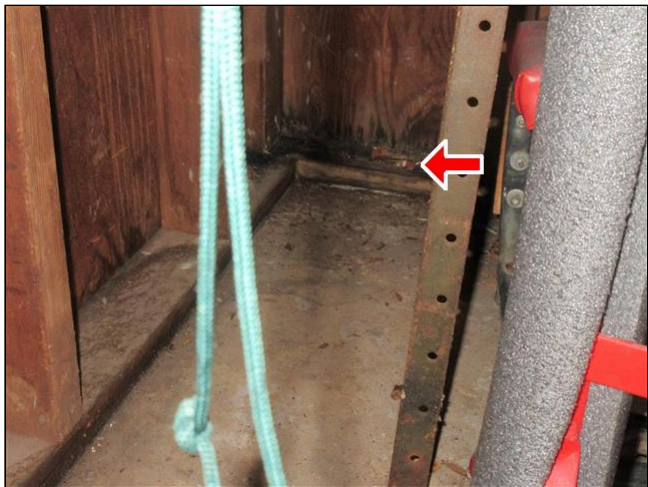
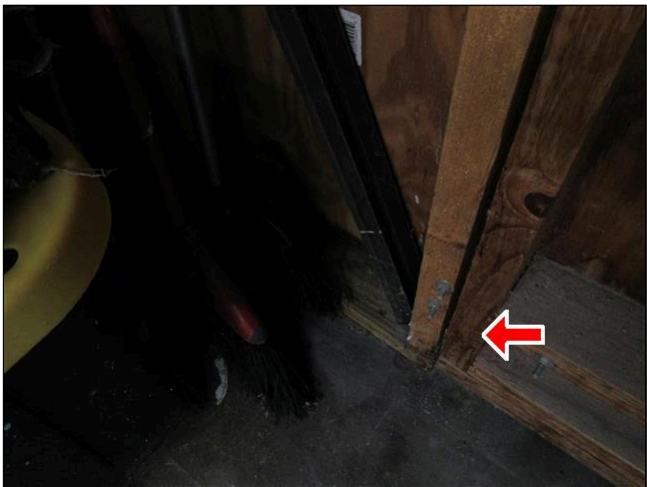
Garage- Several studs and bottom plates at the rear and side walls of the garage are deteriorated and need repairs. Water stains are present at several locations.

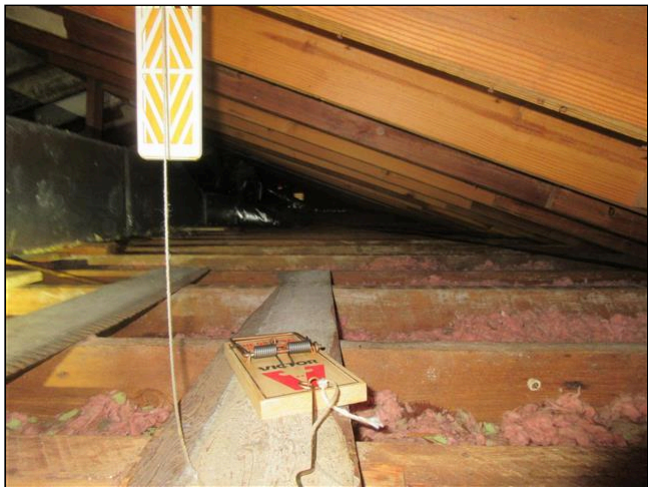
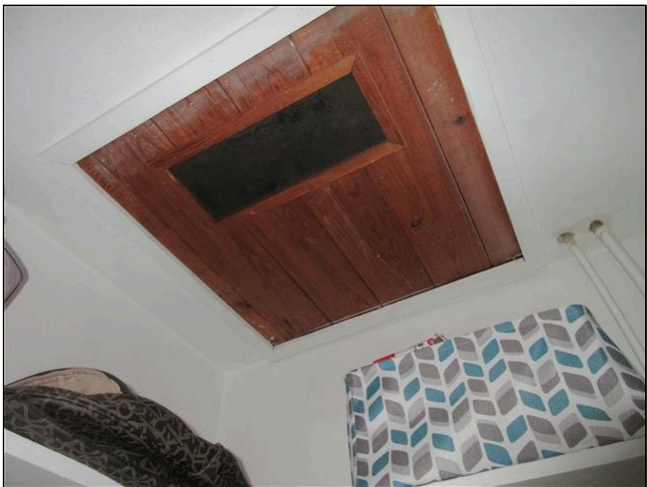
1732/1736- Firewall separation between the units is not present in the attic (for your information). Recommend install as needed. All Remaining Units- attic access was not present or accessible to view roof structure and components.

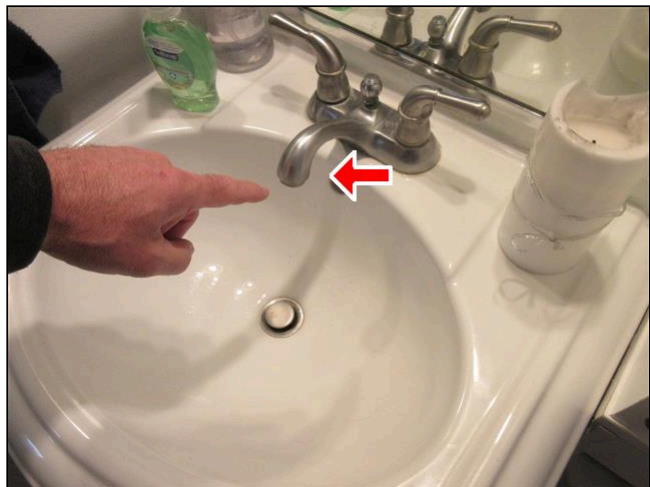
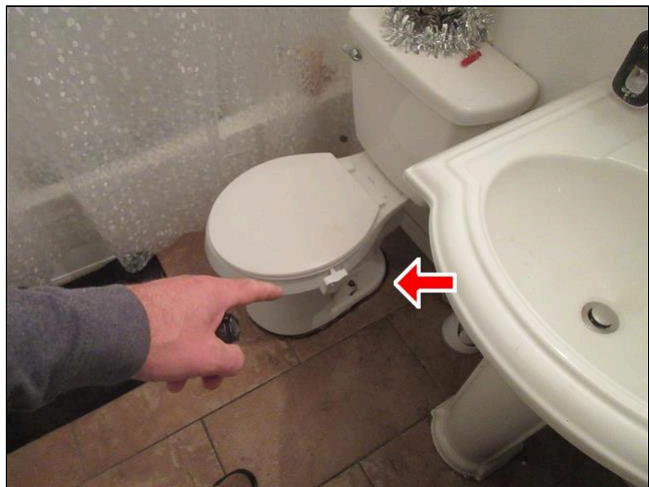
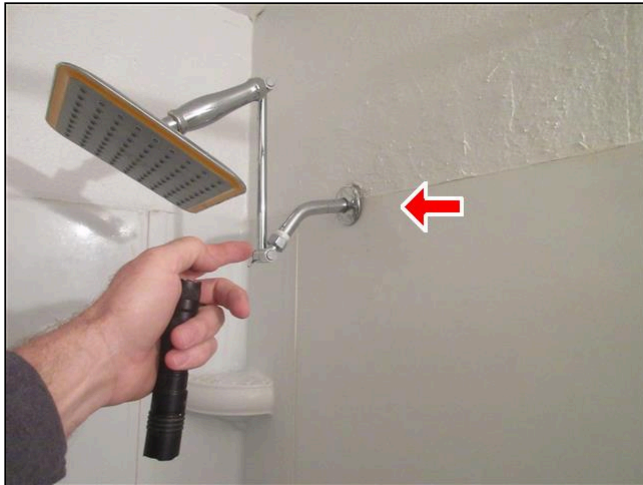
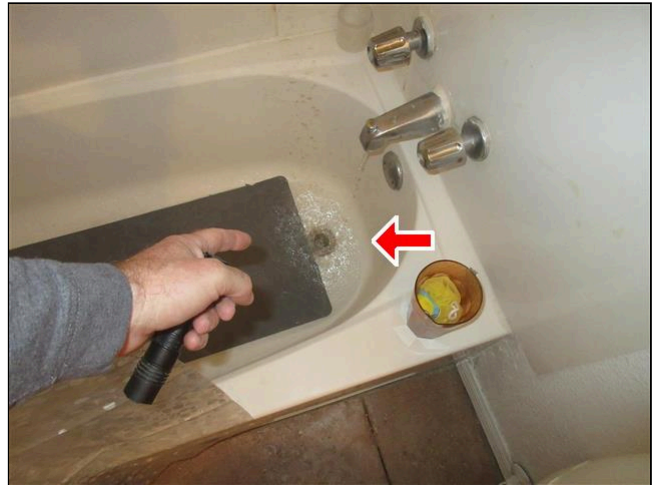
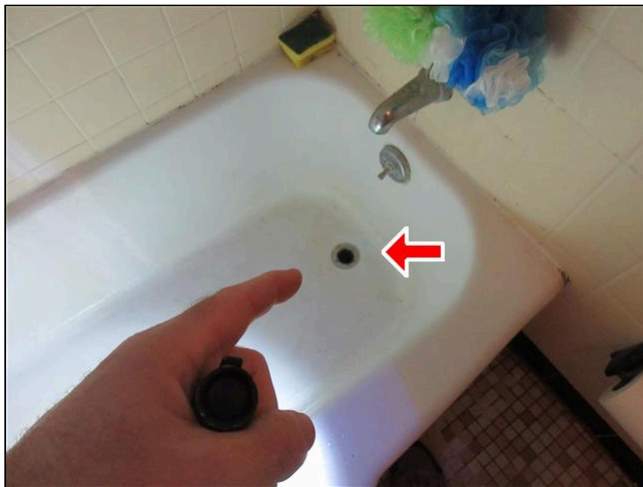
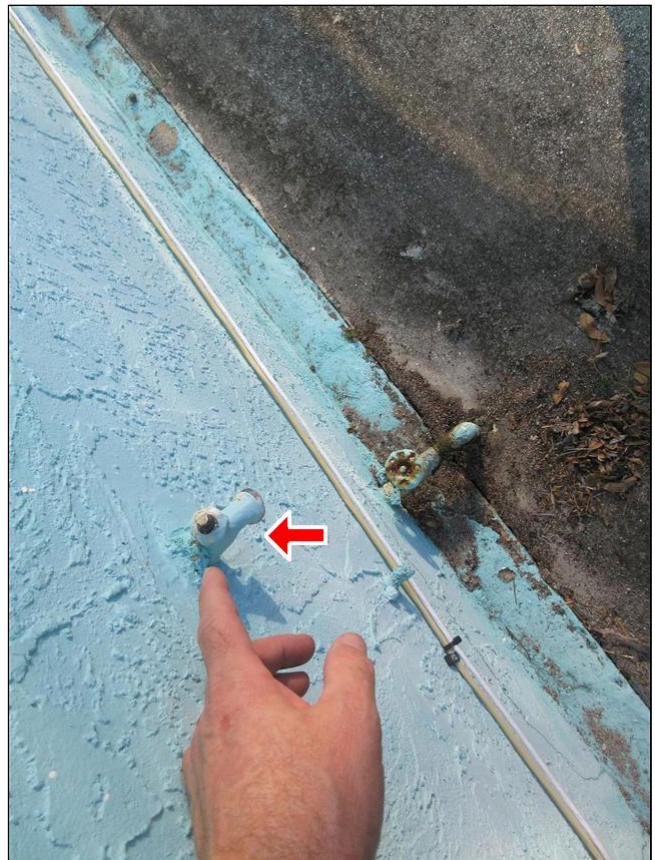
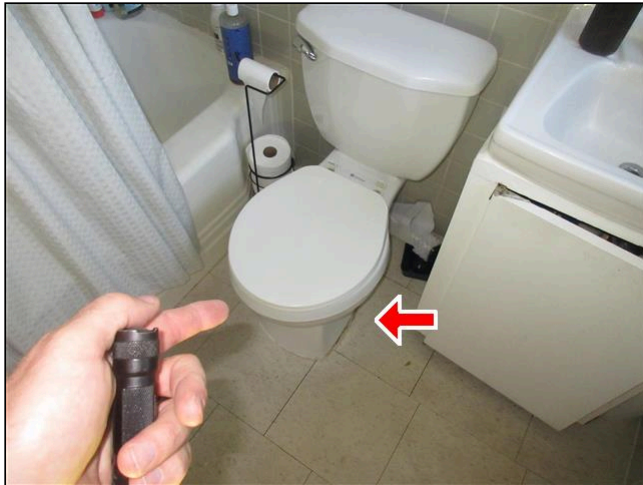
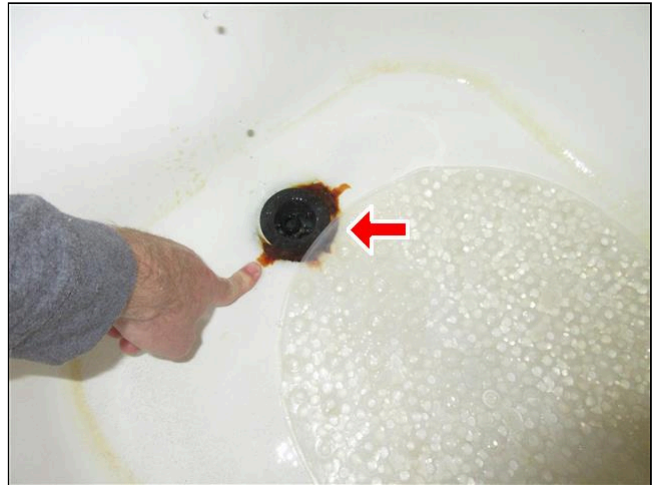
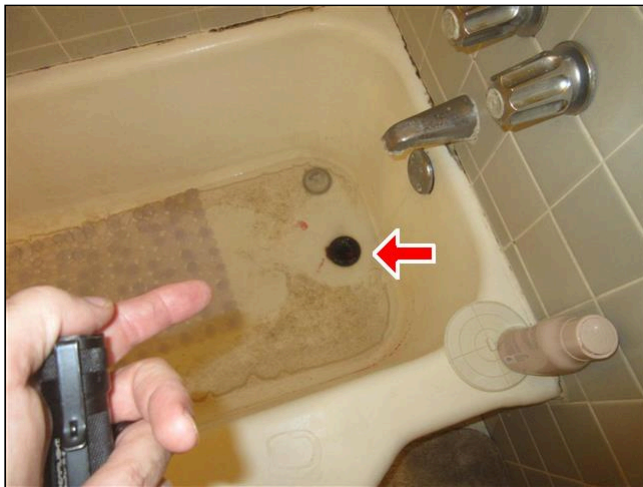
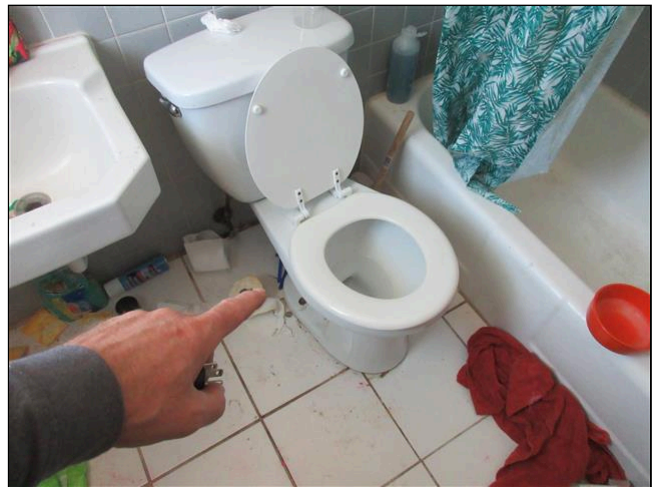
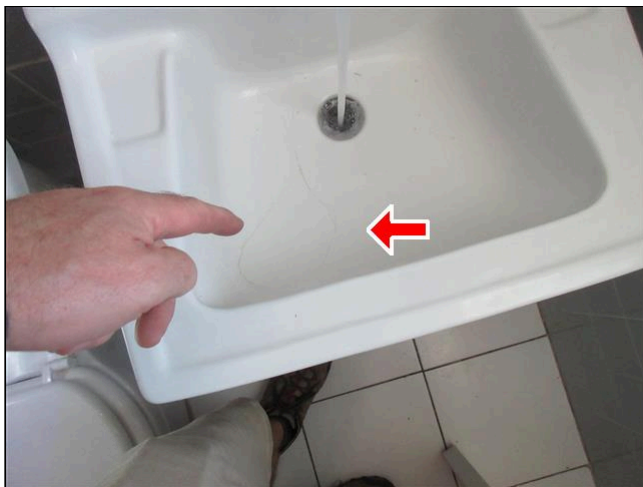
1732- Sink faucet is dripping at the guest bathroom. 1736- Toilet is loose at the floor at the hall bath. Repairs may include replacing the wax ring. We were unable to view this area from below to determine the condition of the flooring component below. Shower head is loose and needs securing. Tub drain is slow to drain. Garage- Tub drain is missing the stopper. 8 Plex- Hose bib knob at the rear of the building is damaged and needs replacing. Unit 3- Toilet is loose at the floor at the hall bath. Unit 3- Tub drain area is corroded and tub is missing the stop valve. Unit 2- Tub drain is slow to drain. Unit 8- Toilet is loose at the floor at the hall bath. Unit 7- Bathroom sink has several hairline cracks present.
