Inspection Report

308 Ohio Place, 1730 Morrill St, 1732/1736 Morrill St.
Sarasota Florida 34236

KMI Home Inspections, Inc.

Date: 11/26/2021	Time:	Report ID:
Property: 308 Ohio Place, 1730 Morrill St, 1732/1736 Morrill St. Sarasota Florida 34236	Customer: George Chung Cho Chung	Real Estate Professional: Kimberly Colgate Private Wealth Realty, Inc.

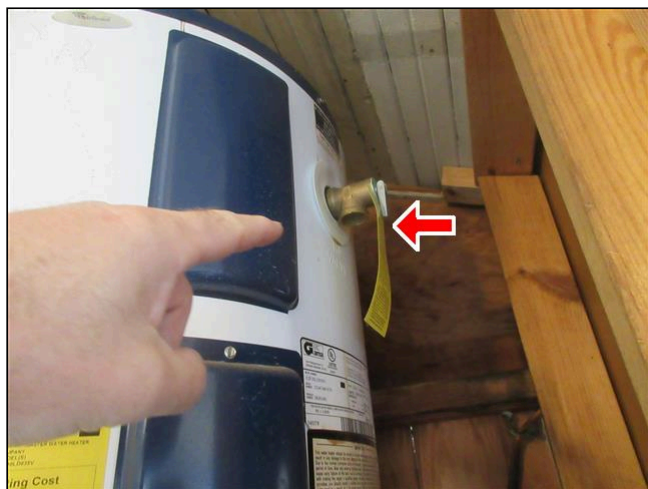
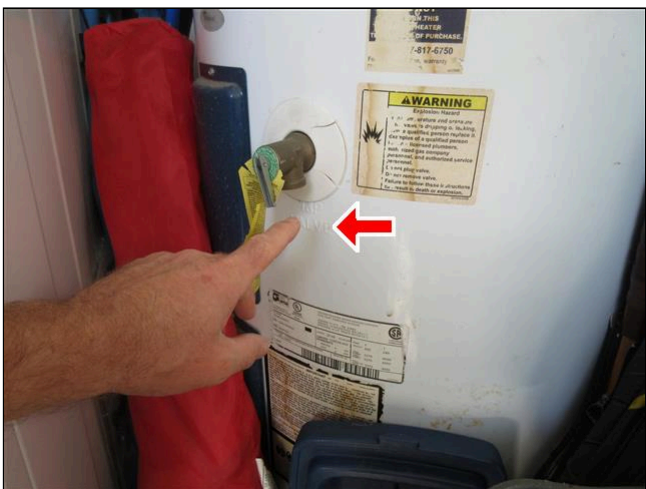
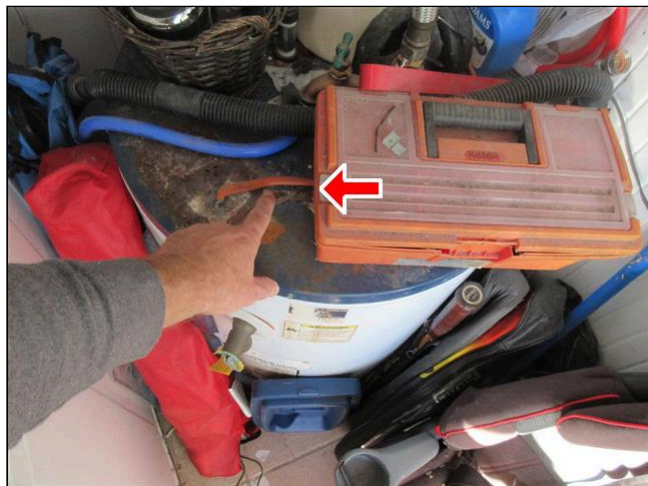
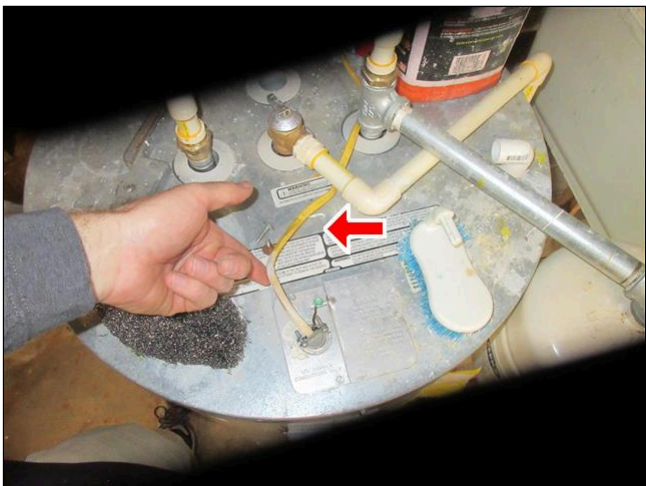
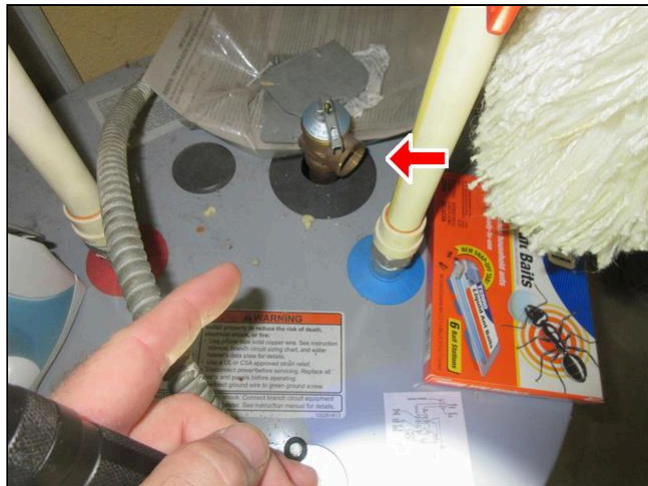
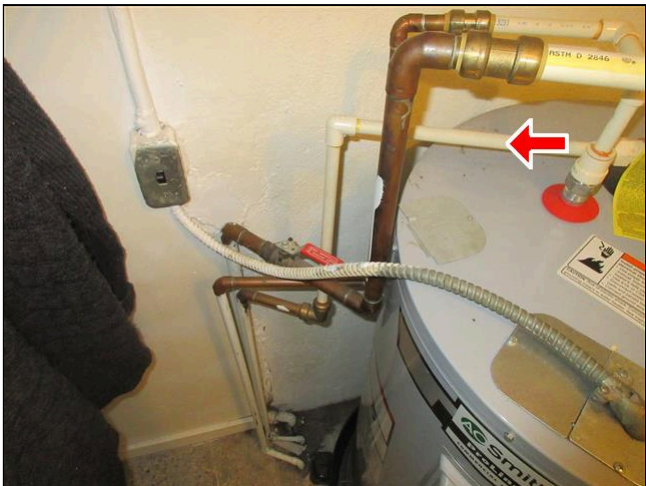
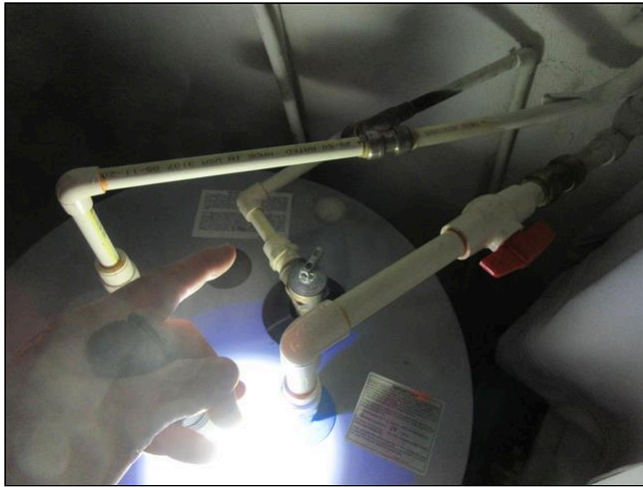
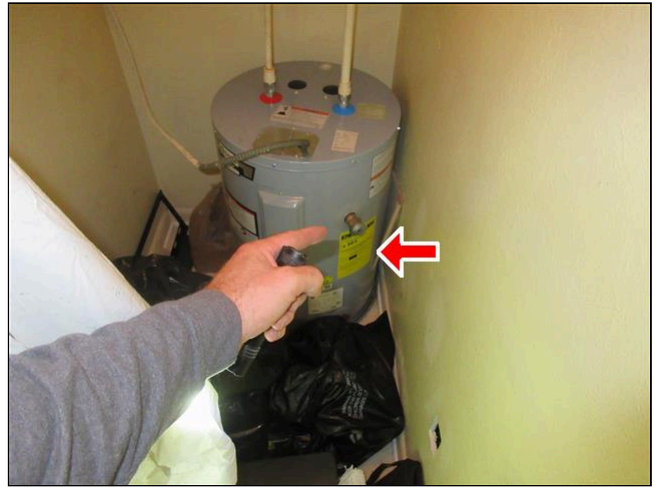
1732- Water Heater is missing a T & P Relief valve pipe. 1736- Water Heater is missing a T & P Relief valve pipe and has exposed romex wiring that should be encased. Garage- Water Heater has exposed romex wiring that should be encased. Unit 4- Water Heater is missing a T & P Relief valve pipe. Unit 3- Water Heater has an inappropriately sized T & P Relief valve pipe. T & P Pipes should be 3/4" diameter and not reduced to 1/2". Unit 2- Water Heater has an inappropriately sized T & P Relief valve pipe. T &

P Pipes should be 3/4" diameter and not reduced to 1/2". Unit 7- Water Heater is missing a T & P Relief valve pipe.

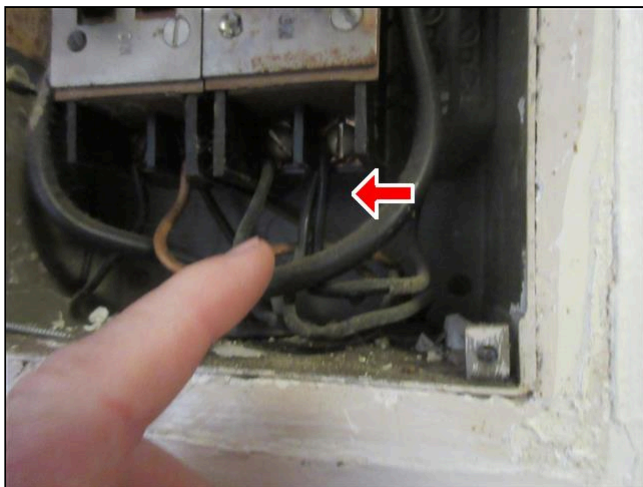
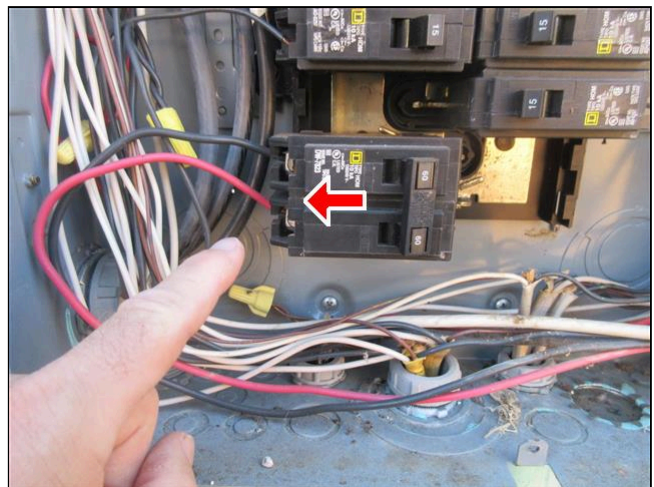
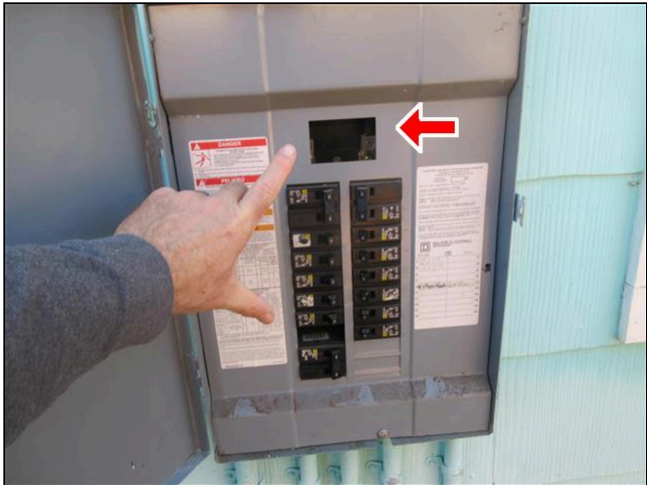
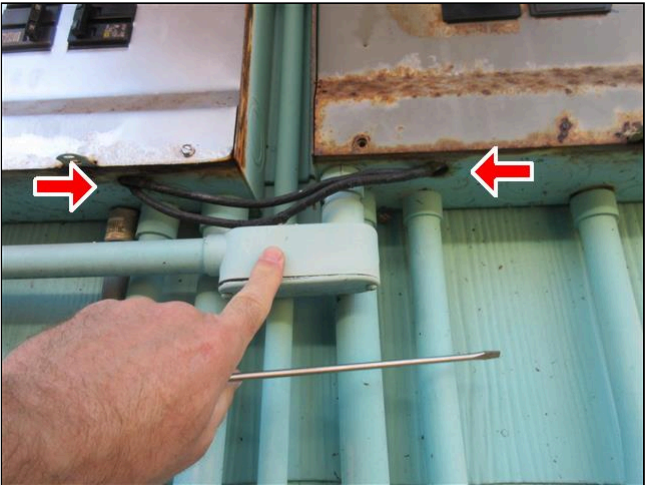
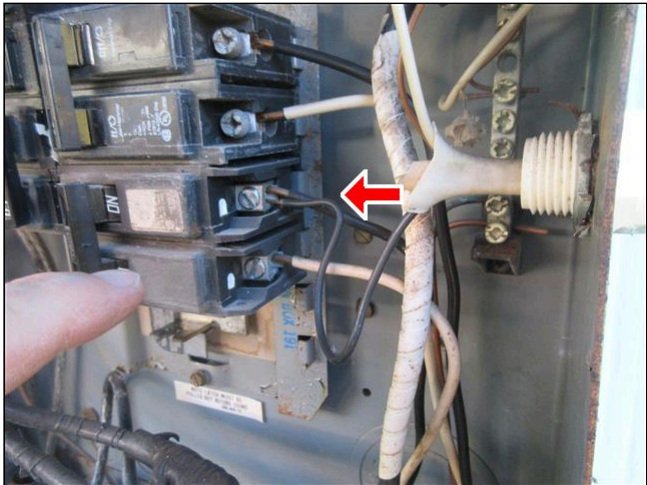
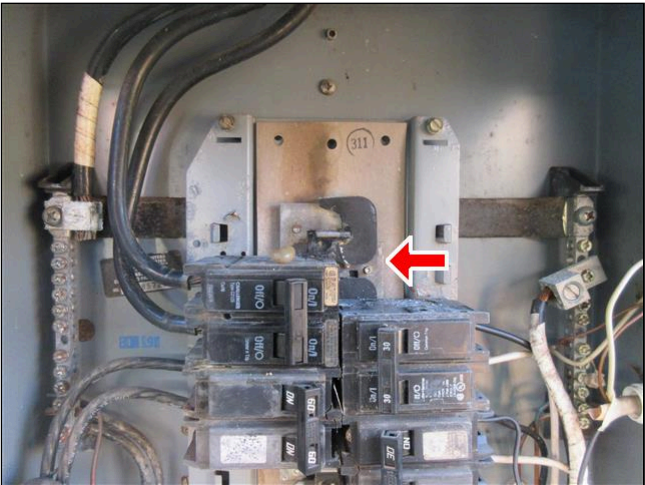
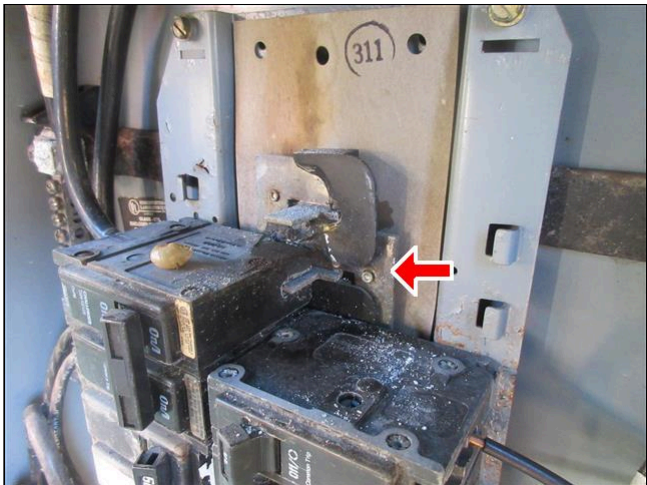
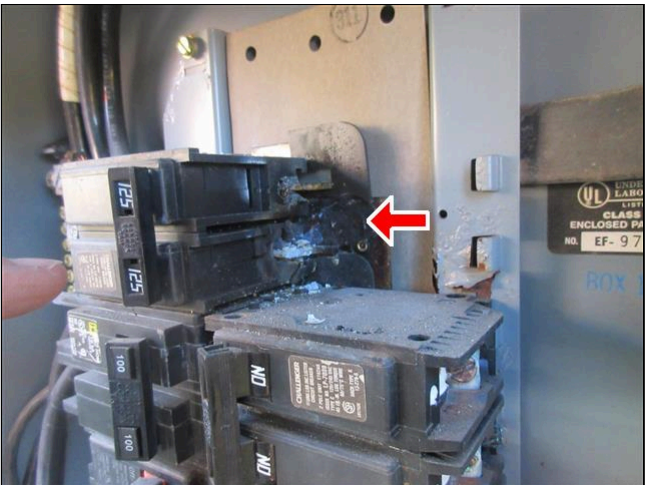
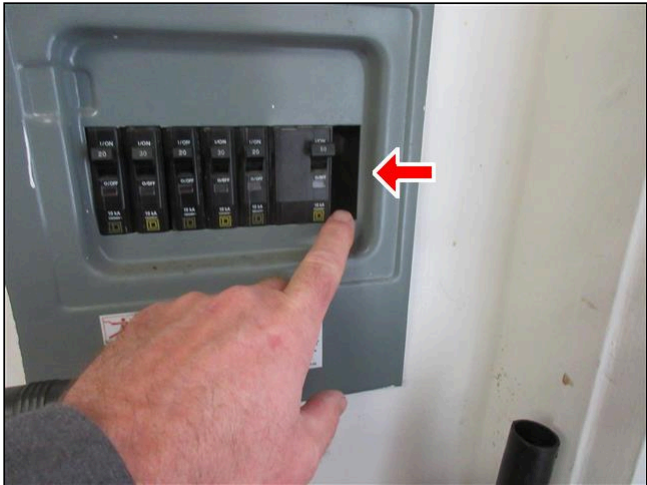
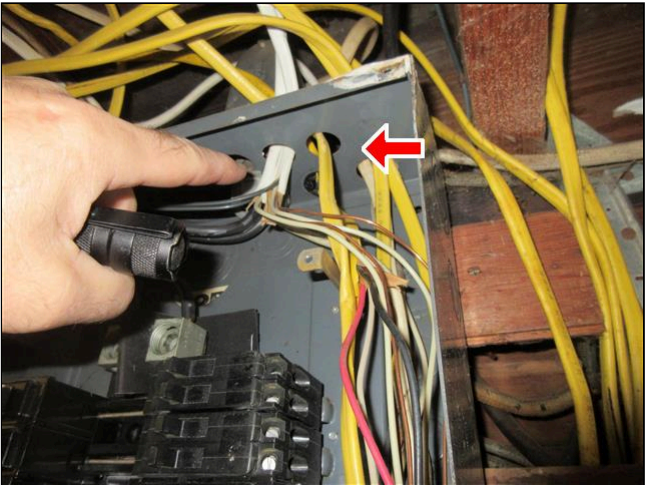
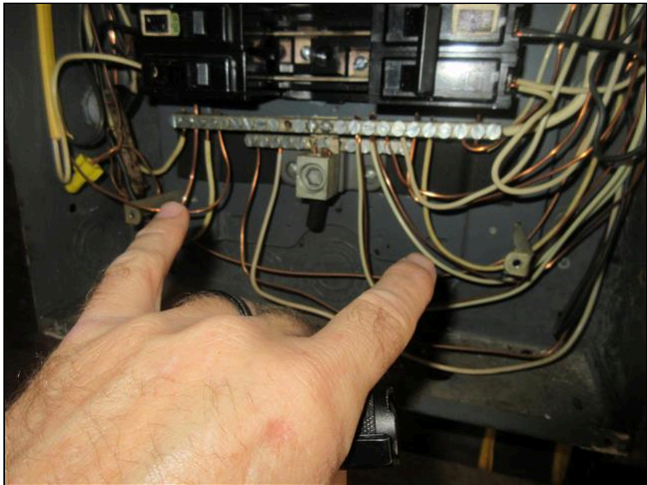
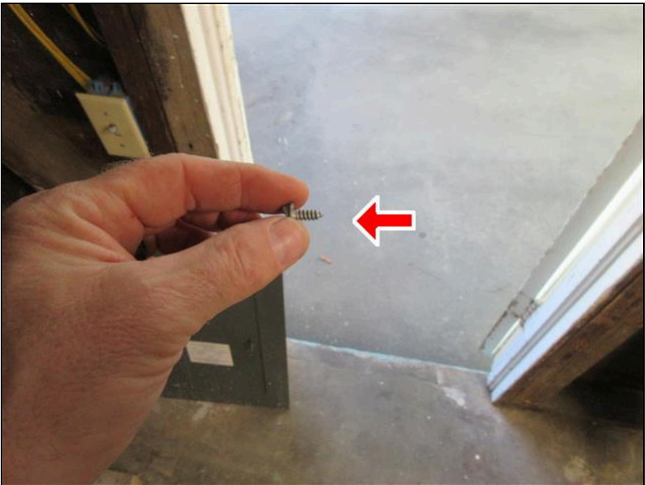
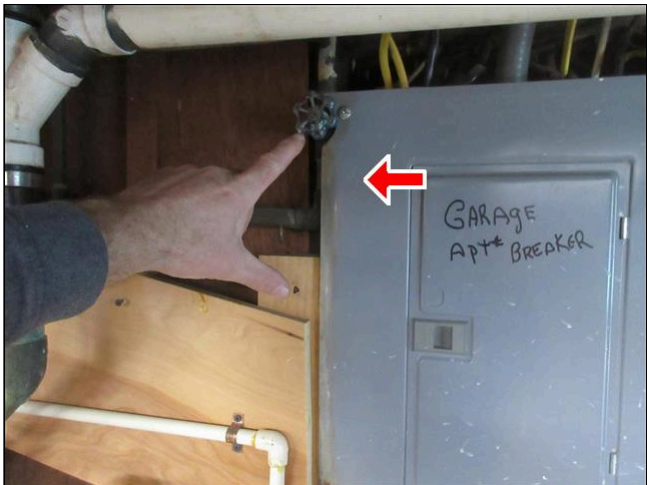
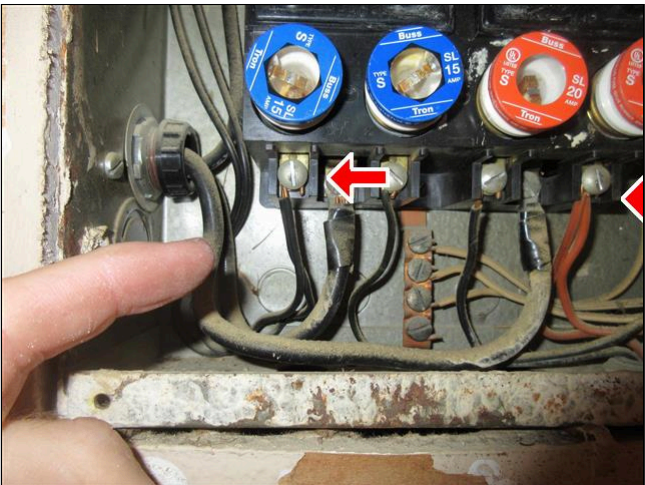
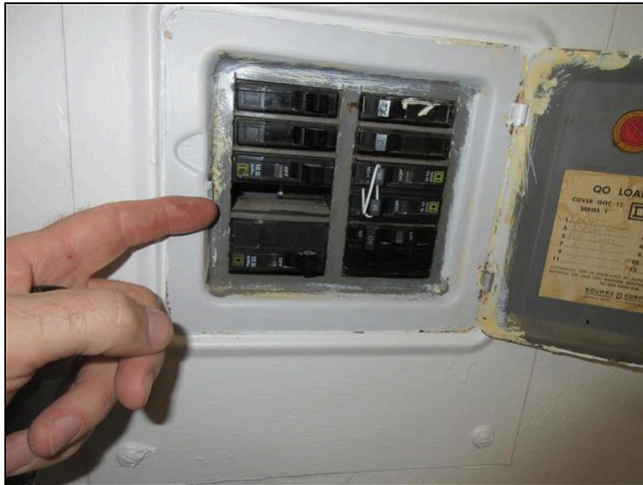
1732- Double tap present in the Federal Pacific sub-panel in the kitchen. Multiple issues are present at the Challenger meterbase panels at the right side of the home including: missing romex connectors, exposed wires, double wiring at circuits, burned or damaged breakers. Repairs are needed and safety hazards are present within these panels. Many insurance companies have issues with Federal Pacific and Challenger electrical panels. We recommend you check with your insurance company regarding these panels. 1736- Square D distribution panel in the kitchen is missing a knock out cover. Garage- Main panel has missing romex connectors, improper panel cover screws and mixed ground and neutral wires that should be terminated on separate grounding and neutral bars. Panel cover has water stains on the front from a leaking valve above. Unit 3- Double taps are present in the sub-panel in the kitchen. Unit 7- Square D distribution panel in the kitchen is missing a knock out cover. Recommend further evaluation from a licensed electrical contractor and repair as needed.

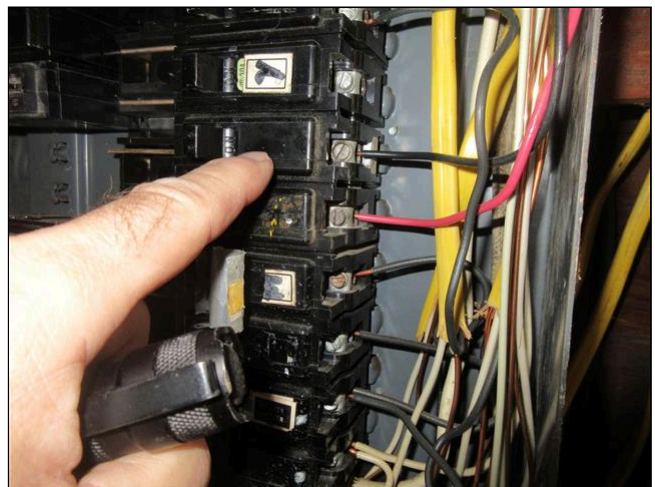
7.2 Item 2(Picture)

Garage- Several breakers have double wiring and/or over fused breakers. Recommend further evaluation from a licensed electrical contractor and repair as needed.

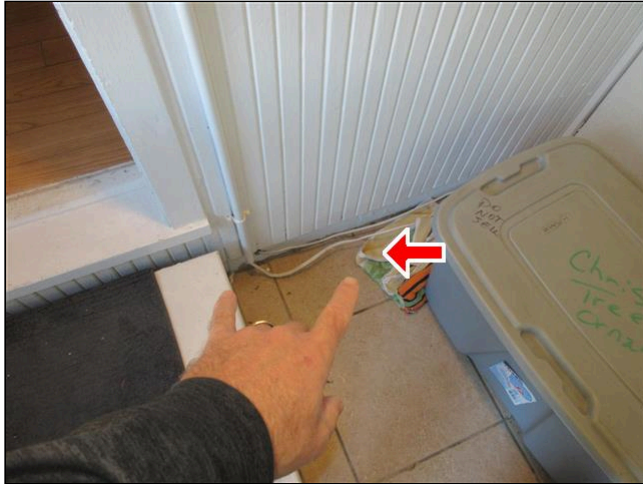
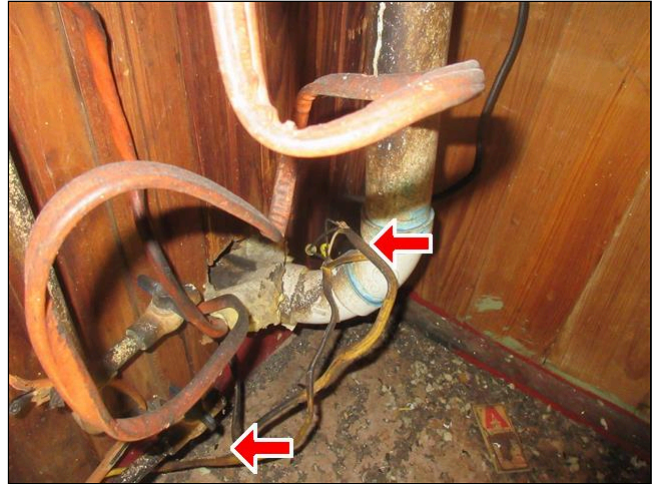
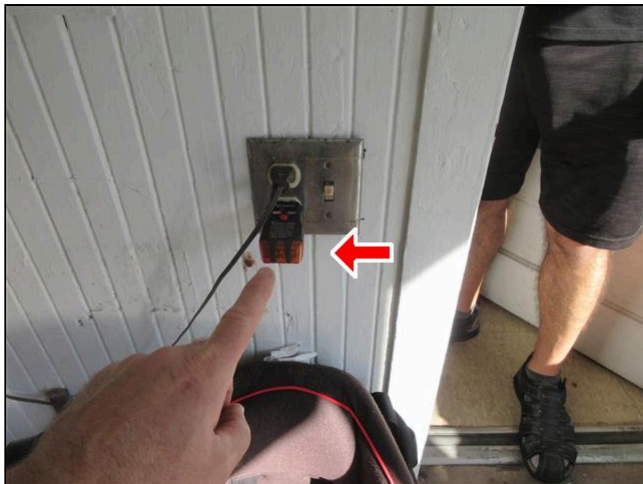
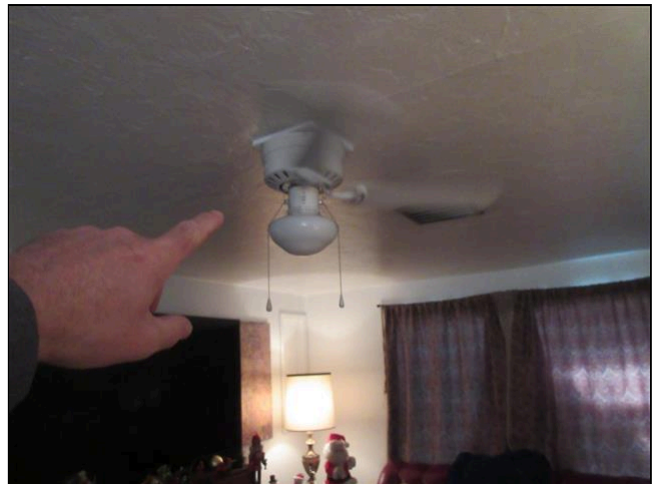
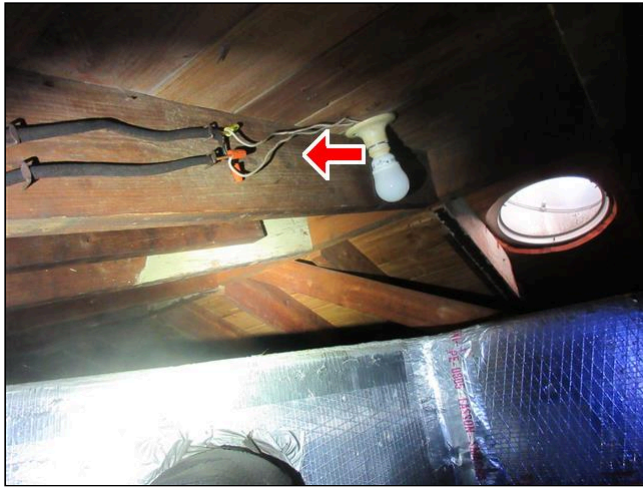
1732- Exposed romex wiring running along the floor near the rear entry door should be secured and encased in conduit. Several open slices are present in the water heater area. 1736- Three prong outlet at the rear of the home at the left side of the rear entry door is either not working properly or is ungrounded. Ceiling fan in the living room is missing a blade. Improperly wired attic light is present in the attic above the pull down stairs. Garage- Open splice observed above the electrical distribution panel. Rear storage area has an improperly wired and installed overhead light. Unit 8- At least one three prong outlet is wired incorrectly at the living room (hot/neutral reversed). Unit 5- At least one three prong outlet is wired incorrectly at the dining room (open ground). Recommend further evaluation from a licensed electrical contractor and repair as needed.

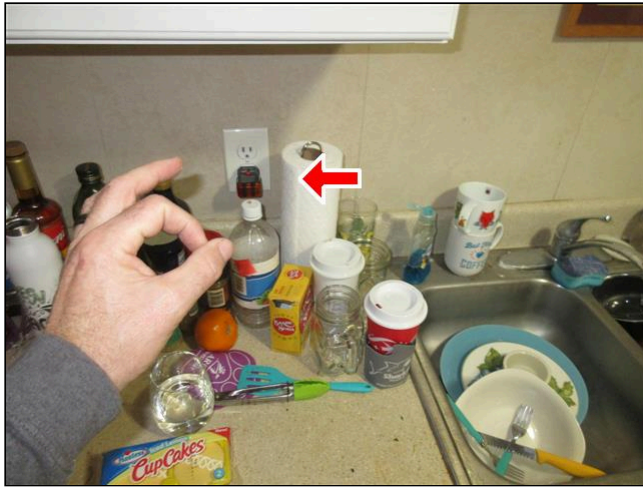
7.4 Item 1(Picture)

Unit 4- Three prong outlet near the kitchen sink did not work when tested. Unit 5- Three prong outlet near the kitchen sink is showing an open ground. Recommend further evaluation from a licensed electrical contractor and repair as needed.

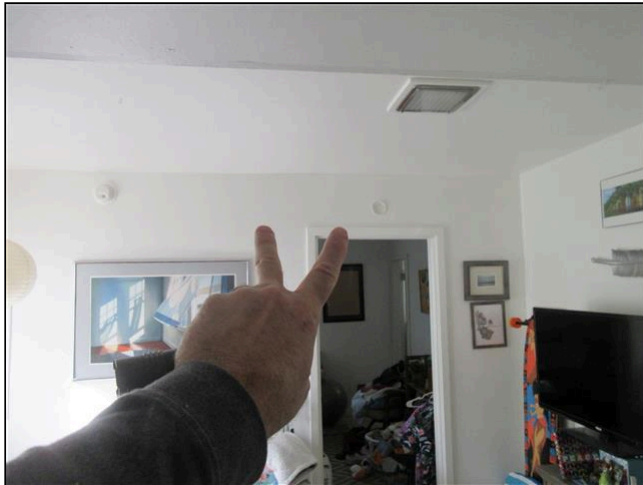
7.8 Item 1(Picture)

Multiple Smoke detectors missing or not working throughout the units. Recommend safety upgrade to include smoke detectors in each room of every unit.

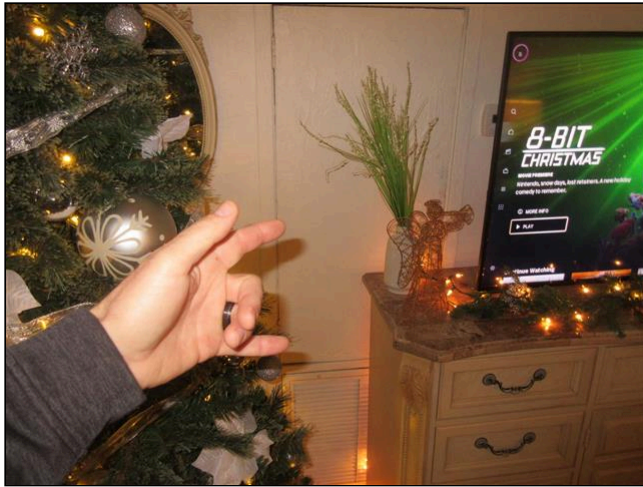
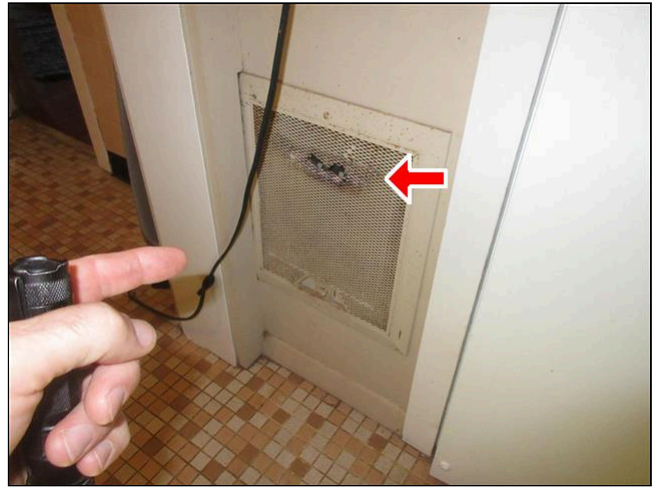
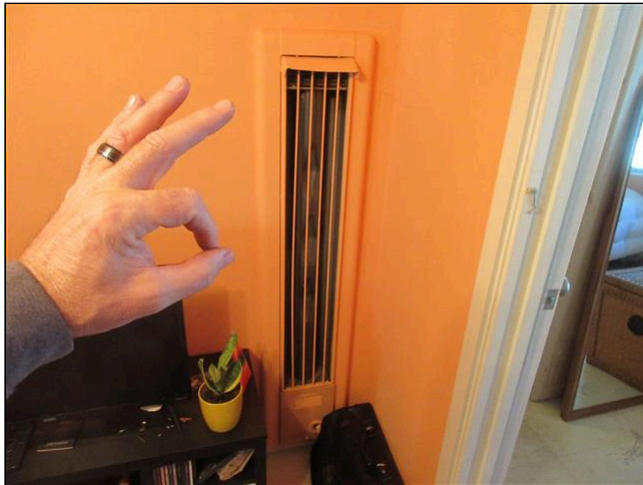
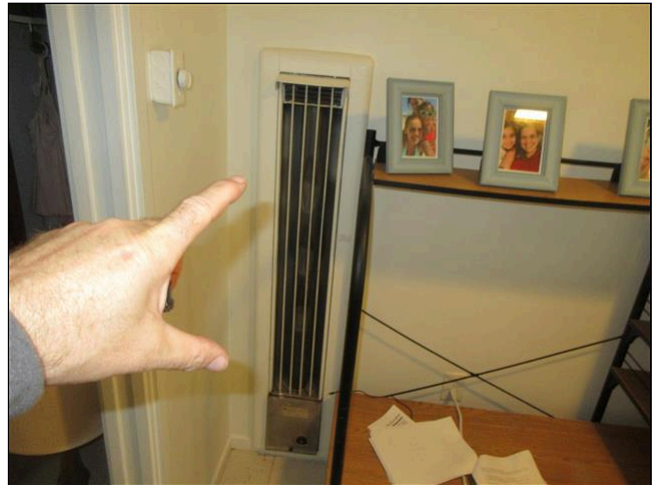
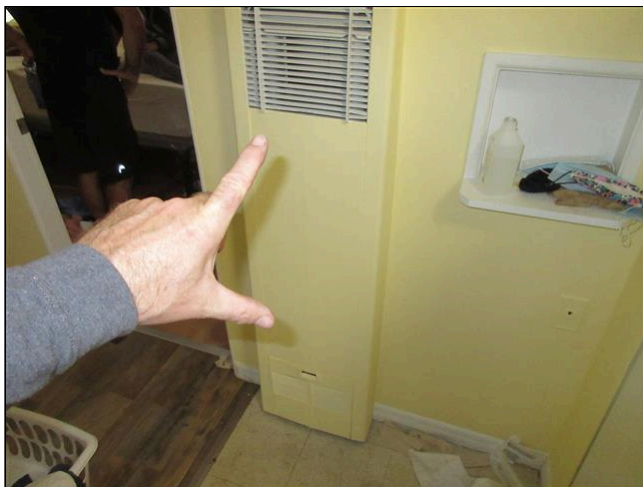
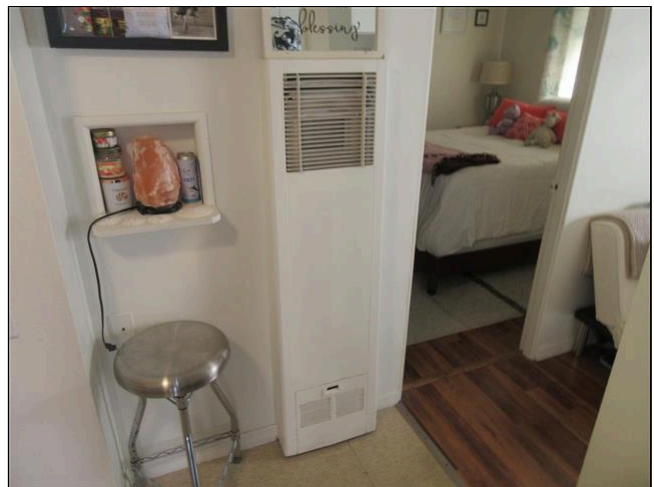
1732- The air handler closet is blocked with a large entertainment center. We were unable to observe this area. Garage- Wall mounted heater in the guest bath has a damaged or melted cover. This is considered unsafe and should be repaired or removed. 8 Plex- Older Wall Mounted Heating Elements were not inspected.

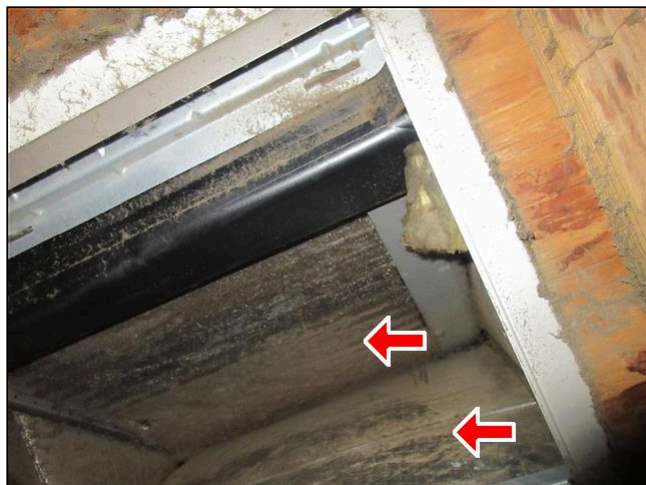
8.3 Item 1(Picture)

Garage- A-coil at the air handler is dirty and needs cleaning and servicing. Recommend service from a licensed HVAC Contractor.

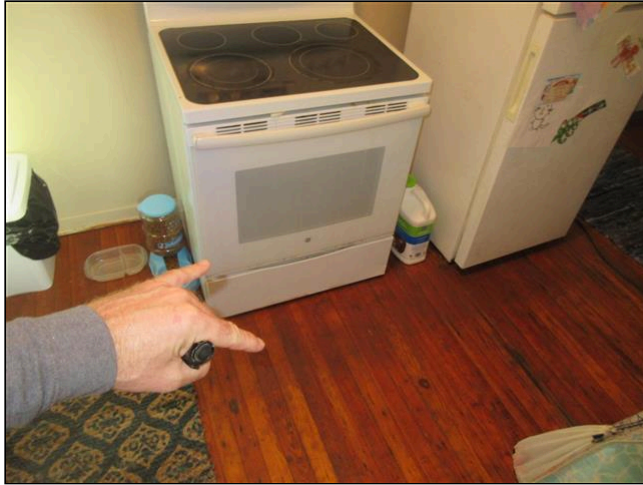
10.1 Item 1(Picture)

Garage- The anti-tip bracket is missing at the range. The anti-tip bracket prevents the range from inadvertently tipping over. Recommend install as needed.

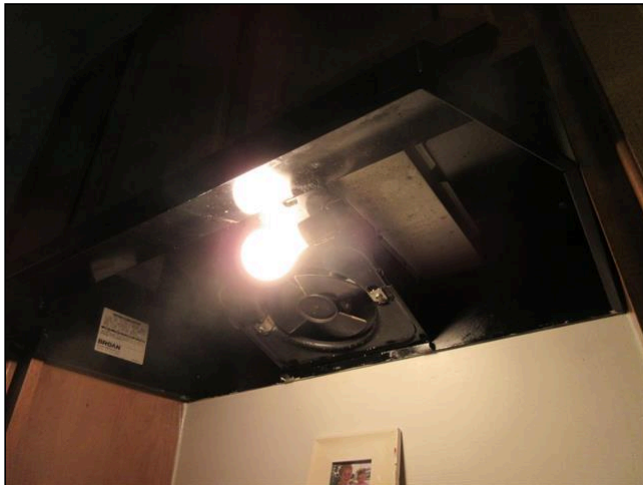
10.2 Item 1(Picture)

1732- Range hood is missing light covers and filters.
