# **RV** Inspection Report

Ranger RV, LLC

Scott Mansito Cibolo. TX 78108

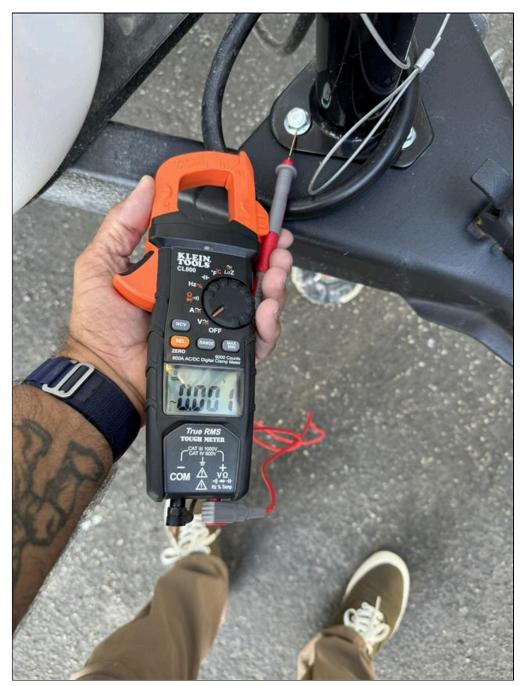
Hot Skin Test Photo

- **2.1 Hot Skin Test Exterior Wall Surface Voltage**Acceptable
- **2.2 Hot Skin Test Door Handles and Frames Voltage**Acceptable
- **2.3 Hot Skin Test Window Frames and Trim Voltage**Acceptable

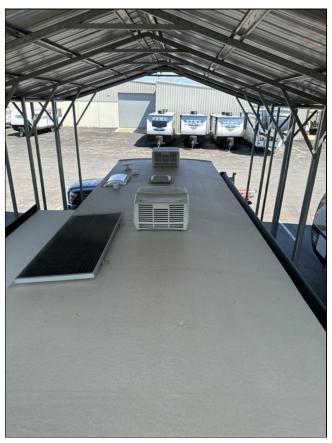
(2) Back to Front

(3) There is an unidentifiable object sticking up under the roof membrane located on the curbside of the front AC unit. It is recommended that this be further evaluated by a qualified RV technician.

Back to Front

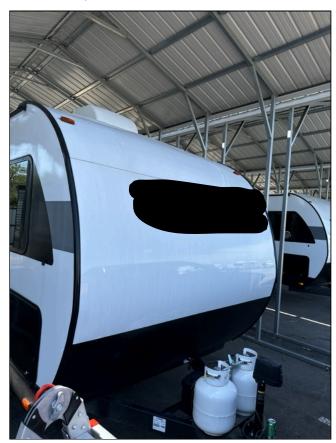
(1) Front Cap

- (1) The front cap from side to side has multiple pin holes and cracks in the sealant. This could allow water intrusion. It is recommended that this be further evaluated by a qualified RV technician.
- (2) Front cap has a dent in the center front of the RV. The sealant has discoloration in this area and has a softer feel when pressing down on it. This area has multiple pin holes in the sealant. This could allow water intrusion. It is recommended that this be further evaluated by a qualified RV technician.

(2) Front cap has a dent on the top curve on the streetside. It is recommended that this be further evaluated by a qualified RV technician.

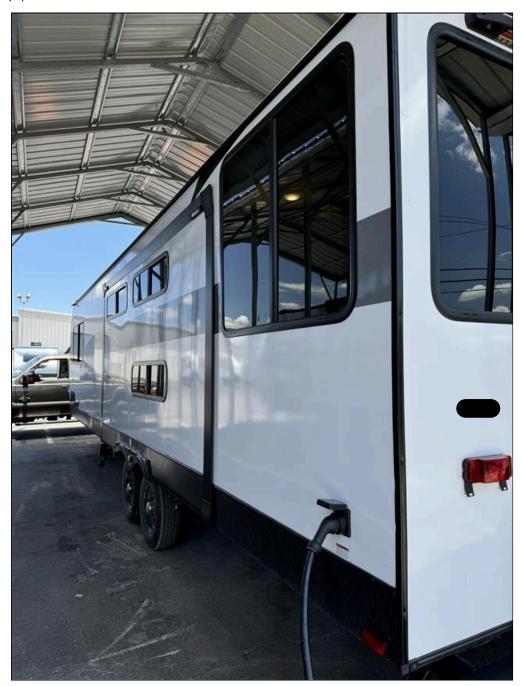
# (1) Streetside Sidewall

(2) The gutter downspout is broken on the streetside gutter. It is recommended that this be further evaluated by a qualified RV technician.

Streetside Sidewall

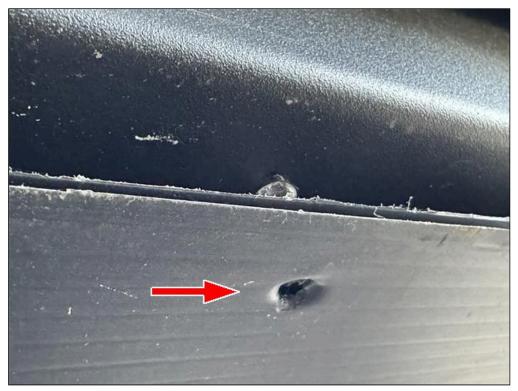
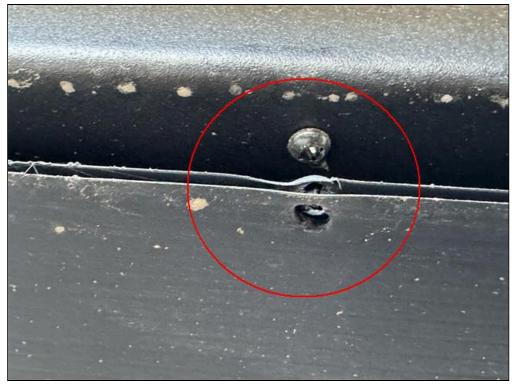
- (6) The underbelly is detached in several spots along the rear of the RV. This could allow water intrusion. It is recommended that this be further evaluated by a qualified RV technician.

**Detached Underbelly**

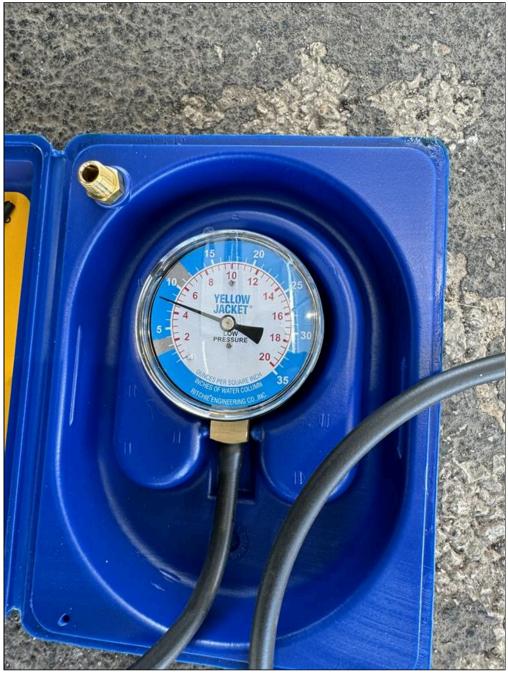
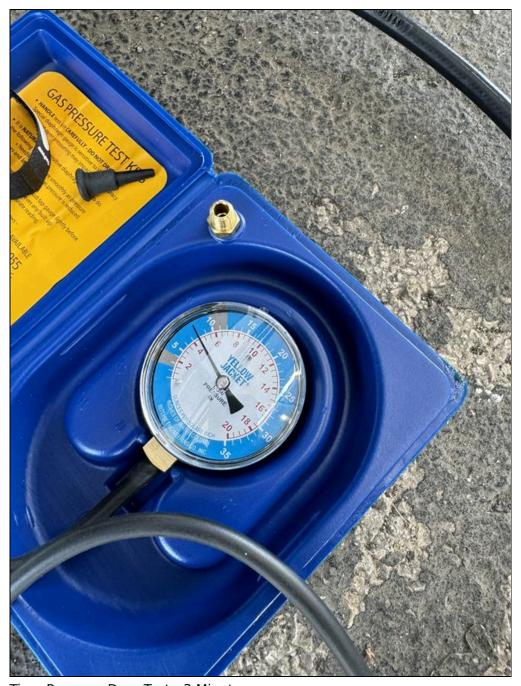
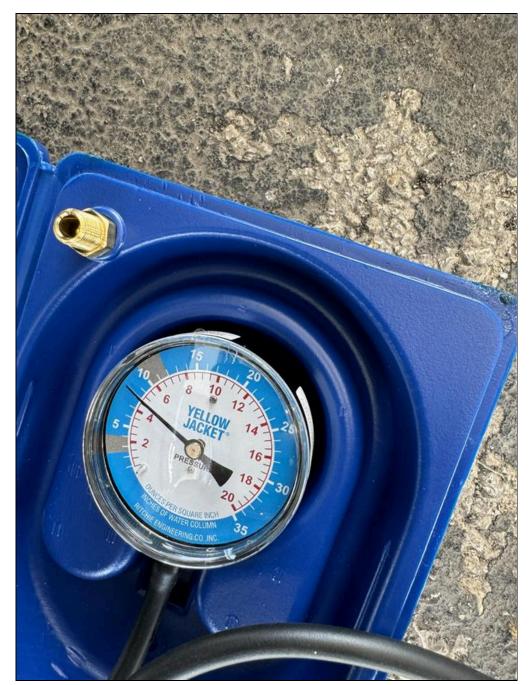
Time Pressure Drop Test - Start

Time Pressure Drop Test - 3 Minutes

Time Pressure Drop Test - 5 Minutes - End

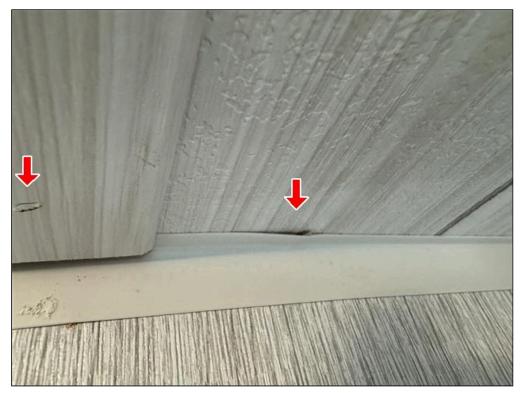
Streetside Bedroom Ceiling

(2) There are multiple place in the bedroom ceiling trim that is separating from the wall. It is recommended that this be further evaluated by a qualified RV technician.

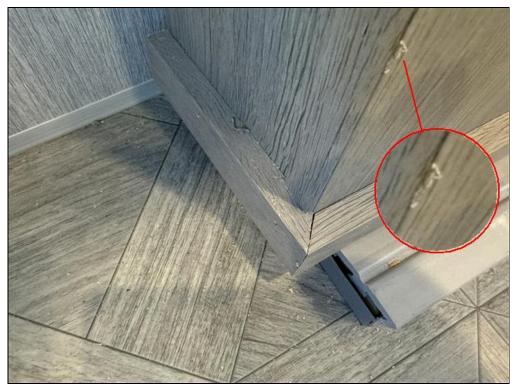
Trim on Left Side of Entertainment Center

There are multiple locations through the RV that have scuff marks, separation or not aligned, pealing or damage trim. It is recommended that this be further evaluated by a qualified RV technician.
