Inside-Out Home Inspectors

Home Inspection Report

Toronto, ONTARIO

Inspected on Wed, Nov 25 2020 at 1:00 PM

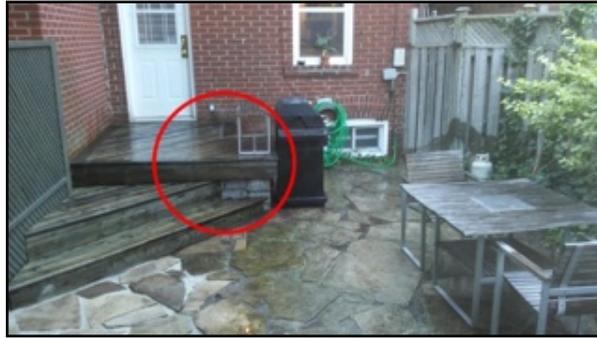
7) Comment 12: A guard rail and railing on the rear deck and patio were not installed. This is an unsafe condition. Missing these components is a significant risk for injury in day-to-day use due to falls. Installation of the components noted will ensure proper function of the system.

A guard rail and railing on the rear deck and patio were not installed. This is an unsafe condition. Missing these components is a significant risk for injury in day-to-day use due to falls. Installation of the components noted will ensure proper function of the system.

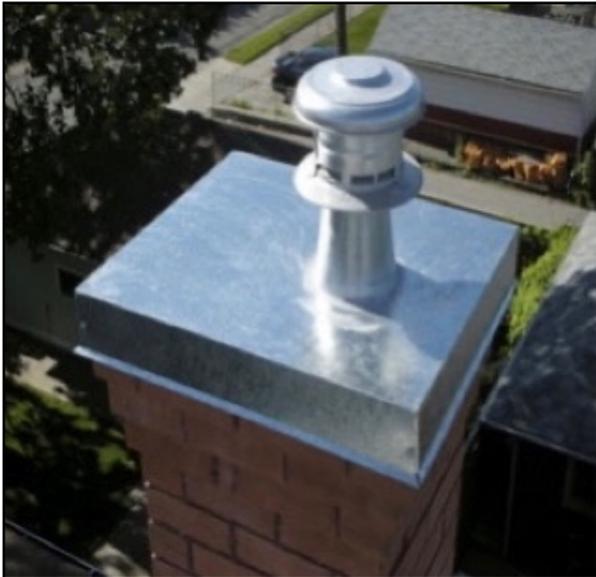
Figure 17-1

Proper installation of cap on the masonry chimney should include a cap and a seal. This is an example of a properly installed cap and vent.

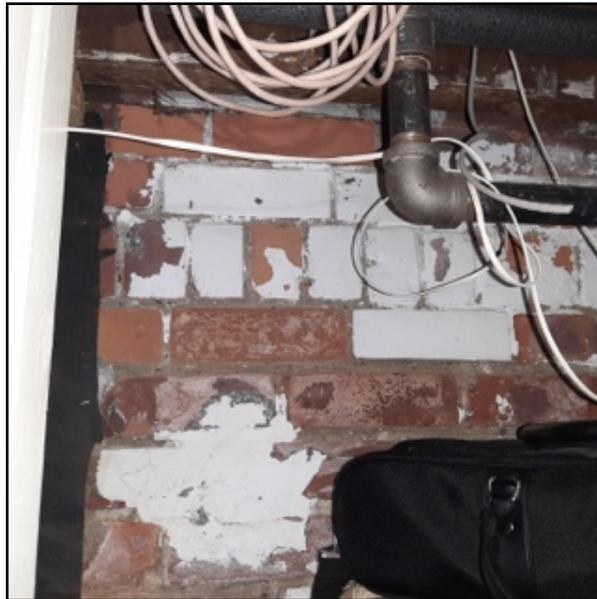
14) Comment 22: Investigation of the foundation walls was limited to an area of the west wall near the water metre. The area was defect free. This small area did not provide enough access to make accurate observations on the integrity of the entire foundation.

Investigation of the foundation walls was limited to an area of the west wall near the water metre. The area was defect free. This small area did not provide enough access to make accurate observations on the integrity of the entire foundation.

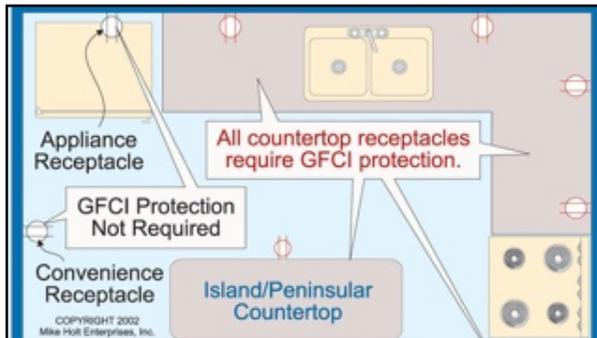
Figure 29-1

Ground fault circuit interrupters (GFCI's) are required in all areas where a sink or water source and electrical outlets are within 5 feet of each other.

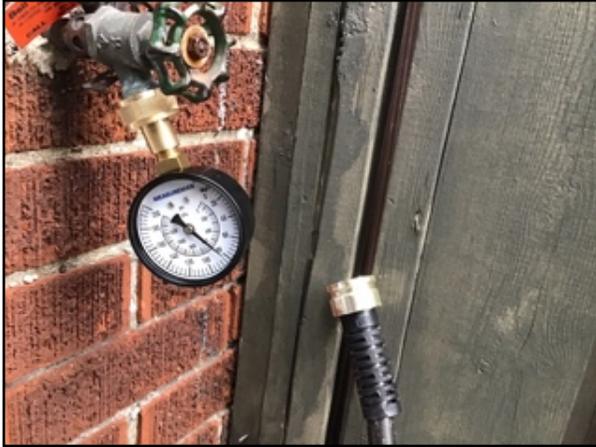
Figure 36-1

Comment 36:
The water pressure from the public supply was tested and found to be 80+ PSI (pounds per square inch). This is average for most homes in the area.

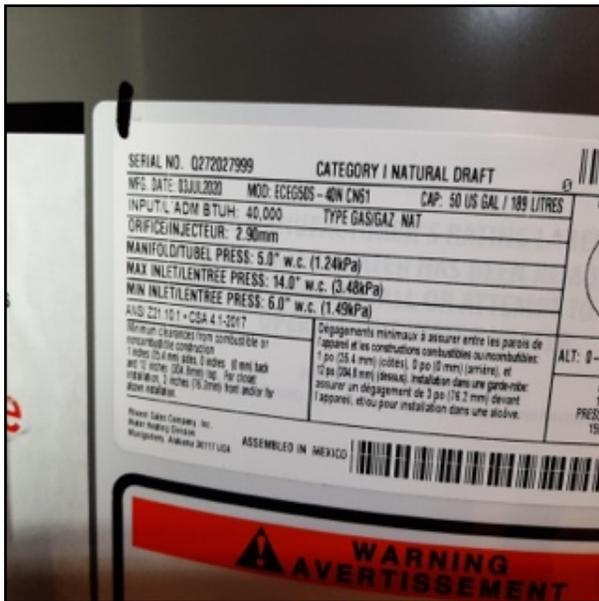
Figure 37-1

Comment 37:
Hot water tank manufacturer's label.

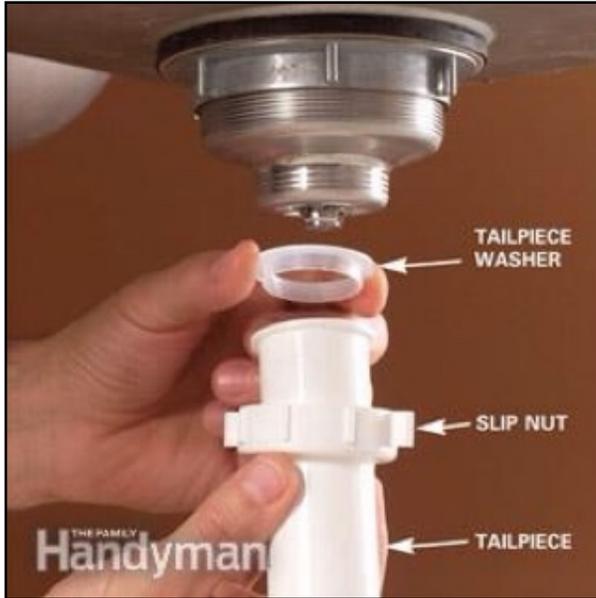
Figure 39-1

Creating a watertight seal under drains is very important to avoid potential water damage.

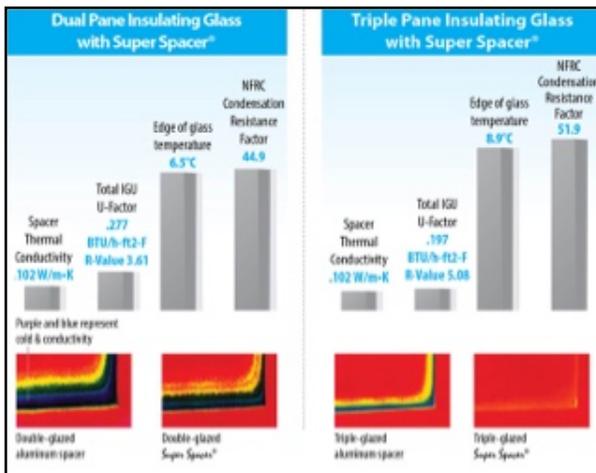
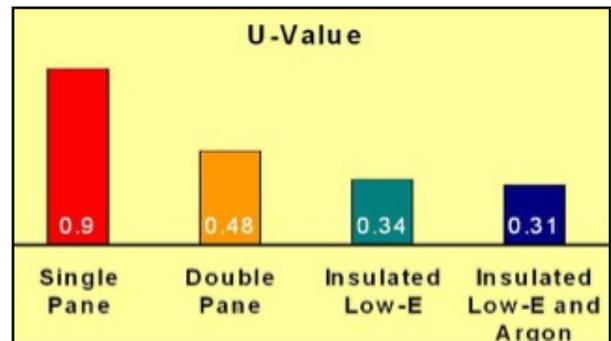
Comparison of single pane windows to more advanced products shows significant increase in energy saving.
