Confidential Inspection Report

Inspected on 1/28/2012 @ 11:00 A.M.

Record Home Inspections

Inspection Date: Saturday, January 28th, 2012 at 11:00 A.M.

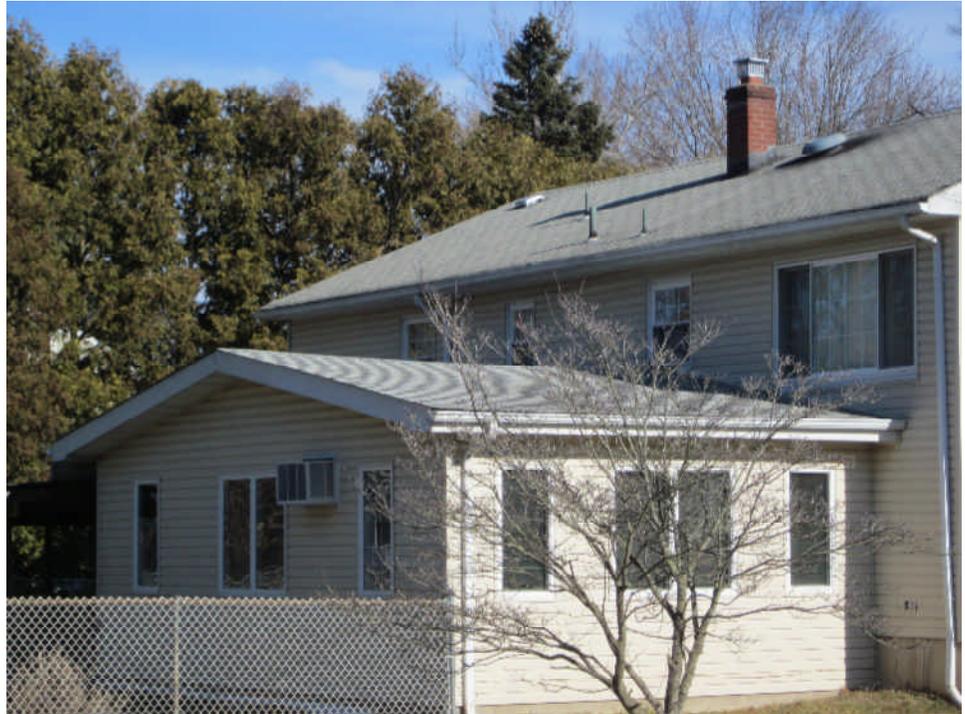
Rear View

The rear of the house faces West.

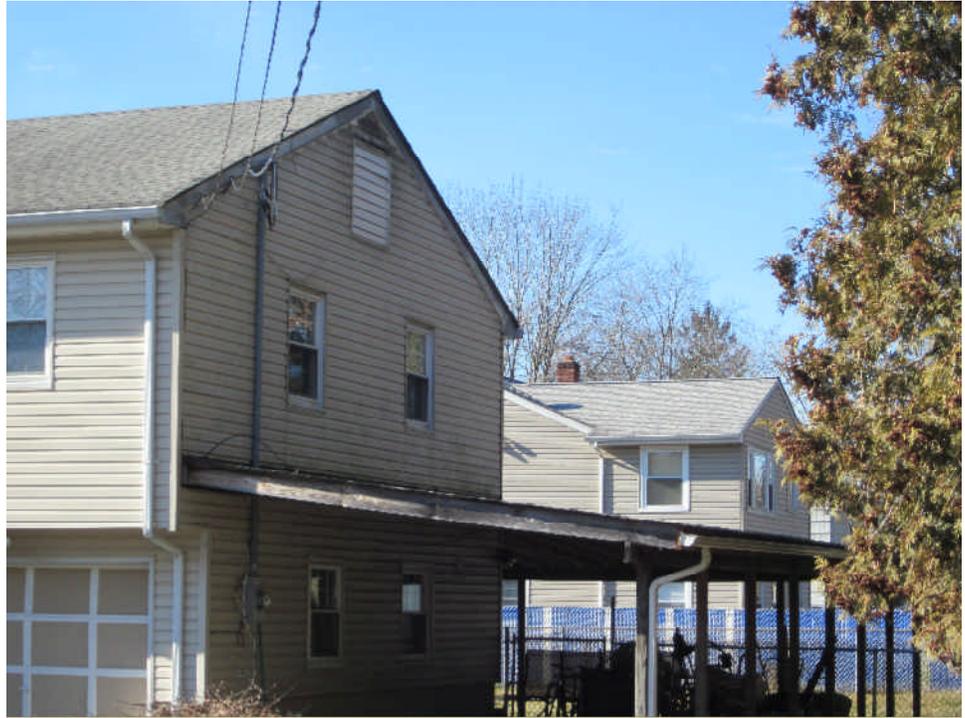
Right Side View

The right side of the house faces North.

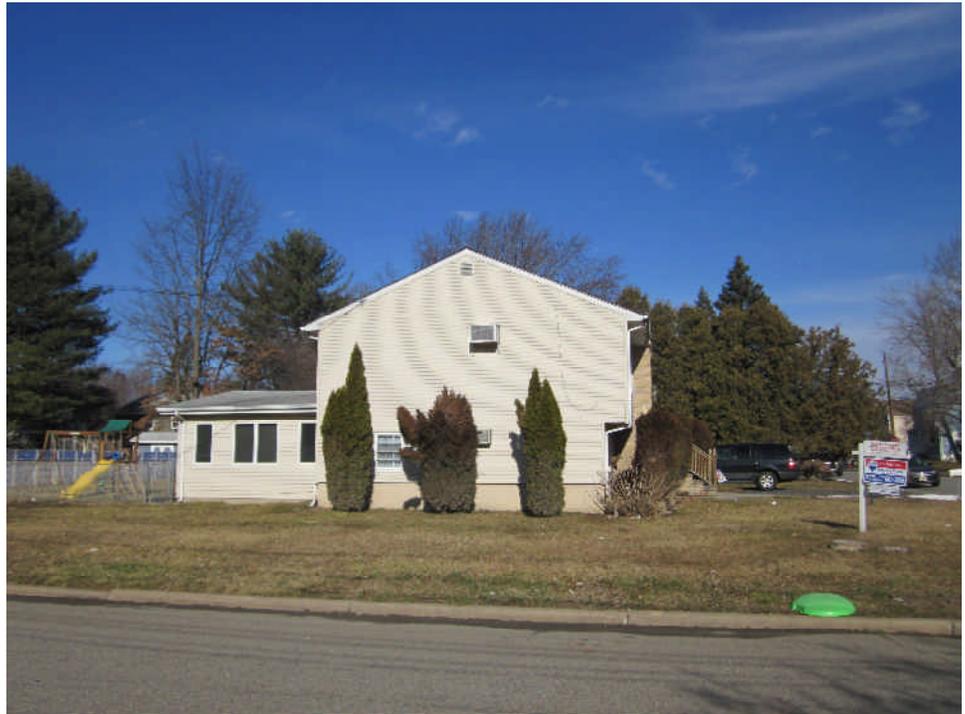
Left Side View

The left side of the house faces South.

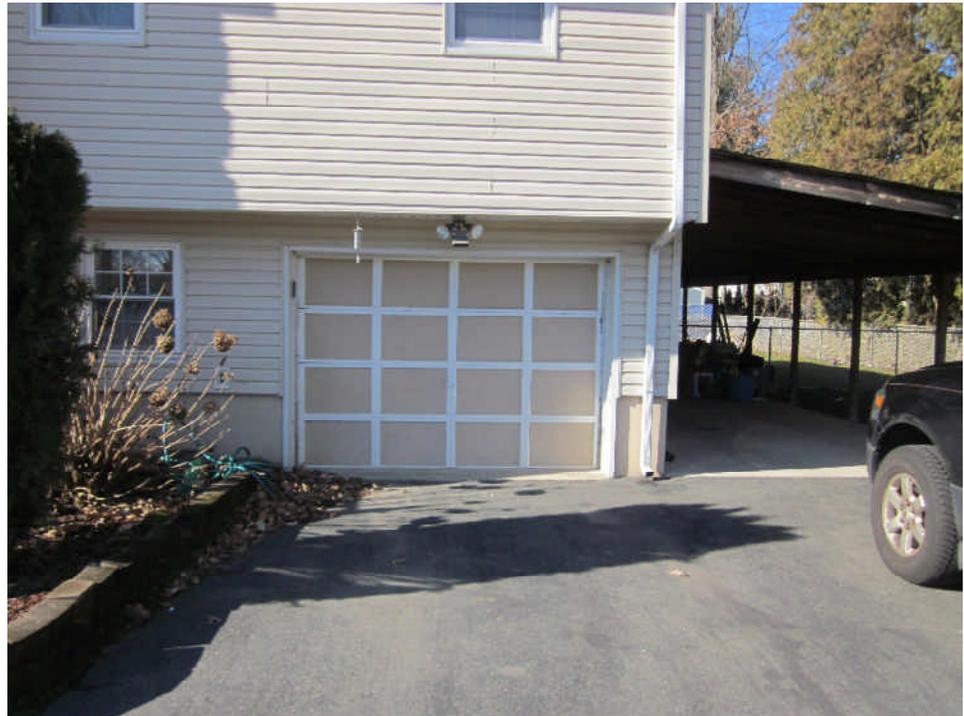
Driveway Paving Material:

Asphalt.

The driveway surface material is in satisfactory condition with only normal deterioration noted.

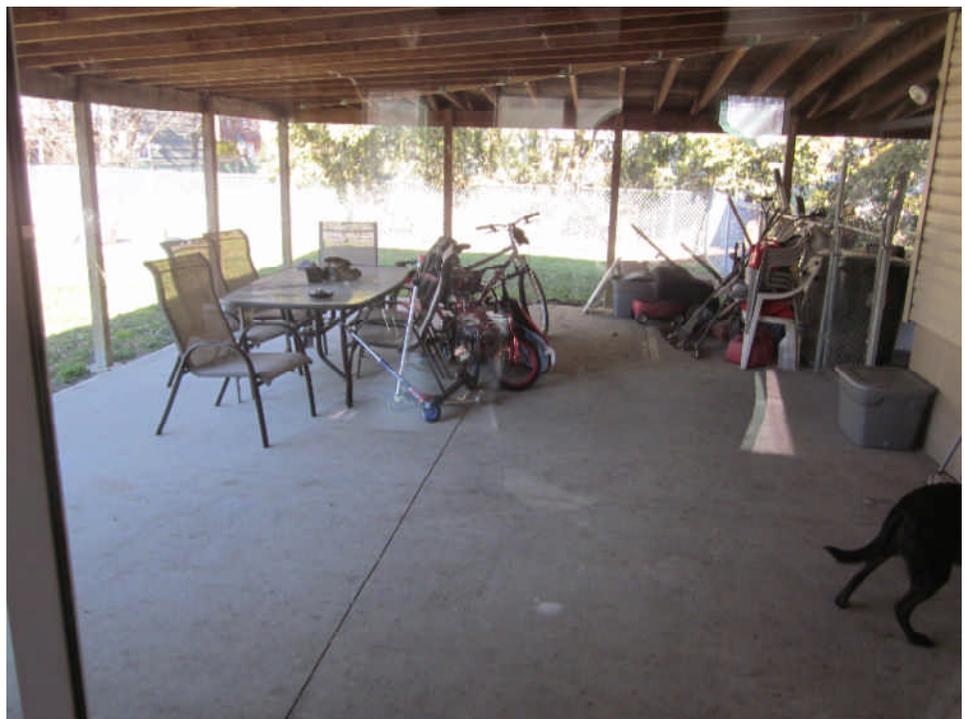
Patio Slab
Materials:

Concrete.

Slab Condition: The slab is in useable condition.
Patio Lighted: Yes.
Patio Cover Condition: The patio cover is functional.

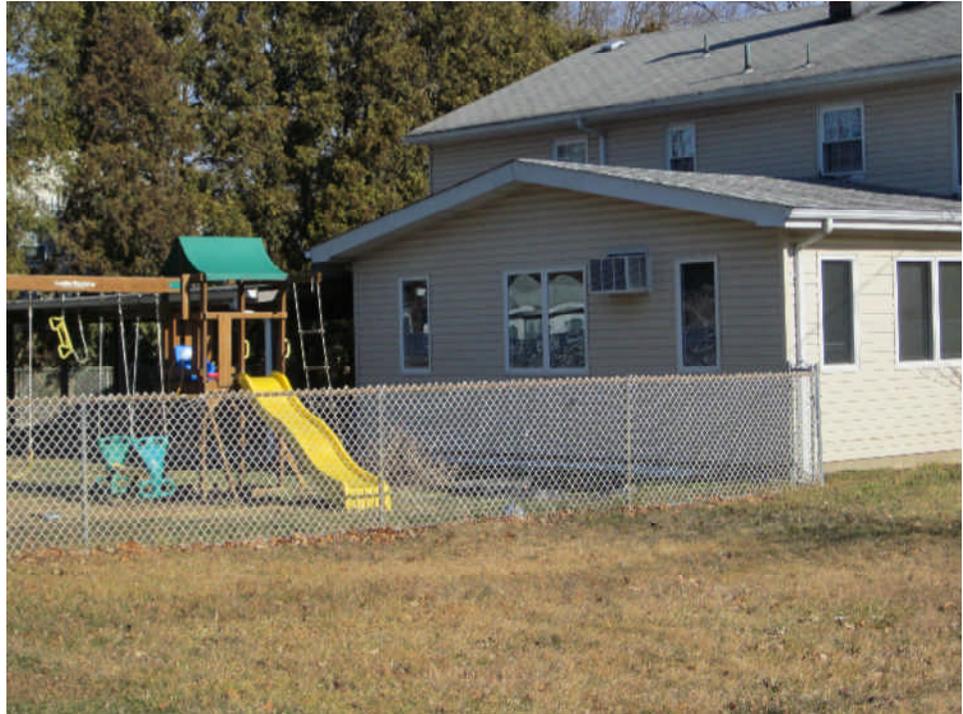
Fencing Materials:

Chain link materials are used for fencing.

Fence Materials Condition: The fencing materials appear to be in satisfactory condition.

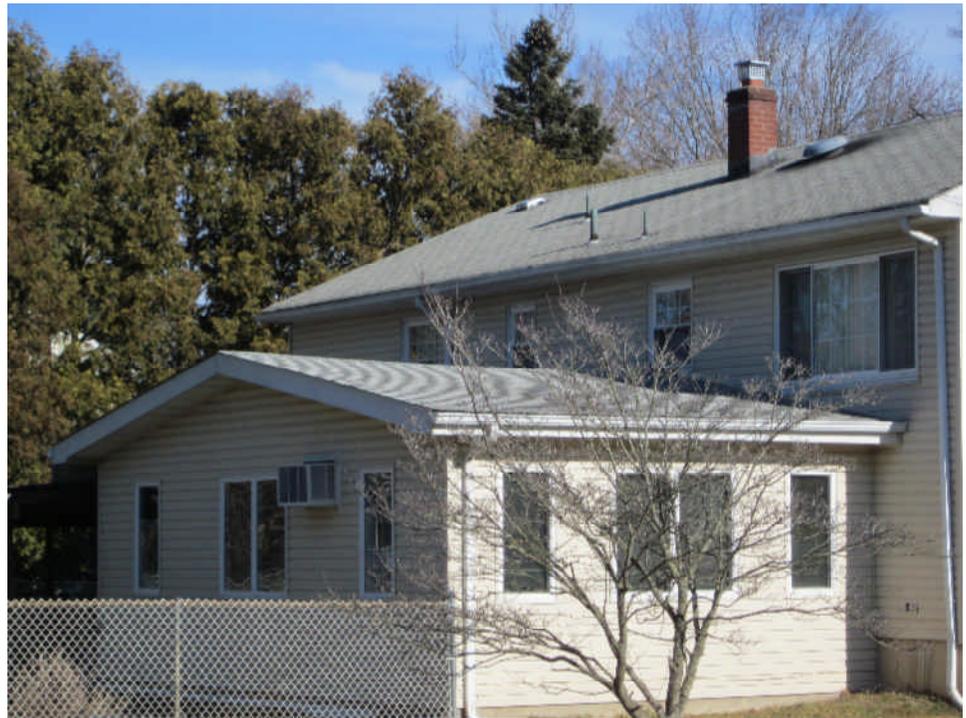
Type Roof:

Gable.

Attention Needed - The roof covering material shows signs of deterioration or damage that needs attention to prevent further deterioration or leakage. Moss build up is noted on the right side roof and lose of granulars is noted on the rear lower area roof.

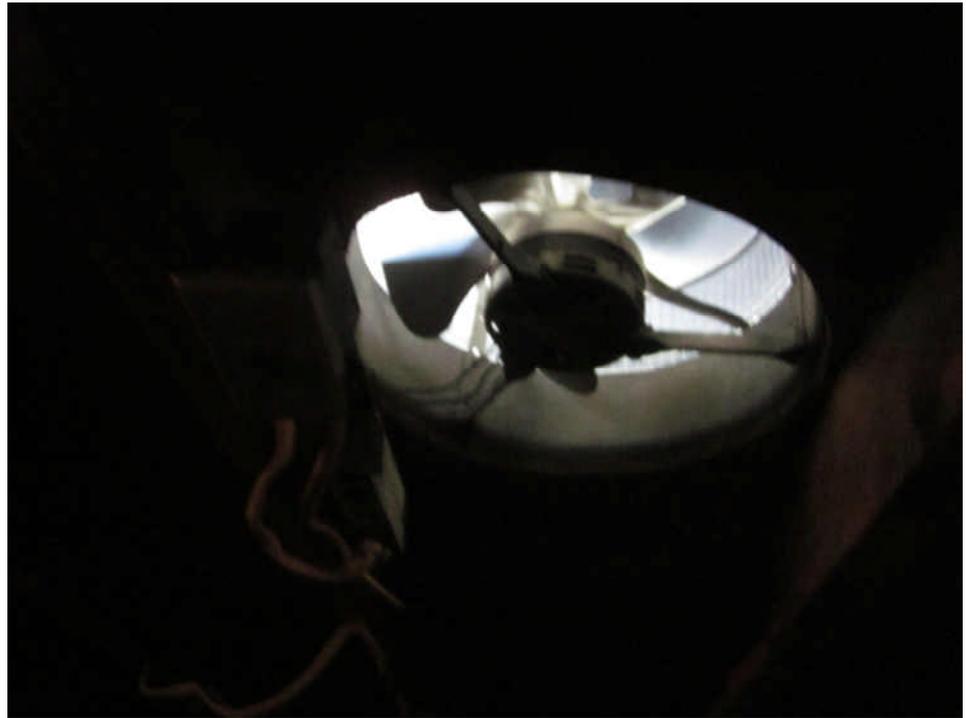
Attic ventilation fan:

There is an attic ventilation fan installed.

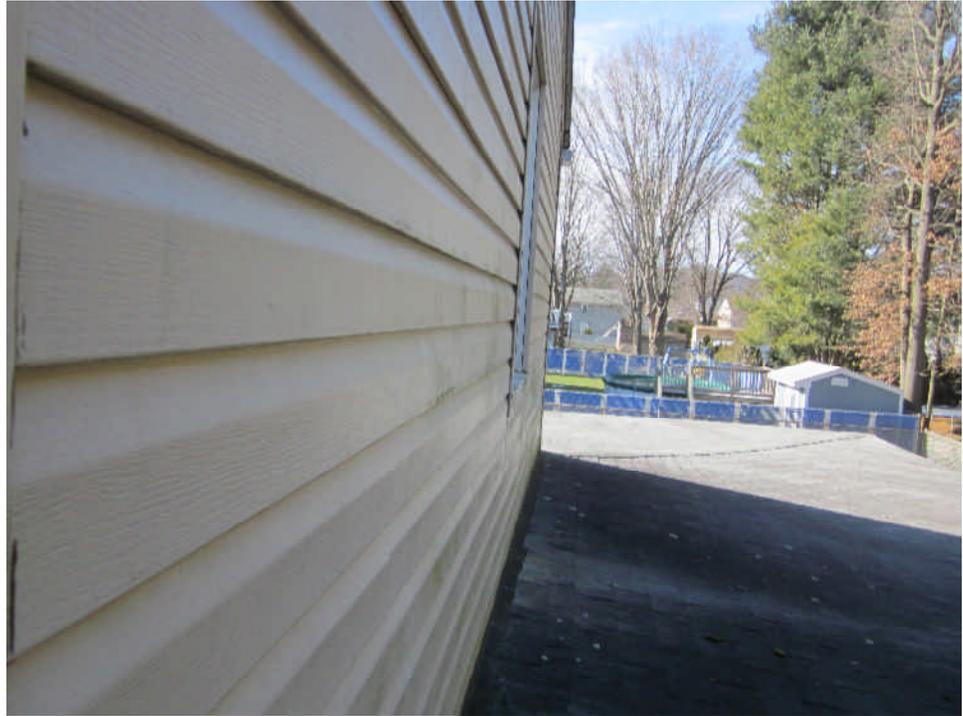
**Exterior Siding
Materials:**

Vinyl Siding.

Attention Needed - The exterior siding material or finish is in a condition that requires minor repair to prevent further deterioration.

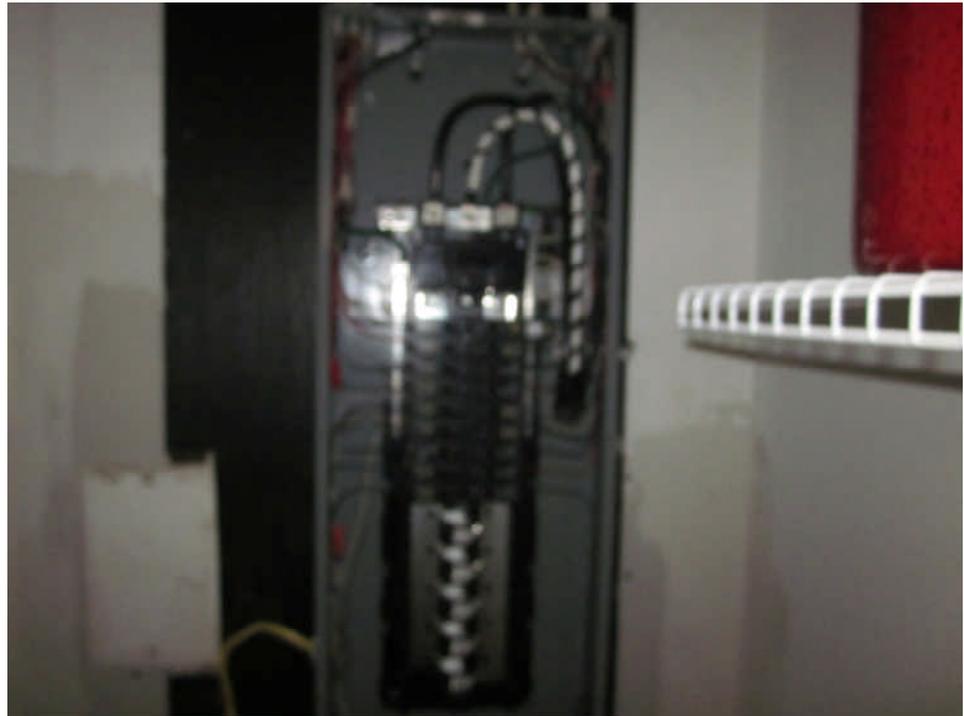
**Panel Cover
Removed:**

Yes.

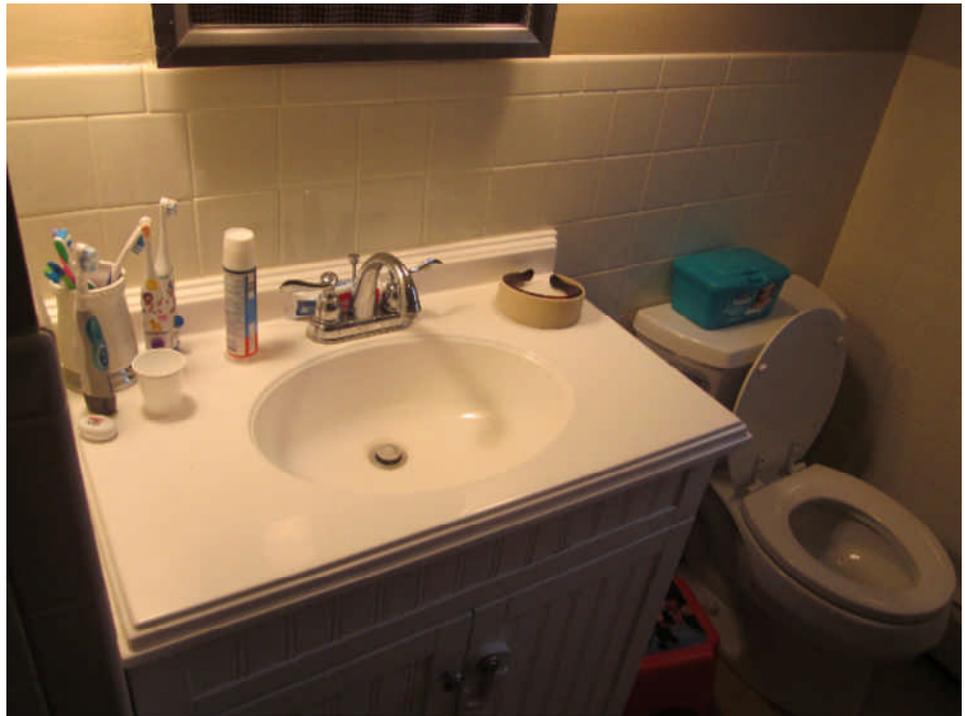
**Basin and Drain
Fixture:**

The basin and drainage fixture appears to be satisfactory.

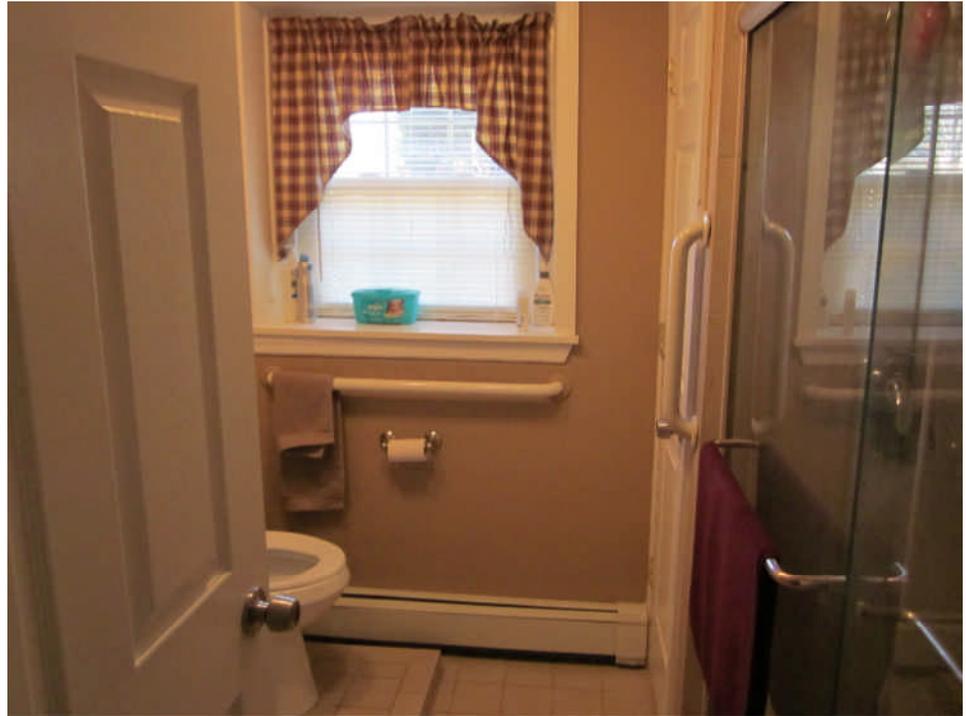
Bathroom #2:
Vanity Cabinet:

This is the basement level bathroom.
The vanity cabinet and top in this bathroom are satisfactory.

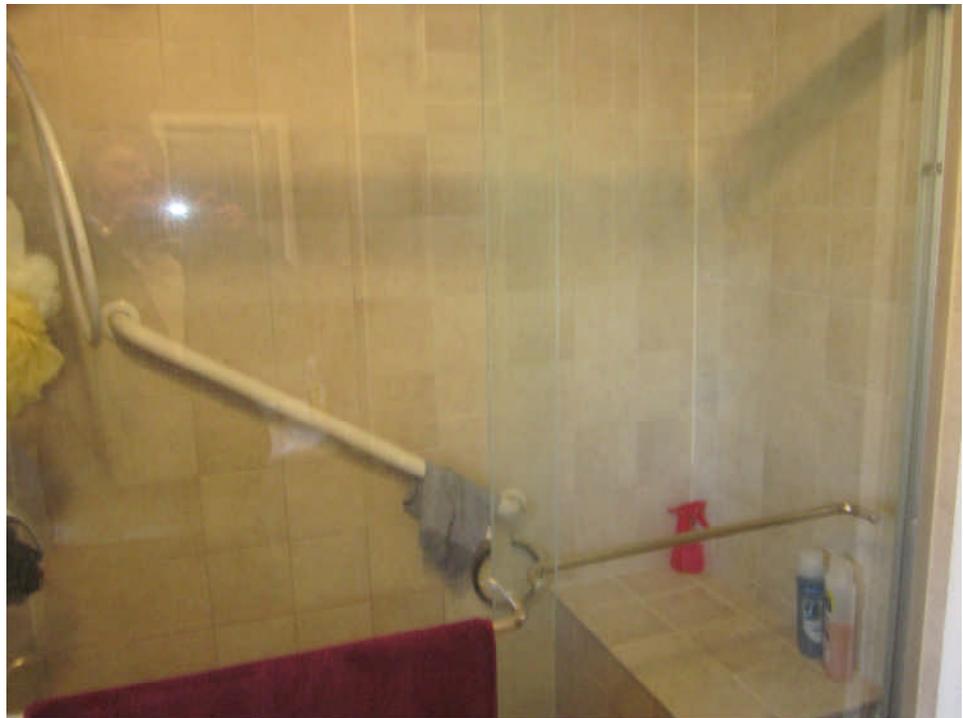
**Glass Tub/
Shower Door:**

The shower stall has a glass door installed. The glass appears to be safety glass.

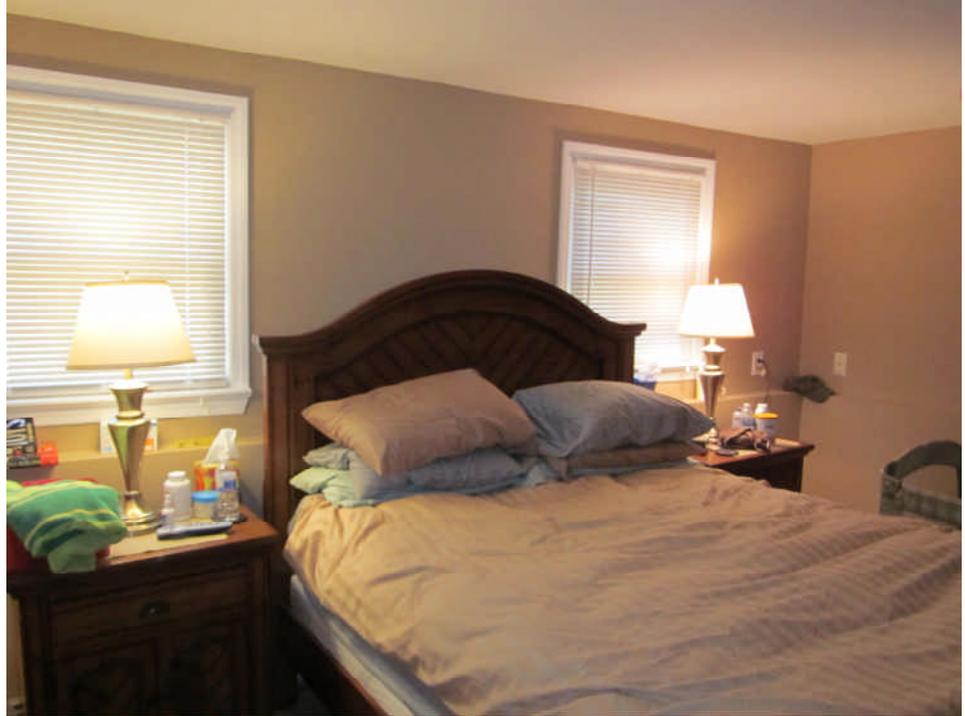
Master Bedroom:
Entry Door:

This is the basement level bedroom.
The entry door on the master room is as I expected, and it is functional.

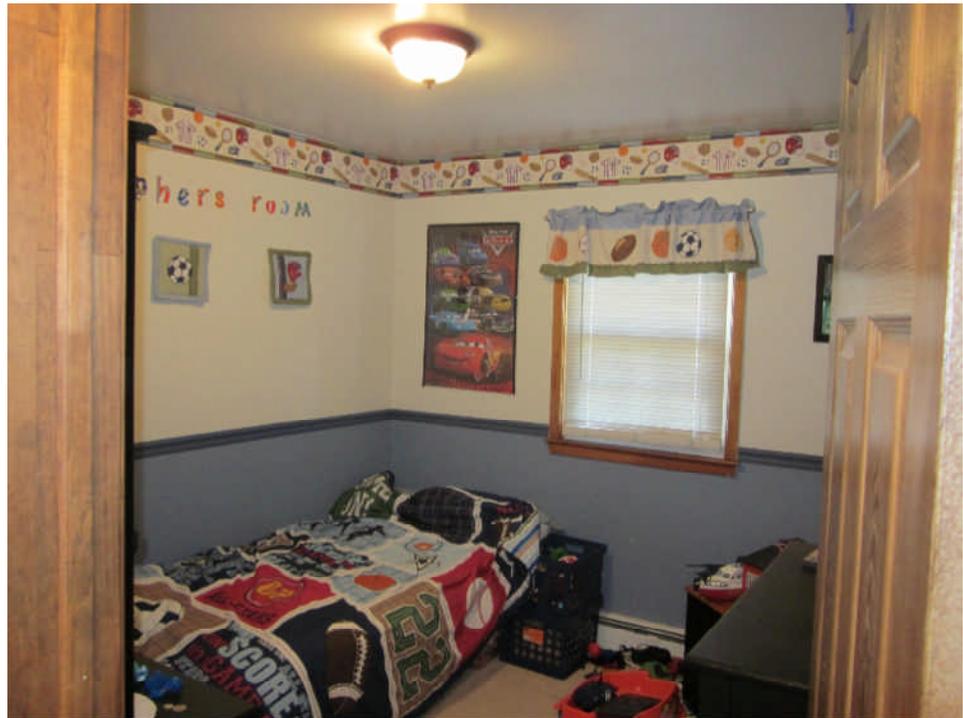
Bedroom #2:
Entry Door:

This is the second floor front center bedroom.
The entry door on this bedroom is as I expected, and it is functional.

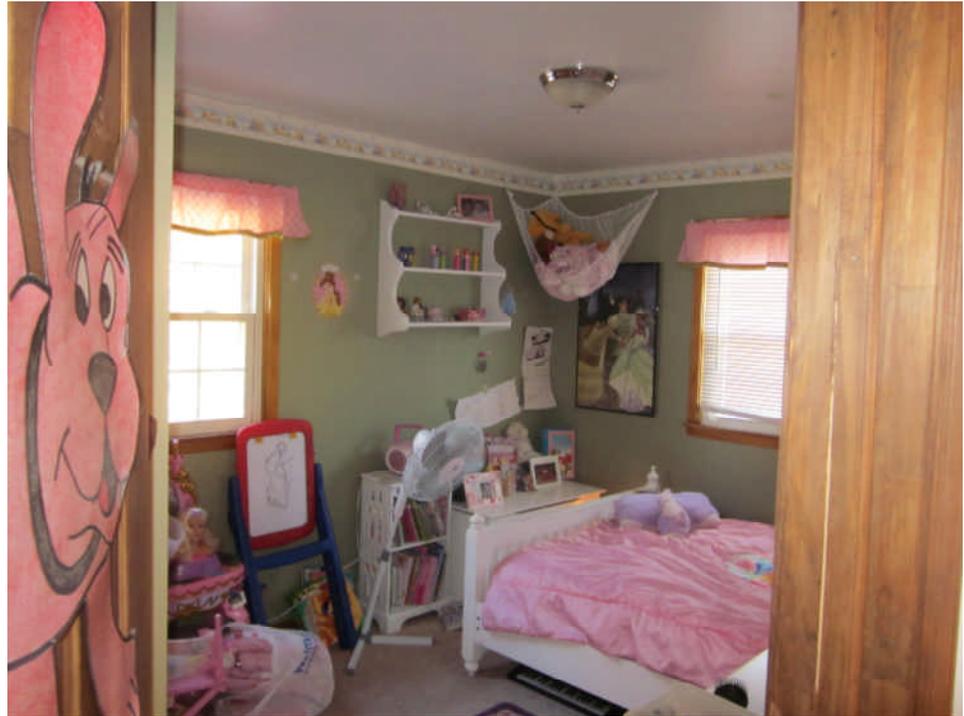
Bedroom #3:
Entry Door:

This is the second floor front right bedroom.
The entry door on this bedroom is as I expected, and it is functional.

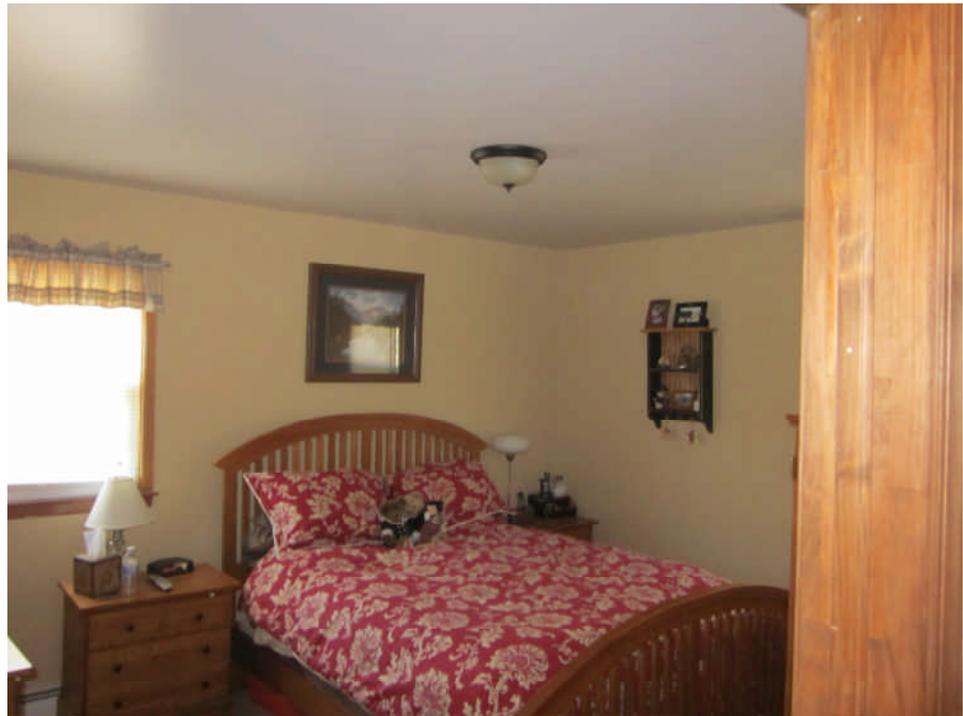
Bedroom #4:
Entry Door:

This is the second floor rear right bedroom.
The entry door on this bedroom is as I expected, and it is functional.

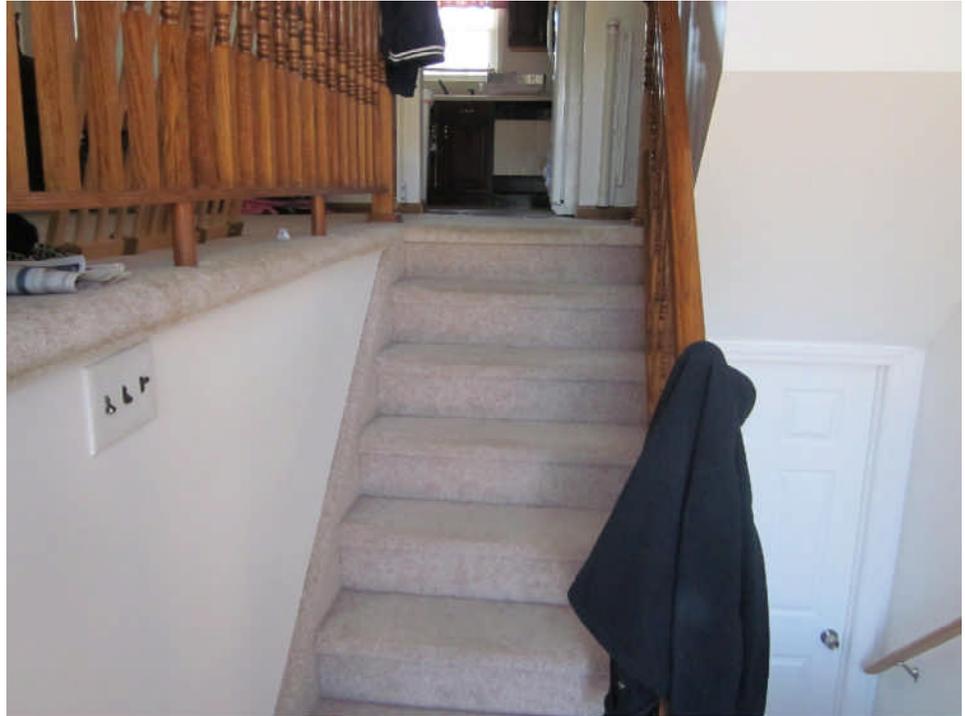
Main Staircase:

The main staircase is appropriately installed.

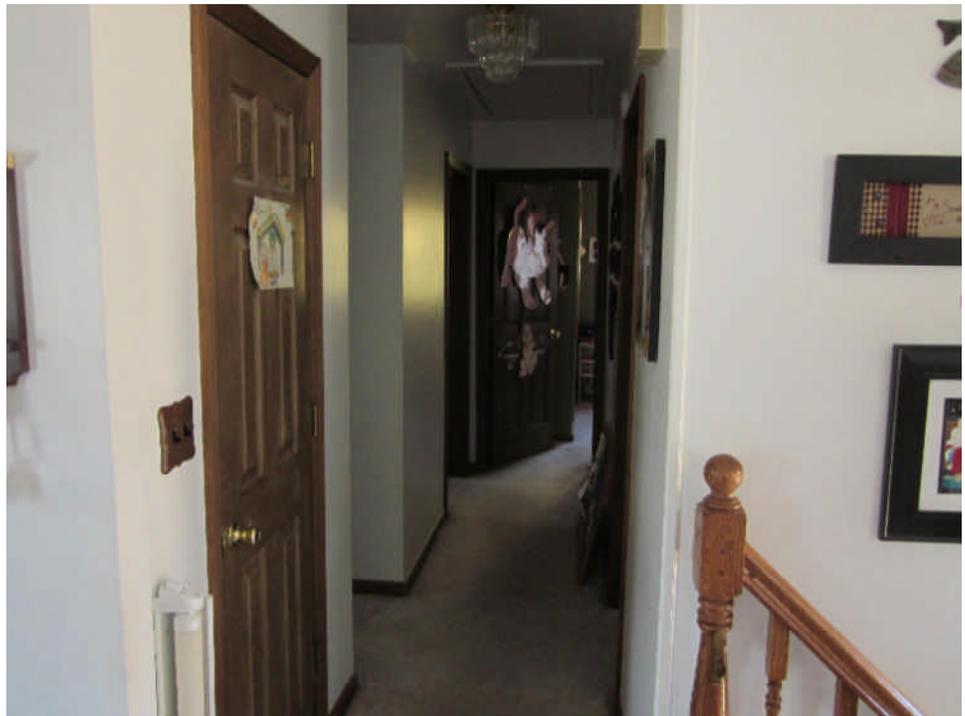
**Upper Level
Hallway:**

The upper level hallway walls and floor are in satisfactory condition.
