# Alamo Cenotaph

## Investigation & Restoration

**Texas Historical Commission Update**  
**SAL Permit #HS 1120**

July 26, 2024

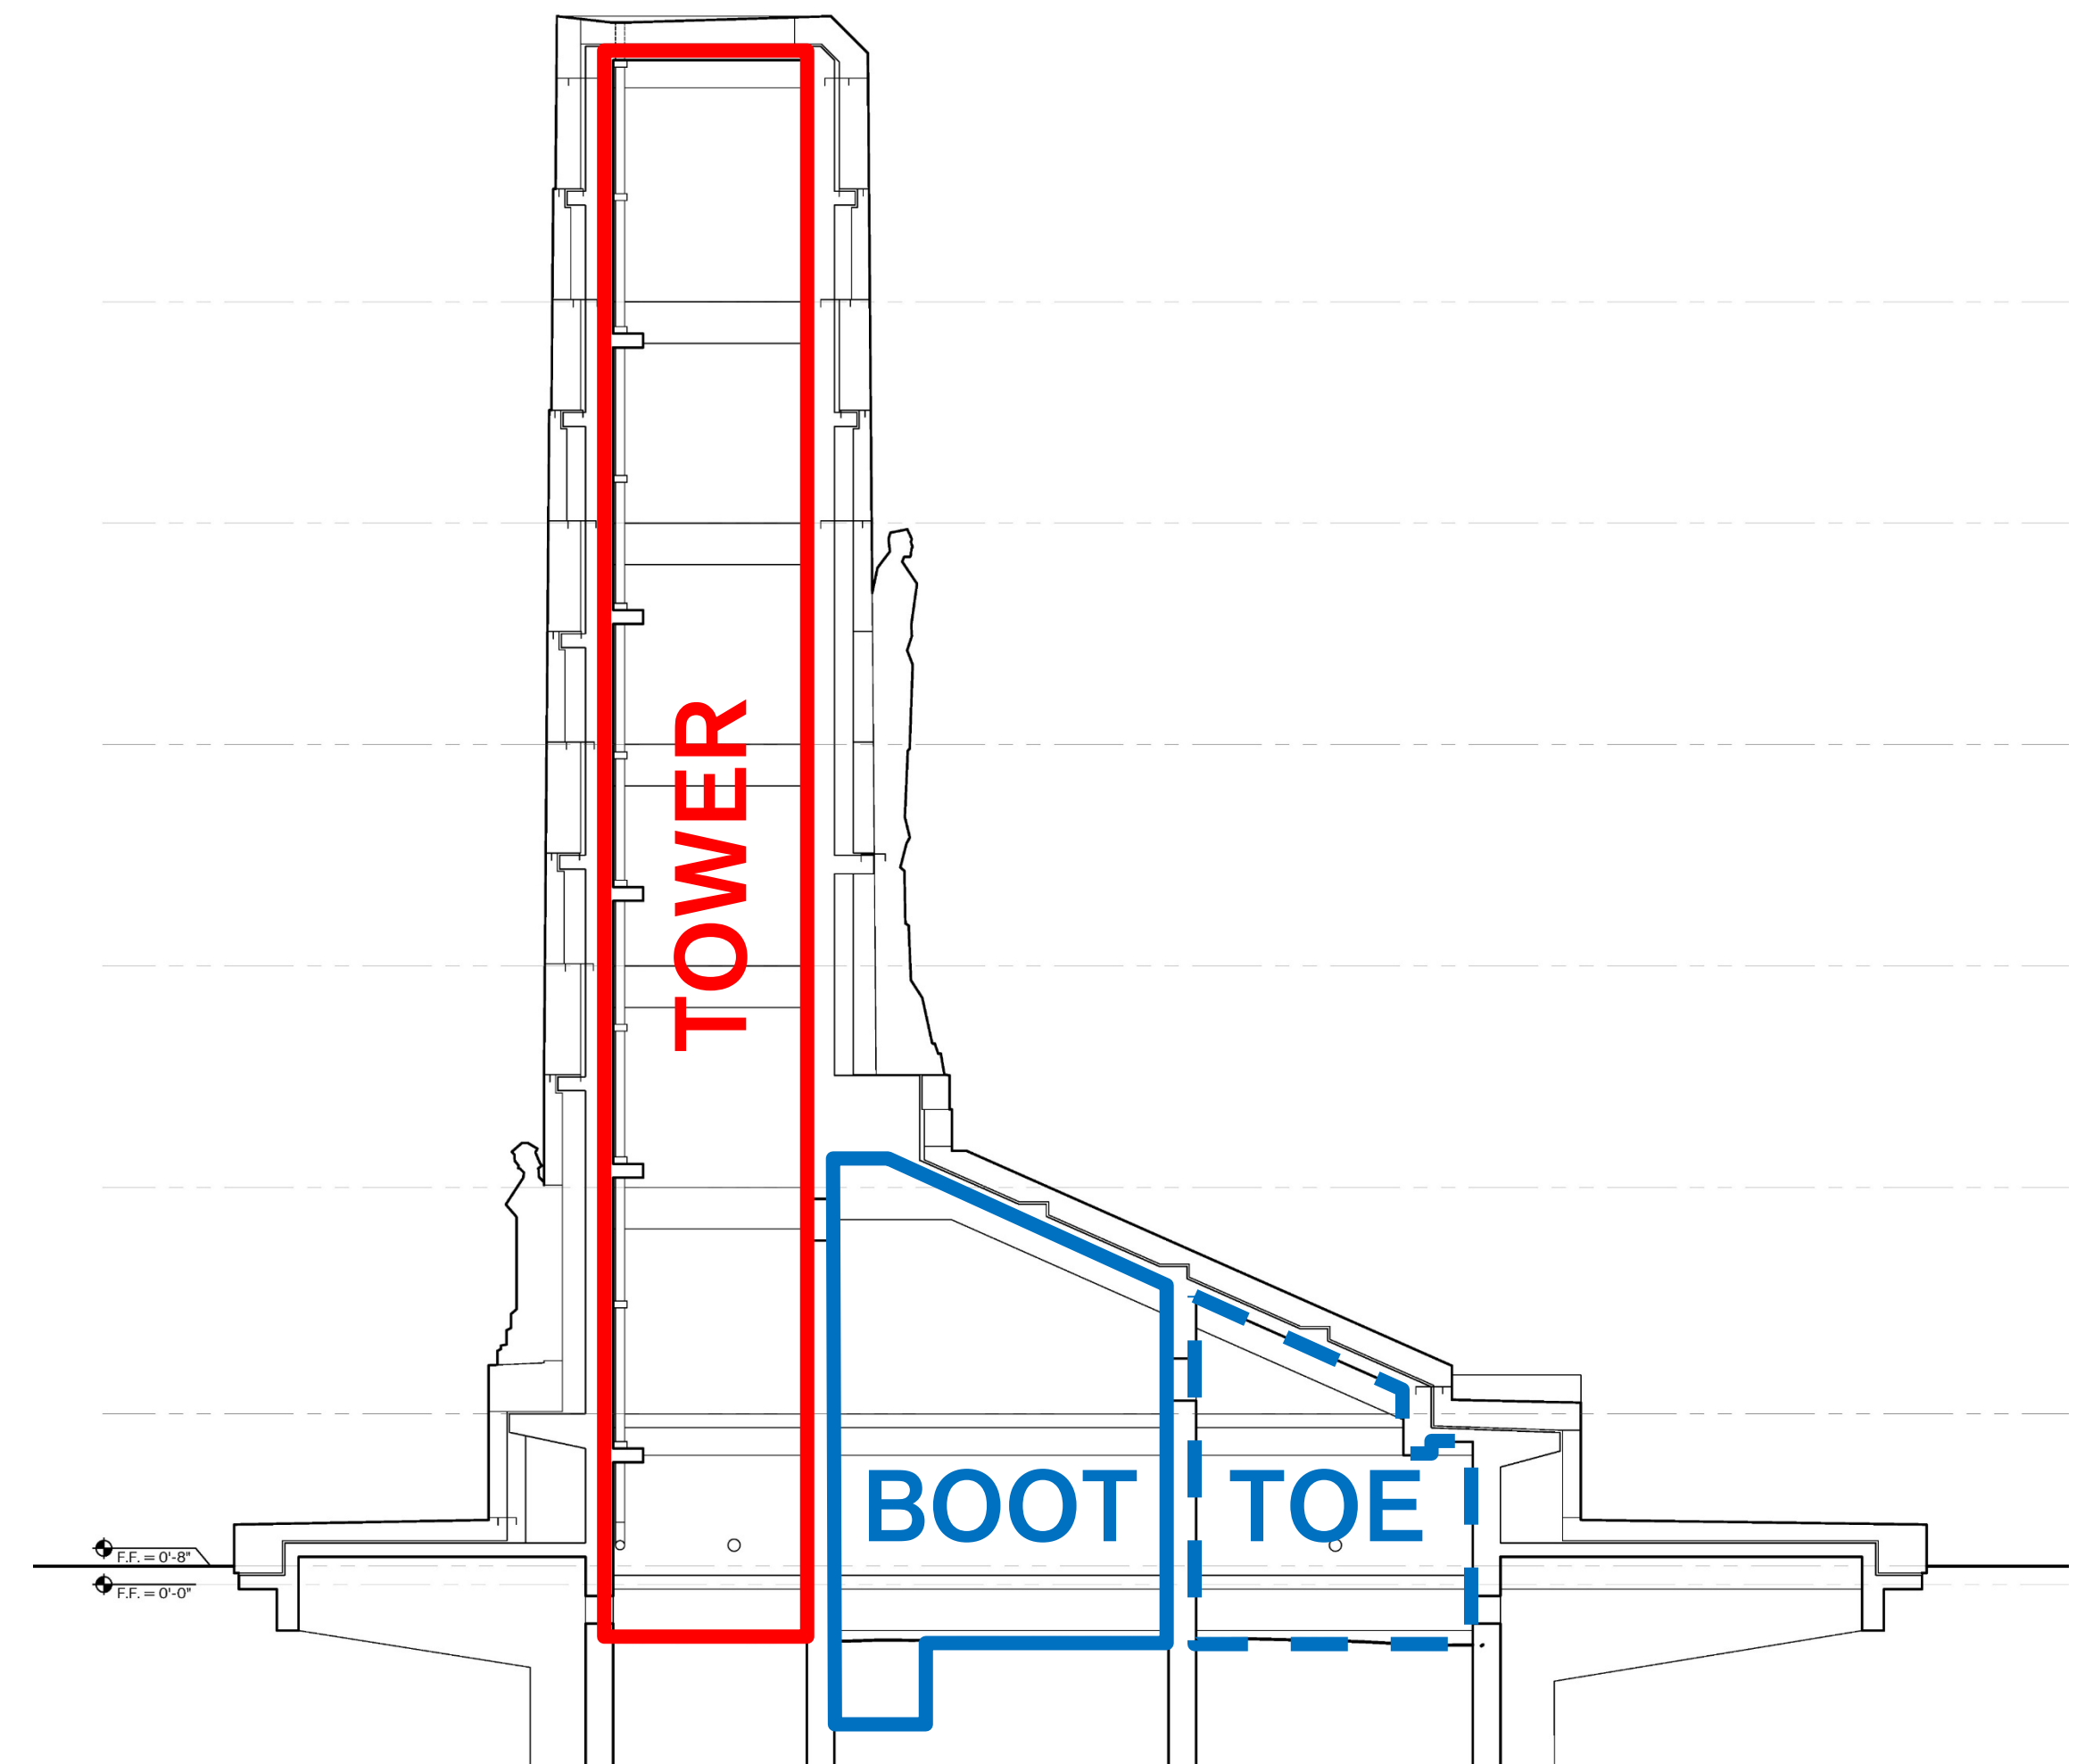
- Access to interior of boot area
- Partial visual access into toe area
- Interior test pit
- Installation of temperature, relative humidity, and CO<sub>2</sub> sensors at tower
- Installation of concrete moisture sensors at boot

*Red = initial investigation, blue = additional investigation*

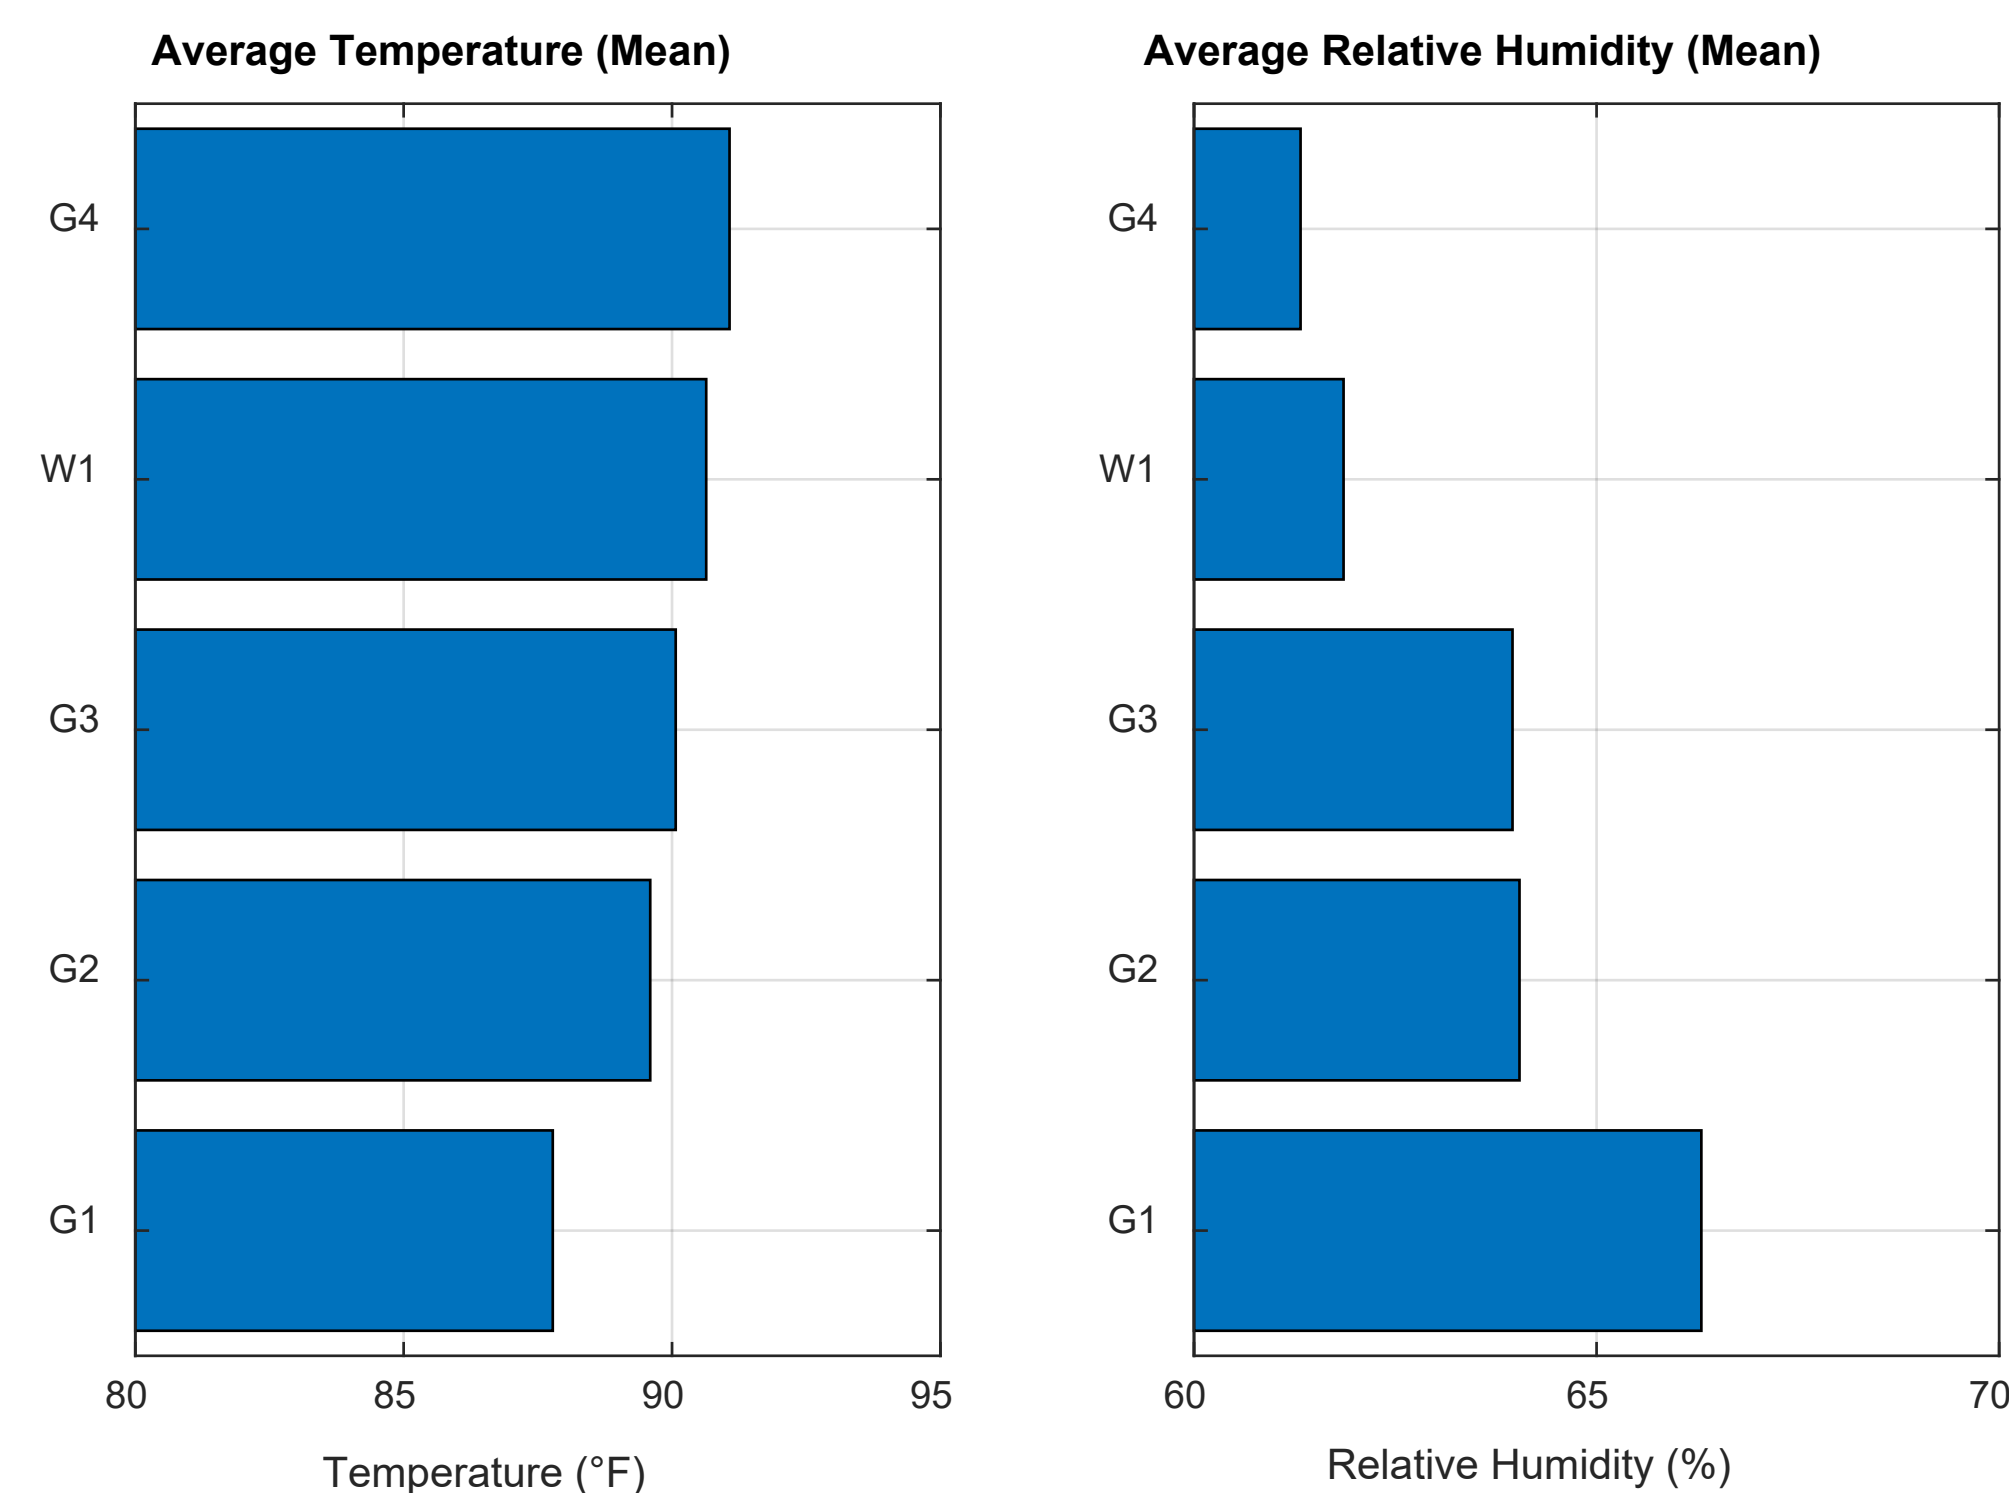
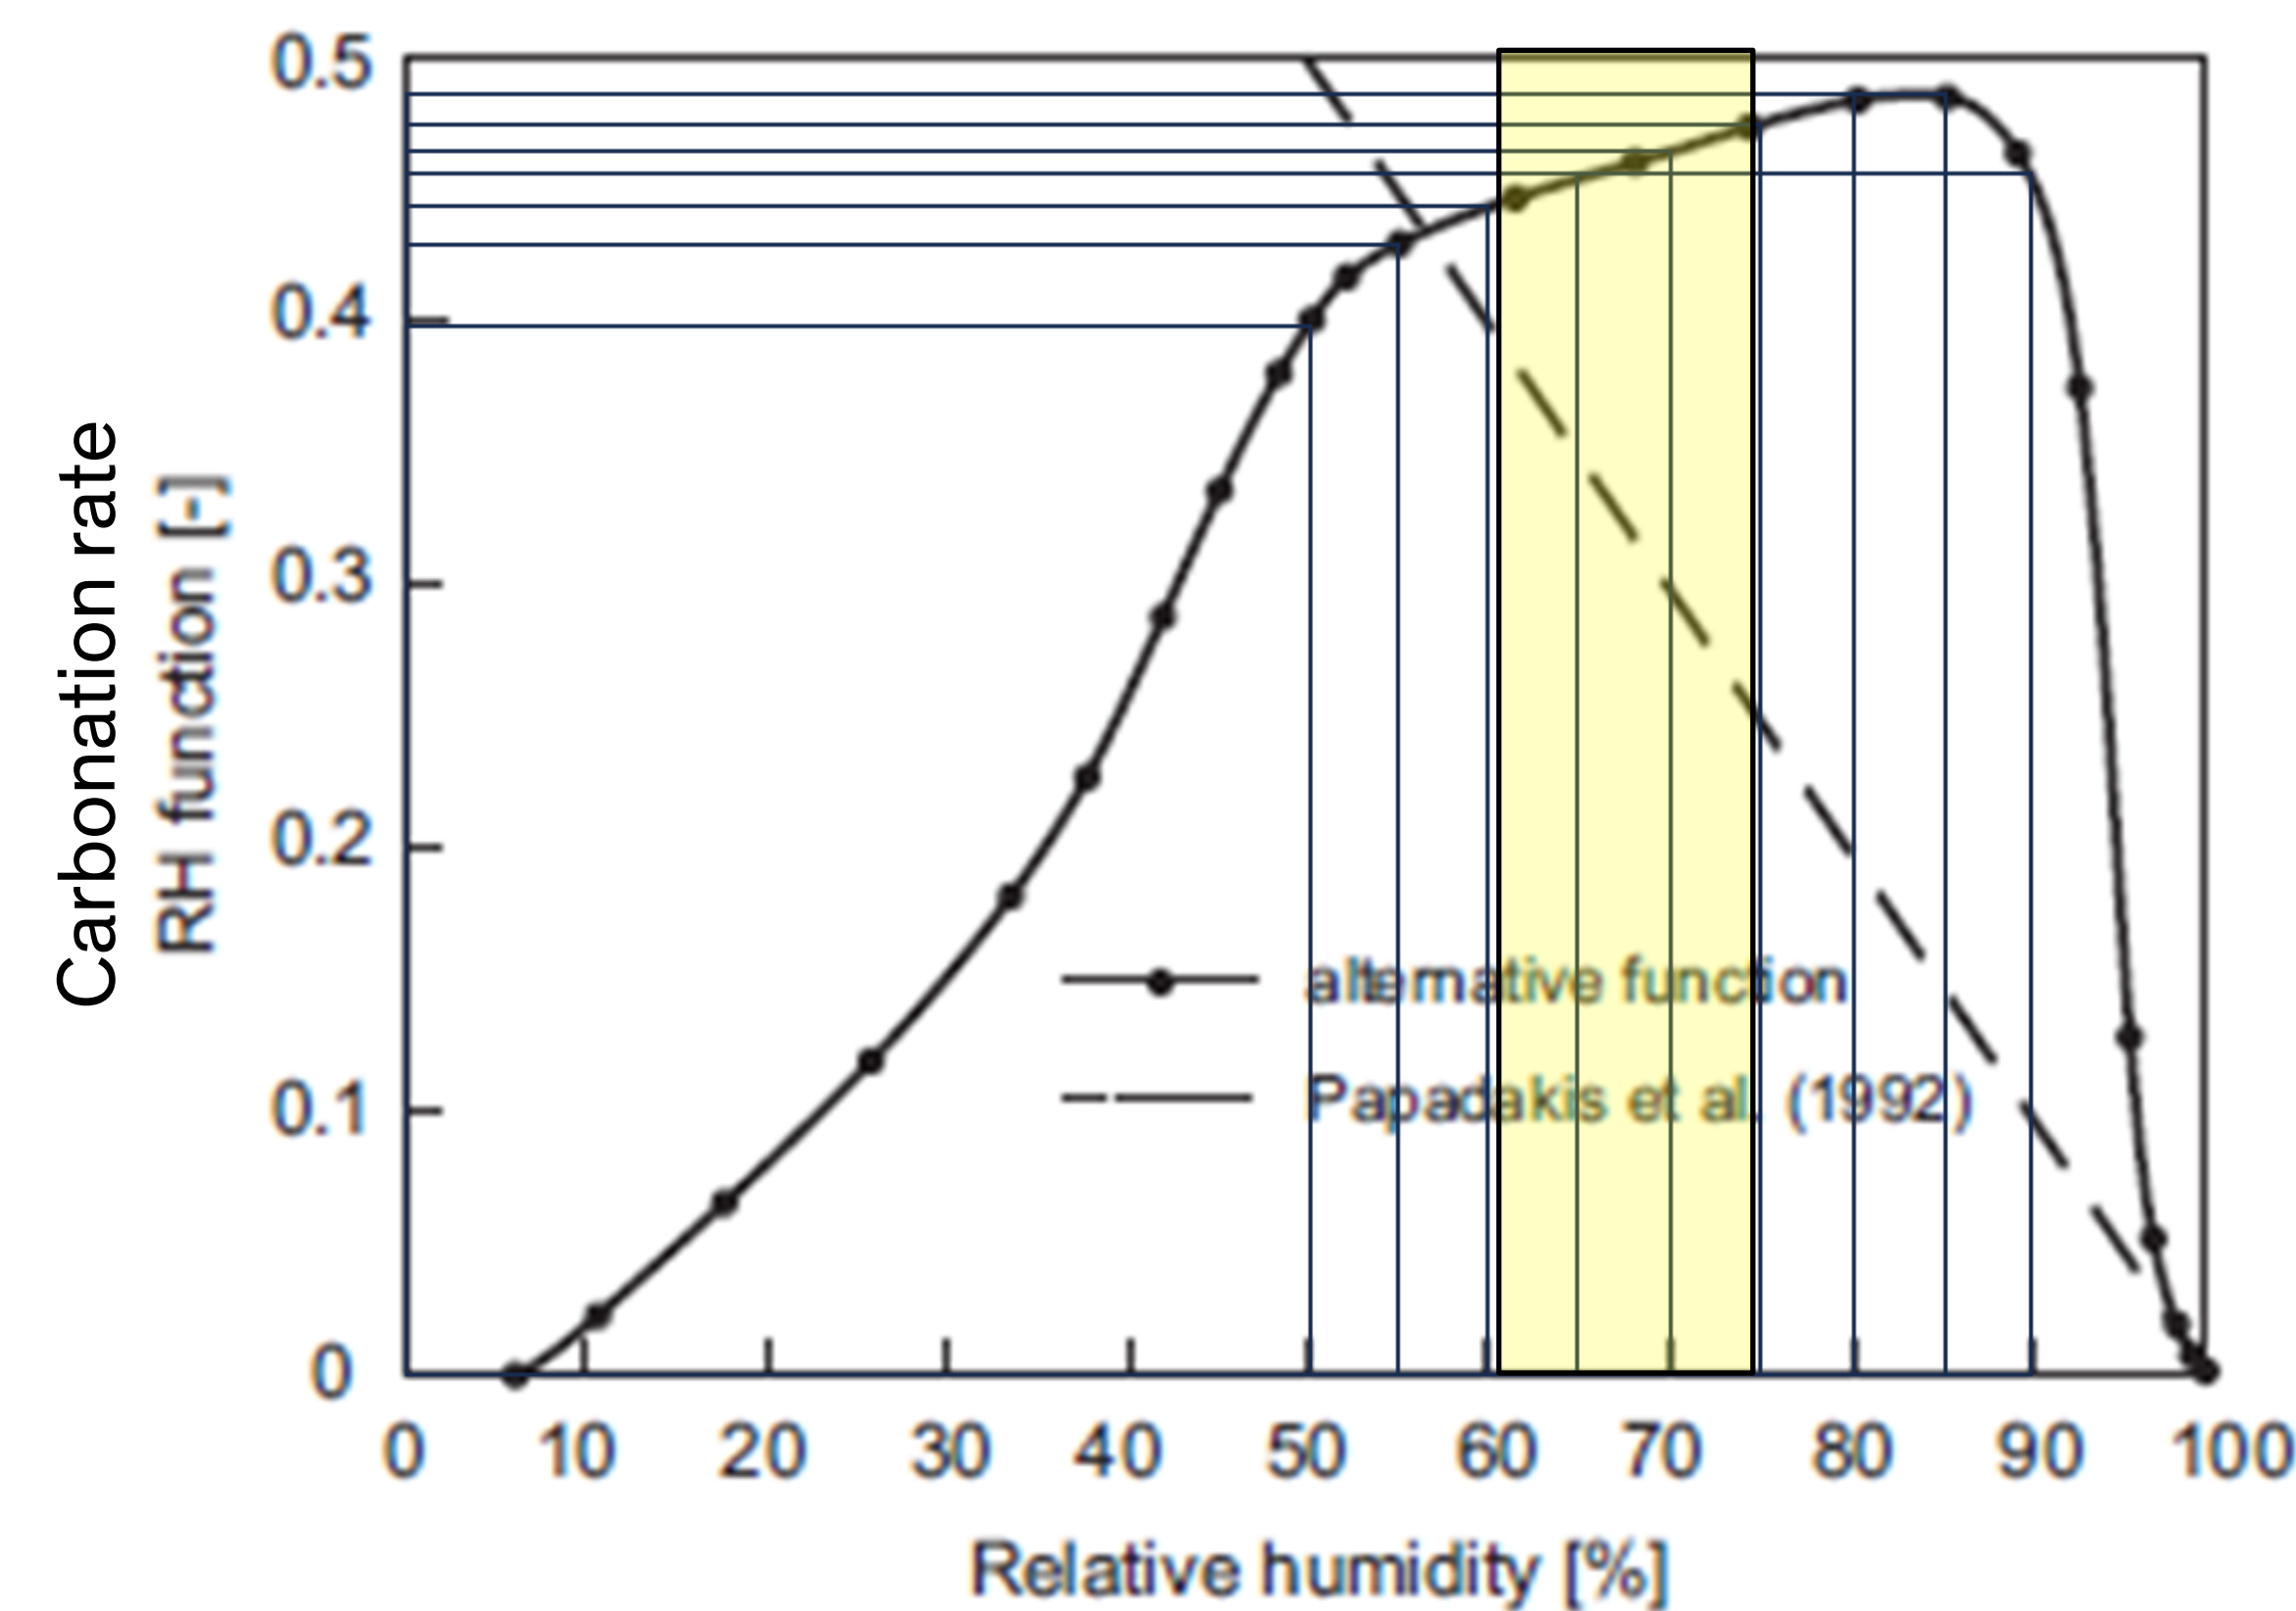
Carbonation rate model

- Temperature and RH fluctuates daily (more fluctuation on top and bottom of tower)
- Higher average temperature at top of tower
- Higher relative humidity at bottom of tower
- Interior CO<sub>2</sub> level higher than average exterior level

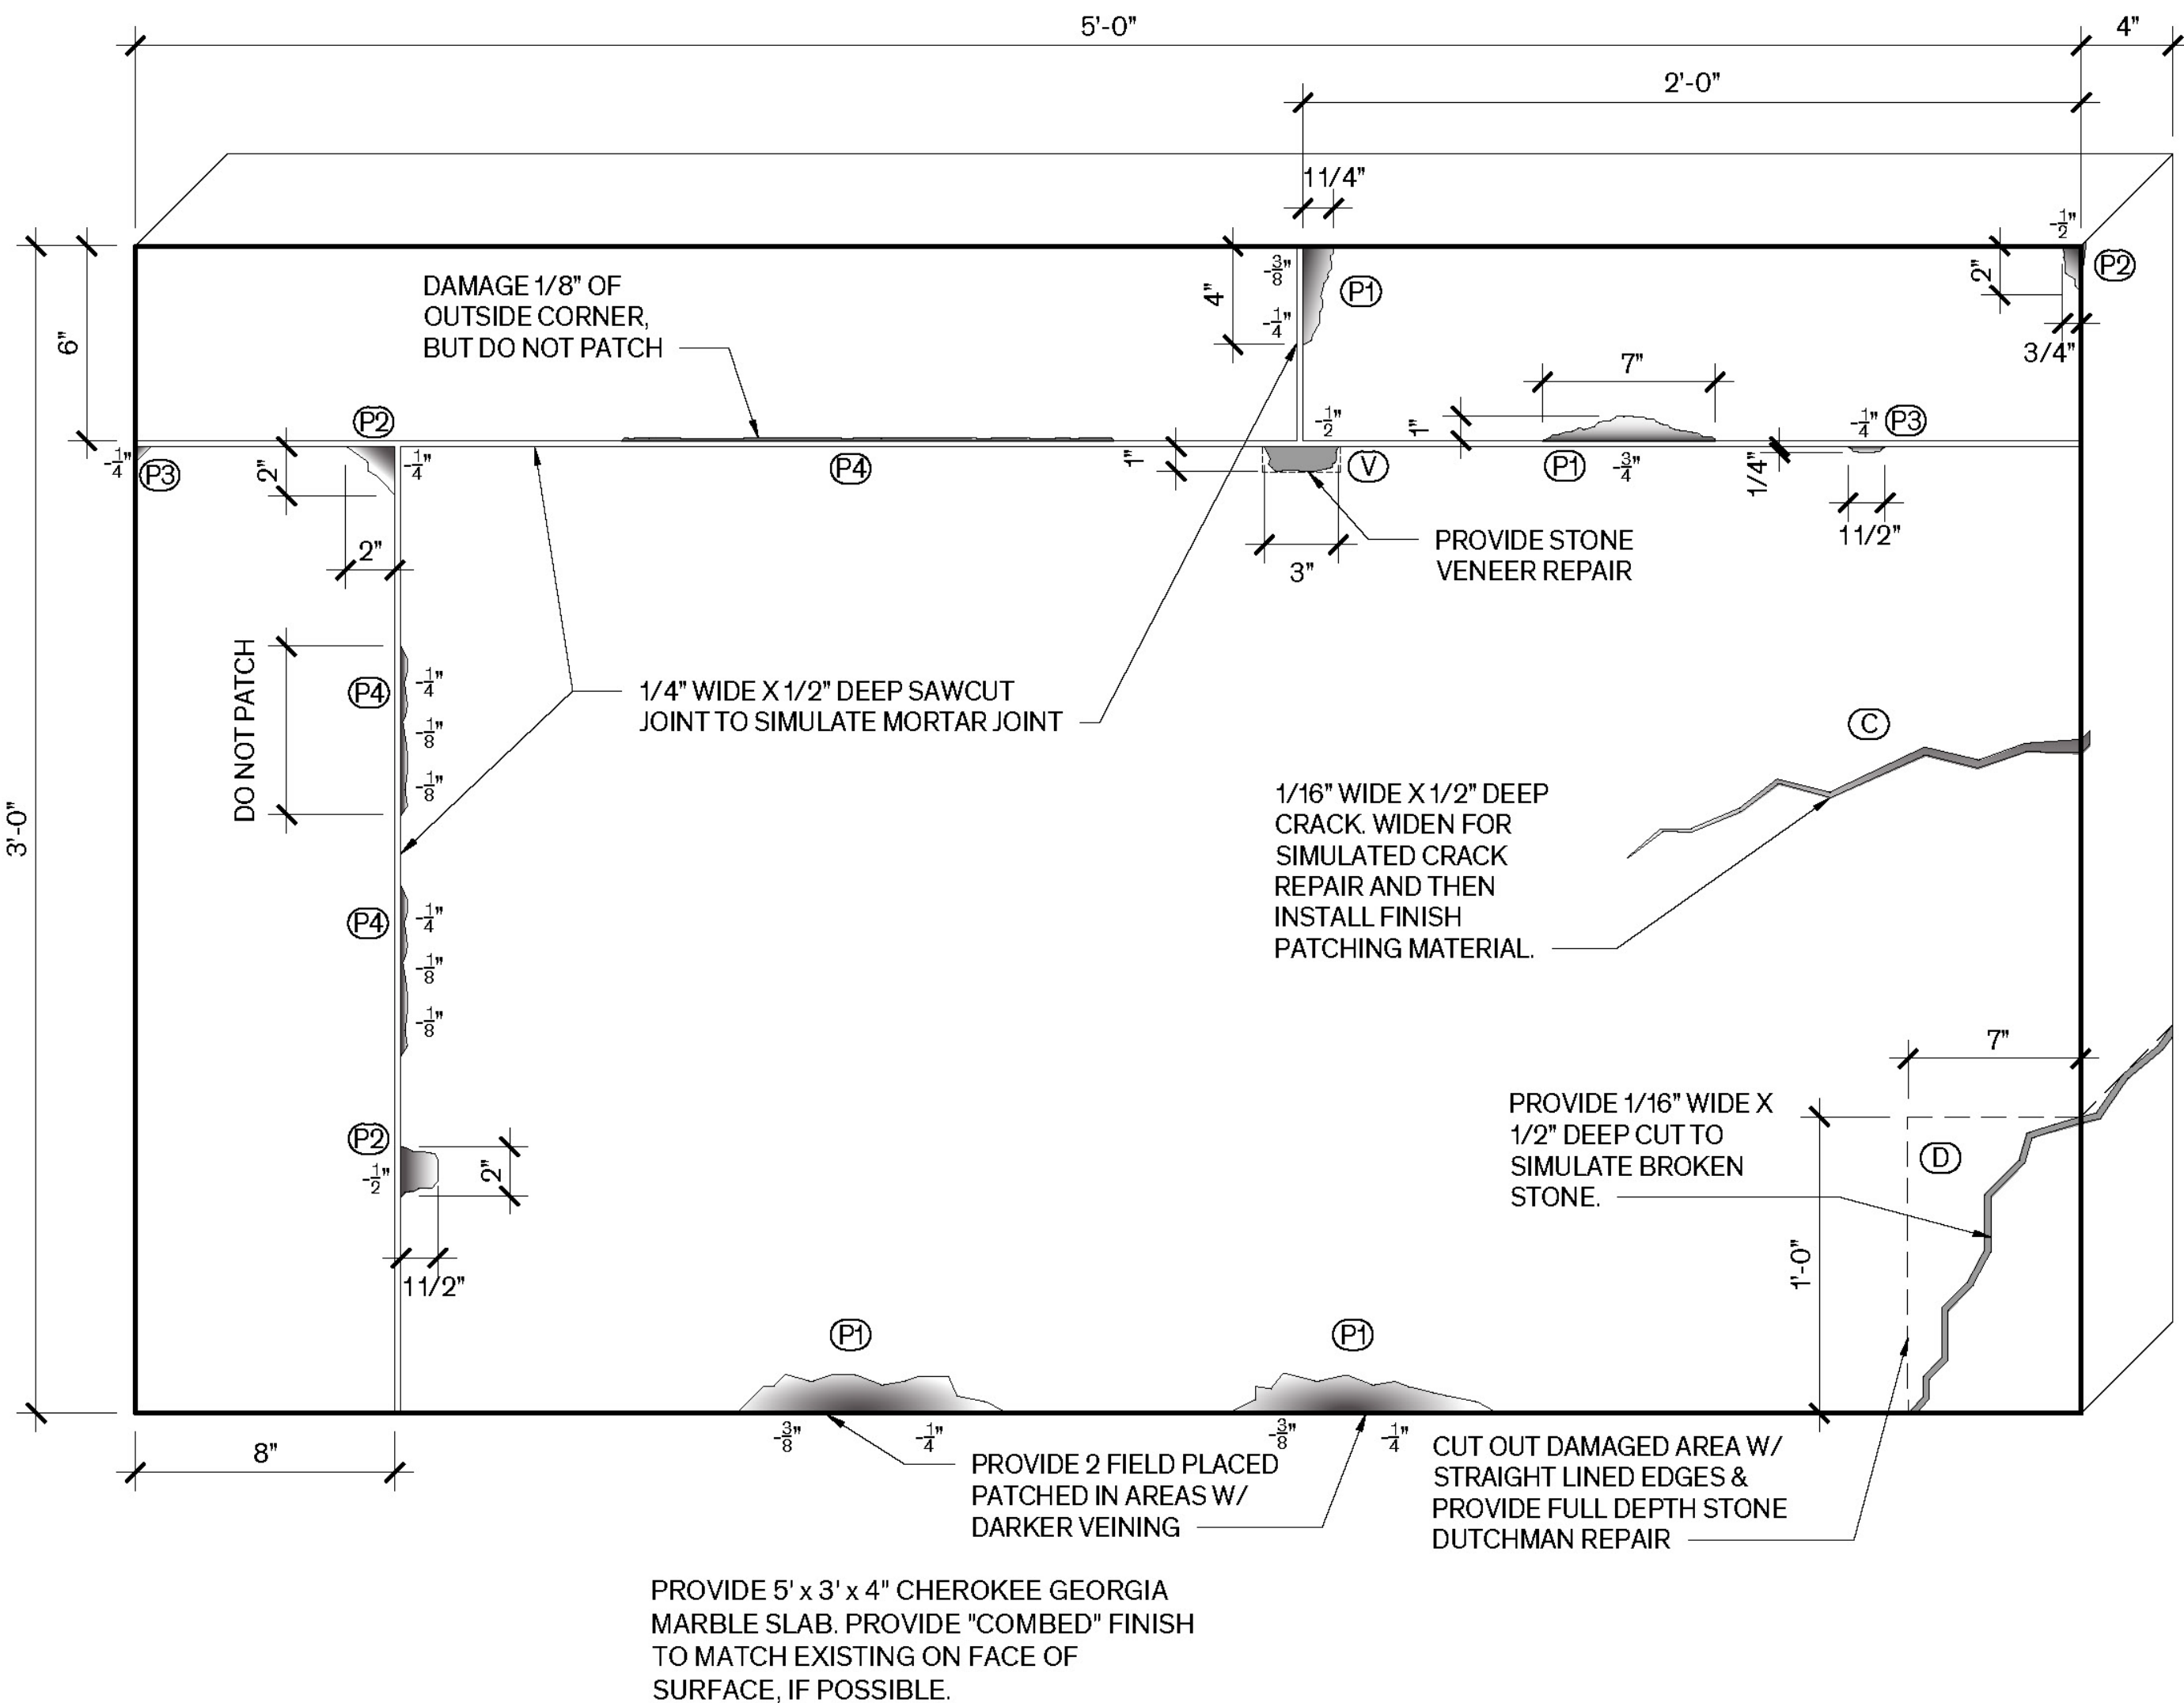
Repair mockup construction drawing

- Marble slab procured from quarry in Georgia that sourced original stone
- Mockup slab will be deliberately damaged and then repaired per restoration recommendations
