REPORT#: 24KY037

REPORT DATE: August 5, 2024

Truck Driver Killed After Semi-Trailer Wheel and Tire Cross Median, Strike Windshield

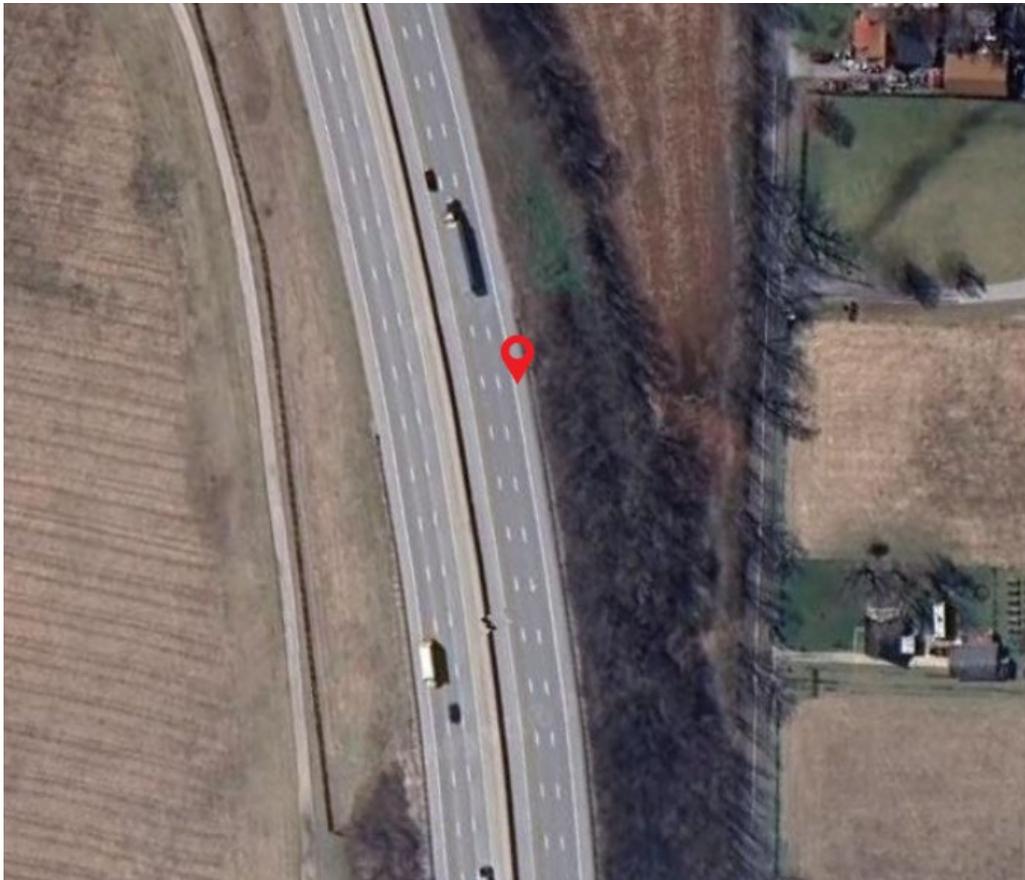
The incident initially began in the southbound lanes of a major six-lane interstate highway with a posted speed limit of 70 miles per hour (photo 1). Northbound and southbound travel lanes are separated by a concrete barrier; a standard W-beam guardrail is positioned on the right shoulder of the southbound lanes. The point of first contact occurred in the far-right lane as the commercial semi-truck and trailer traveled south. After initial contact, the truck veered right, where it struck the guardrail and came to final rest on the shoulder of the interstate (photo 2).

Photo 1. Overhead Google Earth image of Kentucky interstate where the incident occurred. Red location maker indicates approximate location of final rest.

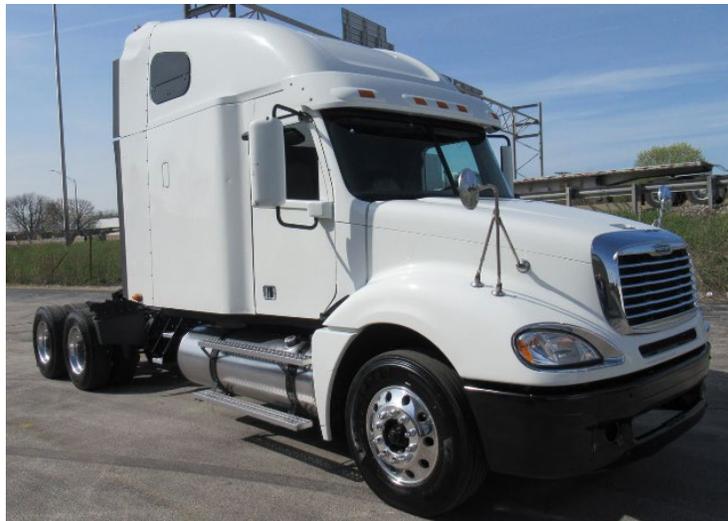
The victim was operating a 2016 Freightliner Columbia semi-truck with a 2015 Walker food-grade tank trailer in tow (photos 3 & 4).

Photo 3. Google image of a 2016 Freightliner Columbia semi-truck similar to the truck involved in the incident. Photo obtained via Google search on June 10, 2024.

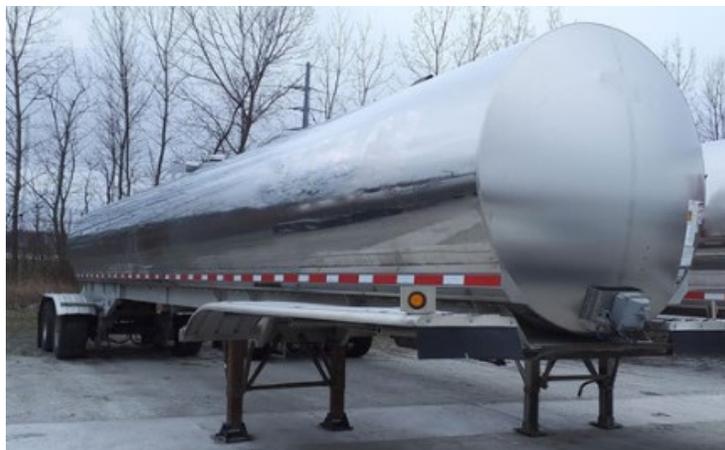
Photo 4. Google image of a 2015 Walker tank trailer similar to the trailer involved in the incident. Photo obtained via Google search on June 10, 2024.
