Property Inspection Report

1234 Channing Way, Exeter, CA, 93221

Date of Inspection: 5/4/2022

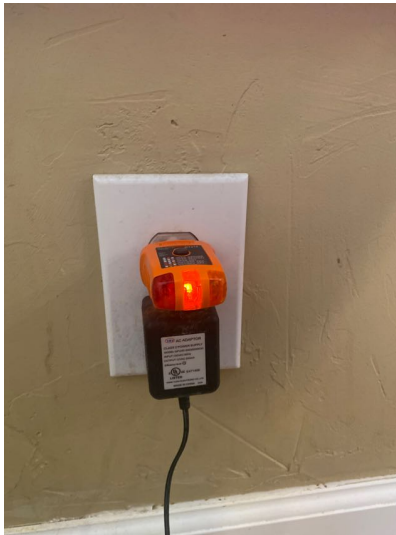
East wall

- An electrical outlet in this room had an open ground. This outlet should be corrected by qualified professional.

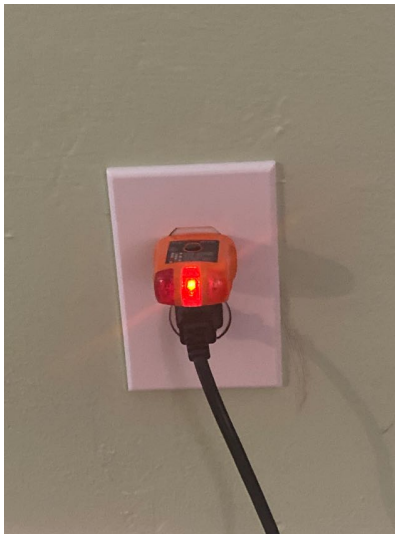
West wall

- All three prong electrical outlets in this room had an open ground. This outlet should be corrected by qualified professional.

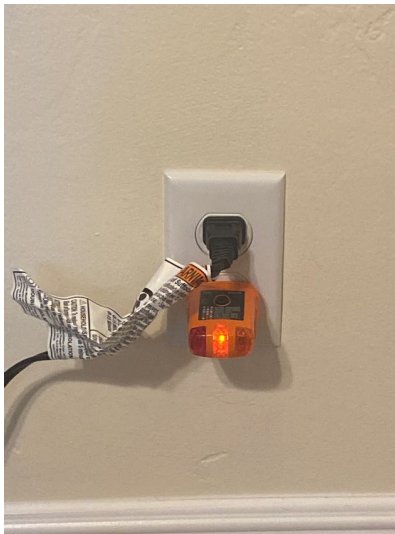
East wall

- All three prong electrical outlets in this room had an open ground. This outlet should be corrected by qualified professional.

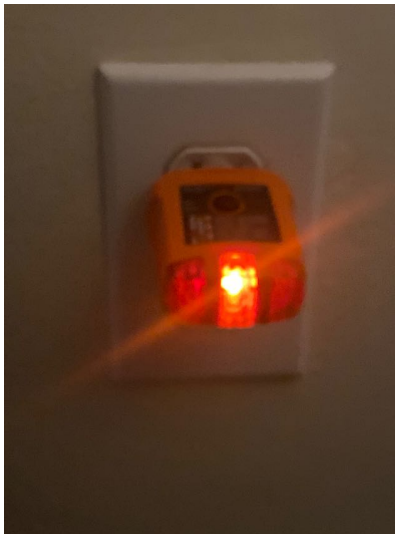
East wall

- All three prong electrical outlets in this room had an open ground. This outlet should be corrected by qualified professional.

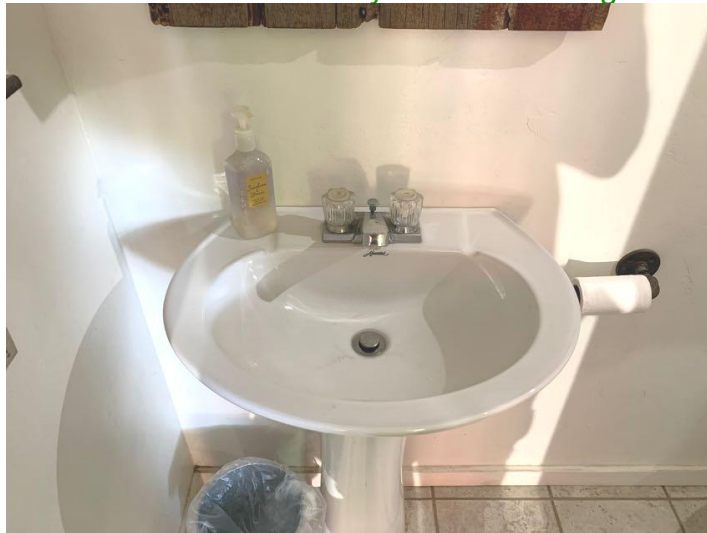
- Bathroom sink is connected to cold water only and runs through the hot water tap.

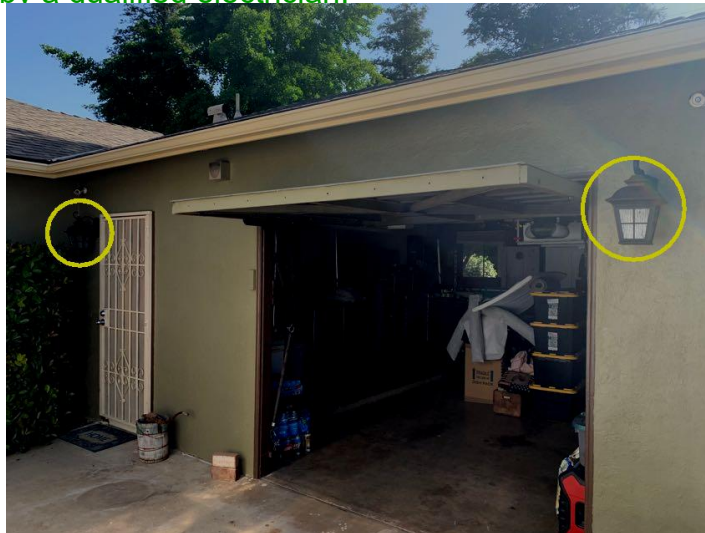
- Exterior light on locations listed by pictures did not operate. This condition can be caused by daylight sensors, burned out or missing bulbs. You should re-test any inoperable light fixtures after replacing the bulbs. If after bulb replacement the lights still fail to respond to the switch, consider evaluation by a qualified electrician.

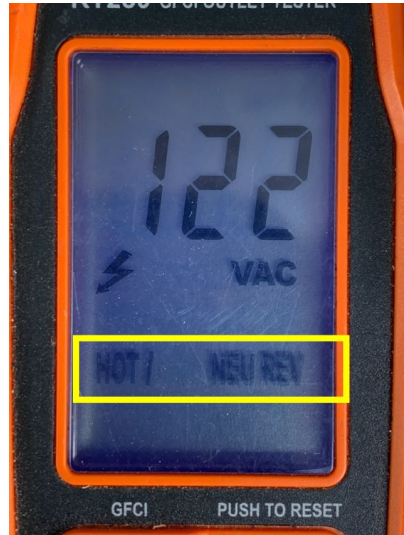
Back patio

- Most electrical outlets in back patio area had open grounds. This is likely due to original outlets being ungrounded two prong types and outlets being replaced with three prong type.
- An electrical outlet on south side of structure had hot and neutral wires reversed. We suggest further investigation and repairs as needed by a qualified professional.

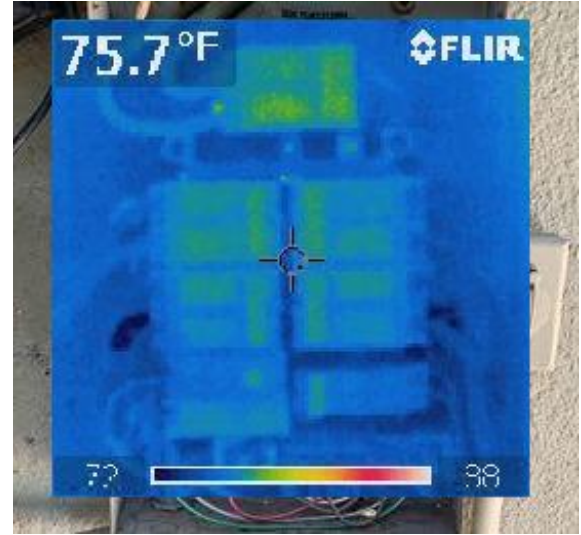
- White wire observed landed on 30 amp breaker at right side of the panel. The white wires normally used in a neutral circuit, not attached to the powered side as installed. We suggest properly marking this wire to avoid possible confusion in the future.

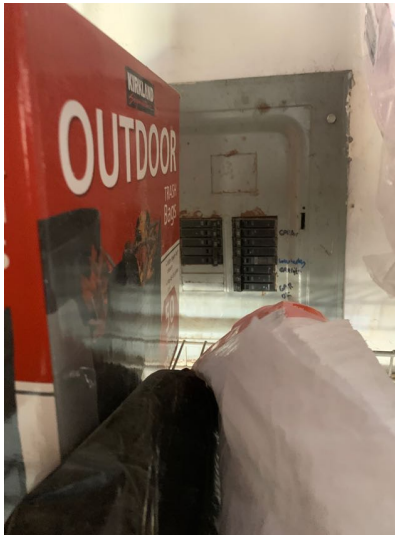
- The inspectors were unable to access the sub panel due to placement of shelving.

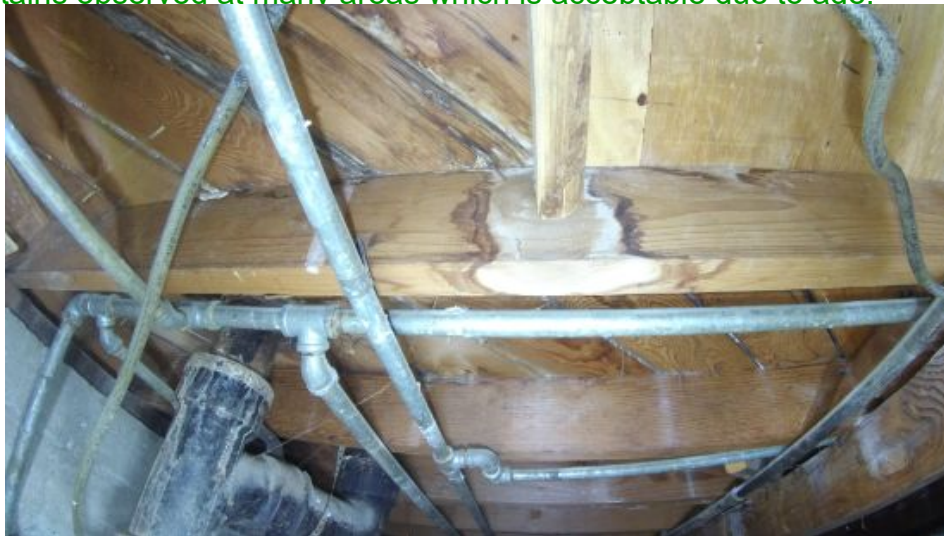
- Moisture stains observed at many areas which is acceptable due to age.

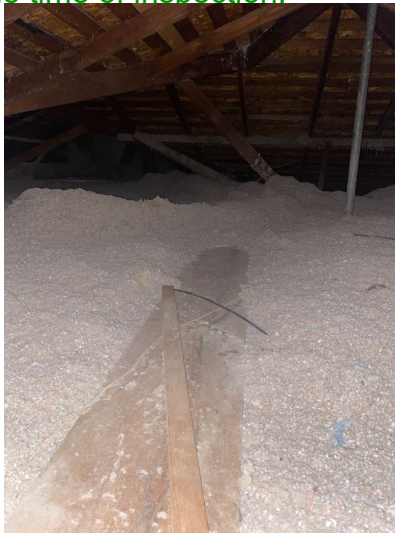
- Attic insulation thickness was approximately 10 to 12 inches. The modern recommended value is R-38.

- Insulation good condition at the time of inspection.

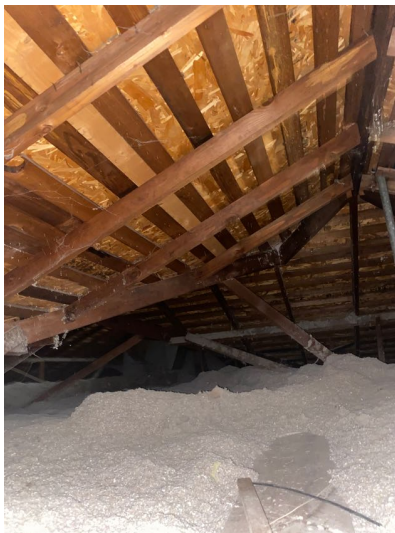
- Structure OK at time of inspection.

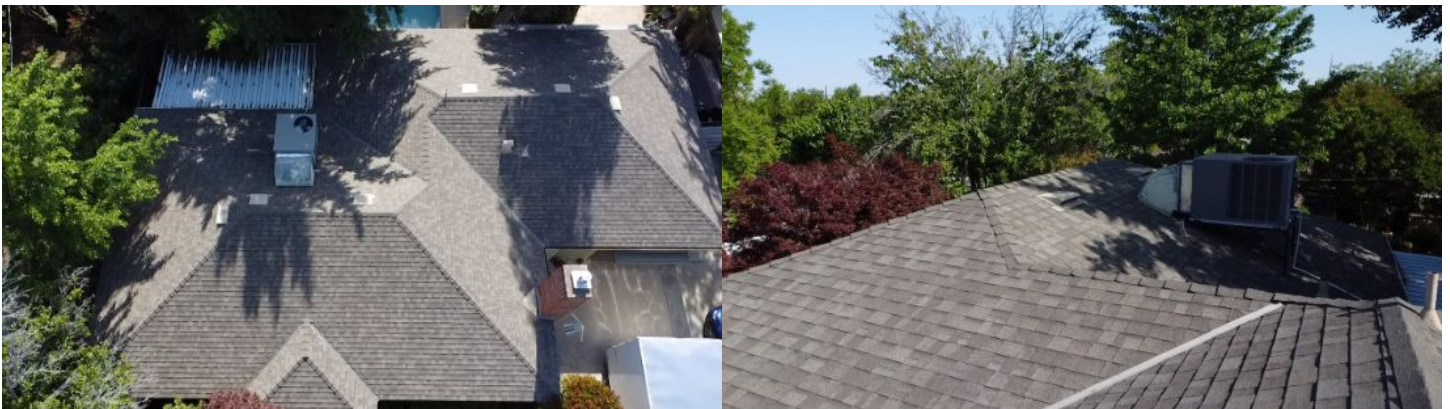
- Asphalt composition shingles covering the roof of this home appeared to be in serviceable condition at the time of the inspection.

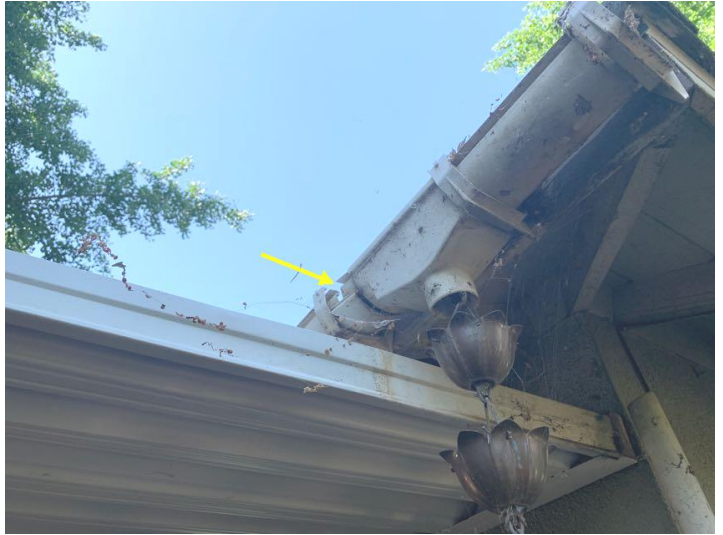
North east corner of structure

- A downspout on west side of structure was missing at the time of the inspection. This condition may cause problems by introducing excessive amounts of moisture to the soil beneath the foundation. Excessive moisture near the foundation can result in structural failure due to foundation movement or moisture intrusion with the potential to cause structural damage from decay. Moisture intrusion can also cause the development of unhealthy conditions in indoor air related to microbial growth such as mold fungi. The Inspector recommends replacement of any missing downspouts to help protect the home structure and occupants. We suggest further investigation and repairs as needed by a qualified professional.
- Gutter joint at northeast corner of structure was disconnected which will not allow proper drainage. We suggest further investigation and repairs as needed by a qualified professional.

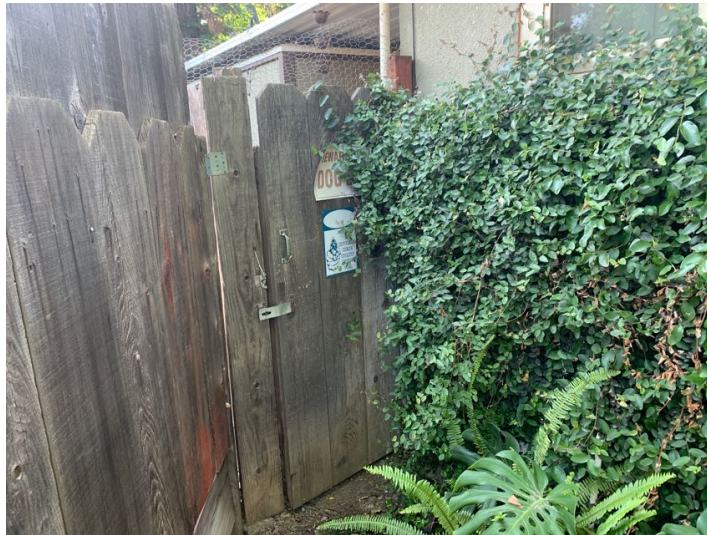
North yard gate

- Gate on North side of yard is hard to latch and in need of adjustment at the time of inspection to operate freely.

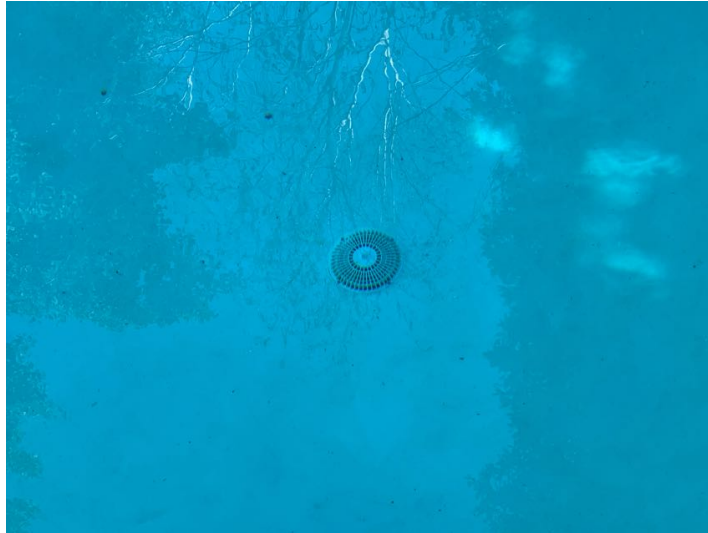
- Anti-entrapment drain cover installed.

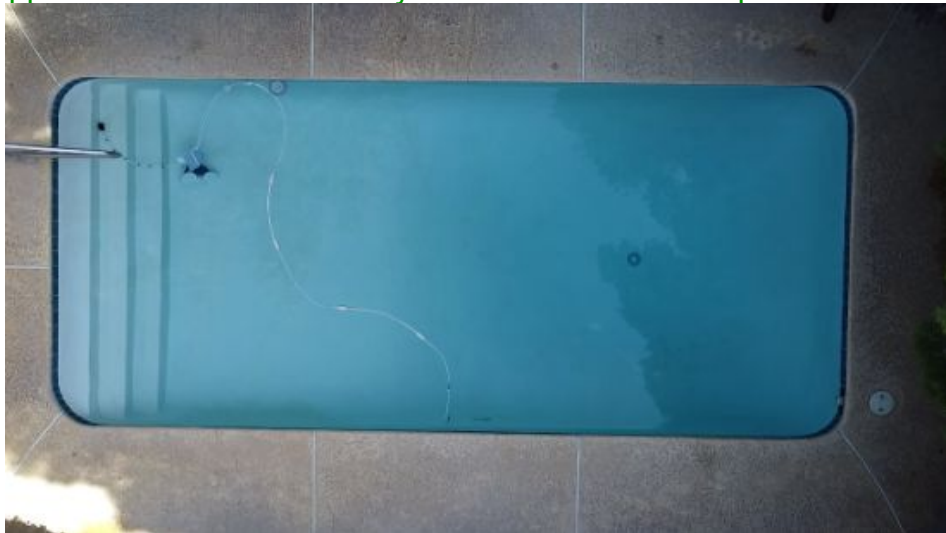
- Structure appeared to be in satisfactory condition at time of inspection.

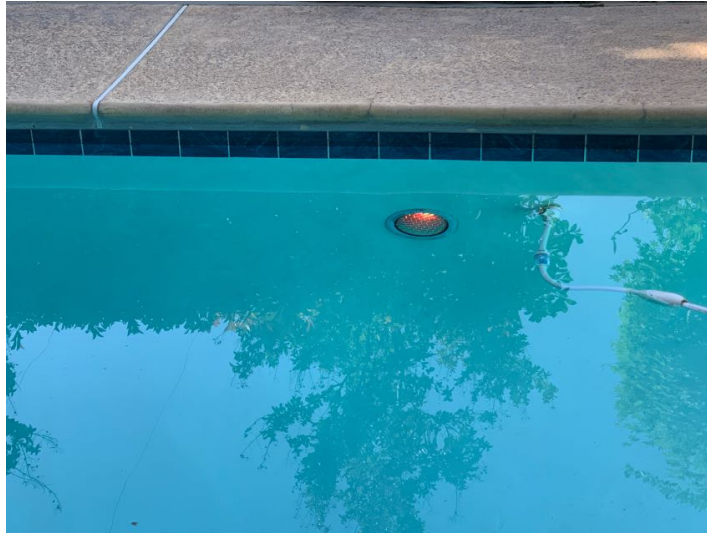
- Lights were operated at the time of the inspection.

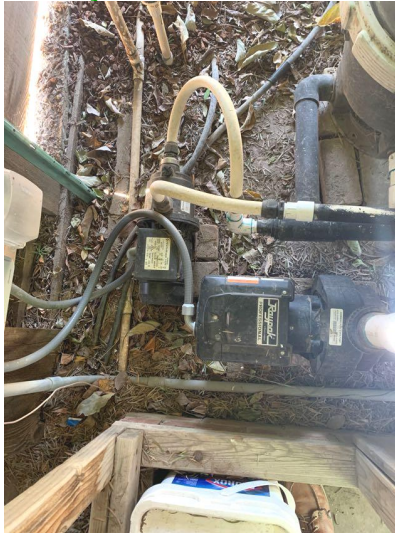
- Pumps appeared to be in satisfactory condition and was operated at time of inspection.

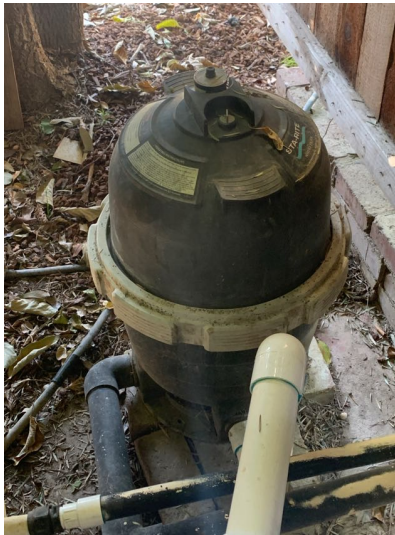
- Filter appeared to be in satisfactory condition at time of inspection.

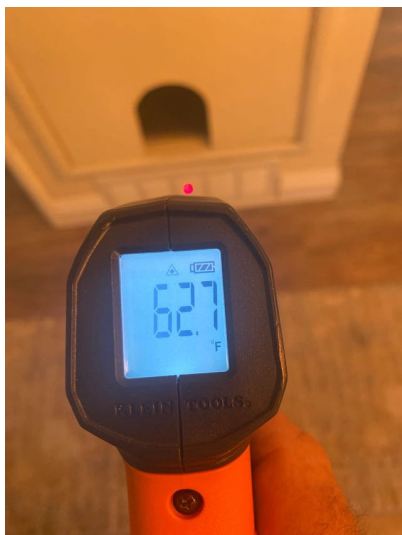
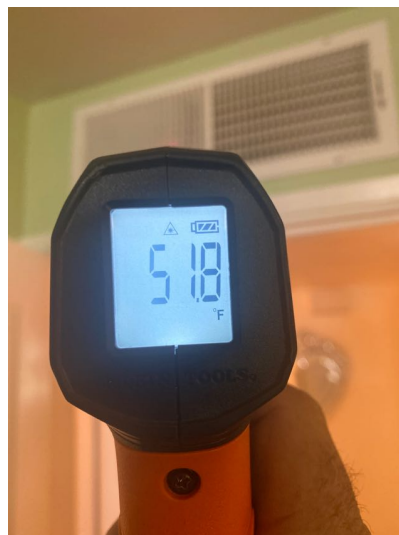
- The differences in air temperature measured at supply and return registers fell within the acceptable range of between 10 and 22 degrees Fahrenheit.

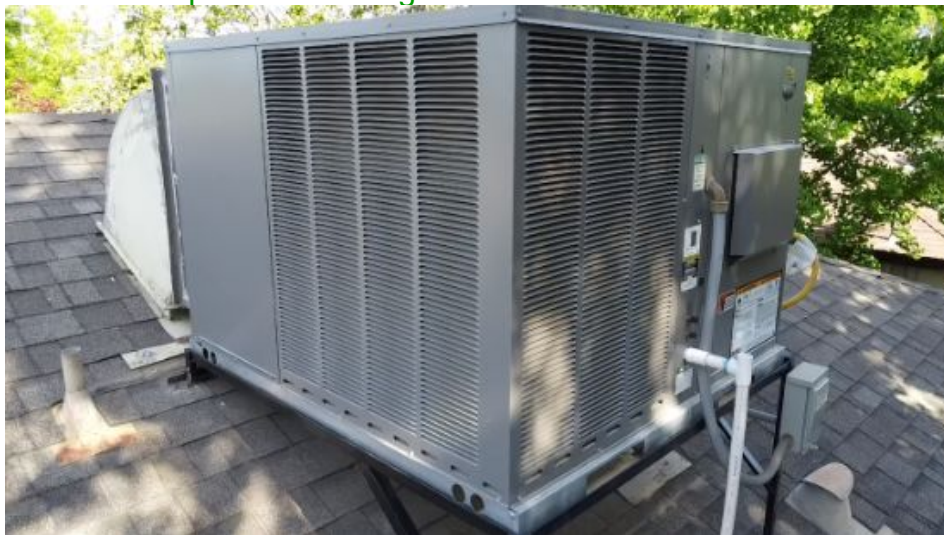
- The air-conditioner compressor housing was located on the roof of the home to the East.

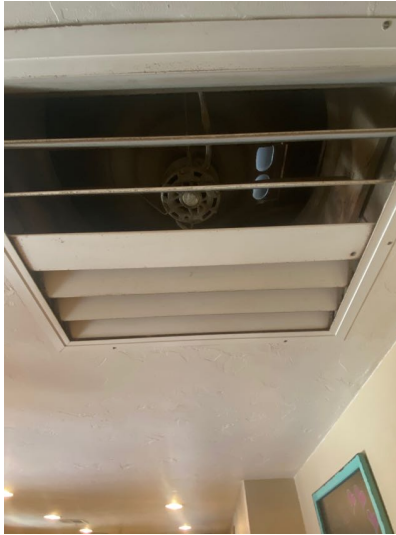
- The whole-house responded to the switch in a satisfactory manner at the time of the inspection.

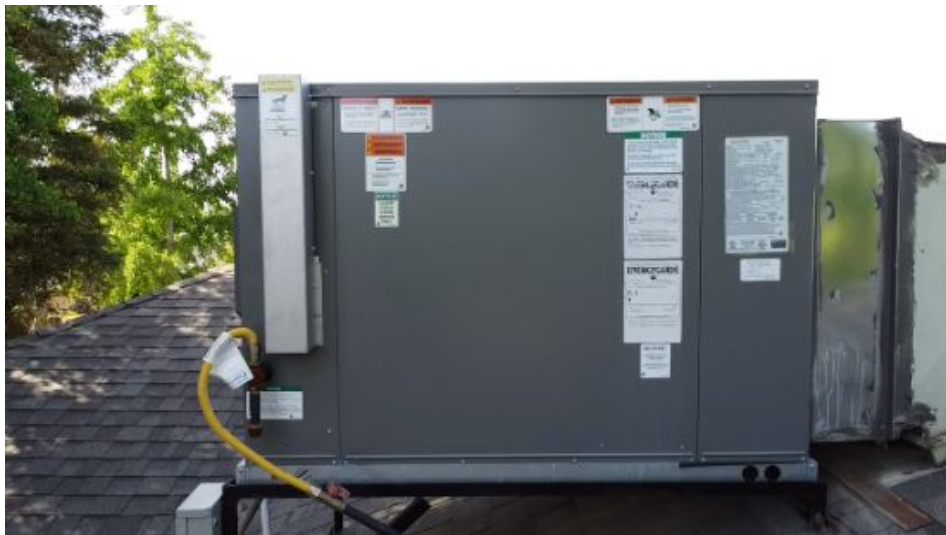
- The heater cabinet exterior appeared to be in serviceable condition at the time of the inspection.
