Property Inspection Report

1234 W Fedora Ave, Fresno, CA, 93705

Date of Inspection: 11/22/2022

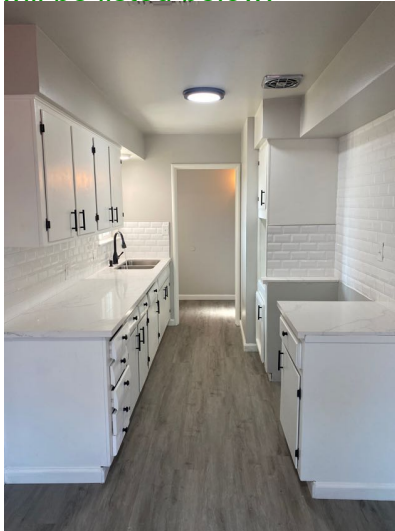
Observations: This room appeared to be in generally serviceable condition at the time of the inspection. Notable exceptions will be listed below.

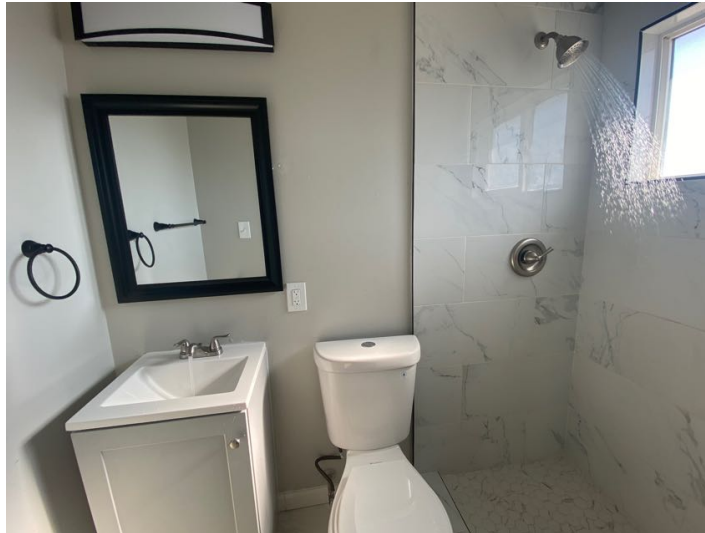
- This room appeared to be in generally serviceable condition at the time of the inspection. Notable exceptions will be listed below.

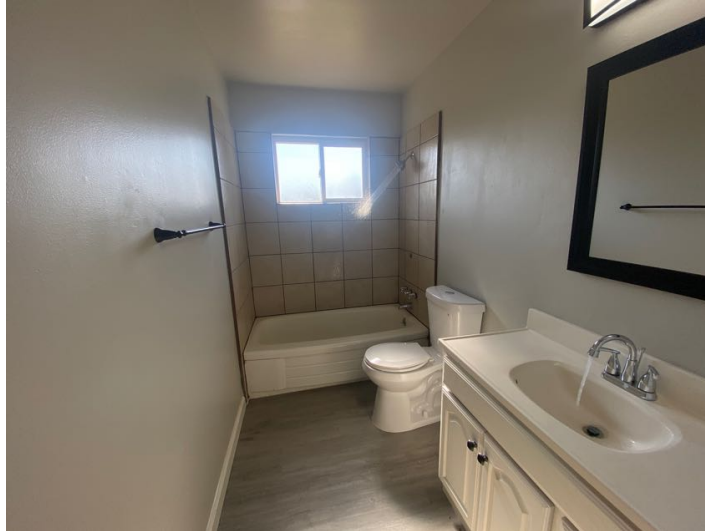
- This room appeared to be in generally serviceable condition at the time of the inspection. Notable exceptions will be listed below.

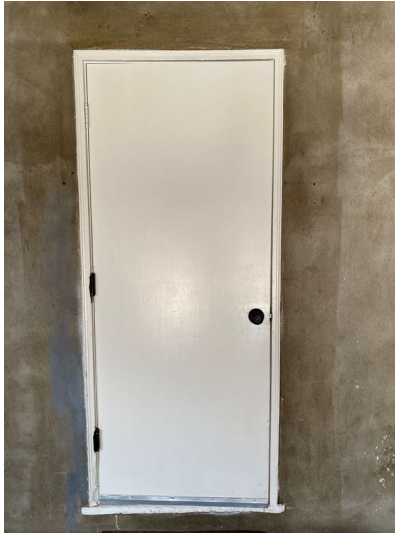
- Fire door appeared to be in serviceable condition at time of inspection.

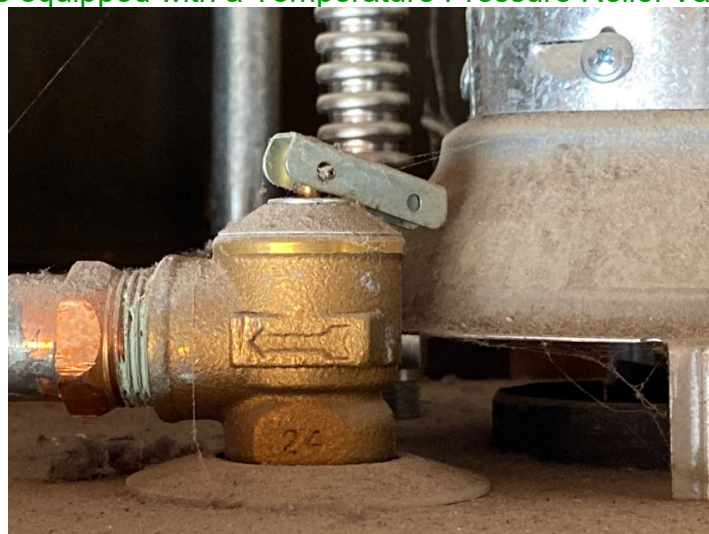
- The water heater is equipped with a Temperature Pressure Relief Valve (TPRV).

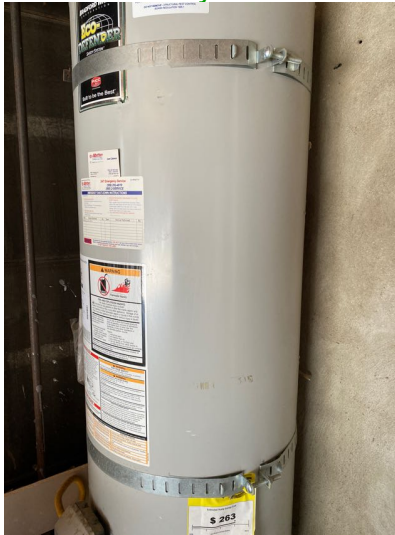
- The water heater appeared to be satisfactory Seismic restraint strapped at time of inspection.

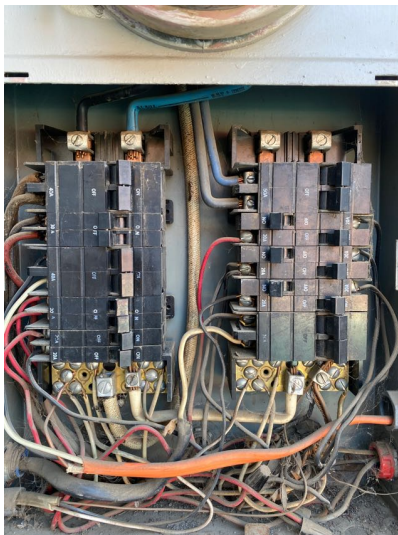
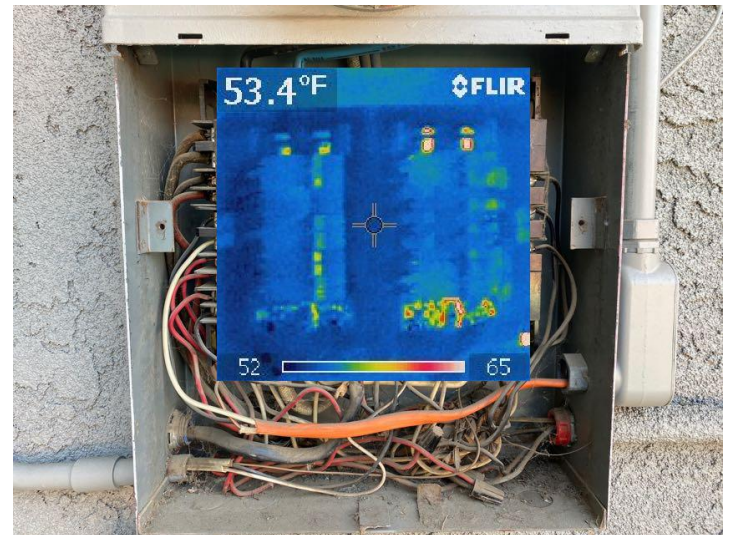
- Circuit breakers in the electrical service panel appeared to be in serviceable condition.
- Breakers were tested with infrared gun. No unusual hot spots seen with infrared camera at time of inspection.
- The red/yellow areas seen in photo are from bright metals reflecting and a normally loaded circuit. These are not abnormal hot spots.

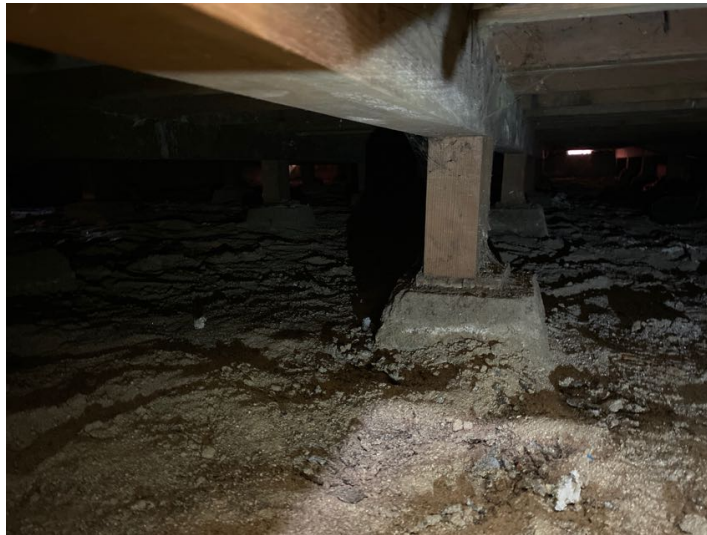
- Posts to concrete footing. Floor framing visible in the crawlspace was supported around the foundation perimeter by posts which rested upon the poured concrete foundation footing.

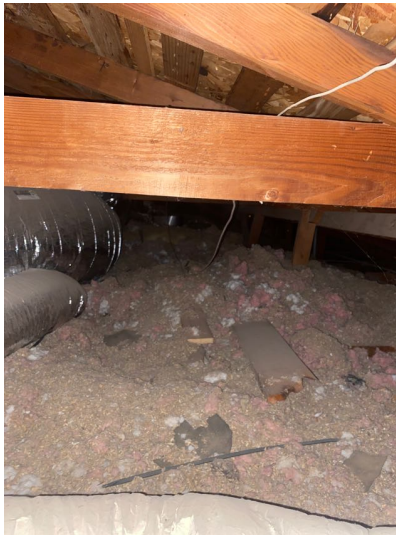
- Attic insulation thickness was approximately 10 to 12 inches. The modern recommended value is R-38.

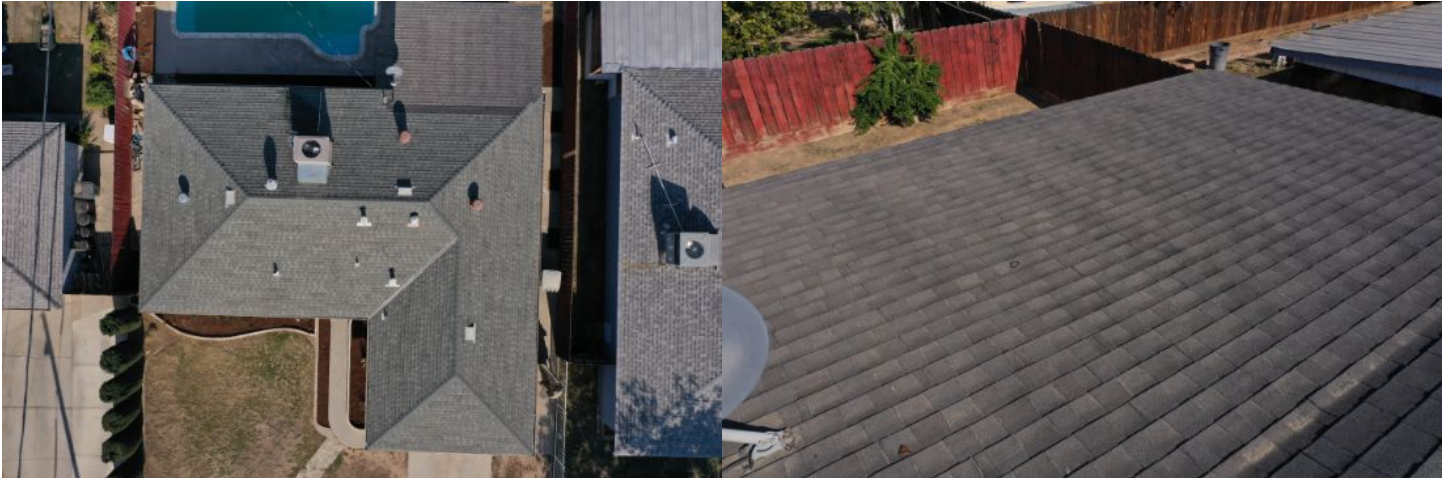
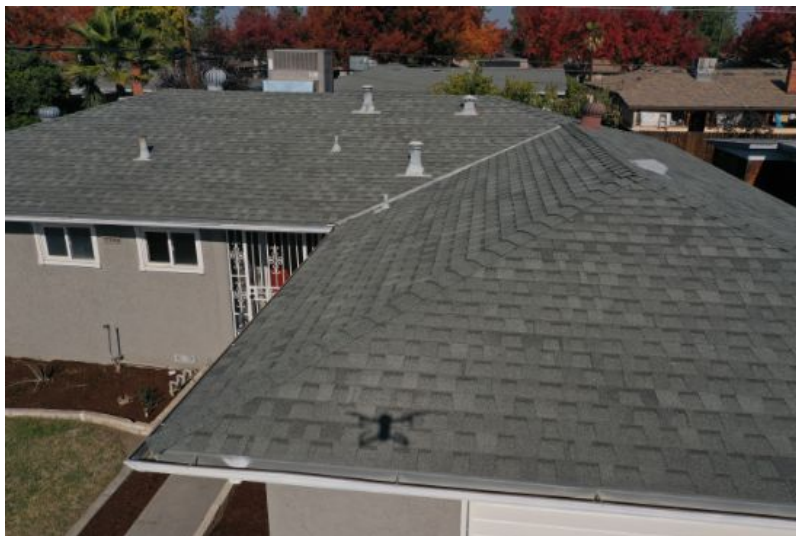
- Asphalt composition shingles covering the roof of this home appeared to be in serviceable condition at the time of the inspection. Areas of concern are noted below.

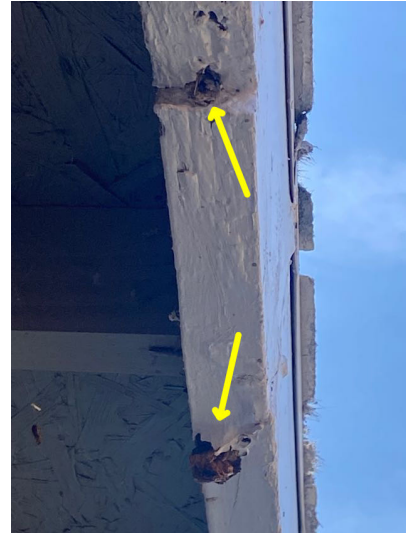
North East corner

Page 23 Item: 2	Facia and Trim Condition	<ul style="list-style-type: none"> Fascia and sheeting showed moderate deterioration requiring repair or replacement at locations listed by pictures. See Hexpod report for further explanation. We suggest further investigation and repairs as needed.
Grounds

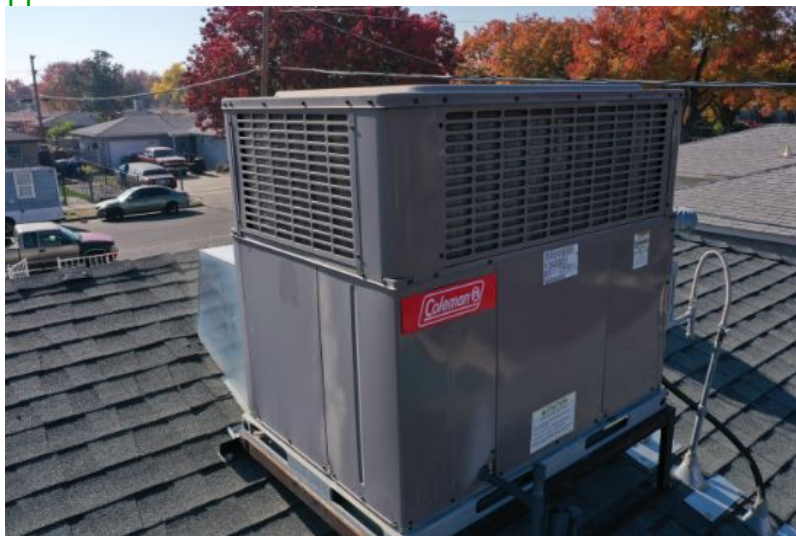
- The air-conditioner compressor housing was located on the roof of the home to the North. We could not safely approach the unit.
