Property Inspection Report

1234 W Midvalley Ave, Visalia, CA, 93277

Date of Inspection: 5/12/2022

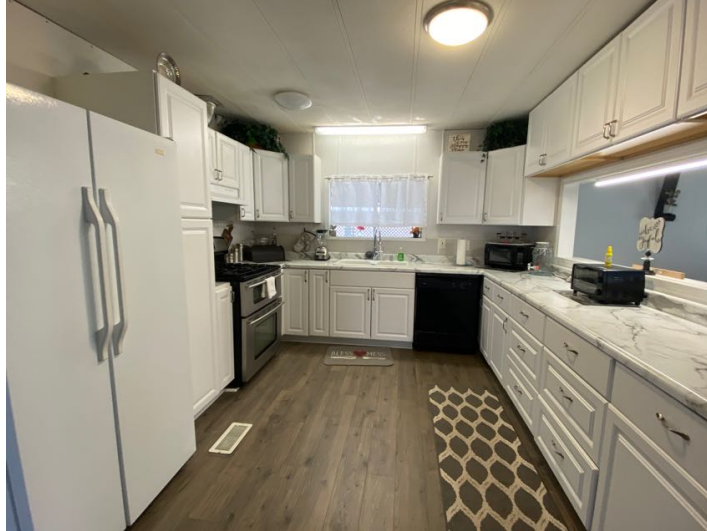
1. Kitchen General Condition

Observations: This room appeared to be in generally serviceable condition at the time of the inspection. Notable exceptions will be listed below.

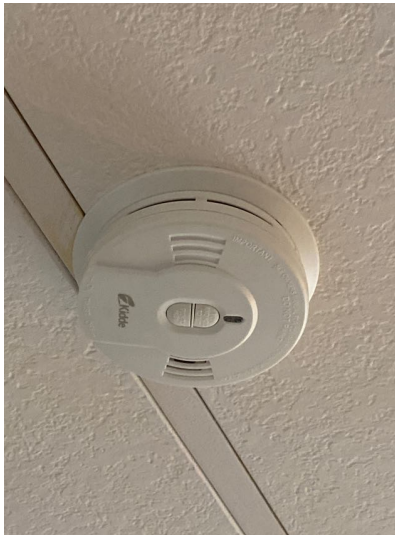
1. Smoke detector Condition

- Most smoke detectors tested fine. We suggest replacement of batteries now and every year to insure indication if smoke is present.

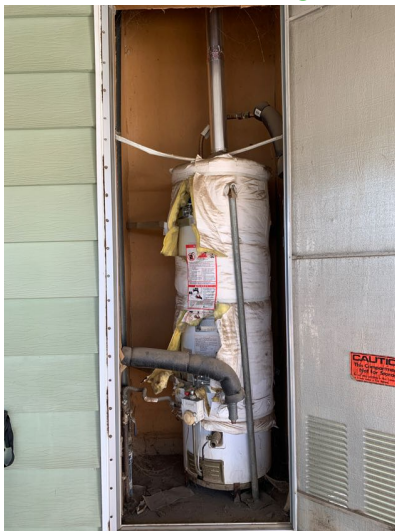
- The Water Heater appeared to be in generally serviceable condition at the time of the inspection. Notable exceptions will be listed below. Unit was installed in 2000.

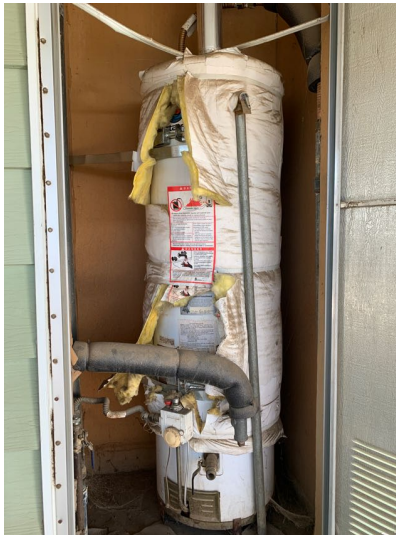
- The water heater appeared to be satisfactory Seismic restraint strapped at time of inspection.

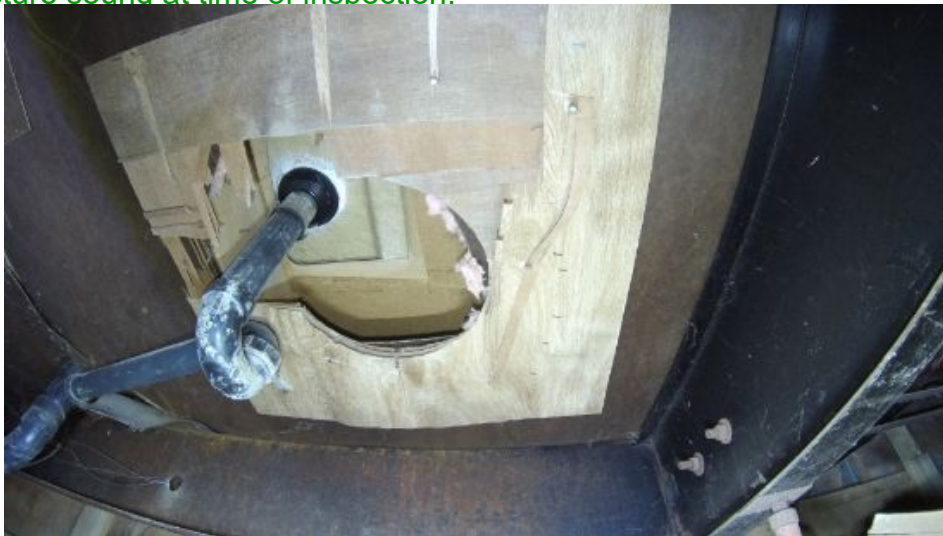
- Floor structure sound at time of inspection.

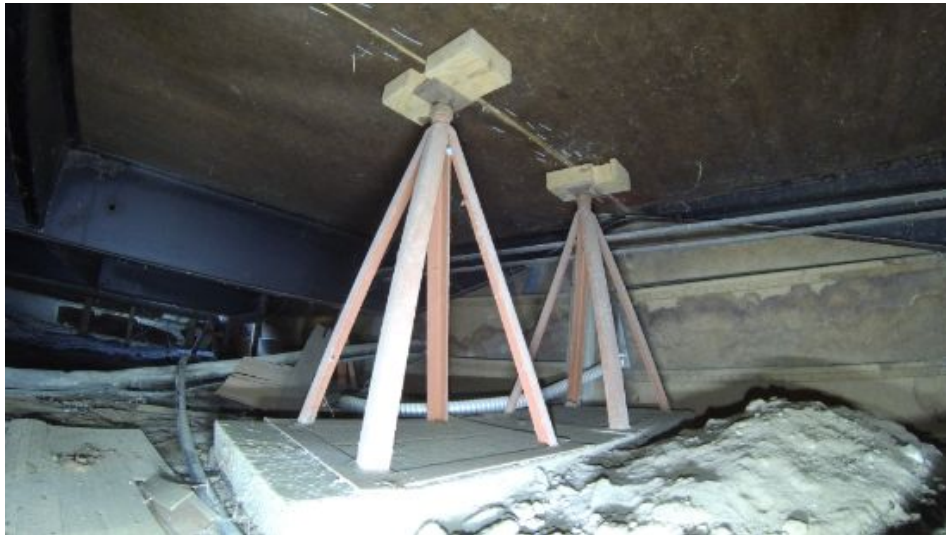
2. Post and Girders

- Metal support on pressure treated wood looks good.

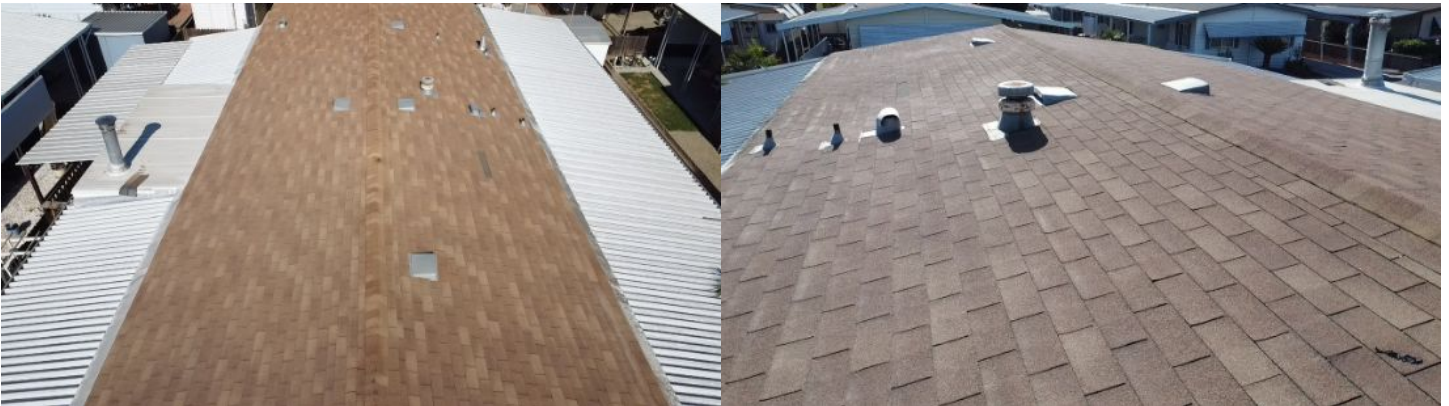
- Asphalt composition shingles covering the roof of this home appeared to be in serviceable condition at the time of the inspection.

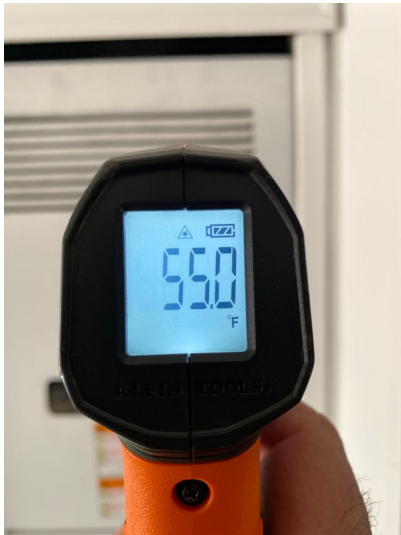
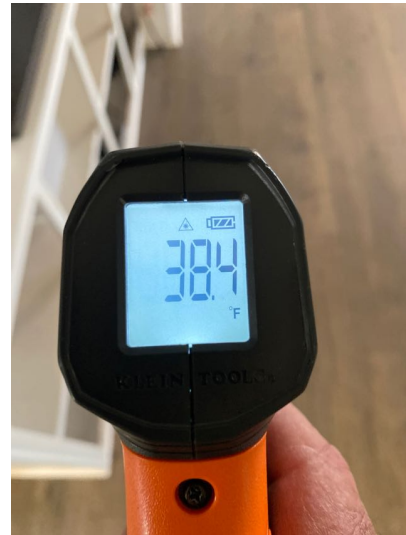
- The differences in air temperature measured at supply and return registers fell within the acceptable range of between 10 and 22 degrees Fahrenheit.
