DRAFT Technical Memorandum

Date: September 1, 2020

Project: Water System Recommendations Improvements

Re: Water System Evaluation and Recommended Improvements

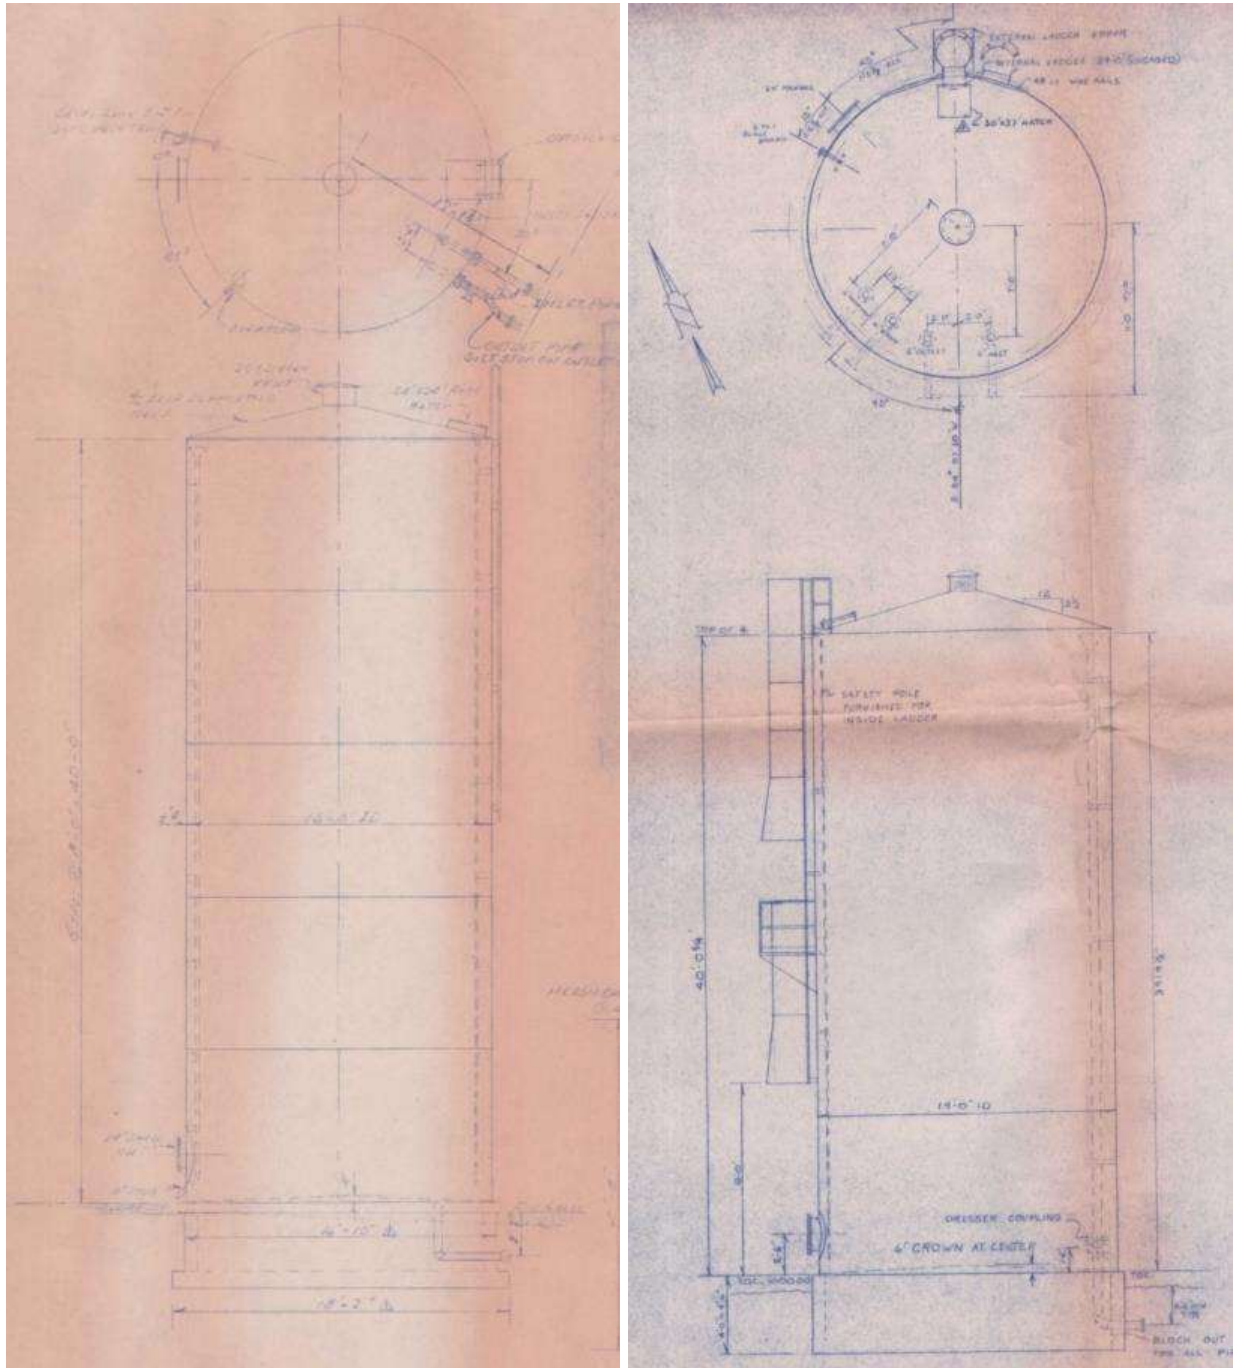
Figure 3
Reservoir 1 (Left) and 2 (Right) Plan and Elevation

It appears that Reservoir 1 was originally equipped with an external level indicator, which has since been removed from operation, but the guide pipes and other welded features are still in place. The reservoir roof has no handrailing, painter's appurtenances, or tie-off locations. The roof appears to be constructed of overlapped plates that are only welded on the outside (not seal-welded, corrosion is evident from interior photos provided by the tank divers from a separate cleaning and inspection effort in 2016). The interior ceiling appears to have erection bolts in place, and corrosion is evident at the crevice interface between the roof and the shell (evidence of not being seal-welded). The bottom of the reservoir shell is backfilled over a portion of the bottom plate on the west and north sides, which appears to be mainly from tree debris that has accumulated over time. At the time of the observation, most of the reservoir exterior was fairly clean and clear of organic growth, however the south side which is infringed-upon by trees did have some green growth where it could not be reached during recent cleaning efforts.

From a review of EWC records, the Reservoir 1 interior was last painted in 1991, wherein the interior was abrasive blasted to a near-white surface preparation standard and two coats of Tnemec Series 20 Pota-Pox were applied. The exterior was painted in 2005, including an overcoat system with a polyurethane topcoat. Both the reservoir interior and exterior, from the site observation and a review of diver-produced interior photos, appear to be in good condition without much evidence of compromised coating systems or excessive corrosion.

From a review of EWC records, the Reservoir 2 interior was last painted in 1984, wherein the interior was abrasive blasted and re-painted. The records do not indicate the level of surface preparation, nor the materials used, although it is believed to be the same or similar materials to the surface preparation and coating work done on Reservoir 1 in 1991, as previously discussed. The exterior was painted in 2005, including an overcoat system with a polyurethane topcoat. Both the reservoir interior and exterior, from the site observation and a review of the dive report for the interior, appear to be in good condition without much evidence of compromised coating systems or excessive corrosion.

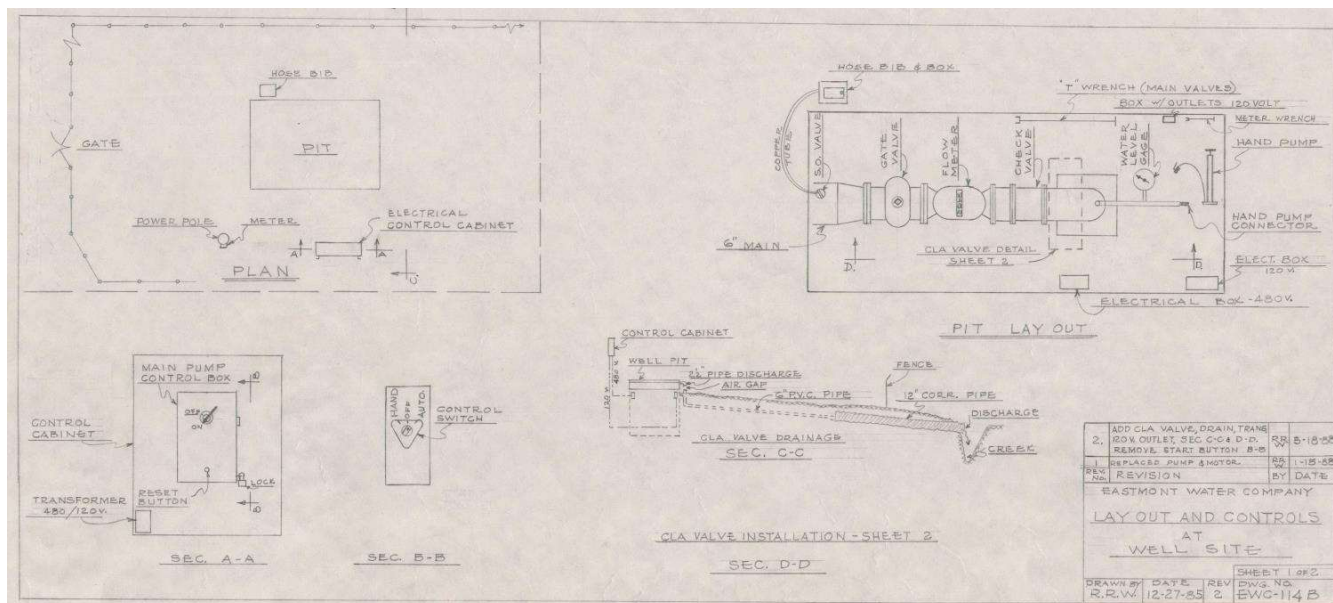
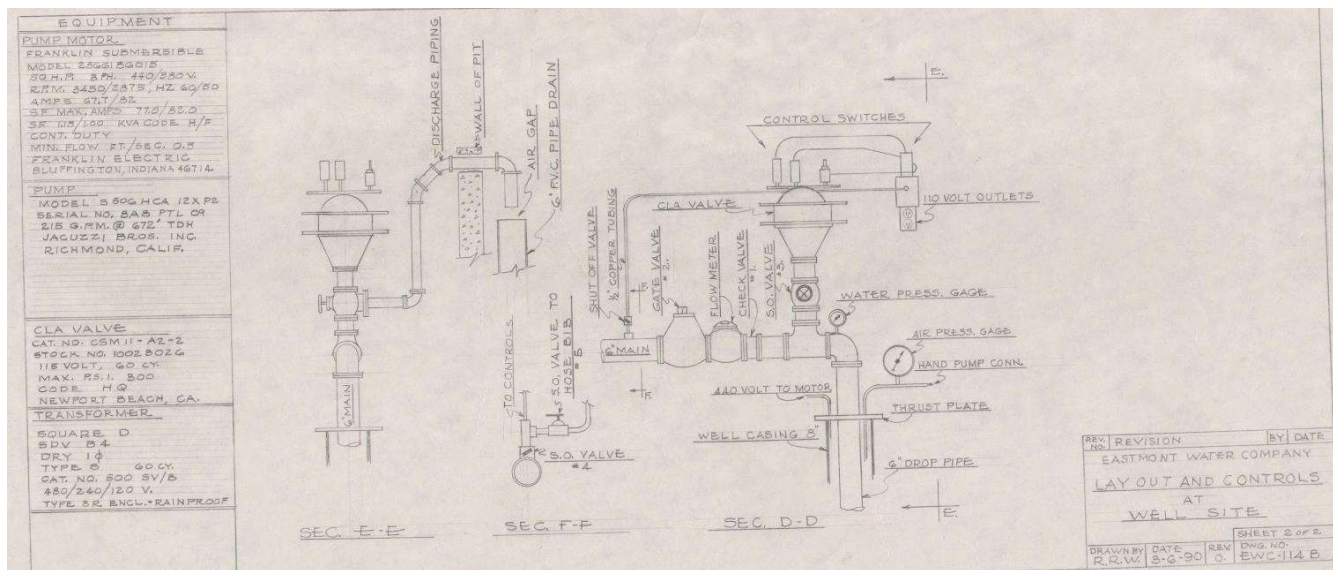
Figure 8
Well Site Pump and Piping Configuration

The EWC reports that the submersible well pump is currently being replaced approximately every **five years <<EWC to confirm>>**. This may be due to issues regarding pump cooling or other

mechanical failures, or simply be a result of the wear and tear the pump receives in order to pump the over 500 feet of elevation to pressurize the EWC system and fill the reservoirs.
