Report of Investigation

Title of Investigation:
743 Main St. Fire (Firefighter Fatality)

Investigation Number:
765070-23-0021

ORIGIN AND CAUSE REPORT

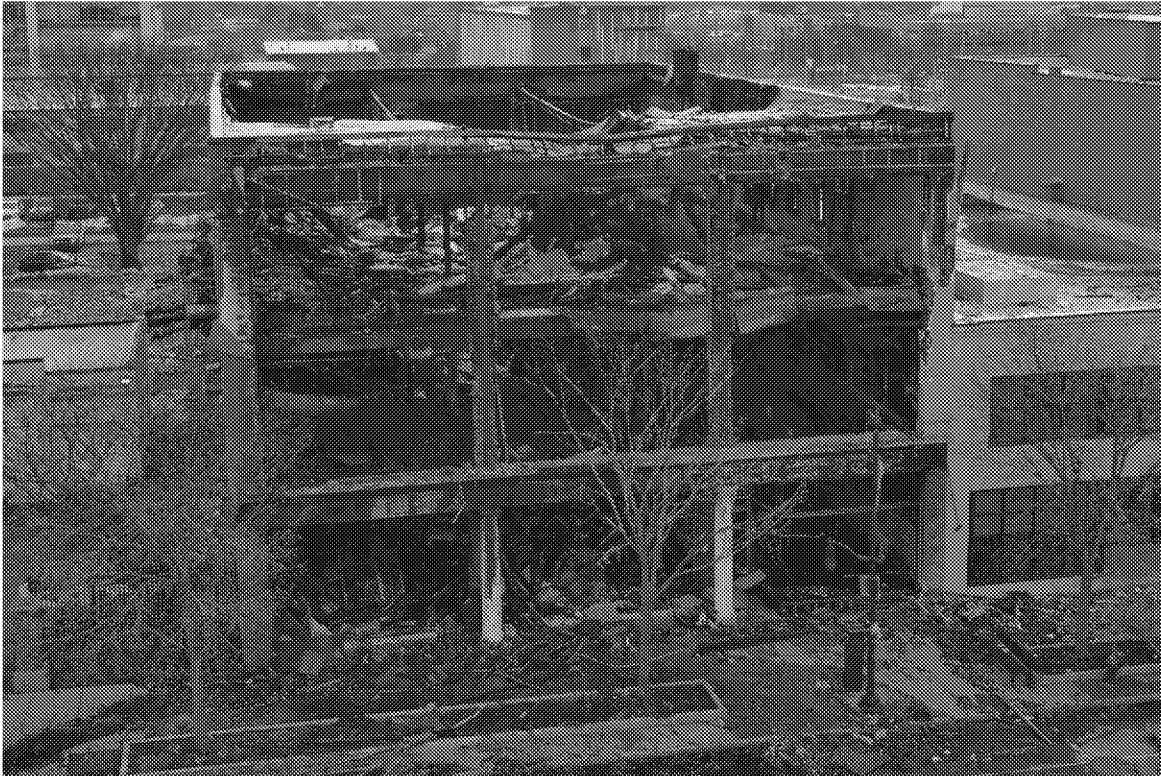
Figure 1 – West side of 743/745/747 Main Street, Buffalo, New York.

136. **West side (Figure 1):** The west side of the structure was heavily damaged during the fire. Much of the façade on the west side of the building was consumed and/or failed during the fire. Large sections of structural brick and metal I-beams were exposed. All windows failed except for the northern-most first floor windows. Those windows were broken by the fire department during suppression operations. Soot and smoke deposits were observed on surfaces that did not fail during the fire.

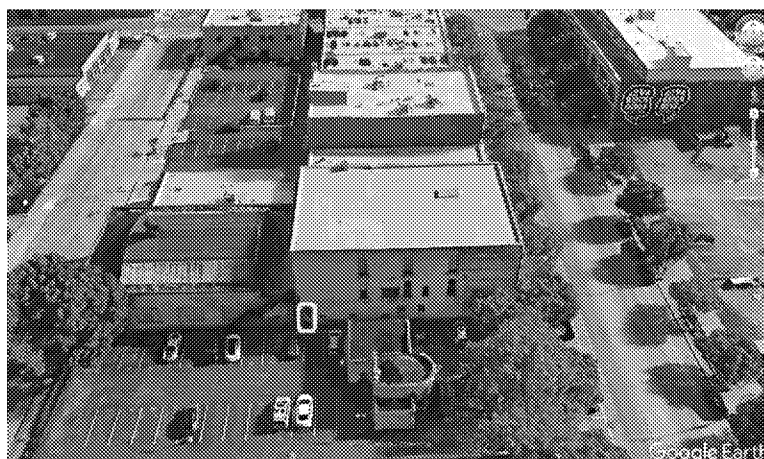
14. The exterior north wall of the three-story portion of the structure contained one door and 13 windows. Based on witness statements and pre-fire photographs, at the time of the fire, the metal ingress/egress door had been removed and replaced with a sheet of particle board. (b)(6)/(b)(7)(C) reported that the sheet of plywood measured 85 ½" in height, 46" in width, and was ½" thick (ROI 99). A gap of unknown size was located along the bottom of the particle board. A piece of plastic sheeting covered the plywood and adjacent brick. Five of the windows were on the first floor, five were on the second floor, and three were on the third floor. The glass for the easternmost first floor window had been previously replaced with a piece of plywood. The polyvinylchloride (PVC) intake and exhaust piping for the basement natural gas-fueled furnace extended outward through the plywood. Plywood covered the upper portions of the windows on the third floor. The exterior north wall of the single-story portion of the structure contained three arched windows that were covered with plywood. See Figure 6 and Figure 7.

Figure 6 - Screen capture from Google Earth facing south.
North exterior metal door encircled in yellow.

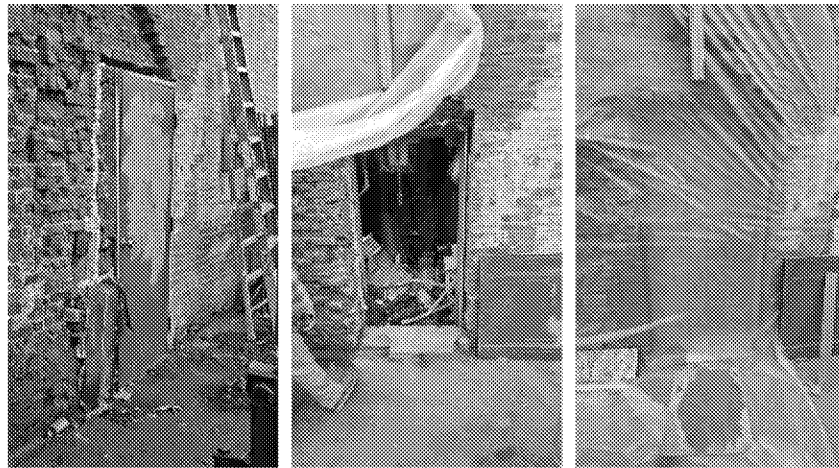
Figure 7 - Side by side pre-fire images of the north exterior metal door in place, the metal door removed, and the plywood and plastic sheeting.

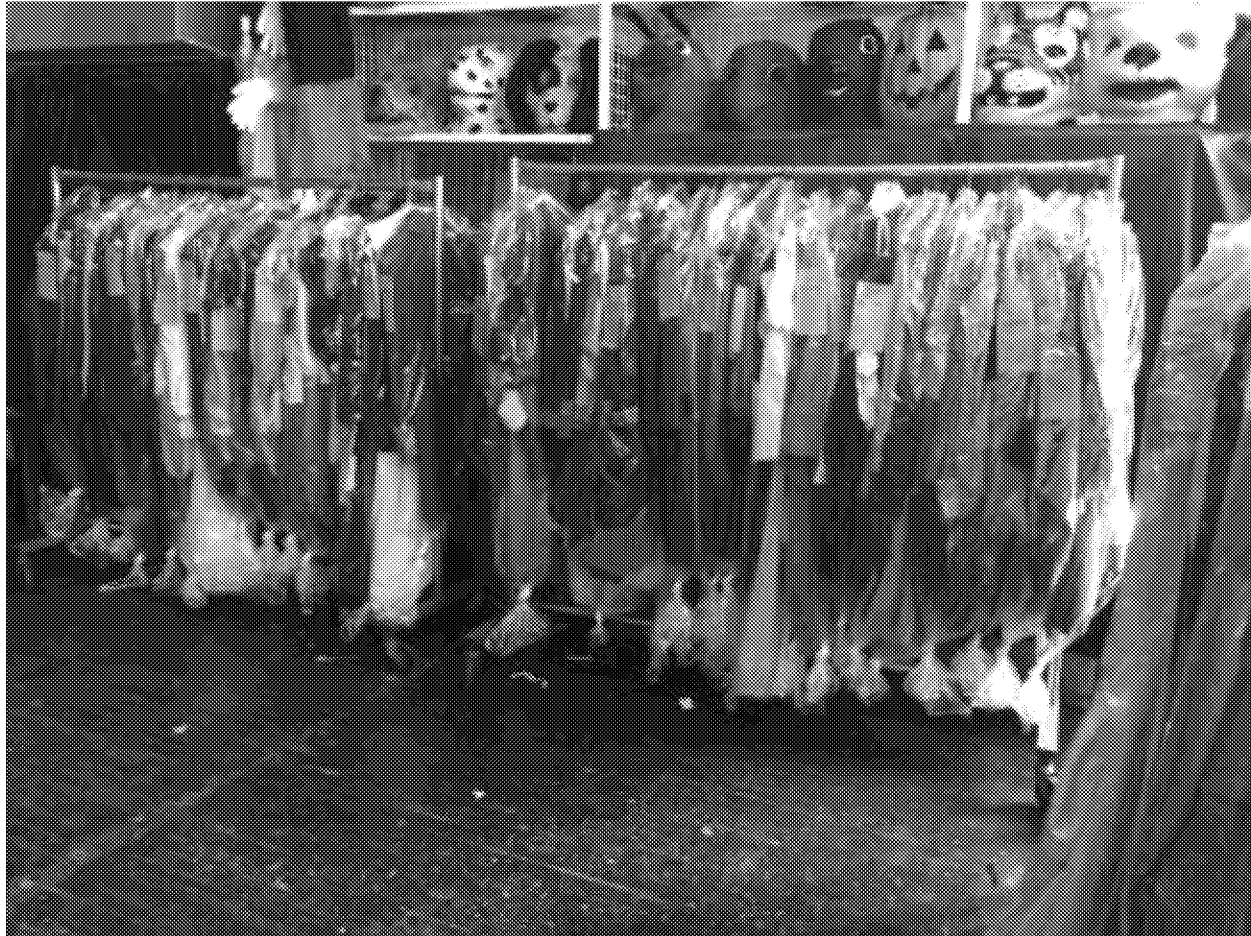
51. The day before the fire, (b)(6)/(b)(7)(C) had washed three loads of clothing/costumes in the washing machine located in the northeast corner of their store. DC Theatricks did not have a working dryer, so the materials were hung to dry. (b)(6)/(b)(7)(C) provided investigators with several photographs of the interior of the store prior to the fire. (b)(6)/(b)(7)(C) described racks of clothing/costumes throughout the store. Some of these racks had two rows of

clothing/costumes stored side by side with additional racks above. There were also numerous foam mascot heads throughout the business.

Figure 16 – Photograph of clothing in plastic bags on racks.

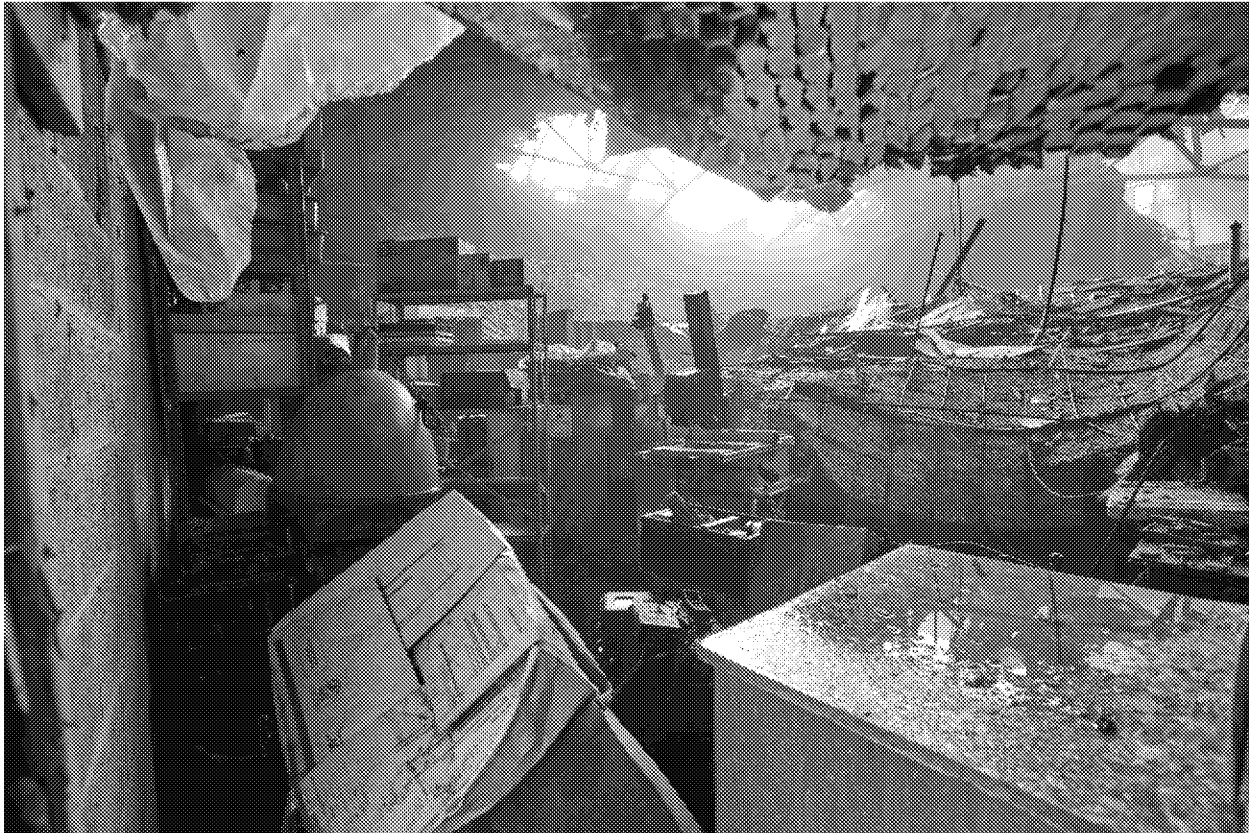
68. (b)(6)/(b)(7)(C) – ATF ROI #28: On March 3, 2023, investigators interviewed (b)(6)/(b)(7)(C) who rented a small storage area in the northeast corner of the single-story warehouse. (b)(6)/(b)(7)(C) stated that his tenancy was terminated, and he was asked to remove his items from the warehouse. On January 13, 2023, (b)(6)/(b)(7)(C) took a video inside the warehouse to document the condition. He also stated that the south side of the three-story structure on the first floor was empty, along with all the second and third floor.
69. On the day of the fire, (b)(6)/(b)(7)(C) took photographs of the building including the warehouse area. (b)(6)/(b)(7)(C) provided the previously mentioned video and photographs to investigators. The photographs show items at floor level to be free of thermal damage.

Figure 19 – Post-fire photo of the warehouse taken by (b)(6)/(b)(7)(C)

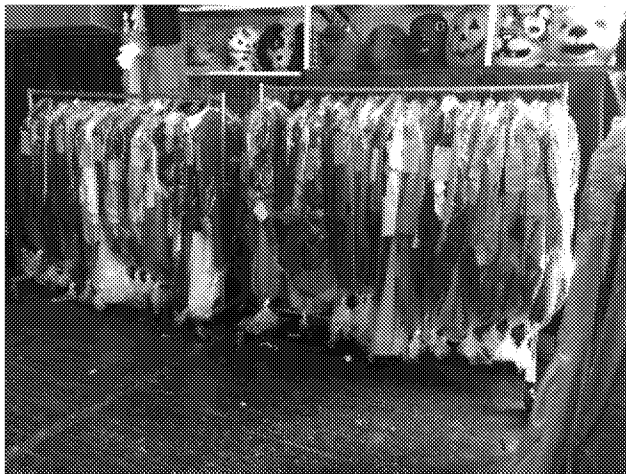
208. In 2001, the National Institute of Standards and Technology (NIST) published research regarding clothing fires. [2] In the tests NIST conducted, men's suits were placed on a metal rack approximately six feet in length. The racks had two rows of suits. DC Theatricks had similar arrangements of clothing suspended from metal racks. However, some of the racks in DC Theatricks were longer and some racks were stacked two or three levels high. NIST performed three tests. In each test, a heat release rate of one megawatt was sustained for about five minutes. However, one test briefly spiked to two megawatts.

Figure 40 - DC Theatricks – Pre-fire.

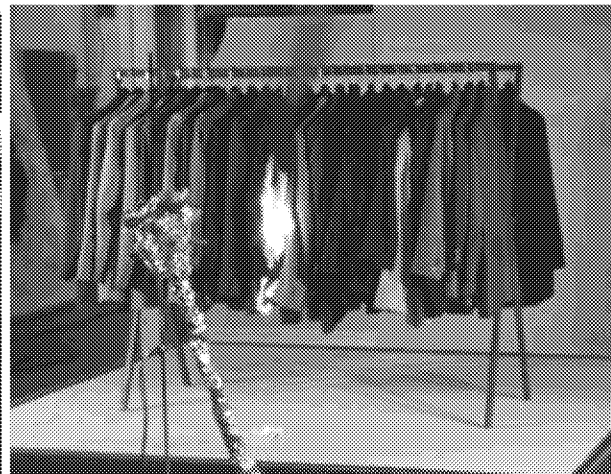
Figure 41 - NIST Testing.
