Property Inspection Report

**PROSPECTOR
HOME INSPECTIONS**

**123 Main St.
Inspection Prepared For: Joe Smith
Agent: Top Seller -**

**Date of Inspection: 9/13/2023
Home Age: 47 yrs Size: 1700 Sq. Ft.**

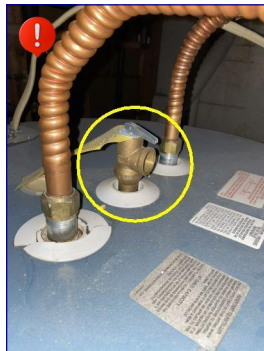
TPRV

- I observed the temperature-pressure relief valve extension was improper on the water heater. This is a safety concern. The extension should be installed to be 4"-6" off of the floor. I recommend a licensed plumber make the necessary repair.

I observed the temperature-pressure relief valve extension was improper on the water heater. This is a safety concern. The extension should be installed to run to the side of the unit and terminate 4"-6" off the floor. I recommend a licensed plumber make the necessary repair.

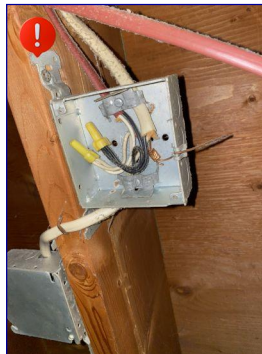
House Wiring

There were open junction boxes in the crawl space. I recommend having covers installed. This is considered a safety hazard.

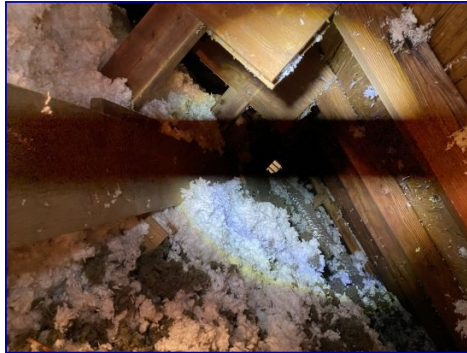
Insulation

I observed blown in insulation on top of other insulation. The insulation depth in the attic is appropriate.

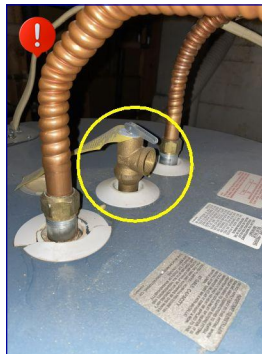
- I observed the temperature-pressure relief valve extension was improper on the water heater. This is a safety concern. The extension should be installed to be 4"-6" off of the floor. I recommend a licensed plumber make the necessary repair.

I observed the temperature-pressure relief valve extension was improper on the water heater. This is a safety concern. The extension should be installed to run to the side of the unit and terminate 4"-6" off the floor. I recommend a licensed plumber make the necessary repair.

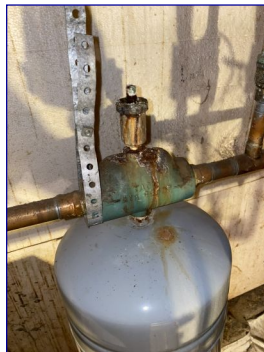
Expansion Tank

I observed corrosion on the air scoop and air vent. This could affect the operation of the **expansion tank**. I recommend evaluation by a licensed HVAC technician.

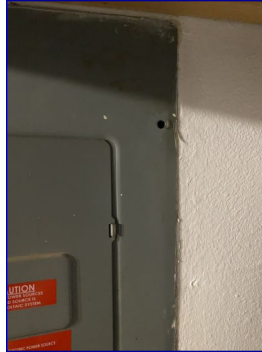
Main Panel General

I observed the main electric panel was missing a screw. I recommend having the screw replaced.

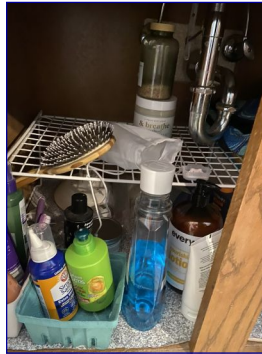
Cabinets

The downstairs bathroom cabinet floor could not be viewed and was covered with contact paper. The pipes did not show water leaks. It was not possible to assess for water damage. I recommend removing all items and inspecting for water damage.

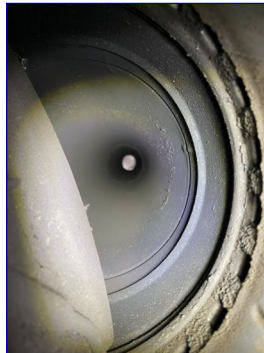
Fireplace

I observed the damper operate properly. This is a view looking up the flue. The flue was mostly clean with a small amount of soot at the bottom. It is recommended to have the flue cleaned and the fireplace inspected every few years.
