Property Inspection Report

**PROSPECTOR
HOME INSPECTIONS**

**123 Main St.
Inspection Prepared For: Joe Smith
Agent:**

**Date of Inspection: 9/13/2023
Home Age: Size: 1700 Sq. Ft.**

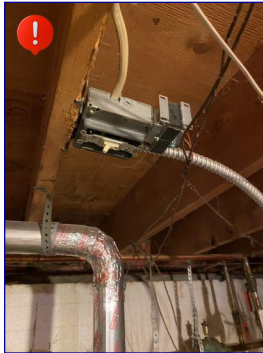
The Master Shut-off for the Boiler. I recommend installing a cover plate. Not having a cover plate is a safety hazard.

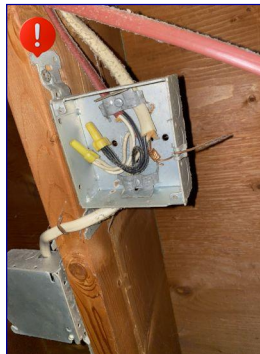
There were open junction boxes in the crawl space. I recommend having covers installed. This is considered a safety hazard.

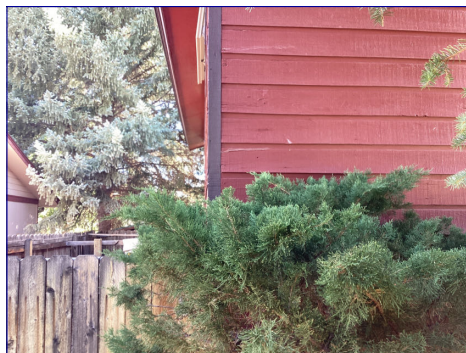
The exterior walls all looked straight and true.

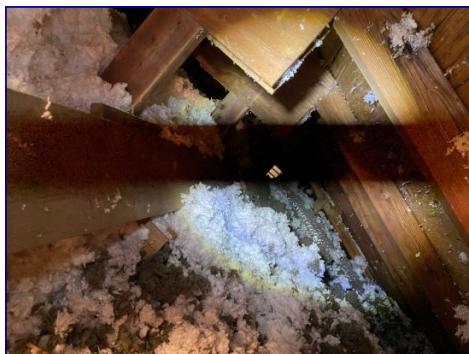
I observed blown in insulation on top of other insulation. The insulation depth in the attic is appropriate.

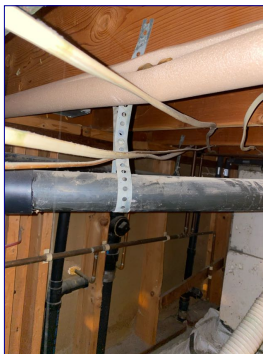
I observed plastic drain piping supported with metal hangers. Metal hangers can damage the plastic piping over time. I recommend having the metal hangers replaced with the proper hangers.

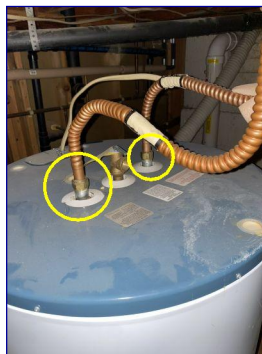
- Dielectric connection is not present. Recommend repair by qualified technician.

I observed the lack of a dielectric connection between dissimilar metals at the water heater. Attaching dissimilar metals directly to each other can result in corrosion and failure at the connection. I recommend evaluation and repair by qualified technician.

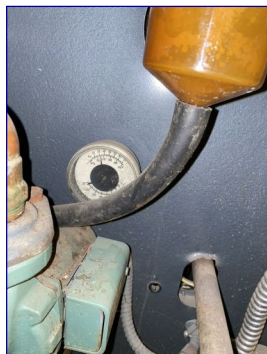
Pressure Gauge showing pressure in the correct range.

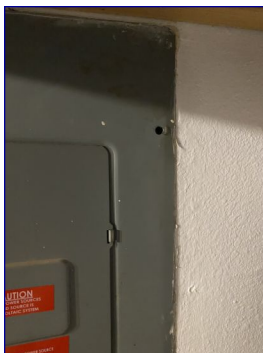
I observed the main electric panel was missing a screw. I recommend having the screw replaced.

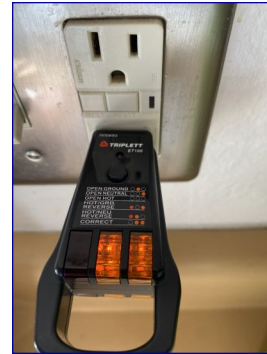
The electrical outlet tester showed branch wiring in the house is wired correctly.

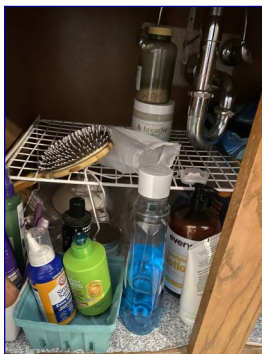
The downstairs bathroom cabinet floor could not be viewed and was covered with contact paper. The pipes did not show water leaks. It was not possible to assess for water damage. I recommend removing all items and inspecting for water damage.

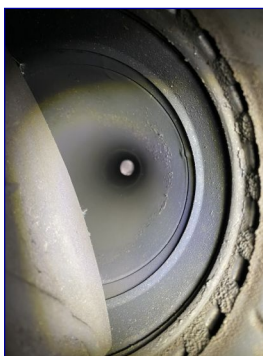
I observed the damper operate properly. This is a view looking up the flue. The flue was mostly clean with a small amount of soot at the bottom. It is recommended to have the flue cleaned and the fireplace inspected every few years.

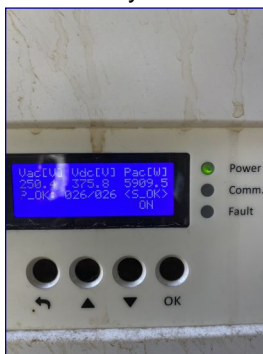
The solar system is not included in the Standards of Practice for a home inspection. Any information on the system is shared as a courtesy. The solar system appears to be operating correctly.
