Property Inspection Report

**PROSPECTOR
HOME INSPECTIONS**

**757 Main St.
Inspection Prepared For: Mary Doe
Agent: Support - Home Inspector Pro**

**Date of Inspection: 12/5/2022
Home Age: 22 Size: 1448**

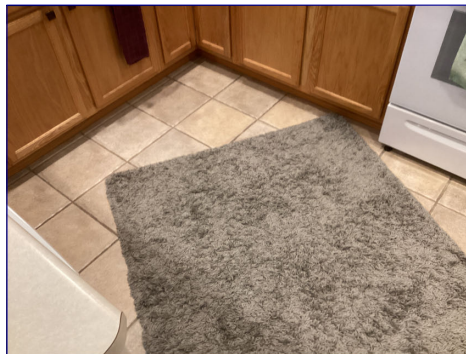
The area rug in the kitchen was taped to the floor. This limited my inspection of the floor tiles.

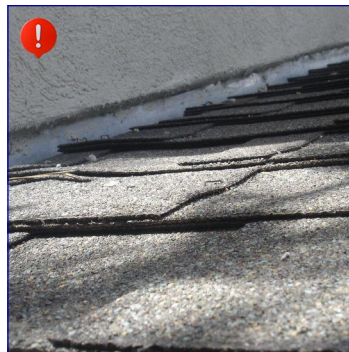
Flashing is not visible between the roof and the wall. I recommend consulting with a qualified roofer to address this concern.

In this picture, not 757Pine Ct, the flashing can be seen between the stucco and roof. I recommend a licensed roofer evaluate the current roof, including the intersections with the walls and the flashing.

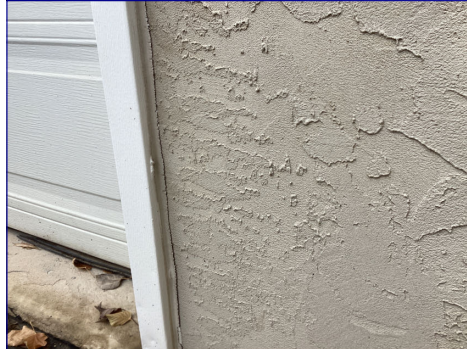
Trim

The exterior trim is in need of normal caulking maintenance.

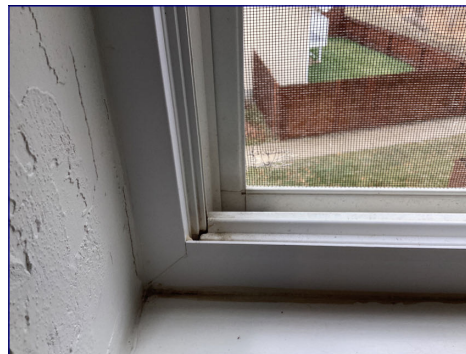
There is a small tear in the screen in the loft living area.

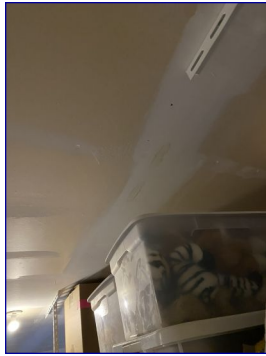
Additional picture of the garage ceiling water staining.

There are signs of water leaking on the garage ceiling. I recommend further investigation to determine the cause of the water staining. It could be associated with the disconnected water line and water damage in the upstairs bathroom or the non-booted vent in the attic.

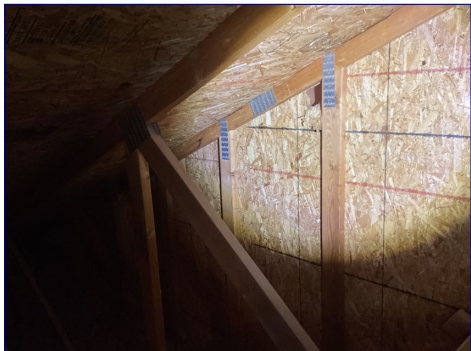
This is a hole in the wall sheathing in the attic. There is no hole on the exterior siding in this area.

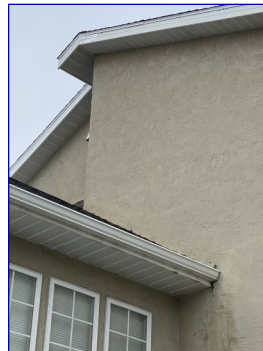
This is the exterior view where the hole in the attic sheathing is.
