Why Pumps Fail

Report by David White

9/12/2025

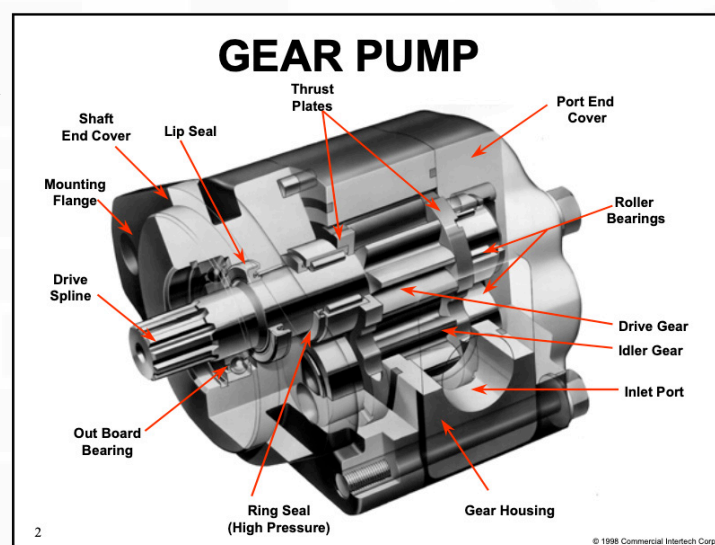
Historically, when pumps have failed during the initial break-in period, the explanation has almost always been attributed to a single cause: **oil starvation leading to cavitation**. In practice, this is often described as an operator inadvertently closing the inlet valve and depriving the pump of oil. This explanation has generally gone unchallenged for two main reasons: (A) power units are not equipped with sensors capable of disproving whether a valve was closed at startup, and (B) no compelling alternative has been offered. Nevertheless, there is strong evidence that many of these early failures occurred under conditions where oil starvation was highly unlikely, suggesting that cavitation is not the universal explanation it has been assumed to be.
