Affordable Home and Building Inspections

Property Inspection Report

115 Main Court, Community Name, Milford, PA 18337
Inspection prepared for: Carl Cass
Real Estate Agent: YOUR REALTOR - REAL ESTATE COMPANY

Date of Inspection: 5/7/2021 Time: 12:00 pm
Report # 1234

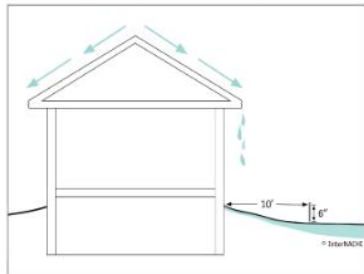
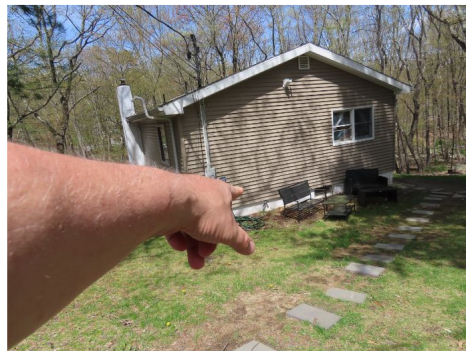
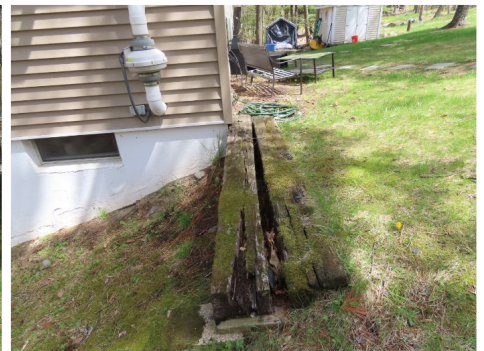
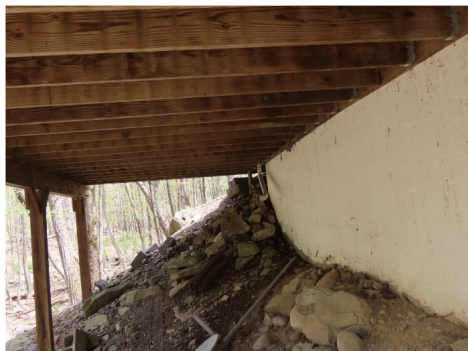
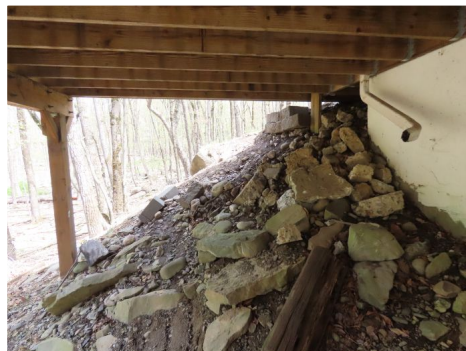
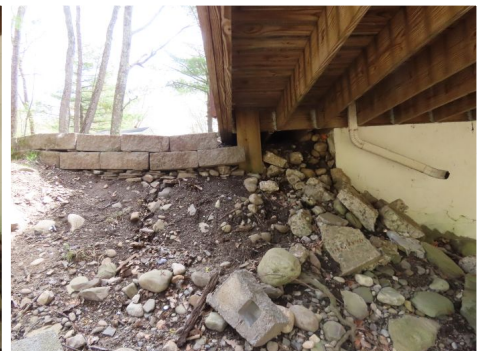
Grade is pitched towards foundation front, sides. Retaining walls have shifted and have water damage. Some of the grade is raw and has no stability. Erosion is noted on right side and under rear deck. Further evaluation is needed by a qualified escalator to determine the scope and cost of corrections. Ideally, the grading should slope away from the house's foundation about 6 inches over the first 10 feet. Adjust grade in area to divert/remove surface water.

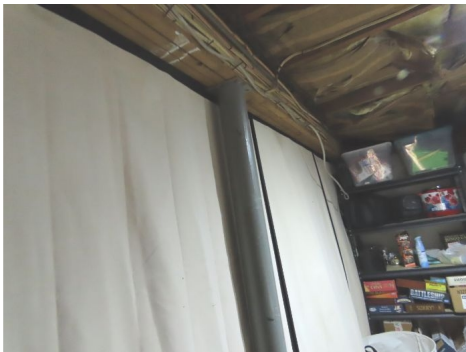
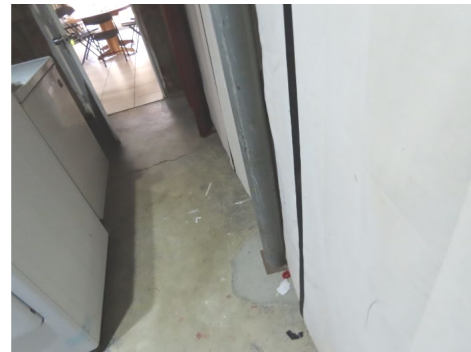
Observations: Finished basement area limits view. No visual inspection was performed on portions of the floor structure. There are no indications of structural distress. Steel post should be secured to the beam and to the slab to prevent movement.

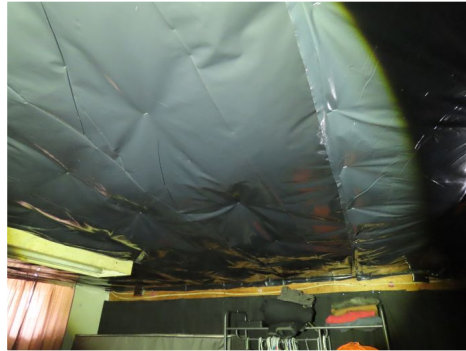
Observations: Visible sections appear to be functional. Some areas are not viewable or inspected. The vapor barrier on the basement ceiling should be removed as it can trap moisture.

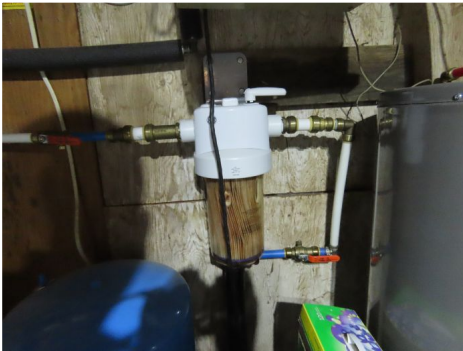
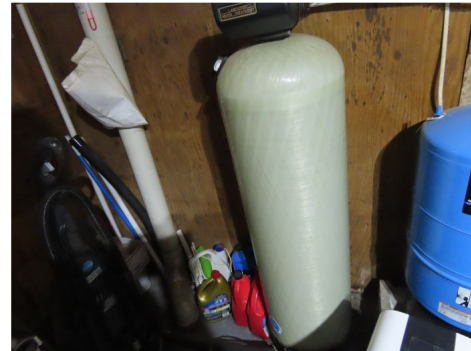
Filter system

Type of system: Water filter and softener installed and not inspected. Clogged water filters can cause a drop in water pressure.

Observations: Consult with seller and review manufacturers instructions as to use and maintenance. It is usually recommended to service units annually.

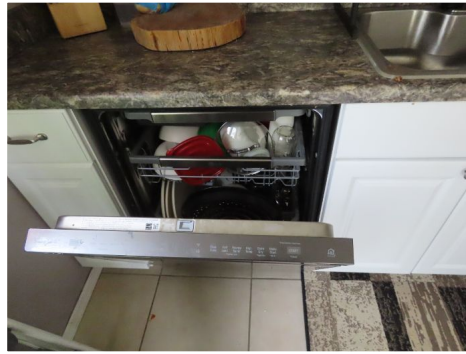
Observations: The dishwasher has dishes in it and the unit is untested. Please consult with seller as to function.

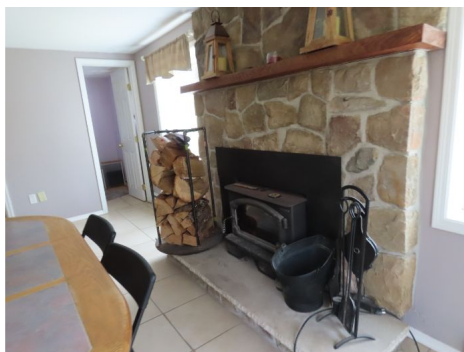
Wood burning stove. Unit is located in dining room. DO NOT USE THE UNIT unless you completely understand the functionality.

Observations: Appears to be functional. Chimney and fire box offer limited view or no access during inspection. There is no access to flue from fireplace or roof area. Inspection of all fireplaces and stoves is recommended by a qualified specialist prior to use.
