Your survey and valuation report

The House
The Street
The Town
AA1 7AB

31st December 2021

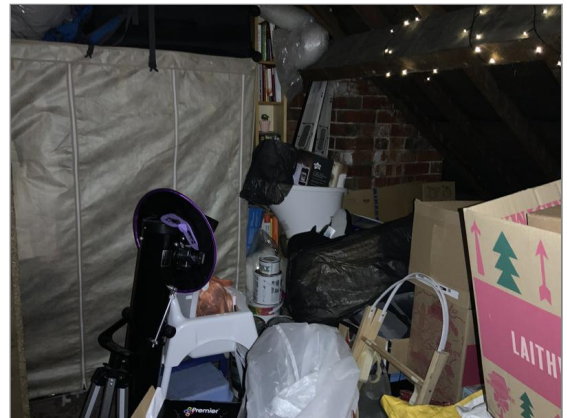
Photo - 11 Vendors belonging restricted access

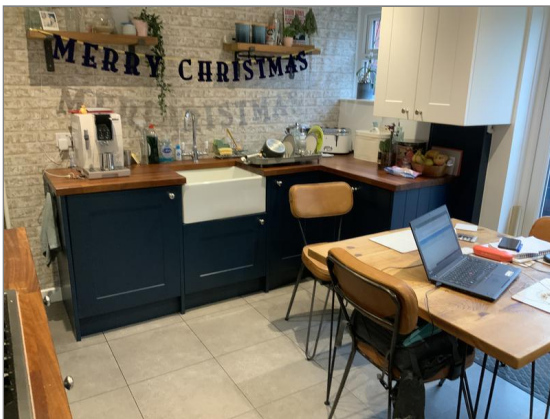
The kitchen fittings are modern and functional with no signs of significant defects noted at the time of inspection.

Photo - 16 Kitchen fittings

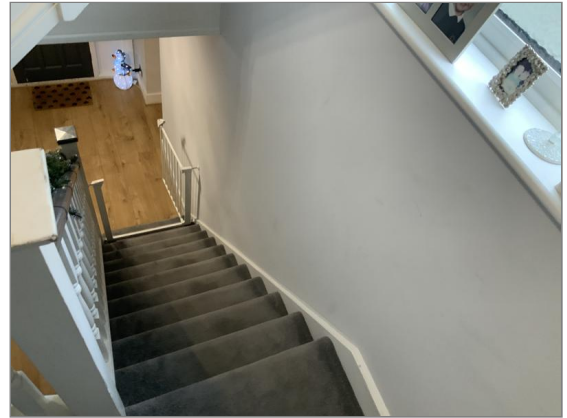
Photo - 18 Timber staircase

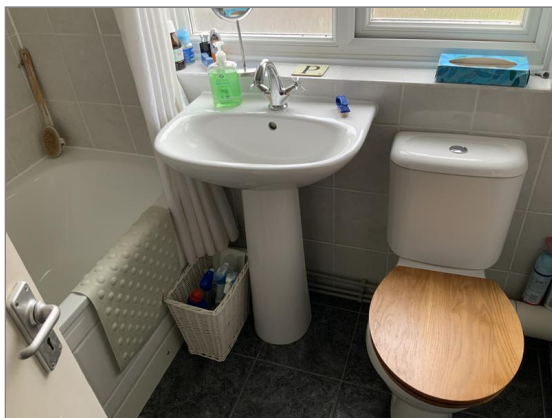
The bathroom benefits from an electronically operated air extraction unit which is designed to expel the warm moist air produced within the bathroom to the external environment, as such helping to prevent the build up of condensation occurring. Condensation can affect the surfaces within the bathroom, particularly the ceilings.

Photo - 19 Bathroom fittings

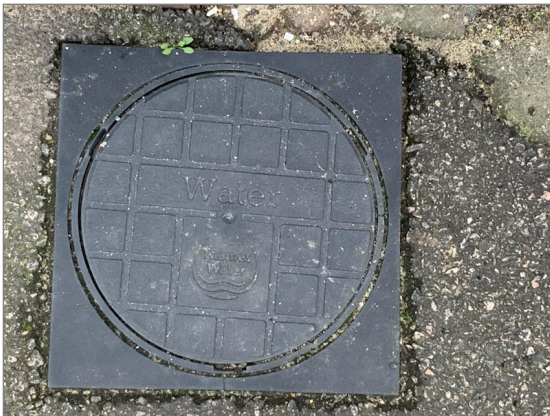
There is an independent mains water supply to the property. The external stop valve/water meter is located to the front elevation on the public highway. Internally, the location of the stop valve was not identified. The water pressure within the property appears to be normal, and I have no reason to believe there are any defects with the system.

Photo - 22 Mains water intake and isolation valve

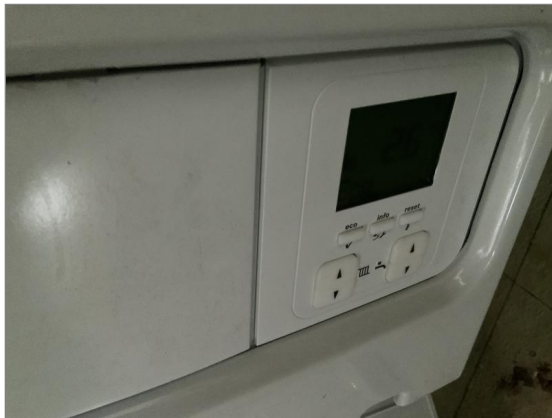
The property benefits from a hot water supply which is provided by the main gas fired boiler which provides instantaneous on demand hot water without supplying a storage tank. 2

Photo - 24 Combination boiler

See comments in section F4 above in respect of having the boiler tested.
