LEVEL 3

Your survey report

The House
Any Street
Any Town
AN1 2OW

22nd April 2022

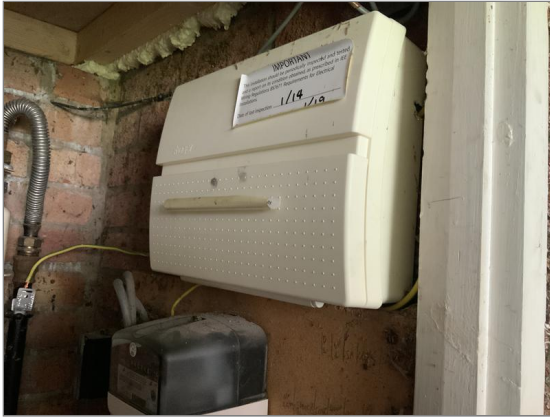
Photo - 35 Mains electricity intake and distribution board

From the sockets selected, there were no defects identified, although guidance published by the Institute of Electrical Engineers recommends electrical installations within residential property should be inspected and tested at least every 10 years and when occupiers of the property change.

I would therefore recommend that a full electrical test and report be undertaken prior to a legal commitment to purchase the property, in order to determine the cost and extent of any remedial works required to the system. You are therefore advised to instruct an NICEIC registered electrician to undertake an electrical test and report on the system.

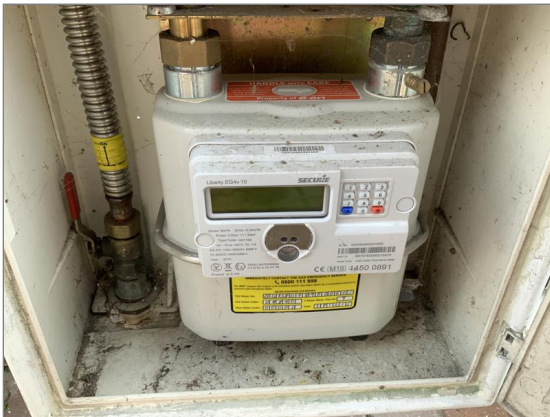
Photo - 36 Mains gas intake and meter

There is a mains gas supply, and the meter and control valve are located in an external box. During my inspection, I was only able to make a superficial examination of the pipework but from their appearance I am satisfied they are in reasonable condition. It is nevertheless recommended that you obtain a copy of a GasSafe™ certificate from the vendor.

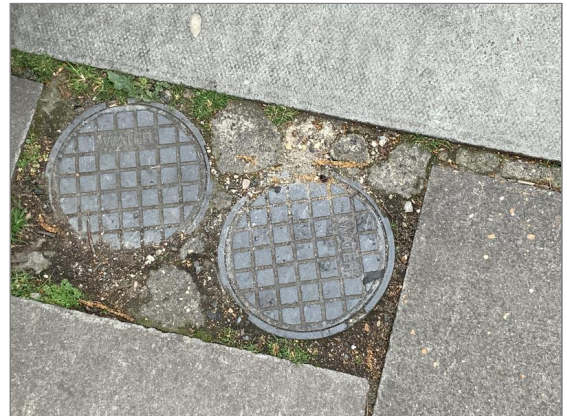
Photo - 38 Mains water intake and isolation valve

Before 1970, many water supply pipes were made of lead and research has shown that small quantities can pass into the water. This can be a particular problem in areas that have soft water. If you want to remove this potential health risk completely, you should replace all the lead piping on the property soon.

If you want to remove this potential health risk completely, you should replace all the external lead piping on the property as well. For further advice, visit the Drinking Water Inspectorate at www.dwi.gov.uk.

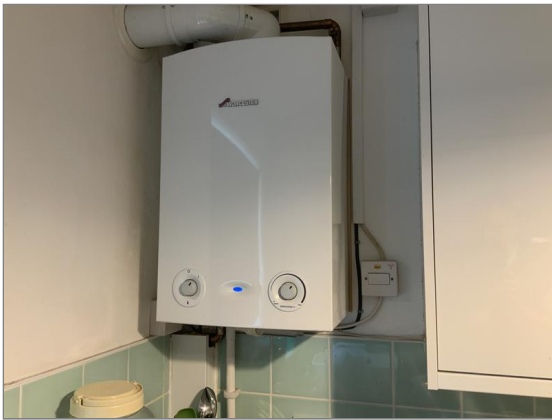
Photo - 39 Mains gas fired boiler

The heating system could not be tested at the time of inspection, and therefore, I would consider it prudent for a specialist test and report to be undertaken prior to entering into a legally binding commitment to purchase in order to determine its adequacy and any upgrading works required.

The radiator to the living room is leaking. Although this is not yet serious, the problem can quickly get worse and damage other parts of the property. You should ask an appropriately qualified person to check this now and resolve the situation soon.

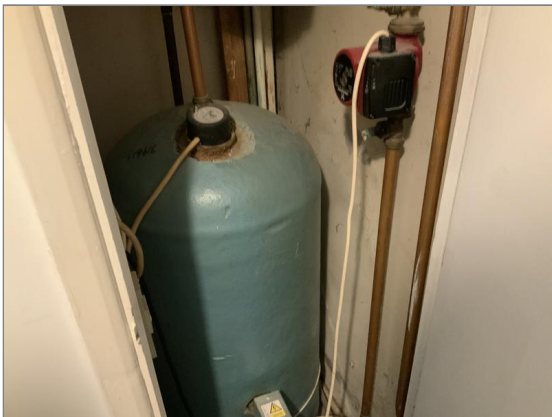
Photo - 40 Hot water cylinder

The hot water within the property is provided by the main gas fired boiler which feeds a copper cylinder located to the cupboard off the first floor landing. The cylinder and associated pipework appear to be in reasonable condition, but the system is somewhat dated. As such, it would be prudent to budget for some degree of maintenance at some stage in the foreseeable future. You should also ensure that the system is tested by a suitably qualified GasSafe(TM) registered engineer, at the same time as the main boiler is tested.
