CORPORATE AUTOMOTIVE BULLETIN

Subject: Ford Drag Link -Torn Boots

Bulletin #: D19-09

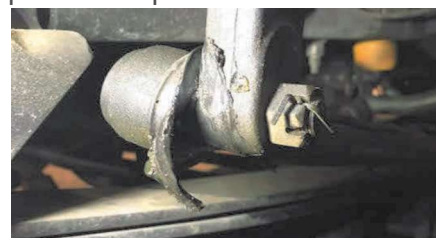
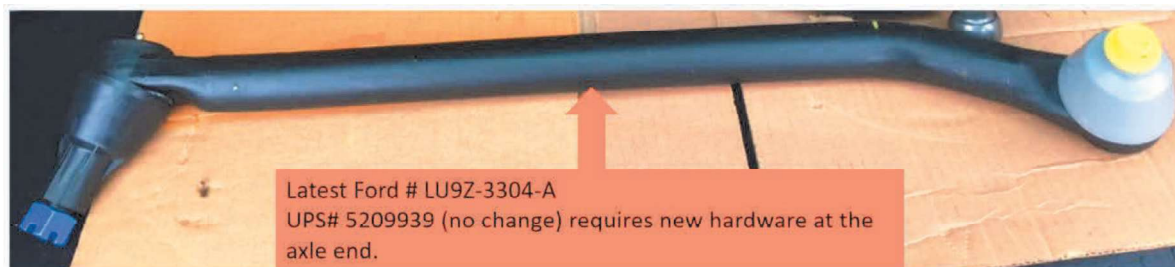
Nut – UPS # ~~5211910~~ (5211910)
Castellated Retainer – UPS# 5211913
Cotter pin – UPS# 5211916

Torque, for latest Drag link only, is 250Nm (184 ft/lb) with the required hardware.
