**Illuminating real estate  
investment decisions since 1999**

1568 Sample Street , Any City, CA  
Inspection prepared for: Sample Client  
Date of Inspection: 3/26/2022

Inspector: Scott Schildknecht  
ASHI Certification # 252268  
1485 Maria Avenue , Concord , CA 94518  
Phone: (707)649-8700  
Email: [scott@northbayinspection.com](mailto:scott@northbayinspection.com)  
[Northbayinspection.com](http://Northbayinspection.com)

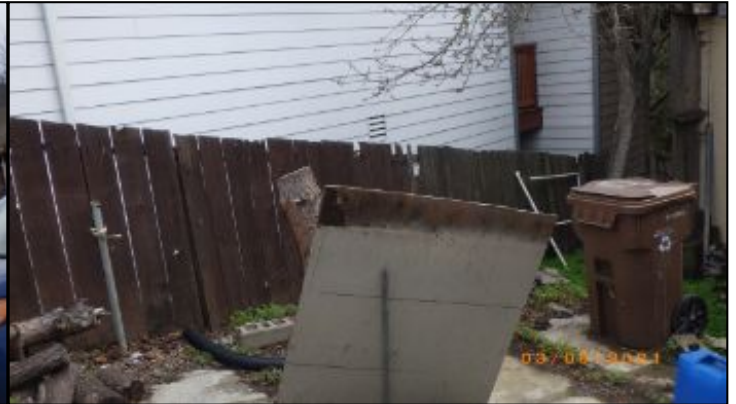
steep slope at the rear

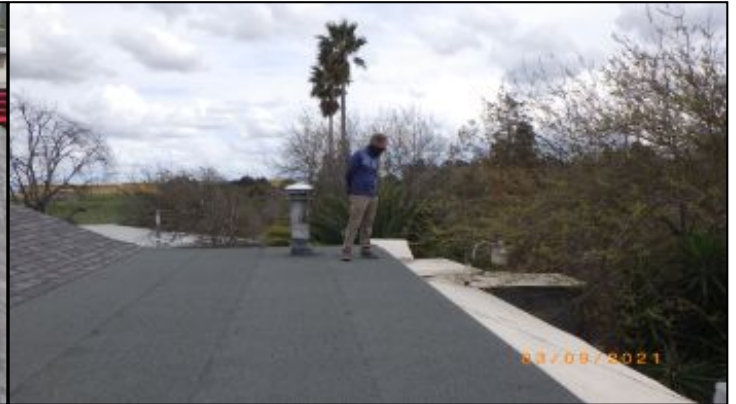
torch down section of roof

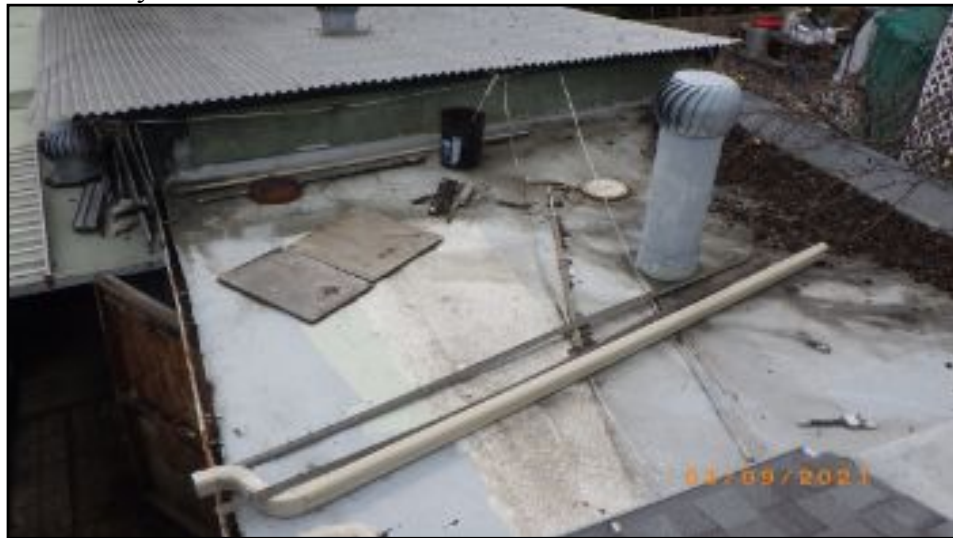
debris on roof

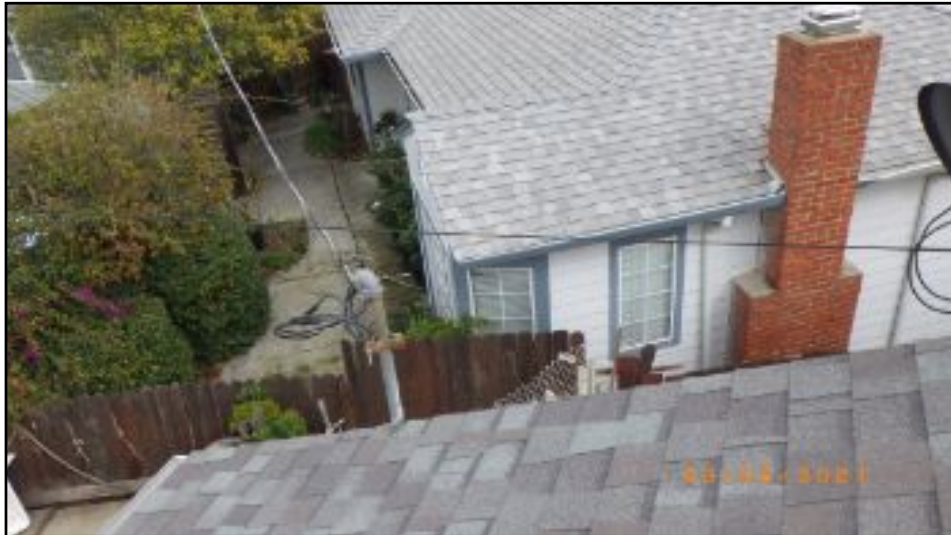
overhead service drop

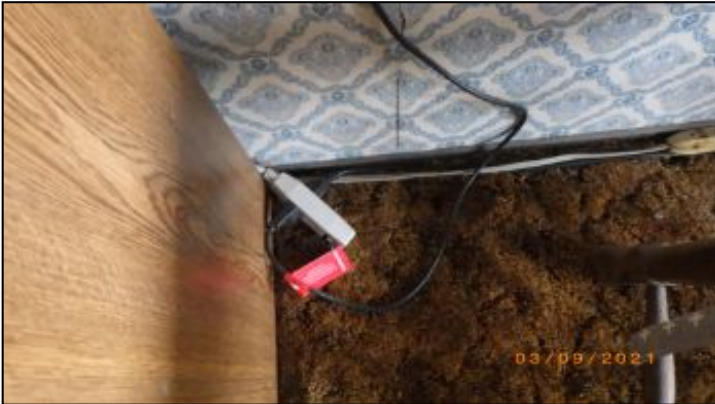
extension cords at interior

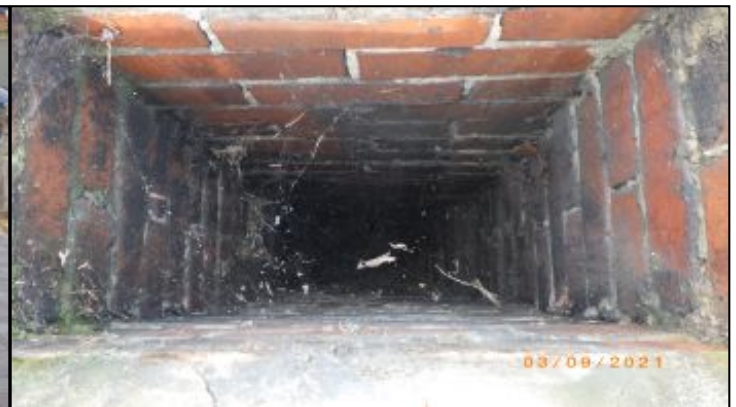
unlined masonry chimney

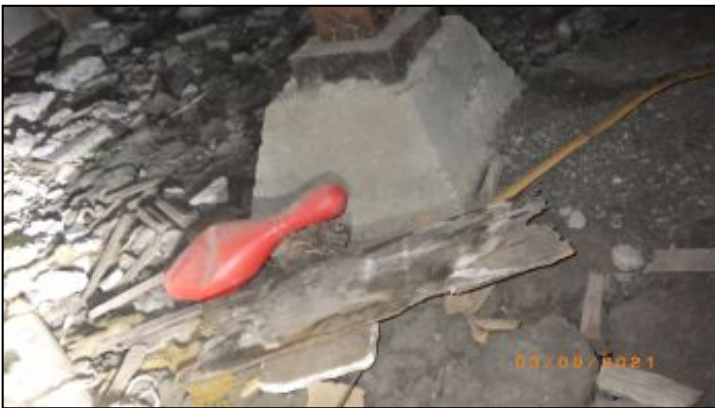
There is debris in the crawlspace. Debris in the crawlspace is conducive to insect and vermin activity. As a part of this homes routine maintenance we recommend all loose wood, electrical wire, sawdust, loose insulation be removed.

debris in crawlspace
