This **Summary Report** is meant to organize any **Moderate Recommendations** and **Significant and/or Safety Concerns** into a shorter, straight to-the-point format. It does not, however, include **Upgrade/Maintenance** recommendations or Informational data that can be found in the Full Report.

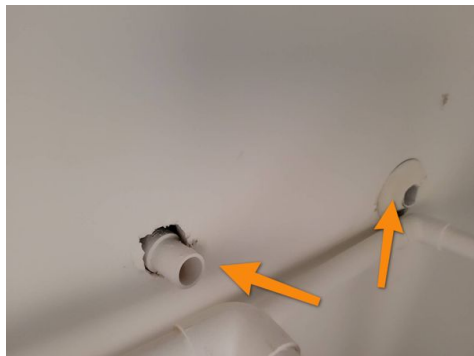
Abandoned old pipe system
