CONDITION ASSESSMENT OF LARGE DIAMETER CAST IRON OUTFALL PIPES UNDER PIERS 33 & 35 IN THE SAN FRANCISCO BAY

JDH CORROSION CONSULTANTS, INC.

12/7/2017

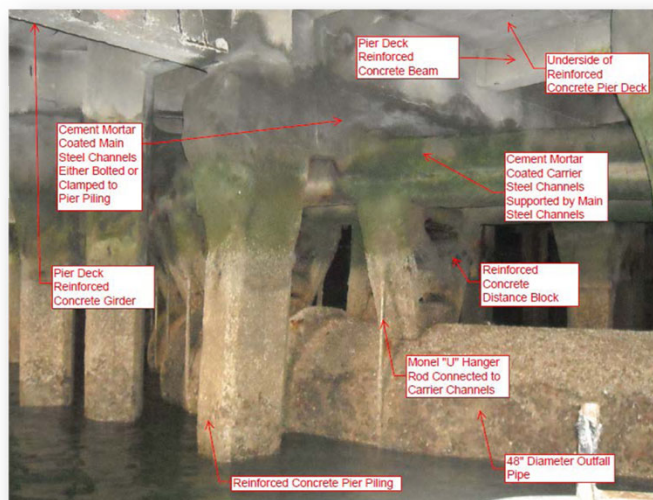
EXTERNAL INSPECTIONS WERE CONDUCTED DURING LOW TIDE AS THE OUTFALL PIPES ARE TOTALLY SUBMERGED DURING HIGH TIDE.

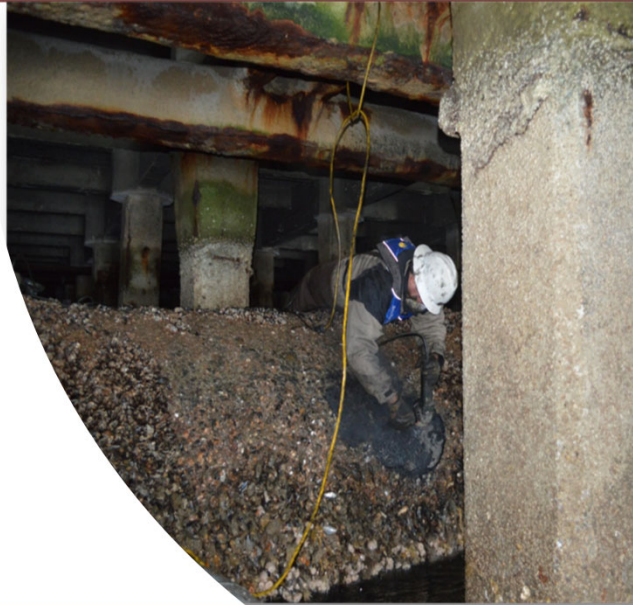
MARINE GROWTH REMOVAL

REMOVAL OF MARINE GROWTH AND MORTAR COATING TO PERFORM INSPECTION ON EXTERIOR OF OUTFALL PIPELINE.

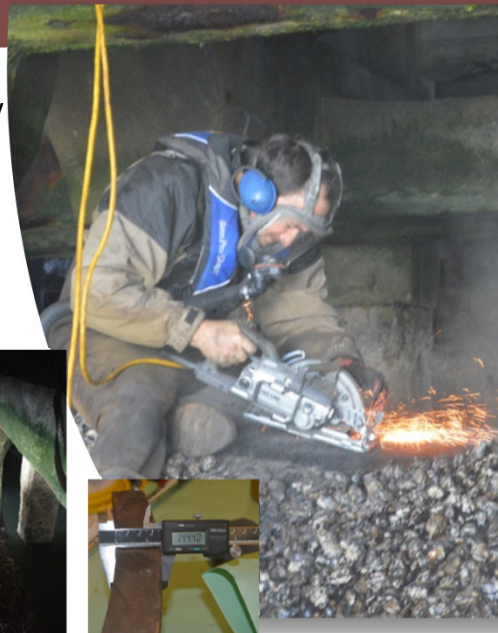
A piece of abandoned section of 33 B South was removed to construct a calibration block for the UT equipment

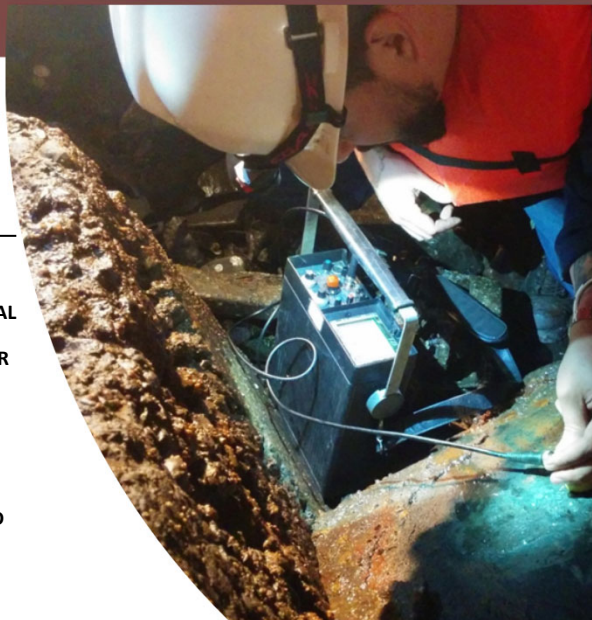
LOCATIONS OF MAXIMUM INTERNAL CORROSION WERE LOCATED BY DIVERS WORKING ON THE INTERIOR OF THE FLOODED PIPE

THESE AREAS WERE IN TURN LOCATED ON THE EXTERIOR OF THE PIPE WHERE WALL THICKNESS WAS MEASURED USING THE CALIBRATED UT EQUIPMENT

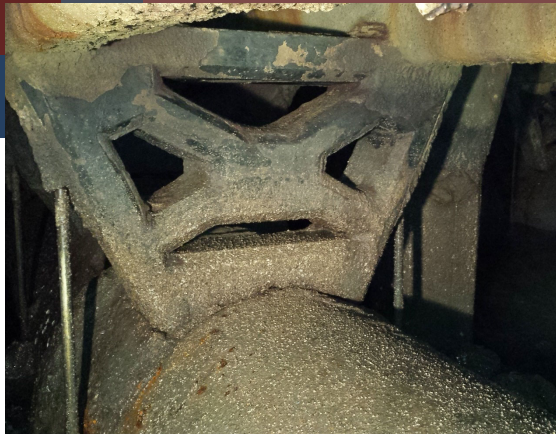
Ultrasonic Thickness Testing North Point Outfall Pipelines			
Outfall Pipeline	Minimum Thickness	Maximum Thickness	Average Thickness
33A North	0.98"	1.57"	1.41"
33B South	1.30"	1.56"	1.47"
35A North	1.10"	1.65"	1.48"
35B South	1.35"	1.54"	1.45"

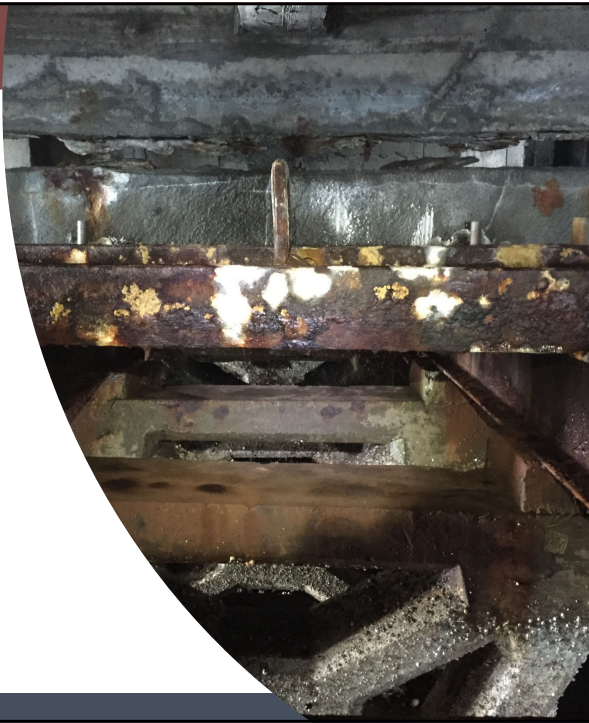
- THE SUPPORT STRUCTURES:
- DISTANCE BLOCKS
 - DELAMINATION TESTING
 - TESTING PERFORMED PER ASTM C4580
 - PHENOLPHTHALEIN TESTING
 - PINK COLOR IS ACTIVATED AT A PH OF 8.4
- THE DISTANCE BLOCKS WERE FOUND TO BE IN GOOD CONDITION
- TRANSVERS & LONGITUDINAL BEAMS
 - STEEL MESH & CONCRETE COATING WAS REMOVED AT SELECTED LOCATIONS TO INSPECT UNDERLYING STEEL
 - THE UNDERLYING STEEL BEAMS WERE FOUND TO BE IN FAIR CONDITION. FURTHER INVESTIGATION AND RECOATING WAS RECOMMENDED
- ALLOY 400 (MONEL) HANGER RODS
 - SOLID MONEL ROD HANGERS
 - THE ROD HANGERS WERE FOUND TO BE IN EXCELLENT CONDITION

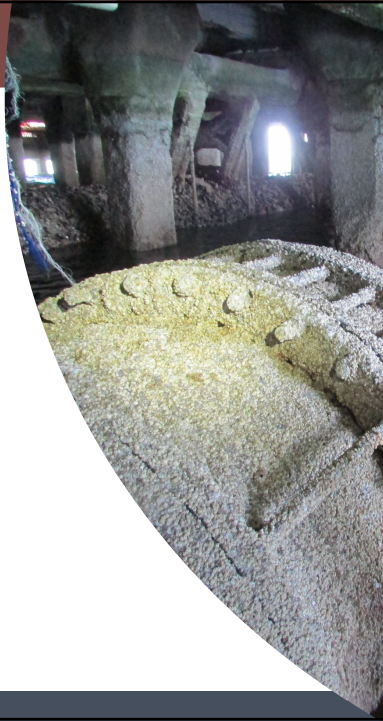
- AVERAGE PIPE THICKNESS OF 1.45 INCHES
- IMPLIES CATEGORY OF A CLASS B PIPE UNDER THE AWWA STANDARDS
- BASED ON THIS THE OUTFALL PIPELINES WOULD BE RATED FOR 200-FOOT OF HEAD OR 86 POUNDS OF PRESSURE (PSI), WHICH GREATLY EXCEEDS THE REPORTED MAXIMUM OPERATING PRESSURES FOR THESE PIPELINES (I.E. 16-FOET OF HEAD OF 7 PSI
- THE PIPE IS IN GOOD CONDITION AND CAN BE UTILIZED FOR ADDITIONAL 30 YEARS AFTER INTERNAL LINING AND EXTERNAL CATHODIC PROTECTION
- THE PIPE SUPPORTS WILL NEED COATING AND REPAIRS
