Re: Storm Related Structural Glazing Assessment

TSSA Project # [REDACTED] - 2021-10-29

Final Report Dated - 3/17/2022

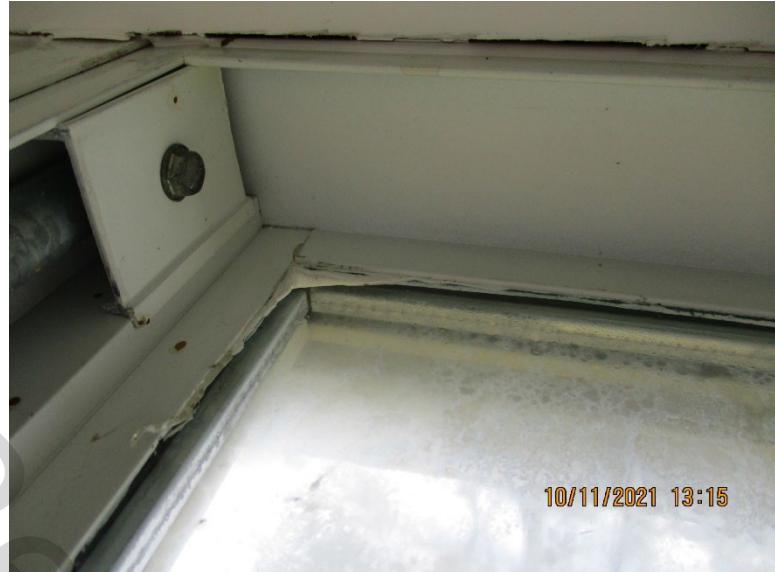
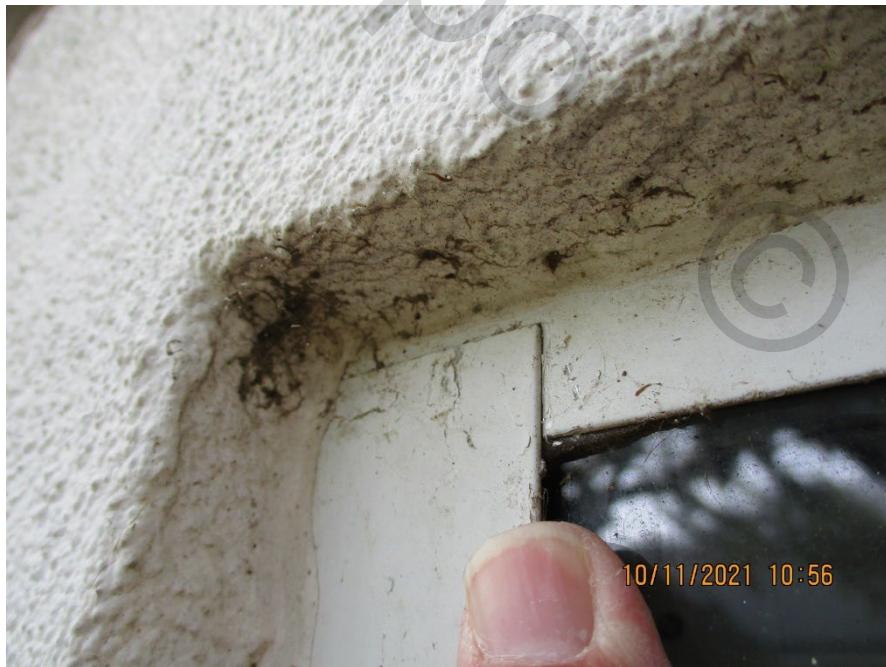
During our investigation of the [REDACTED] residence, our inspectors witnessed Sealant Disruption created from high wind buffeting and system movement. The buffeting of the systems during a high wind event allowed the glazed lites and frame systems to vibrate and move within their installed position. This movement allowed the glazing sealant to avulse from its installed position between the glass lite and the glazing stool.

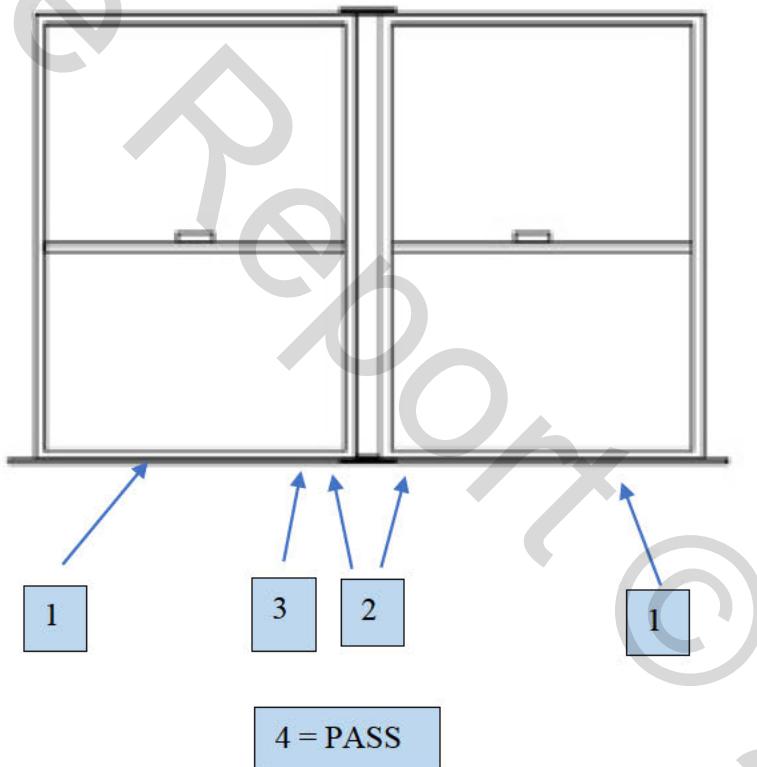
Double Mulled Single Hung Window

Location	System Type:	Window Observation Cycle Number:	Flow Rate (Gal/min)	Water Pressure (PSI)	Vacuum Pressure (in of H ² O)	Result	Time
Spec 1	GA	2SH	2	7.5	12 PSI	0.19	F 1:49
Spec 2	LR	2SH	1	7.5	12 PSI	0	F 1:48
Spec 3	LR	2SH	3	7.5	12 PSI	0.39	F 0:37
Spec 4	LR	2SH	4	7.5	12 PSI	0.58	P 5:00

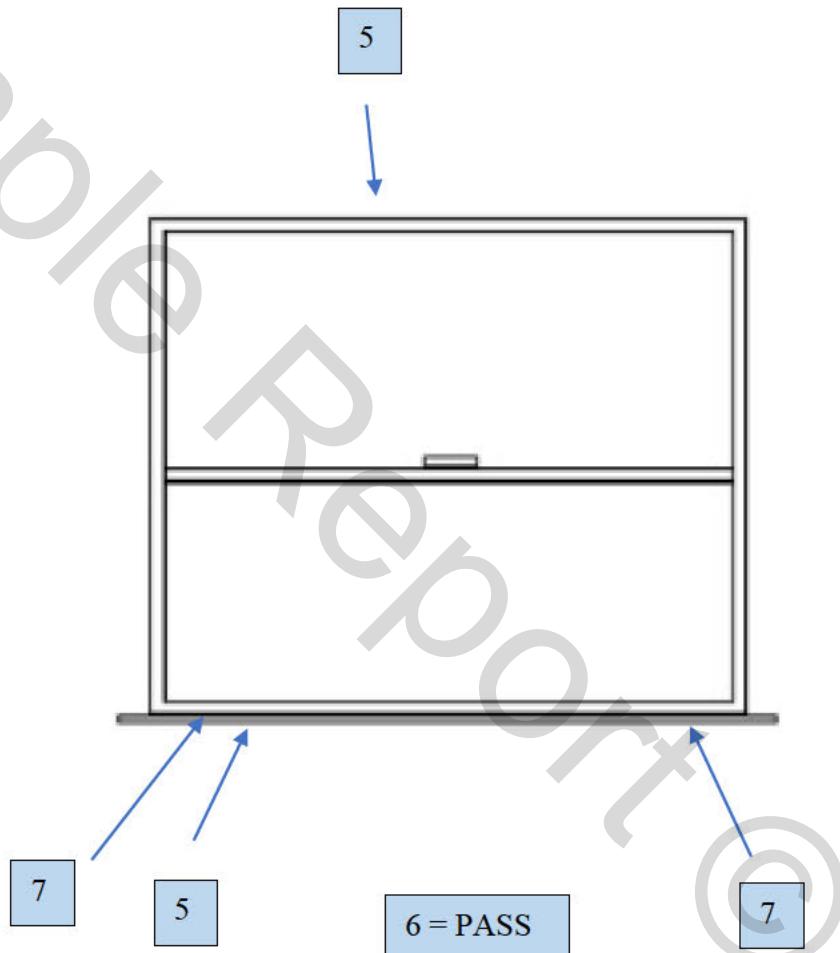
Single Hung Window

Location	System Type:	Window Observation Cycle Number:	Flow Rate (Gal/min)	Water Pressure (PSI)	Vacuum Pressure (in of H ² O)	Result	Time
Spec 5	D	SH	4	7.5	12 PSI	0.68	F 3:40
Spec 6	D	SH	4	7.5	12 PSI	0.68	P 5:00
Spec 7	3BR	SH	3	7.5	12 PSI	0.65	F 1:49

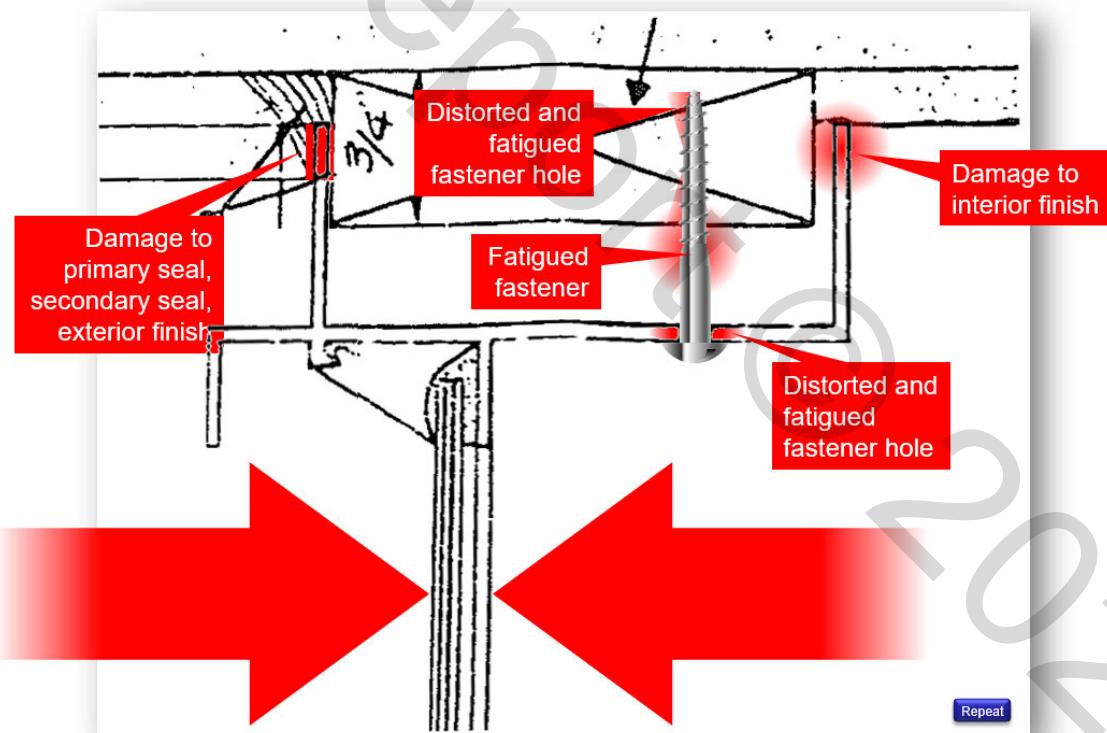
This photograph was taken during a cyclic pressure test of a single hung window system. This photograph demonstrates how high wind speed, pressure, and buffeting force affects glazed systems during a Hurricane. The rapid positive and negative cyclic movement and high wind buffeting create separations and disruptions in a window system framing joints, installation fasteners, and glazing system causing failure in the components allowing water to penetrate through the exterior building envelope into the interior living space.

Physical damage created by Hurricane
High Wind Buffeting, Speed, and Pressure.

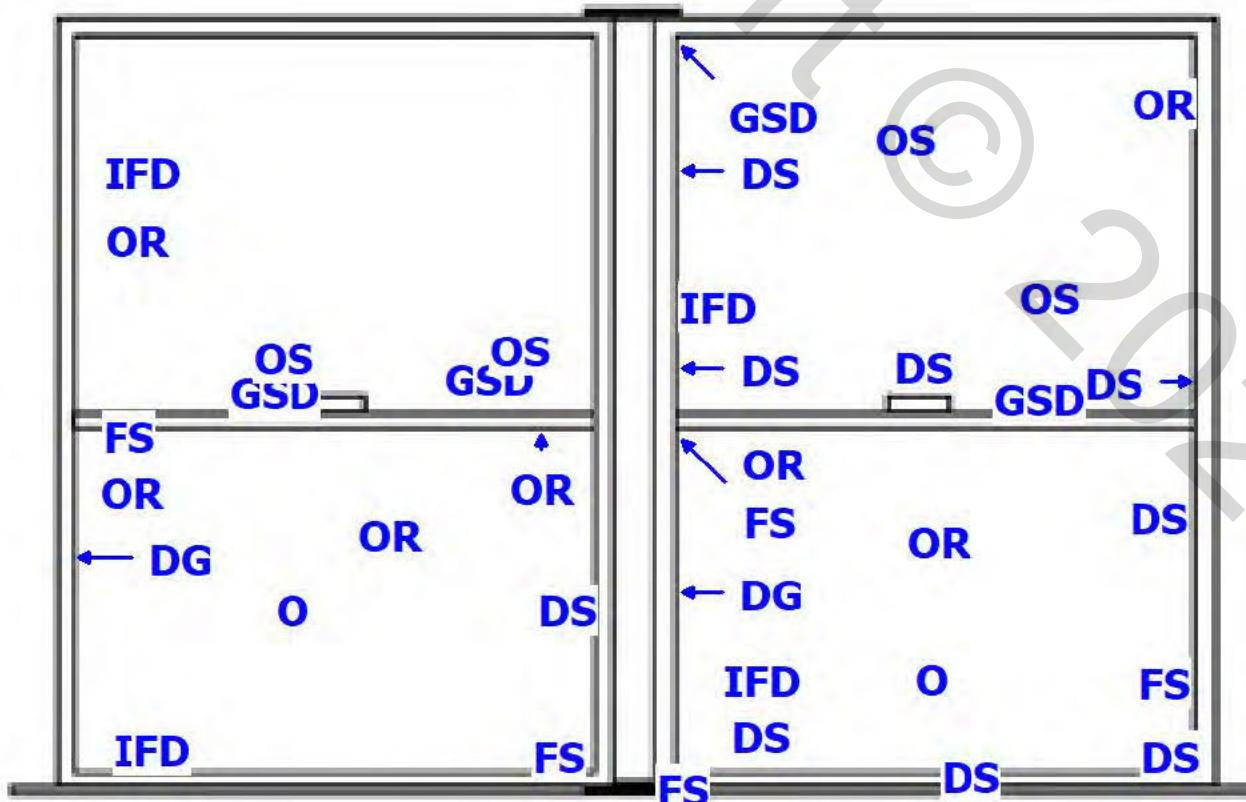
WINDOW CODE: 2SH_71X60

Project: 1 Residence
Building #/Letter: 1 Stack: A
Floor: 1 Unit: XXXXXXXXXX
Room: Foyer / Specimen #: 2 Facing: E / Corner Unit: No

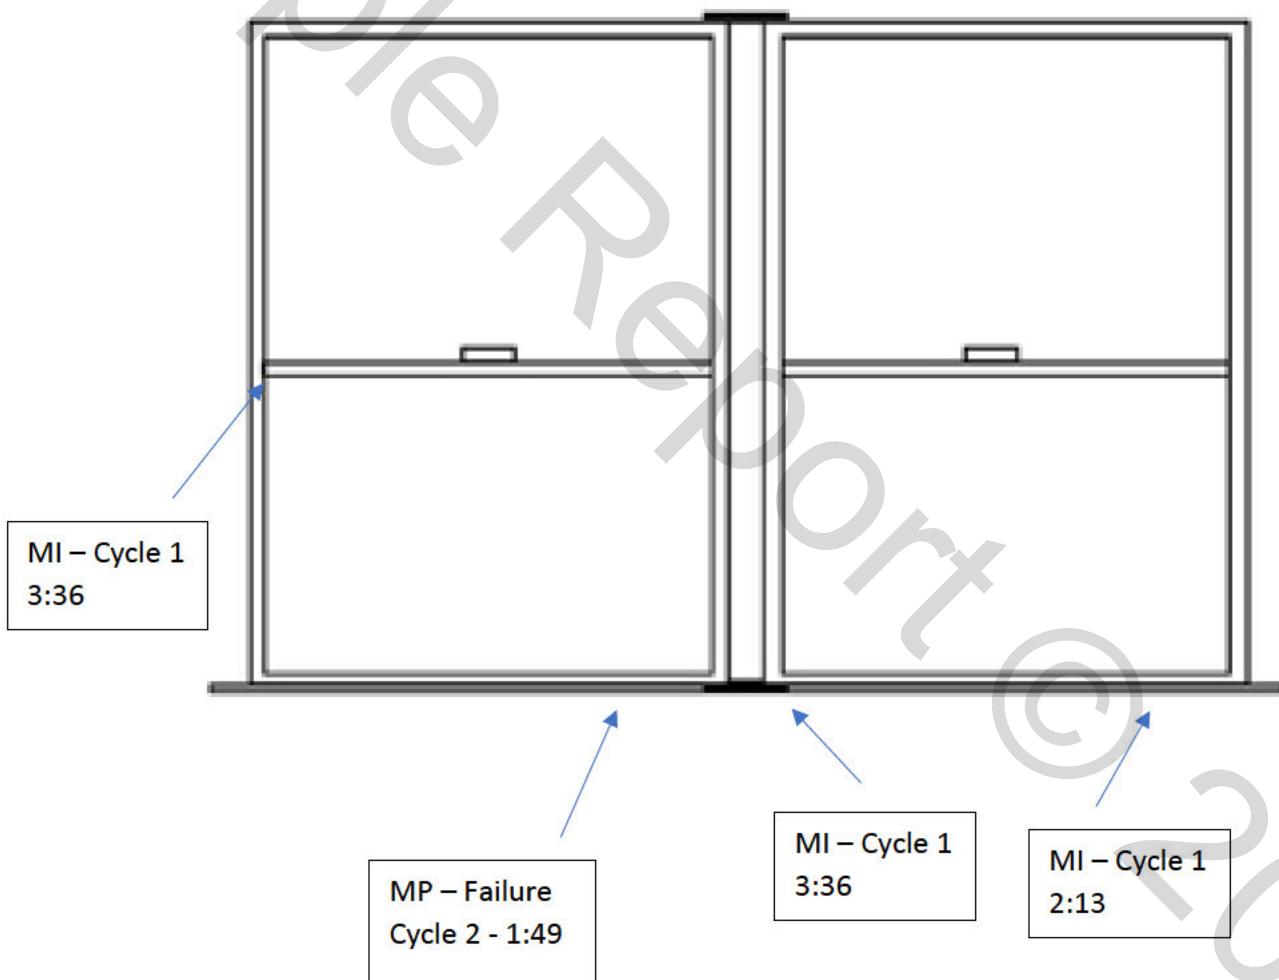
**Water PENETRATION DIAGRAM**

WINDOW OBSERVATION CYCLE NUMBER	FLOW RATE (Gal/Hr./Sq Ft.)	WATER PRESSURE (PSI)	VACUUM PRESSURE (in of H ² O)	PASS/FAIL	Time
1	7.41 (g/h/sf)	12 psi	0	P	5:00 min
2	7.41 (g/h/sf)	12 psi	0.19	F	1:49 min
0	7.41 (g/h/sf)	12 psi	0		
3	7.41 (g/h/sf)	12 psi	0.39		
0	7.41 (g/h/sf)	12 psi	0		
4	7.41 (g/h/sf)	12 psi	0.58

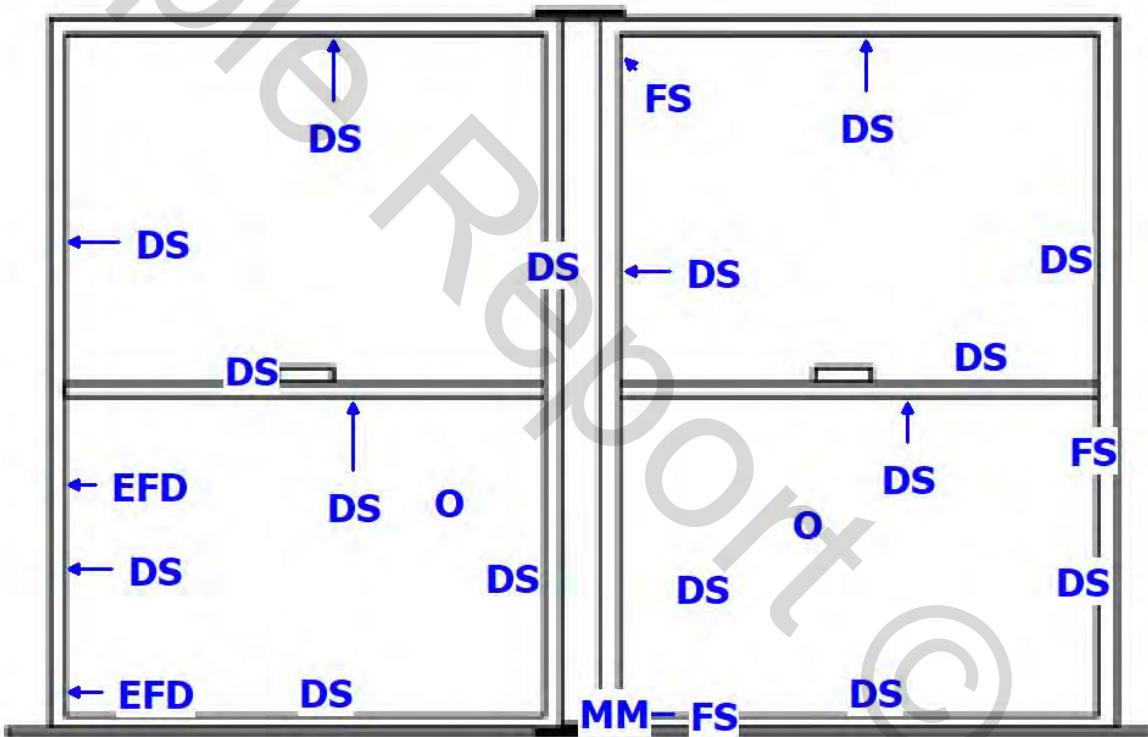
**NOTES & OBSERVATIONS****Physical Damage Assessment**

NOTE – for complete Physical Damage Assessment – see Tabby inspection results for Ga age – Sp 1

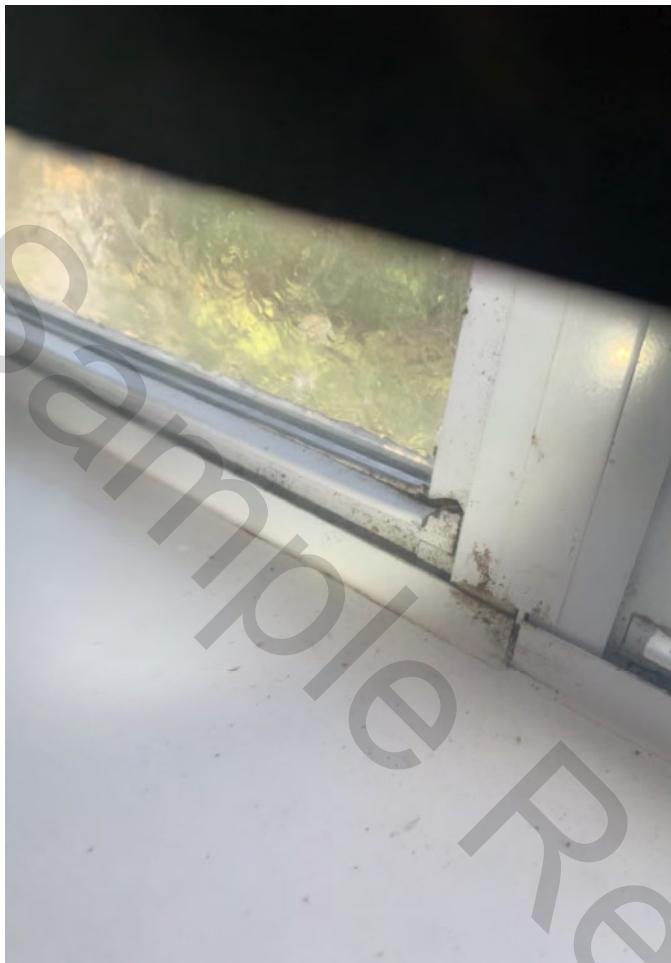
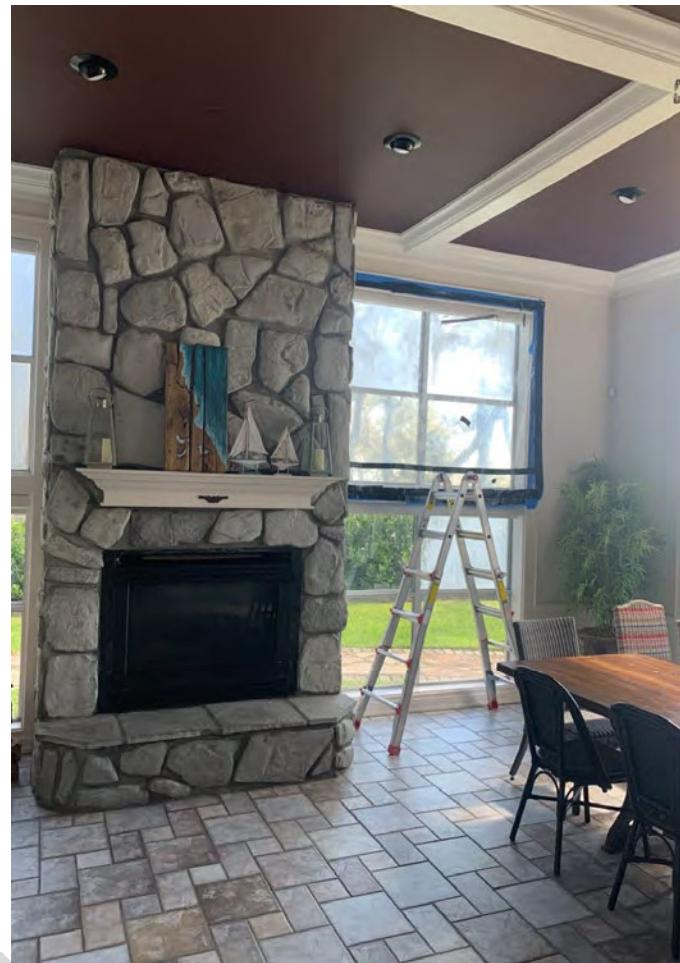
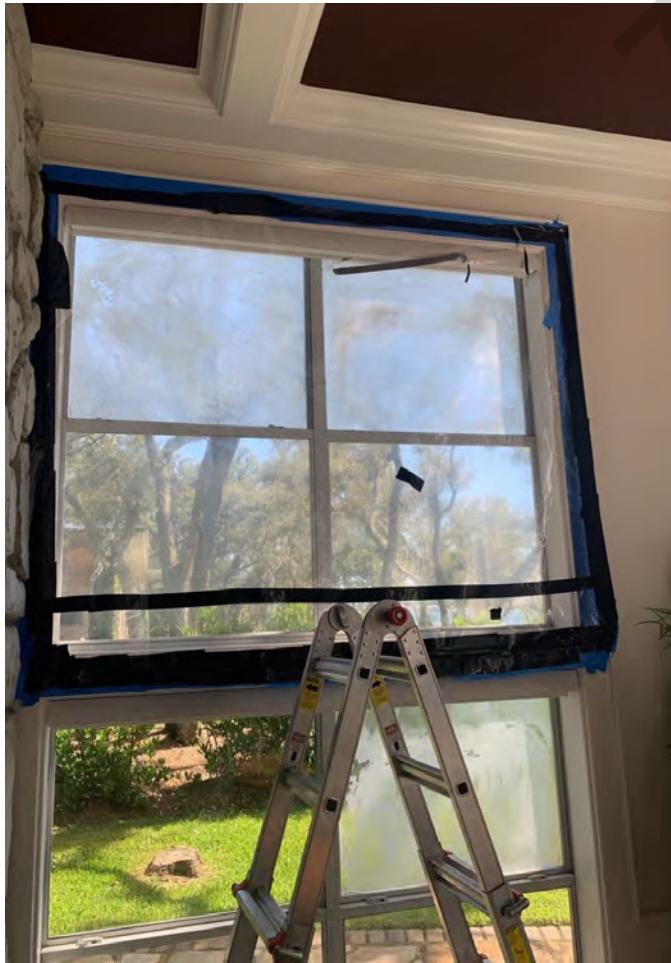
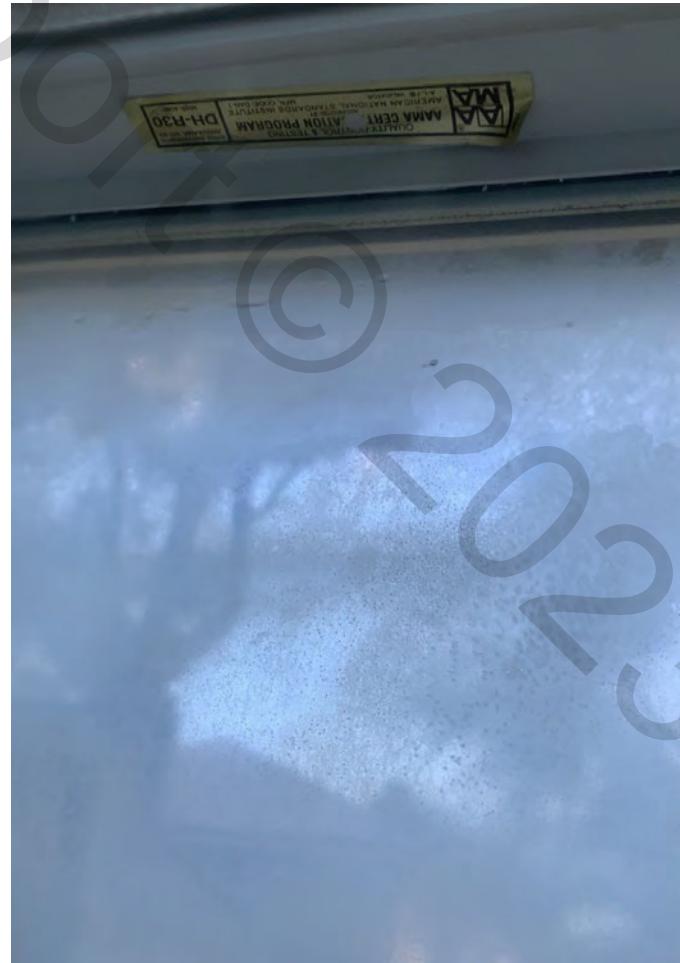
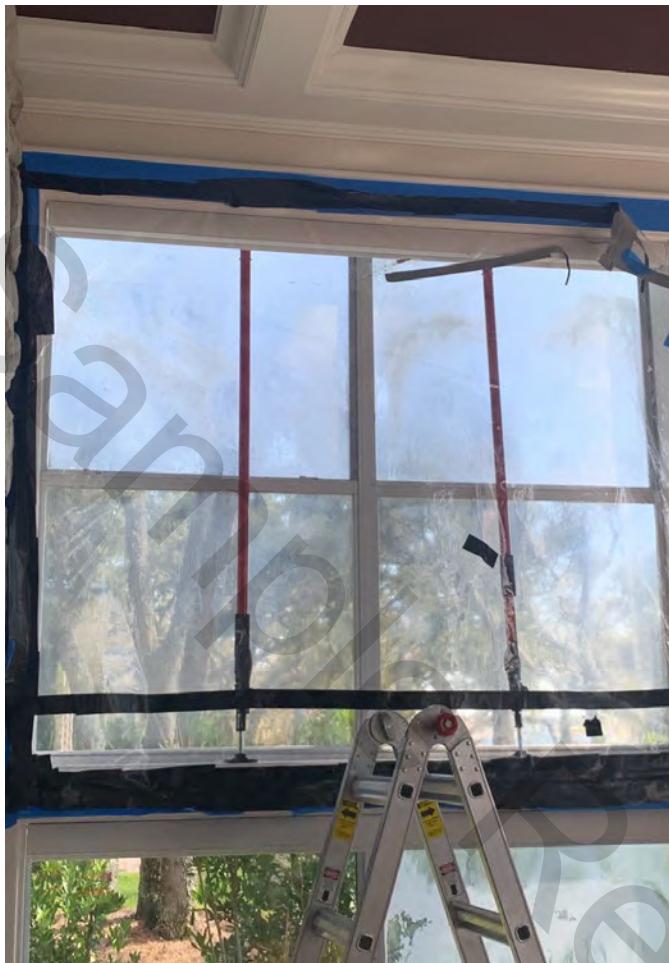
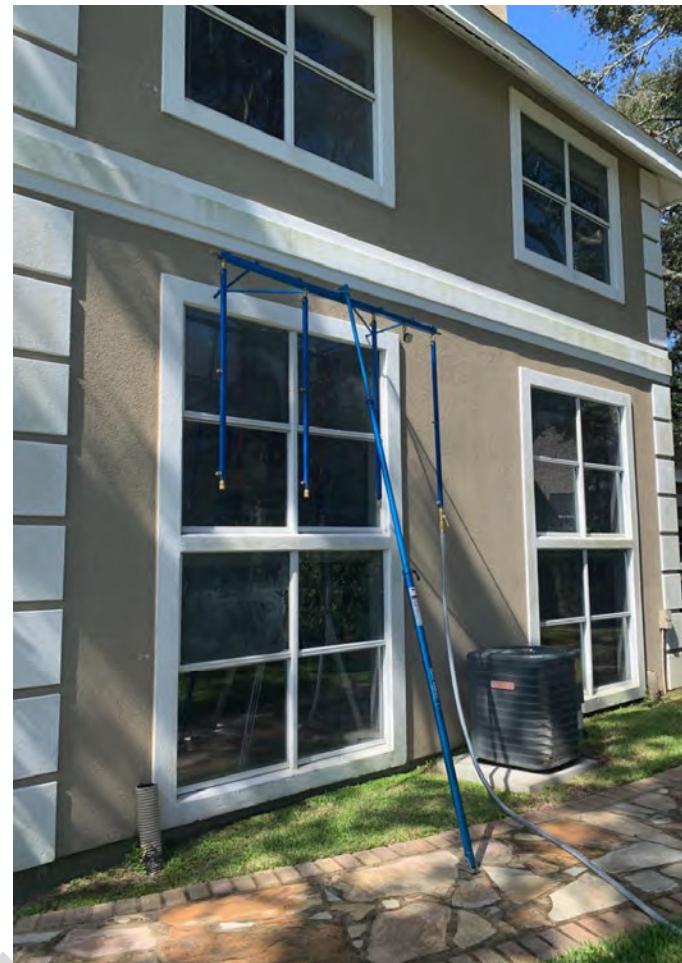
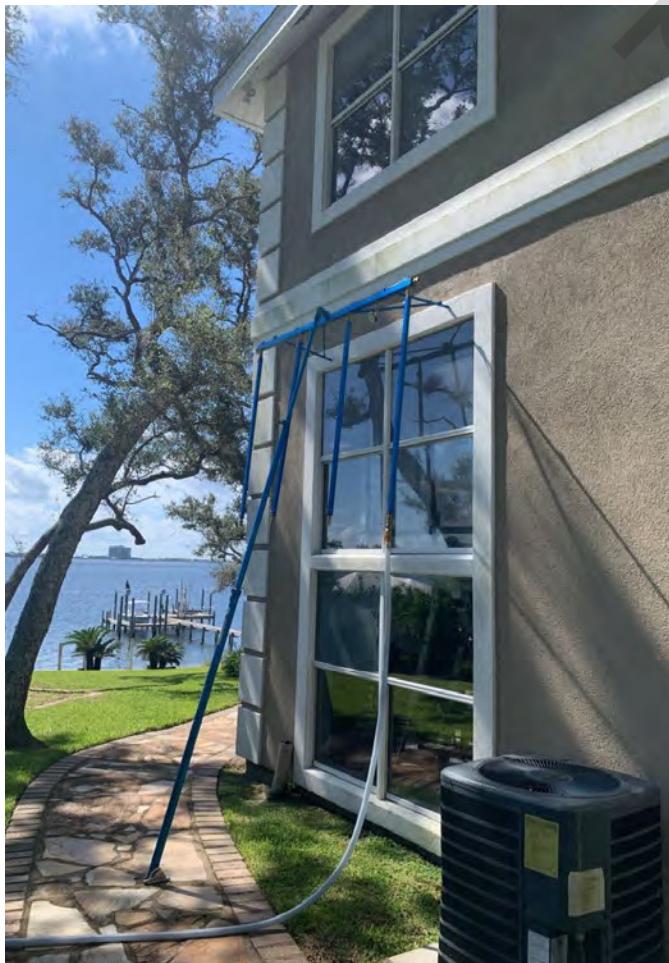
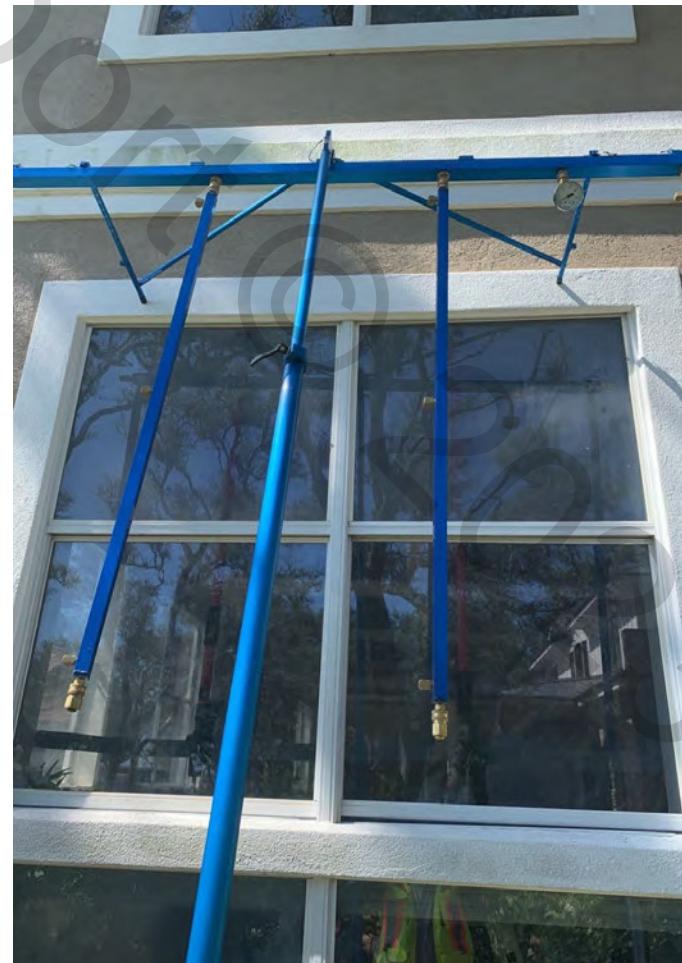
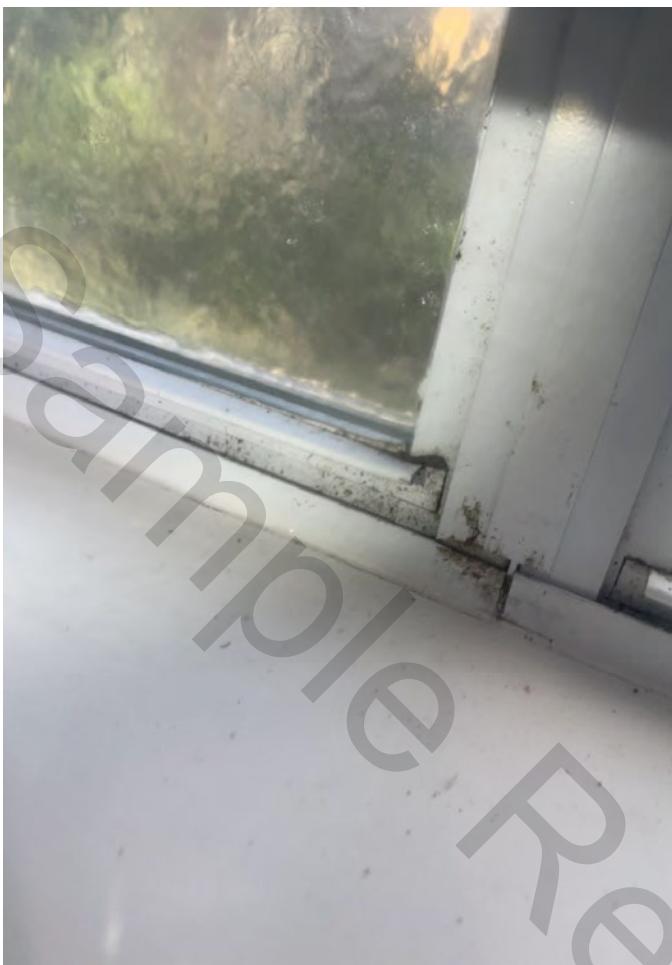
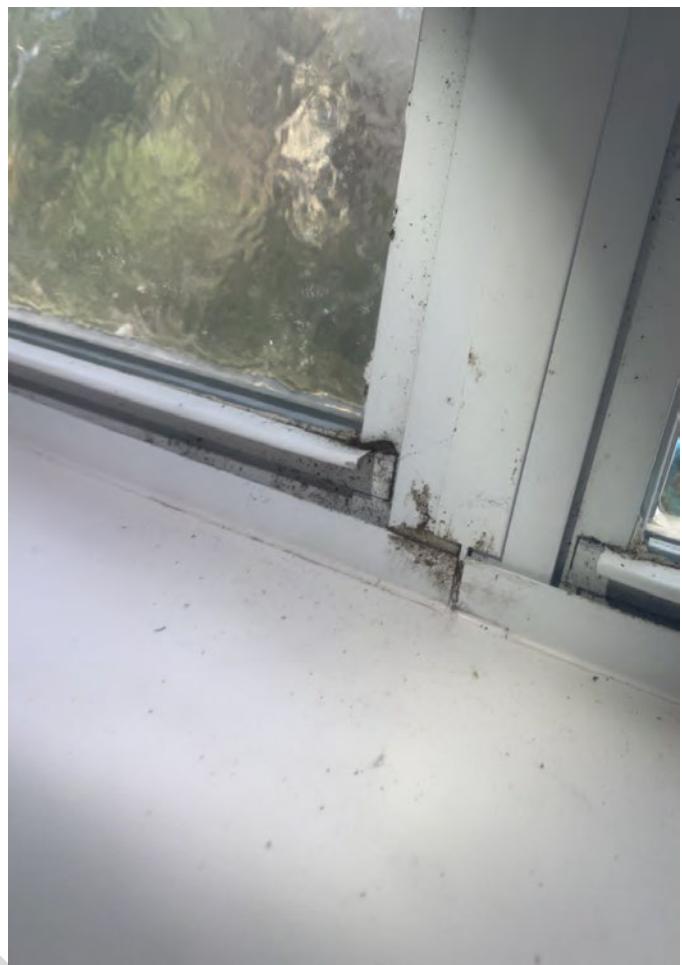
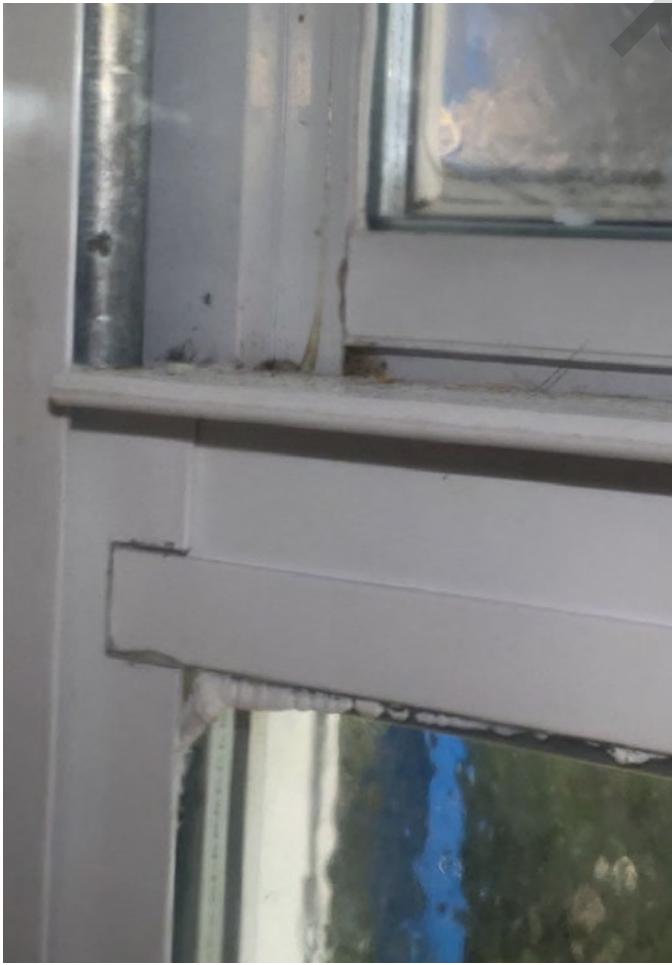
NOTE – for complete Physical Damage Assessment – see Tabby inspection results for Living Room – Spec 3.
