Glazing Inspection Report

[REDACTED]
[REDACTED]
[REDACTED]
Pembroke Pines, FL 33028

[REDACTED] Report date 8-1-21

At the request of [REDACTED] TSSA Storm Safe DAC Inc. performed a diagnostic water penetration inspection of the installed glazed systems at the [REDACTED] on the following dates:

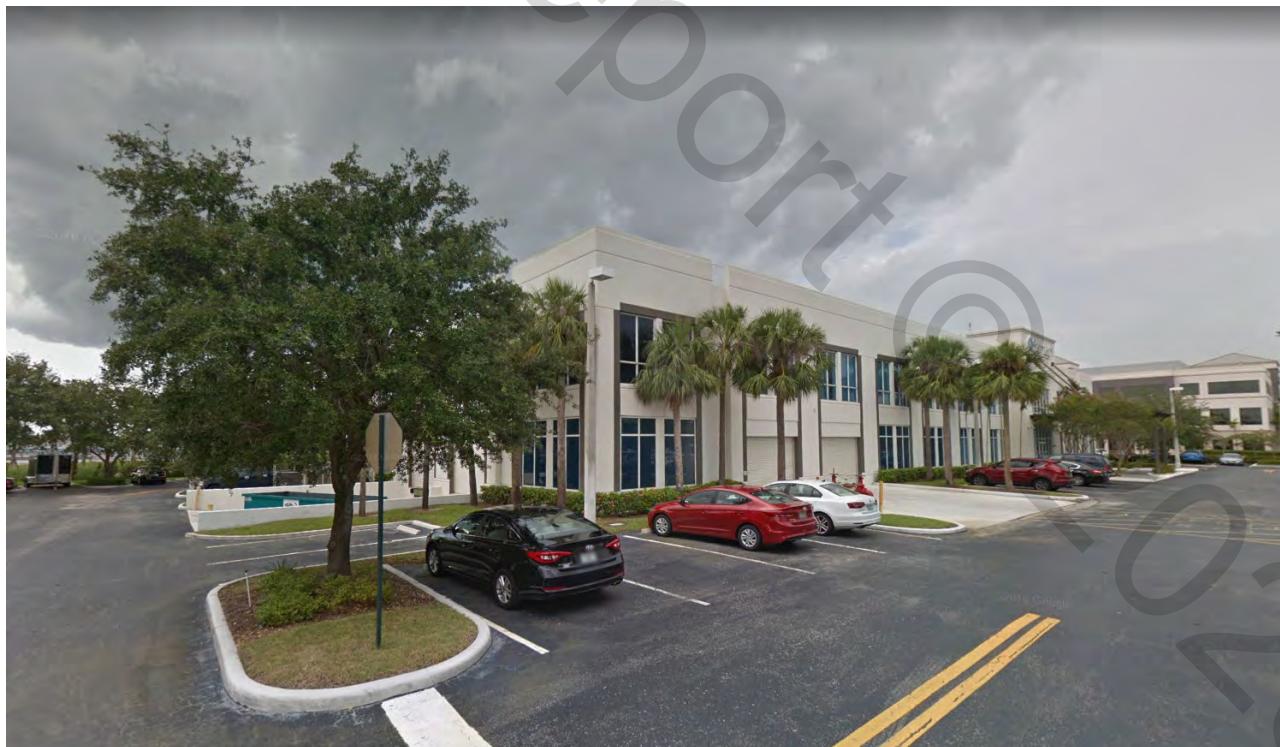
Original building footprint before renovation:

[REDACTED] explained that the facility used to be a warehouse complex constructed with overhead garage doors, concrete loading ramps, and storefront window systems. In preparation for a new occupant, the concrete loading ramps and garage doors were removed, and new sections of pre-cast concrete panels were constructed and tied into the existing structure. Openings were punched into the new wall sections and glazed with Storefront window systems to match the original building construction.

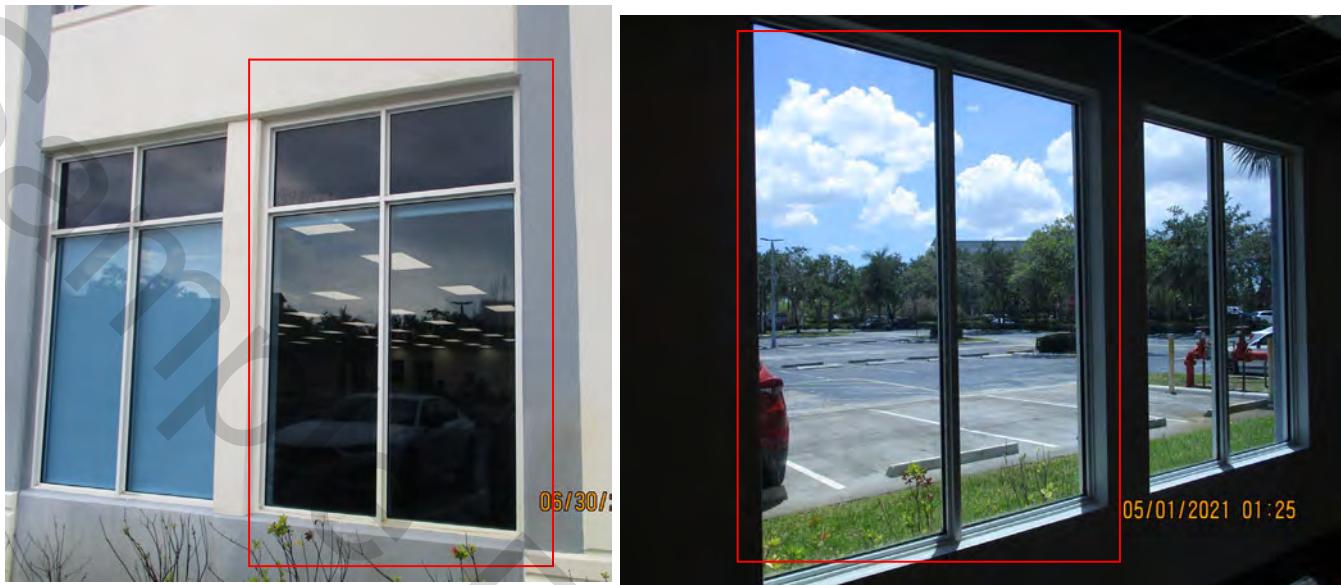
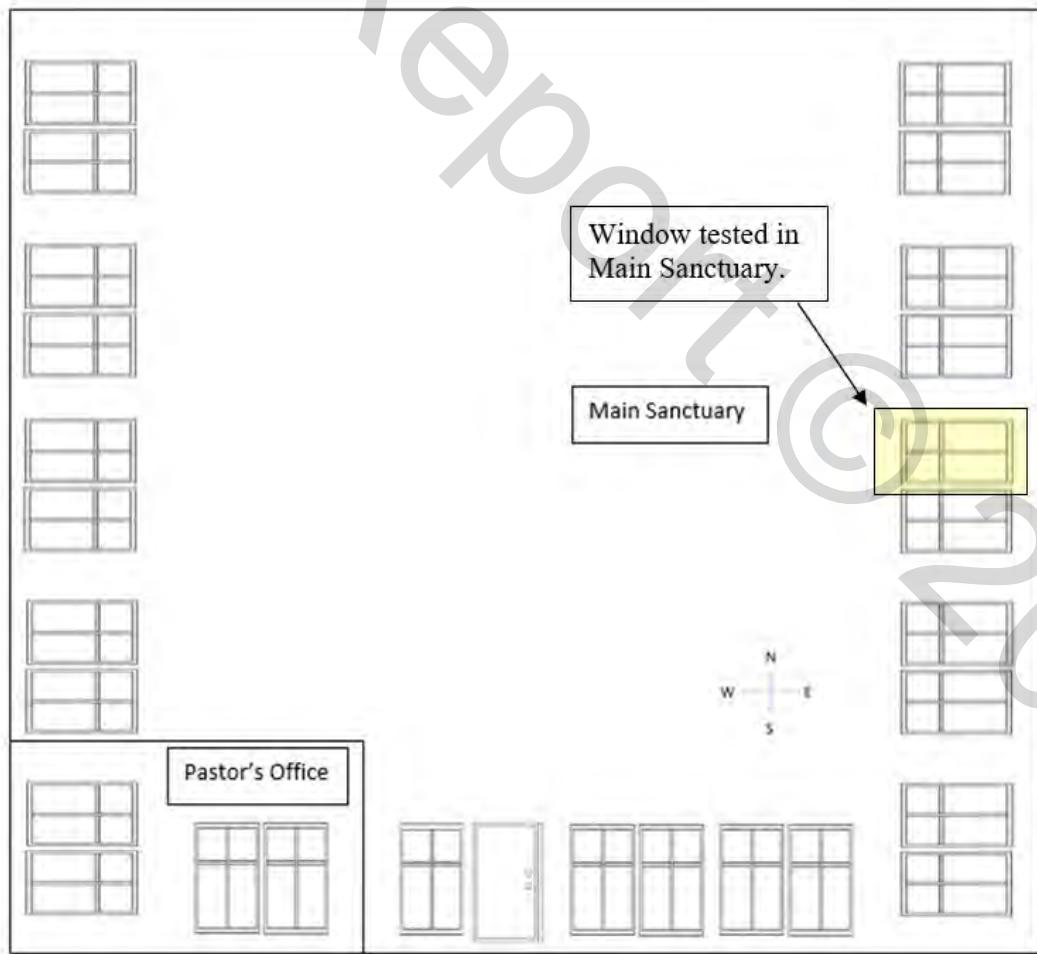
Specimen #1 – Main Sanctuary

TSSA Storm Safe DAC Inc. performed testing on one of the Storefront window systems installed within a new wall section.

The specimen was the 6th east-facing window assembly from the Southeast corner of the building.

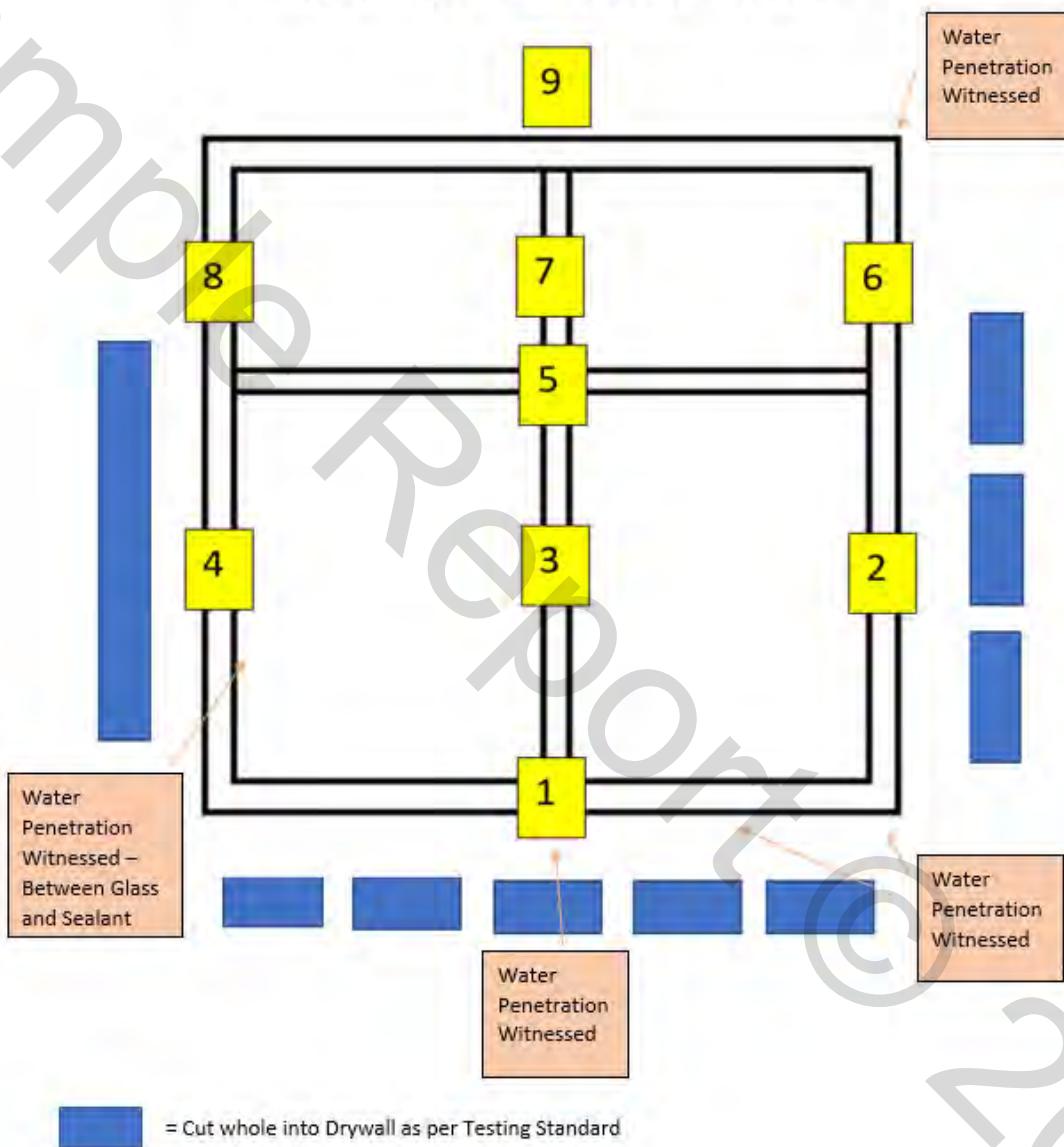
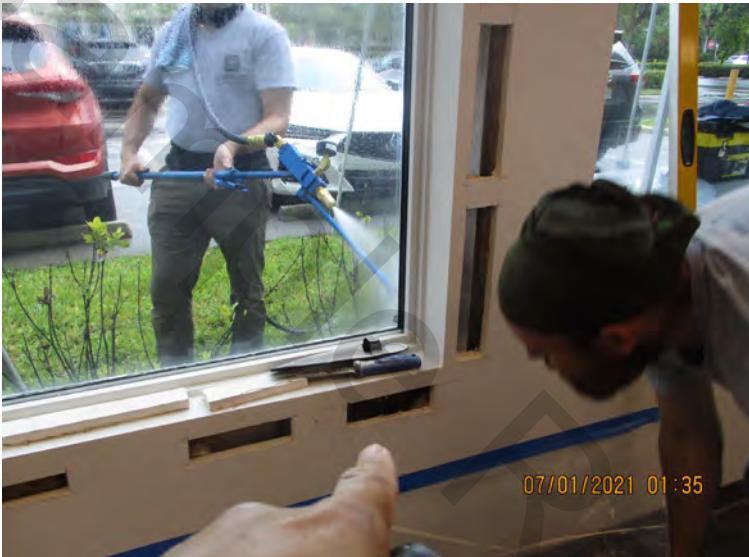
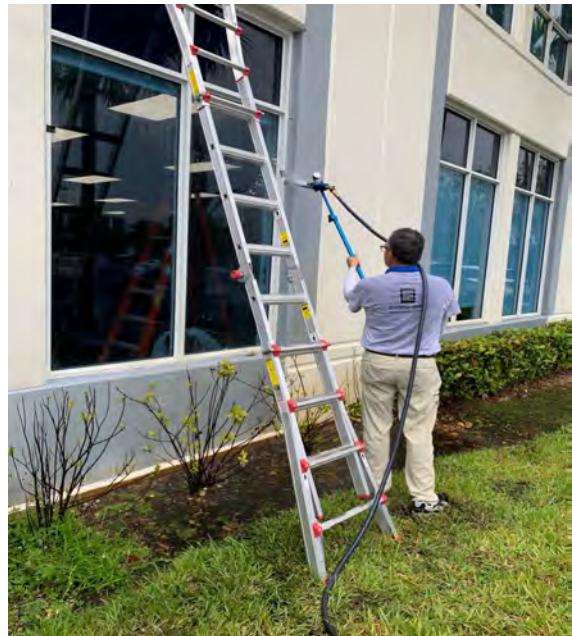
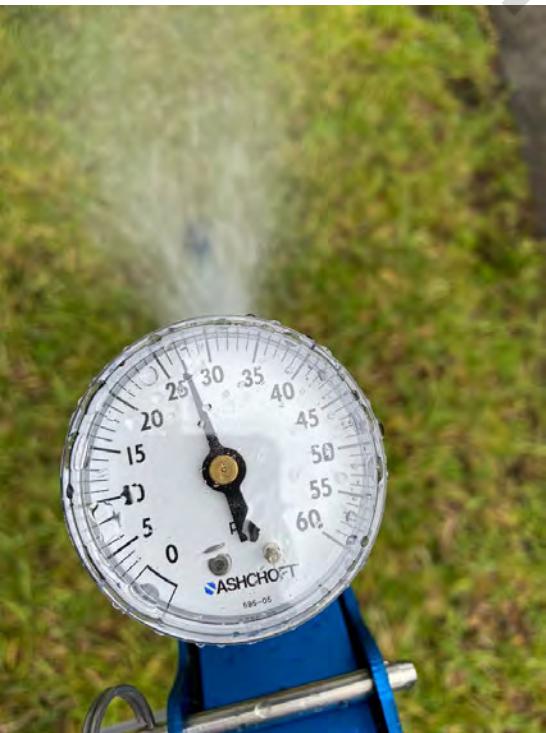
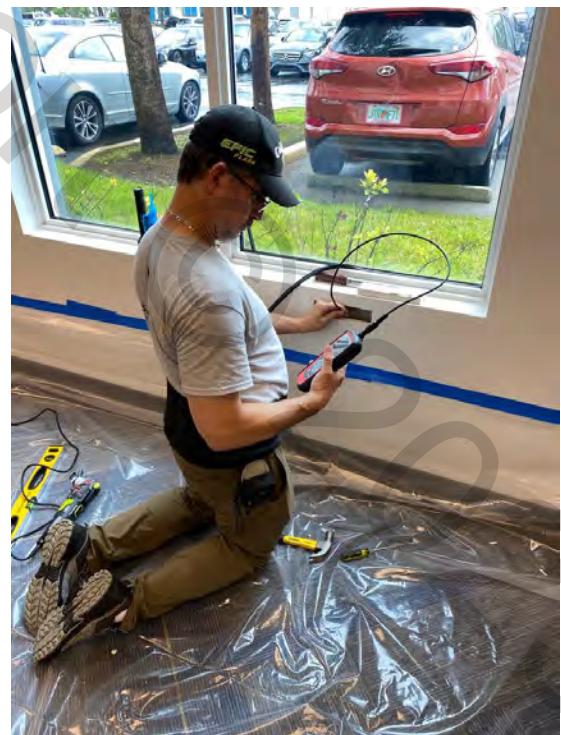
Interior View – Inspection Results

Step	Mullion type	Frame member (Interior view)	Mullion Testing Size				# Of 5 ft testing lengths per mullion	Minutes of testing	Water Penetration Witnessed (interior view)
1	Horizontal Mullion	Sill Frame Member	69.3	in.	5.77	ft.	1.154	5.77	1. Directly under Intermediate Vertical Mullion at Sill 2. Below right jamb at sill connection
2	Vertical Mullion	Right Jamb	54	in.	4.50	ft.	0.900	4.50	1. Below right jamb at sill connection
3	Vertical Mullion	Intermediate Vertical	54	in.	4.50	ft.	0.900	4.50	1. Directly under Intermediate Vertical Mullion at Sill
4	Vertical Mullion	Left Jamb	54	in.	4.50	ft.	0.900	4.50	1. Water witnessed at glass lite between the exterior sealant and foam glazing tape
5	Intermediate Horizontal	Intermediate Horizontal	69.3	in.	5.77	ft.	1.154	5.77	1. Directly under Intermediate Vertical Mullion at Sill 2. Below right jamb at sill connection
6	Vertical Mullion	Right Jamb	54	in.	4.50	ft.	0.900	4.50	1. Below right jamb at sill connection 2. At Head to Right jamb Connection point

7	Vertical Mullion	Intermediate Vertical	54	in.	4.50	ft.	0.900	4.50	1. Directly under Intermediate Vertical Mullion at Sill
8	Vertical Mullion	Left Jamb	54	in.	4.50	ft.	0.900	4.50	None
9	Horizontal Mullion	Head Frame Member	69.3	in.	5.77	ft.	1.154	5.77	1. At Head to Right jamb Connection point
			Totals	44.31	ft.	8.863	44.31

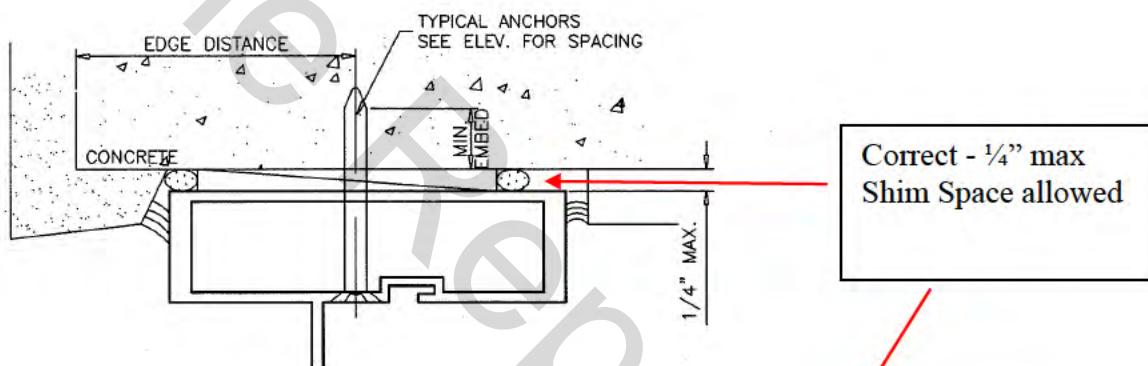
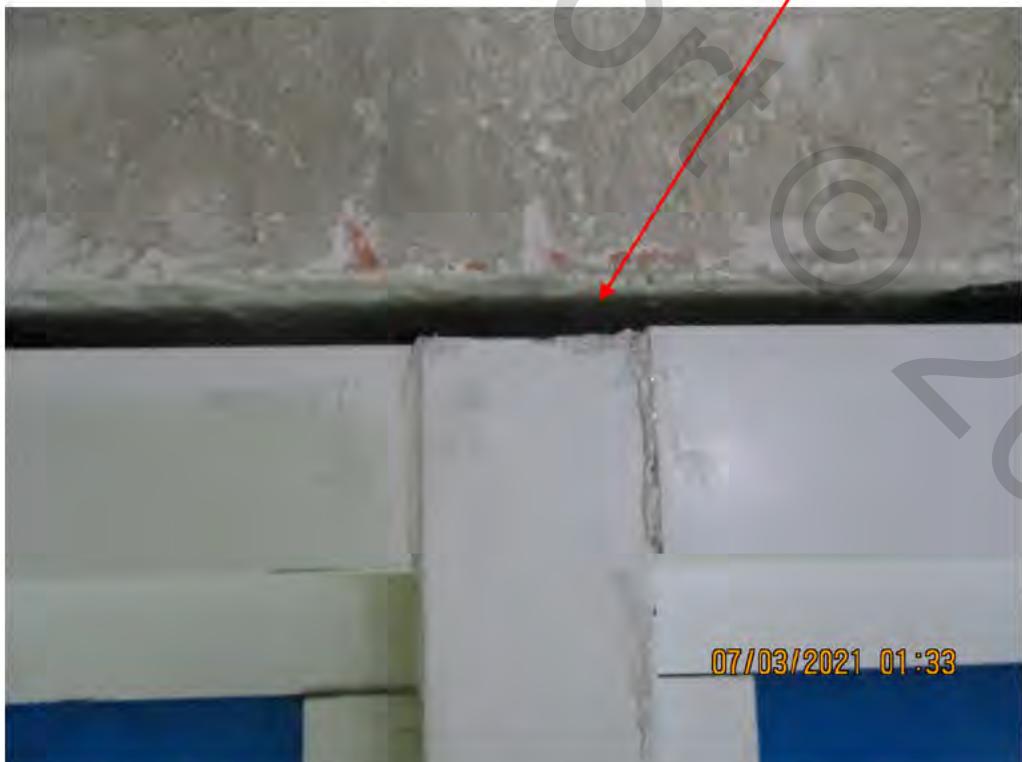
Page 9 of 11 in the Miami Dade NOA 17-1017.16 allows for the installation of the Storefront System into concrete with no bucking, as long as the min embedment into the concrete is adhered to, and the system is shimmed with $\frac{1}{4}$ " max space between the Masonry Opening and the system frame.

The window systems installed into the new punch openings were installed contrary to the directions outlined in the Miami Dade NOA 17-1017.16. An Example of the correct shim space for installation into concrete is shown below:

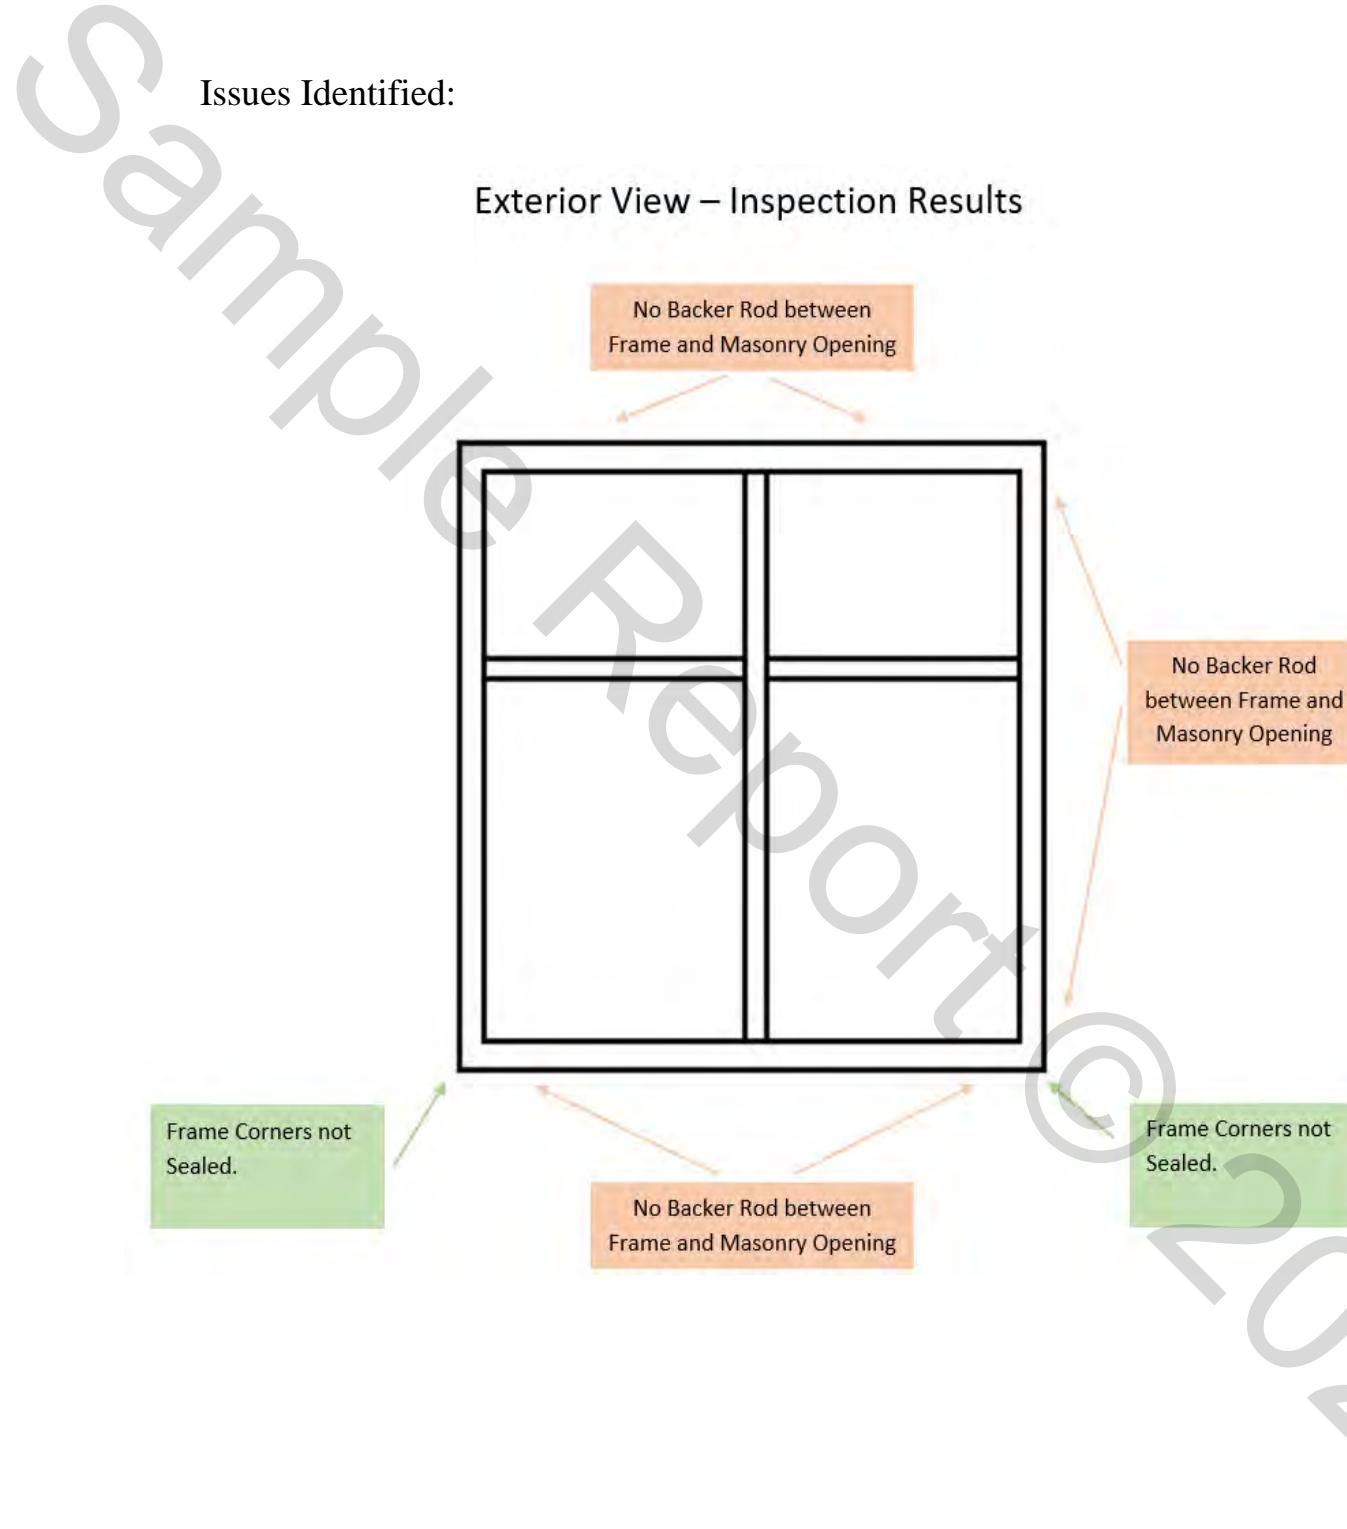
TSSA Storm Safe DAC, Inc. and [REDACTED] were able to identify several key issues that were found to contribute to the Water Penetration through the Storefront system inspected.

1. Backer Rods not found installed between the Head, Right Jamb, and Sill frame members and the Masonry Opening.

2. Rolled-up paper was found to be used as a Backer Rod between the Head Frame member and Masonry Opening.

6. The Glass panes were found to be resting on small pieces of hard plastic shim material, which did not correctly support the entire width of the glazing edge.

7. One of the Glass lites was found to be 1/2" short, allowing excess space between the edge of the glass lite and the glazing frame.

8. Frame Corner joints and End Dams were not sealed before glass installation.

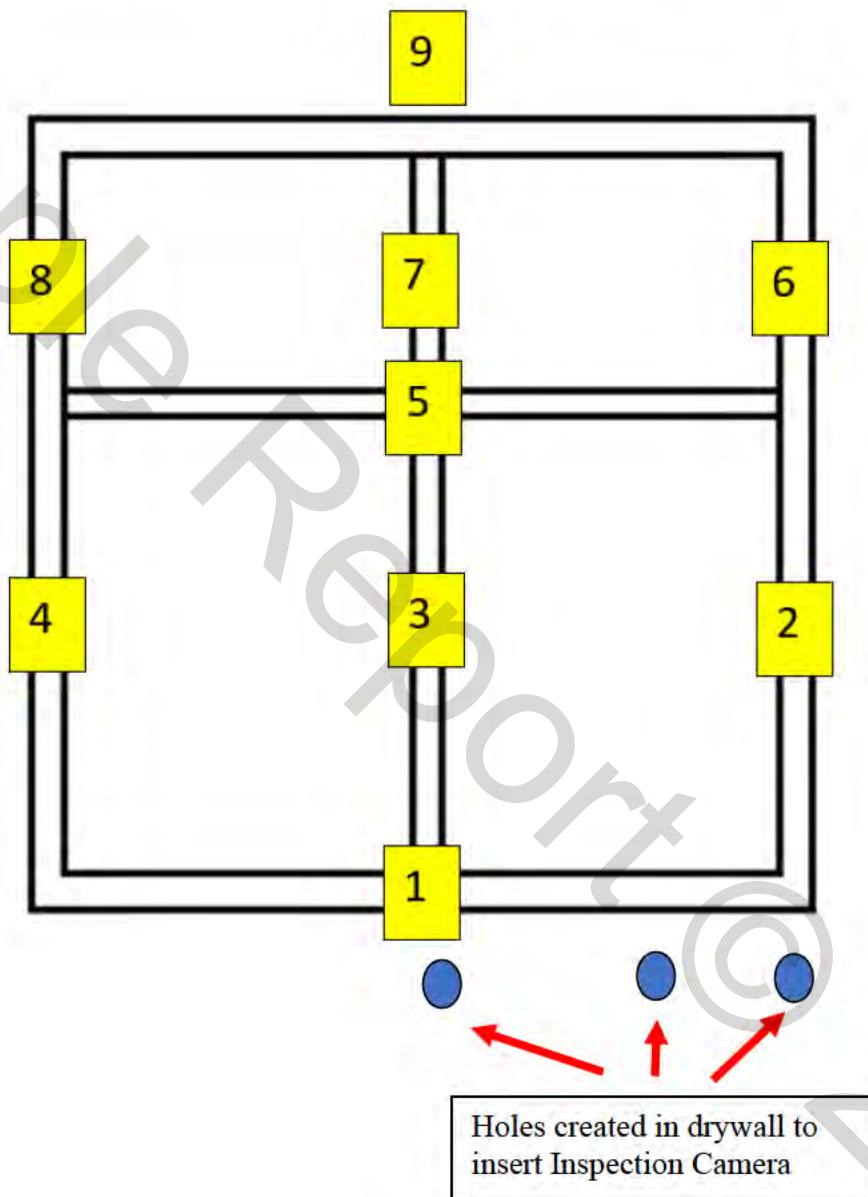
Interior View – Inspection Results

Upon following the prescribed testing protocol during the re-test, it was verified that no water was witnessed penetrating the exterior of the storefront system into the interior wall.
