Glazing Inspection Report

XXXXXXXXXXXXXXXXXXXX
CONDOMINIUM ASSOCIATION.
1234 NE Testing Street
Anytown, USA
SAMPLE - Report date XXXXXXXX

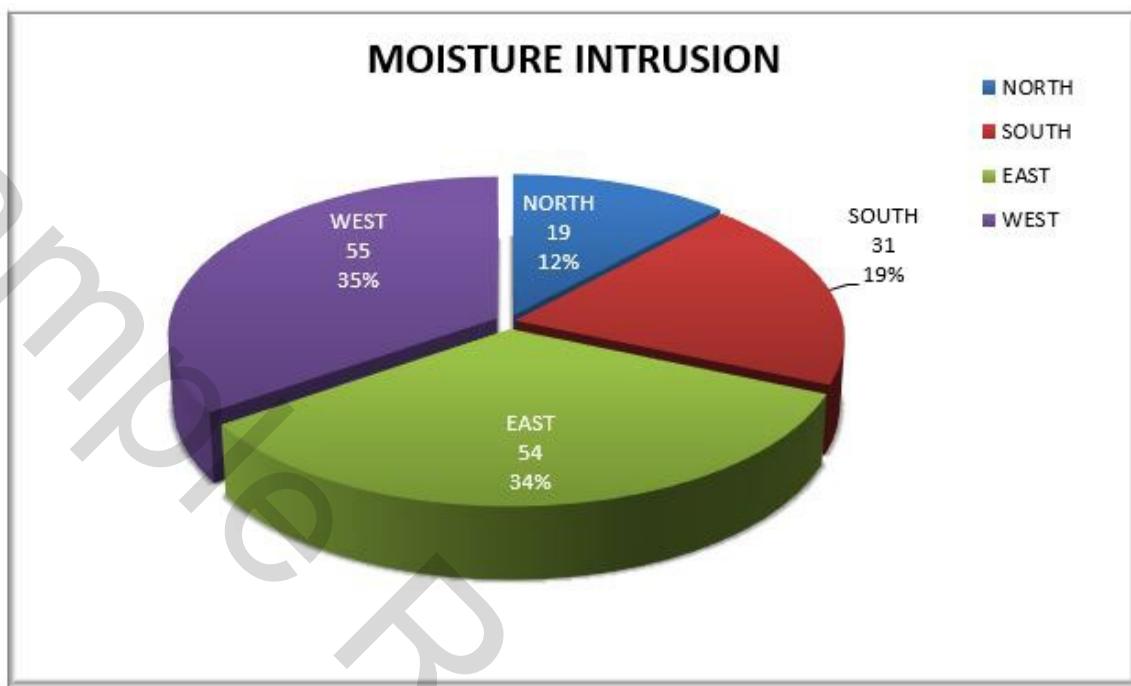
During our investigation of the XXXXXXXXXXXXXXXXXXXX Condominium Association, TSSA Storm Safe Inc. inspectors witnessed a great deal of moisture intrusion seen around the entire perimeter of the installed glazed systems. A combination of system buffeting with subsequent primary seal disruption allowed moisture to intrude between the installed systems and the weather barrier finding its way into the interior living space. This physical damage was noted on a large percentage of the units that we inspected.

The above chart represents the number of times this specific damage type was noted by the TSSA Storm Safe Inc. field inspection team with relation to the compass heading. The findings presented in this chart are populated from pure inspection data which was extrapolated by querying our server Database. The statistical analysis is performed after inputting the data collected onsite by following our inspection protocol.

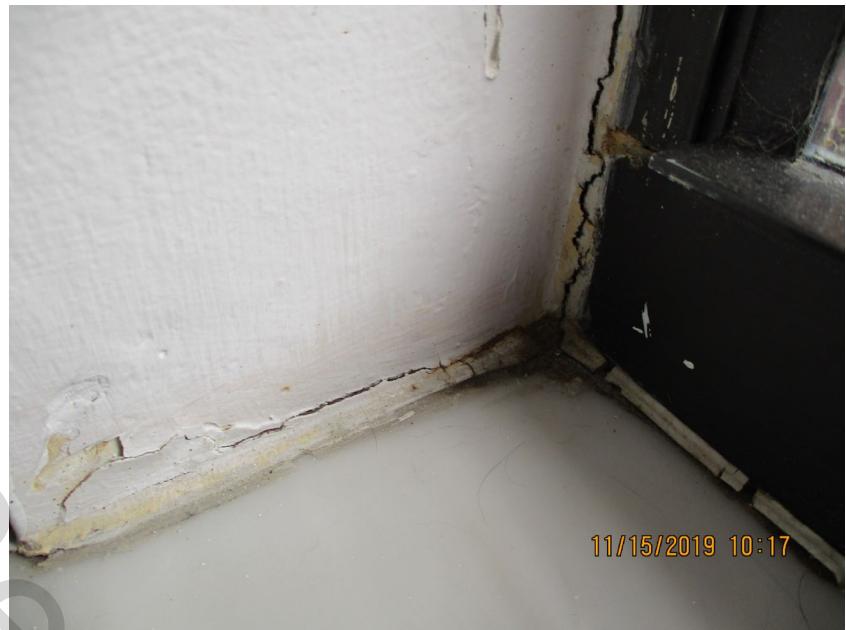
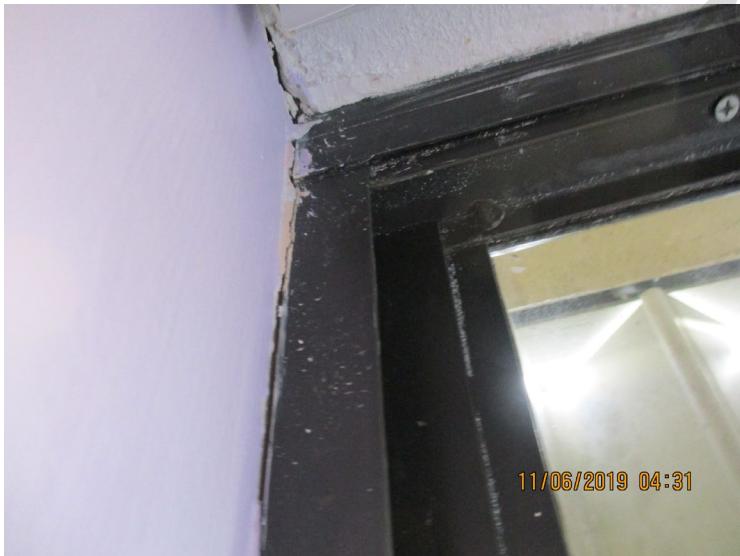
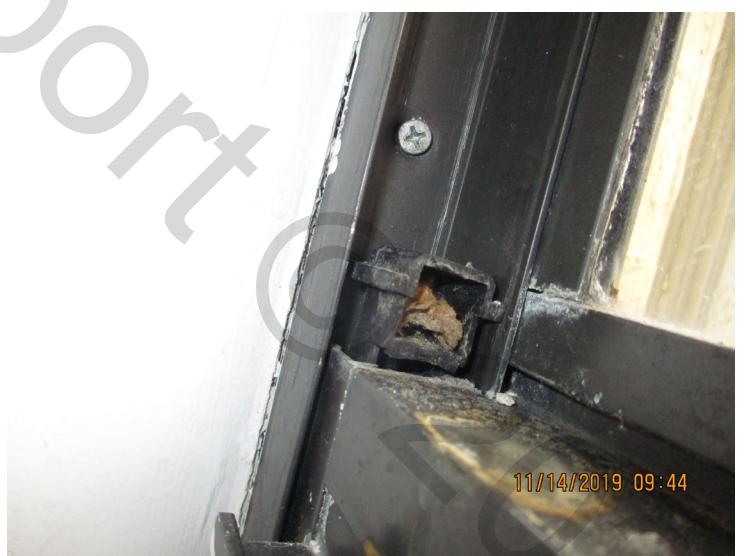
The following photos depict examples of the amount of system movement with corresponding interior finish distress that was witnessed during our investigation of the XXXXXXXXXXXXXXXXXXXX Condominium Association inspection. The buffeting of the systems during a high wind event allowed the glazed systems to vibrate and move within their installed position. This movement affected the installation fastening system and created system movement which disrupted the interior finish between the systems framing and its interior finish

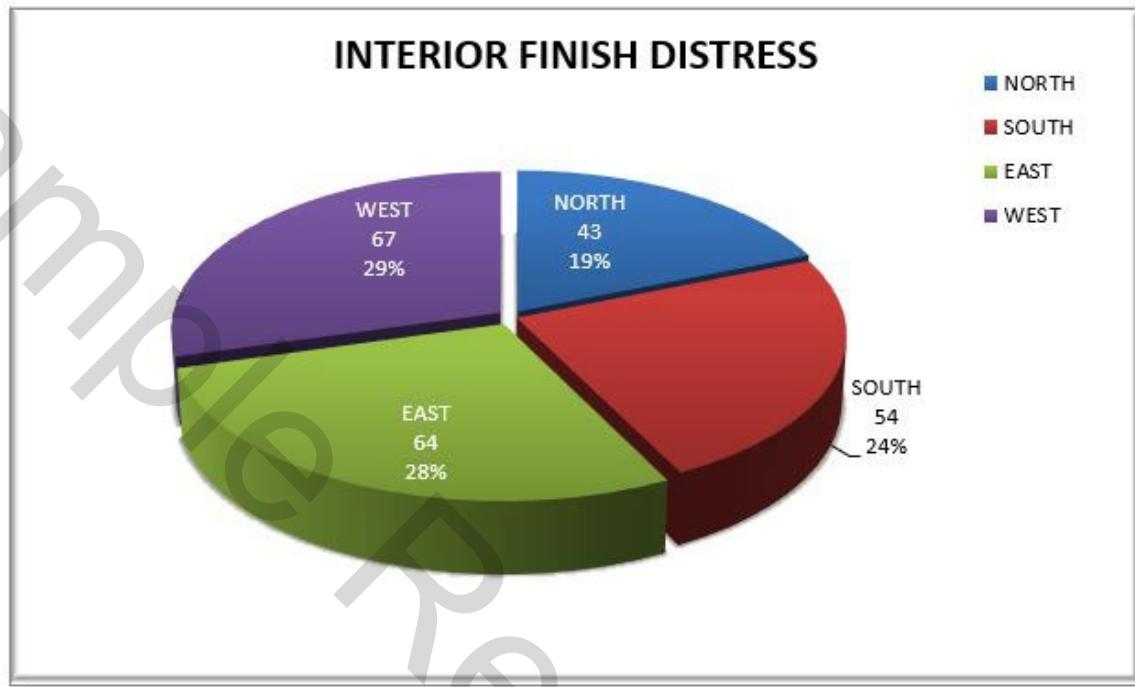
The above chart represents the number of times this specific damage type was noted by the TSSA Storm Safe Inc. field inspection team with relation to the compass heading. The findings presented in this chart are populated from pure inspection data which was extrapolated by querying our server Database. The statistical analysis is performed after inputting the data collected onsite by following our inspection protocol.

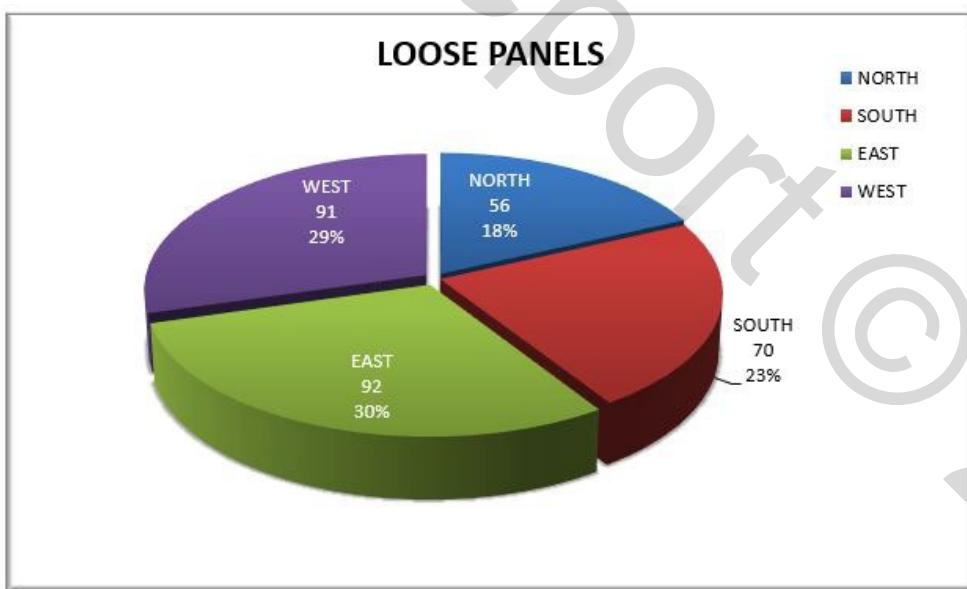
Throughout the TSSA Storm Safe Inc. Glazing Damage Assessment of the XXXXXXXXXXXXXXXXXXXX Condominium Association, our inspectors witnessed wide spread loose panels on a great deal of the installed window and sliding glass door systems. As the window systems react to wind buffeting and cyclic pressure, the load is transferred from the installation system to the assembly system which eventually force the panels to become loosened in their operational tracks leaving them in a diminished state. This specific damage is difficult to capture photographically, as the panel movement is a physical reaction to our inspection

The above chart represents the number of times this specific damage type was notated by the TSSA Storm Safe Inc. field inspection team with relation to the compass heading. The findings presented in this chart are populated from pure inspection data which was extrapolated by querying our server Database. The statistical analysis is performed after inputting the data collected onsite by following our inspection protocol.

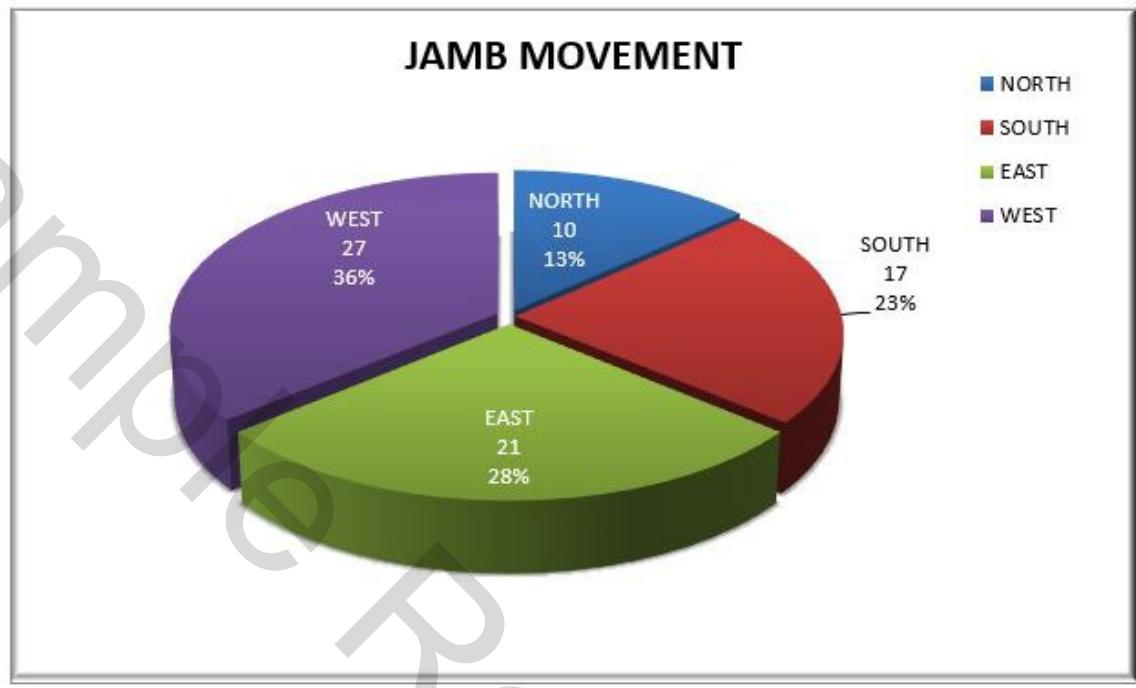
Condominium Association inspection. The buffeting of the systems during a high wind event allowed the glazed systems to vibrate and move within their installed position. This movement affected the installation fastening system and created system movement which disrupted the interior finish between the systems framing and its interior finish reveal. (Note – the photo of the inspector's hand touching the framing system is to demonstrate that it was moving freely upon inspection.)

The above chart represents the number of times this specific damage type was notated by the TSSA Storm Safe Inc. field inspection team with relation to the compass heading. The findings presented in this chart are populated from pure inspection data which was extrapolated by querying our server Database. The statistical analysis is performed after inputting the data collected onsite by following our inspection protocol.

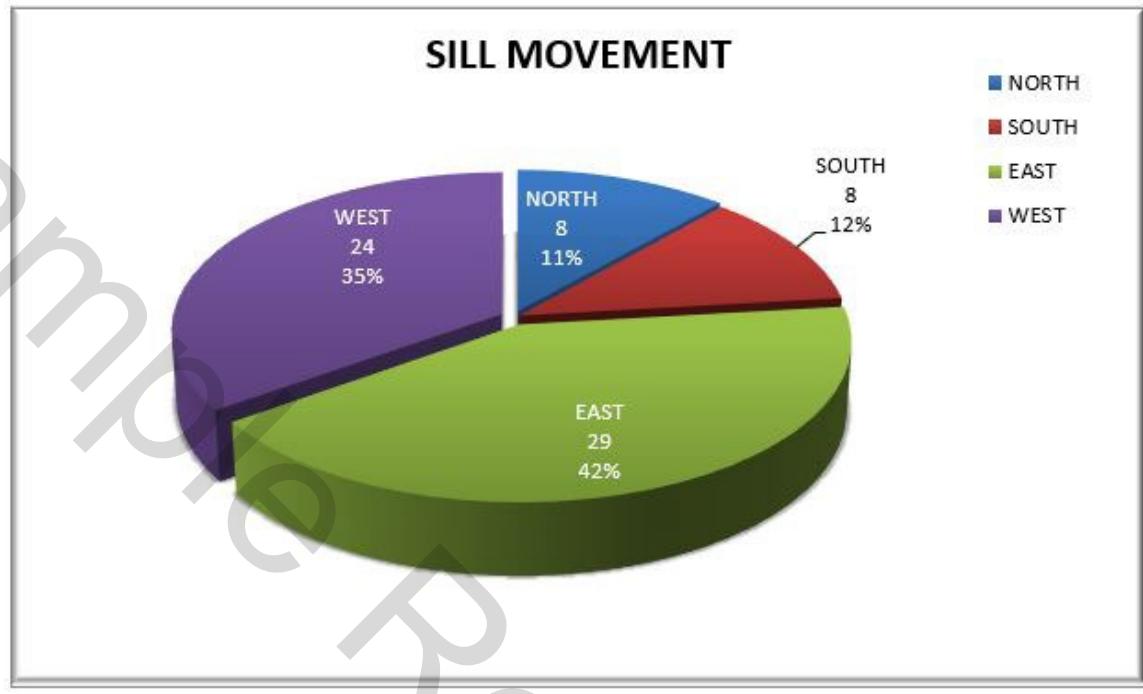
The following photos depict examples of the amount of system movement with corresponding interior finish distress that was witnessed during our investigation of the XXXXXXXXXXXXXXXXXXXX Condominium Association inspection. The buffeting of the systems during a high wind event allowed the glazed systems to vibrate and move within their installed position. This movement affected the installation fastening system and created system movement which disrupted the interior finish between the systems framing and its interior finish reveal. (Note – the photo of the inspector's hand touching the sill frame member is to demonstrate that it was moving freely upon inspection.)

The above chart represents the number of times this specific damage type was notated by the TSSA Storm Safe Inc. field inspection team with relation to the compass heading. The findings presented in this chart are populated from pure inspection data which was extrapolated by querying our server Database. The statistical analysis is performed after inputting the data collected onsite by following our inspection protocol.

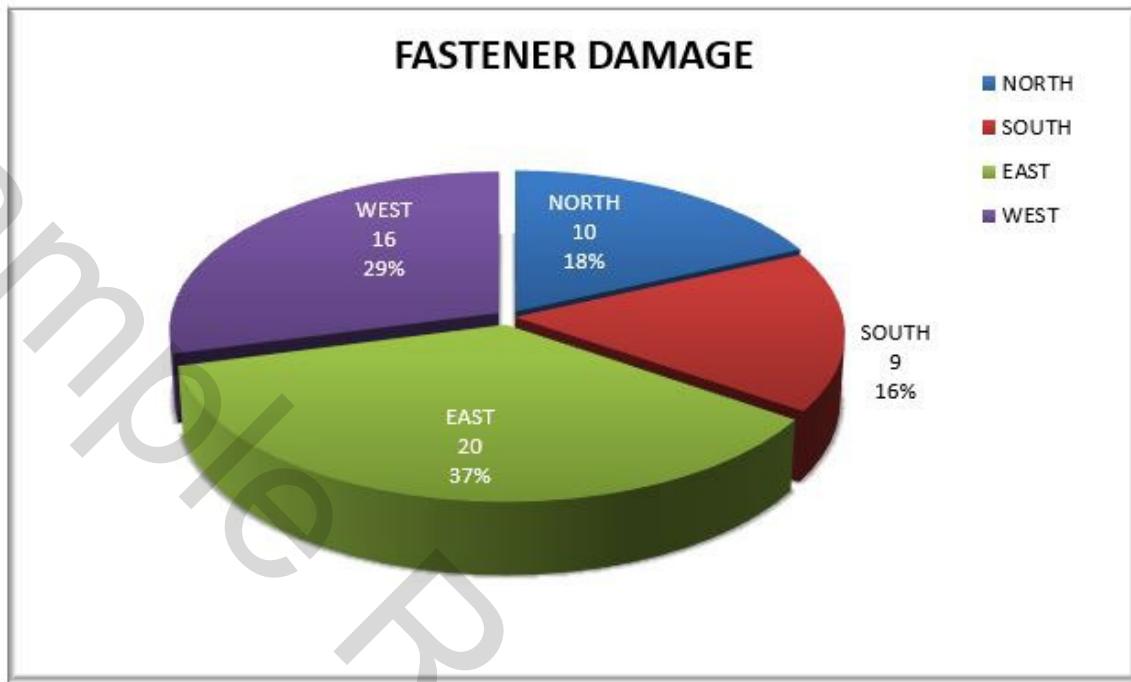
The following photos depict evidence damage to the installation fasteners seen during our inspection. The intense buffeting of the window systems during Hurricane Irma allowed the attached window systems to vibrate and move within their installed positions. This movement affected and loosened the installation fasteners connection and attachment to the host structure leaving the window systems in a damaged and compromised state.

The above chart represents the number of times this specific damage type was noted by the TSSA Storm Safe Inc. field inspection team with relation to the compass heading. The findings presented in this chart are populated from pure inspection data which was extrapolated by querying our server Database. The statistical analysis is performed after inputting the data collected onsite by following our inspection protocol.

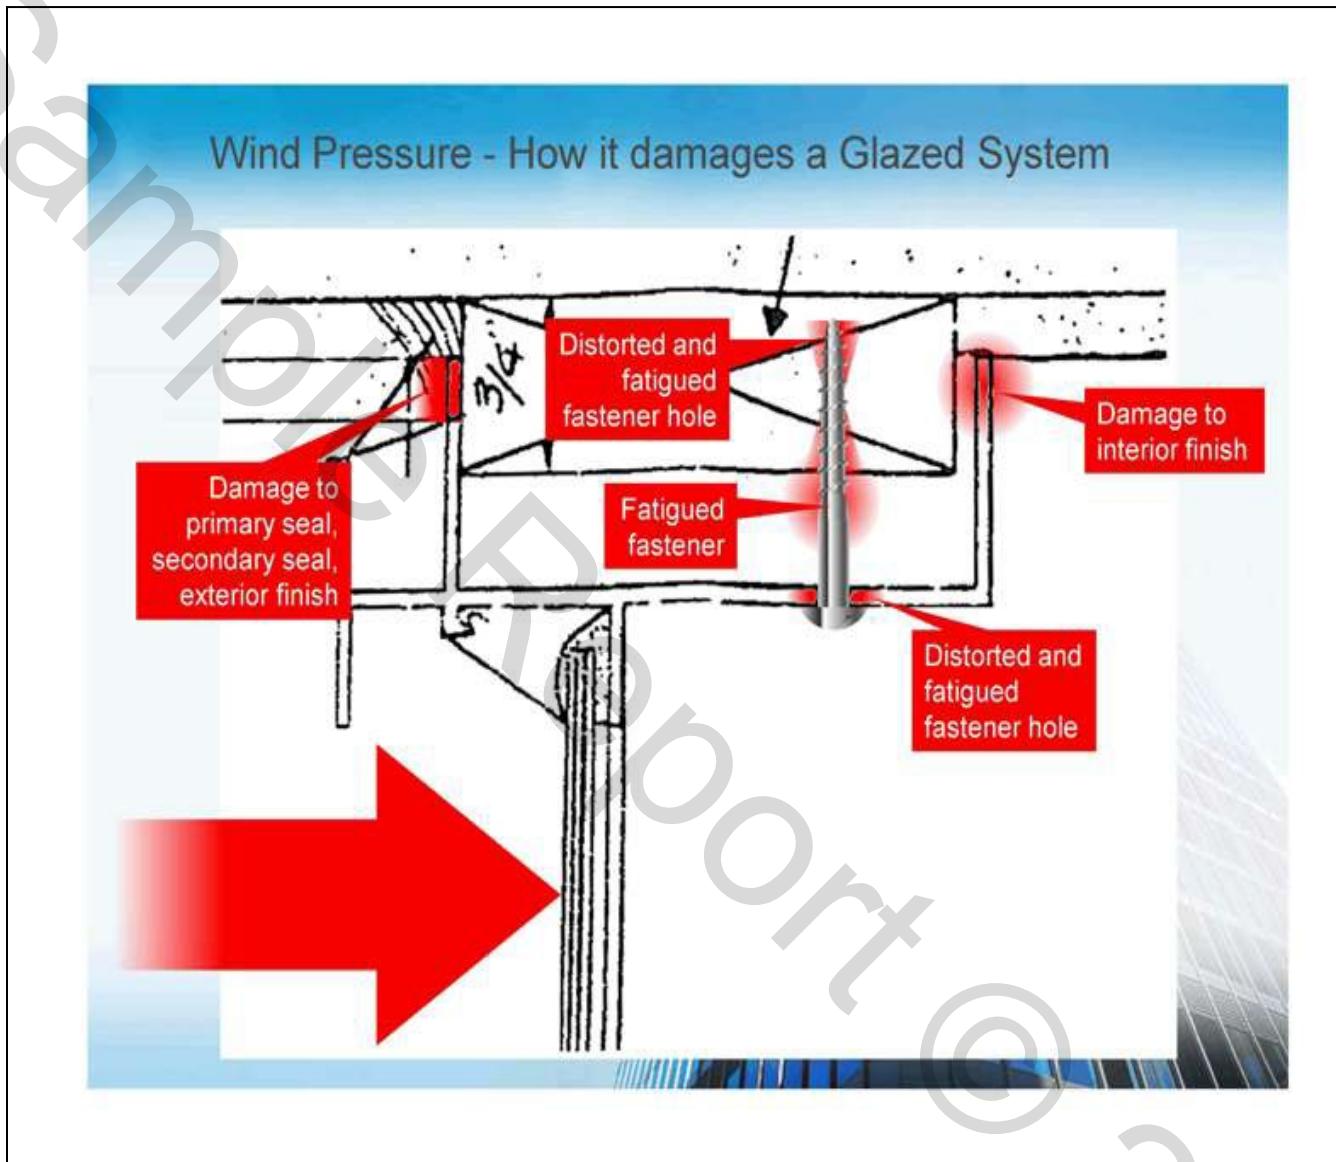
The above diagram illustrates how a window system is damaged during a high wind event, such as a hurricane. The graphic is a demonstrative representation depicting damage and fatigue to some of the major components found in a window system such as the ones found installed at the XXXXXXXXXXXXXXXXXXXX Condominium Association.

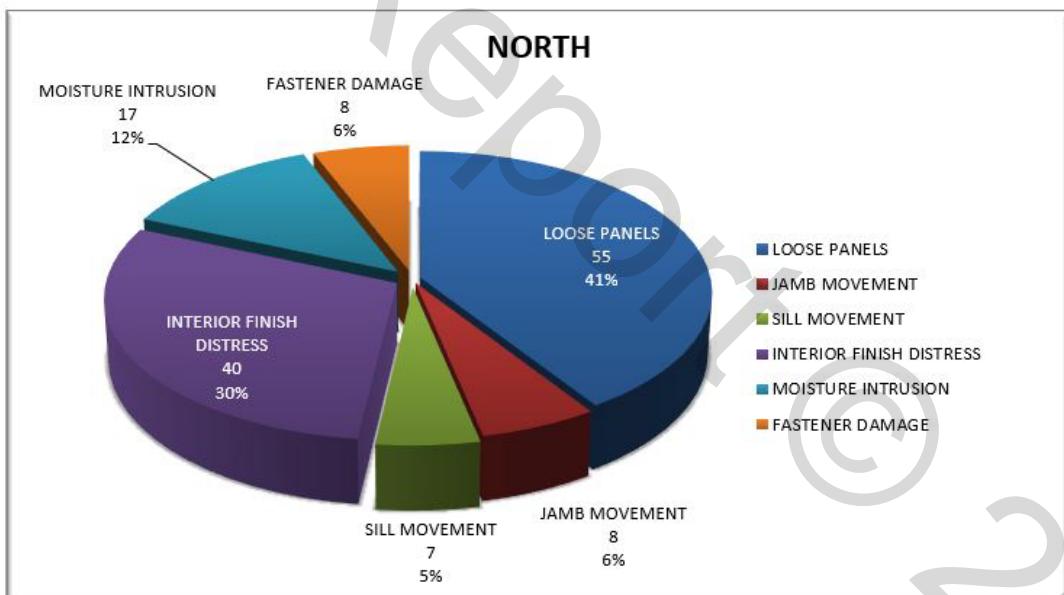
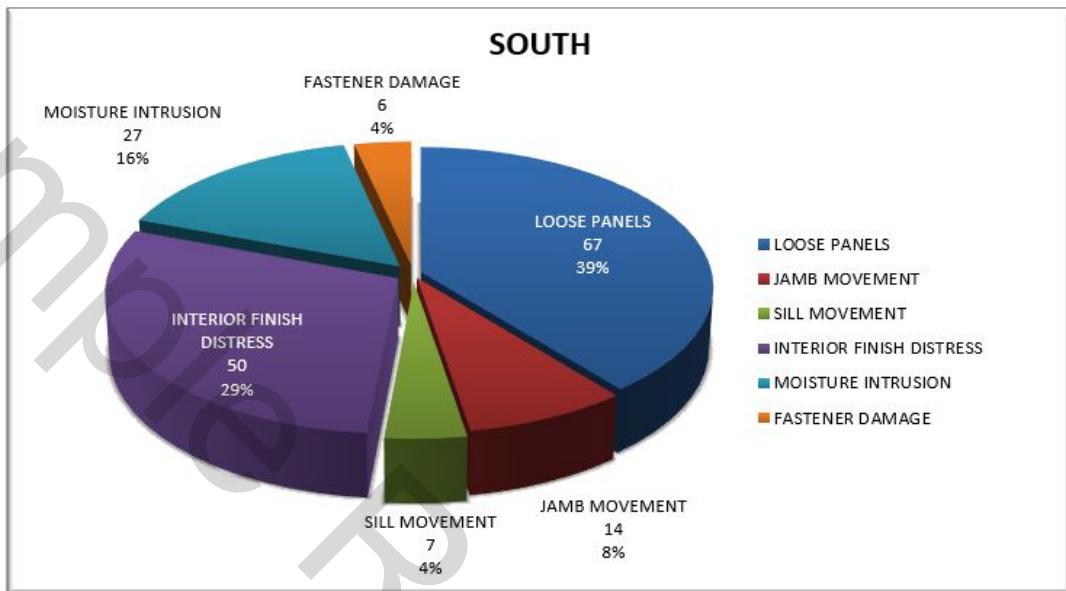
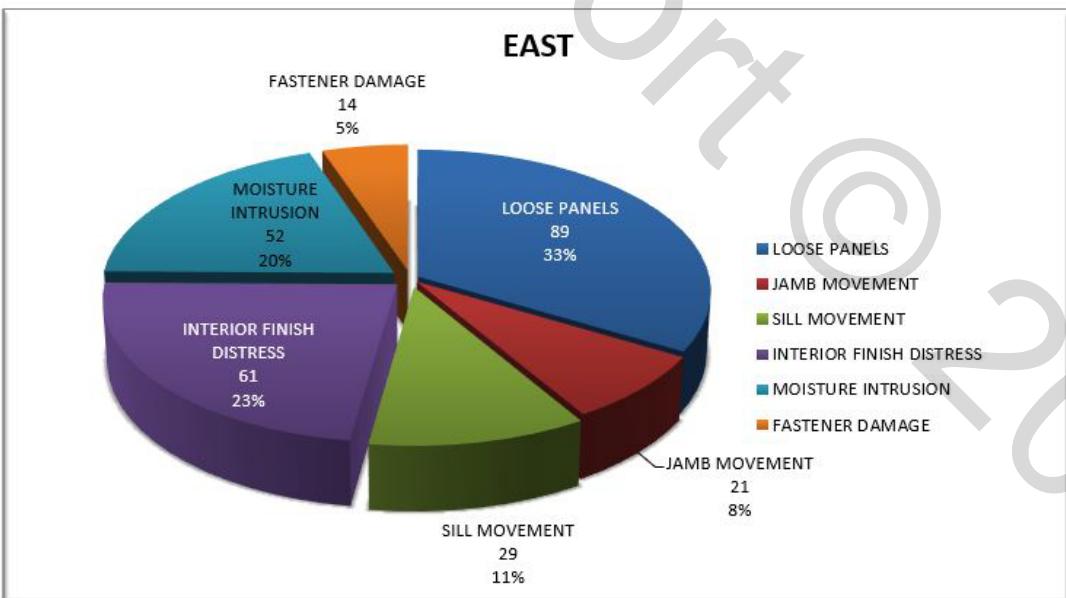
The following charts represent the number of times the various major structural and system damages occurred in relation to compass heading and directional facing. The findings presented in this chart are populated from pure inspection data, which was extrapolated by querying our server Database. The statistical analysis is performed after inputting the data collected onsite by following our inspection protocol.

It is TSSA Storm Safe Inc, professional opinion that the glazed systems installed at the XXXXXXXXXXXXXXXXXXXX Condominium Association need to be replaced. This opinion is based on the fact that our investigation revealed excessive amounts of Primary Seal Damage, System Movement, Assembly system distress, screw spline disruption, and moisture damage.

These are all structural issues that have to do with the internal assembly system of these windows and sliding glass door components. It is our opinion that a temporary sealant repair protocol would not sufficiently remediate these severe issues. The internal assembly systems within the framing components would remain in a compromised state under the sealant layer, and the systems would need to be replaced.
