# STORM SAFE

Glazing Damage Assessment

## **Re: Storm Related Structural Glazing Assessment**

TSSA Project # [REDACTED] - [REDACTED] - 2021-10-9

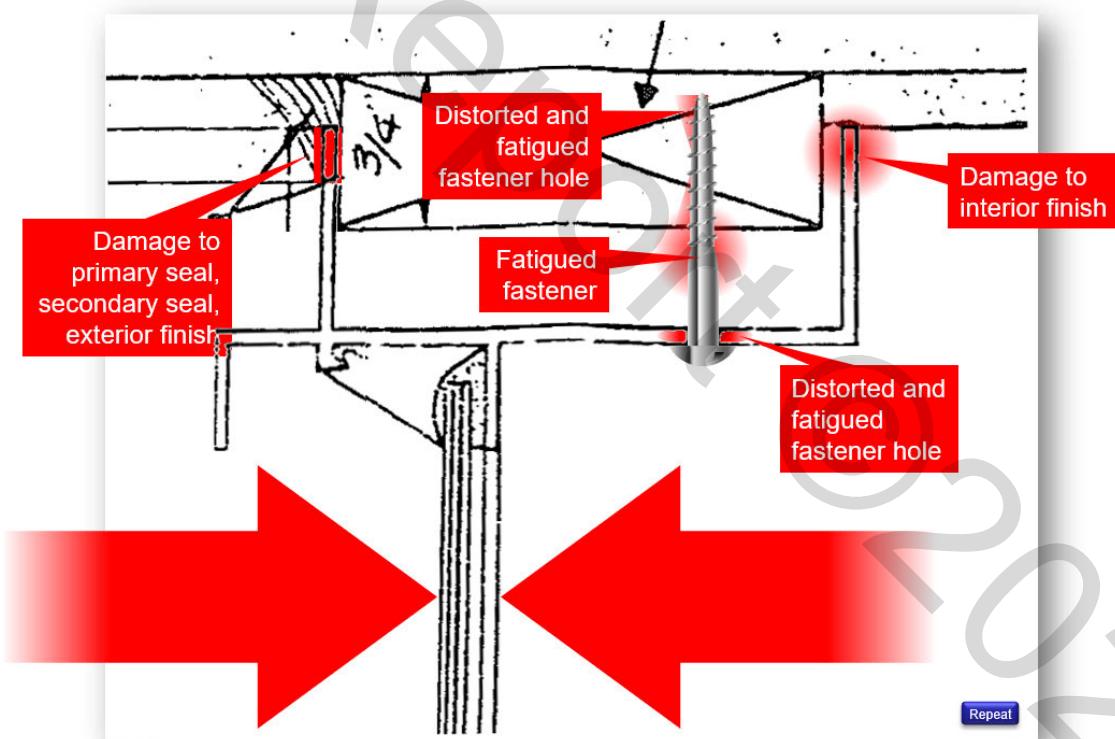
This photograph was taken during a cyclic pressure test of a single hung window system. This photograph demonstrates how high wind speed, pressure, and buffeting force affects glazed systems during a High Wind Event with extensive wind created buffeting. The rapid positive and negative cyclic movement and high wind buffeting create separations and disruptions in a window system framing joints, installation fasteners, and glazing system causing failure in the components allowing water to penetrate through the exterior building envelope into the interior living space.
