SERVICE INSTRUCTION

Service Instruction No. 1011N
(Supersedes Service Instruction No. 1011M)
Engineering Aspects are
FAA Approved

SUBJECT: Tappets and Lifters

MODELS AFFECTED: All Lycoming engines

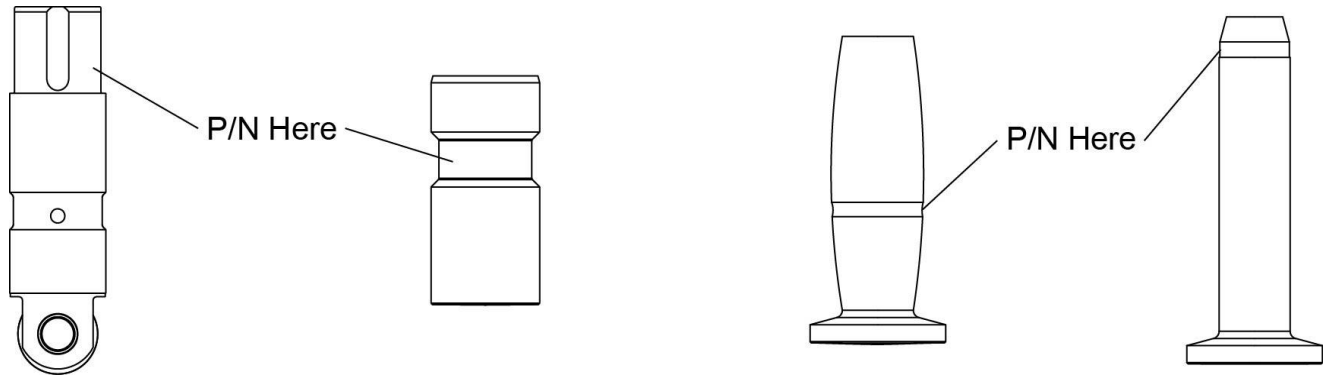
Figure 7
Part Number Locations on Tappets and Hydraulic Lifter Assembly

NOTICE: Figure 7 shows the location of part number stampings (the last 5 digits of the part number) of the various parts identified in Tables 3 and 4.

Task	Findings	Corrective Action
1. Examine the tappet body (and plunger on the tappet) for part number identification as shown in the illustrations in Figure 7.		If the part number cannot be identified, remove and replace the tappet body with a new tappet body.
