Hidden Lake Condominiums

CAPITAL RESERVE STUDY

Report Number: 24-10
Site Inspection Date: June 7th, 2024
Report Submittal Date: September 11th, 2024

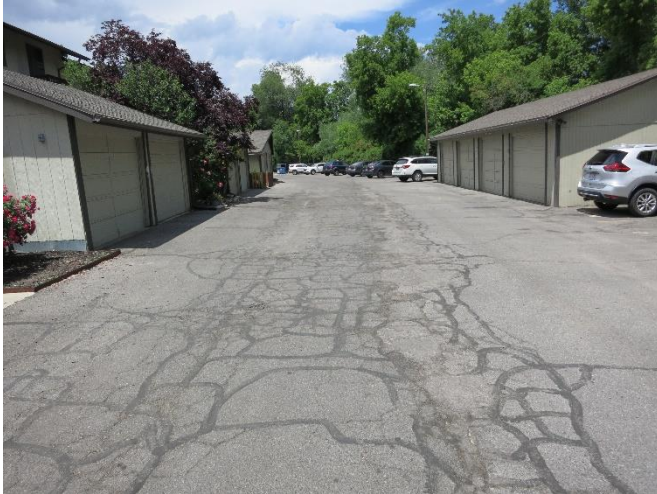
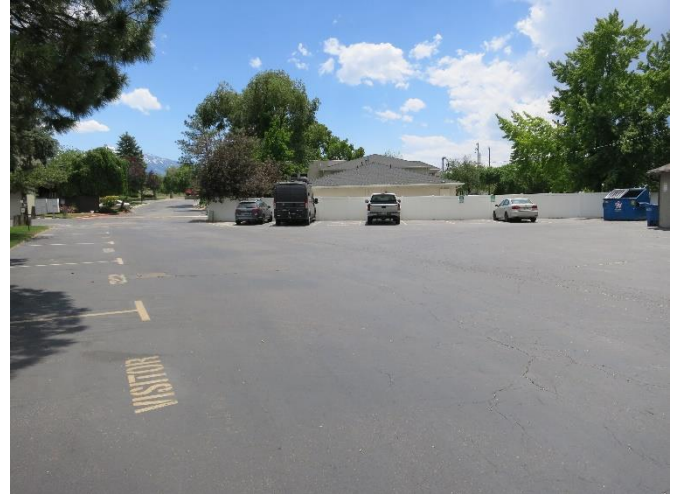
Component Name: Asphalt Slurry Seal
 Component Number: Drive Materials 1002

Component Life Expectancy: 6 Years
 Age of Component: 4 Years
 Remaining Component Life: 2 Years

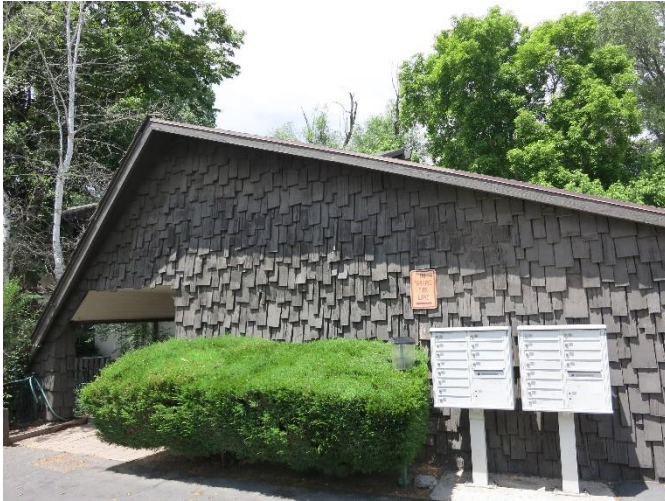
Component Name: Shake Siding
 Component Number: Residential Building 2002

Component Life Expectancy: 30 years
 Age of Component: 20 years
 Remaining Component Life: 10 years

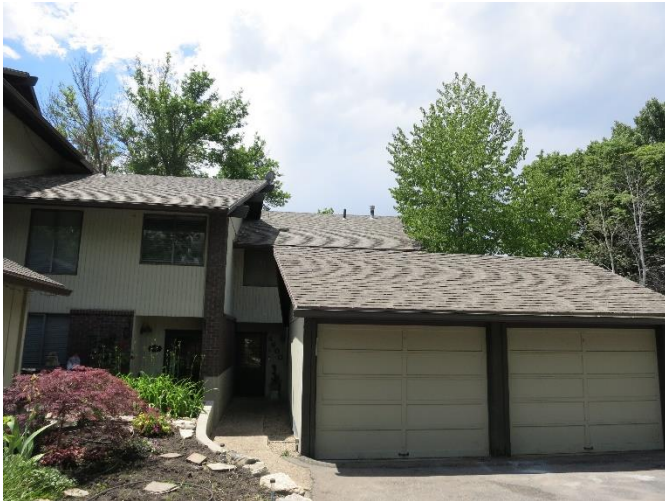
Component Name: Architectural Style Shingles
 Component Number: Residential Building 2004

Component Life Expectancy: 30 years
 Age of Component: 12 years
 Remaining Component Life: 18 years

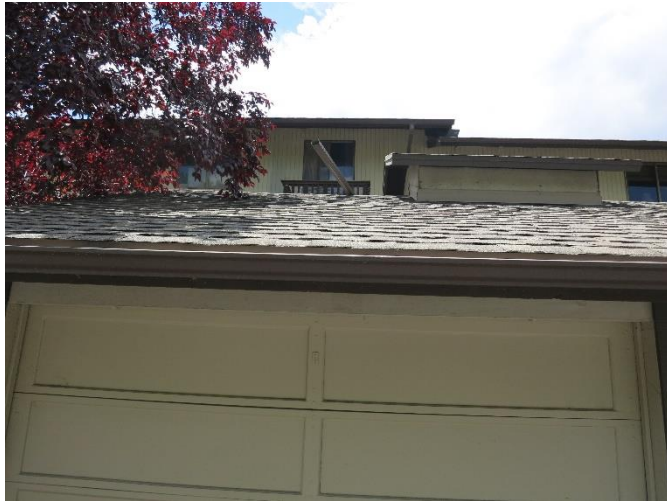
Component Name: Aluminum Roof Gutters
 Component Number: Residential Building 2005

Component Life Expectancy: 30 years
 Age of Component: 12 years
 Remaining Component Life: 18 years

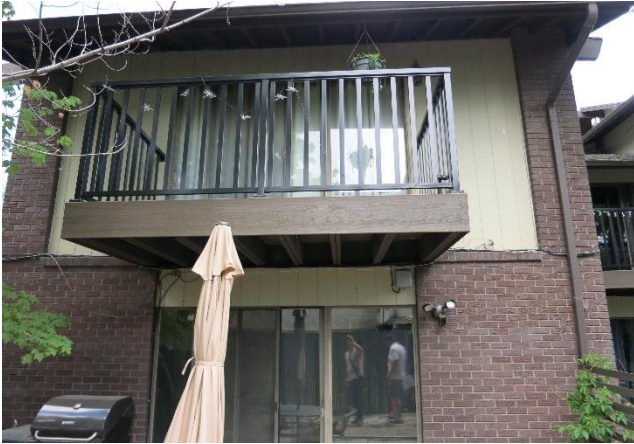
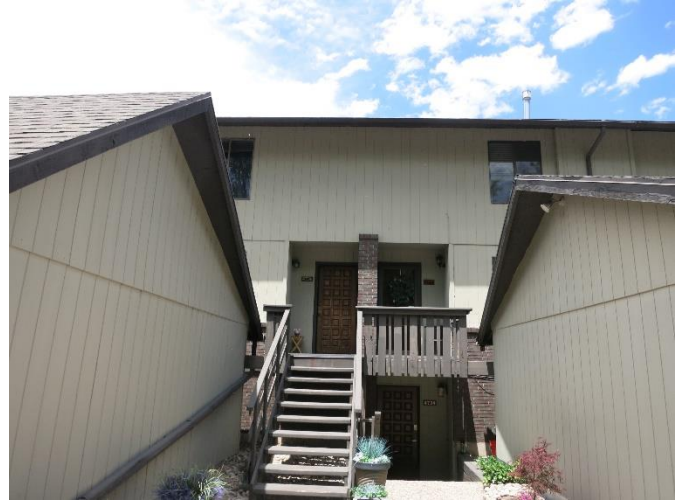
Component Name: Composite Decking
 Component Number: Residential Building 2006

Component Life Expectancy: 40+ years
 Age of Component: _____ years
 Remaining Component Life: _____ years

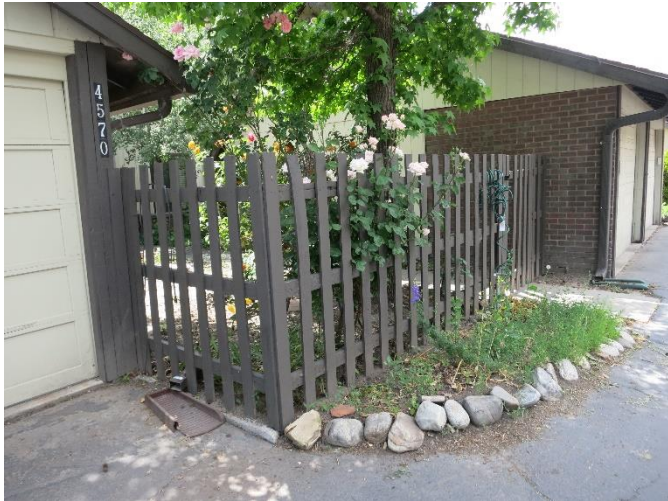
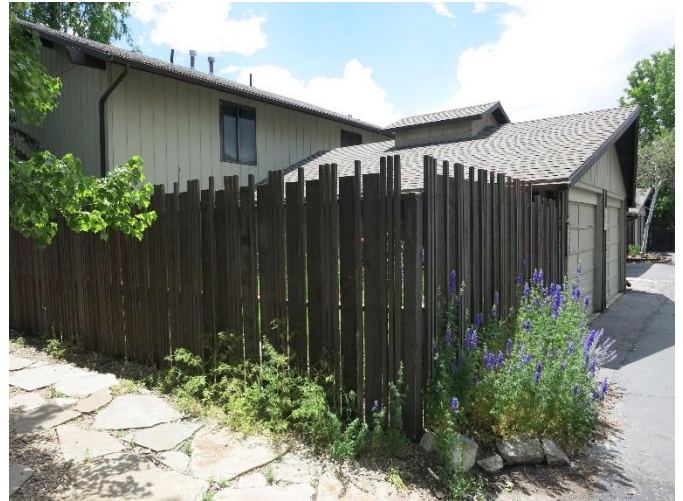
Component Name: Privacy Fencing
 Component Number: Residential Building 2008

Component Life Expectancy: N/A years
 Age of Component: _____ years
 Remaining Component Life: _____ years

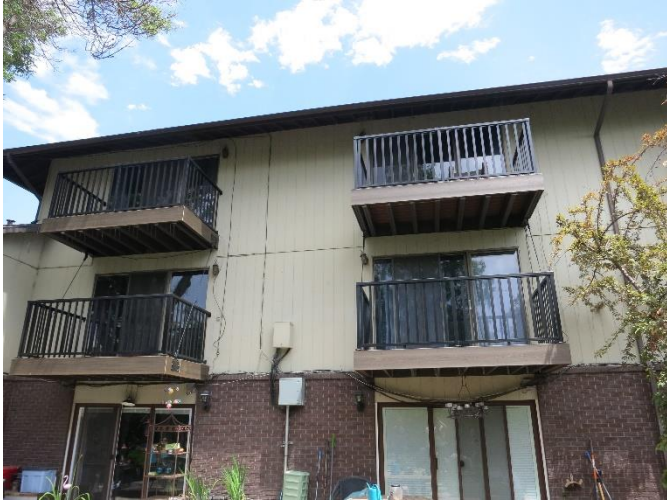
Component Name: Metal Railing Maintenance
 Component Number: Residential Building 2009

Component Life Expectancy: 10 years
 Age of Component: 0 years
 Remaining Component Life: 10 years

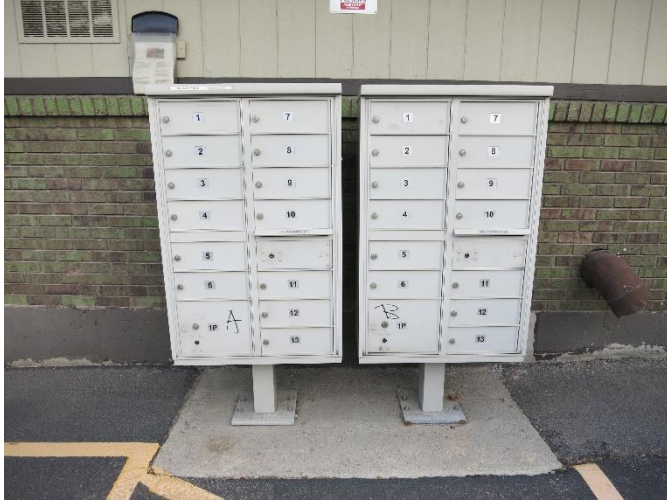
Component Name: Mailboxes
 Component Number: Common Development 3001

Component Life Expectancy: 25 years
 Age of Component: 10 years
 Remaining Component Life: 15 years

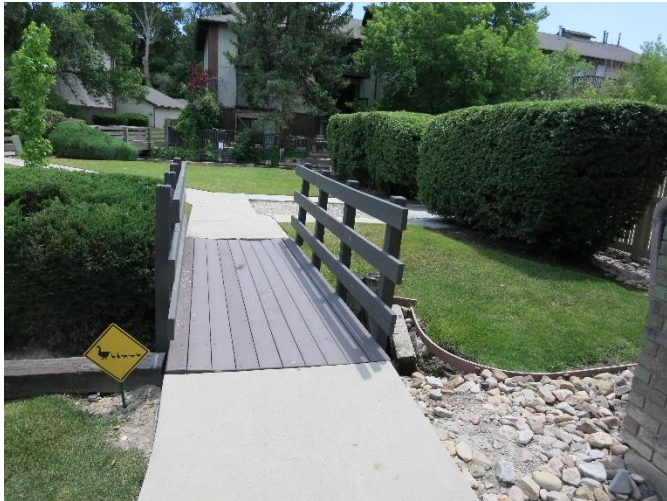
Component Name: Bridges
 Component Number: Common Development 3002

Component Life Expectancy: 30 years
 Age of Component: 0 years
 Remaining Component Life: 30 years

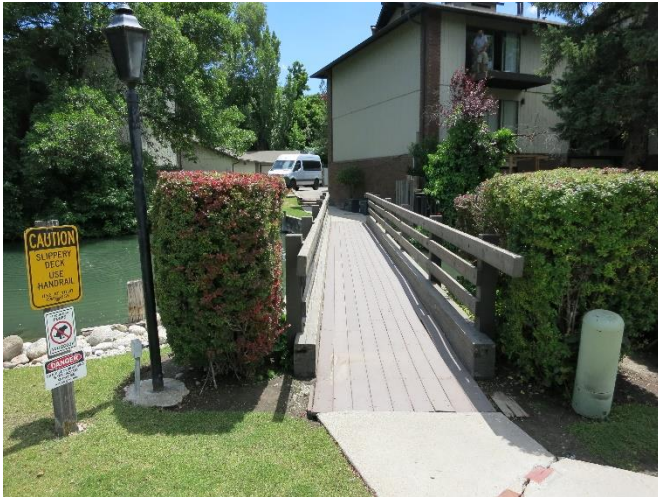
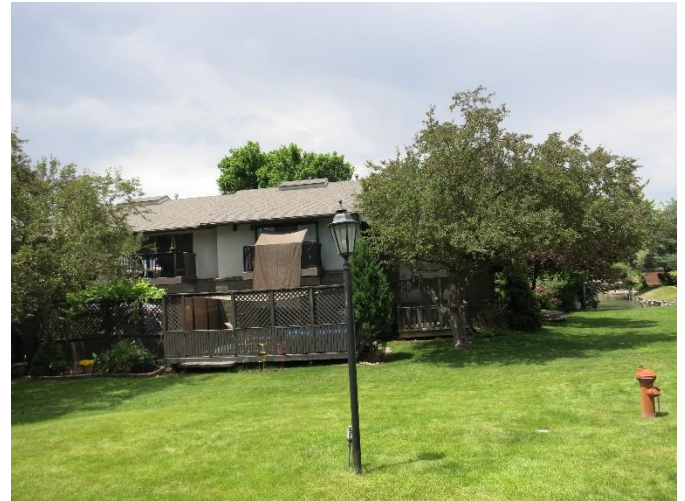
Component Name: Light Poles
 Component Number: Common Development 3003

Component Life Expectancy: N/A years
 Age of Component: _____ years
 Remaining Component Life: _____ years

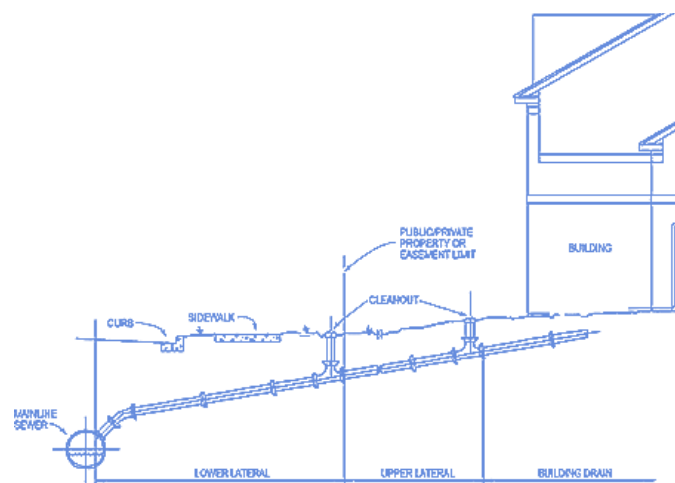
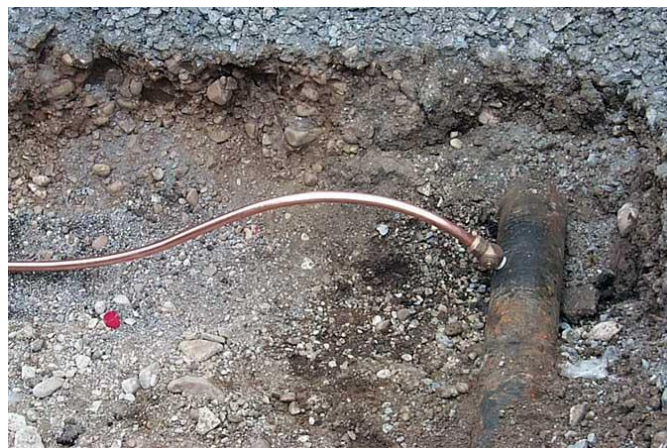
Component Name: Sewer & Water Lines
 Component Number: Common Development 3005

Component Life Expectancy: N/A years
 Age of Component: _____ years
 Remaining Component Life: _____ years

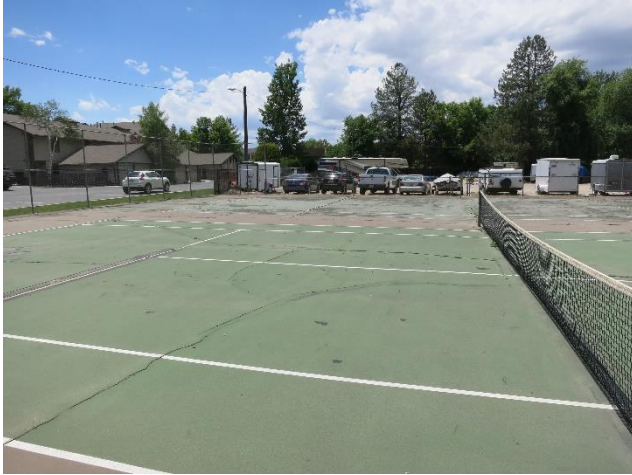
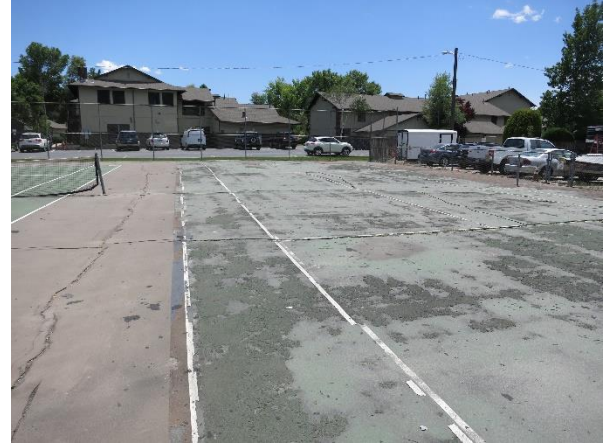
Component Name: Tennis Court
 Component Number: Common Development 3006

Component Life Expectancy: 8 years
 Age of Component: 8+ years
 Remaining Component Life: 0 years

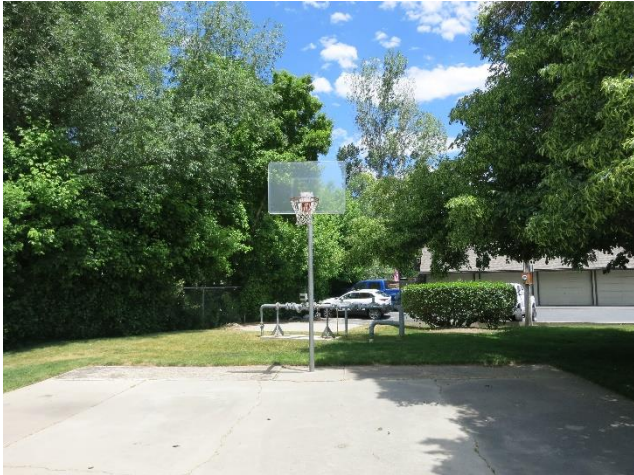
Component Name: Basketball Hoop
 Component Number: Common Development 3007

Component Life Expectancy: 15 years
 Age of Component: 10 years
 Remaining Component Life: 5 years

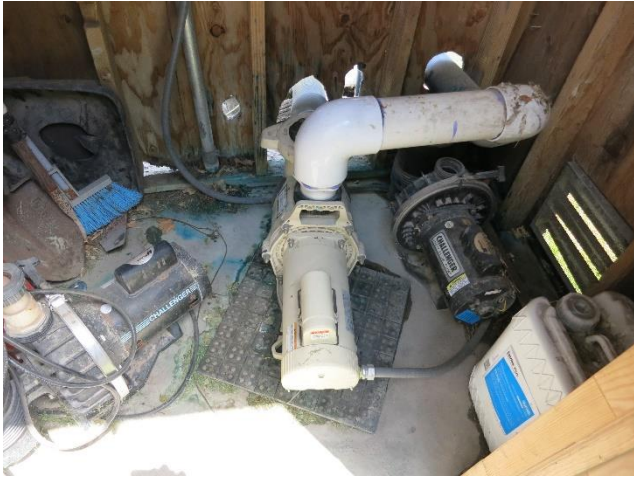
Component Name: Pond Pumps
 Component Number: Common Development 3008

Component Life Expectancy: 10 years
 Age of Component: 5 years
 Remaining Component Life: 5 years

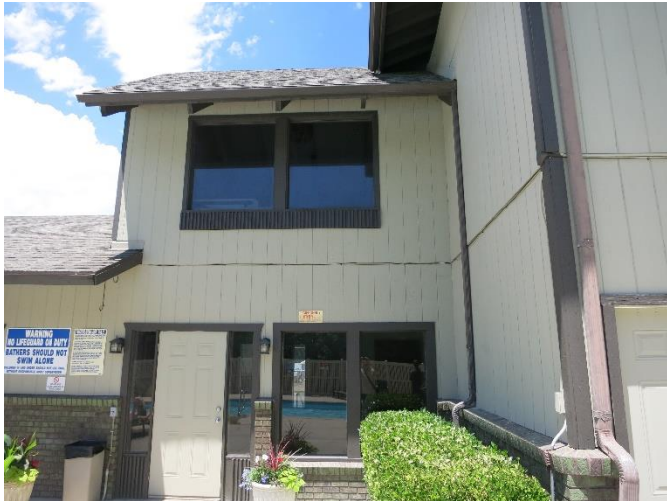
Component Name: Exterior Repaint
 Component Number: Clubhouse 4001

Component Life Expectancy: 12 years
 Age of Component: 1 years
 Remaining Component Life: 11 years

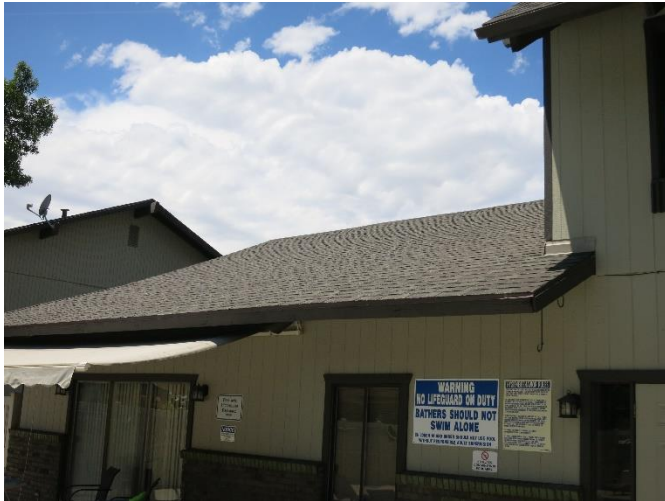
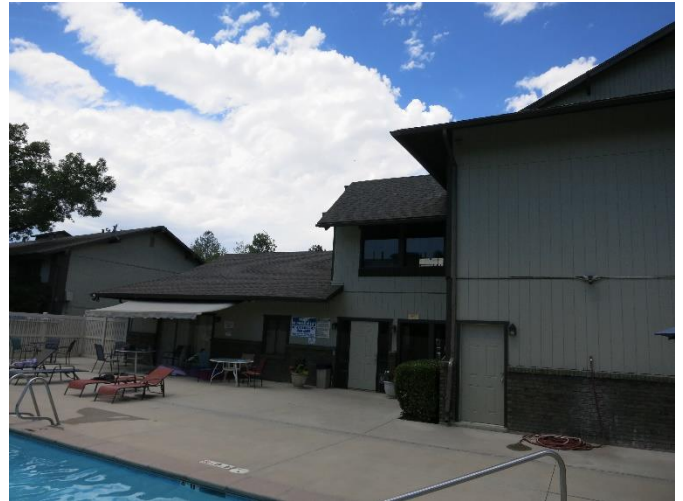
Component Name: Shingle Replacement
 Component Number: Clubhouse 4002

Component Life Expectancy: 30 years
 Age of Component: 12 years
 Remaining Component Life: 18 years

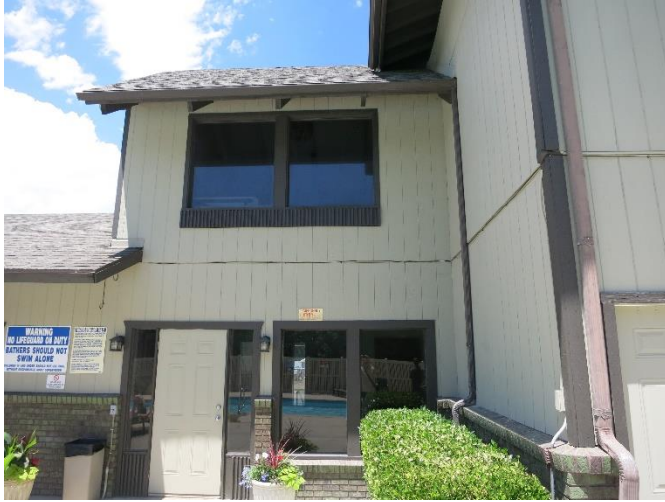
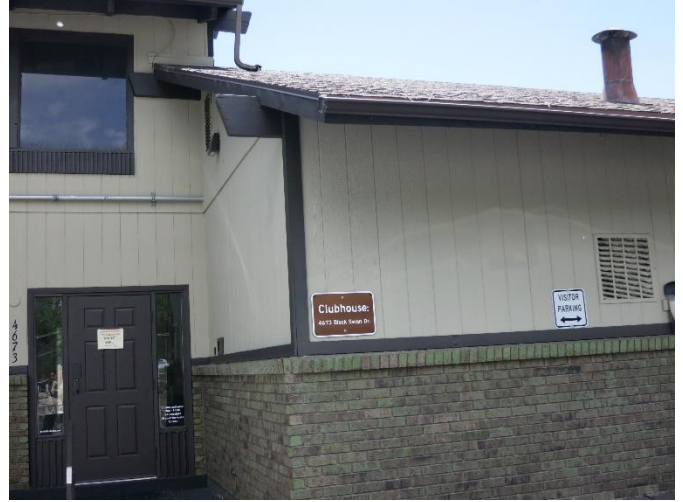
Component Name: Gutter & Downspout Replacement
 Component Number: Clubhouse 4003

Component Life Expectancy: 30 years
 Age of Component: 12 years
 Remaining Component Life: 18 years

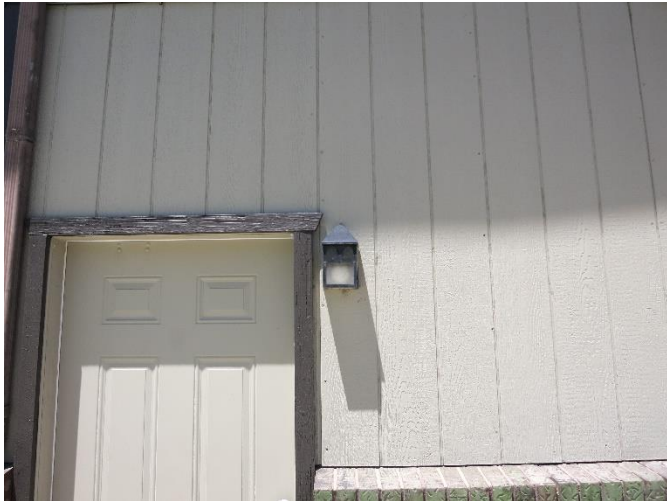
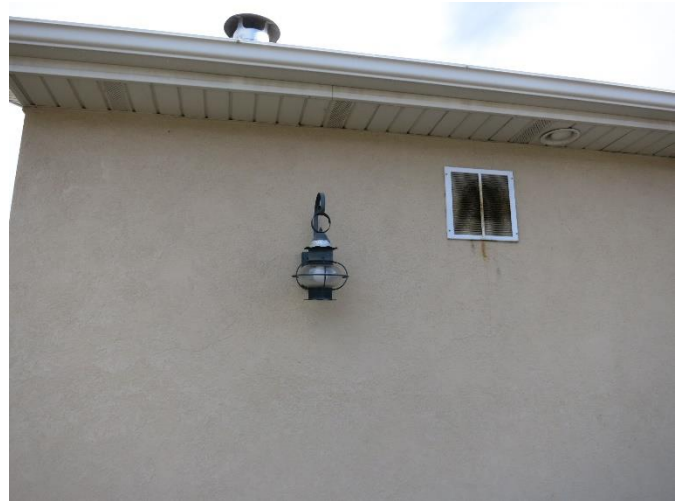
Component Name: Exterior Lights
 Component Number: Clubhouse 4004

Component Life Expectancy: N/A years
 Age of Component: _____ years
 Remaining Component Life: _____ years

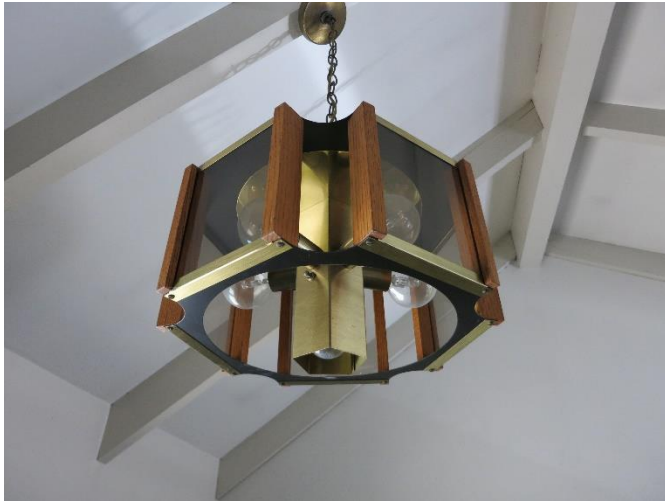
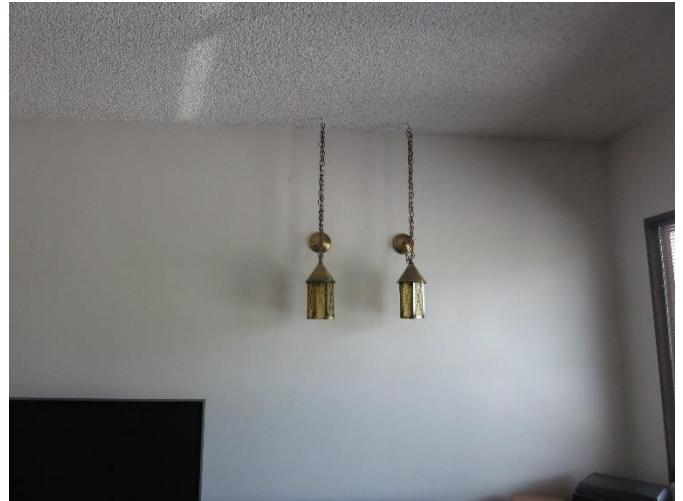
Component Name: Interior Lights
 Component Number: Clubhouse 4005

Component Life Expectancy: N/A years
 Age of Component: N/A years
 Remaining Component Life: N/A years

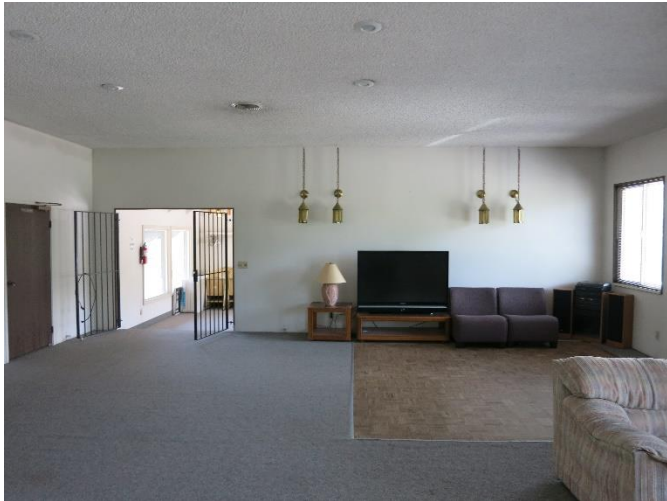
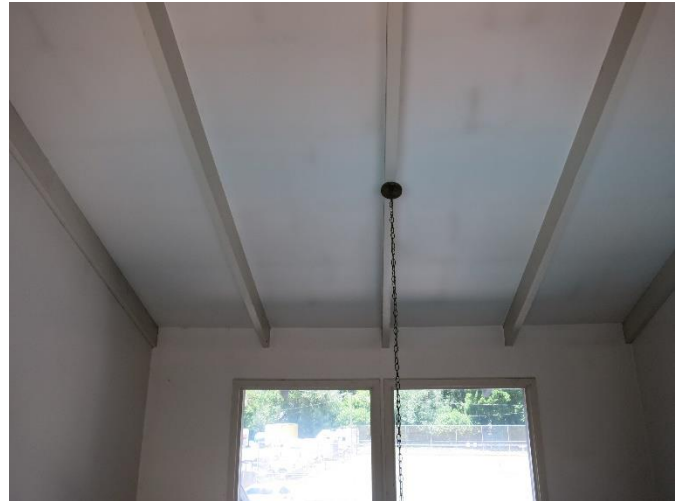
Component Name: Interior Repaint
 Component Number: Clubhouse 4006

Component Life Expectancy: 15 years
 Age of Component: 10 years
 Remaining Component Life: 5 years

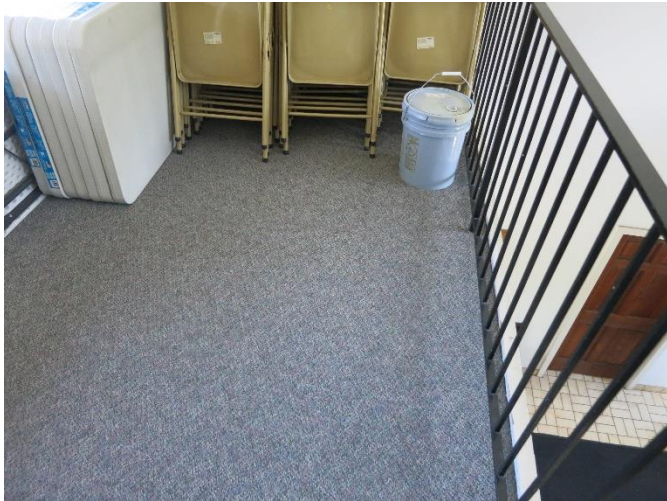
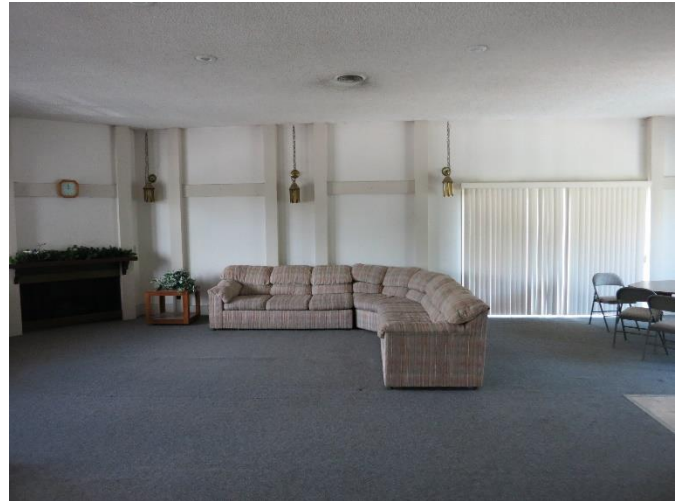
Component Name: Carpet Replacement
 Component Number: Clubhouse 4007

Component Life Expectancy: 12 years
 Age of Component: 12+ years
 Remaining Component Life: 0 years

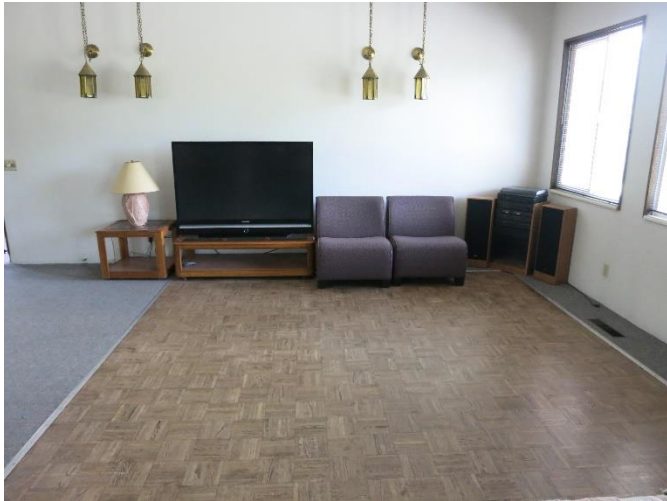
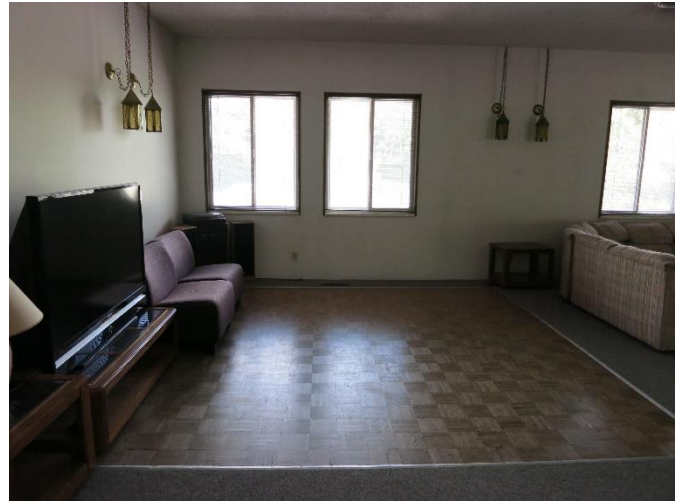
Component Name: Wood Flooring Replacement
 Component Number: Clubhouse 4008

Component Life Expectancy: 60 years
 Age of Component: 50 years
 Remaining Component Life: 10 years

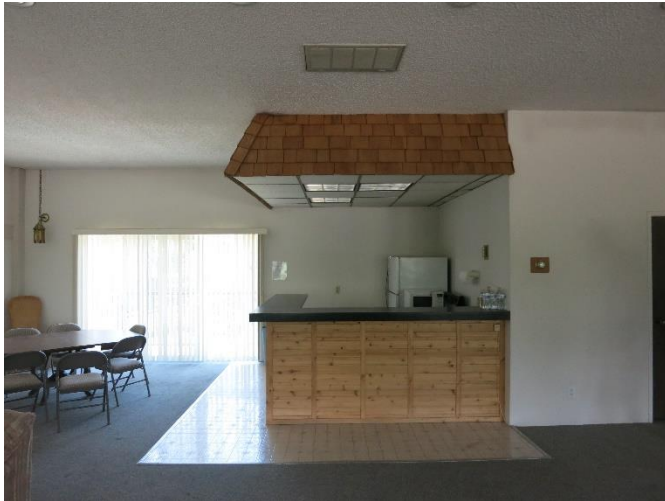
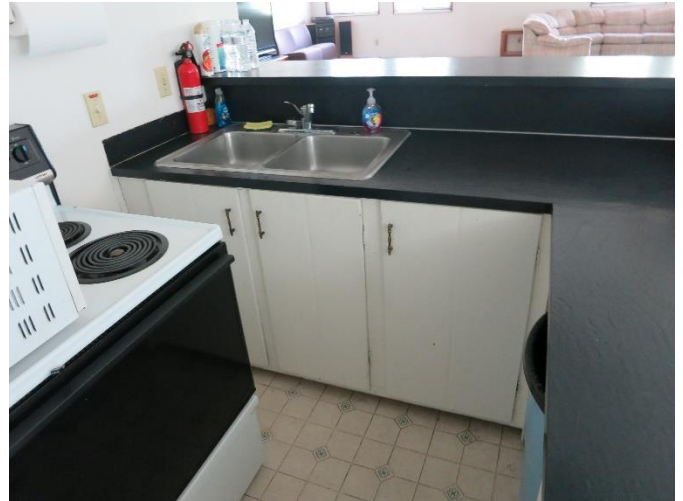
Component Name: Kitchen Renovation
 Component Number: Clubhouse 4009

Component Life Expectancy: 40 years
 Age of Component: 30 years
 Remaining Component Life: 10 years

A remodel budget is being provided for the clubhouse Kitchen. This allowance includes kitchen appliances, cabinetry and flooring. Property management noted that the HOA is not planning on a remodel of the kitchen; therefore, the low budget amount has been set to zero.

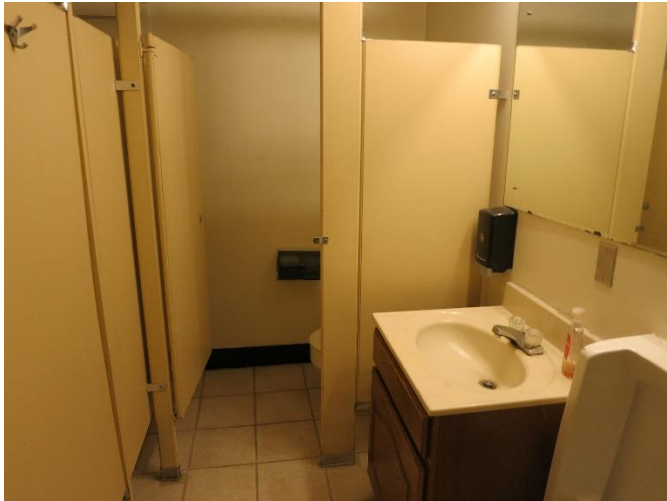
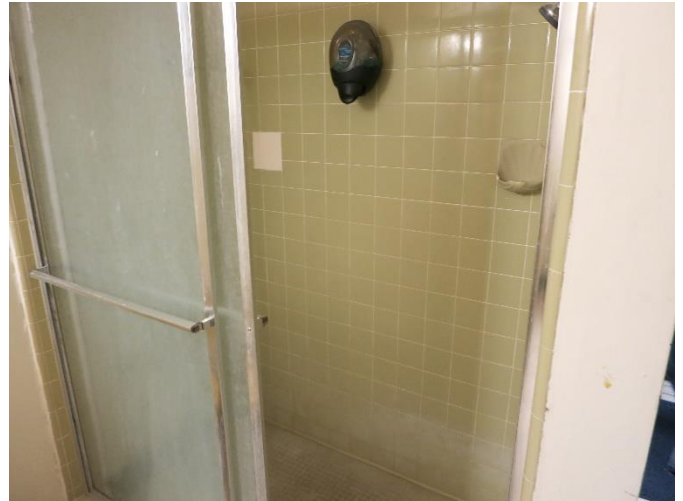
Component Name: Restroom Renovation
 Component Number: Clubhouse 4010

Component Life Expectancy: 40 years
 Age of Component: 30 years
 Remaining Component Life: 10 years

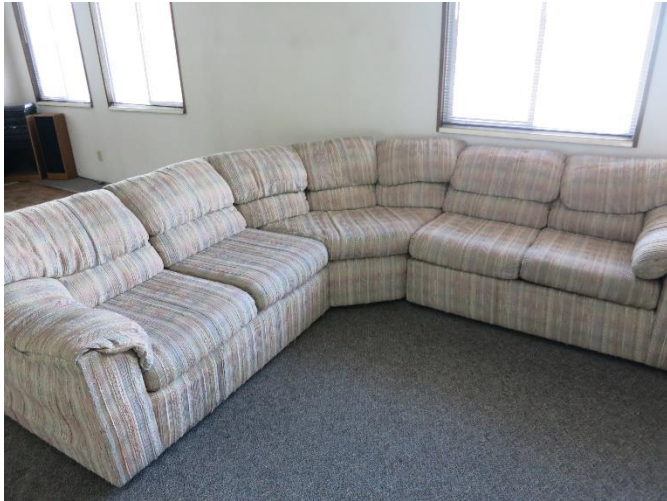
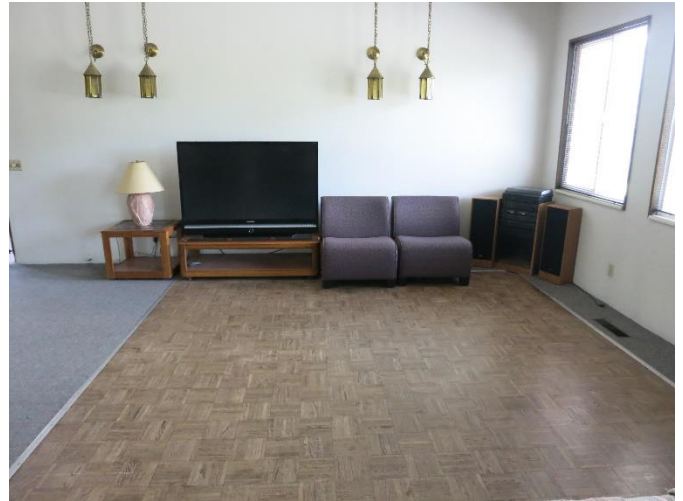
Component Name: Furniture Replacement
 Component Number: Clubhouse 4011

Clubhouse furniture frequently receives damage and sometimes stolen. The amount of traffic through the clubhouse will determine the need for replacement. An allowance is proposed to replace items as needed. The low funding has been set to zero if the HOA elects to not provide new furniture.

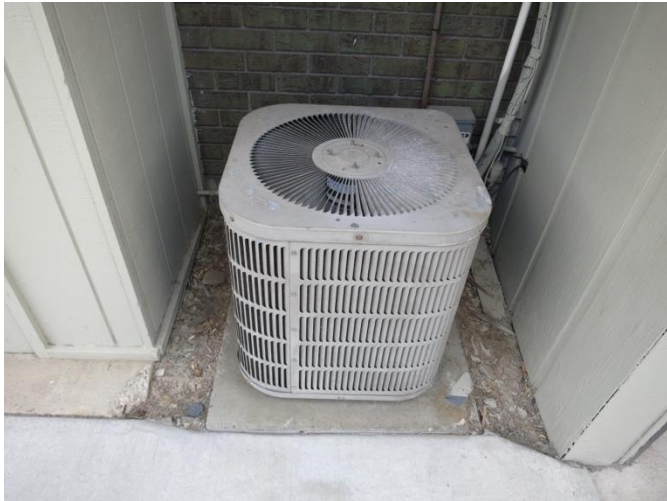
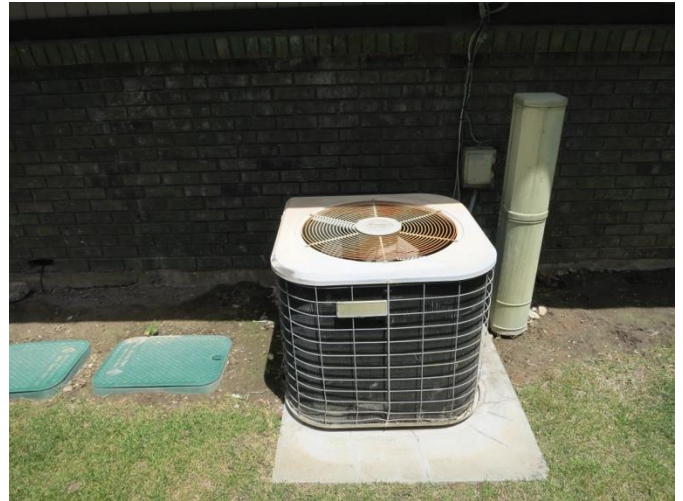
Component Name: Air Conditioners
 Component Number: Clubhouse 4012

Component Life Expectancy: 20 years
 Age of Component: 20 years
 Remaining Component Life: 0 years

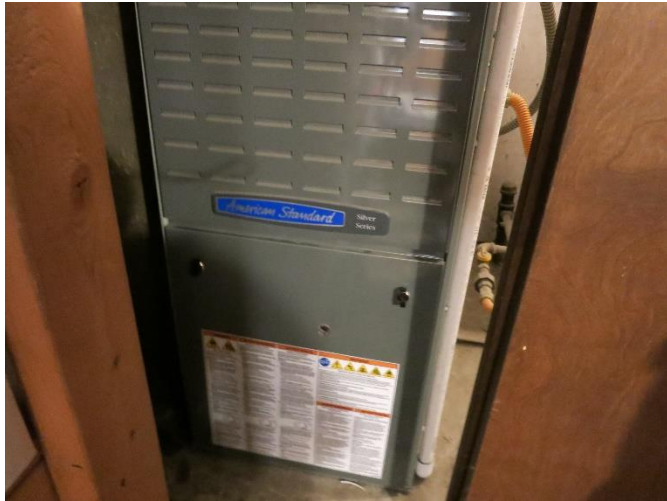
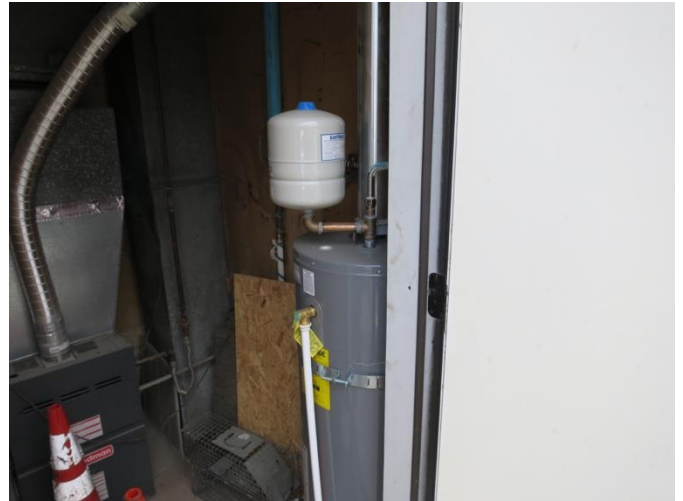
Component Name: Furnace Replacement
 Component Number: Clubhouse 4013

Component Life Expectancy: 20 years
 Age of Component: 20 years
 Remaining Component Life: 0 years

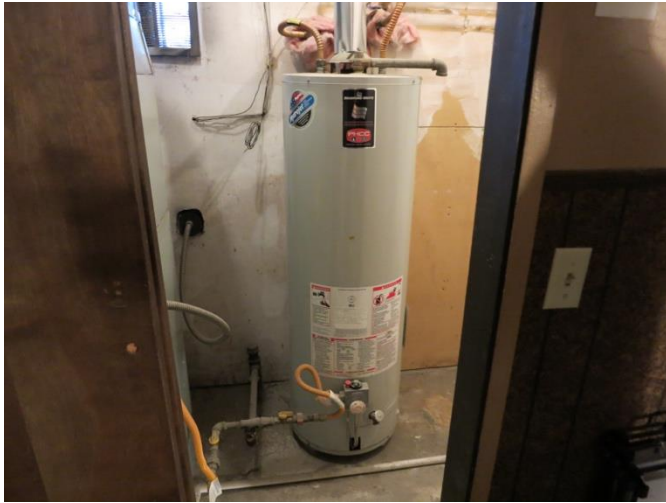
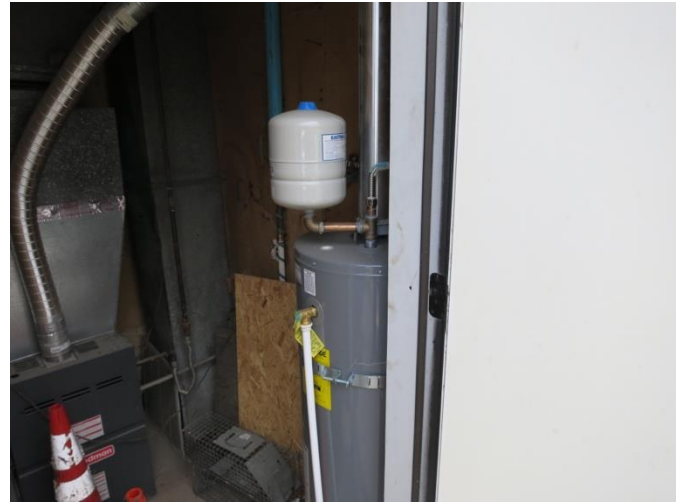
Component Name: Hot Water Heaters
 Component Number: Clubhouse 4014

Unit 1	Unit 2	
Component Life Expectancy:	12	12	years
Age of Component:	12+	1	years
Remaining Component Life:	0	11	years

One of the two hot water heaters was replaced in July 2023.

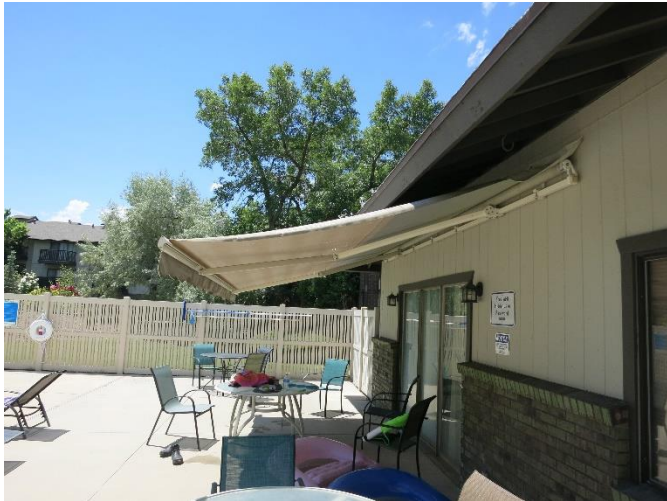
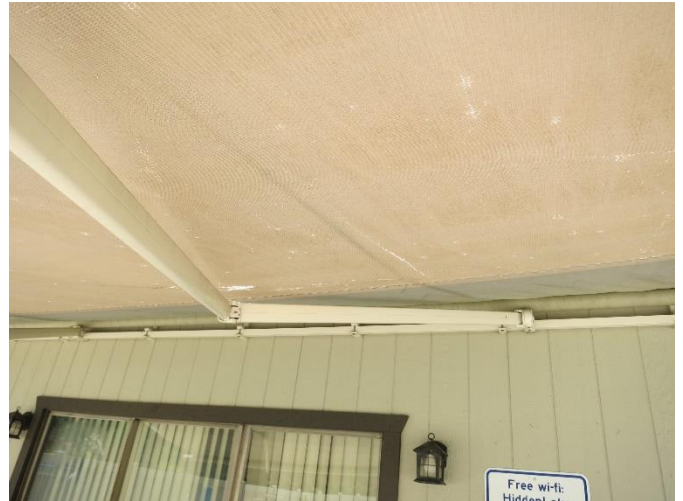
Component Name: Retractable Awning
 Component Number: Clubhouse 4015

Component Life Expectancy: 15 years
 Age of Component: 10 years
 Remaining Component Life: 5 years

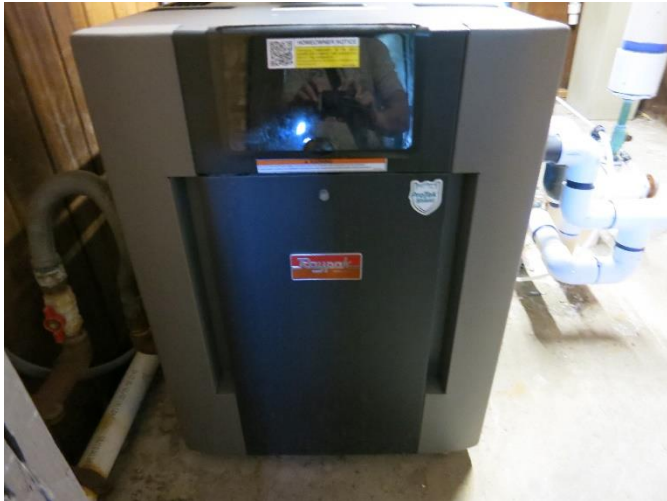
Component Name: Heater
 Component Number: Pool 5001

Component Life Expectancy: 12 years
 Age of Component: 6 years
 Remaining Component Life: 6 years

The life expectancy of the pool heaters is 12 years with proper maintenance. It is recommended that the heaters be wiped down to help achieve the design life of the heaters.

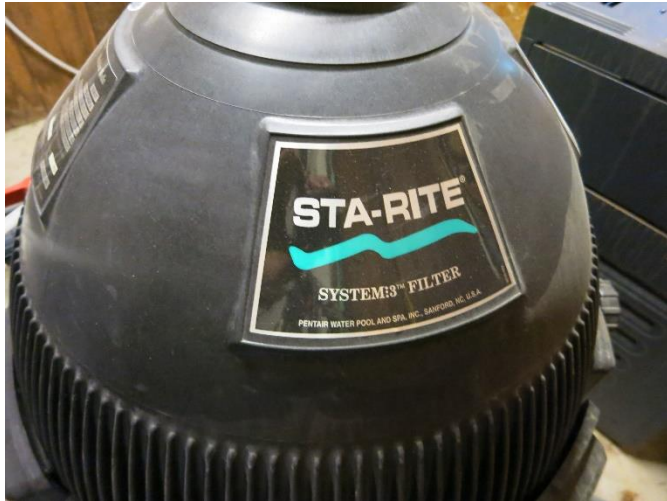
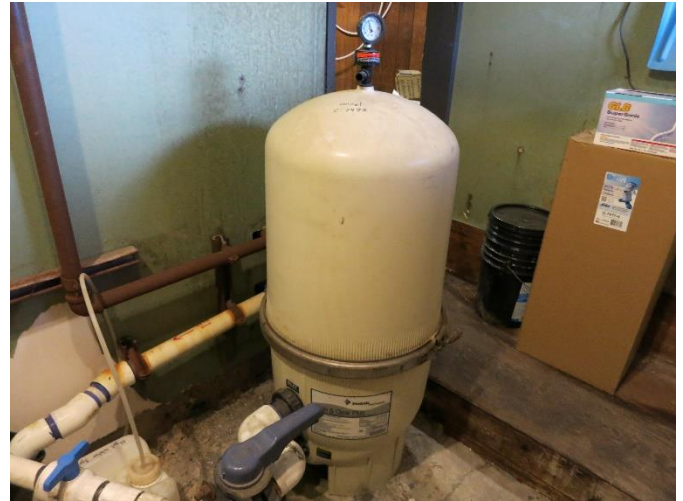
Component Name: Sand Filter
 Component Number: Pool 5002

F1	F2	
Component Life Expectancy:	12	12	years
Age of Component:	12+	6	years
Remaining Component Life:	0	6	years

A properly maintained sand filter is expected to have a design life of 12 years if properly maintained. The filters appear to be in good condition and properly maintained which will prolong the life of these units.

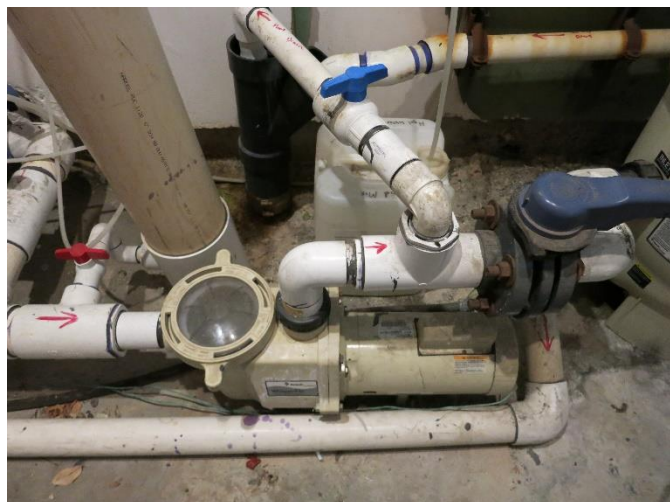
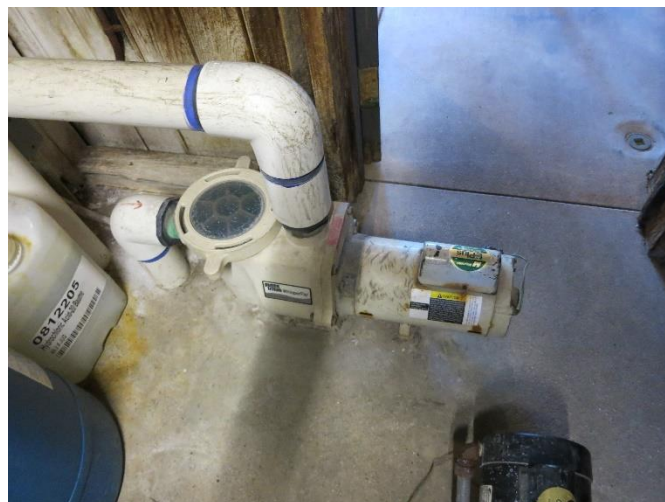
Component Name: Pumps
 Component Number: Pool 5003

Component Life Expectancy: 10 years
 Age of Component: 6 years
 Remaining Component Life: 4 years

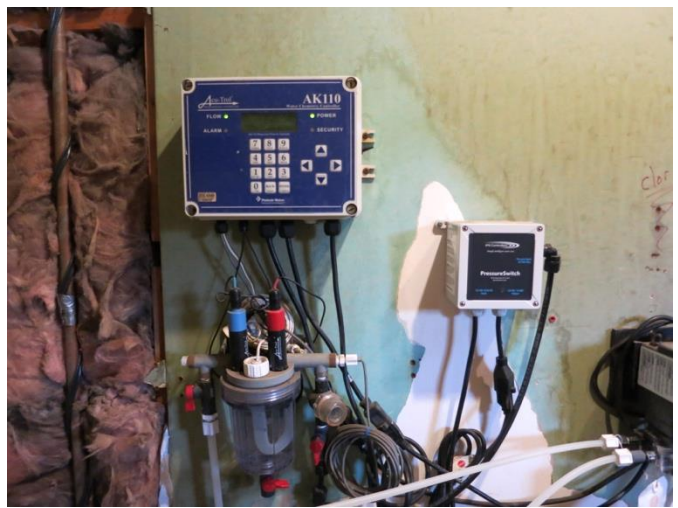
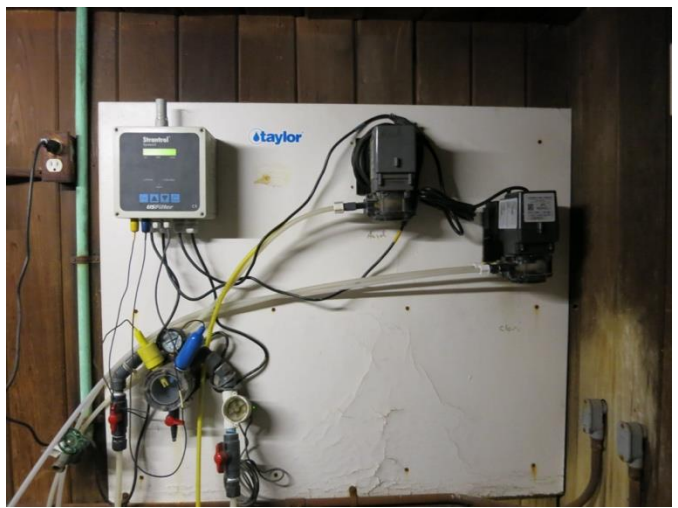
Component Name: Chemical Controllers
Component Number: Pool 5004

Component Life Expectancy: 10 years
Age of Component: 4 years
Remaining Component Life: 6 years

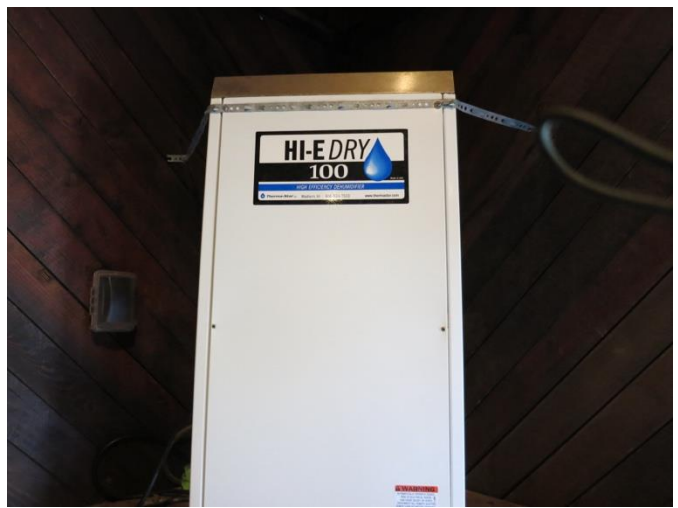
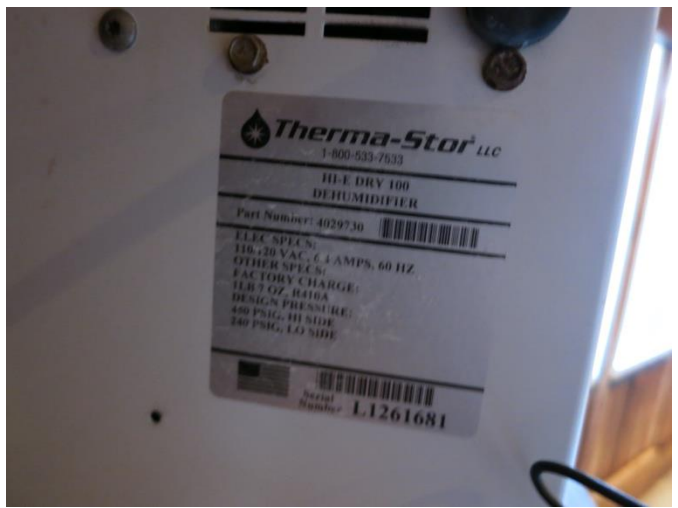
Component Name: Dehumidifier
Component Number: Pool 5005

Component Life Expectancy: 10 years
Age of Component: 5 years
Remaining Component Life: 5 years

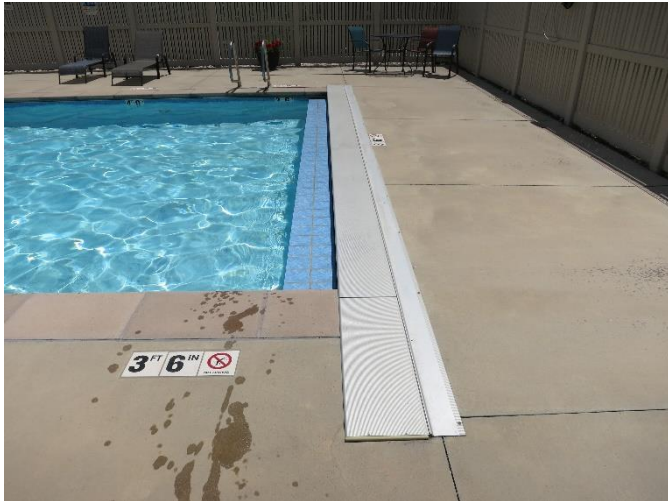
Component Name: Automated Pool Cover Housing
 Component Number: Pool 5006

Component Life Expectancy: 12 years
 Age of Component: 1 years
 Remaining Component Life: 11 years

Property maintenance noted that the pool cover is scheduled for replacement in Fall of 2024.

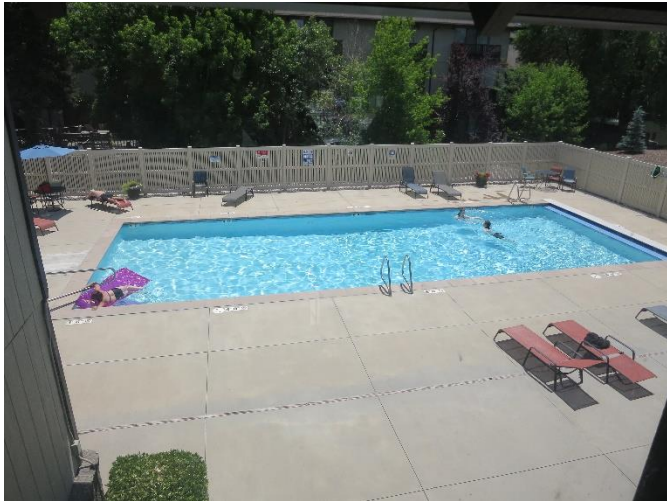
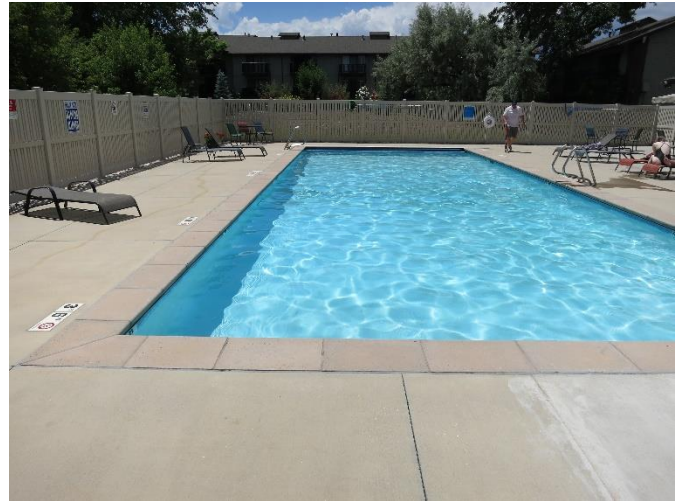
Component Name: Pool Resurfacing
 Component Number: Pool 5008

Component Life Expectancy: 12 years
 Age of Component: 8 years
 Remaining Component Life: 4 years

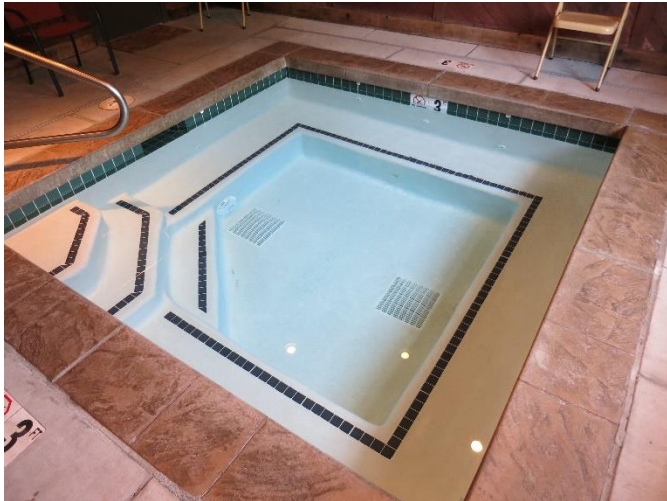
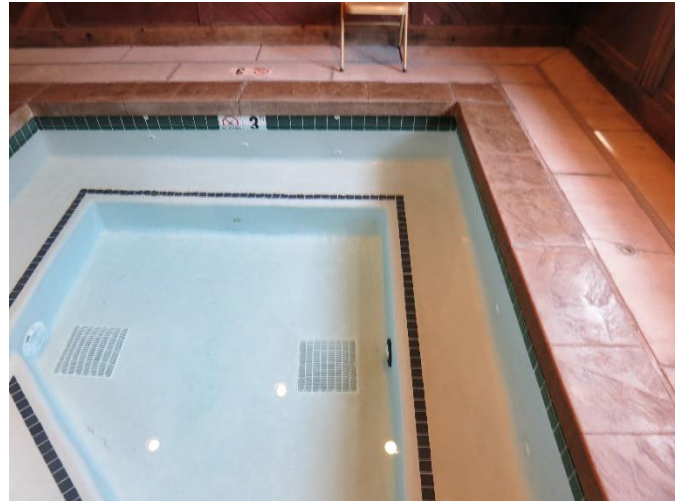
Component Name: Hot Tub Resurfacing
 Component Number: Pool 5009

Component Life Expectancy: 12 years
 Age of Component: 4 years
 Remaining Component Life: 8 years
