Hidden Lake Condominiums

CAPITAL RESERVE STUDY

Report Number: 24-10
Site Inspection Date: June 7th, 2024
Report Submittal Date: September 11th, 2024

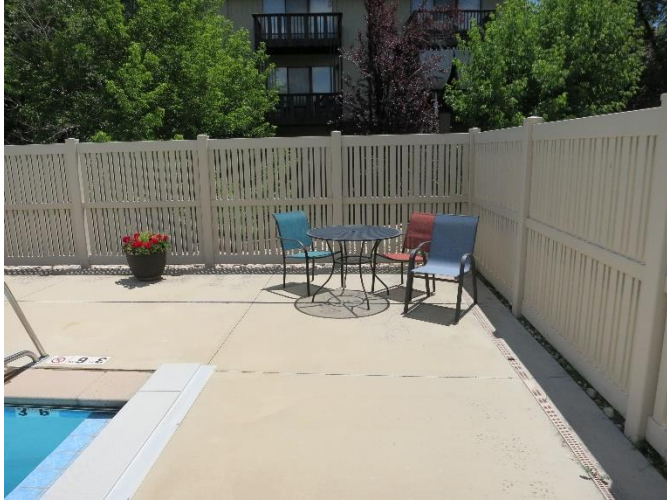
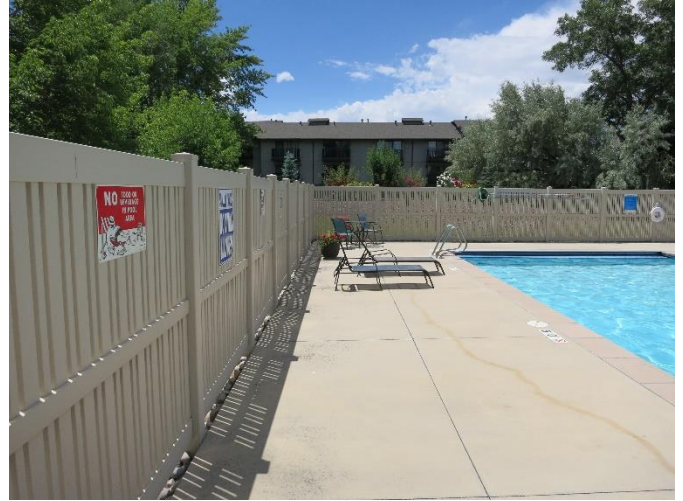
Component Name: Pool Furniture
 Component Number: Pool 5010

An allowance was used in the analysis for the pool furniture. The furniture should be replaced when considerable wear is noticed. The metal furniture used at this facility is more durable than the typical vinyl pool furniture and can be expected to have a longer life expectancy.

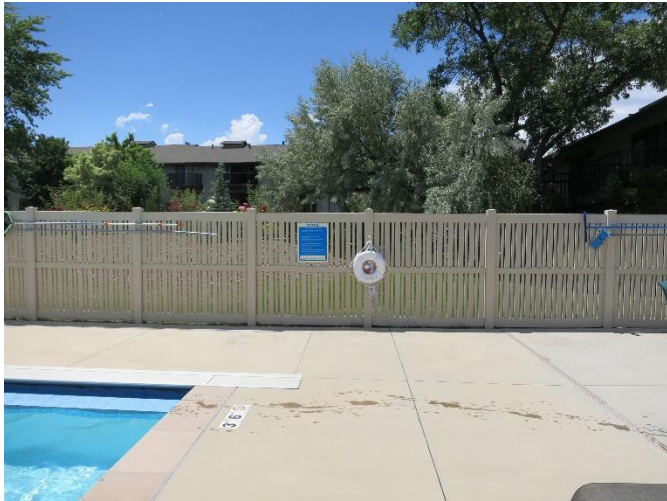
Component Name: Pool Security Fencing
 Component Number: Pool 5011

Component Life Expectancy: 35 years
 Age of Component: 10 years
 Remaining Component Life: 25 years

The pool area is secured by vinyl fencing. This component is covered by the fencing allowance provided for the entire community when spot replacement is needed.

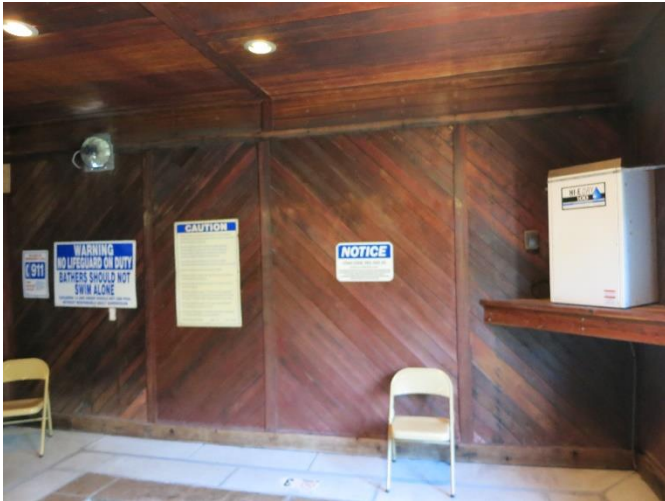
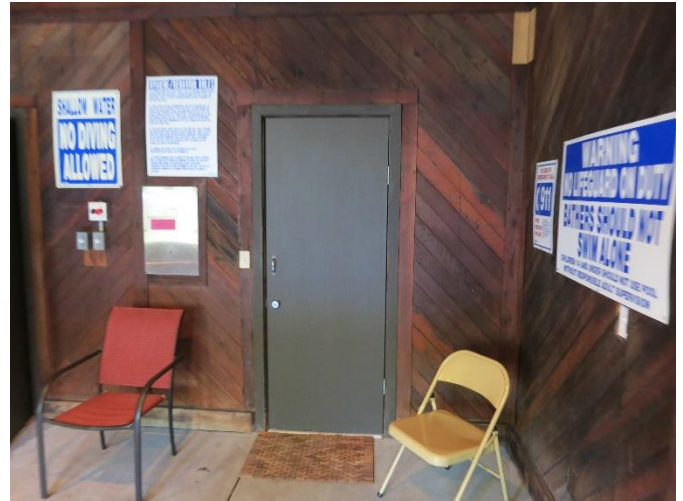
Component Name: Cedar Wood Paneling
 Component Number: Pool 5012

Component Life Expectancy: 40 years
 Age of Component: 20 years
 Remaining Component Life: 20 years
