Cause and Prevention of Microkeratome Jamming Related to Lid Squeezing

Mark E Johnston MD FRCSC
nebraskaeye.com

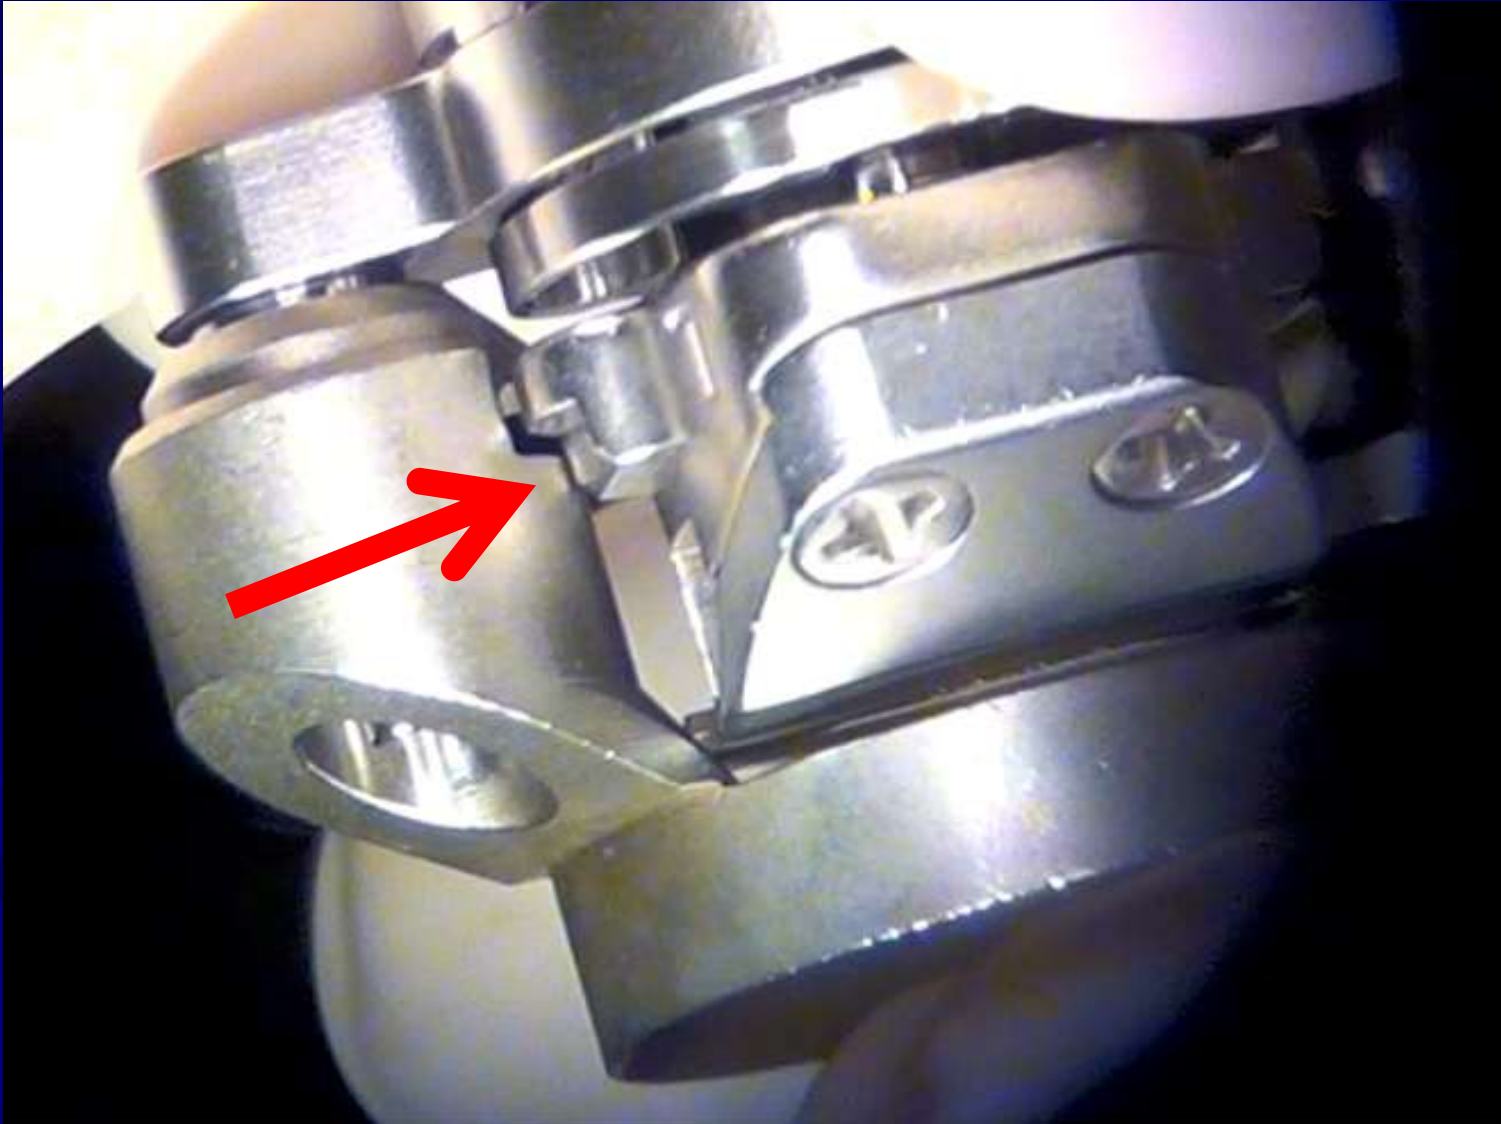
Caution: It may be difficult to unjam the keratome

Upper guide displacement makes the keratome difficult to unjam

Since the mechanism of this jamming has been understood, extra care is taken, especially in squeezers, to assure that the microkeratome head guide is properly seated and lower than the ring overhang before advancing the head
