# Your survey & valuation report

Property Address

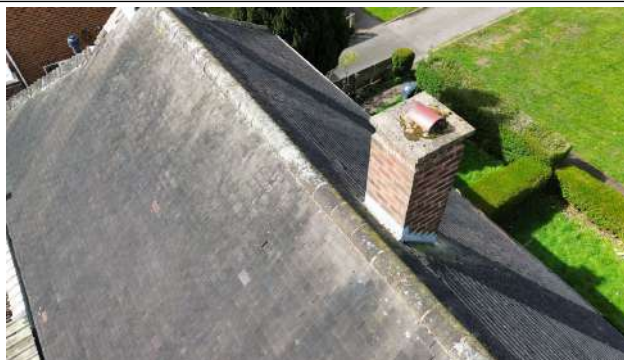
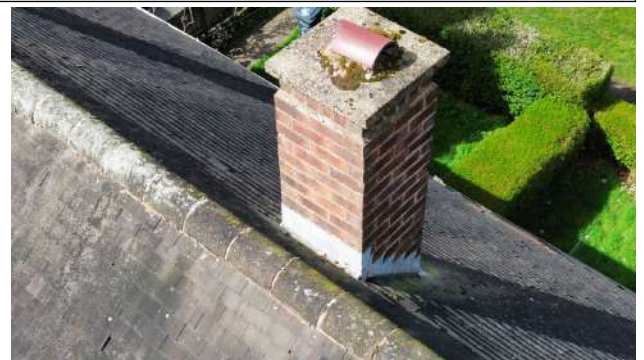
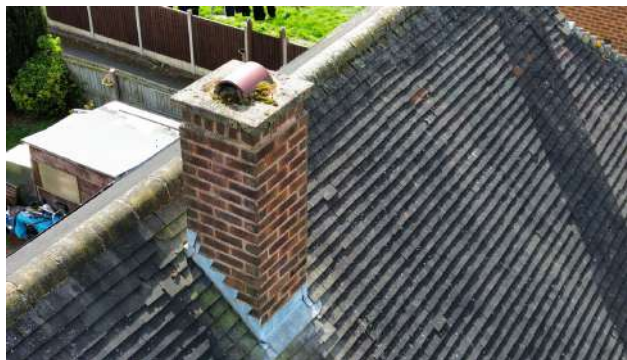
The stack appears to be in generally satisfactory condition, well-formed and with no significant defects noted. Normal maintenance will be required.

The condition and integrity of any flues and their layout within the chimney stack could not be verified and further upgrading and improvement in this regard may be necessary. Flues should be tested at the same time as any gas or solid fuel appliance testing is undertaken.

As the stack is redundant, you should consider removing it and making good the roof covering. If the masonry is retained, the flues that are redundant should be ventilated at the top either with air bricks or special chimney pots which allow ventilation and at the same time prevent rain penetration.

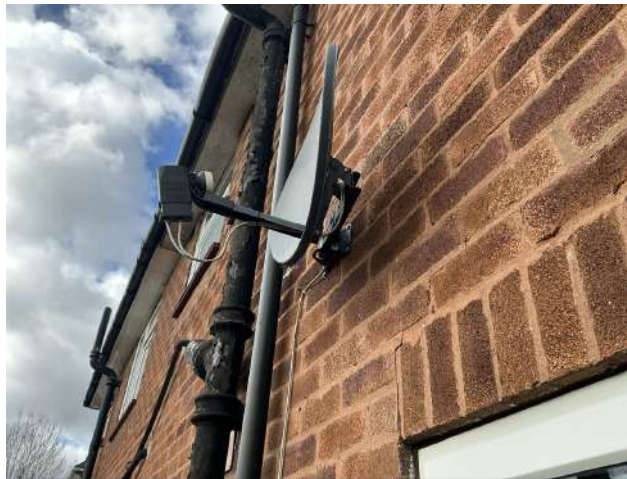
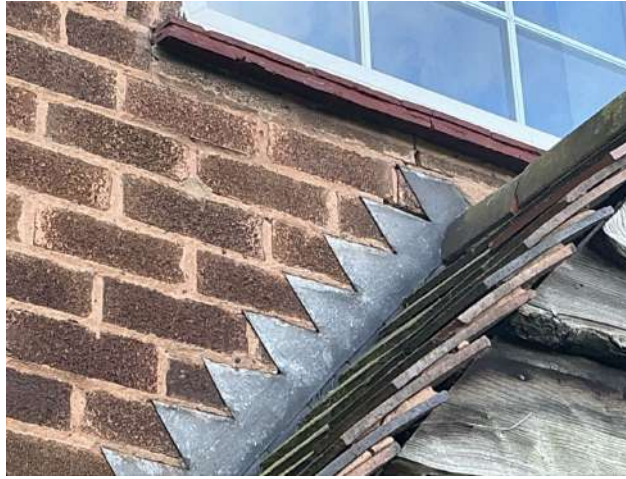
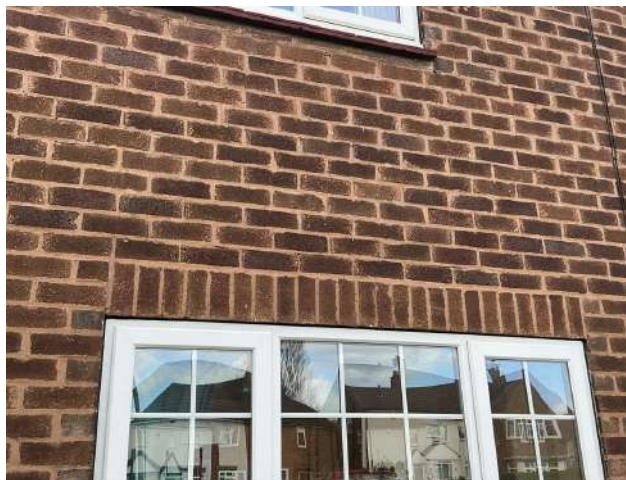
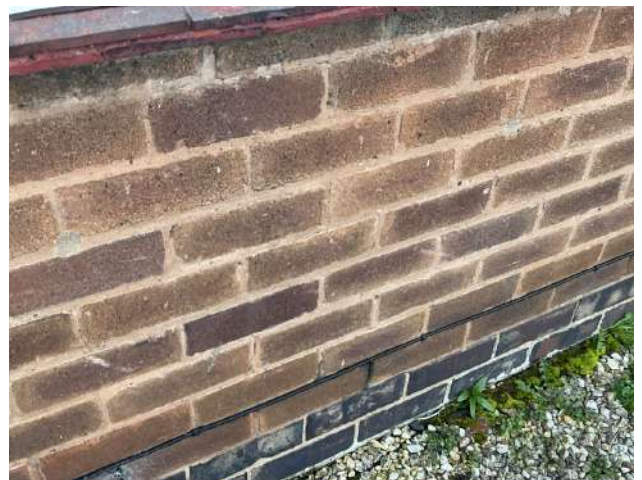
#### D4 Main walls

There is evidence that cavity wall insulation has been installed. Your legal adviser should make enquiries to verify the type of insulation and the existence of valid guarantees. In some circumstances, cavity insulation can cause damp penetration and/or result in accelerated corrosion of wall ties that will require remedial treatment.

A satellite dish is attached to the main walls. At the moment the dish and fixings appear satisfactory but they should be checked every 6 months for signs of deterioration.

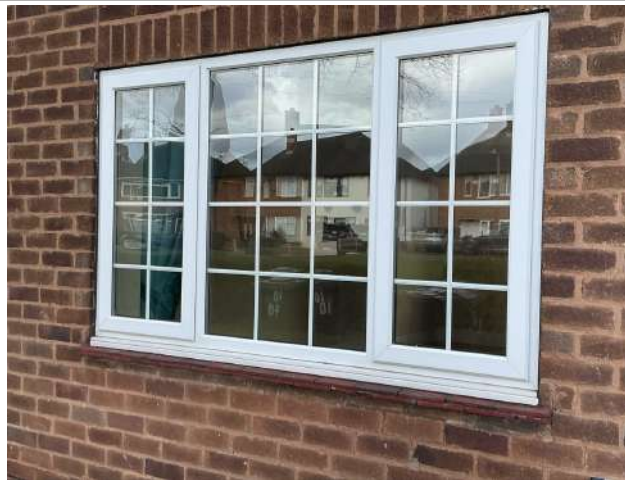
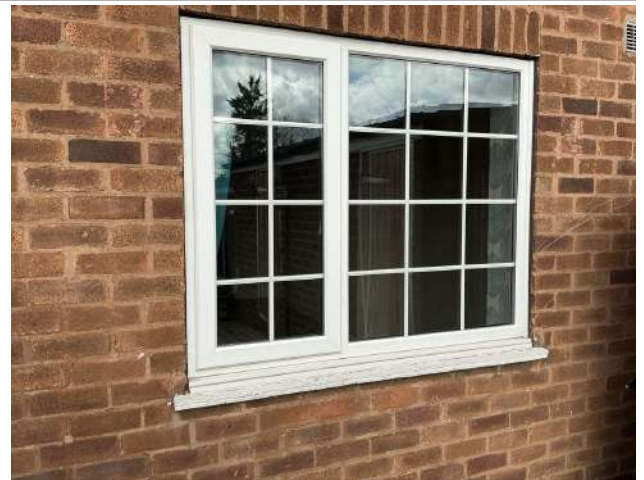
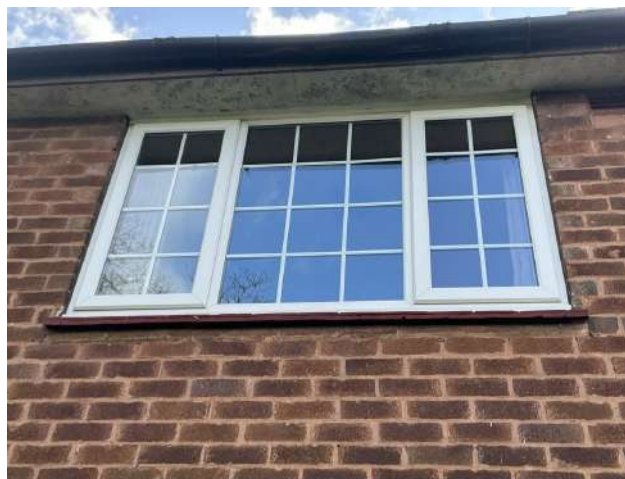
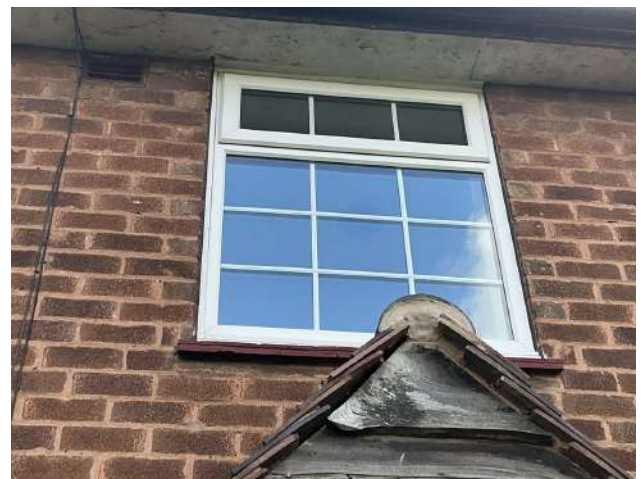
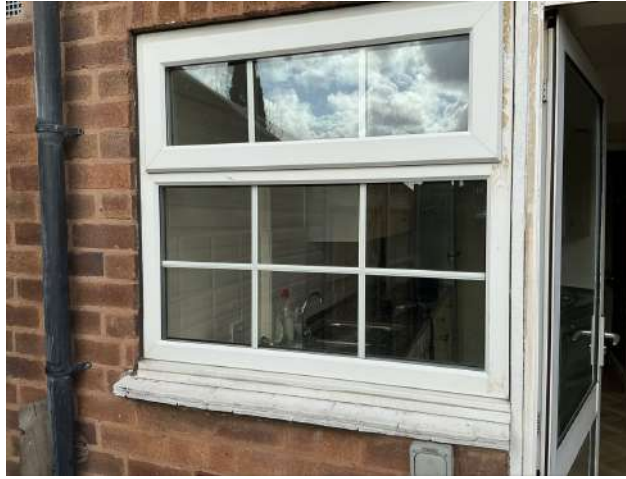
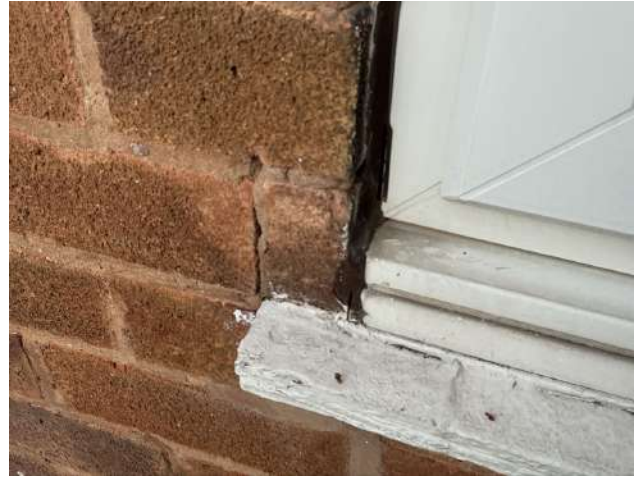
## D5 Windows

penetration, particularly during severe weather conditions. It is important that the sealing material that protects these joints is regularly checked and maintained in good condition.

Properties of this age may not have lintels to support the masonry above the openings. Lintels may need installing or replacing when renewing windows.

Ongoing maintenance should always be anticipated to window joinery in the form of regular attention to items such as hinges, latches, locking mechanisms, framework, sills and glazing seal edges, etc. This is something all homeowners should anticipate and budget for.

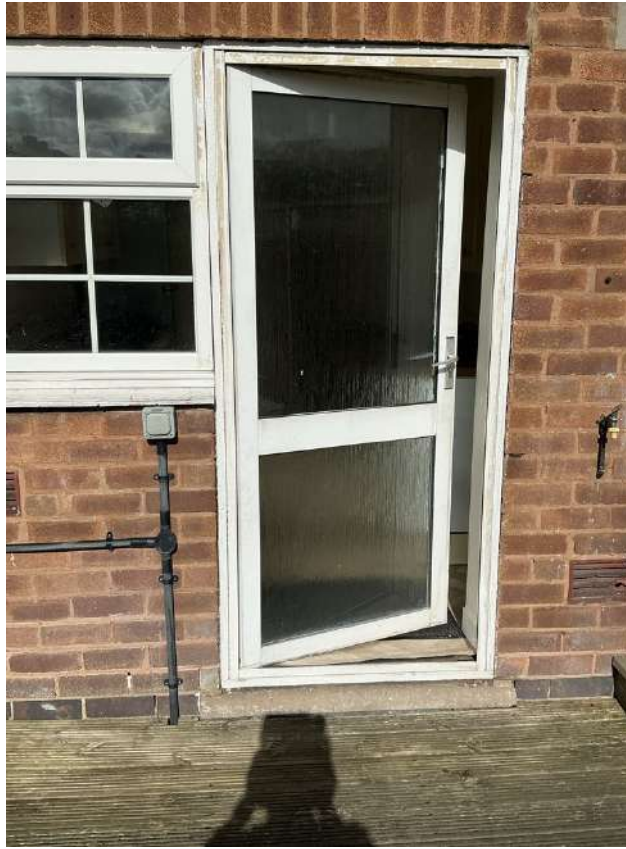
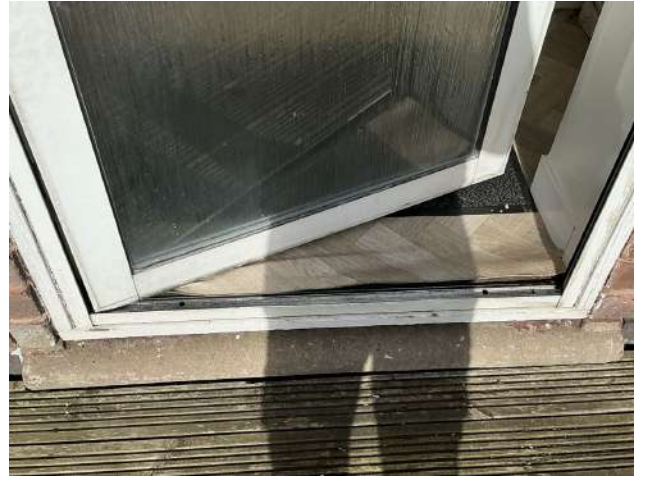
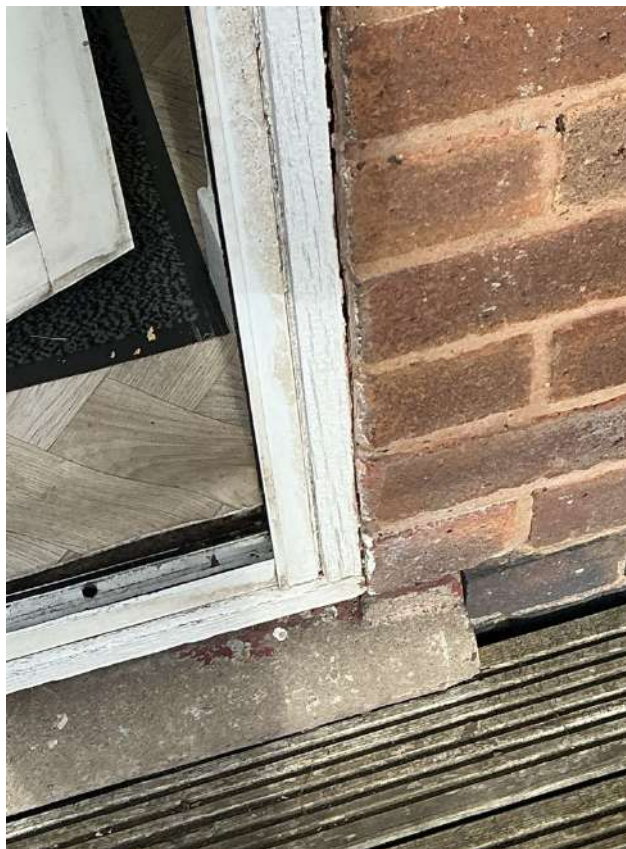
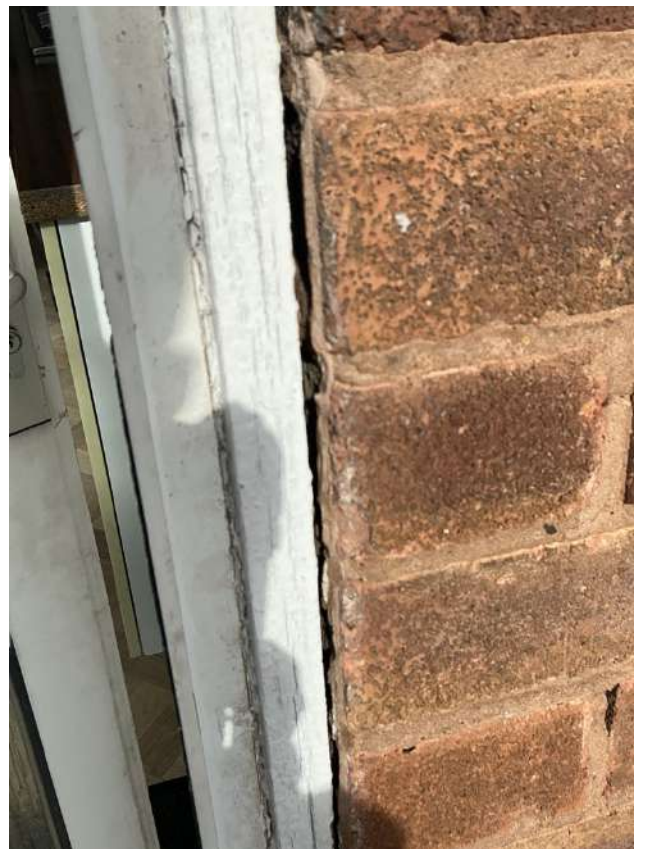
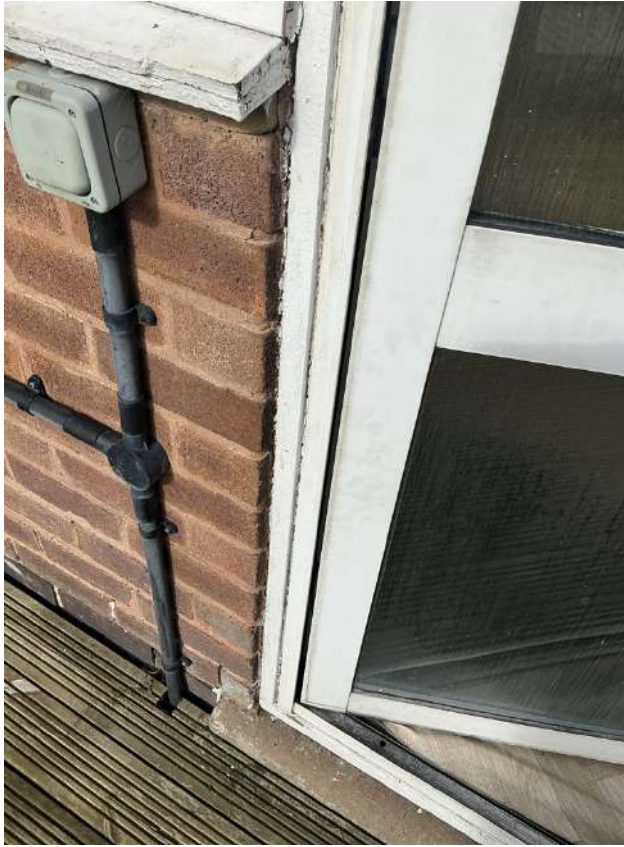
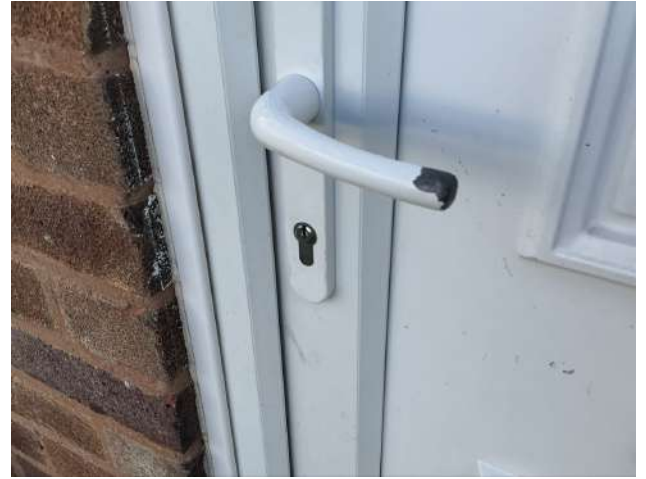
## D6 Outside doors (including patio doors)

Properties of this age may not have lintels to support the masonry above the openings. Lintels may need installing or replacing when renewing doors.

Ongoing maintenance should always be anticipated to door joinery in the form of regular attention to items such as: hinges, latches, locking mechanisms, framework, weatherboard threshold strips and glazing seal edges, etc. This is something all homeowners should anticipate and budget for.

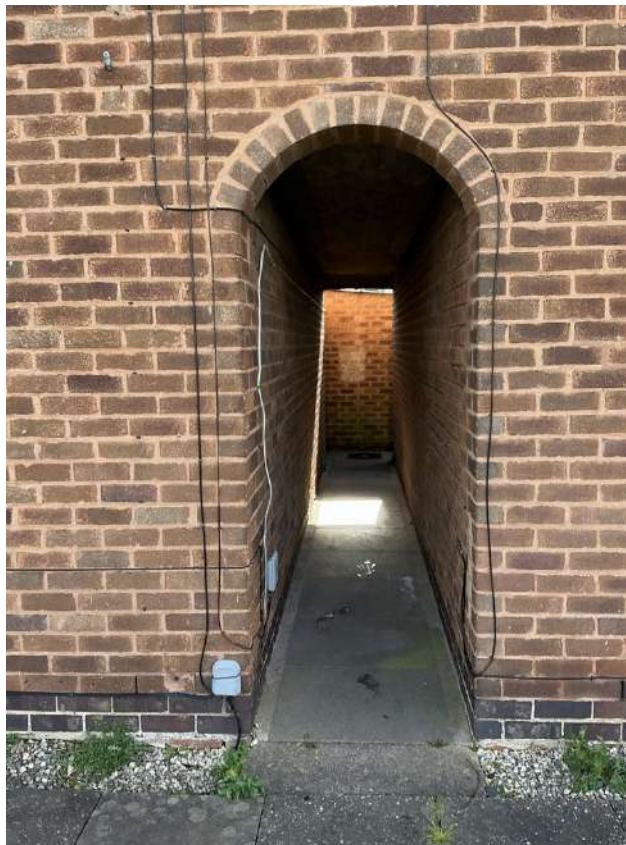
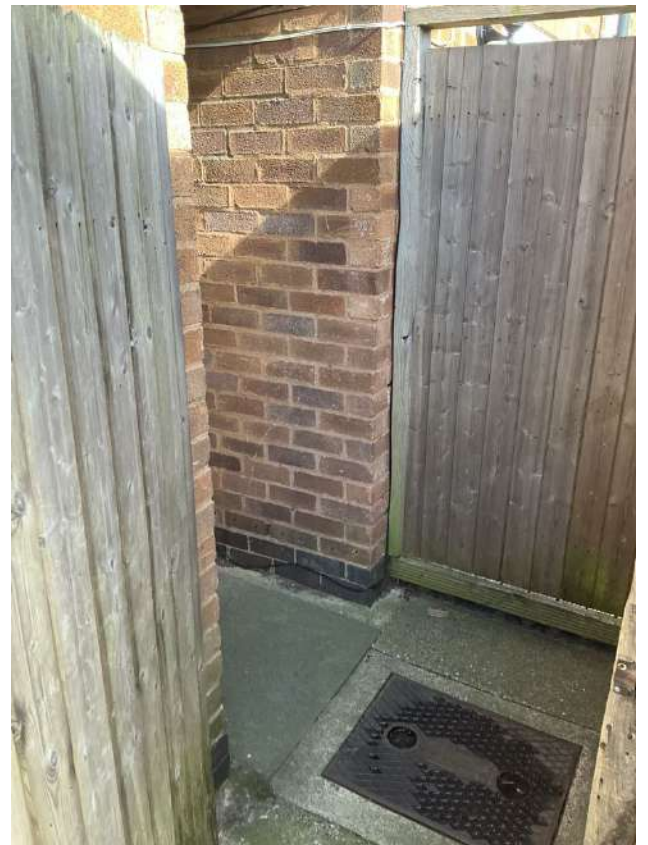
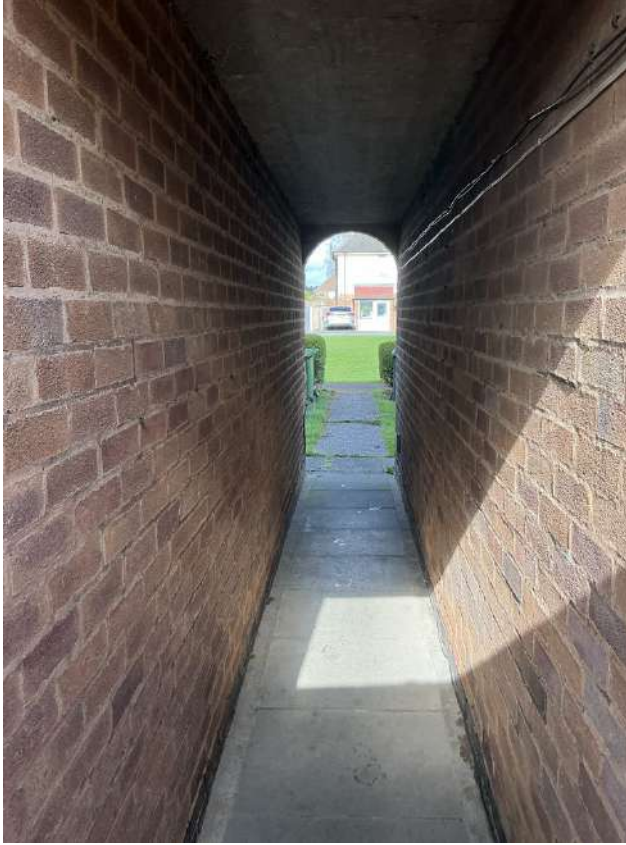
## D9 Other

The maintenance and upkeep of the right of way and the side tunnel should be investigated by your legal adviser.

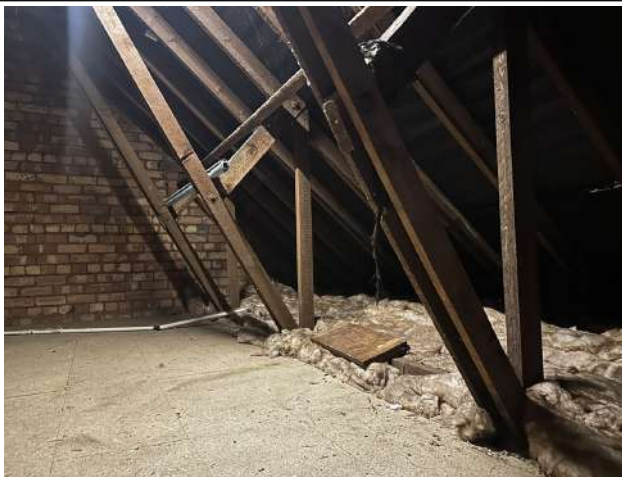
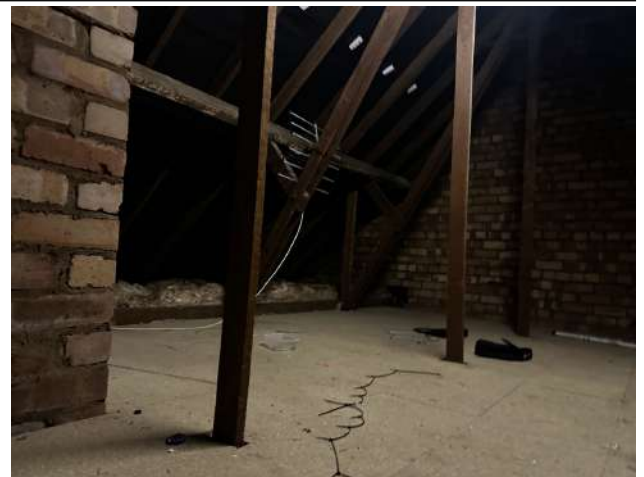
Roofing felt can become brittle with age, particularly when exposed to sunlight, rainwater and wind action. Deterioration often occurs at the bottom of the roof and at the edges where the lining is more exposed. Coverings should be kept in good condition at all times. The felt should be replaced as soon as any deterioration is seen. A closer inspection of the eaves over-lap areas is advised and you may also want to consider installing PVC liners to provide greater protection against damp penetration whilst also improving ventilation.

You should ensure that your electrician checks the electrics within the loft area as part of the overall system inspection.

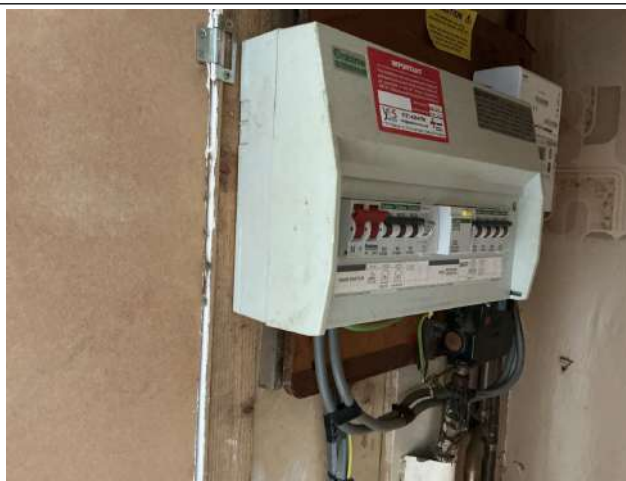
Mains electricity is connected, with the meter and consumer unit located in the under stairs cupboard.

Our visual inspection revealed that the installation appeared to be functional. However, in view of the guidance given above relating to the change of occupancy, we recommend that the installation should now be checked by an appropriate specialist registered with either the NICEIC or a similar approved body prior to the exchange of contracts.

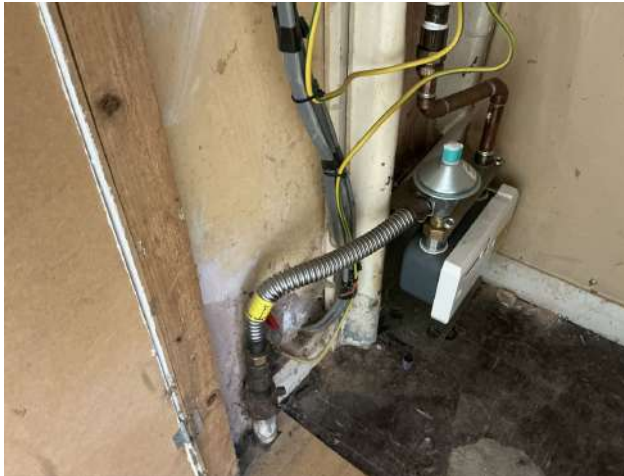
Mains gas supply is connected, with a meter located in the under stairs cupboard.

In view of the guidance above and as a matter of safety, you should now arrange for the installation and all gas appliances to be inspected and tested by a Gas Safe engineer prior to the exchange of contracts.

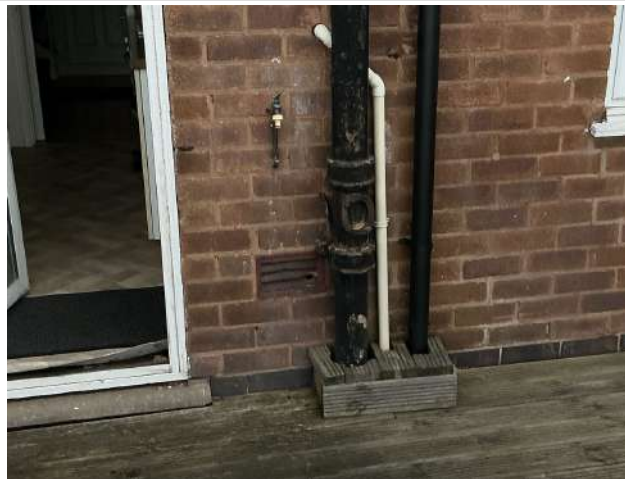
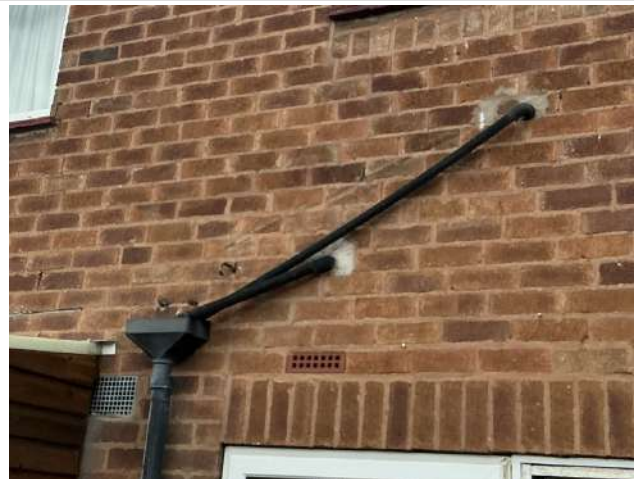
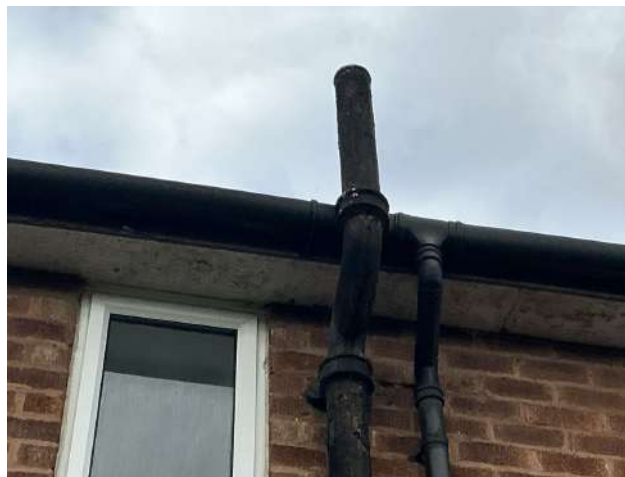
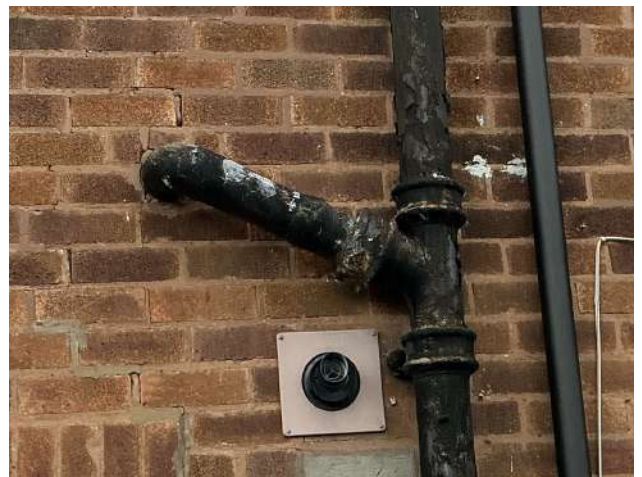
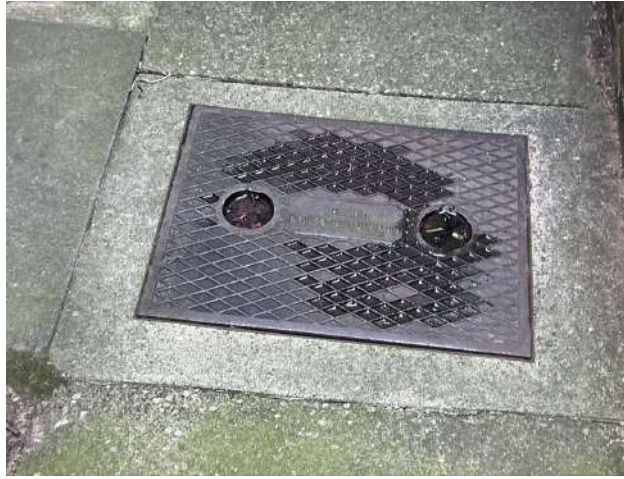
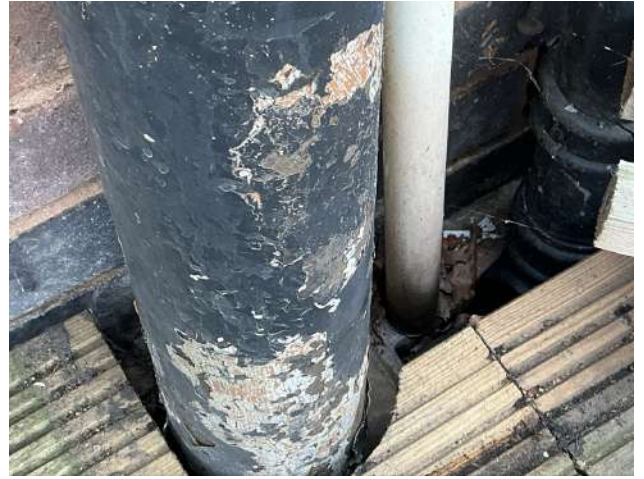
The visible system was generally functional but we noted corroded sections in parts, inadequately supported pipes in parts and lack of cover. Repairs and improvements should be carried out soon after occupation.

As stated above, partial corrosion was evident to the cast-iron soil pipe. Repairs can be carried out to prolong the units but deterioration is likely to be ongoing. If they are to be retained, frequent maintenance should be expected with increased costs. You should anticipate and budget for the renewal with modern equivalents in the short to medium term.

A hopper head is connected to the waste pipe system. Whilst these were commonly installed around the time the property was constructed they are prone to failure and as an open receptacle can become blocked by leaves and debris. Periodic maintenance should be undertaken until such time as it is replaced.

A bird guard should be fitted to the summit of the stack to prevent blockages and associated defects.

The property would benefit from the installation of drainage channels at the base of the main walls. Over time rainwater deteriorates masonry, particularly at ground level, and this increases the likelihood of dampness to the interior. We recommend you obtain estimates for the installation of French drains or suitable equivalent before the exchange of contracts.

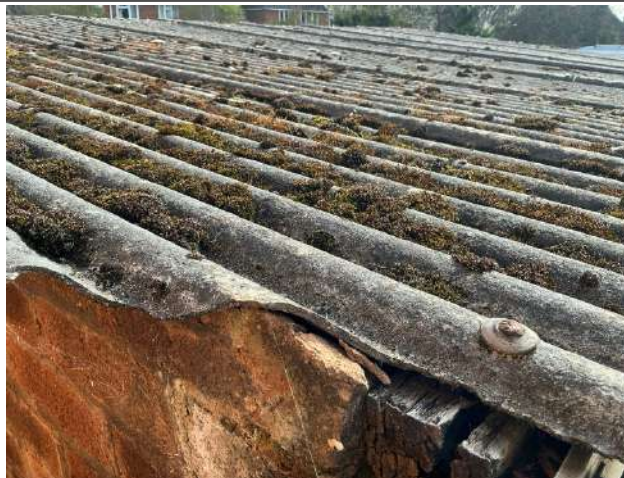
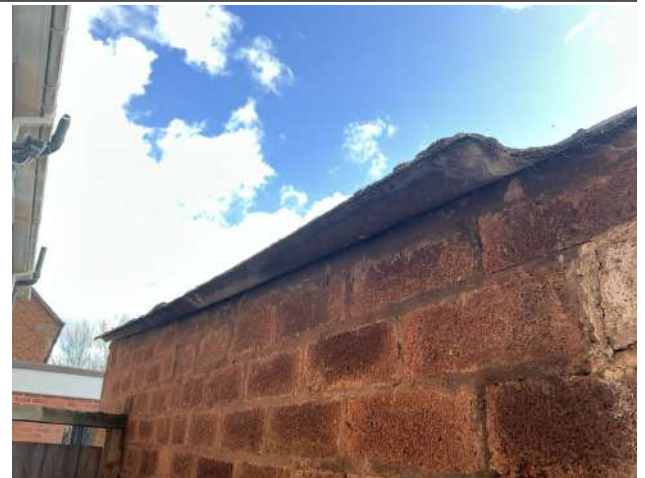
This appears generally satisfactory and fit for purpose but is of basic construction and will be more prone to damp and decay. Ongoing maintenance will be required that may be more frequent in the future.

Parts of the outbuilding are made out of material that may contain asbestos. These appear to be in satisfactory condition at present and should present no health risk if undisturbed. However, they should not be cut or worked in any way and specialist advice must be sought prior to being removed as this will prove costly.

Should you wish to store items inside be advised that this space will likely be subject to ongoing water penetration and/or condensation.

The electrical components within the garage should be checked and tested as part of the wider electrical installation inspection.

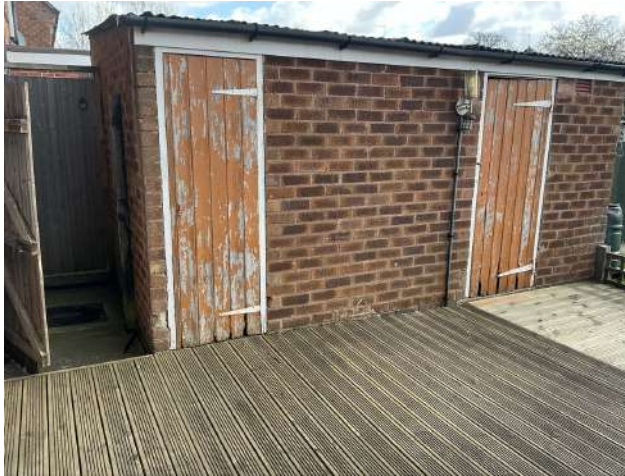
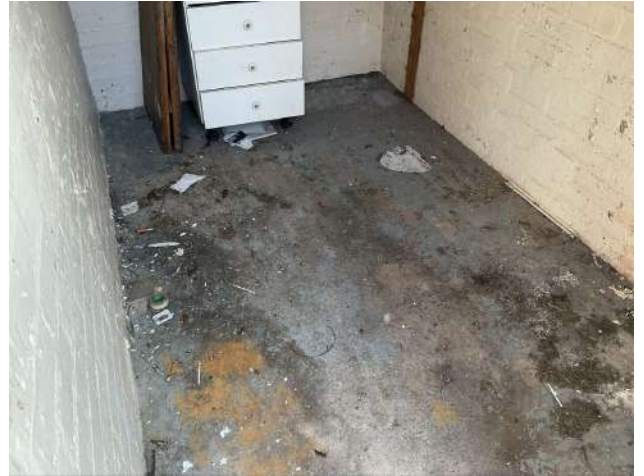
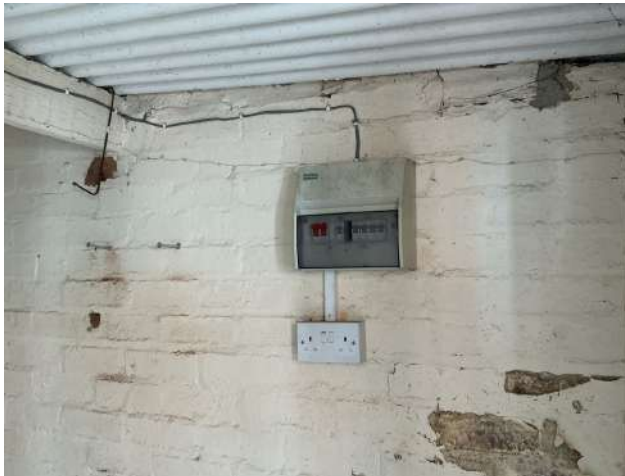
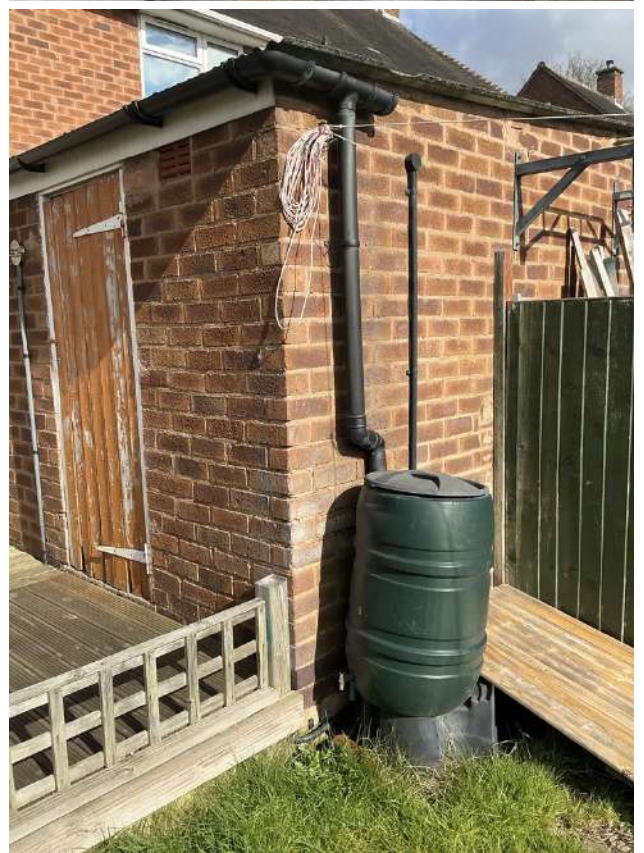
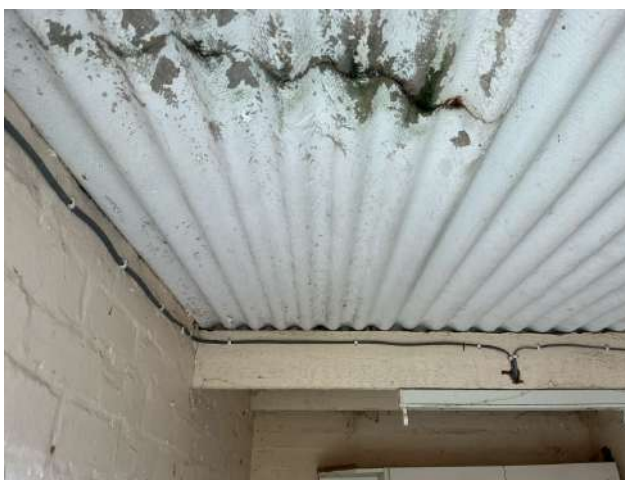
The external areas appeared generally maintainable but we noted some defects/issues that will require repair or renewal including deterioration of the timber fencing and deterioration of the gate. Repairs and improvements are now required in order to prevent issues from arising in the future.

Periodic maintenance of the decking will be required to prevent deterioration and the build-up of algae/grime which can cause the surface to become slippery when wet.

There are various trees and shrubs within the proximity of the building. Trees and shrubs can cause damage to buildings and services but none were seen. Arrangements should be made for the trees and shrubs to be kept regularly pruned to prevent them from increasing in size.
