LEVEL 3

Your survey report

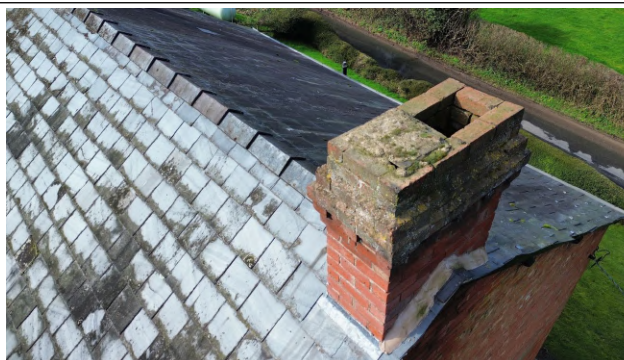
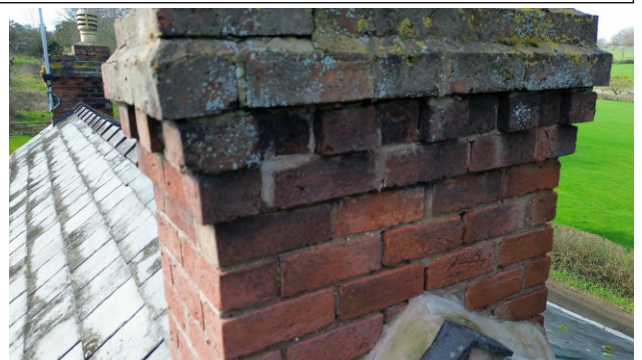
From the available vantage points at ground level and using a drone, the masonry to the stacks appeared generally serviceable for their age and type. However, a number of maintenance issues and defects were noted which now require attention to improve weather resistance and reduce the risk of water penetration.

The chimney stack located to the side elevation of the property is fitted with two flues. One flue has been covered, although the covering arrangement appears basic. The second flue is entirely open and exposed, with no protective terminal or capping and no visible flashing detail to properly bed and seal the pot or opening. In its current condition, this open flue allows direct rainwater penetration into the chimney structure, which can lead to dampness within the stack and internally within the building. The top of the stack should therefore be repaired with appropriate flashing and the flue suitably capped or fitted with a ventilated terminal to prevent rain entry while allowing airflow if the flue is redundant.

The second chimney stack, located on the opposite side of the property, also serves two flues. One flue has been fitted with a ventilated chimney pot which will assist with airflow and help reduce moisture accumulation within the flue. The second flue, however, has been covered with what appears to be a loose roofing slate which has simply been placed over the opening. No proper flashing detail was visible to secure this covering in position. This arrangement is unlikely to provide an effective or durable weather seal and may become dislodged by wind or movement over time. The slate covering should therefore be removed and replaced with a suitable ventilated cap or properly bedded terminal with appropriate flashing to ensure a stable and weather-resistant finish.

The third chimney stack is located above the utility area of the property. The top of this stack has been entirely covered with a layer of concrete flashing. While this approach may provide some protection from direct rainwater penetration, such solid coverings can sometimes restrict ventilation within redundant flues. If the flues below are no longer in use, it is generally preferable to provide controlled ventilation to reduce the risk of condensation and dampness developing within the stack. The condition of the concrete flashing should therefore be monitored, and consideration should be given to introducing suitable ventilated terminals if the flues are redundant.

The mortar flashing around chimney pots and flue openings is particularly exposed to driving rain, frost action and general weathering. Where defective, cracked, or absent, water can enter the chimney structure and migrate internally through the masonry. The various flue terminations across the stacks are inconsistent and in some cases poorly detailed. A programme of repairs is therefore recommended

Internally, damp staining was noted to the ceiling adjacent to the side chimney breast at first floor level. This staining indicates that moisture has entered the structure at some stage. While chimney stacks of this age do not normally contain a damp proof course and can therefore absorb moisture during periods of prolonged or wind-driven rain, the position of the staining adjacent to the stack suggests that defective flashing or detailing at the roof junction may also be contributing to water ingress. The lead flashings and adjacent masonry should therefore be inspected at close quarters and repaired or renewed where necessary to ensure the junction between the stack and roof covering is properly sealed.

The condition, continuity and internal arrangement of the flues within the chimney stacks could not be verified during the inspection. If any fireplaces or heating appliances are connected to these flues, they should be inspected and tested by an appropriately qualified specialist as part of routine servicing of the relevant appliance. If the flues are redundant, they should be properly capped and ventilated to prevent rainwater ingress while allowing adequate airflow.

Any repair works to the chimney stacks should include a close inspection of all accessible hidden elements, including the flashings, masonry joints and adjacent roof coverings, as additional deterioration may become apparent once safe access is available. As is common with repair work to older buildings, further defects may be identified during these works which could increase the scope and cost of repairs.

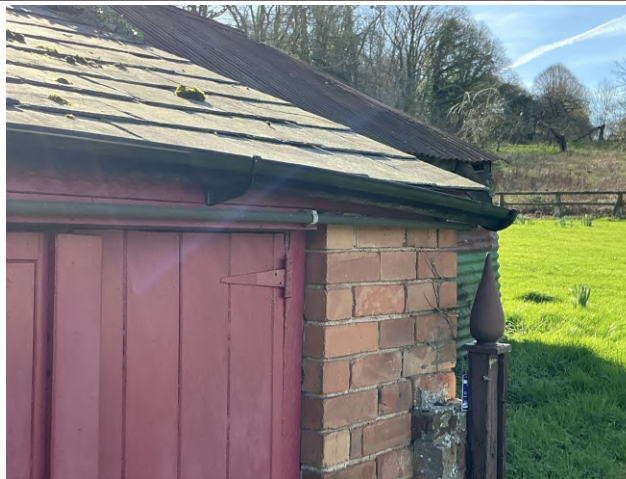
At the time of inspection, there were signs of organic growth and debris accumulation associated with the roof coverings, particularly moss from the adjacent roof slopes. This material can wash into the gutters and contribute to blockages over time. It is therefore advisable that the gutters are cleaned shortly after occupation, removing any moss, leaves and general debris that may have accumulated. Thereafter, the rainwater goods should be inspected and cleared periodically as part of routine property maintenance, typically at least once or twice annually depending on surrounding vegetation and environmental conditions.

Where repairs or maintenance are required to high-level rainwater pipes and gutters, it should be anticipated that suitable access arrangements will be required. This typically involves the erection of scaffolding or the use of other safe access equipment. The cost of providing such access can often exceed the cost of relatively minor repair works. For this reason, it is generally cost-effective to undertake any other necessary maintenance to adjacent high-level elements, such as roof coverings, flashings or chimney stacks, at the same time where possible.

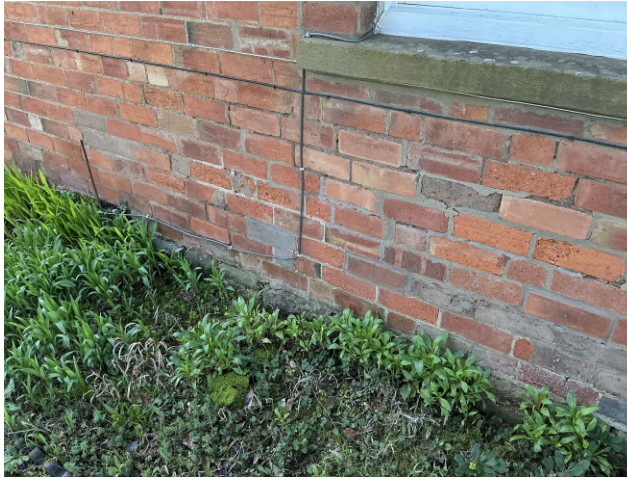
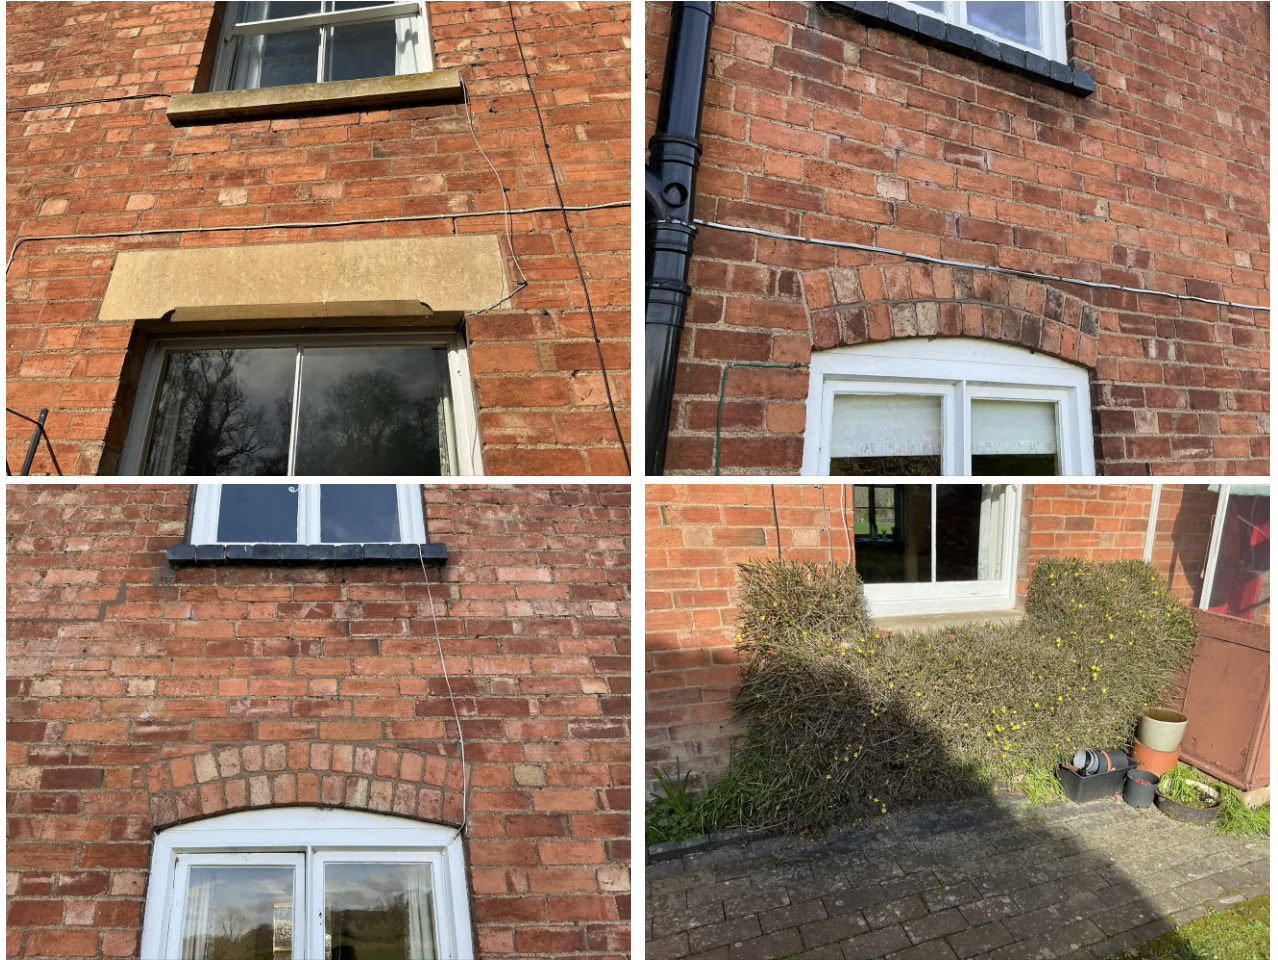
D4 Main walls

Finally, vegetation was noted growing close to parts of the external walls. While this is unlikely to cause immediate structural harm, plants and shrubs located close to masonry surfaces can trap moisture against the wall and restrict airflow, increasing the risk of damp penetration and gradual deterioration of the wall fabric. Vegetation should therefore be cut back and maintained to ensure that foliage does not obstruct windows, ventilation openings, rainwater goods or external wall surfaces.

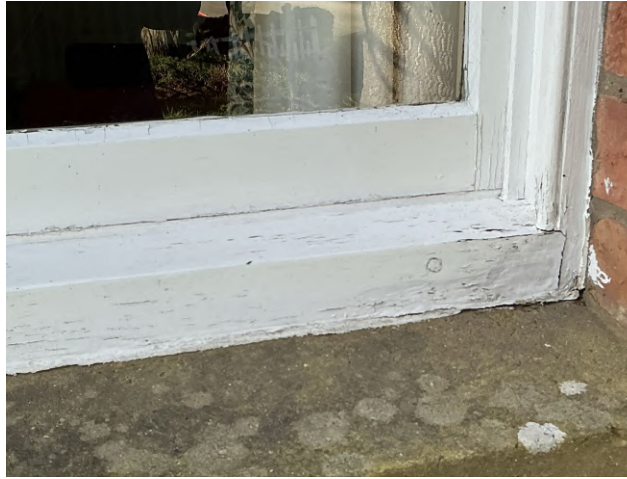
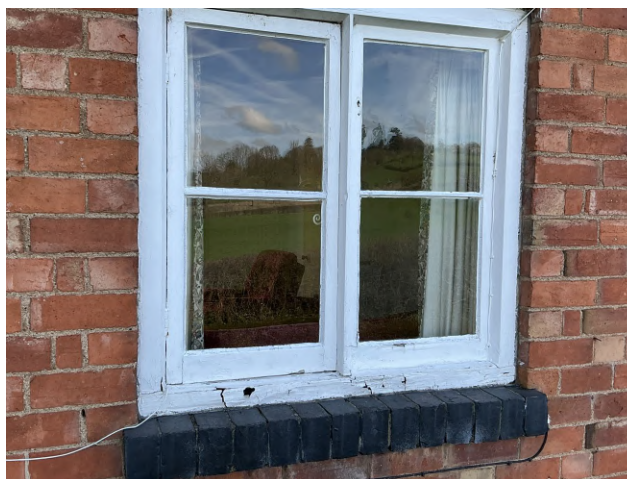
D5 Windows

In summary, the existing timber sash windows are broadly in keeping with the character of the property but require ongoing maintenance and periodic repair to ensure their continued performance. Routine maintenance should include regular inspection and attention to moving parts, ironmongery, sash cords, glazing putty, seals, frames and sills, together with periodic repainting of the timber joinery to protect it from weathering and decay. Homeowners should anticipate and budget for such maintenance as part of the normal upkeep of traditional timber windows.

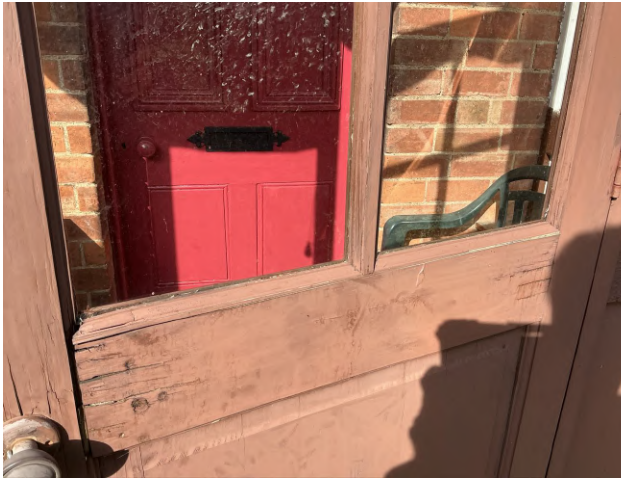
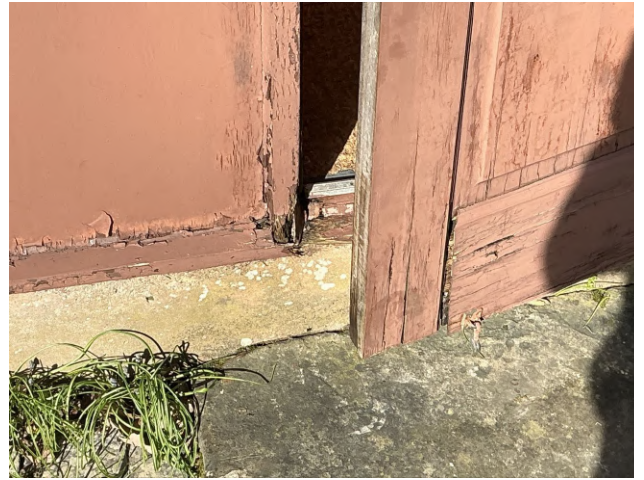
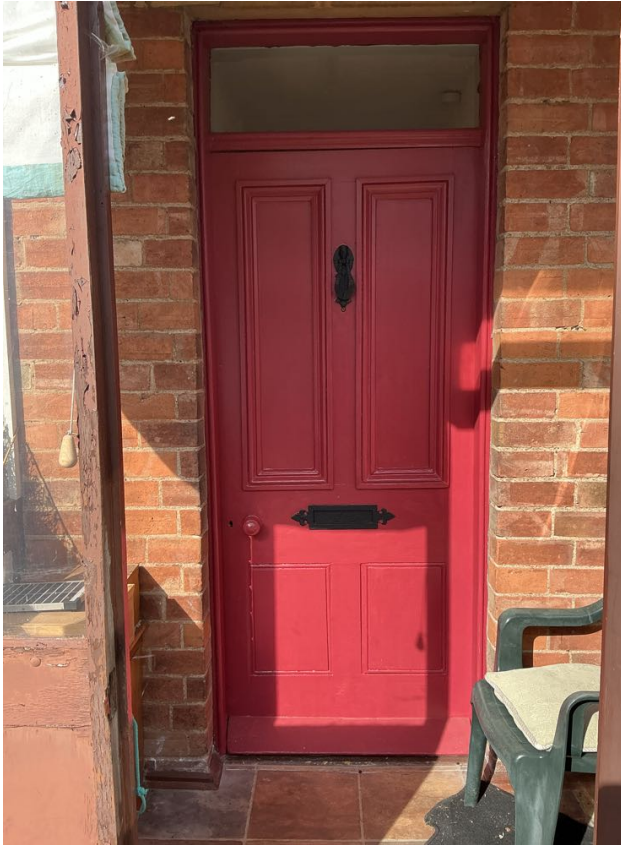
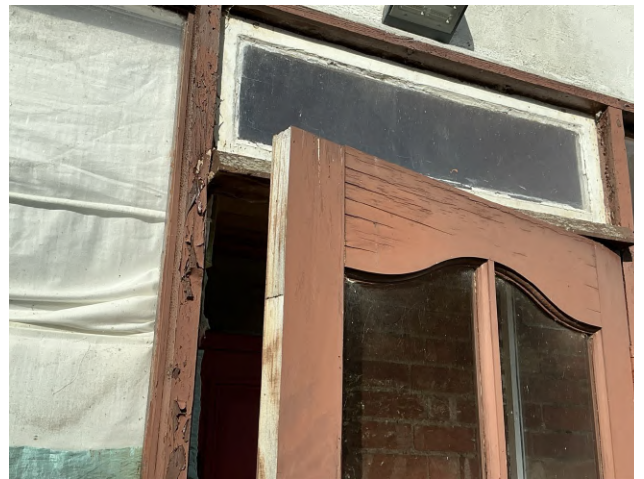
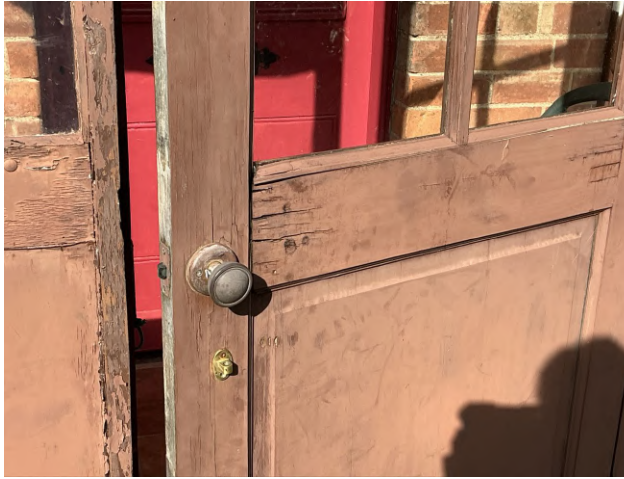
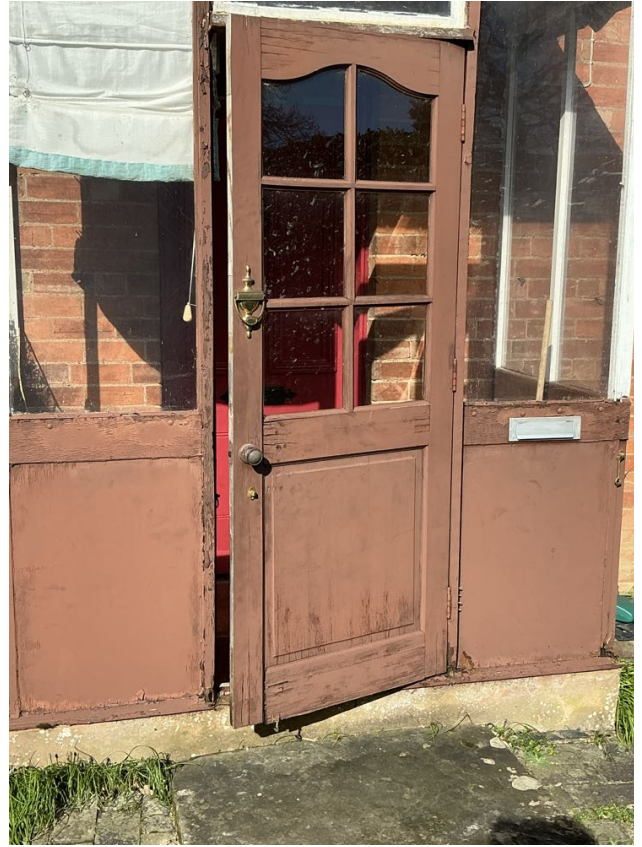
D6 Outside doors (including patio doors)

As with all external timber joinery, ongoing maintenance should be anticipated. This typically includes periodic repainting or protective treatment of the timber surfaces, together with routine inspection and maintenance of components such as hinges, latches, locking mechanisms, door frames, weatherboards,

threshold strips and glazing seals. Proper maintenance will help to extend the service life of the doors and maintain their weather resistance and functionality.

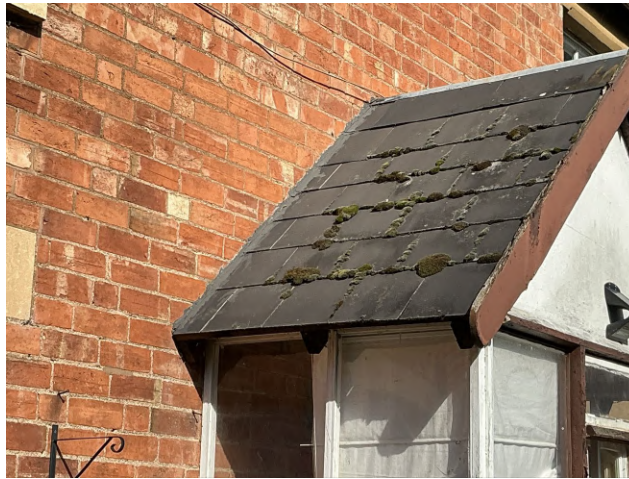
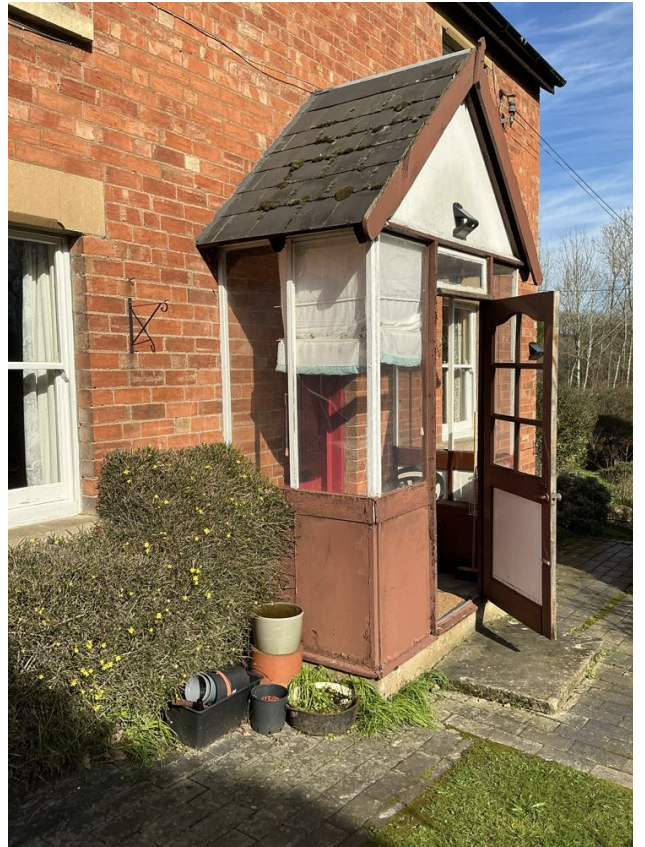
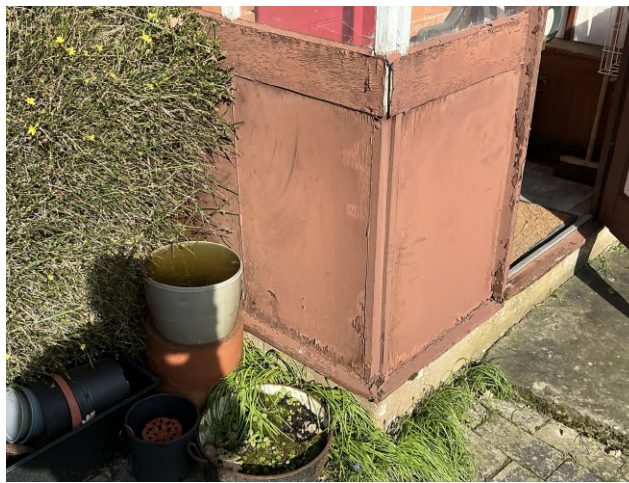
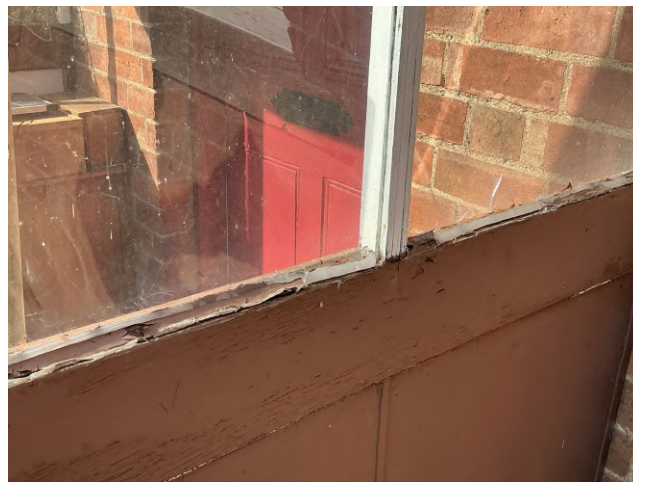
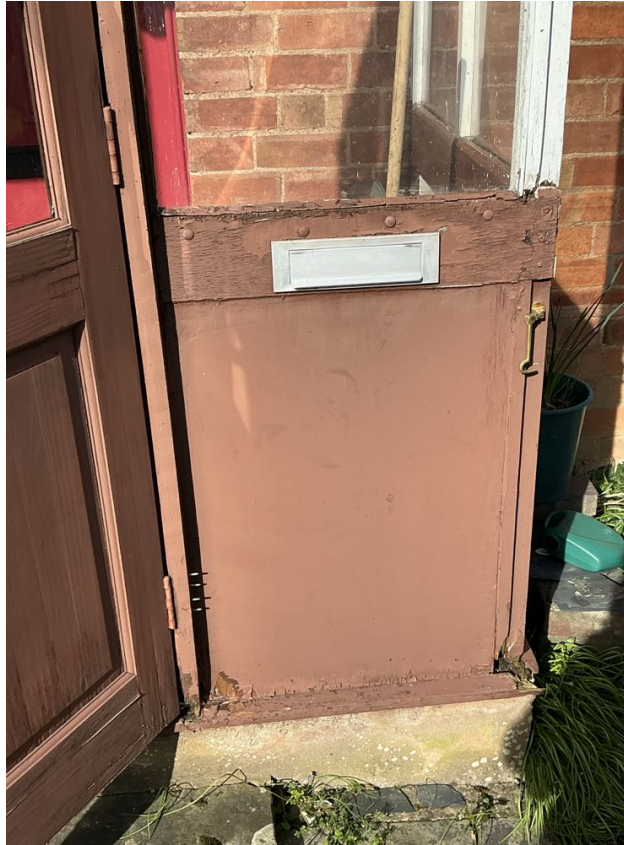
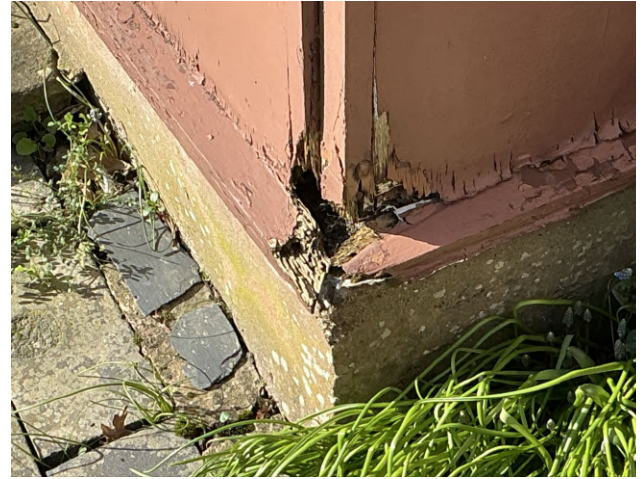
D7 Conservatory and porches

It is also common for porches and similar lightweight additions to have foundations that are shallower than those used for the main building. This can increase the risk of minor movement, distortion or cracking developing over time. In addition, glazing within such structures may not meet modern safety standards and construction details may not conform fully with current building regulations.

Finally, the junctions between the porch frames and the surrounding building fabric are common points for water penetration, particularly during periods of heavy or wind-driven rain. The sealing materials at these junctions should therefore be regularly inspected and maintained in good condition to minimise the risk of moisture ingress into the structure and the adjoining parts of the main building.

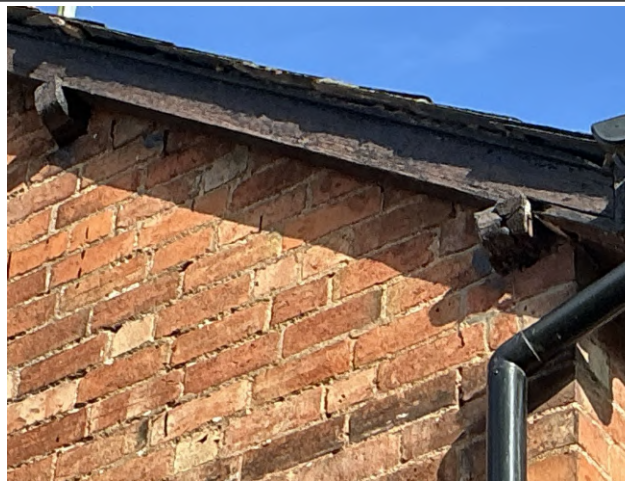
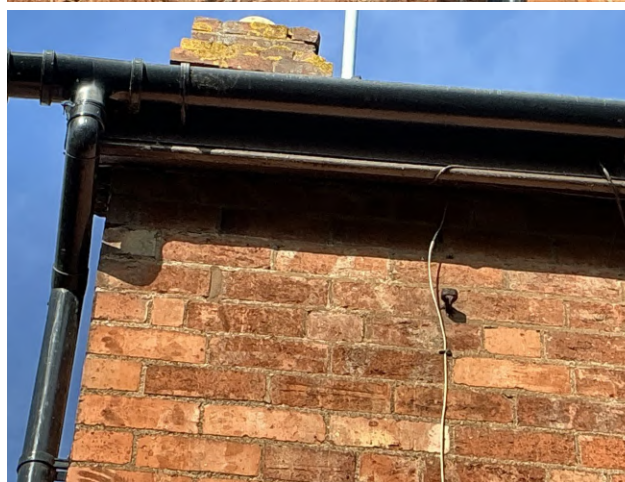
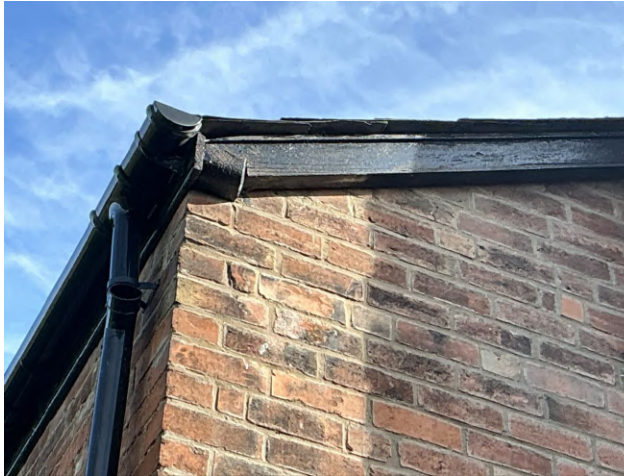
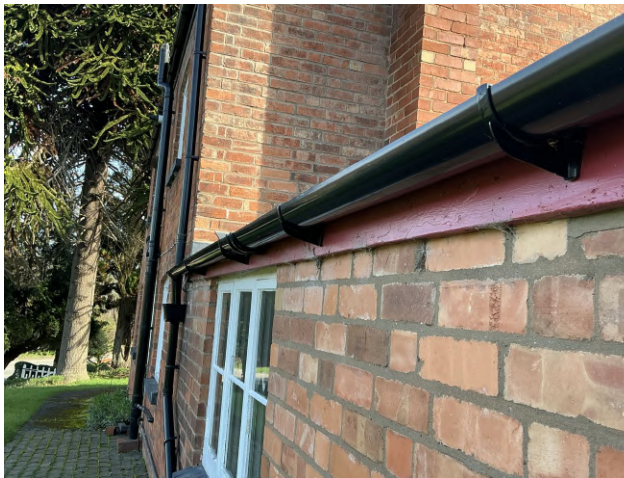
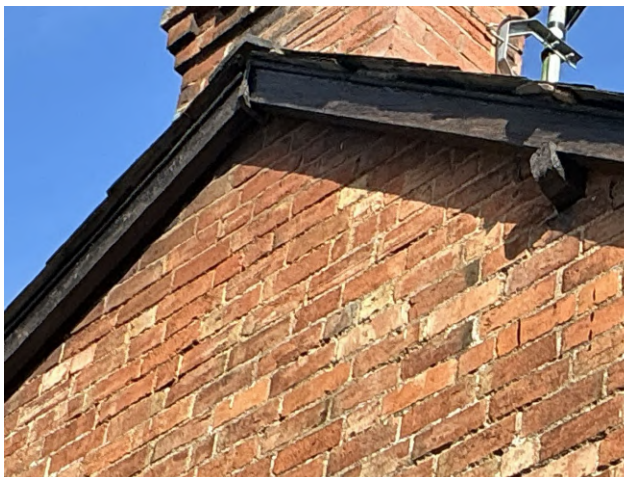
D8 Other joinery and finishes

Given the age of the property, it is possible that some of the historic paint finishes applied to the external joinery may contain lead. Lead-based paints were commonly used in older buildings due to their durability but can pose a health risk if disturbed without appropriate precautions. Urgent action is not required; however, if paint removal or extensive preparation work is planned, appropriate guidance should be followed. Advice can be obtained from the Health and Safety Executive regarding the safe management and removal of lead-based paints.

Timber joinery exposed to external weather conditions requires ongoing cyclical maintenance. As a general guide, external timber elements should be inspected regularly and redecorated on approximately a three to five year cycle, depending on the quality of previous coatings, levels of exposure to weather and the condition of the underlying timber surfaces. Regular maintenance will help protect the timber, prolong the life of the joinery and reduce the likelihood of more extensive repairs being required in the future.

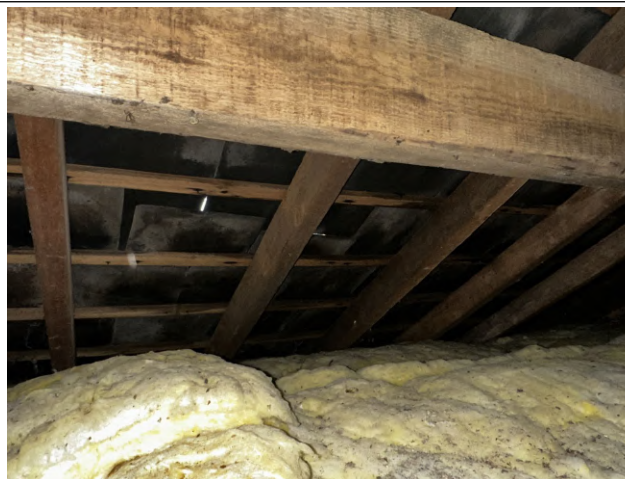
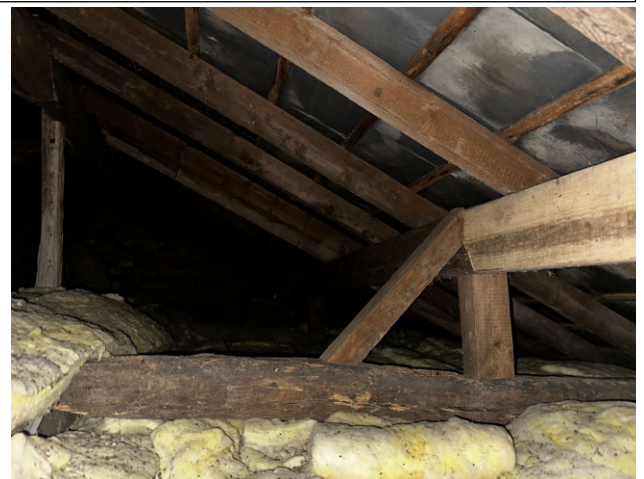
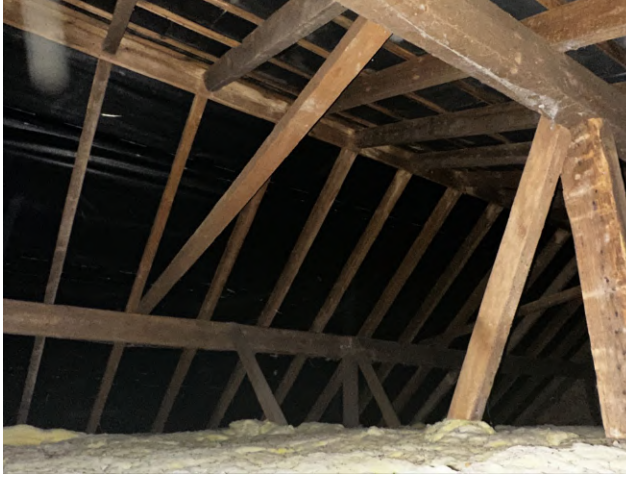
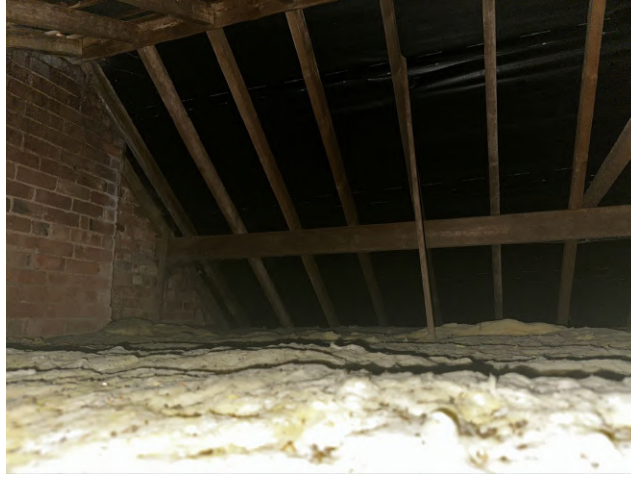
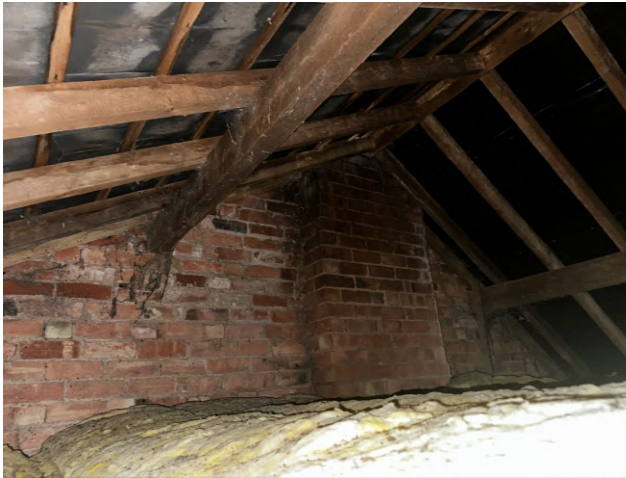
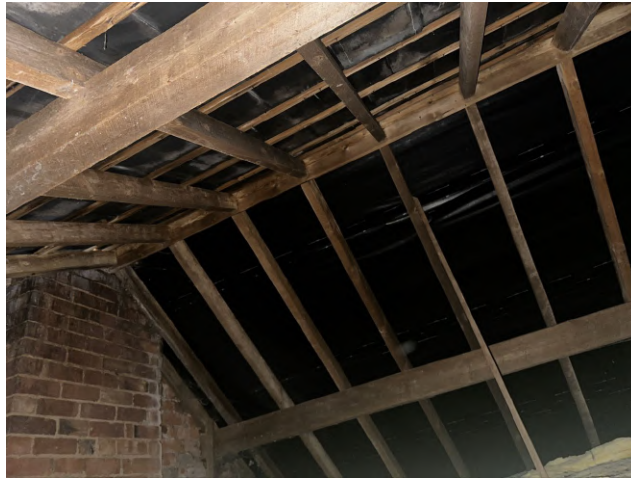
The property was constructed before it became standard practice to install a roofing underfelt or membrane beneath the roof coverings. As a result, the roof slates are likely fixed directly to battens without a secondary waterproof barrier. While this form of construction was typical at the time and can function satisfactorily, it means the roof structure relies heavily on the condition of the roof coverings themselves to remain weather-tight. For this reason, regular inspection and maintenance of the roof coverings is particularly important. Both external roof surfaces and the internal roof void should be periodically inspected for any signs of leaks or dampness so that necessary repairs can be undertaken promptly.

Electrical wiring and fittings were observed within the roof space. As part of the overall inspection of the property's electrical system, it would be prudent for a suitably qualified electrician to inspect the wiring within the loft area to ensure that it is safe and in satisfactory condition.

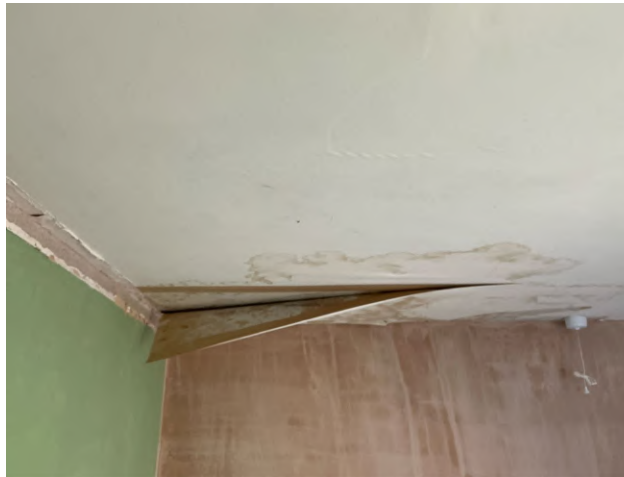
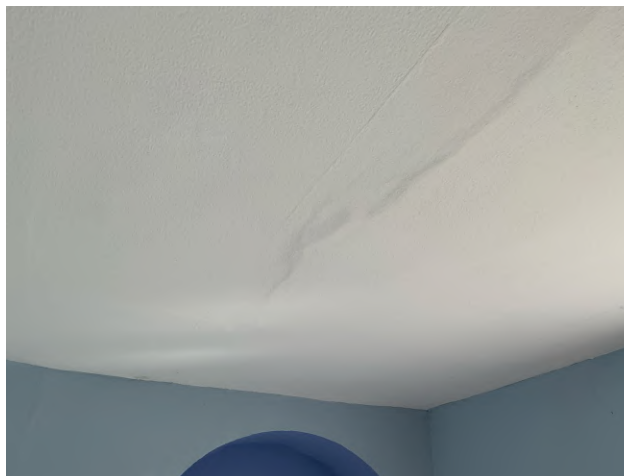
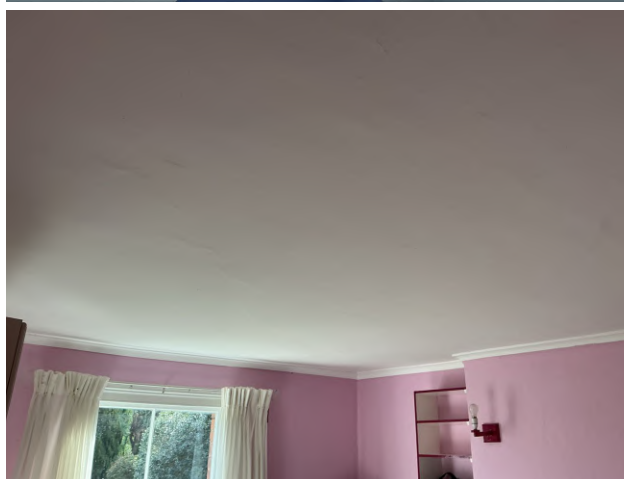
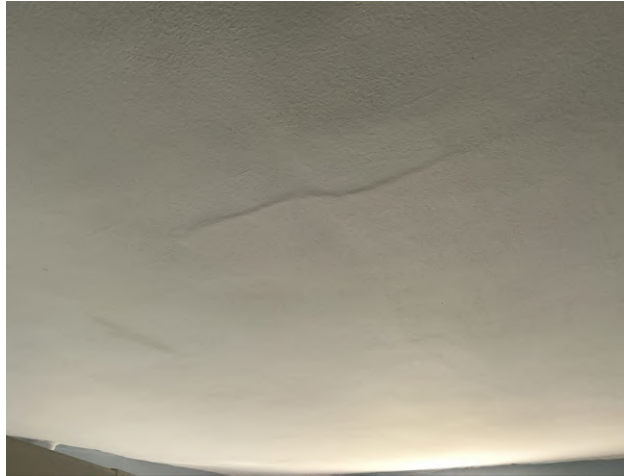
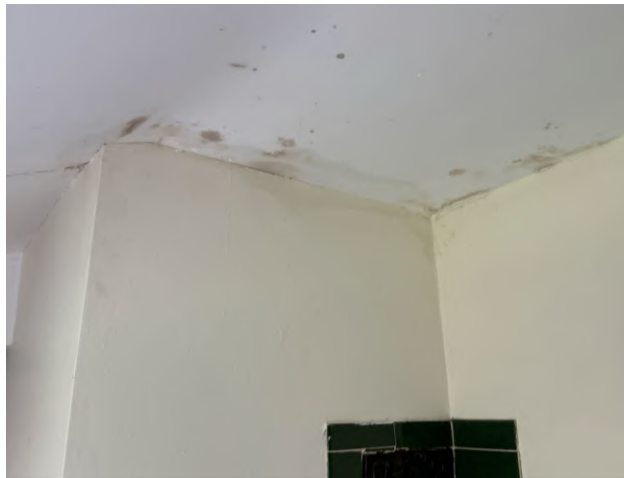
was evident at the time of inspection, it is realistic to anticipate ongoing repairs to defective areas and, in the longer term, more extensive renewal may be required in some locations. The risk of detachment can also increase where old wallpaper linings are removed during redecoration, as these can sometimes be providing additional support to weakened plaster.

Some ceiling surfaces were concealed by decorative linings. Where ceilings are covered in this way, it is possible that underlying defects remain hidden. If such linings are removed in the future as part of refurbishment works, previously concealed defects may become apparent and areas of plaster may loosen or detach. You should therefore allow for the possibility of localised repairs, or potentially more extensive replastering, if these coverings are removed.

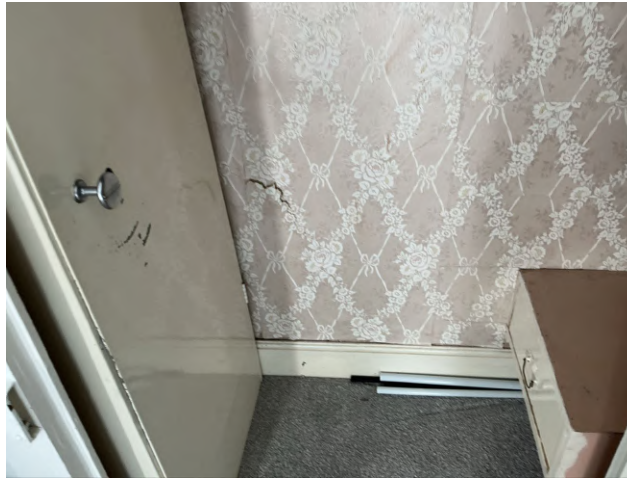
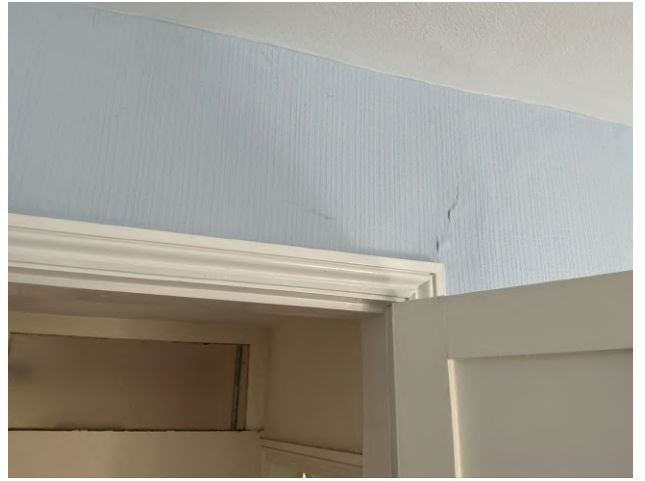
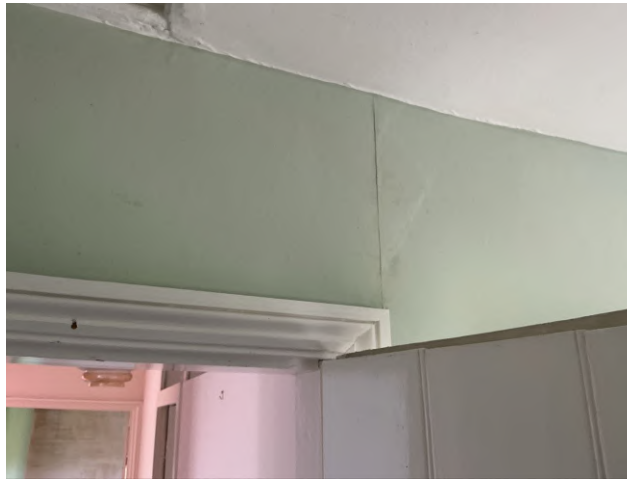
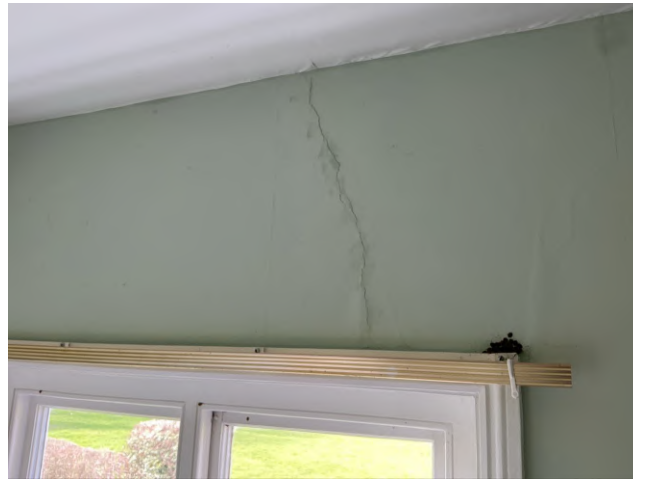
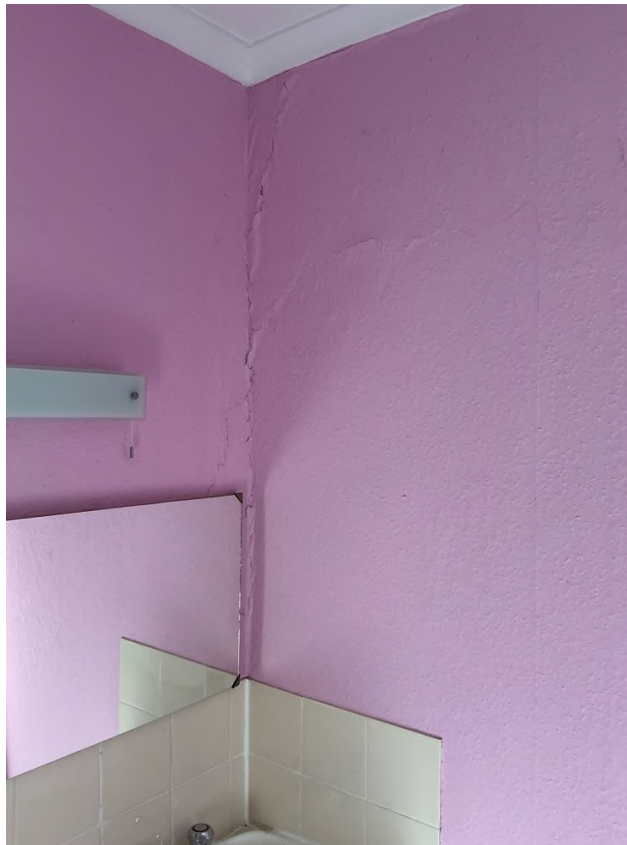
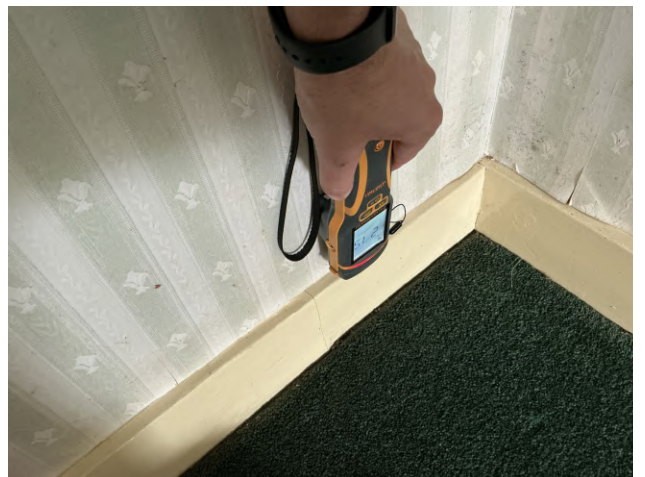
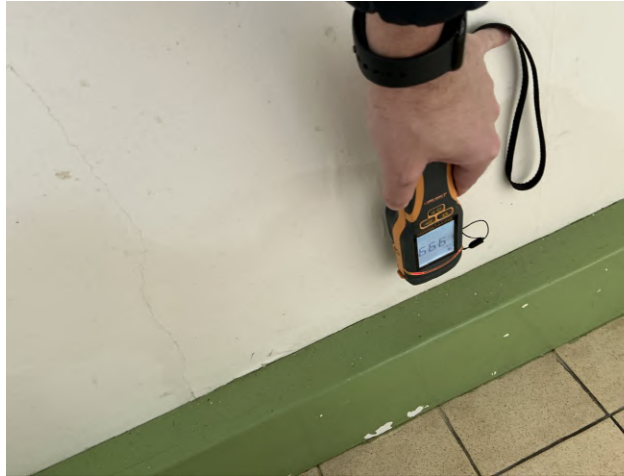
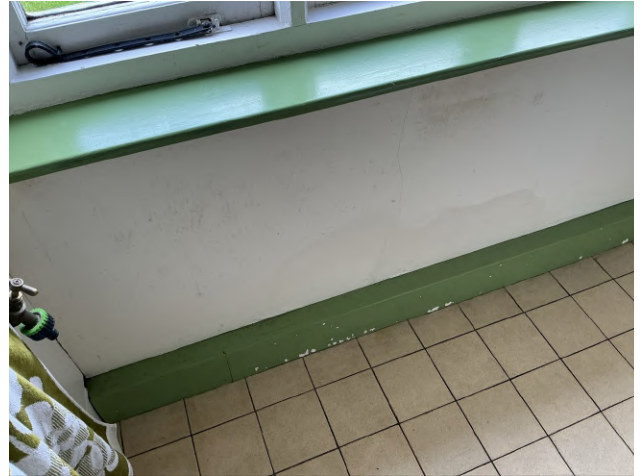
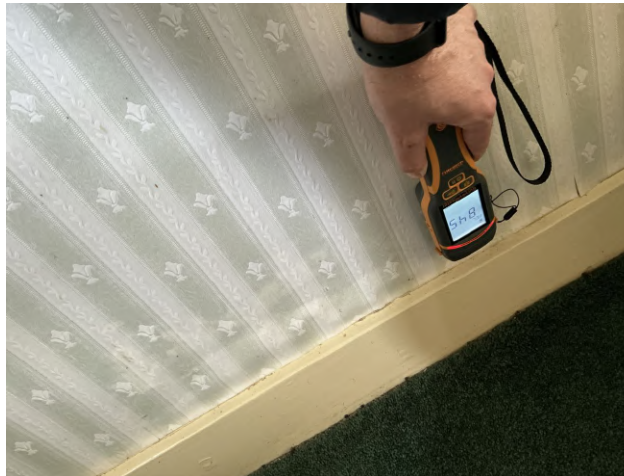
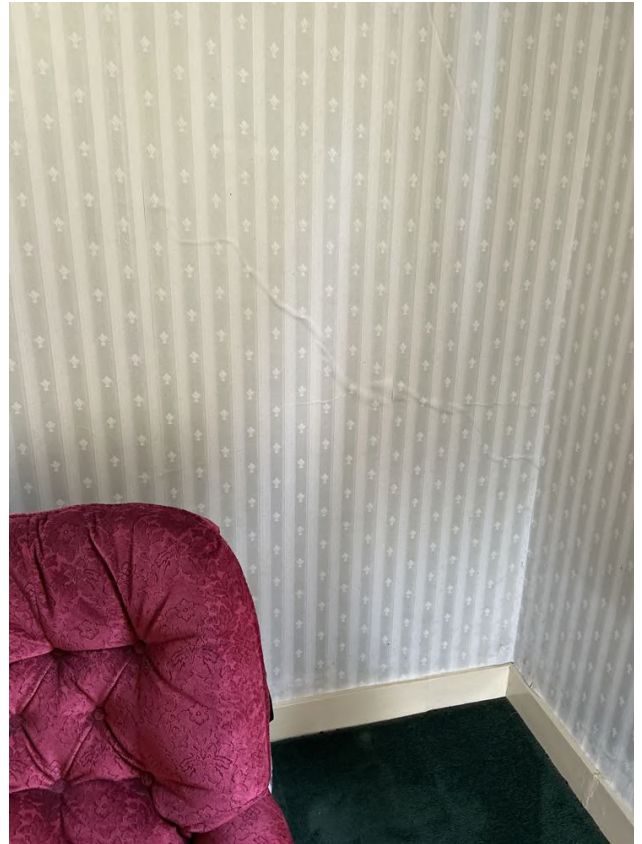
E3 Walls and partitions

During the inspection, some areas of damaged, loose and blown plaster were noted. These defects are commonly associated with older plaster finishes where the bond between the plaster and its supporting background has weakened over time. It would be reasonable to anticipate some localised repair or replastering works when internal redecoration is next undertaken.

Cracking was observed to internal walls in several locations. In particular, cracking was noted internally in the area corresponding with the front left corner of the building. In some locations this cracking has been sufficient to distort and tear decorative finishes such as wallpaper. As noted in the Main Walls section of this report, more pronounced cracking was also observed externally in this same area of the building, close to the large tree. While such cracking could potentially be consistent with historic settlement that is no longer progressive, the presence of corresponding internal and external cracking means that the possibility of ongoing structural movement cannot be ruled out from a visual inspection alone.

Evidence was also noted to suggest that a potentially load-bearing wall has been removed within the ground floor accommodation. Where structural walls are removed, it is necessary to install suitable structural support, typically in the form of a beam or lintel, to carry the loads from the structure above. This support is concealed within the building fabric and therefore it was not possible to confirm either its presence or adequacy during the inspection. No obvious signs of distress were visible; however, your legal adviser should make enquiries with the local authority Building Control department to confirm that the works were carried out with the appropriate approvals and certification.

However, moisture meter readings taken at a number of locations within the ground floor walls indicated elevated damp levels, particularly within the kitchen/utility area where visible damp staining is also present. These readings and visual observations suggest that moisture is affecting parts of the internal wall surfaces to a greater degree than would normally be expected for background levels within a traditional solid wall building.

As previously recommended within the Main Walls section of this report, a more detailed inspection should be undertaken by a contractor who is a member of the Property Care Association (PCA) with experience in timber and damp investigations. The scope of that inspection should include the affected internal walls as well as the roof timbers within the loft space, so that the extent and source of moisture within the building can be properly assessed. The contractor should identify the likely causes of the dampness and provide recommendations for any appropriate remedial works.

If remedial damp-proofing measures are recommended, these often involve the removal of affected plaster finishes and reinstatement with appropriate moisture-resistant plaster systems. Such works can be disruptive and may involve additional reinstatement costs, particularly where built-in fixtures such as kitchen units are present. It is therefore important that the likely scope of works, associated costs and timescales are clearly established before proceeding. You are advised to obtain at least two independent quotations and detailed specifications from suitably qualified contractors before committing to any works.

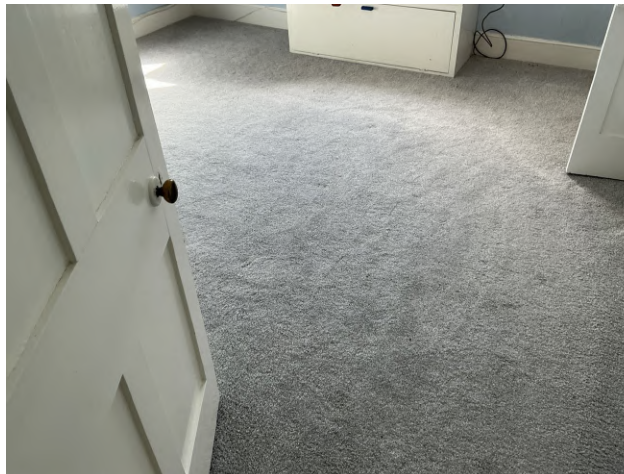
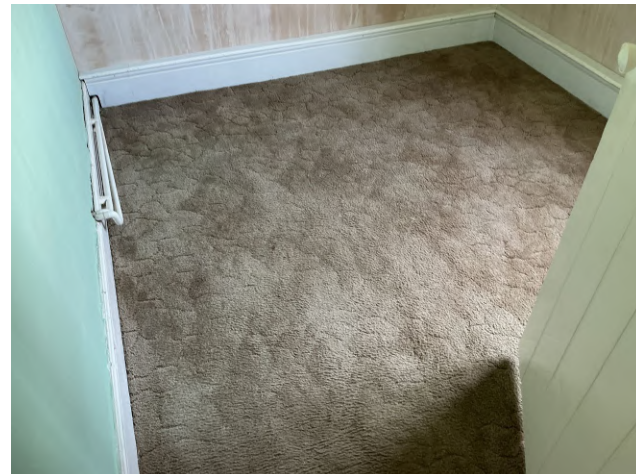
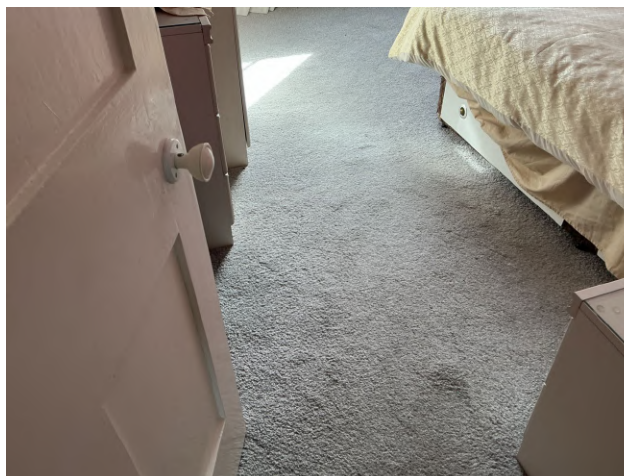
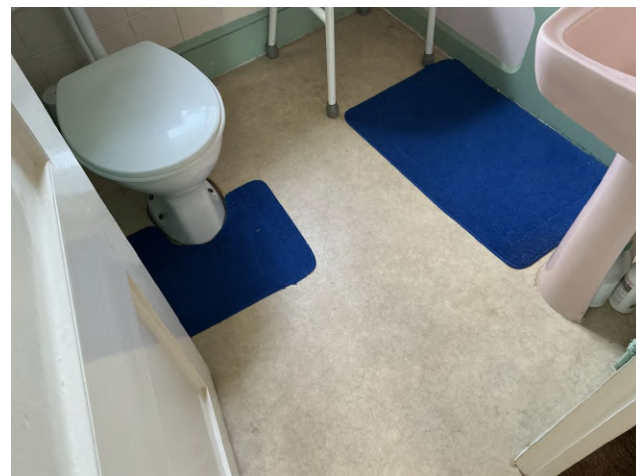
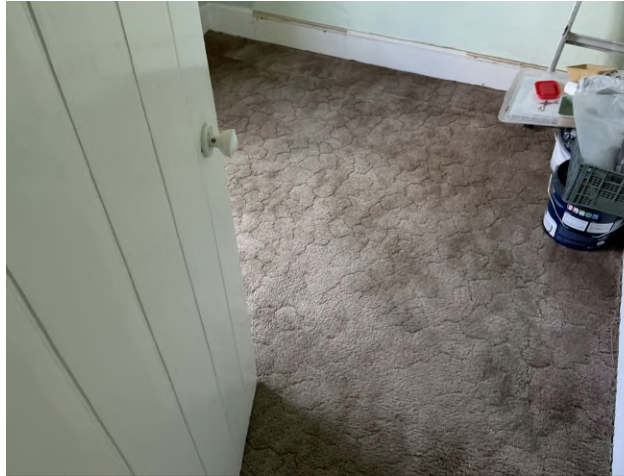
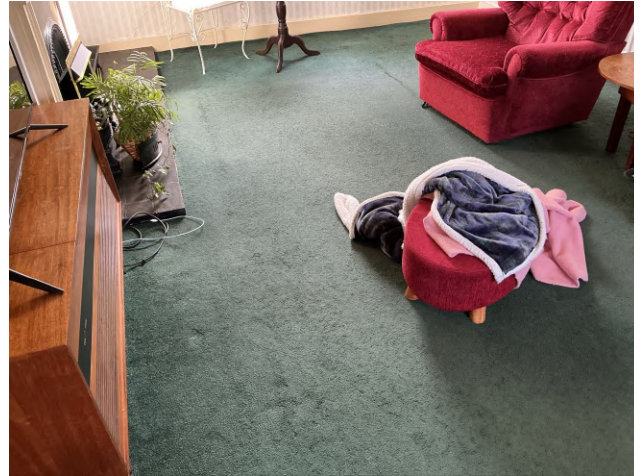
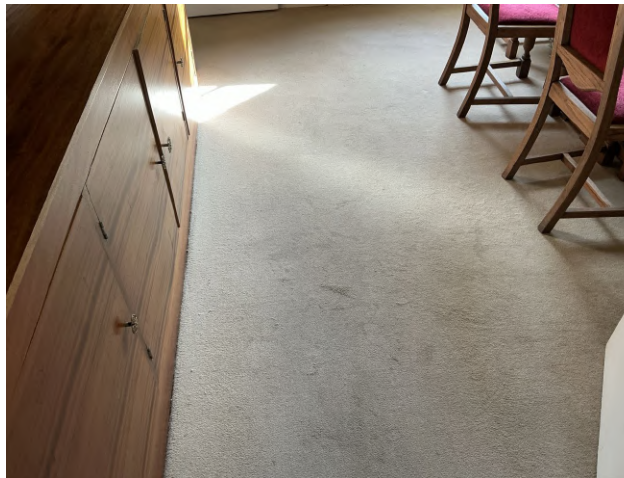
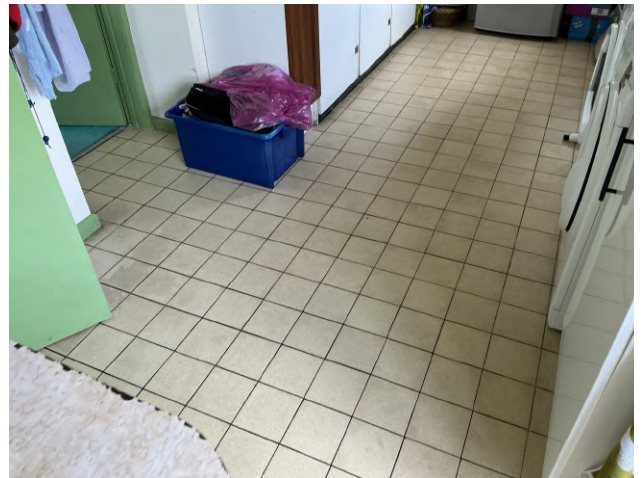
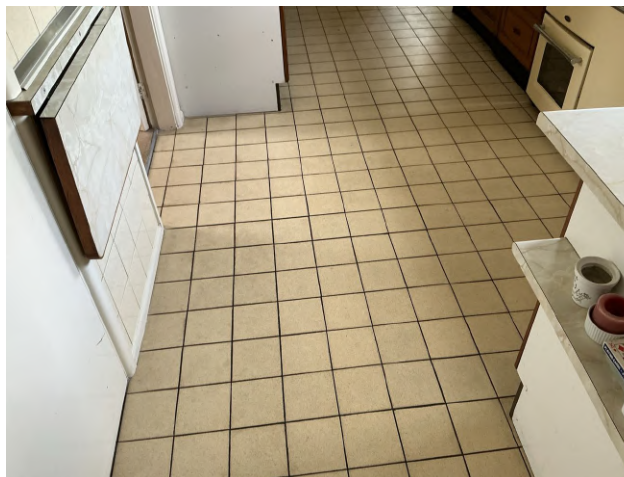
E4 Floors

The solid floors are concealed beneath various floor coverings and finishes which prevented detailed inspection of the underlying construction. As a result, the condition of the floor structure beneath these coverings could not be confirmed. It is possible that additional defects or maintenance issues may become apparent if floor finishes are removed or replaced in the future.

The suspended timber upper floors were generally found to be firm and stable under normal use at the time of the inspection. However, some minor defects were noted including areas of loose and creaking floorboards. This is common in older timber floors where fixings may have loosened over time or where boards have experienced slight movement due to seasonal changes in temperature and humidity. Localised repair and refixing of boards should be anticipated as part of routine maintenance.

The floor finishes throughout the property show signs of general wear consistent with age and use. The adequacy and suitability of these finishes will ultimately depend on your own preferences and intended use of the property, and you have likely already considered their condition when viewing the property. Replacement or upgrading of floor finishes may be required as part of future refurbishment or redecoration works.
