LEVEL 3

Your survey report

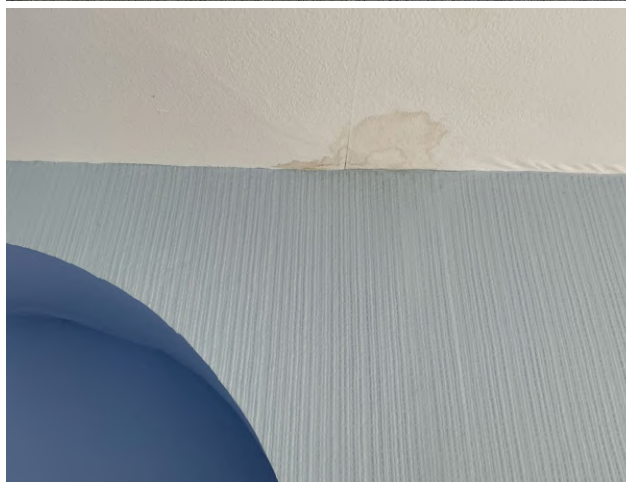
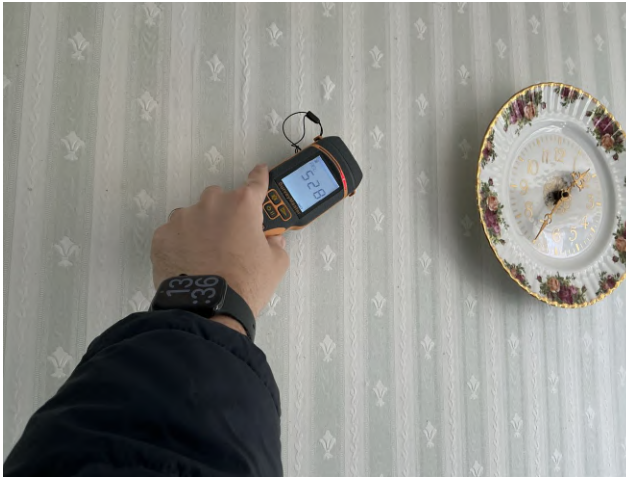
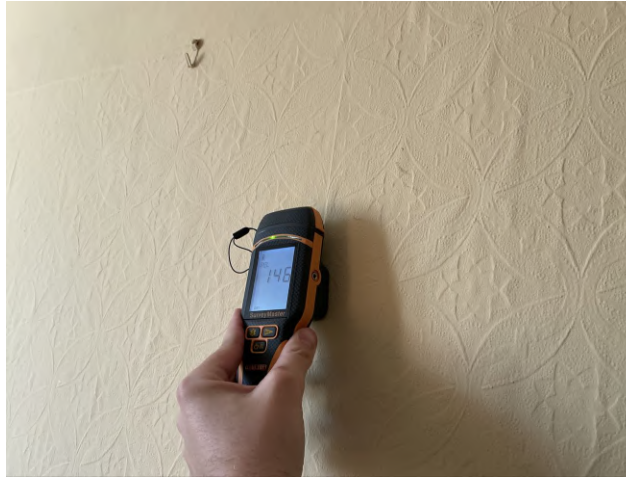
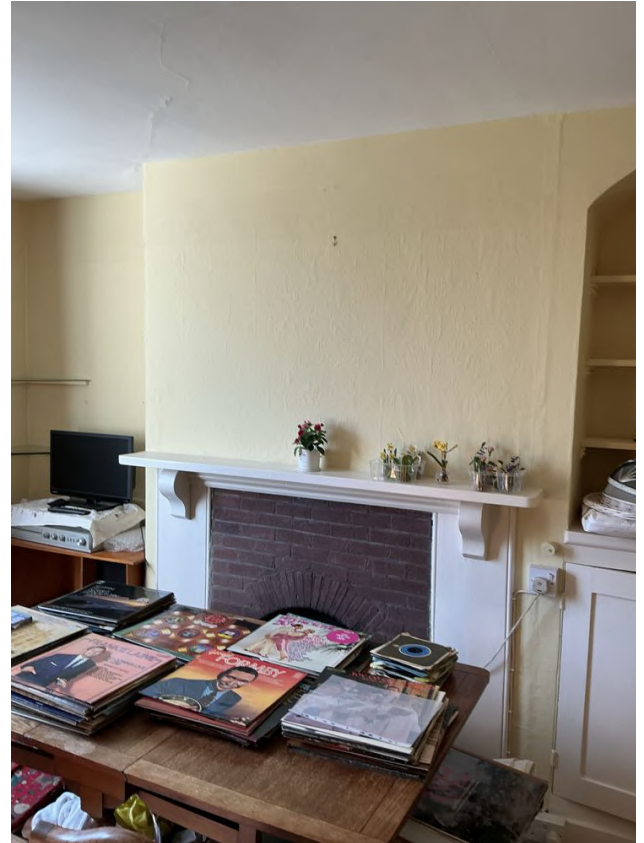
E5 Fireplaces, chimney breasts and flues

The property contains chimney breasts associated with the masonry chimney stacks noted elsewhere in this report. The fireplaces appear largely redundant and in a number of locations the original fireplace openings have been covered or sealed. This is a common arrangement where fireplaces are no longer in use.

Localised dampness and staining were noted to parts of the chimney breast masonry. As noted elsewhere in this report, damp staining was observed in areas including the kitchen/utility ceiling and within the roof void around the chimney stack. These findings suggest that moisture may be entering the chimney structure, potentially due to issues such as defective flashing details, rainwater entering poorly protected or redundant flues, or the natural movement of moisture through the masonry where no damp proof course is present within the chimney construction.

In addition to external moisture sources, chimney breasts can also be affected by salt contamination within the plaster finishes. Ammonium salts are a by-product of the historic burning of fossil fuels and are commonly present within older chimney flues and chimney masonry. These salts can migrate through the plaster finishes over time and attract atmospheric moisture, giving the appearance of dampness. Where this occurs, localised replastering may be required. When replastering chimney breasts affected by salt contamination, it is important that suitable preparatory treatments are used to neutralise salts within the masonry before new plaster finishes are applied. Failure to do so can allow salts to migrate into new plaster and cause recurring staining and deterioration.

Given the various damp-related observations noted around the chimney structures, the chimney breasts should be included within the scope of the specialist damp and timber inspection recommended elsewhere in this report by a Property Care Association (PCA) contractor. This will allow the underlying causes of moisture affecting these areas to be properly assessed and appropriate remedial measures recommended.

If you intend to reinstate the use of any fireplaces in the future, the associated flues should first be inspected and swept by a suitably qualified specialist. Older flues may not be lined, or existing linings may have deteriorated over time. It may therefore be necessary to install new flue liners to ensure safe operation. In addition, adequate combustion air and background ventilation must be provided in accordance with current standards. Advice should be obtained from a suitably qualified heating specialist, such as a contractor registered with HETAS, before any fireplaces or solid fuel appliances are brought back into use.

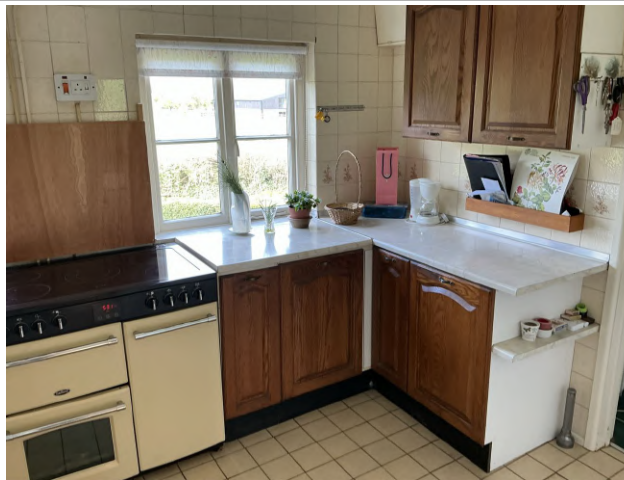
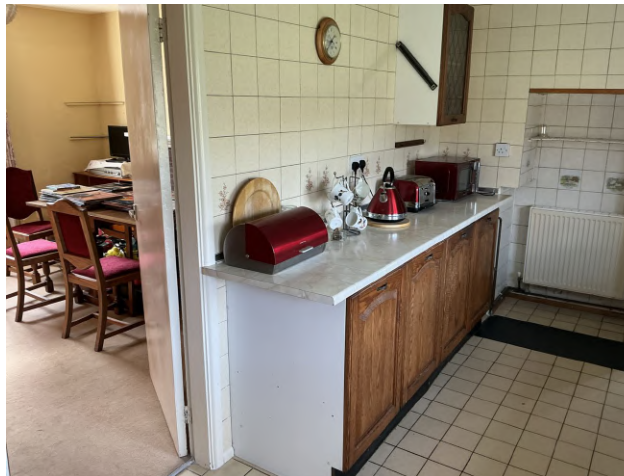
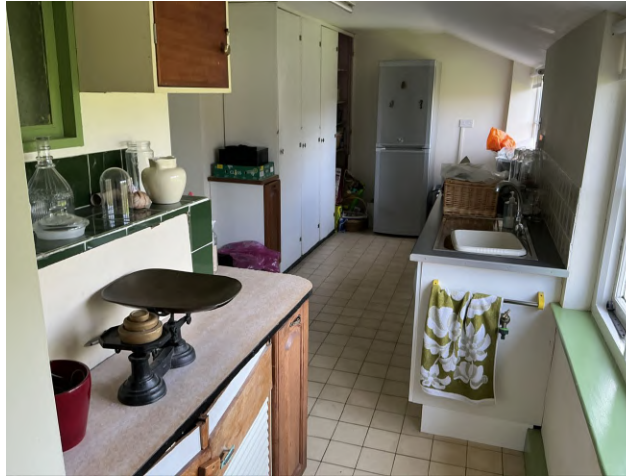
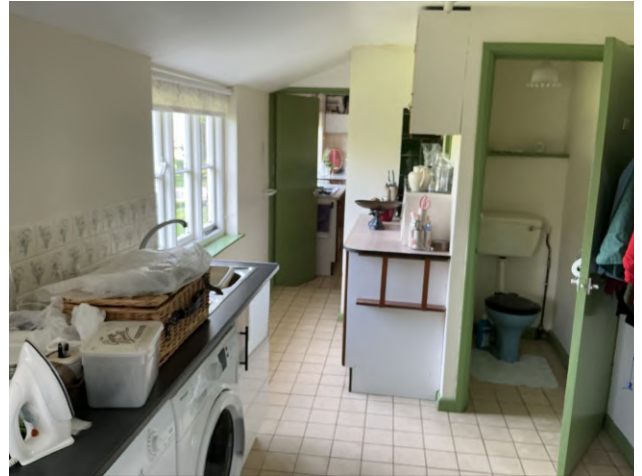
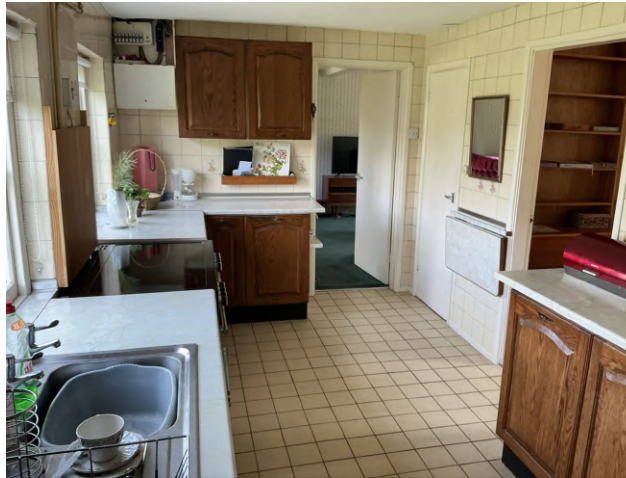
E6 Built-in fittings (built-in kitchen and other fittings, not including appliances)

The property contains fitted kitchen units and associated worktops typical of a domestic kitchen installation. At the time of inspection, the kitchen fittings were observed to be dated and in a generally poor state of repair, with visible wear and deterioration to some components. In practical terms, you should anticipate budgeting for early replacement of the kitchen units as part of refurbishment works following purchase. Given the potential cost implications, it would be prudent to obtain quotations for replacement or refurbishment prior to the exchange of contracts so that these costs can be properly considered.

The flexible sealant around parts of the kitchen worktops and units was observed to be worn or deteriorated. Where sealant fails, water can penetrate behind units and into the surrounding structure. The sealant should therefore be renewed to maintain an effective waterproof barrier. A continuous mastic seal should be maintained along the rear edges of worktops to prevent water ingress behind the units. The carcassing of many kitchen units is typically formed from chipboard which is particularly vulnerable to swelling and deterioration if exposed to moisture. Maintaining effective seals and protective surface finishes is therefore important to prolong the life of the fittings.

Overall, the kitchen fittings appear dated and show signs of general wear and tear consistent with age and use. Replacement or upgrading of these fittings is likely to form part of future improvement works to the property. You have likely already considered the adequacy and suitability of these fittings, and other built-in elements, when assessing the property for your own purposes.

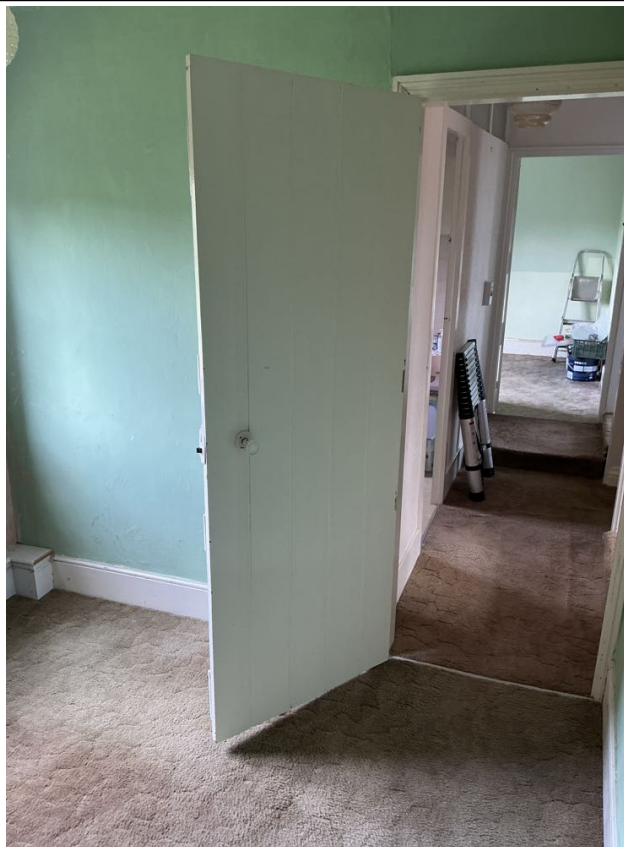
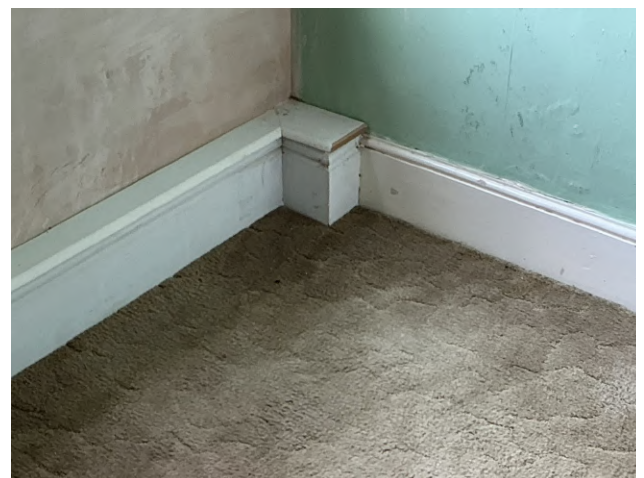
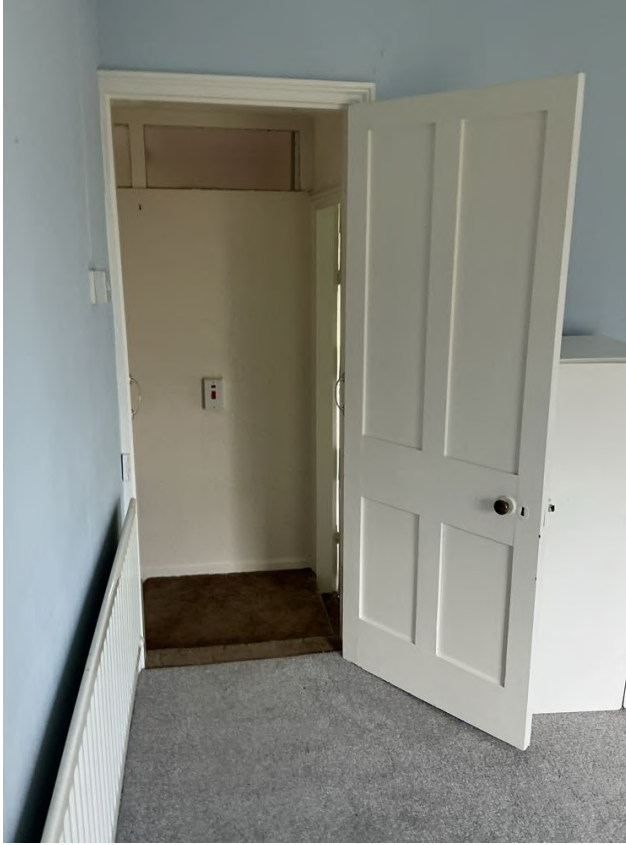
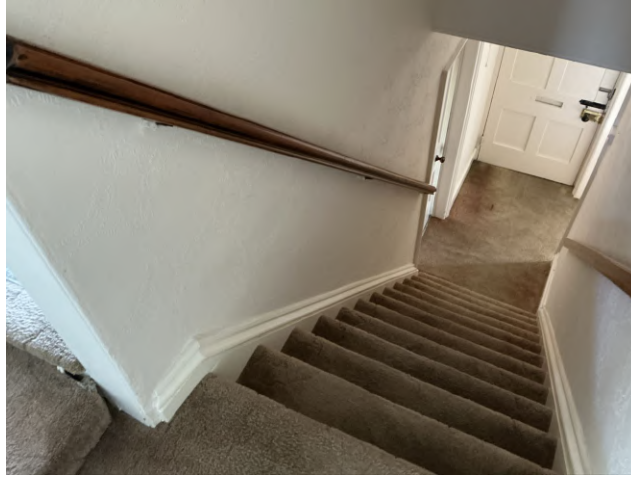
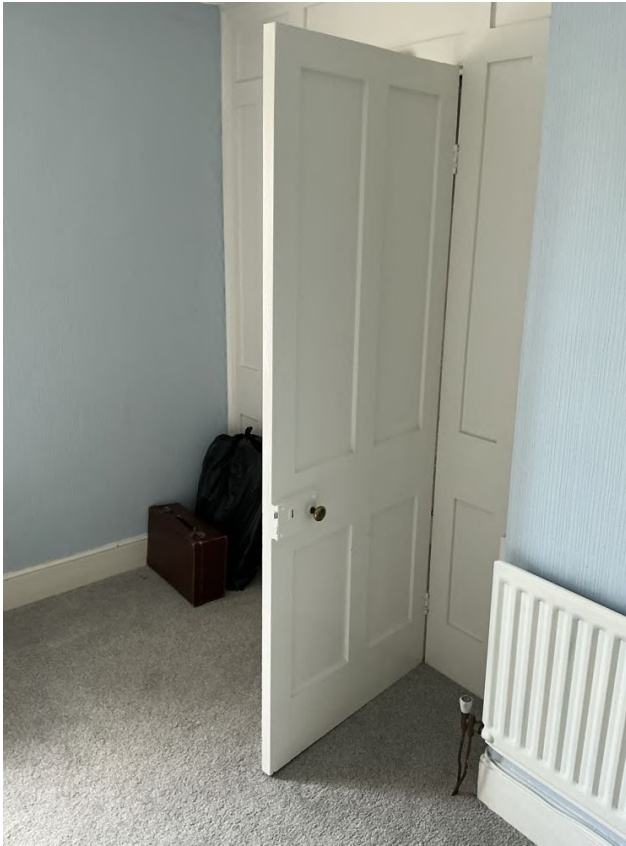
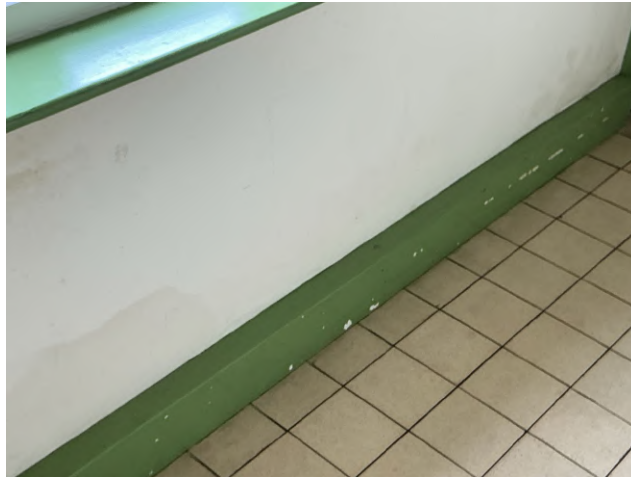
E7 Woodwork (for example, staircase joinery)

No visible evidence of active wood-boring beetle infestation was identified to the exposed internal joinery during the inspection. However, it should be noted that fitted coverings, furniture and stored items can conceal parts of the timber structure, and concealed areas could not be fully inspected. As previously recommended elsewhere in this report, the specialist Property Care Association (PCA) inspection relating to damp and timber should include consideration of accessible timber elements within the property where appropriate.

Finally, given the age of the property, it is possible that some historic paint finishes applied to the internal joinery may contain lead. Lead-based paints were widely used in older buildings due to their durability but can present health risks if disturbed without appropriate precautions. Urgent action is not required; however, if paint removal or extensive preparation work is planned during refurbishment, appropriate guidance should be followed. Advice can be obtained from the Health and Safety Executive regarding the safe management and removal of lead-based paints.

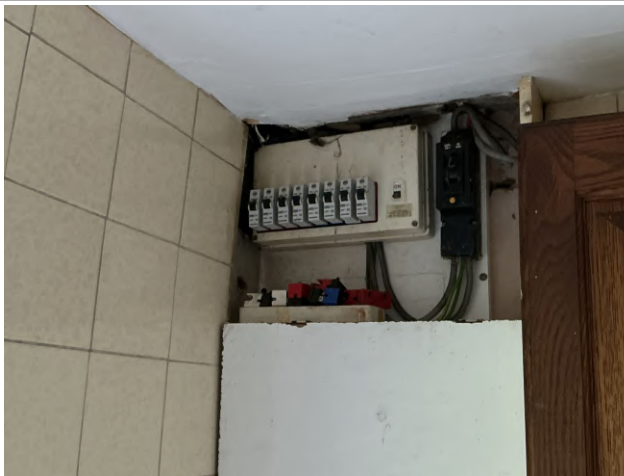
Mains electricity is connected, with the meter located in the external box. The consumer unit is located in the kitchen.

Deficiencies within the electrical installation were noted during our inspection and the installation is unlikely to comply with modern regulations. The installation should now be checked by an appropriate specialist registered with either the NICEIC or a similar approved body prior to the exchange of contracts. Some repair work or upgrading is likely to be necessary.

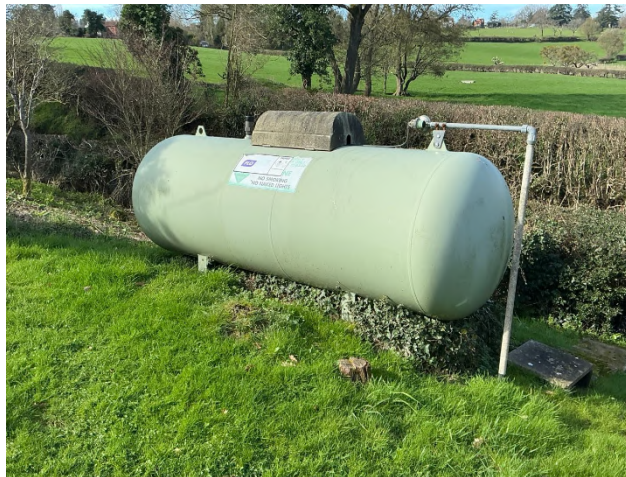
F2 Gas/oil

The absence of a mains gas connection is not uncommon in rural locations; however, it should be noted that some purchasers may view this as a disadvantage when compared with properties served by mains gas, and this may have an impact on market perception in the future.

Where LPG is used, the gas storage tank, supply pipework and associated appliances require periodic inspection and servicing to ensure safe operation. LPG installations are typically either owned by the property owner or supplied under a contract arrangement with a fuel supplier. Your legal adviser should therefore confirm the ownership of the tank and whether any supply agreement is in place.

The installation, together with all associated gas appliances, should be inspected and tested by a suitably qualified Gas Safe registered engineer prior to legal commitment to purchase. This inspection should confirm that the LPG installation, pipework and appliances are safe, correctly installed and operating efficiently. Any recommendations for repair, servicing or upgrading should be implemented as necessary following the inspection.

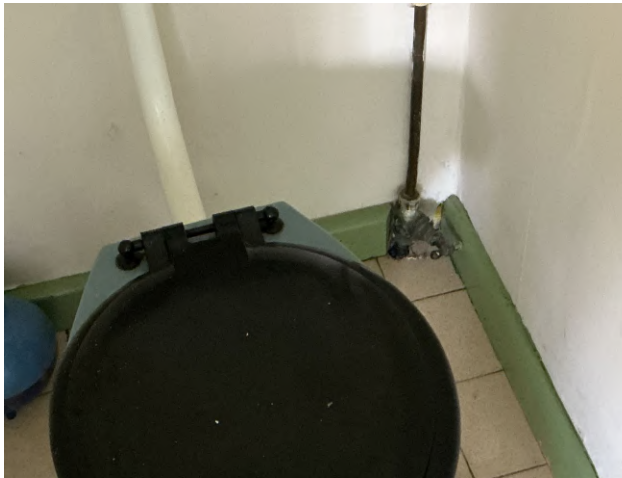
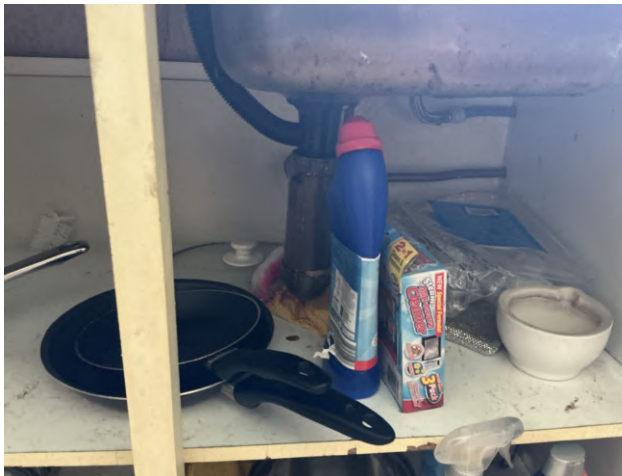
F3 Water

In view of the age of the property the incoming water main may be of old lead pipe. Lead is now considered to be inappropriate material to carry drinking water supplies due to the toxins that can be deposited. We recommend that you establish the nature of the pipes and consider upgrading to modern polypropylene if necessary.

The internal water system includes a number of different types of metal pipes in the same plumbing system and this may result in leaks. Although there are no leaks at present, you should plan to replace some of the pipes with suitable alternatives soon. In some cases, you may find it more economical to replace the whole system.

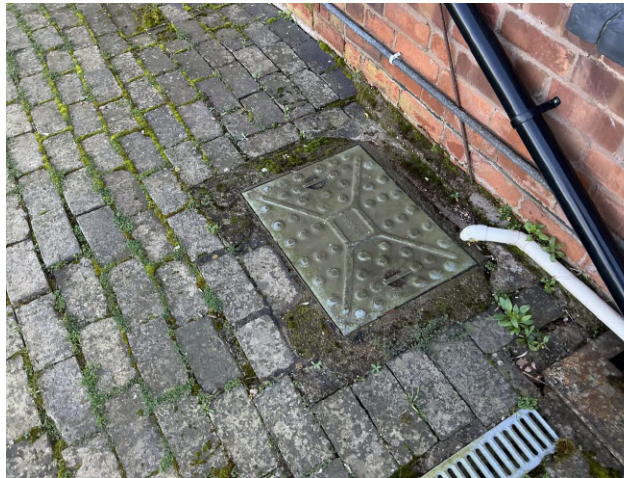
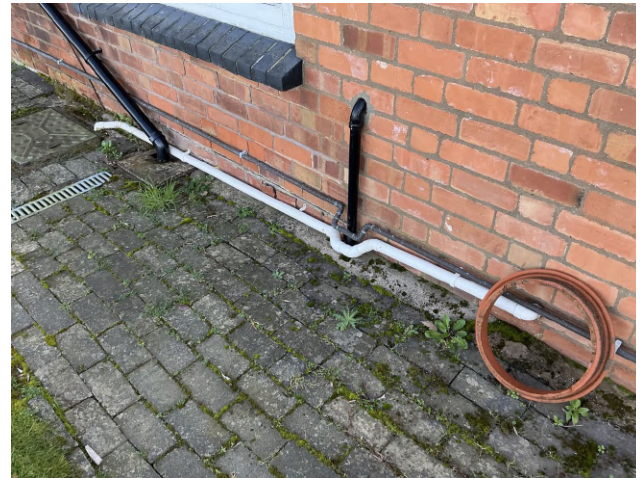
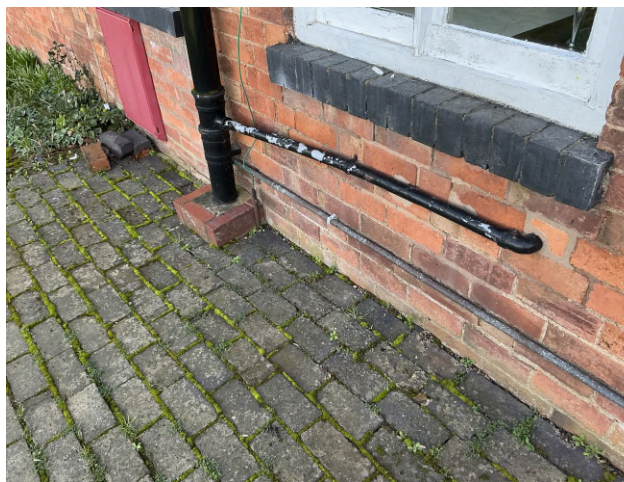
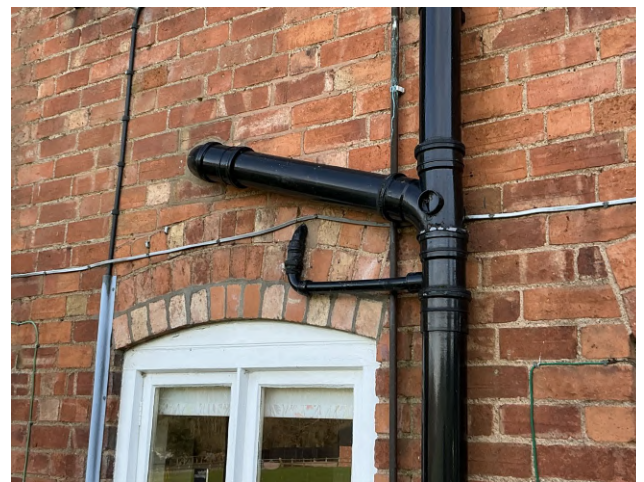
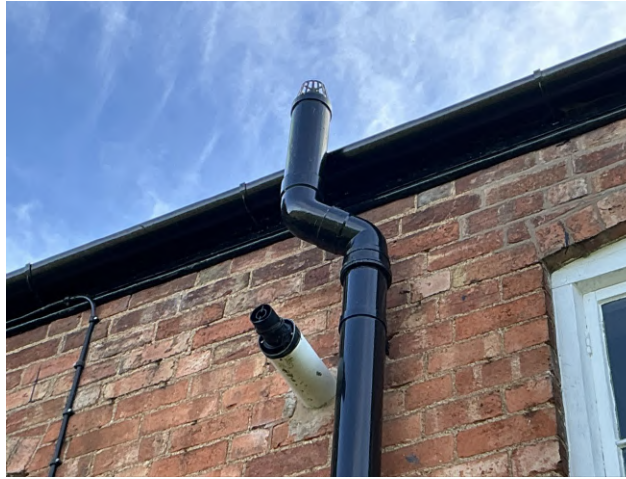
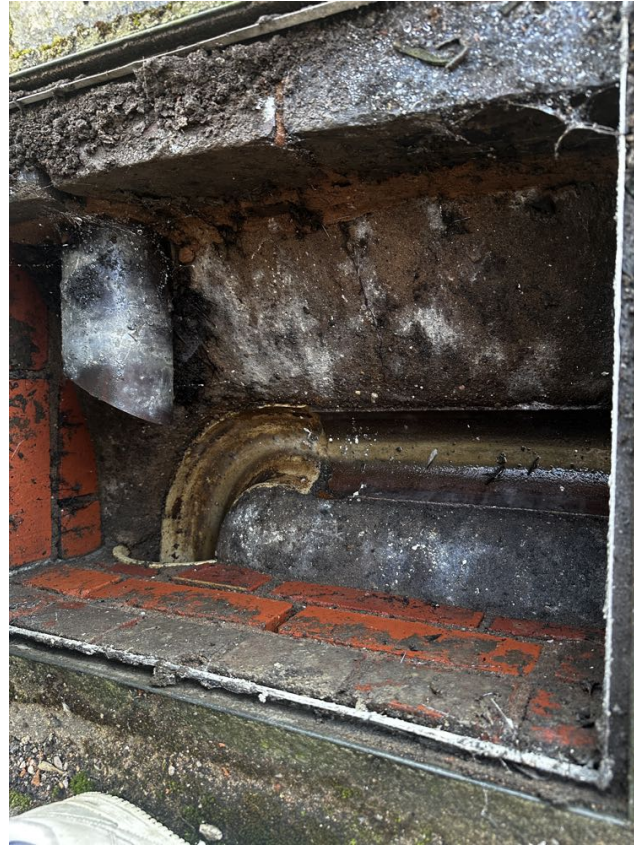
Septic tank systems require periodic emptying and maintenance in order to operate effectively. This is typically undertaken at intervals ranging from approximately six months to two years, depending on the size of the tank, usage levels and manufacturer's recommendations. Although no obvious problems with the drainage arrangements were identified during the inspection, the actual septic tank installation, associated pipework and discharge arrangements were not inspected as part of this survey. The condition, capacity and compliance of the system therefore could not be verified.

Given the age of the installation, it is possible that the system may not comply with more recent environmental regulations governing private drainage systems. Current regulations, including the General Binding Rules applicable in England, set out requirements for septic tank discharge and environmental protection. Non-compliant systems may require upgrading, modification or replacement in order to meet regulatory standards.

The above-ground drainage system comprises PVC waste pipes serving internal plumbing fixtures. Where visible, these pipes appeared to be in generally serviceable condition with no obvious evidence of leakage or significant defects at the time of inspection. Nevertheless, ongoing maintenance should be anticipated and pipework should be periodically checked to ensure joints remain watertight and adequately supported.

Inspection chamber covers were lifted where possible during the inspection. In the limited areas examined, the chambers appeared free from obvious blockages or significant defects. However, this form of inspection is necessarily limited and does not constitute a full drainage test.

The underground drainage system serving the property could not be fully inspected and no specialist testing was undertaken. As with all older drainage systems, some deterioration may have occurred over time and there is a possibility that sections of the drainage pipework may be cracked, leaking or

otherwise damaged. Defective drains can allow water to escape into the surrounding ground which, in some circumstances, may contribute to soil erosion and potentially affect nearby foundations.

It is therefore recommended that further investigation is undertaken by a suitably qualified drainage specialist prior to legal commitment to purchase. This inspection should confirm the type, condition and compliance of the septic tank system, including the arrangement of the discharge point, the adequacy of the drainage field and any maintenance requirements.

If you wish to obtain greater certainty regarding the condition of the drainage system, it would be prudent to commission a full drainage survey by a specialist contractor prior to legal commitment to purchase. Such investigations typically involve CCTV inspection of the pipework and testing of the system to identify any hidden defects.

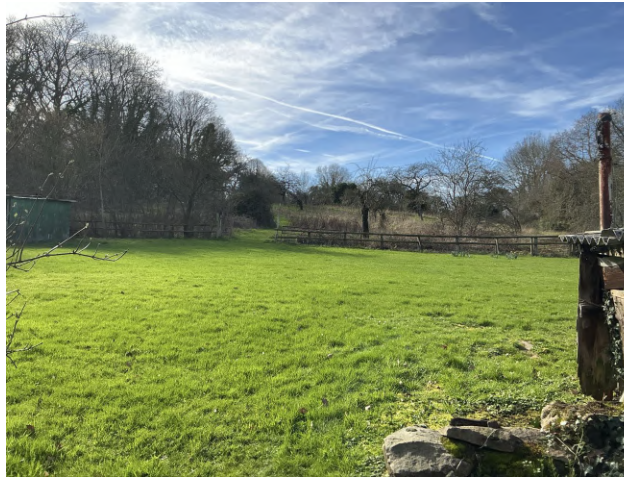
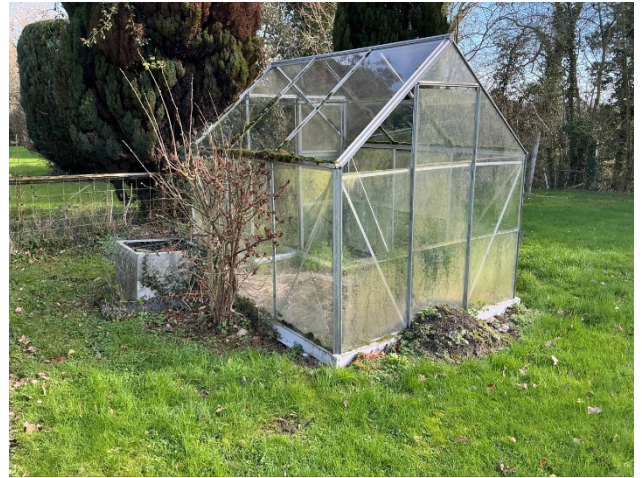
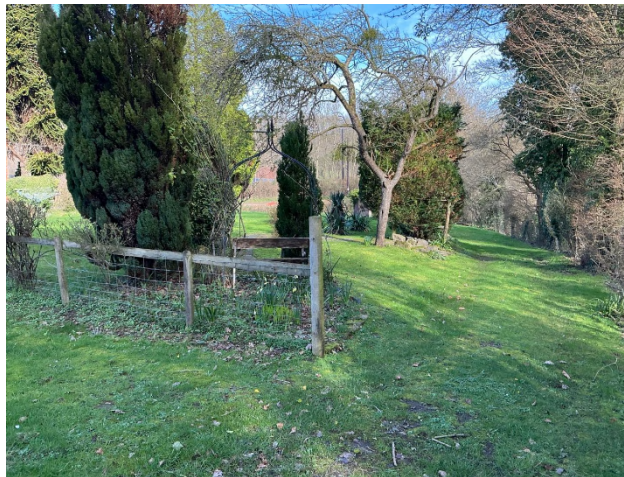
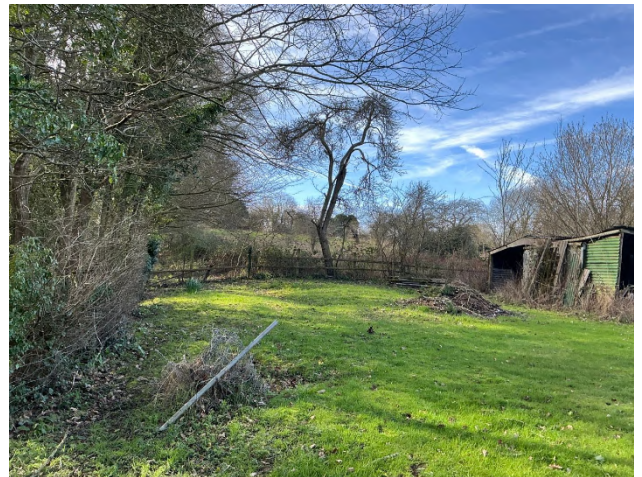
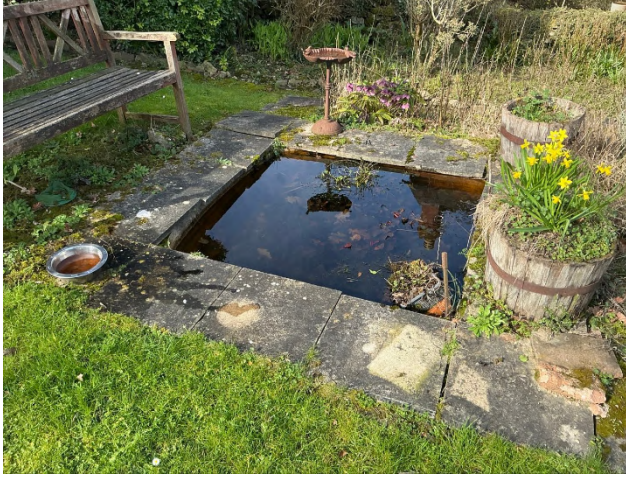
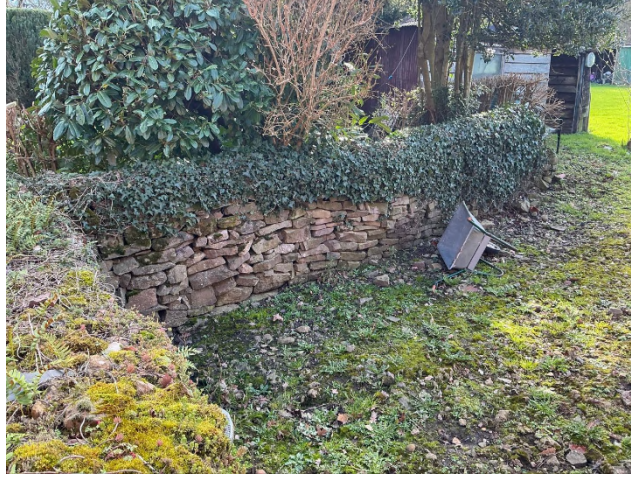
G3 Other

There are a number of trees and shrubs located within the grounds and in proximity to parts of the building. Vegetation can, in some circumstances, affect structures through root growth, moisture extraction from soils or through physical contact with buildings and services. No specific damage attributable to vegetation was identified at the time of inspection. Nevertheless, trees and shrubs should be kept appropriately maintained and regularly pruned to control their growth and prevent them from becoming excessively large or encroaching on the building or drainage systems.

Where vegetation is located close to boundaries or within neighbouring land, maintenance may require agreement with neighbouring property owners before works can be undertaken. Regular management of planting within the grounds will help reduce the likelihood of future issues arising.
