Inspection Report

Sunday, September 4, 2016

PROPERTY INSPECTION REPORT

Present at Inspection: Buyer Selling Agent Listing Agent Occupant
Building Status: Vacant Owner Occupied Tenant Occupied Other
Weather Conditions: Fair Cloudy Rain 92 F Outside Temp.
Utilities On: Yes No Water No Electricity No Gas
Special Notes: New Home Final Construction

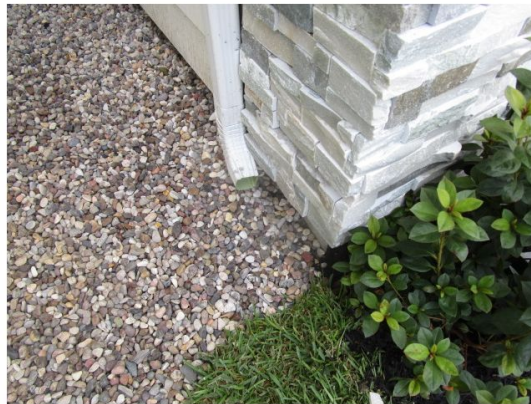
B. Grading and Drainage

Comments: It is recommended that splash plates be installed at the gutter downspout terminations to prevent erosion and to direct rain water away from the perimeter of the foundation.

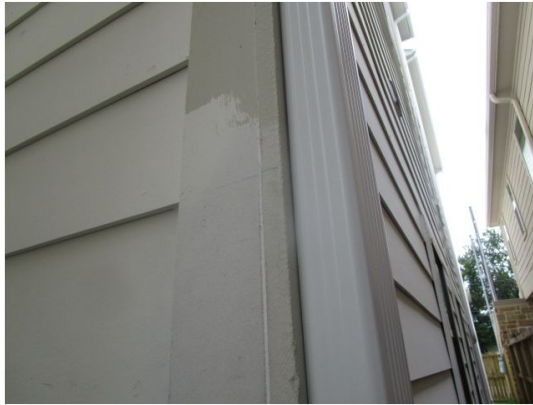
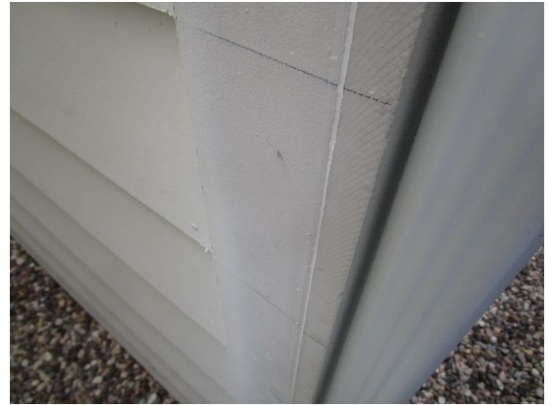
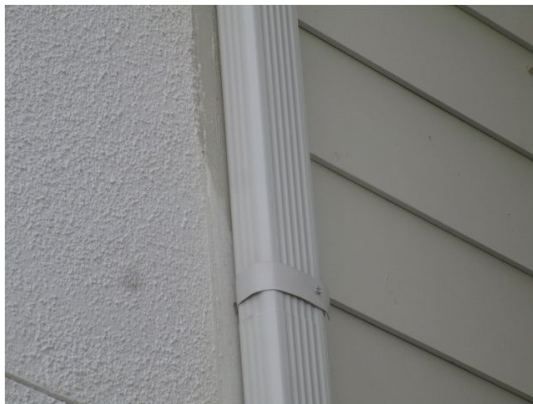
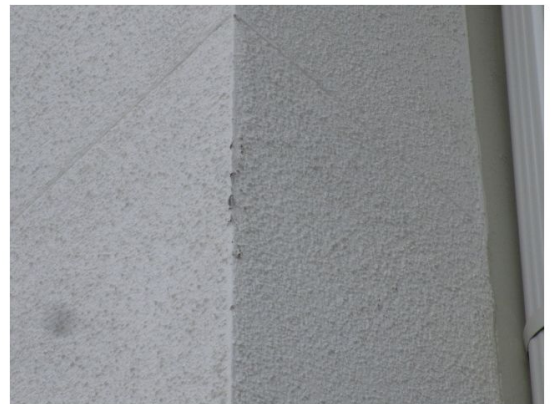
Comments: The exterior paint is not complete in some areas.

The exterior siding has been installed notably not level on the front of the home at the fourth floor deck area.

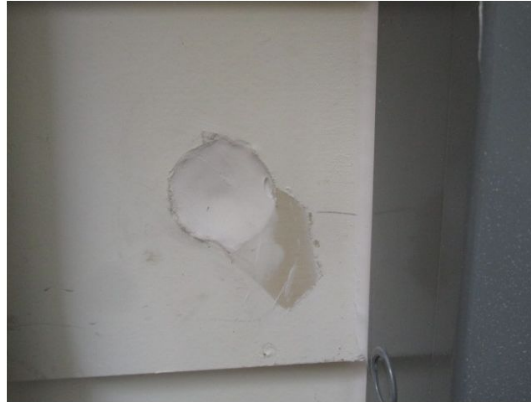
Some of the corners of the exterior siding are damaged in several areas and there is a damaged piece of exterior trim at the rear southwest corner of the home.

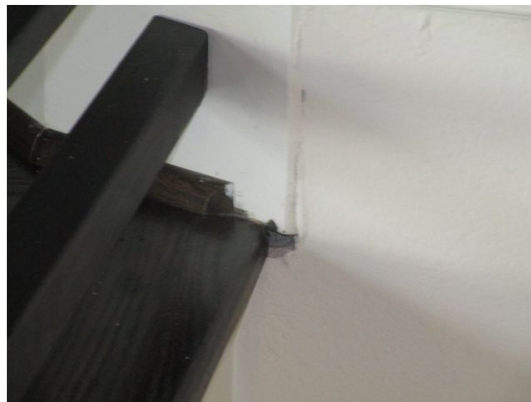
There is a gap in the sheetrock next to the stairs on the second floor landing going up to the third floor that should be repaired.

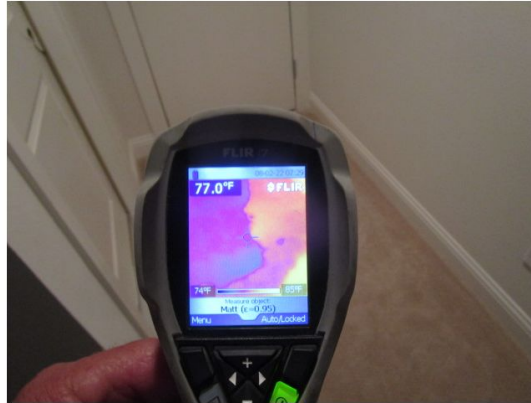
Comments: The flooring in the upstairs hallway in front of the door to the roof patio is wet. This condition appears to be caused by water penetration from the door not sealing properly. Hidden damage is a possibility. This area of carpet should be replace and the subfloor should be inspected after the carpet has been removed.

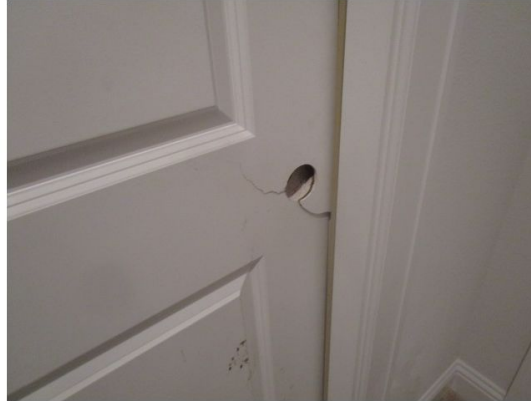
There is damage to the attic access door and the door knob is not installed.

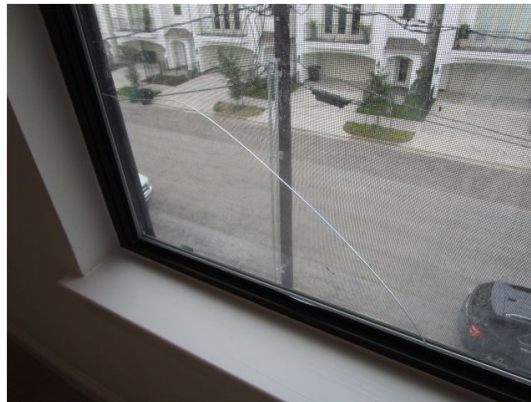
Comments: There was broken glass in the front master bedroom window. Broken glass is considered a recognized safety hazard and limits the energy efficiency of the glass. Effort should be taken to exclude the use of defective windows until such time as they can be repaired.

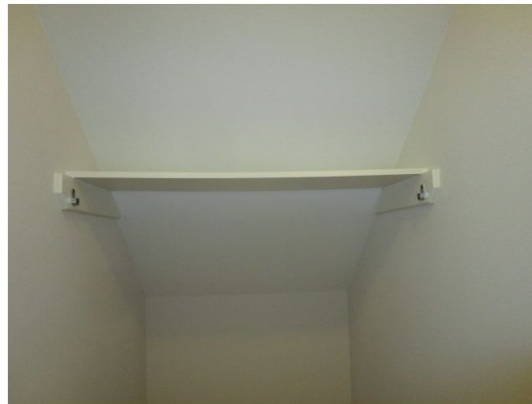
The shelf in the first floor closet under the stairs is notably bowed downwards.

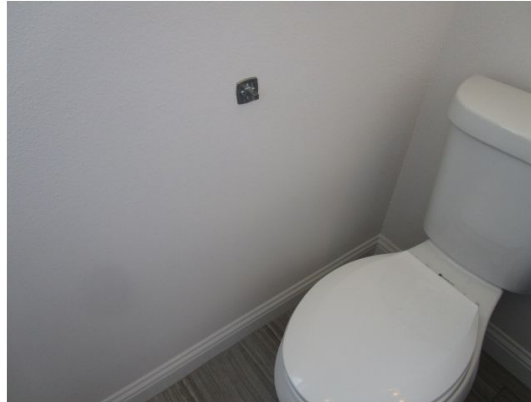
The toilet paper holder is not installed in the half bathroom.

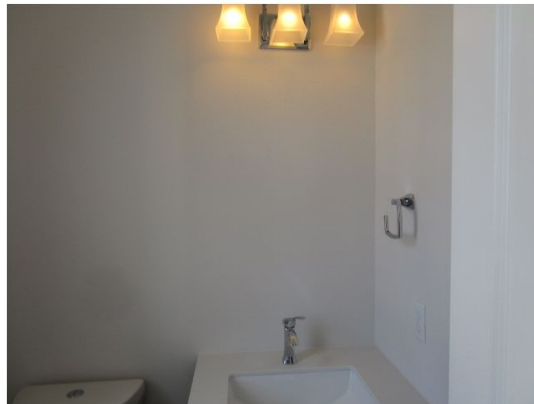
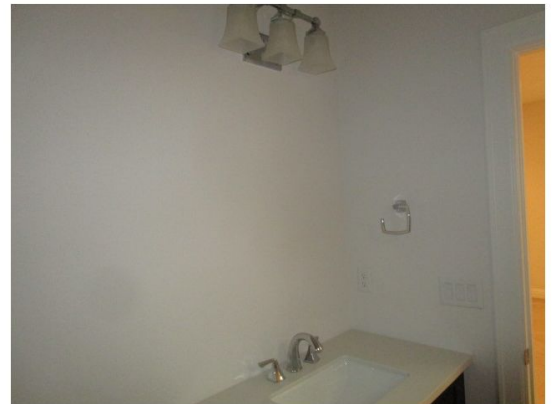
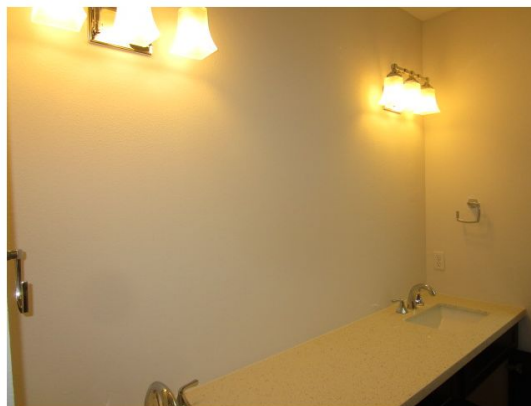
The mirrors are not installed in the bathrooms.

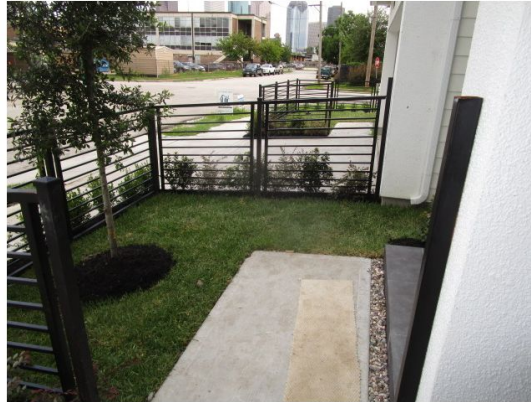
The gate is not installed in the front yard area.

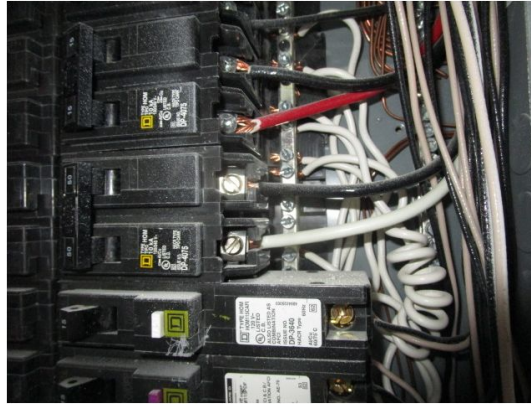
Comments: One white wire is being used as a “hot” wire and is connected to a circuit breaker. In most instances the white wires are the grounded conductors, and if they are used as a “hot” wire, they must be wrapped with black or red tape to identify them as a “hot” wire.

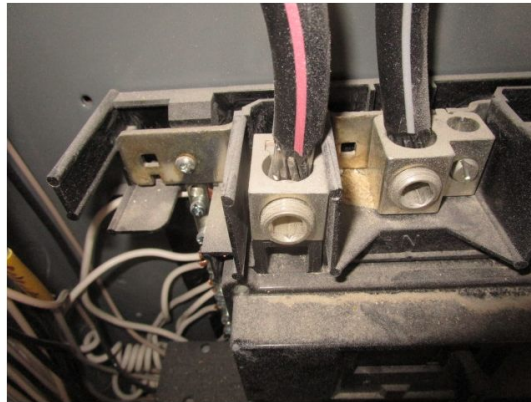
An inhibitor paste has not been applied to the main aluminum wires. The surface of aluminum can oxidize when it is exposed to air resulting in a poor connection.

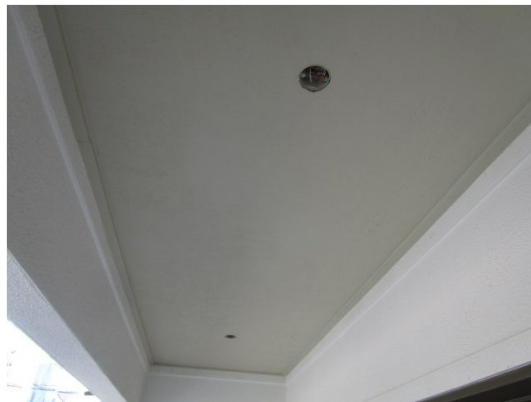
The exterior light fixtures are not installed at the front of the garage.

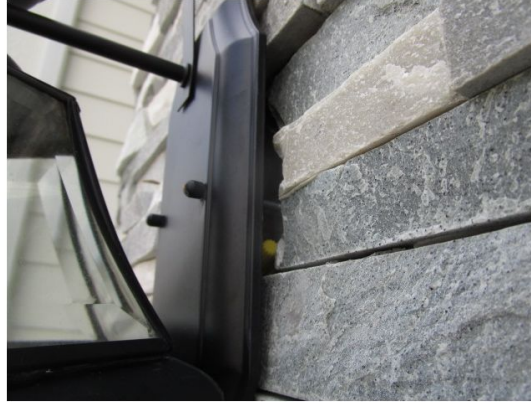
The base of the exterior light fixtures are not sealed where they meet the home as they should be in order to prevent water penetration into the fixture where the electric connections are located.

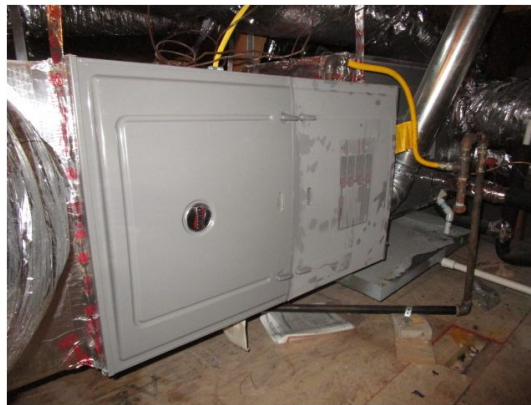
Comments: The furnace was not operational as the gas supply to the equipment at the time of the inspection.

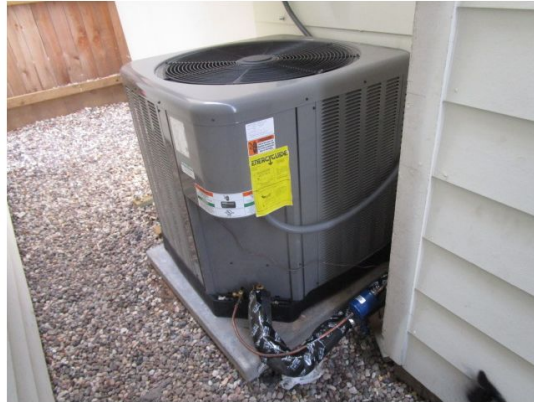
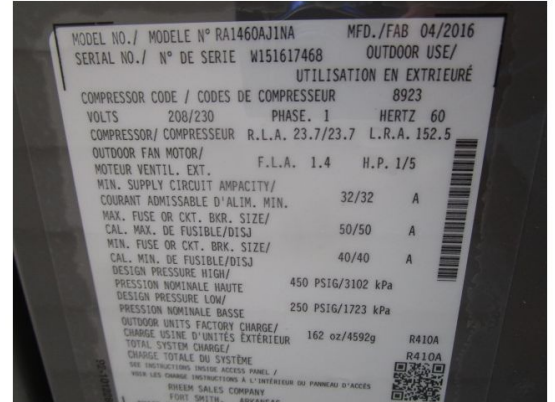
**Differential Air Temperature Drop During Operation:
Air Going Into System: 74 f Returned Air: 64 f**

The system did not operate within the allowable tolerances. The air coming out of the vents should be 14 to 21 degrees cooler than where it goes into the cold air return. It is recommended that a qualified contractor be consulted regarding this matter.

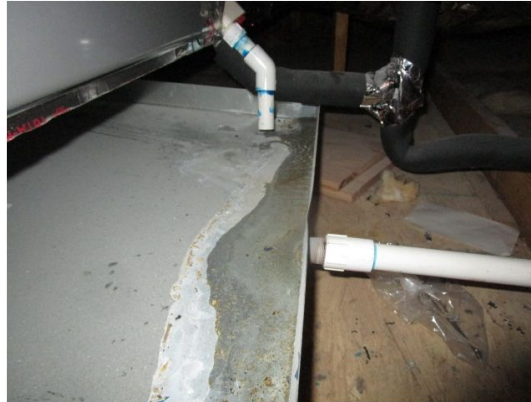
Water was observed in the safety pan under the evaporator coil box. This condition can cause severe damage if the safety pan was to overflow. A licensed technician should address this situation as soon as possible.

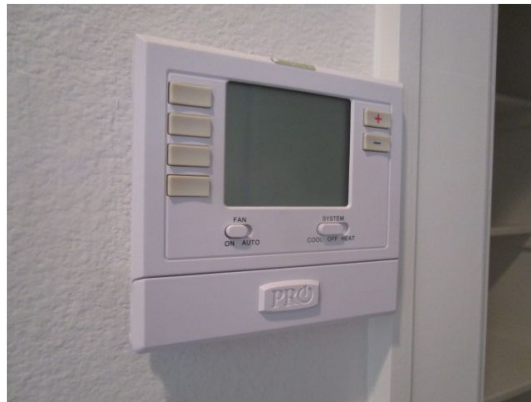
The thermostat at the third floor hall location did not operate.

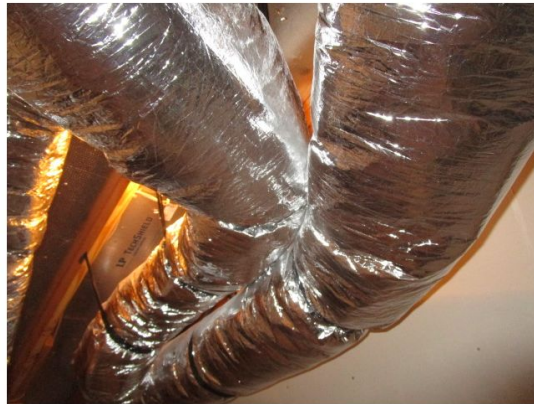
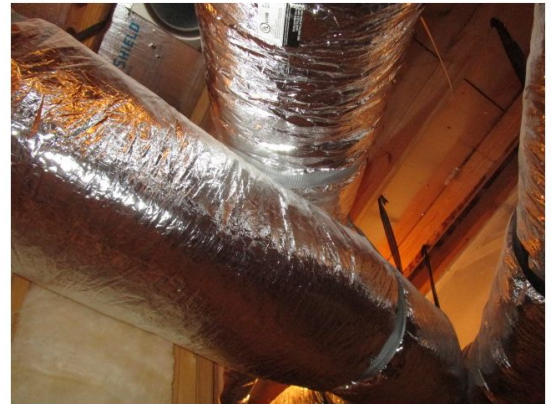
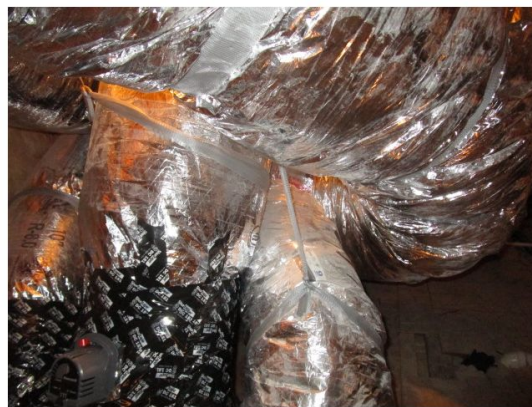
Comments: The filter/filters in the return air chase/chases were missing. Proper filtering of the air is important. A defective filtering system can lead to dirty evaporative coils and allergy problems. It is a good idea to change these filters every month or as suggested by the manufacturer.

Ducts in the attic area are in contact with each other which may cause condensation and damage to the outer coating. These ducts should be separated a minimum of one inch or unfaced insulation placed between them.

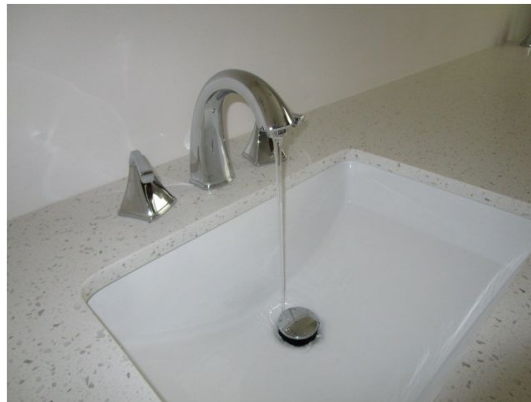
Comments: The drain stop is not operating properly at the left sink in the master bathroom. Sometimes a drain stop can be adjusted or it may need to be replaced.

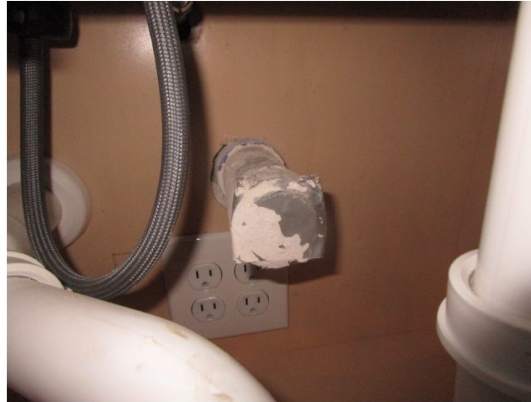
There is an open drain line that is not being used under the kitchen sink that has been covered with tape. The reason for this condition is not known.

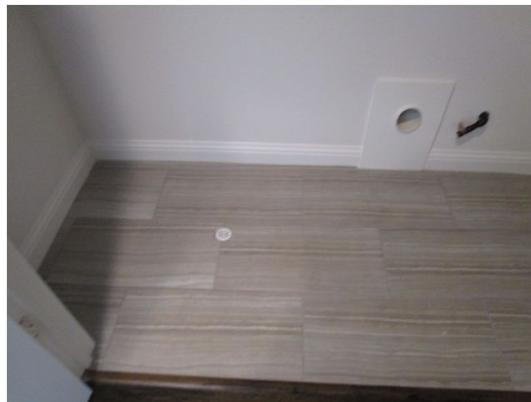
It is recommended that the washing machine located on the third floor have a safety pan installed to prevent water penetration to the ceiling and walls below in case of a leak or malfunction with the equipment.

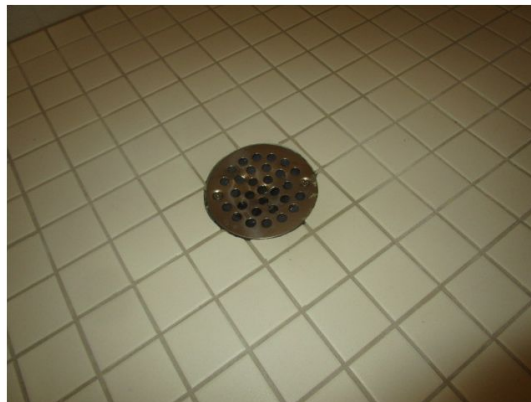
The cover for the master bathroom shower is damaged and is not flush with the tile.

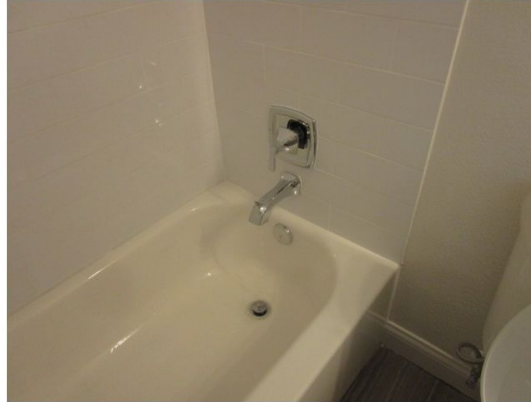
It is necessary that there be inspection ports provided for the bathtub/shower units in all of the bathrooms so that it is possible to check for leaks, as well as for service to be performed on the plumbing if needed.

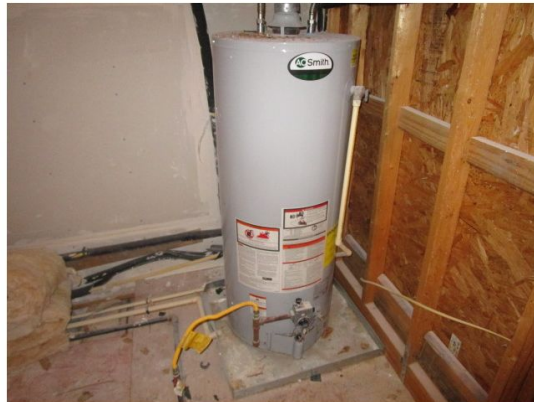
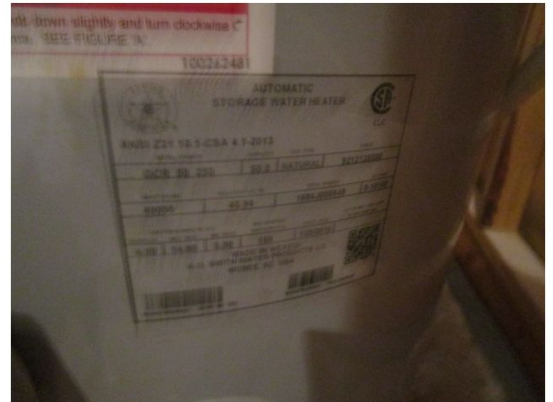
Comments: The flue pipe was not secured to the rafters as is required to prevent movement during high winds.

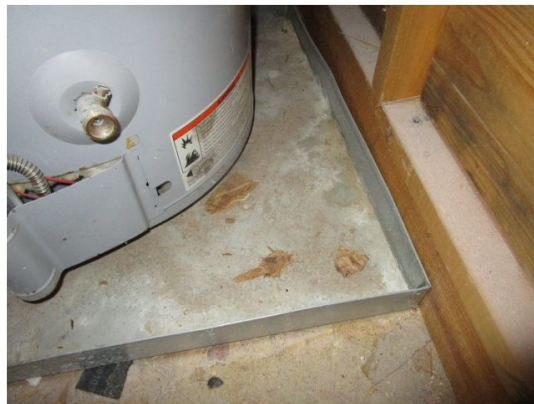
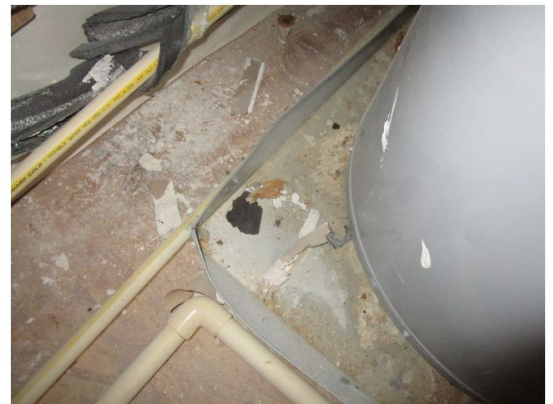
There is debris in the safety pan. In the event of a system malfunction, the safety pan is designed to catch the water overflow and carry it to the outside of the home. It does not take much debris to stop up the safety pan drain line. These pans should be kept clean and checked regularly as a part of a proper maintenance.

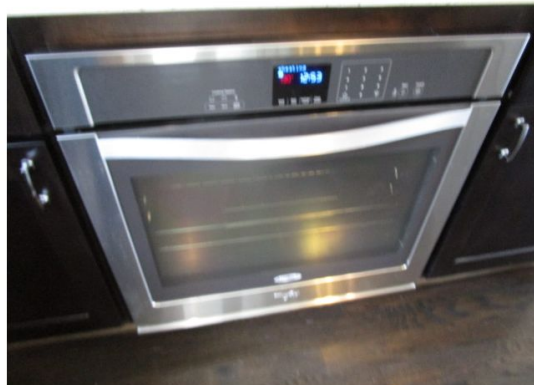
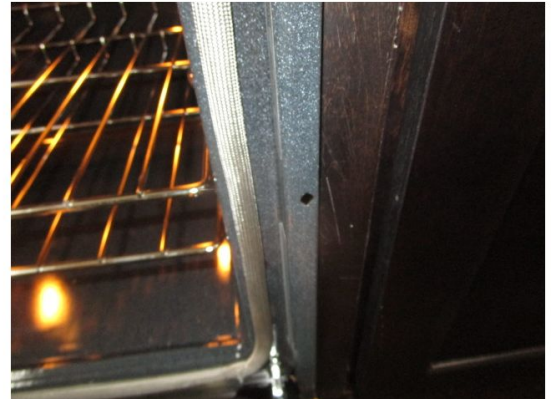
Comments: The securing screw has not been installed on the right side of the oven.

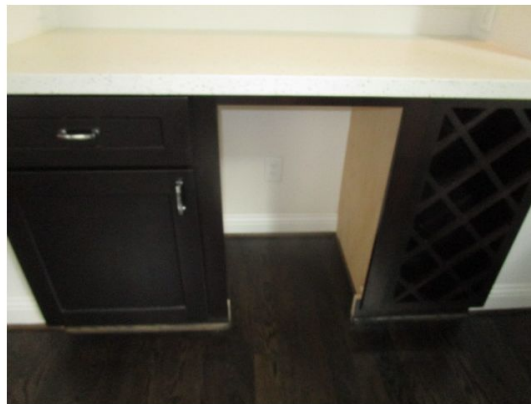
Comments: The wine cooler is not installed.
