## Inspection Report

Tuesday, July 12, 2016

## PROPERTY INSPECTION REPORT

By: Brad Leland, Lic #5229 07/12/2016  
(Name and License Number of Inspector) (Date)

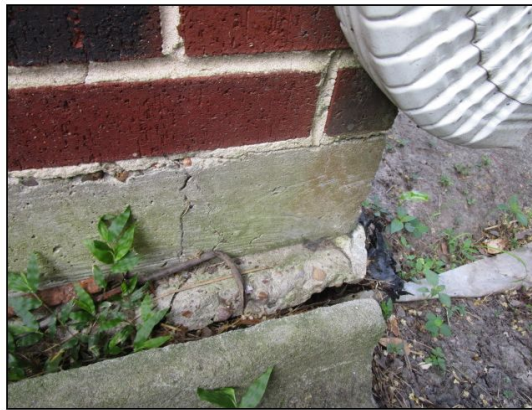
There was a crack in the rear northeast corner of the garage foundation. These type cracks are common in foundations and are not a structural defect. Expansion properties in the brick in the brick veneer can cause these cosmetic blemishes. As these cracks can continue past the finish grade, it is considered to be a likely point of entry for insects as well as moisture. I recommend that these cracks be sealed in order to prevent possible future damage.

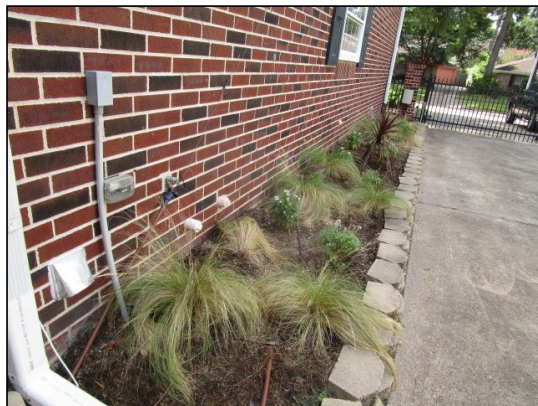
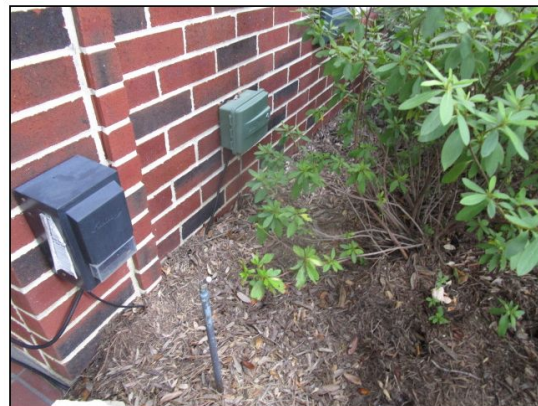
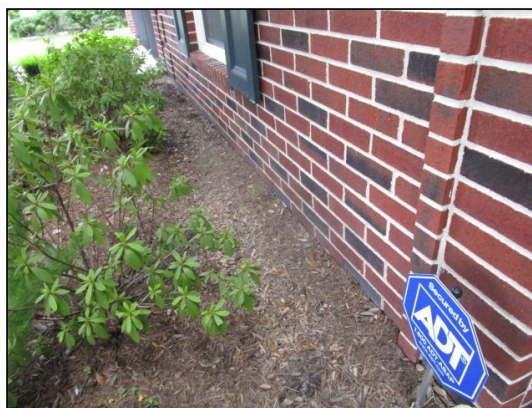
There are low areas that appear to be collecting rain water on the east side of the home and the west side of the garage. The drainage strategy of the yard as it relates to the foundation is important. Expansive soils can be destructive to the foundation if the moisture content of the perimeter varies. Improvement should be made to the grading of the yard in this/these areas.

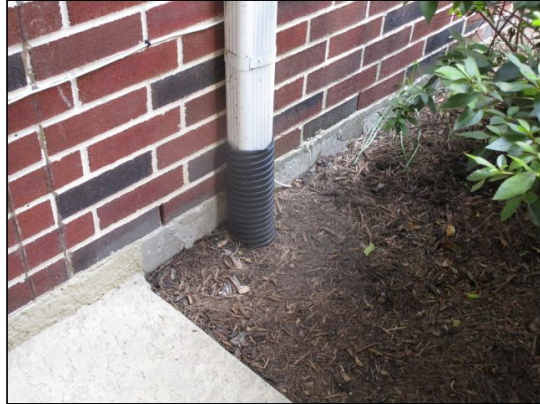
There appears to be a sub surface drain system. This drain system should assist in diverting rain water to the street or storm sewer. The overall effectiveness of this system was not determined. Underground drains can become clogged or obstructed.

It is recommended that splash plates be installed at the gutter downspout terminations to prevent erosion of the soil and to direct rain water away from the perimeter of the foundation.

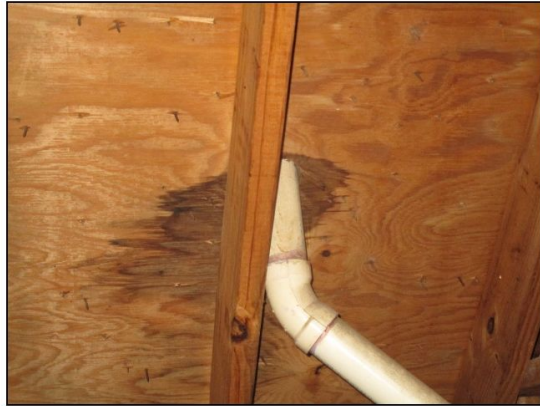
***Comments:*** There were water stains on the roof decking around the plumbing drain vent pipe on the east side of the garage attic. This area was dry at this time. This condition is an indication of previous water penetration. This area should be monitored during heavy rain to determine if the leak is active.

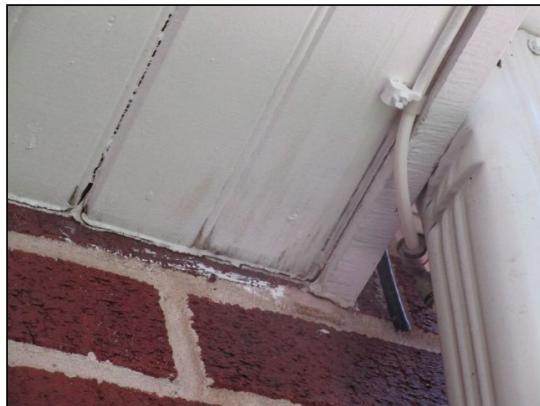
There are water stains on the roof overhang where the back patio meets the garage.

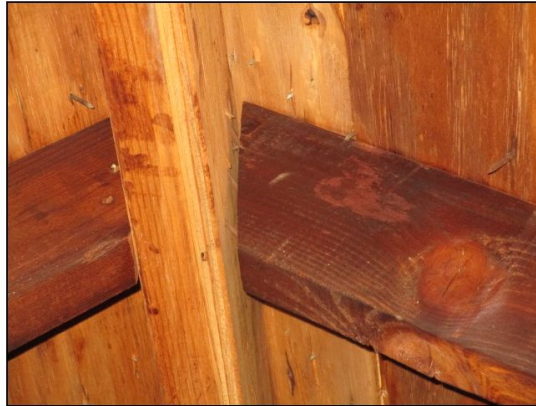
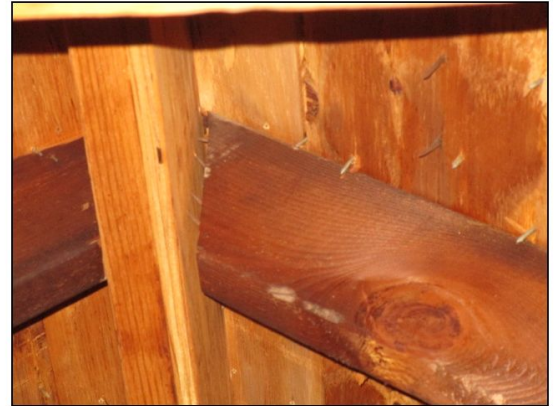
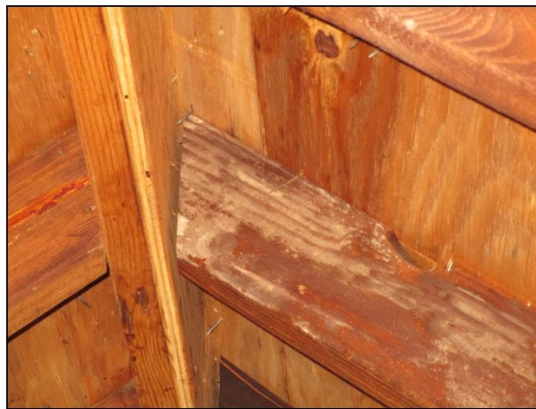
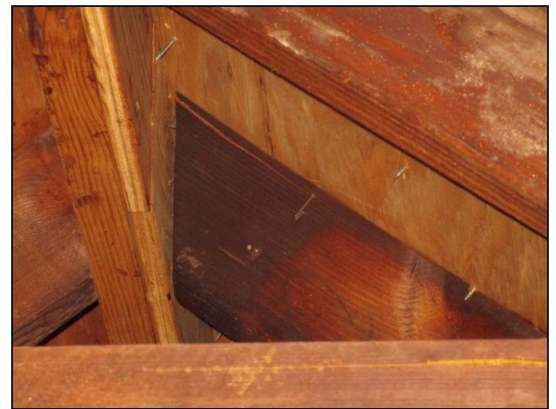
There were separations between some of the rafters and the ridge board in the attic area. These separations can be an indication that the foundation has had more than normal movement occurring but in my opinion are a result of improper cuts during initial construction.

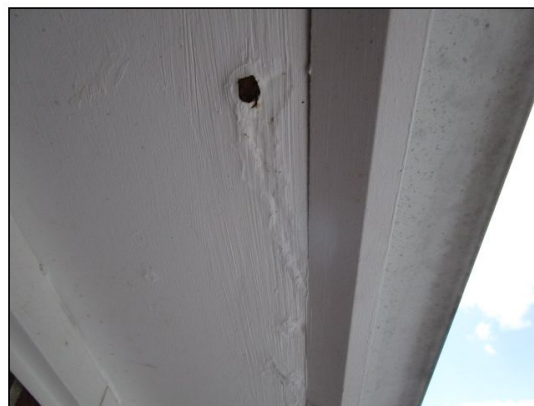
The exterior paint was peeling and there is a small hole at the roof overhang in the back of the master bedroom. There is also a previous repair in this area.

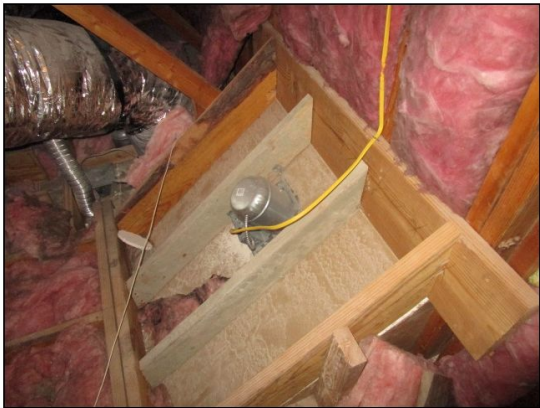
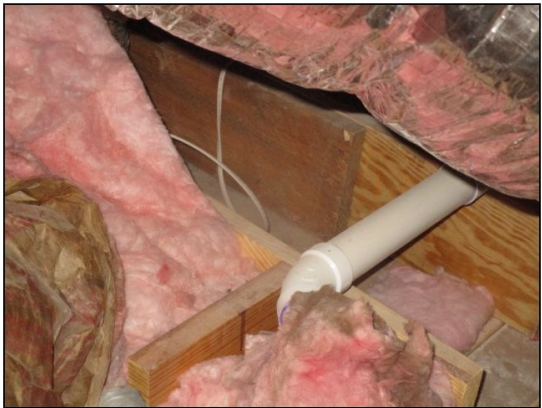
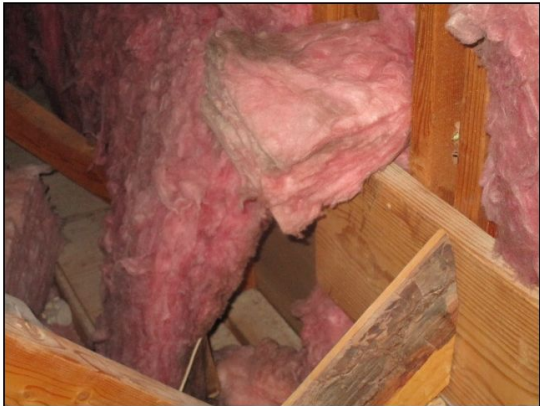
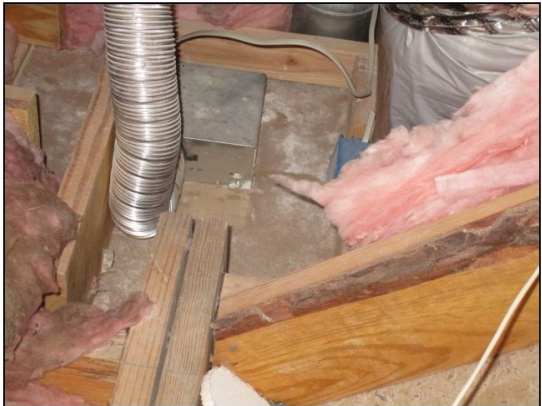
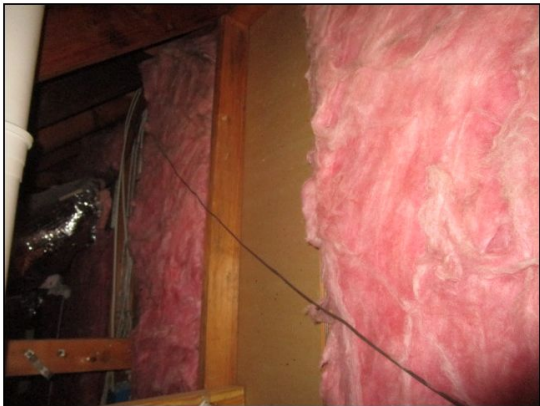
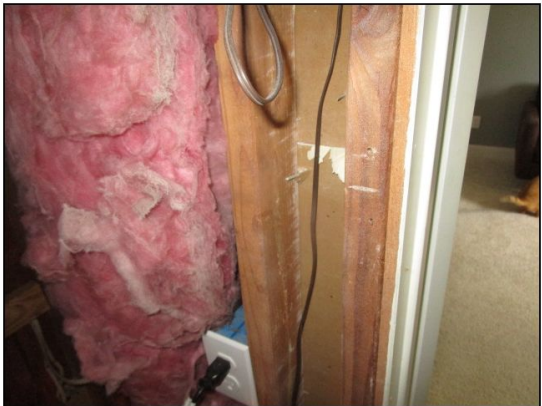
The insulation on the attic floor was thin in some areas to meet minimum current standards (r-30) and incomplete on the attic floor in the front upper attic and over the master bathroom ceiling and on some of the interior attic walls. It is recommended that additional insulation be added for energy efficiency.

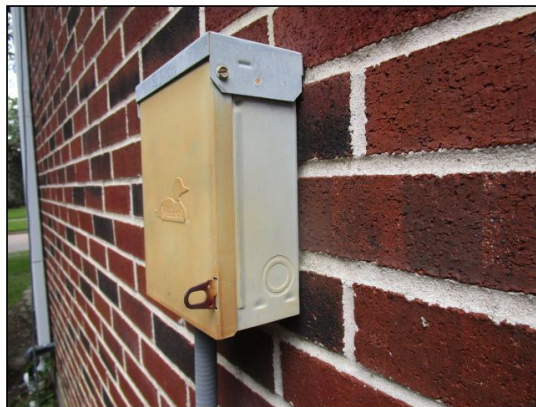
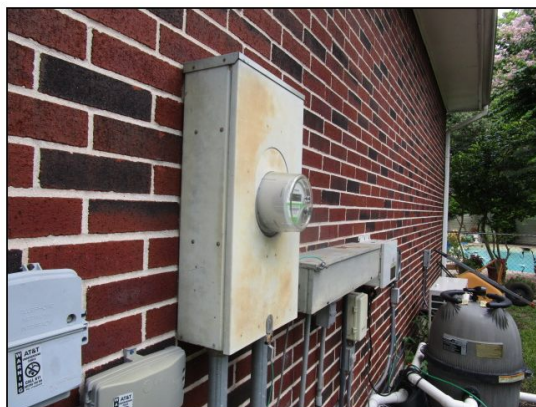
It is necessary to seal around the electric meter box, the air conditioning compressor quick disconnect boxes and where the plumbing lines enter the home to prevent possible water penetration to the structure.

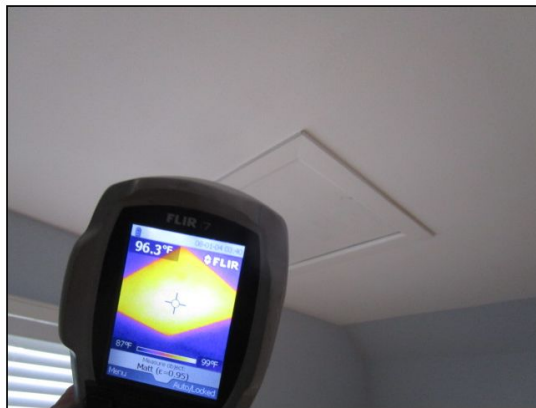
The attic access scuttle panels in the third floor game room and the garage apartment are not insulated. The attic panels should be insulated to prevent radiant heat from transferring from the attic to the living quarters.

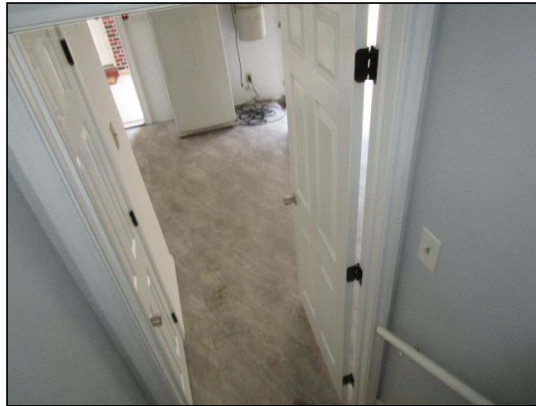
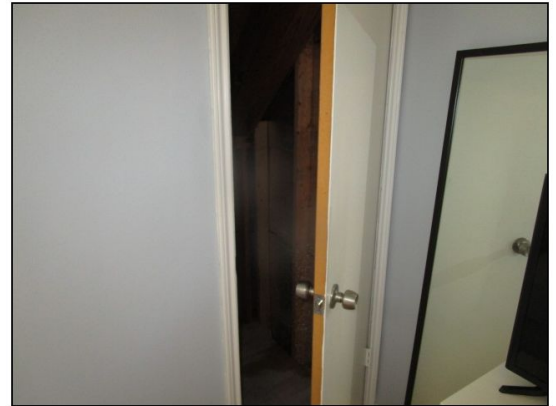
The door to the garage storage closet would not latch when closed. All doors should be present and in working order. Doors that do not latch properly can usually be adjusted.

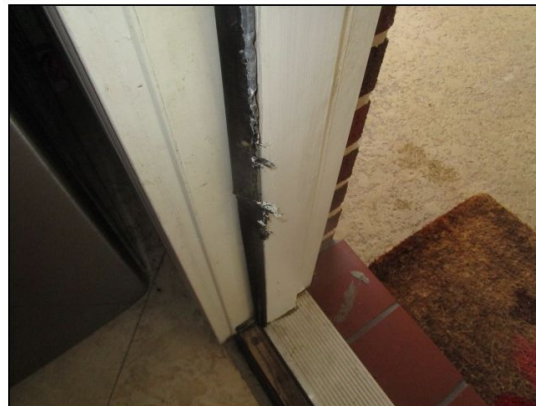
The weather stripping is torn at the back door off the utility room.

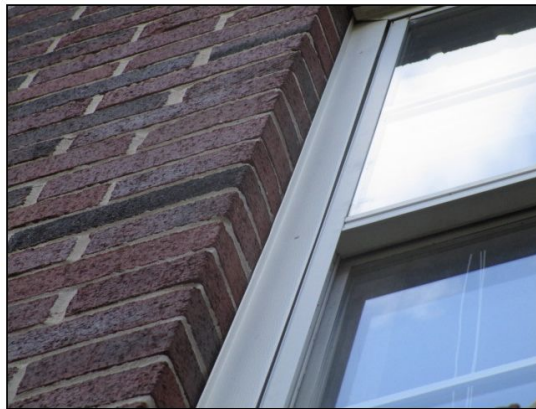
The east side window in the garage apartment does not seal/latch properly when closed and it is loose in the frame.

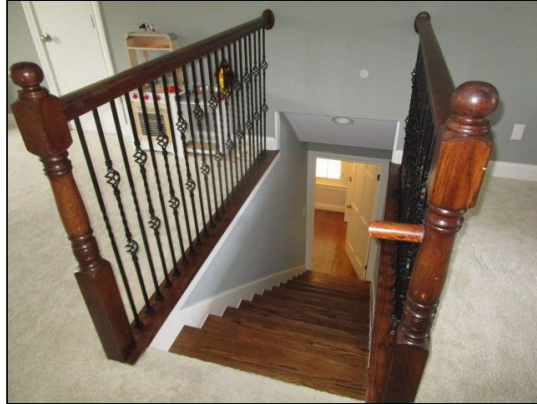
**Comment:** The stair case handrails were loose at the top of the stairs at the third floor. It is required that all banisters and handrails be able to withstand 800 pounds of pressure to ensure the safety of the occupants.

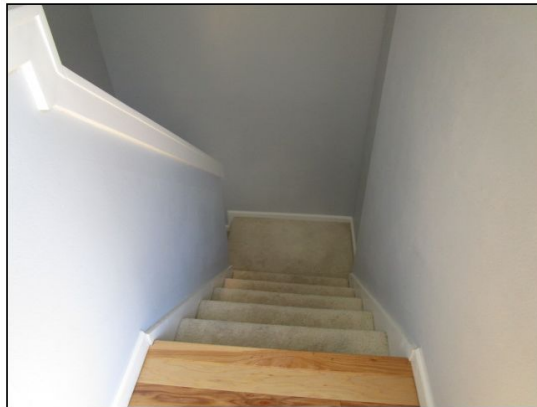
Section of the handrail was missing in the garage apartment stairwell (reference IRC Bldg. Code R315.1). All handrails are required to be continuous and full length of the stairs with two or more risers from a point directly above the top riser of a flight to point directly above the lowest riser of a flight. Handrails are allowed to be interrupted by a newel post at a turn.

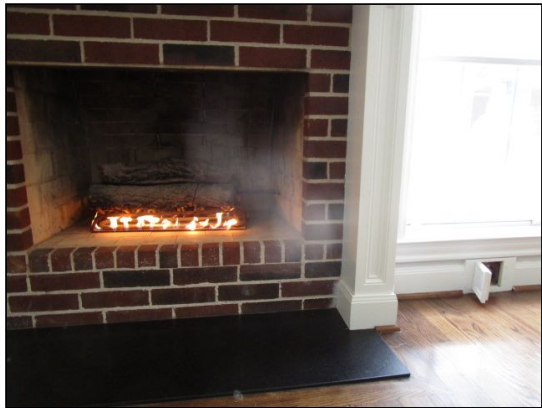
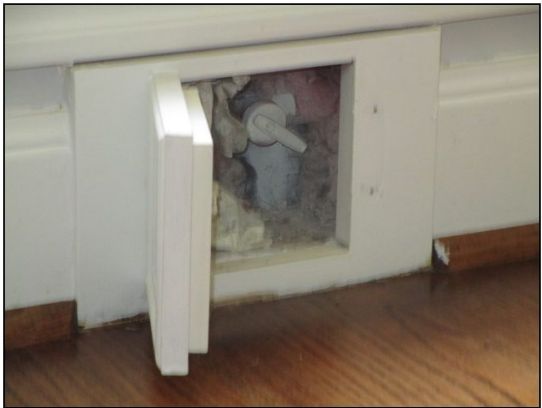
The ash dump door on the exterior is loose.

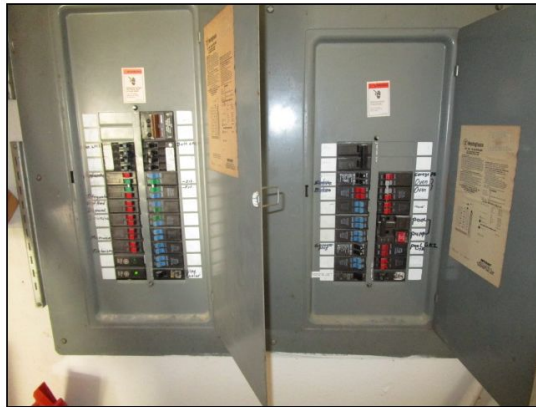
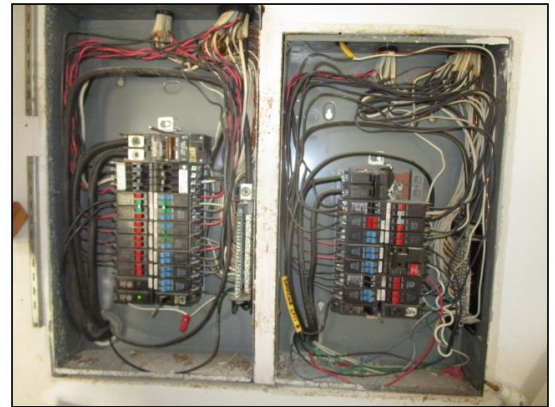
**Comments:** An inhibitor paste has not been applied to the main aluminum wires. The surface of aluminum can oxidize when it is exposed to air resulting in a poor connection.

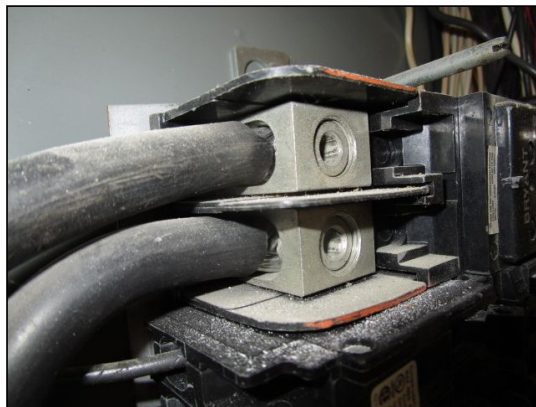
White wires were used as a "hot" wire and are connected to a circuit breaker. In most instances the white wires are the grounded conductors, and if they are used as a "hot" wire, they must be wrapped with black or red tape to identify them as a "hot" wire.

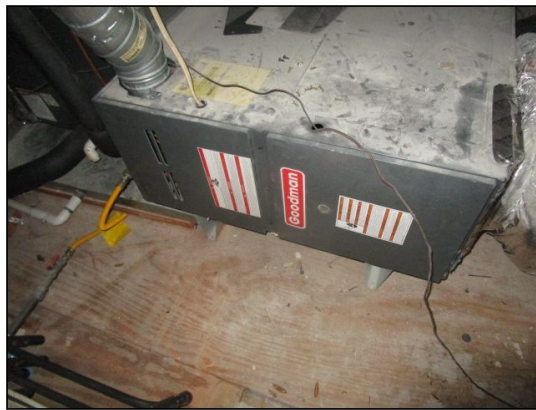
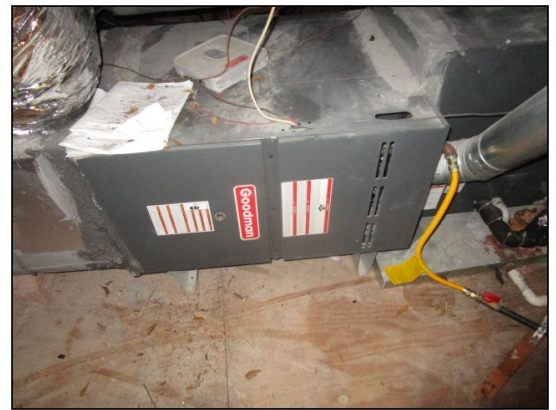
**Comments:** The furnace flue pipe for the downstairs zone is in contact with insulation. This flue pipe must have a minimum of 1" clearance from any combustible materials.

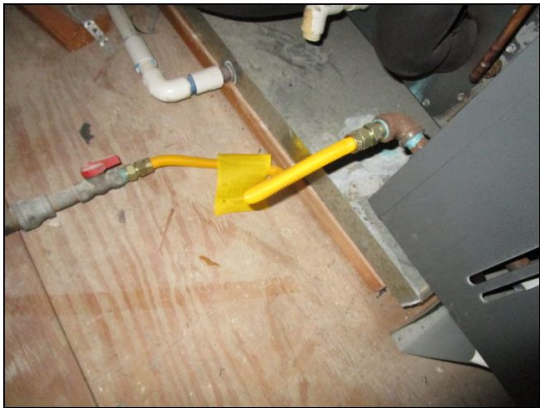
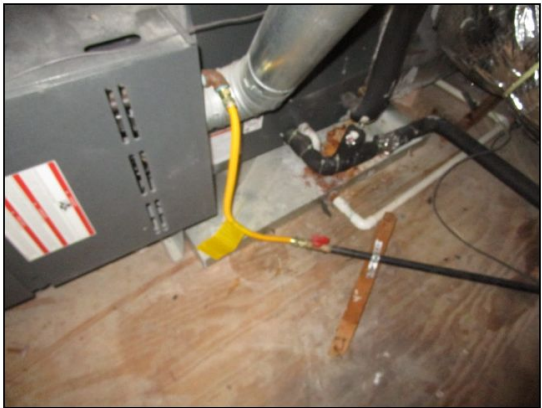
There are no condensate drip legs/sediment traps installed on the furnace gas supply lines as is now required.

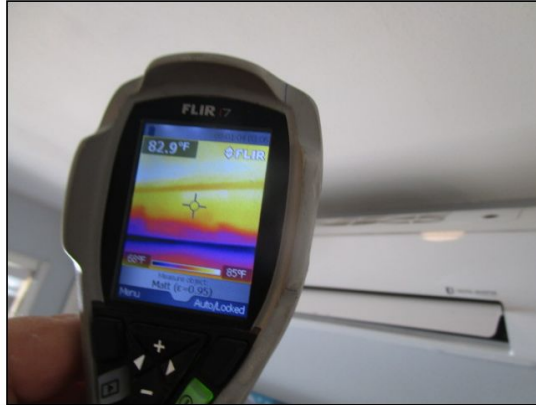
The refrigerant line for the garage apartment zone in the closet was not fully insulated and is actively leaking causing high moisture and dark discoloration on the sheetrock below.

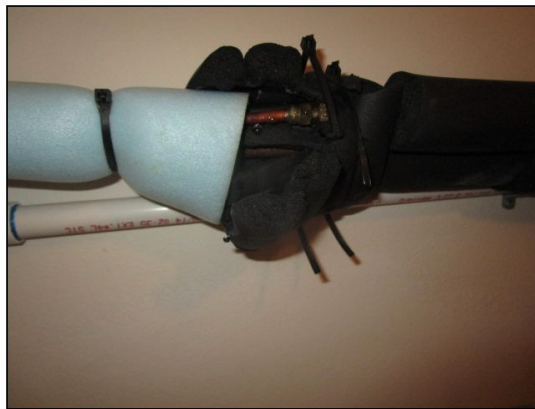
The refrigerant line was not fully sealed to the coil box for the downstairs zone. This condition causes the line to sweat and slightly degrades the performance of the system.

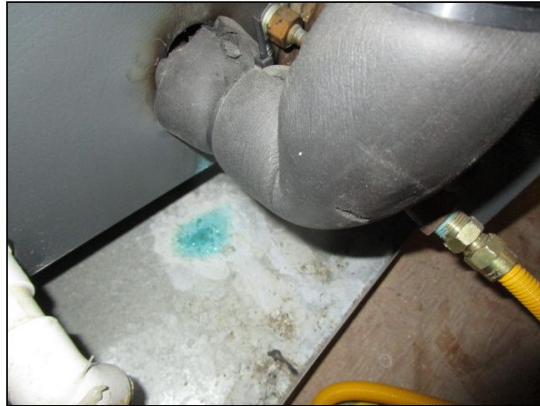
There was corrosion in the safety pan under the coil box for the 2nd/3rd floor zone. This condition is an indication that the unit has leaked in the past or leaks during heavy use.

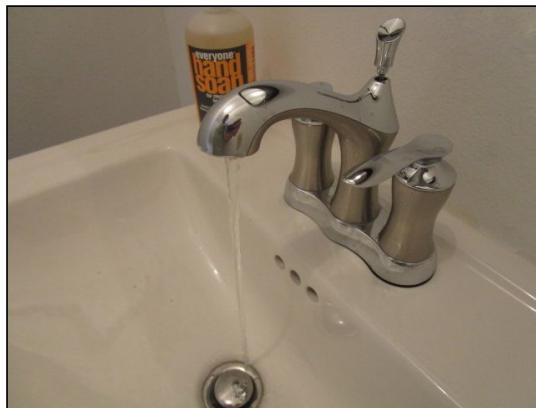
The water pressure was low at the garage bathroom sink and the garage apartment kitchen sink. Water pressure is determined by running two faucets at the same time. There is no guideline for flow rates. If the water pressure appears to be very low, it is mentioned in this report. As there are several causes for low water pressure, a licensed plumber should service the utility.

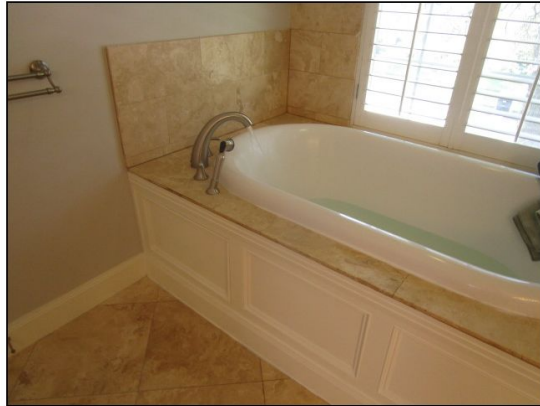
**Comments:** It is recommended that there be an inspection port provided for the master bathtub so that it is possible to check for leaks, as well as for service to be performed on the plumbing if needed.

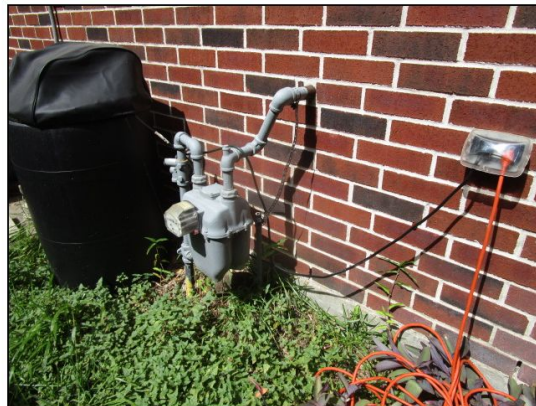
**Location of Gas Meter:** East side of home

**Comments:** Gas meter appears to be performing properly.

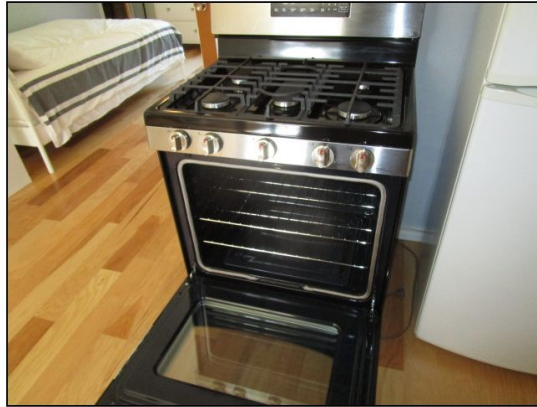
The range unit in the garage apartment is not connected to a power supply. There was not a 110 outlet in the range area for it to be plugged into.

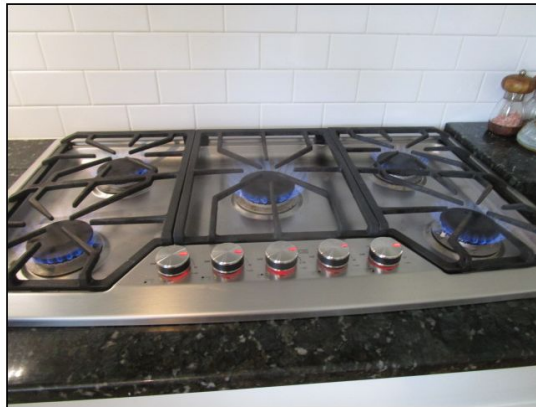
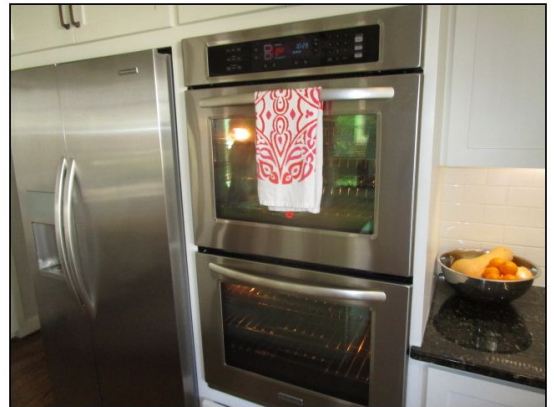
The cooktop and oven appears to be operating properly.

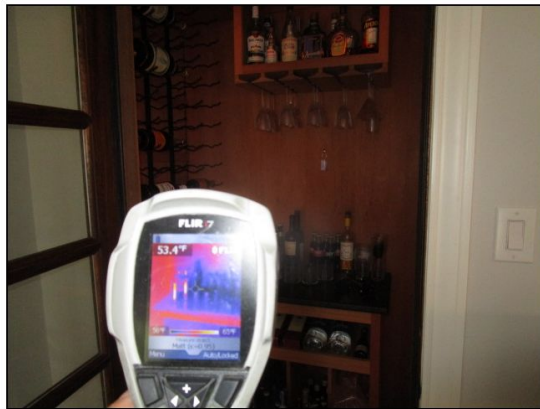
The wine cooling equipment appears to be operating properly.
