## Pre- Sheetrock Frame Phase Inspection Report

Monday, July 18, 2016

# PROPERTY INSPECTION REPORT

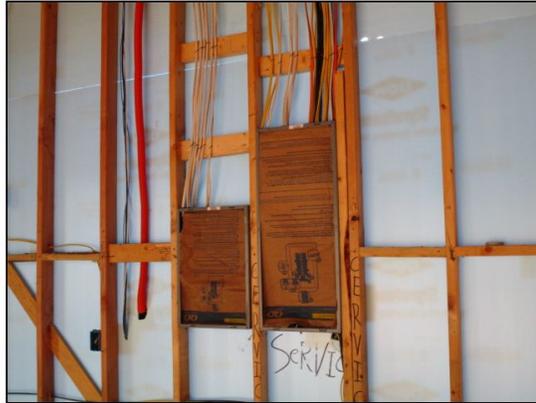
**Comments:** Properly installed for this phase of inspection

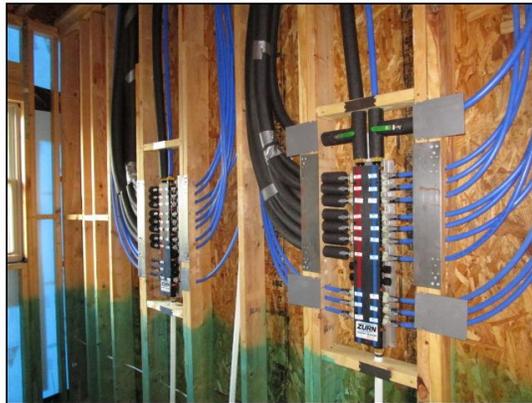
**Comments:** There was no water supply to the home as is necessary in order to check for possible leaks before the installation of the sheetrock and insulation.
