Brad Leland  
Inspections you can Trust

## Inspection Report

Thursday, July 9, 2015

# PROPERTY INSPECTION REPORT

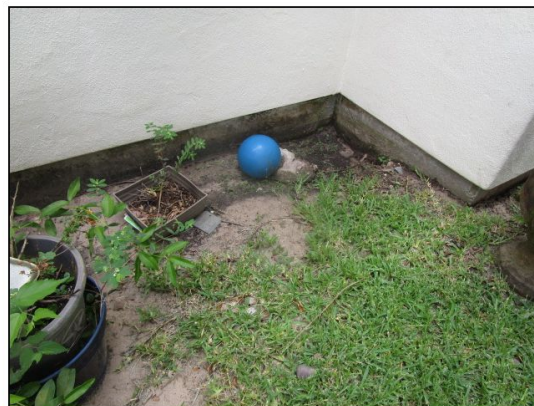
**Comments:** There is a low area at the front of the home outside the study that will collect rain water. The drainage strategy of the yard as it relates to the foundation is important. Expansive soils can be destructive to the foundation if the moisture content of the perimeter varies. Improvement should be made to the grading of the yard in this/these areas.

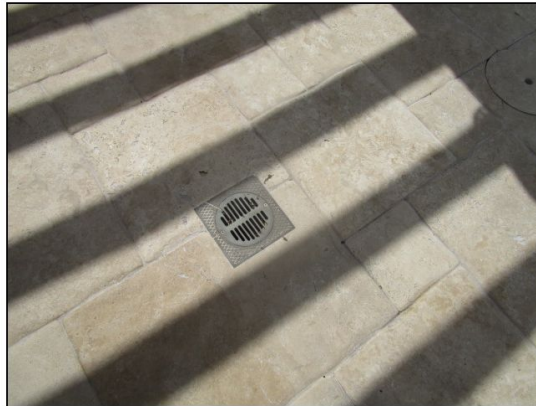
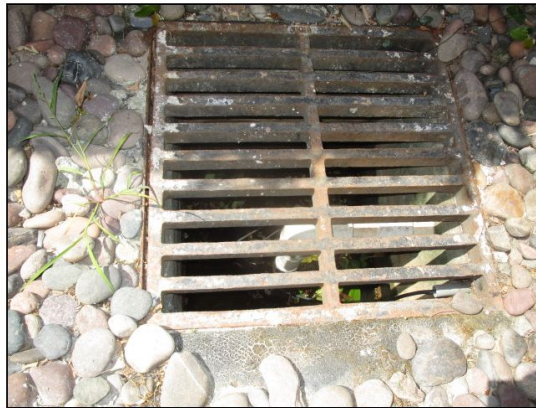
The soil levels are high in relationship with the interior of the home in some areas of the garden beds. When soil levels are high against the face of the foundation it promotes water penetration of the structure and insect infestation. This item should be corrected so there is some exposure of the foundation face without creating reverse drainage. It is generally accepted that in an ideal situation, a house should have about 4-6 inches of clearance.

There is a sub surface drain system with a sump pump installed. This drain system should assist in diverting rain water to the street or storm sewer. The overall effectiveness of this system was not determined. Underground drains can become clogged or obstructed.

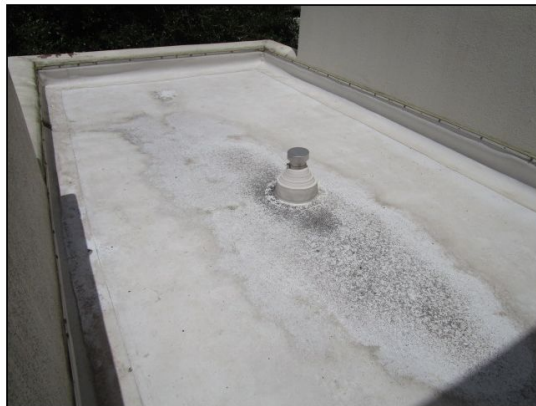
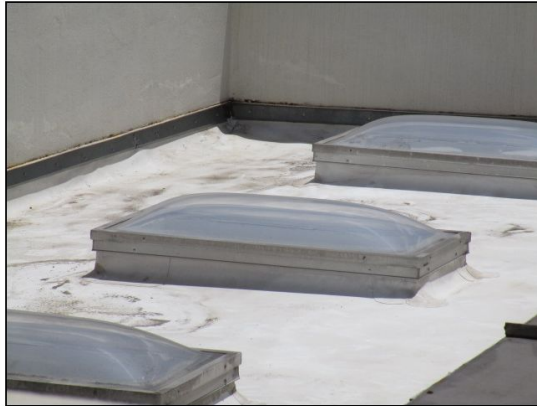
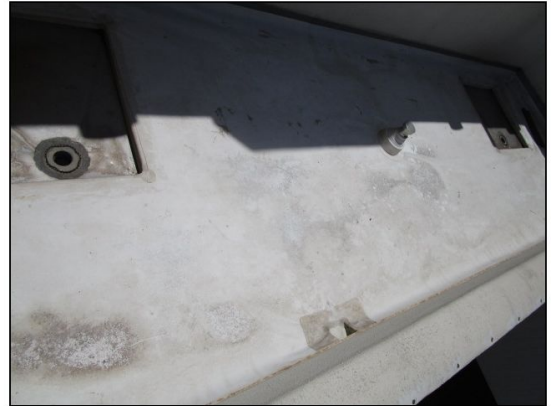
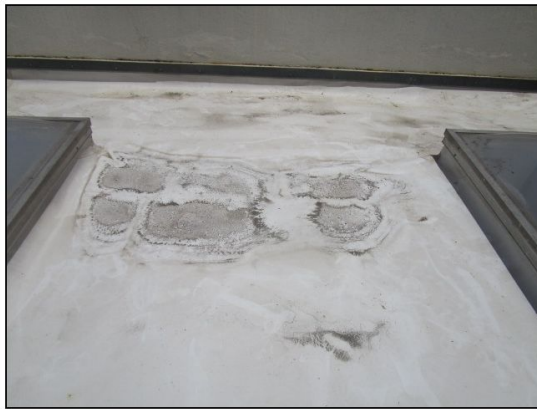
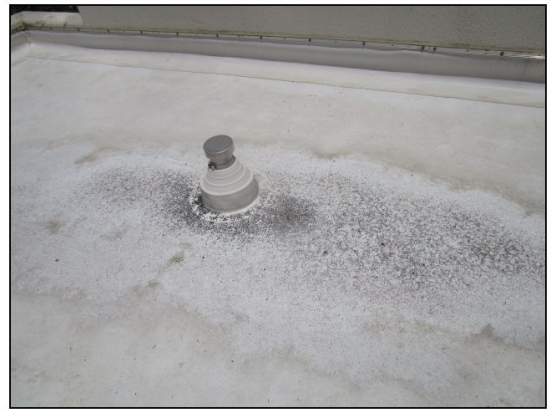
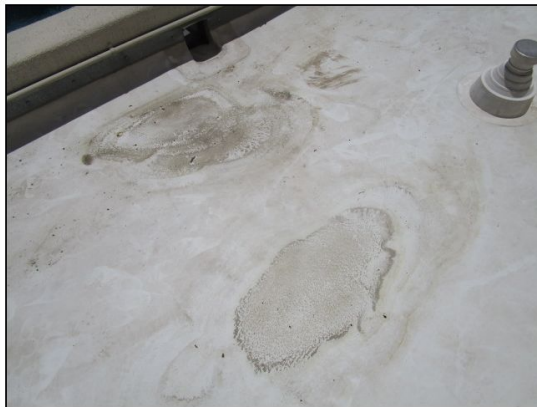
There are several low areas where it appears that water is collecting. Due to the hot dry weather recently, no water was noted collecting but stains were observed. There was dark debris on the roof surface that may be caused by long standing or ponding water.

A qualified roofing contractor should be consulted regarding the above conditions.

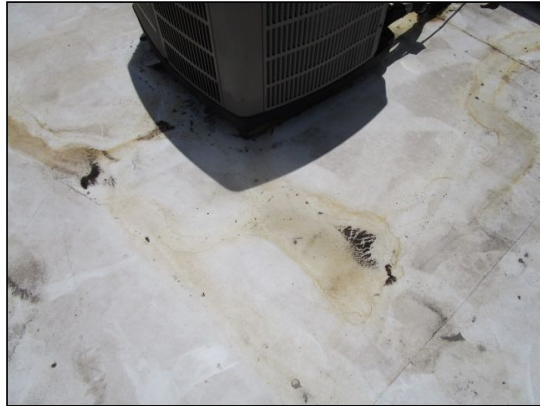
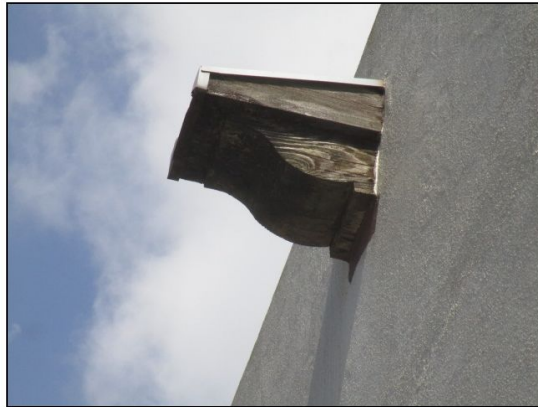
The outriggers on the exterior of the home are weathered and several are water damaged.

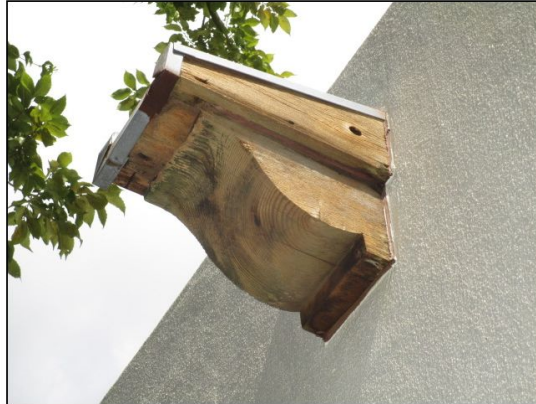
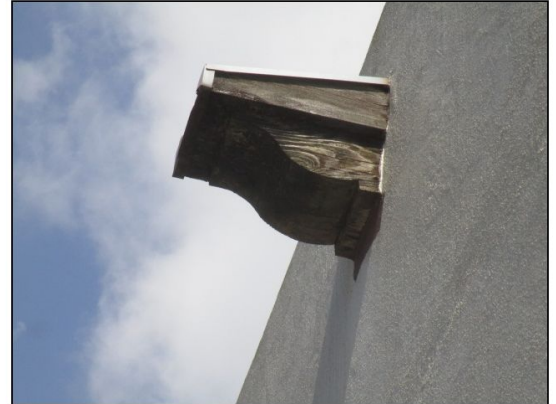
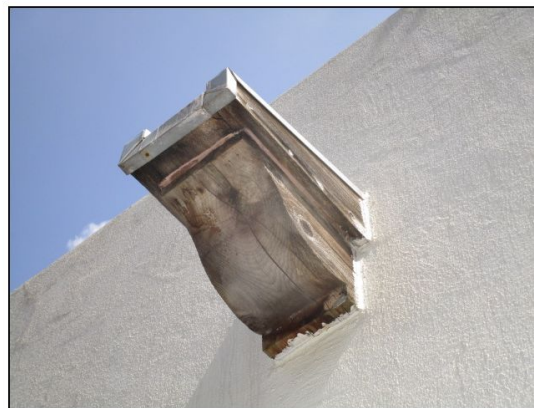
**Comments:** The outriggers on the exterior of the home are weathered and several are water damaged.

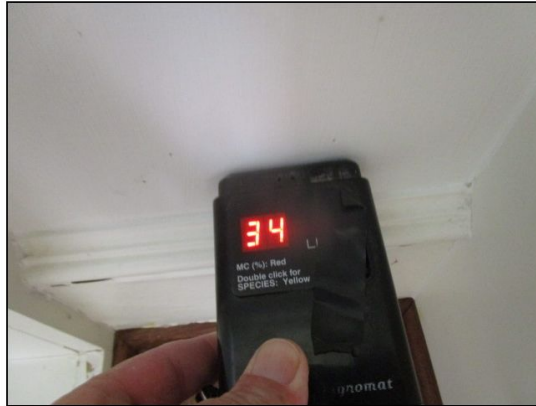
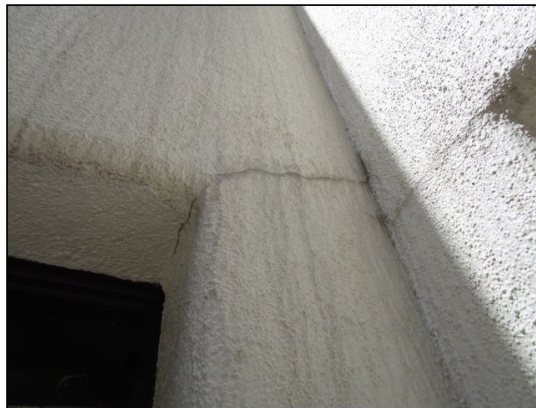
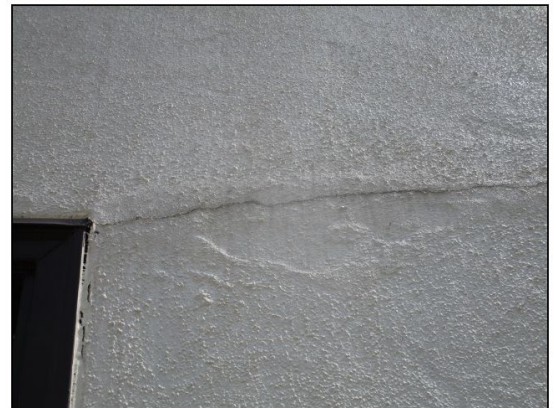
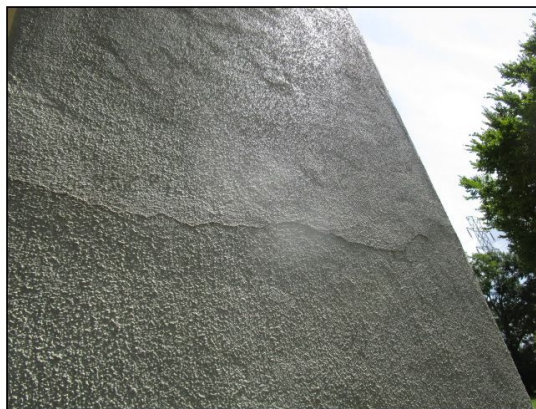
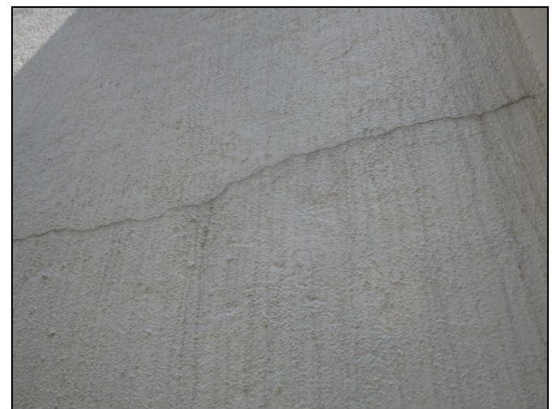
There were cracks in the exterior stucco in several areas around the home. Cracks in the stucco can be indications that there is some degree of movement occurring in the structure. The severity of the cracks can be an indication of the amount of movement in a structure. It is recommended that a stucco expert be consulted regarding this condition.

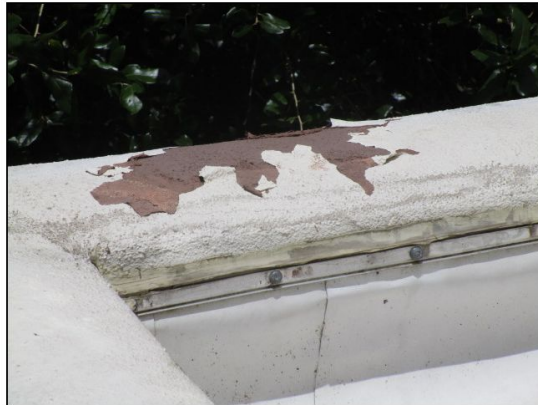
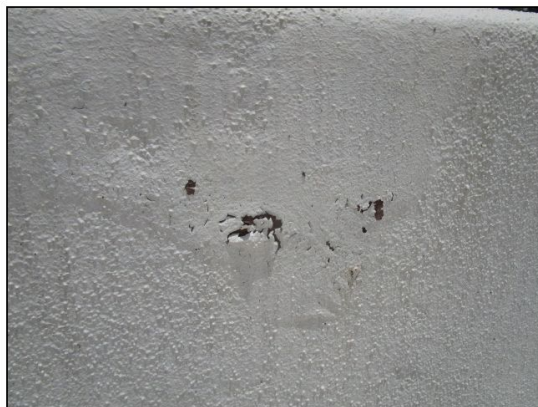
The finish on the roof parapet walls is deteriorating in some areas. This condition should be examined by a stucco expert for proper repair.

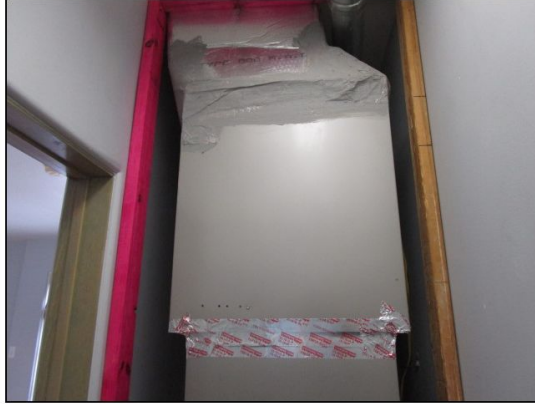
The sheetrock was not complete in the upstairs front north bedroom closet.

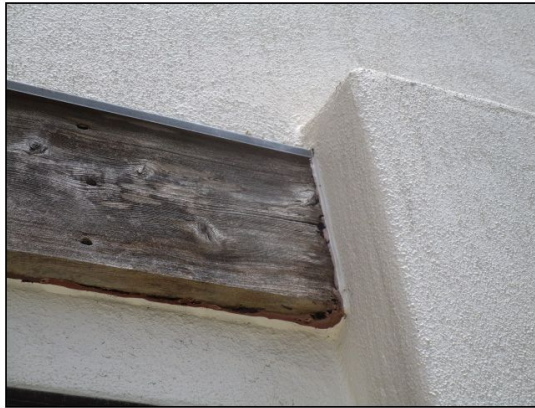
There is water damage to the 2 x 12 above the screen door off the outdoor kitchen.

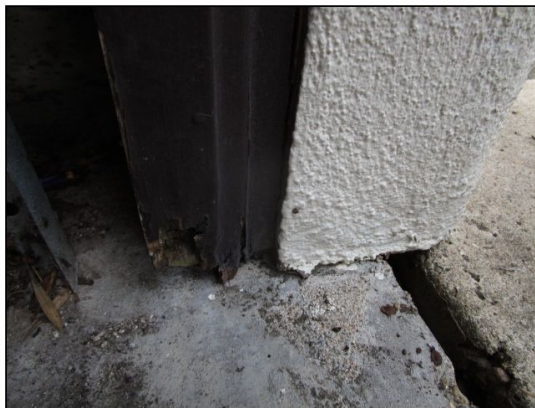
There is water damage to the exterior trim at the bottom of the overhead garage door openings. All damaged material should be repaired/replaced.

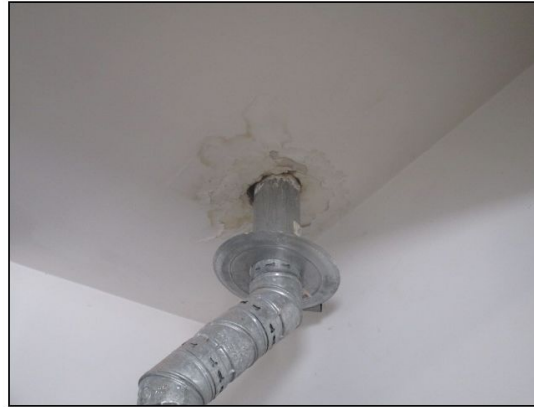
**Comments:** There was evidence of water penetration (water stains on the ceiling around one of the water heater flue pipes. This area was dry when tested. Leaks can cause hidden or concealed damage. All damaged elements should be repaired or replaced. The reason for the water penetration is unknown. The area should be monitored, especially during heavy rain, to determine if the leak is active.

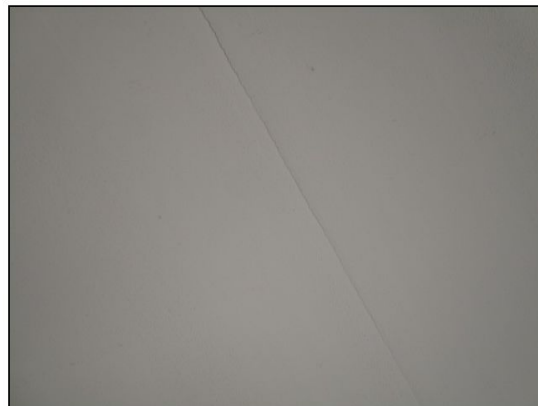
There were cracks in the interior sheetrock ceiling board in the garage. Cracks in the sheetrock ceilings are usually indications that there is some degree of movement occurring in the structure. The severity of the cracks can be an indication of the amount of movement in a structure. These cracks should be repaired and monitored for further activity.

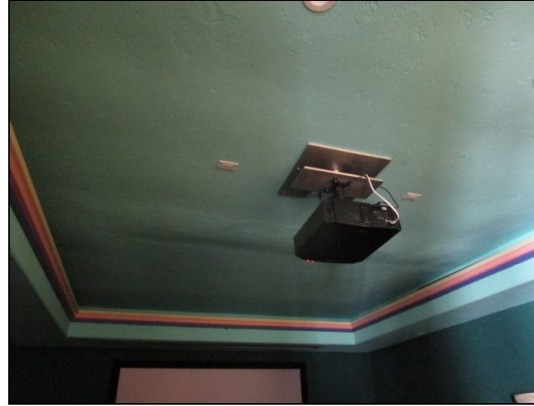
There was a previous repair/bulge in the ceiling in the media room. It is recommended that the current homeowner be consulted regarding the reason for these repairs. This area was dry at the time of the inspection.

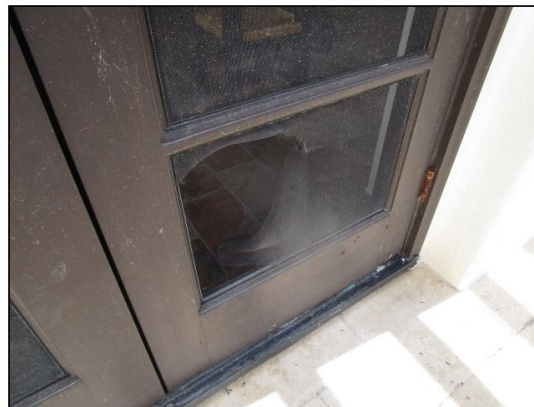
The screen material is damaged/torn at the screen room door.

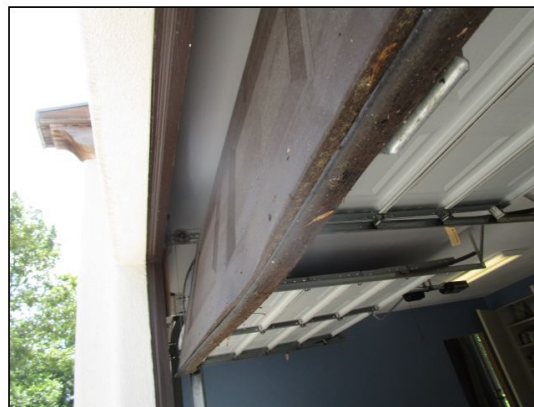
The bottom panel of the middle overhead garage door is damaged/bent.

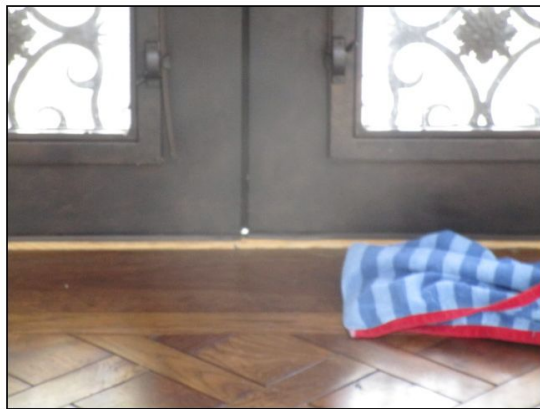
The front door does not seal on the bottom when shut.

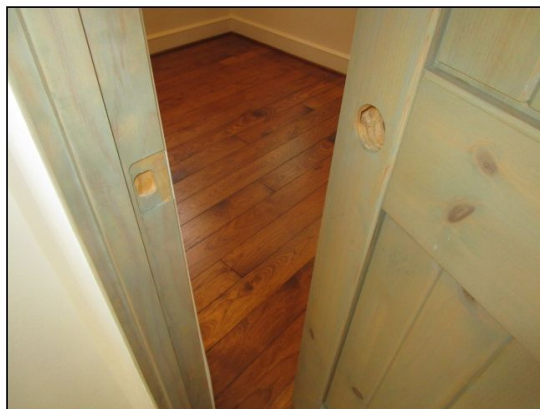
The door knobs are not installed at the master bathroom gym closet and the upstairs front north bedroom closet.

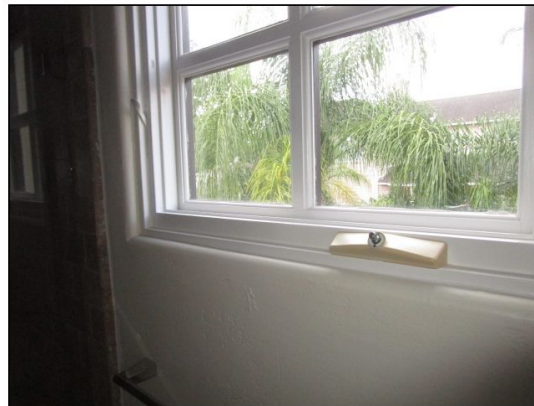
The operating handles are missing on the left side breakfast area window, the upstairs south bathroom window and the upstairs rear middle bathroom window.

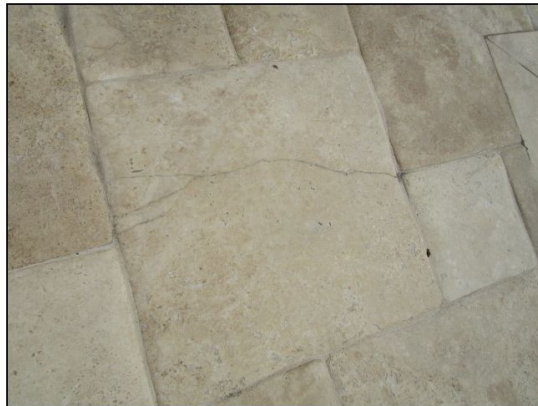
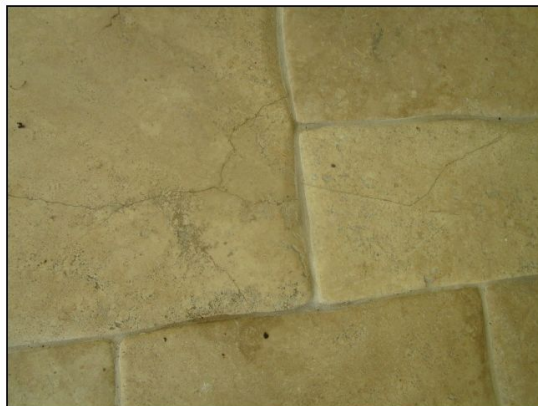
**Comments:** The outdoor kitchen has screen material that has plant growth through it that may damage the screen material.

There are several cracked tiles in the back patio and pool decking area. These cracked tiles may be a result of past movement.

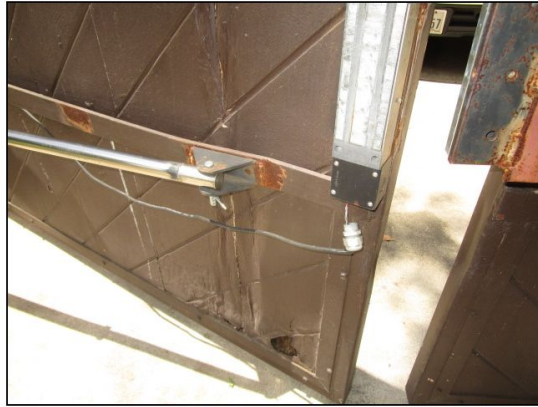
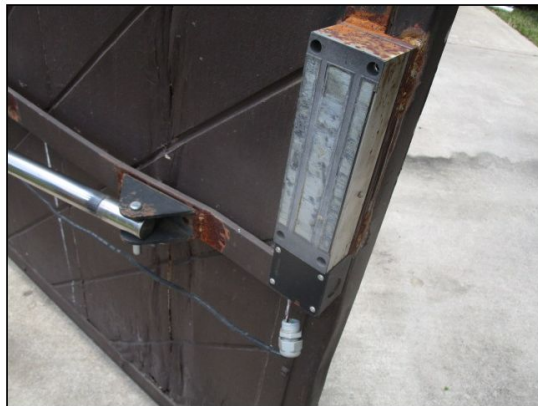
**Comments:** There is water damage to the driveway gate and corrosion on the metal frame. All damaged material should be replaced.

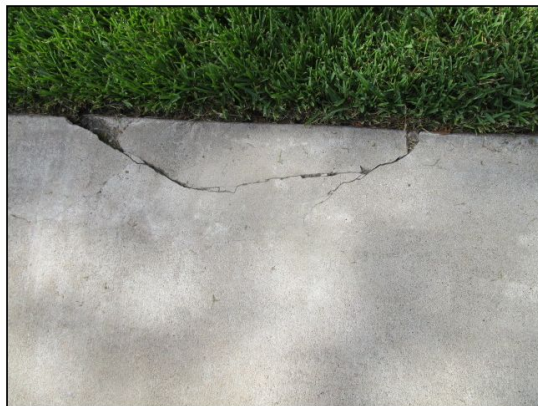
Driveway sections and the area under the carport were cracked and have settled unevenly.

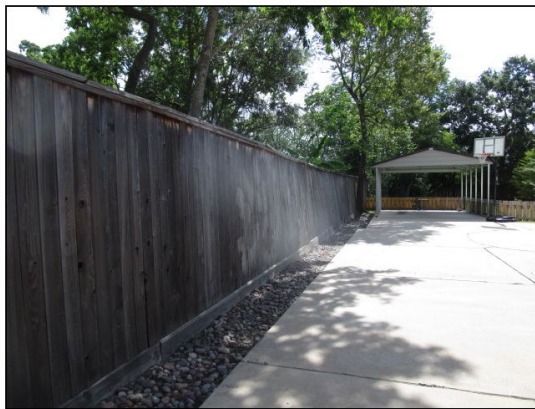
The fence is leaning notably and there are damaged fence boards on the north side of the driveway.

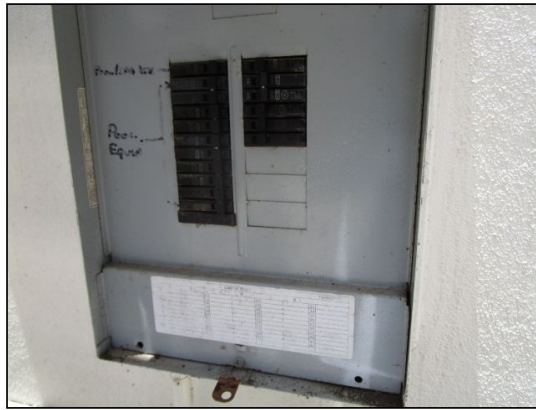
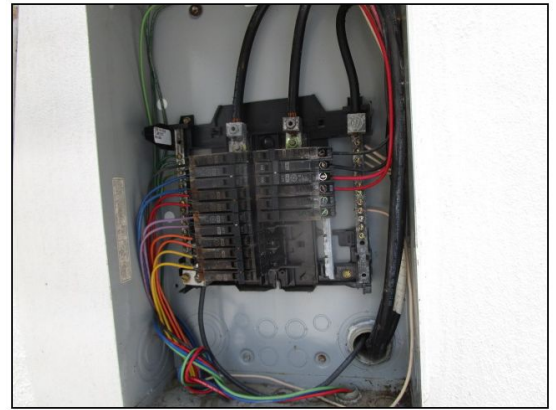
**Comments:** Breakers were not labeled at the service boxes as required.

A licensed electrician should be consulted regarding the repair of the above items as well as check the entire electrical system for any other possible defects.

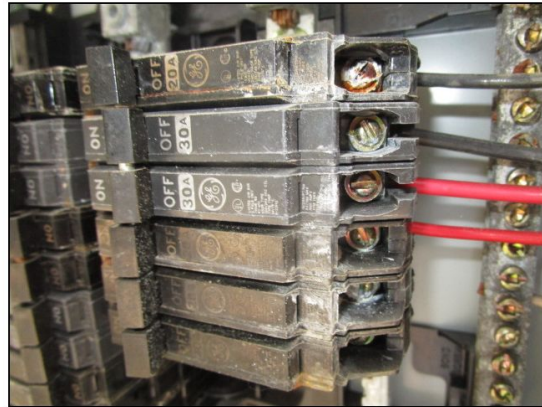
White wires were used as "hot" wires and are connected to circuit breakers. In most instances the white wires are the grounded conductors, and if they are used as a "hot" wire, they must be wrapped with black or red tape to identify them as a "hot" wire.

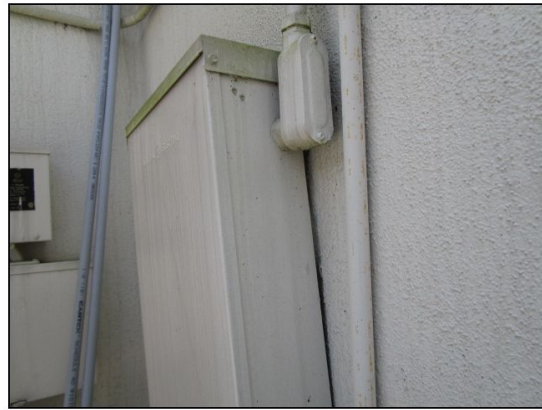
The large 100 amp box was not secured to the wall.

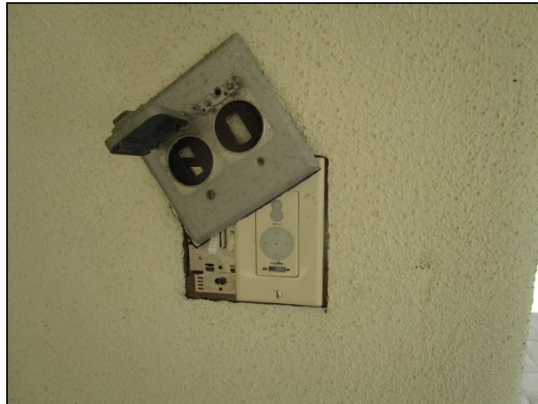
**Comments:** Electrical fixture face plates are missing in the screen room, the master bedroom, the floor outlet in the study and the upstairs front north bedroom closet. The cover is not complete for one of the living room floor outlets and the cover is not the correct type near the outdoor fireplace. Face plates that are missing for either light switches or electrical outlets are considered a safety concern.

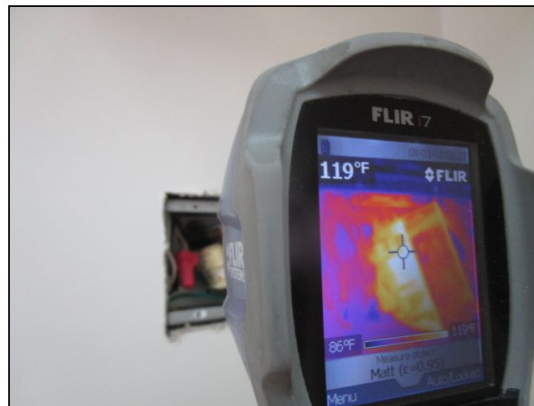
There is an extremely hot junction box on the south wall of the rear master closet that should be evaluated by a qualified electrician.

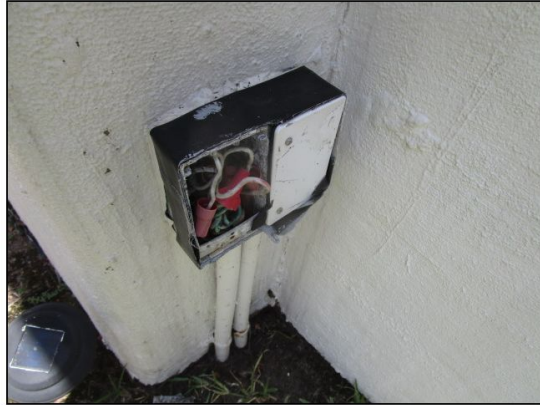
There is an exterior junction box at the front gate/fence that does not have a cover plate installed

and has exposed wiring.

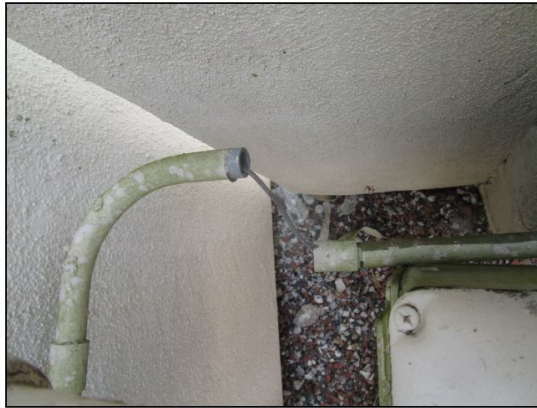
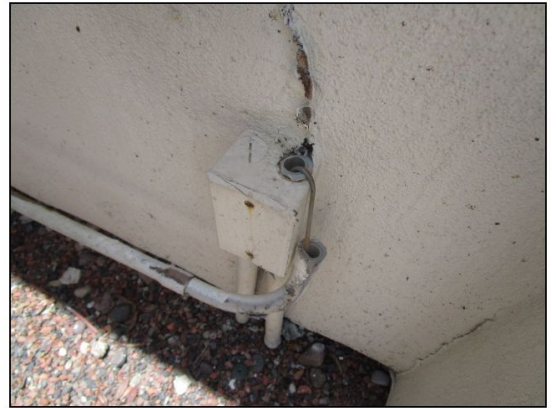
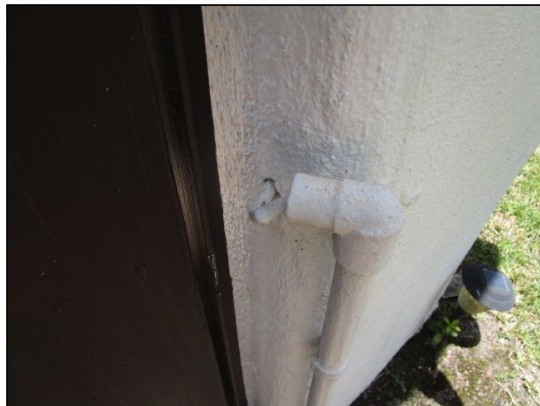
There is exposed exterior wiring that is not completely in protective conduit at the front gate and the electrical breaker box area in the front of the home.

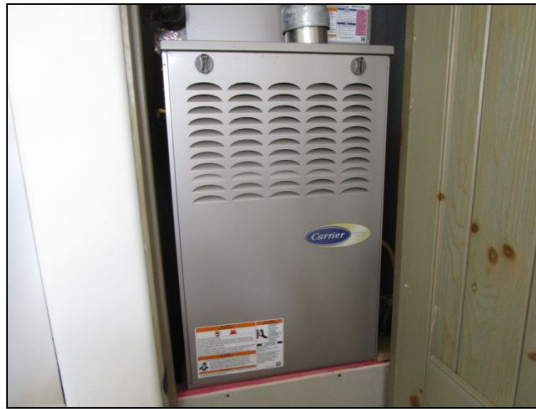
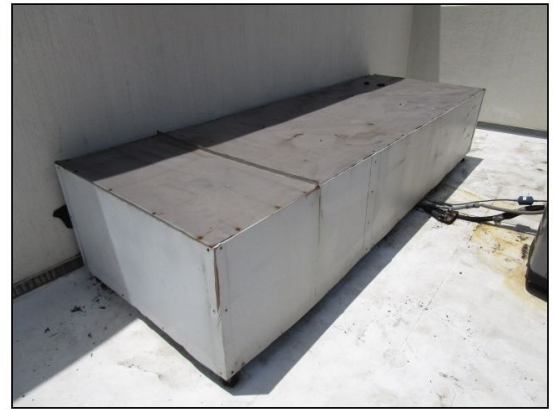
**Comments:** The ductless system in the master bathroom did not respond to the thermostat when tested.

The heaters did not respond to the thermostats for both of the downstairs zones when tested.

A qualified HVAC technician should be consulted regarding the repair of the above items as well as check the entire heating system for any other possible defects.

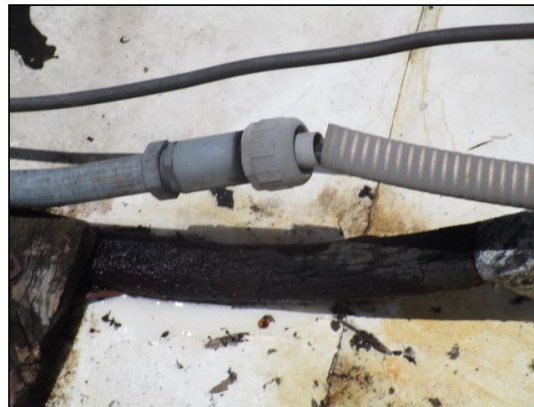
The 3.5 ton exterior compressor on the roof is sweating excessively during operation which is causing water to drain off the roof surface.

A qualified HVAC technician should be consulted regarding the repair of the above items as well as check the entire cooling system for any other possible defects.

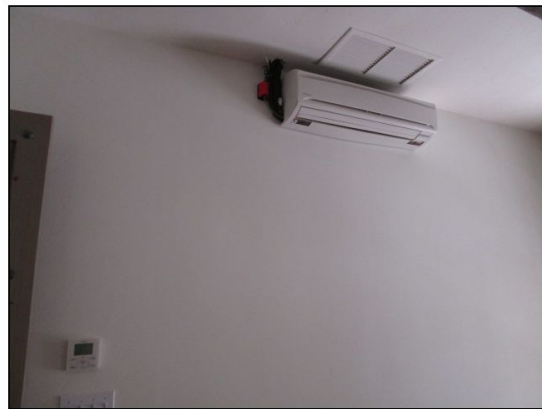
The ductless single unit in the master bathroom was operating and the air going into the system was 82 degrees and the returned air was 65 degrees when tested.

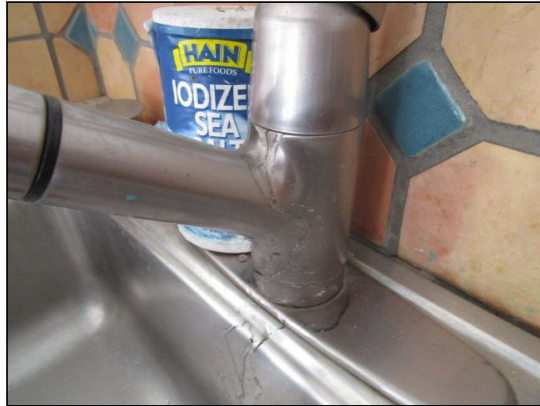
There was no hot water to the utility room sink at the time of the inspection.

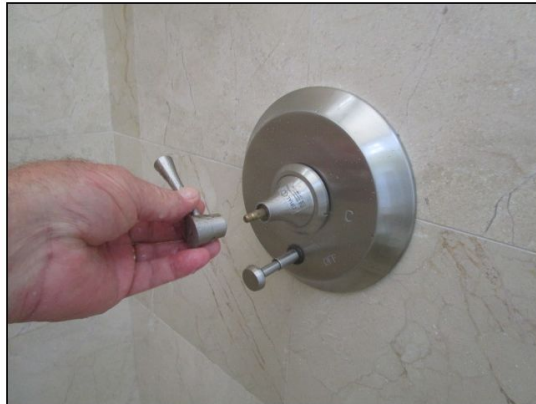
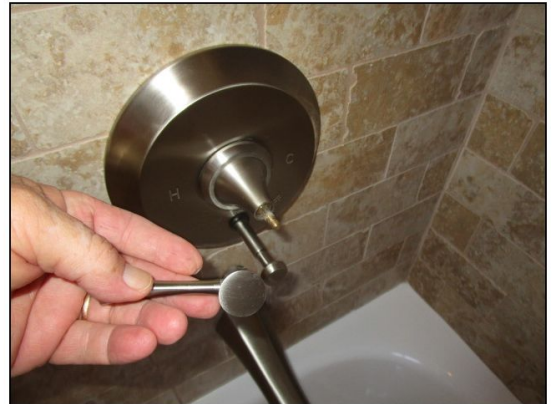
The fixture valve handles are not secured in the downstairs front bathroom shower and the upstairs south side bathtub/shower.

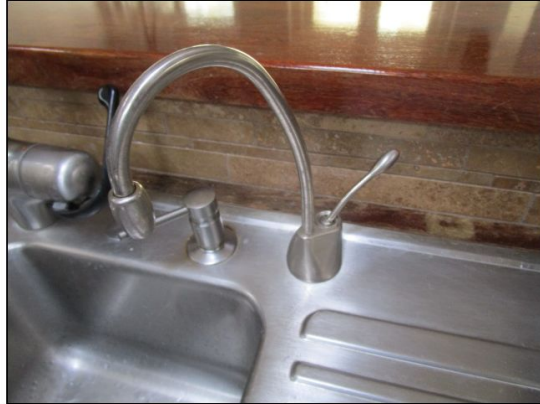
The water filtration system is disconnected/not complete at the kitchen sink.

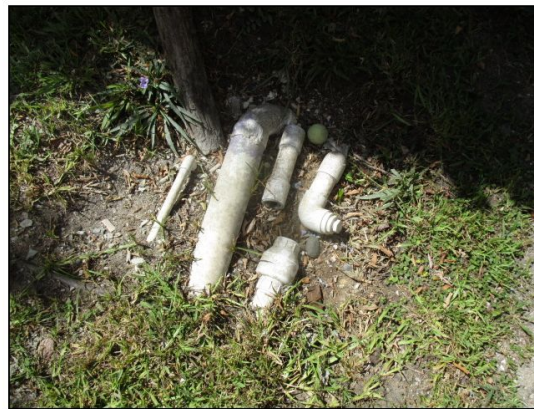
There are exposed pipes some of which appear to have been disconnected on the south side of the yard. The reason for this condition is not known.

It is recommended that a plumber with camera equipment inspect the drain system, or perform a hydro static test to determine if there are any unseen damaged drain lines.

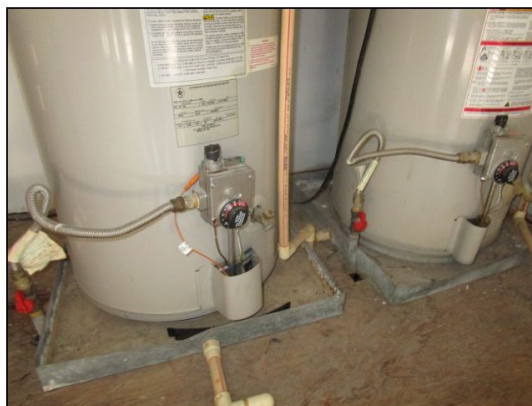
**Comments:** There are no condensate drip legs/sediment traps installed on the water heater gas supply lines as is now required.

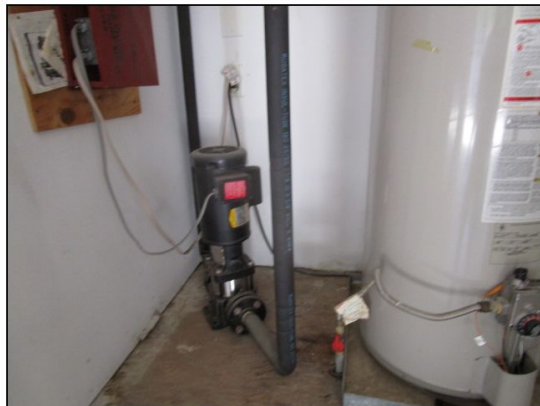
It was not determined if the recirculating pump was operational. A qualified plumber should be consulted regarding the condition and operation of this pump.

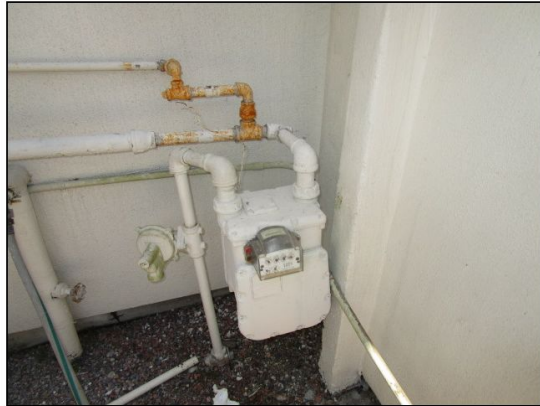
**Comments:** There is corrosion on gas lines coming off the meter.

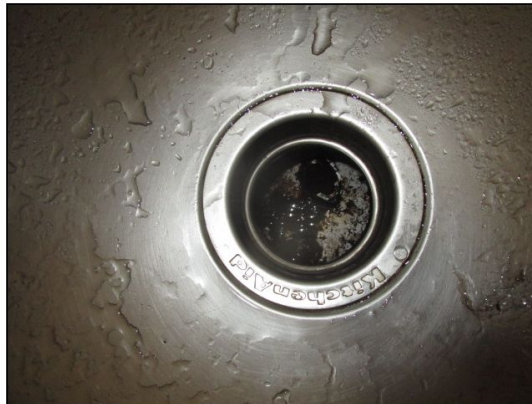
**Comments:** The garbage disposal splash guard was missing in the outdoor kitchen area. This splash guard should be installed before operation.

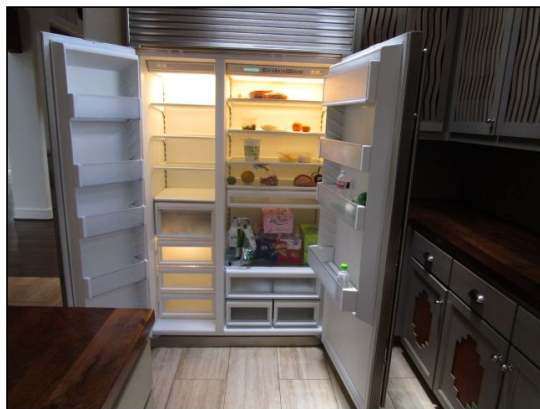
During operation a dripping and loud clicking noise was heard from the compressor/motor area.
